MPC 17-321 | C. Pantelides, D. Brown, J. Parks, and M.J. Ameli

Seismic Retrofit of Spliced Sleeve Connections for Precast Bridge Piers

March 2017

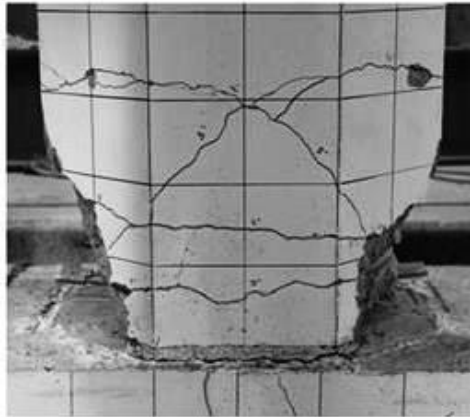
The failure mode of specimen LE-O was fracture of an extreme longitudinal bar. The extreme west longitudinal bar fractured in LE-O. Once the extreme longitudinal bar fractured, the lateral load capacity of the specimens dropped below 20% of the ultimate load capacity. From the hysteresis curves, shown in Figure 3.3, the ultimate load achieved during the test was 37.7 kip; the ultimate drift achieved was 6.50%, and the displacement ductility was equal to 5.8. A very well developed plastic hinge was formed at the column-to-pier cap interfaces where extensive spalling and cracking occurred, as shown in Figure 3.4. Major structural cracking was isolated to three distinct heights from the footing or pier cap interface, where the highest crack was located 12 inches up the column for LE-O; these crack widths ranged from 0.016 to 0.060 inches.

Figure 3.4 Final damage of specimen LE-O showing plastic hinge region

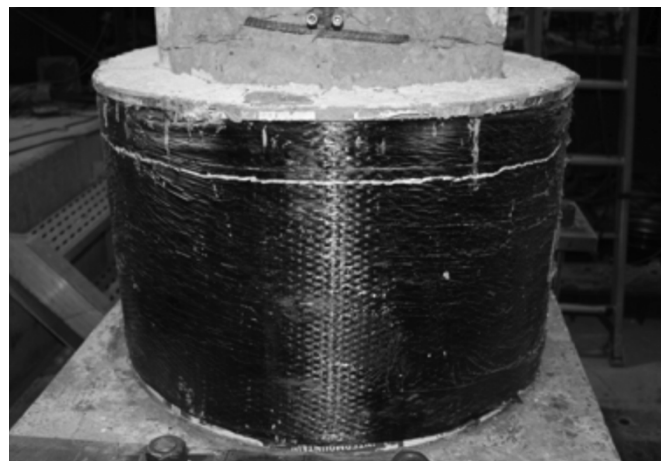
Transverse cracking of the CFRP shell was observed during the test of specimen NM-R, as shown in Figure 4.10. The crack began during the 4-in. displacement step and grew during each subsequent displacement step. At completion of the test, the crack extended halfway around the circumference of the CFRP jacket. The hysteretic response of the specimen was unaffected by the transverse CFRP crack, which was located 3 to 4 inches below the top of the repair, corresponding to the top of the internal headed rebar. The onset of transverse CFRP cracking can be seen from the curvature profile obtained from the experiments in Figure 4.11, which shows the maximum and minimum curvatures during the 0.5-in. to 4-in. displacement steps. There are two curvature values plotted for each displacement step in the east and west directions. The first value is an average curvature value from the top of the footing to the top of the repair. The second value is an average curvature value from the top of the repair to 9.56 inches up the column. From this plot, it can be seen that the curvature of the wrapped section is very small when compared with the column, indicating plastic hinge formation in the column. Also, the onset of the CFRP crack can be seen by the increase in curvature of the repaired specimen when it was displaced to the west during the 4-in. displacement step.

Figure 4.10 Transverse CFRP crack at white line 3 inches below top of CFR shell
