# *Langdon Walkability Assessment 2022*

## Final Report

Prepared for:  
Cavalier County Health District  
Langdon, ND

Prepared by:  
Kshitij Sharma  
Advanced Traffic Analysis Center  
Upper Great Plains Transportation Institute  
North Dakota State University  
Fargo, North Dakota

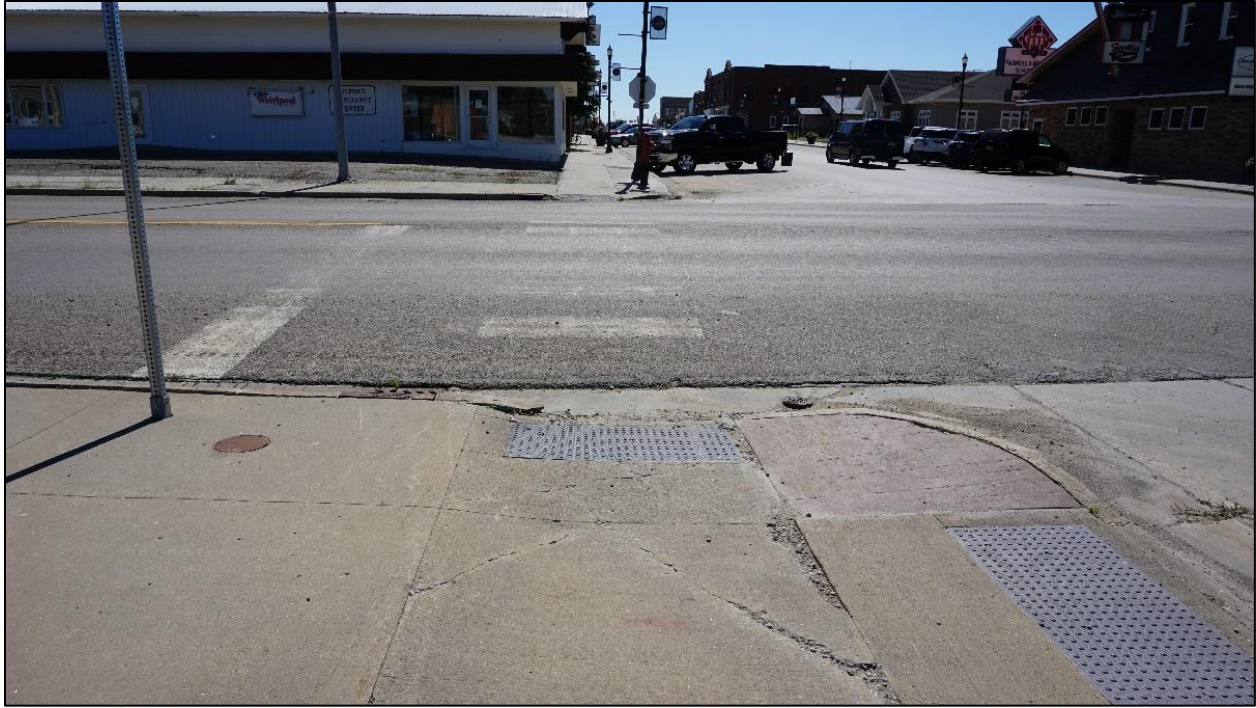
**Figure 4.** Ramps, sidewalk and crosswalk at Third Street across ND Highway 5

At several locations, as seen in Figure 4, the pedestrian related infrastructure was found to be in a general state of disrepair. Cracked concrete, exposed aggregates, and worn out crosswalk/pavement markings were observed.

Sections of the sidewalks that are in poor condition should be rebuilt to current standards. New facilities should be installed in locations where missing. In doing so, special attention needs to be paid to state highways. Although outside of town, these highways provide high-speed connectivity over long distances but within built-up albeit rural areas, the same highways need to accommodate access to businesses and other functions for all users including non-motorized users.

- Repair of ramps and displaced sidewalks
- Pavement/crosswalk marking updates/maintenance
- Sign post relocation
- Ensuring clear demarcation of various zones within the right-of-way

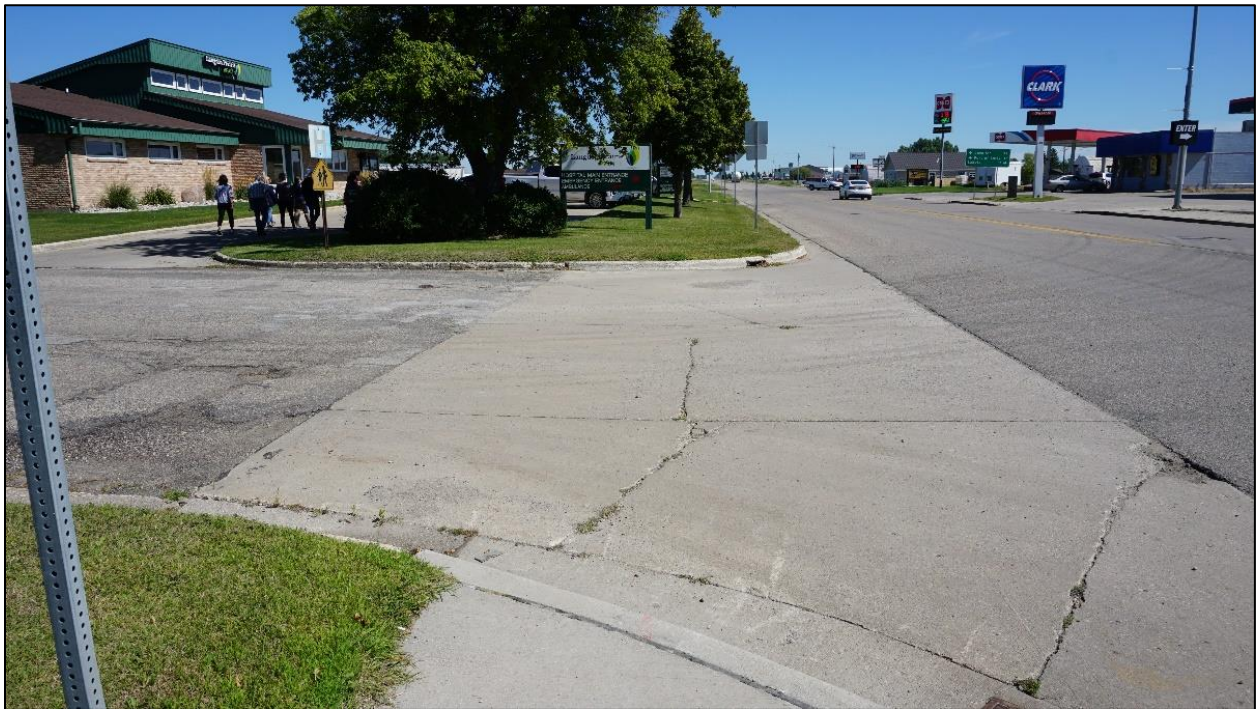
**Figure 5.** Missing ramps, crosswalk and sidewalk along ND Highway 5

At several locations, as seen in Figure 5, the sidewalks/crosswalks were never installed. The participants are seen walking through parking lots instead.

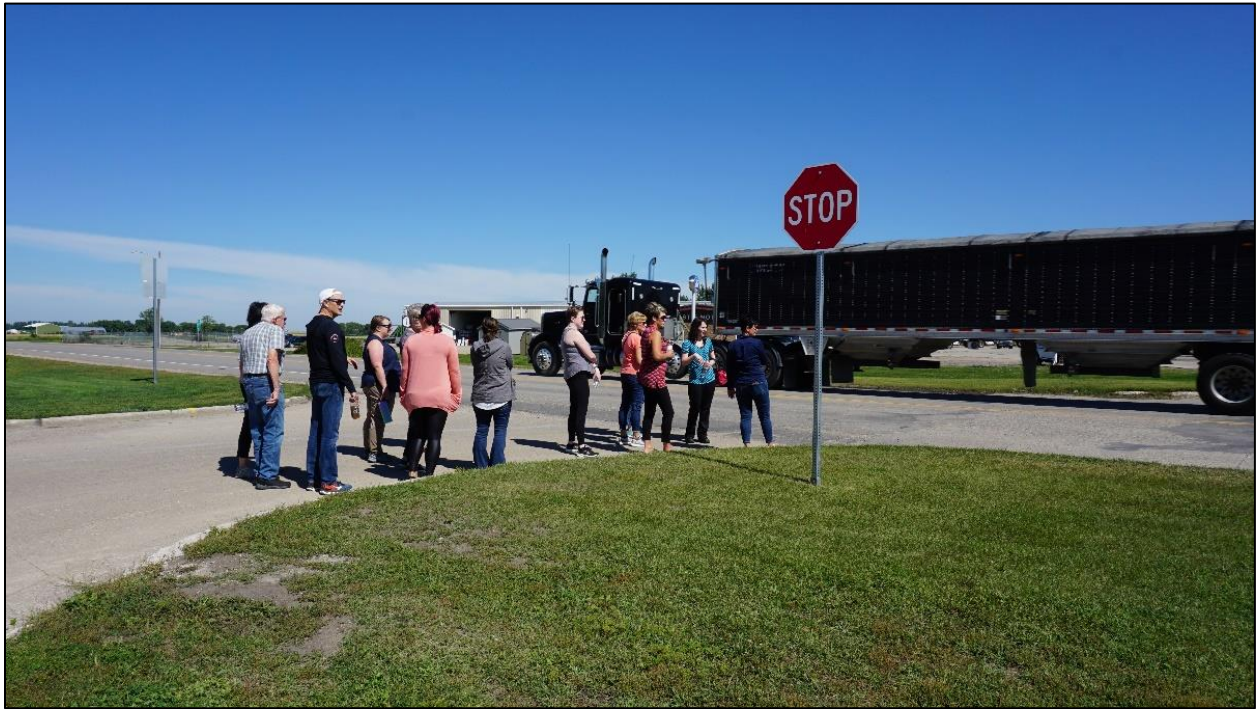
**Figure 6.** Pedestrians crossing ND Highway 1 at Ninth Avenue East

Participants are seen crossing ND Highway 1 at a driveway across from Ninth Avenue East (frontage road) instead of at ND Highway 5 because of a lack of sidewalks/crosswalks, as seen in Figure 6.

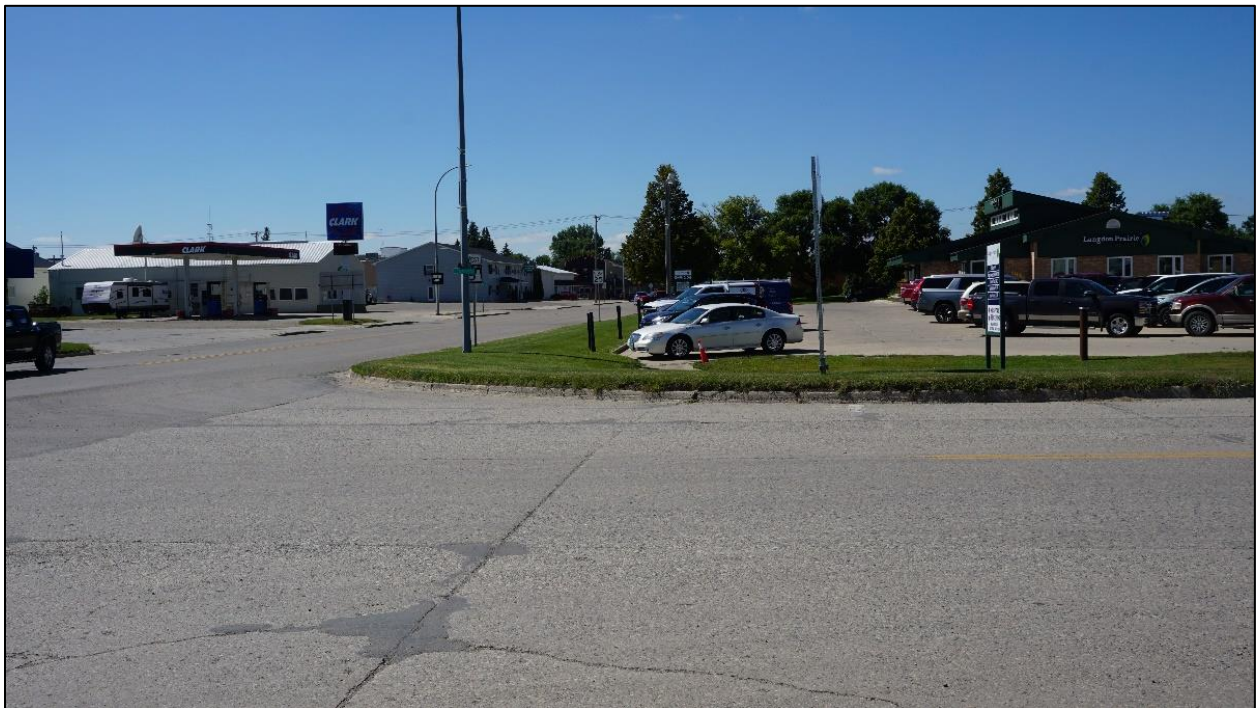
**Figure 7.** A view of the northwest quadrant and the southbound leg of the intersection of ND Highway 1 and ND Highway 5

There is no sidewalk along ND Highway 5 on the north side of the street as it passes through Langdon, as seen in Figure 7.

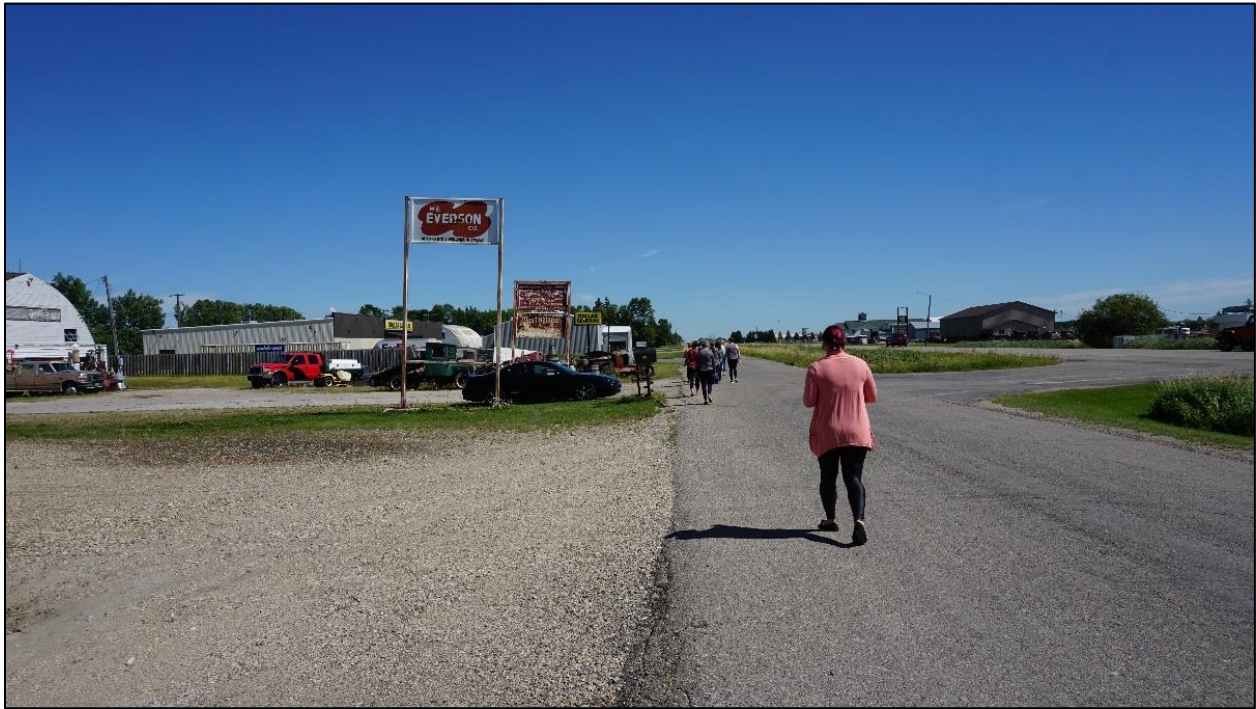
**Figure 8.** Participants walking on Ninth Avenue East

The participants continued the assessment along the frontage road, walking in travel lanes opposing the traffic because of the lack of sidewalk facilities along Ninth Avenue East, as seen in Figure 8.

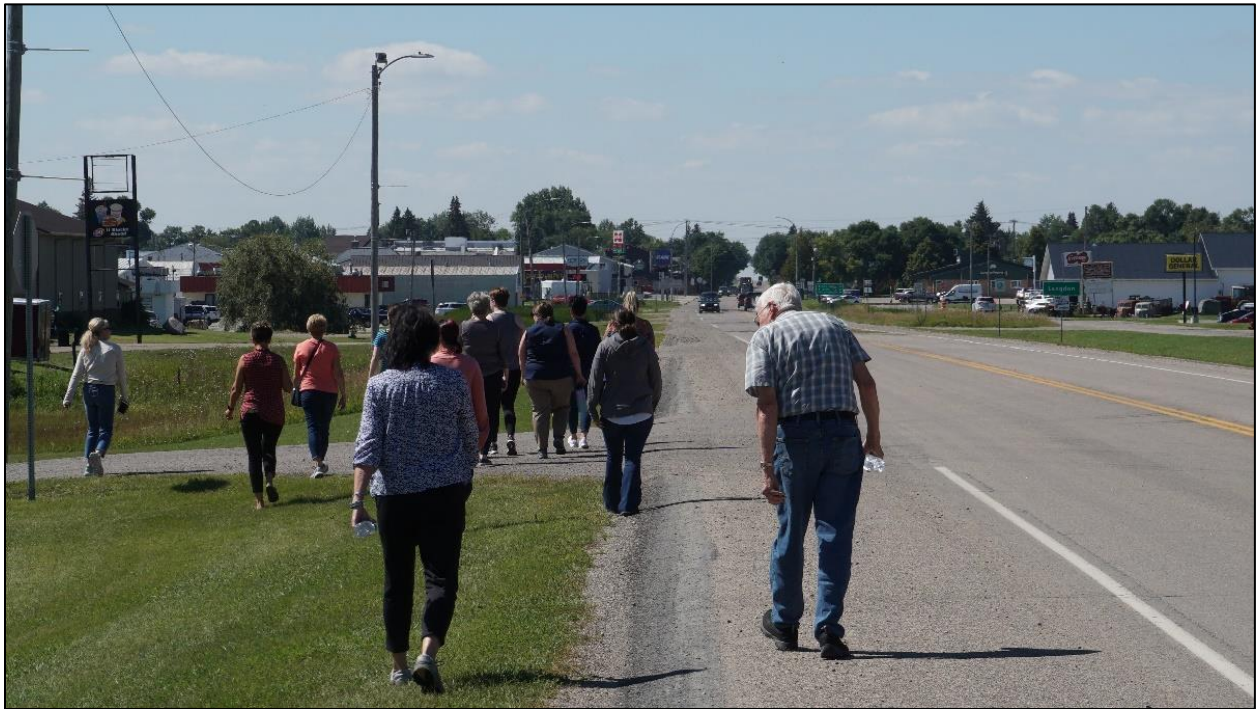
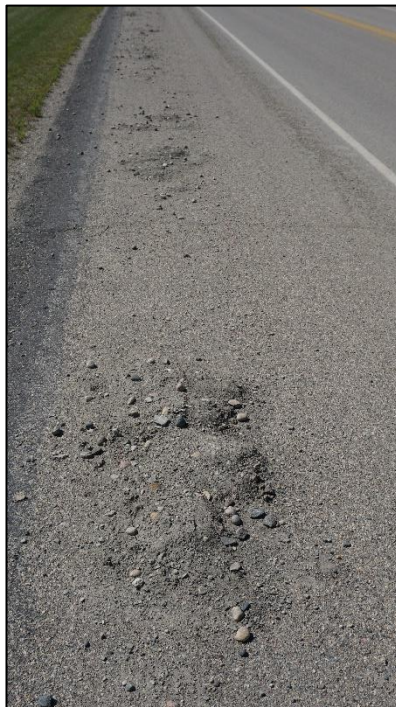
A lot of debris, mud and road hazards were observed especially along ND Highway 5 during the assessment as participants continued the walk facing traffic along the south side of the road as seen in figures 10 and 11.

Most of the debris was observed on the shoulder where a pedestrian/bicyclist may be using the roadway.

**Figure 11.** Debris and mud along the south side shoulder of ND Highway 5

A review of current maintenance practices should be completed to see if additional litter removal needs to be scheduled for state highways through the City of Langdon. Road users should be highly discouraged from tracking mud and debris onto the paved lanes and shoulder, thereby reducing road hazards.

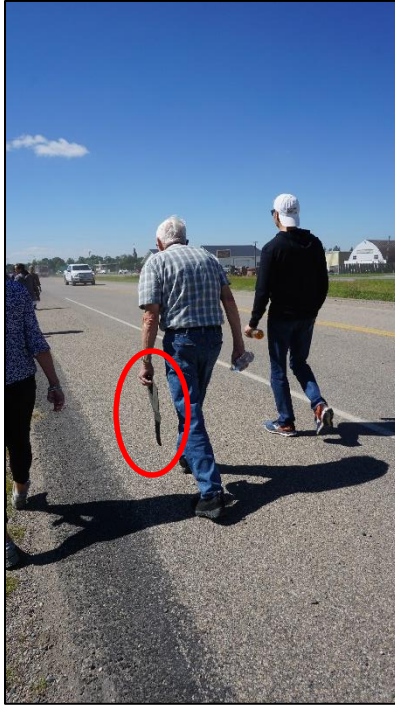
**Figure 12.** Participants helping in picking up metal debris from the shoulder

Participants, at times, were observed picking up debris from the roadway. As seen in Figure 12, the debris picked up included metal that could be dangerous for all types of road users. As seen in Figure 13, a puddle of water was observed at the southeast quadrant of the intersection of ND Highway 1 and ND Highway 5. Participants reported that no rain had been received.

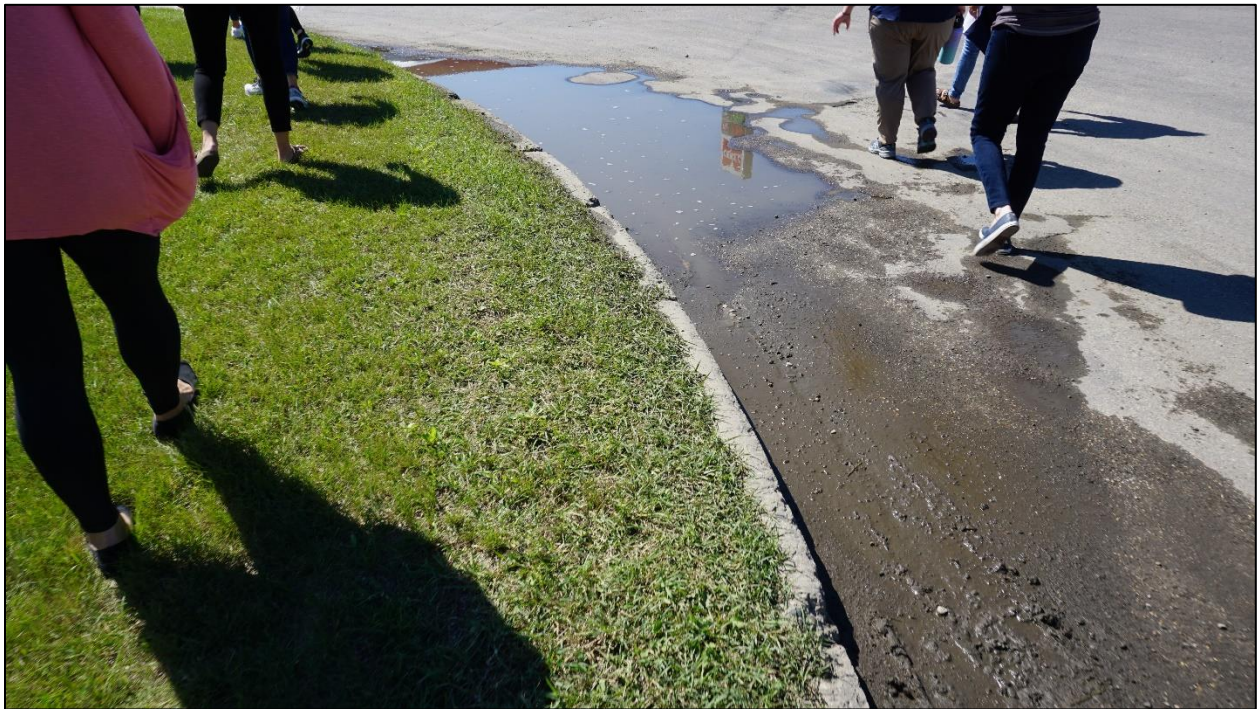
**Figure 13.** Puddled water at the southeast quadrant of the intersection of ND Highway 1 & ND Highway 5

Slope and drainage at the intersection of ND Highway 1 and ND Highway 5 should be reviewed to ensure that puddling of water as observed is not a frequent issue. Apart from being a nuisance, such issues may pose safety concerns especially during the winter, when it may lead to icy conditions.

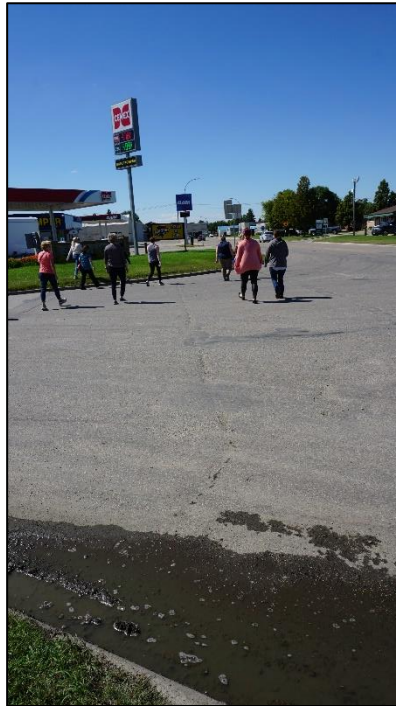
Due to the lack of crosswalk/sidewalk, the participants were observed scattered across the south side of ND Highway 5 while crossing ND Highway 1 as seen in Figure 14.

**Figure 14.** Lack of crosswalk/sidewalk on the south side of ND Highway 5 at ND Highway 1

As and when traffic volume grows, a needs assessment should be completed to determine if a traffic signal is warranted at the intersection of ND Highway 1 and ND Highway 5. Also, a needs assessment should be completed to determine if a midblock crosswalk is warranted along ND Highway 5, especially where such a crosswalk would connect high-pedestrian-demand locations such as where grocery shops are across the highway from residential areas.

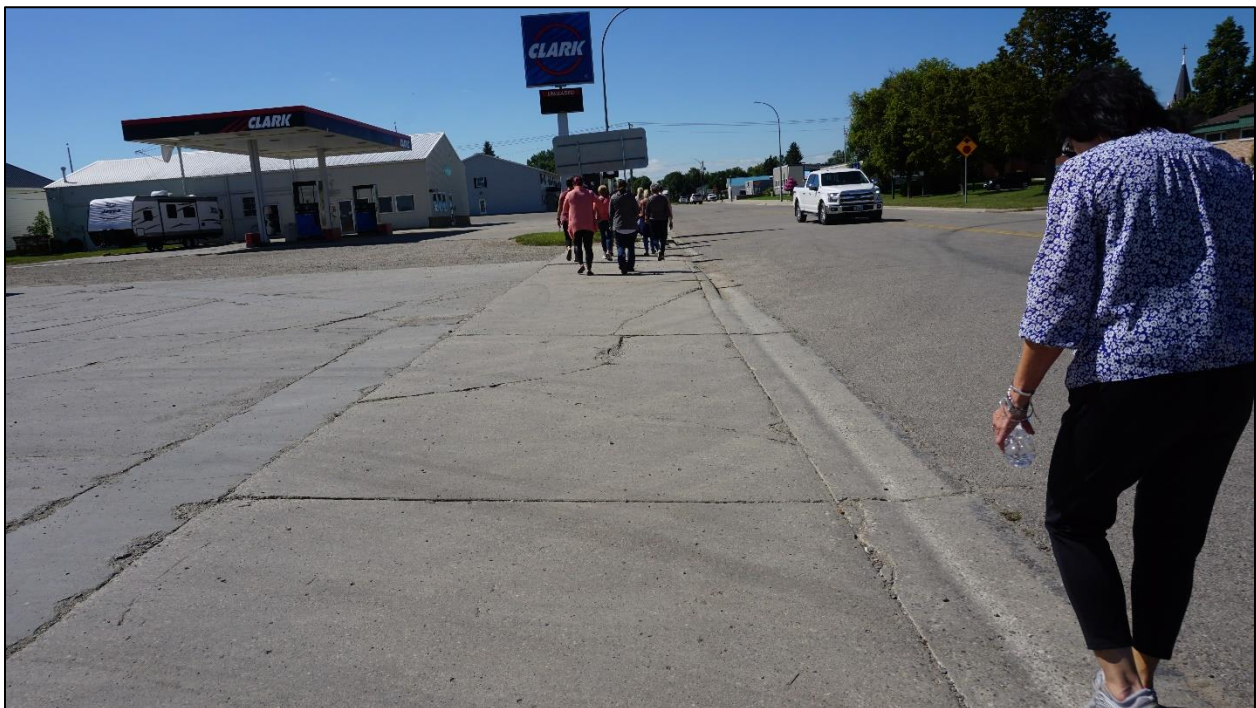
**Figure 15.** Sidewalk along the south side of ND Highway 5

As seen in Figure 15, in some locations along the south side of ND Highway 5, the differences among greenspace/furnishing zone, pedestrian zone, and frontage zone/parking lot were not apparent.

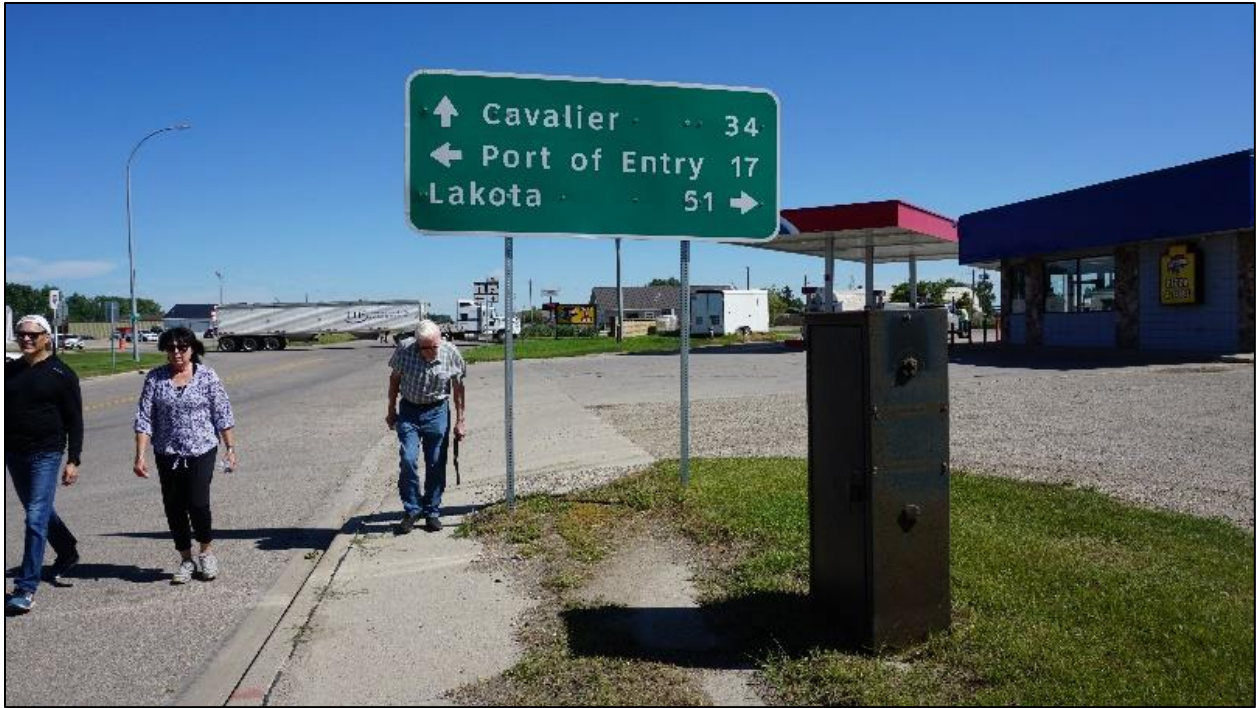
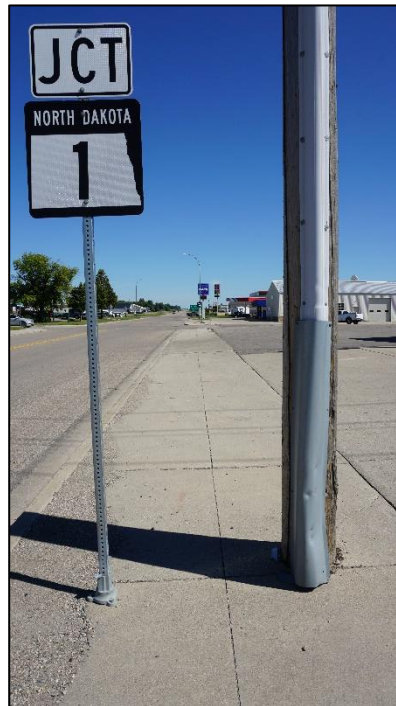
**Figure 16.** Guide sign obstructing the sidewalk

**Figure 17.** Route sign and utility pole obstructing sidewalk

In some locations along the south side of ND Highway 5, guide signs and utility poles were observed obstructing the sidewalk as seen in figures 16 and 17, forcing pedestrians off of the sidewalk and otherwise posing splinter- and creosote-related dangers.

Obstructive utility poles should be relocated to provide a clear pedestrian zone for non-motorized users. In this case close collaboration between transportation agencies and electric service providers would be paramount.

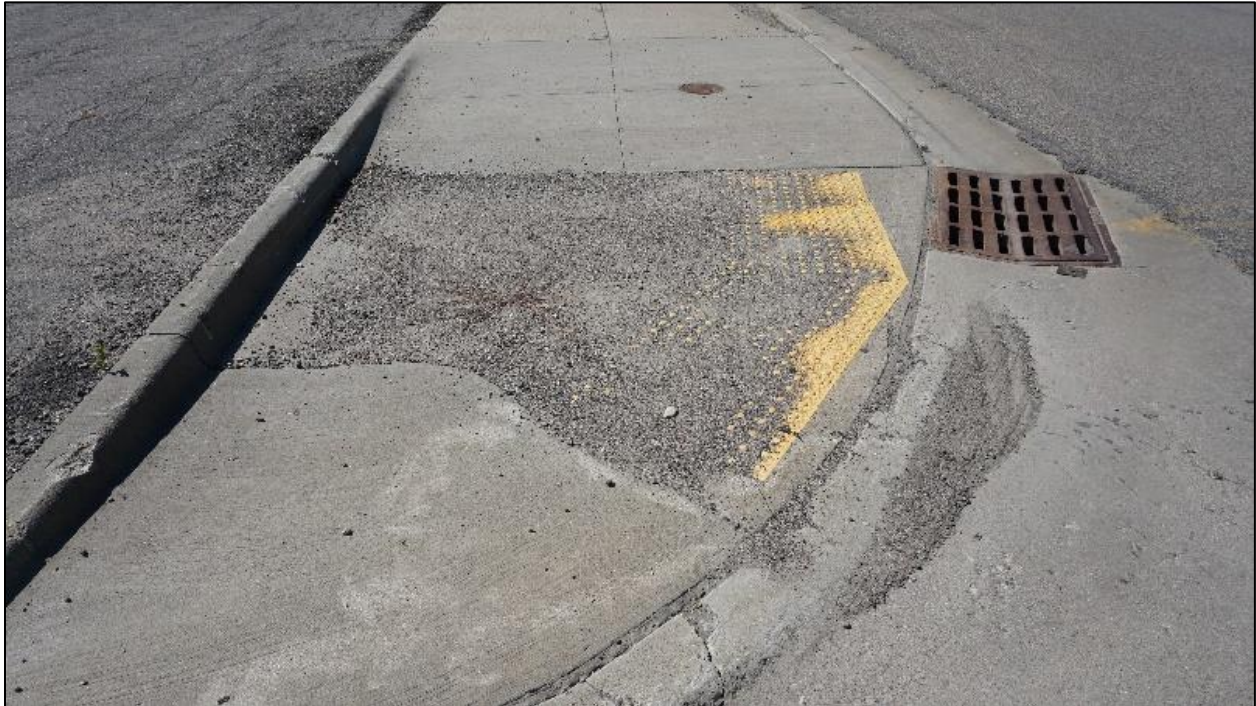
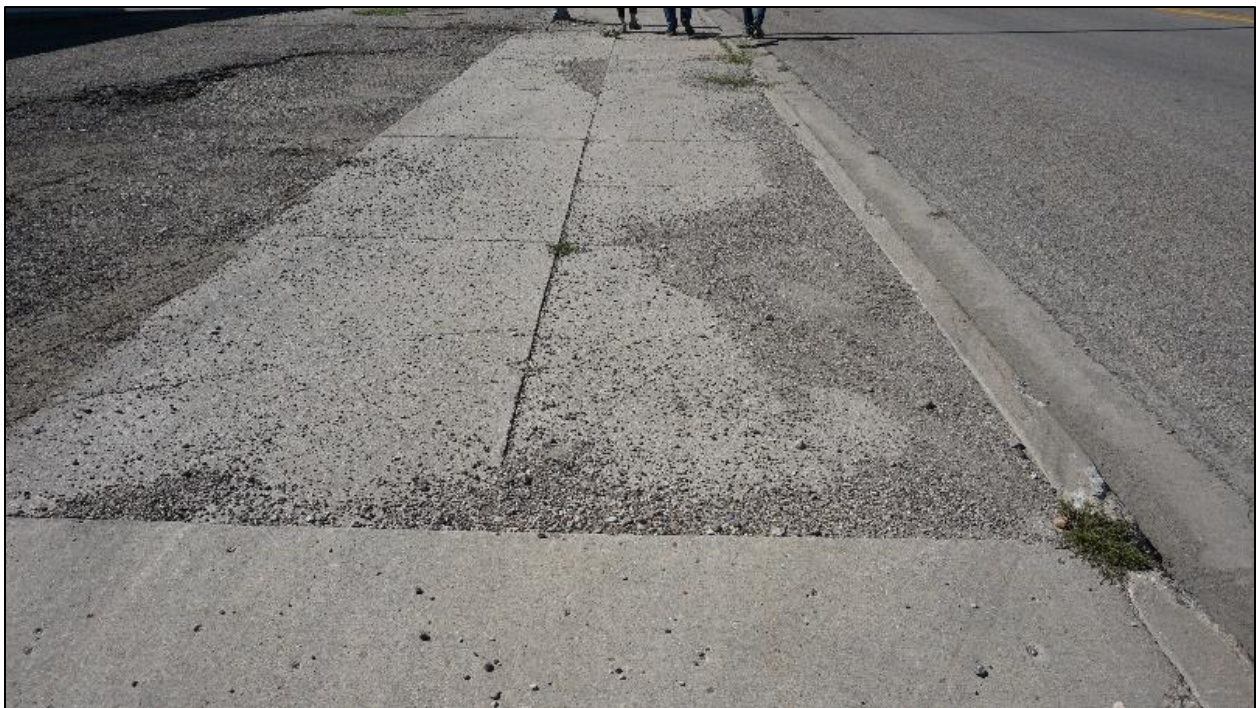
**Figure 18.** Debris strewn across ramp and potentially hazardous grate

**Figure 19.** Debris and weeds on the sidewalk

In some locations, truncated domes in curb ramps and the sidewalk were strewn with gravel, debris, and weeds as seen in figures 18 and 19. Also, at the same location, an almost parallel storm water grate was observed.

Other nearby areas should also be assessed to ensure that grates for storm water drainage are such that they are not parallel to the direction of travel for bicyclists.

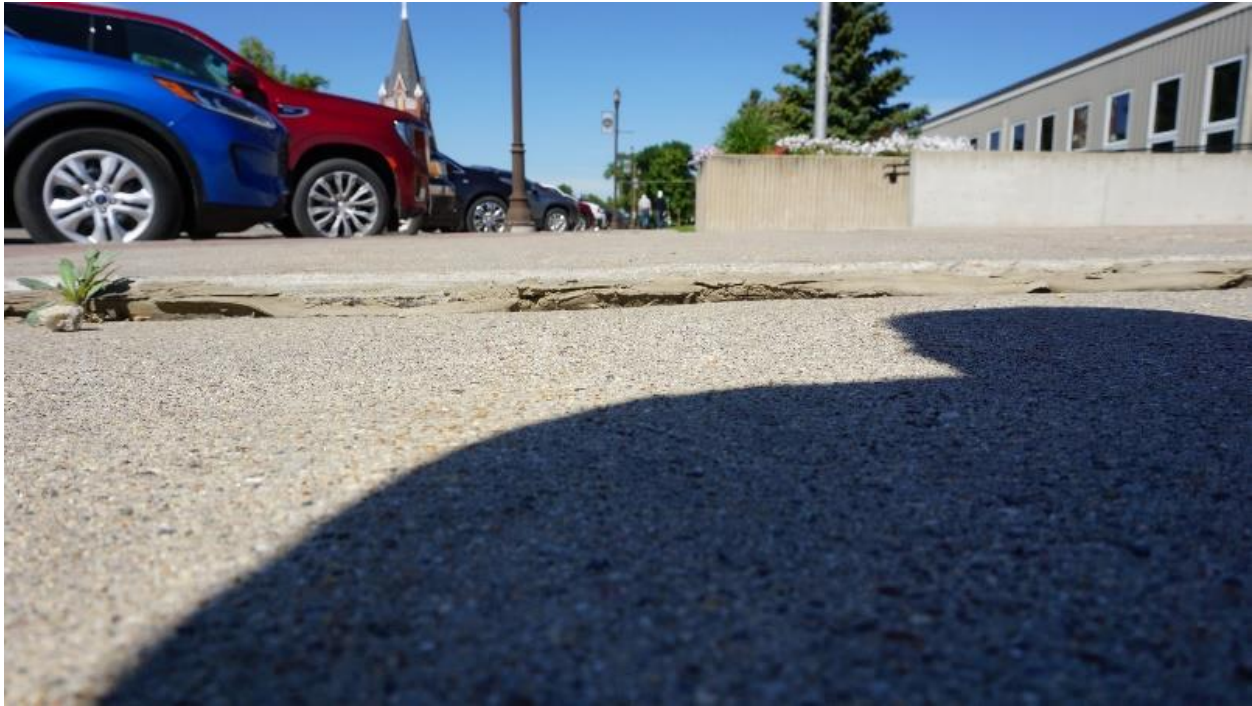
Along Third Street, sidewalk displacements, likely due to frost heaving, were observed presenting potential tripping hazards as shown in Figure 20.

**Figure 20.** Sidewalk displacement along Third Street
