Z-SPIKE REJUVENATION TO SALVAGE TIMBER RAILROAD BRIDGE MEMBERS

Nathan J. Miller
Richard M. Gutkowski, Ph.D., PE
Jeno Balogh, Ph.D.
Dept. of Civil and Environmental Engineering
Colorado State University
Ft. Collins, Colorado

December 2008

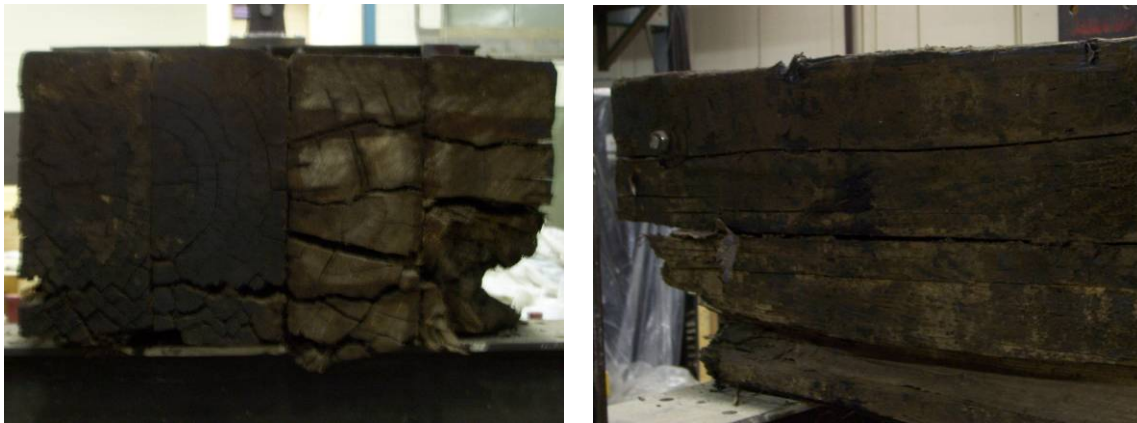
These specimens had varying degrees of deterioration and damage. Specimens 1 and 2 had very little damage. There were some visible cracks on the sides and ends of the specimens. None of these cracks could be considered very significant, and it was anticipated that there would be relatively small increases in the stiffness of these specimens due to the shear spiking process. Specimen 3 had much more significant damage. There were large splits on the sides and ends of the specimen. The damage to Specimen 3 is shown in Figure 3.1. Because of the large degree of damage to this specimen, it was anticipated that it would experience the largest increase in stiffness due to the spiking process.

Figure 3.1 Deterioration and damage for Specimen 3 (left: splits on the end; right: longitudinal cracks)

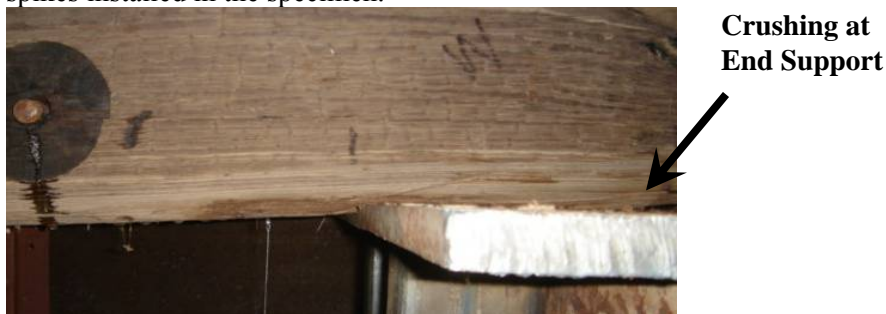
A few characteristics of the test to failure are noteworthy. Under the high loads, the specimen experienced crushing both at the end supports as well as where the load was applied. At the west end support, the crushing was not consistent across the width of the specimen. This created an uneven surface as can be seen in Figure 5.4. As more load was applied, the uneven surface generated a torque in the specimen, and it began to slightly tilt and twist sideways. This caused a concern that the member might topple and that damage may be done to the actuator as the cylinder was being pushed to one side. Thus, the loading was stopped. However, the initial primary failure of the specimen had already been reached. Overall, this specimen displayed a pseudo-ductile mode of failure which is believed to have been due in part to the spikes installed in the specimen.

Figure 5.4 Crushing at west end support of Specimen 1

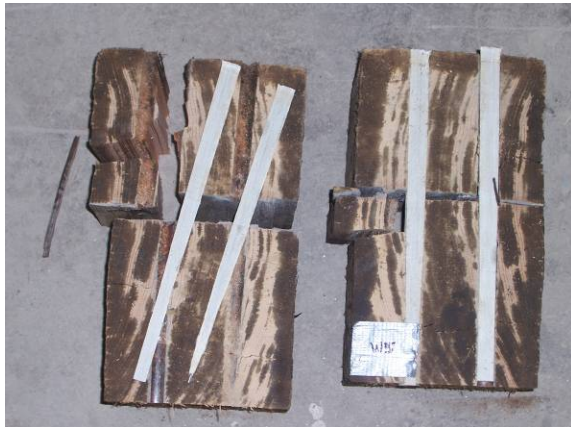
Figure 5.5 shows the two halves of a section cut from Specimen 1. Each block contains half of each spike that was split down the center using the band saw. All of the spikes that were observed were loose in their locations in the block or else simply fell out the block. In the block pictured on the left, the spikes had fallen out of their original locations in the specimen and are pictured lying loosely on top of the block. The spikes in the block on the right are loose in the block and can be slid up and down in their grooves. This picture also gives an indication of the damage that was present in the specimen. The large horizontal crack at approximately half the depth was originally present in the specimen. It was observed that some of the polyester resin had flowed into the crack upon installation of the spike. The other damage that is seen in the upper left corner of the picture was caused primarily through the failure testing of this specimen. These shear cracks would have propagated under the high loads that were present.

Figure 5.5 Spikes from Specimen 1 after failure (polyester resin)

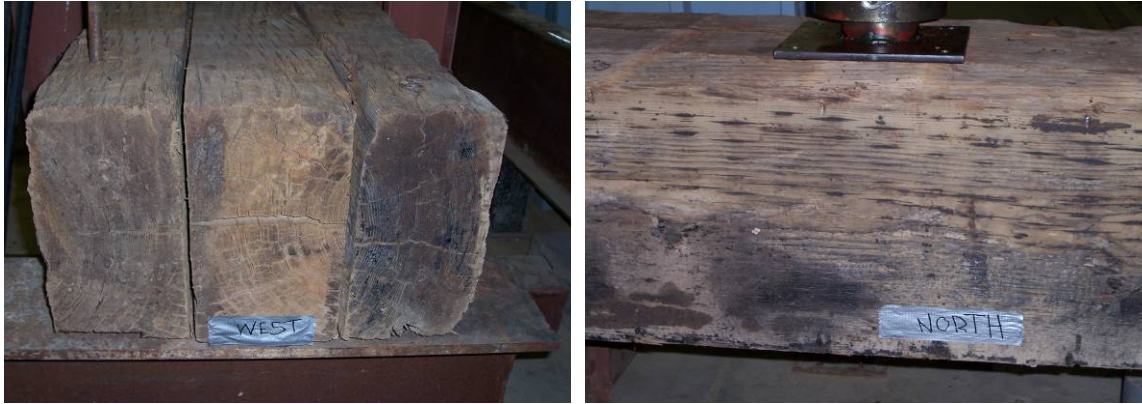
Figure 5.7 shows the condition of Specimen 2. The stringers in the chord appeared to be in better condition than Specimen 1. There were no major visible cracks across the length of the specimen. However, there were some visible cracks on one end.

Figure 5.7 (left) Horizontal cracks visible on one end of Specimen 2. (right) No visible damage on the sides of the specimen.

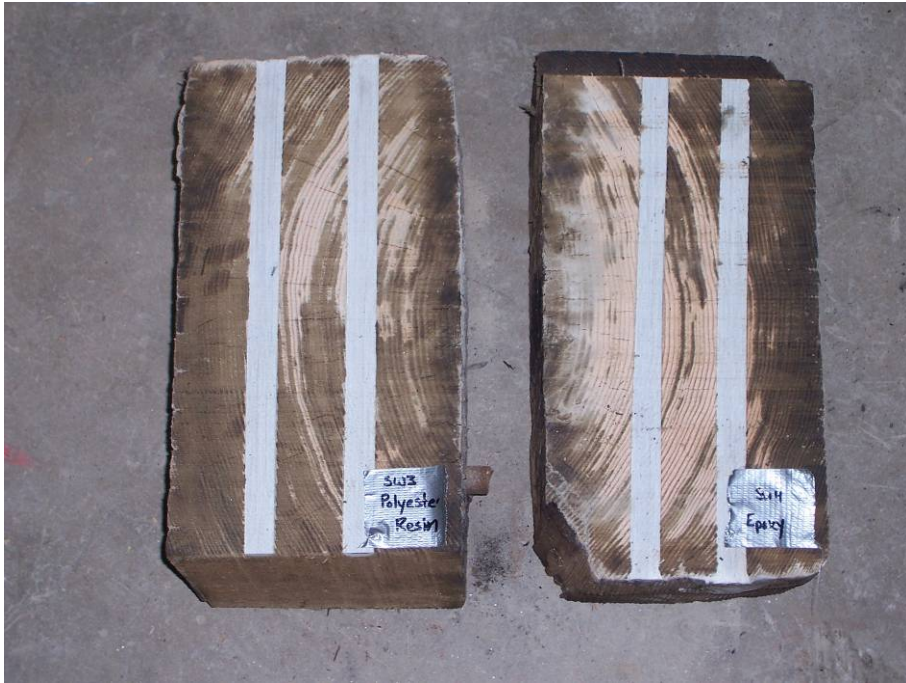
Cuts were made on the west end of the south stringer in the chord. There, each of the four rows of spikes was examined (see Figure 5.9 and 5.10). All of the spikes had been bonded in place as desired. The spikes were solidly held in place and did not fall out of the specimen as they had in Specimen 1. However, upon closer inspection of the spikes, there were some clear differences between the polyester resin and the epoxy. The spikes that had been inserted with polyester resin exhibited some very small gaps that could be seen between the spikes and wood. This indicated regions where the adhesive had not fully bonded the spike and the wood. The epoxy specimens did not have any gaps indicating that a more complete bond had been achieved using the epoxy. Figure 5.10 shows the bond formed by each adhesive and the gaps visible in the polyester specimen. It appeared as though the revisions to the spiking process improved the bond between the spikes and the wood. However, it was concluded that the bonding of the epoxy resin was superior to that of the polyester resin. This may also suggest that the debonding seen in Specimen 1 was in part due to the cutting process since the bonds with the polyester resin were weaker.

Figure 5.9 Spikes from Specimen 2. (polyester resin: left; epoxy resin: right)

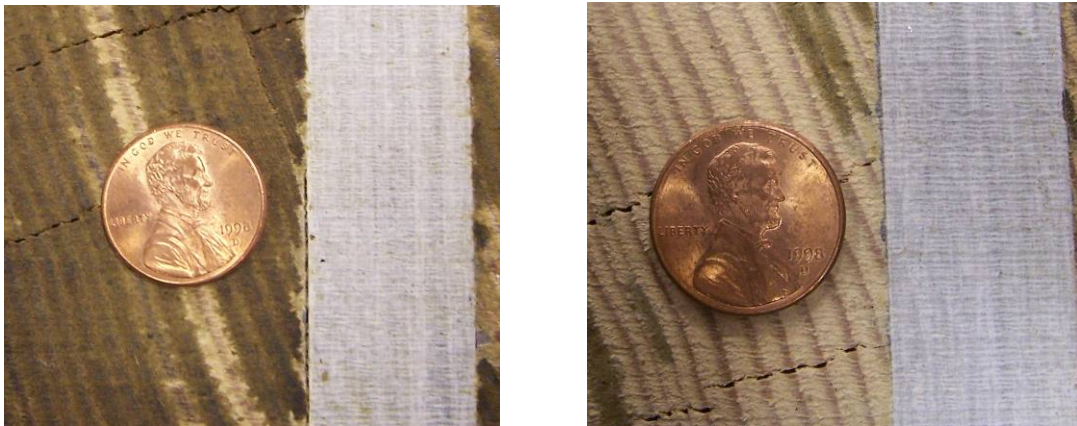
Figure 5.10 (left) Polyester-cracks visible between spike and wood. (right) Epoxy-no visible cracks

Once Specimen 2 had been cut apart, it was observed that the polyester resin had not made a complete bond between the wood and the shear spike as evidenced by hairline cracks between the spikes and the wood. The epoxy had not demonstrated these cracks and appeared to have made a complete bond between the surfaces of the wood and the spikes. To examine the bond more thoroughly, the specimens were oven dried at 180°F to determine the effect of drying and heating the specimens. This was done to examine how changes in moisture content of the wood might impact the bond between the spike and wood. This drying test was a worst case scenario in which the wood was dried to near 0% water content. The expectation was that as the specimens dried, existing cracks would grow, and new cracks would develop.

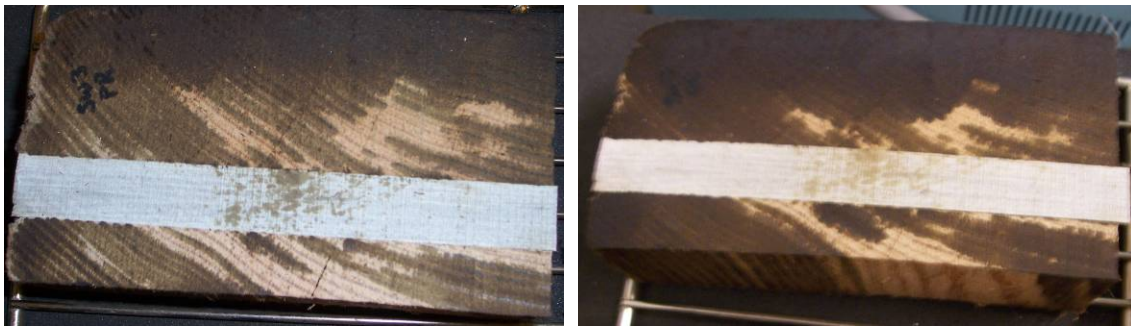
Figure 5.11 shows pictures of one of the polyester resin specimens taken before and after the drying cycle. The picture on the left is the condition before the drying. The specimen exhibited small cracks along the surface between the spike and the wood. Also shown in the picture, the spike slightly overhangs the right edge of the wood specimen. When the specimens were cut, this would have been a flat surface. This suggests that in the few days between cutting the specimens and starting the drying, the specimens had already dried and shrunk as they were exposed to the environment. The bond between the spike and wood appeared nonexistent at least near the end where the spike and wood are separated.

Figure 5.11 Polyester resin drying specimen (left: before drying; right: after drying)

The picture on the right in Figure 5.11 is of the same specimen of the polyester resin adhesive after the drying cycle. The primary visual difference shown in the picture is that the specimen shrunk more as it dried and pulled away from the spike more. There is much more overhang visible on the left end. In the end, the spike extended 1/16" to 1/8" past the end of the specimen. Looking also at the end of the specimen (Figure 5.12), separation can be seen between the spike and the wood. Clearly, the bond has been broken between the spike and wood. All of the specimens tested with the polyester resin exhibited similar behavior after drying.

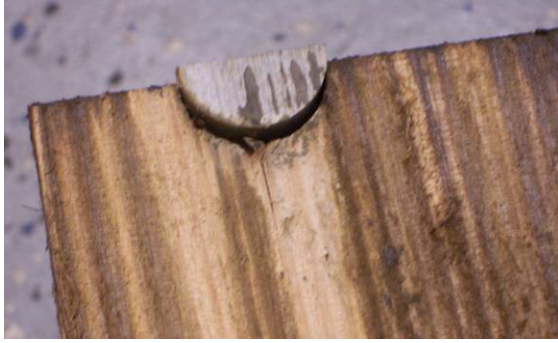
Figure 5.12 End view of dried polyester resin specimen

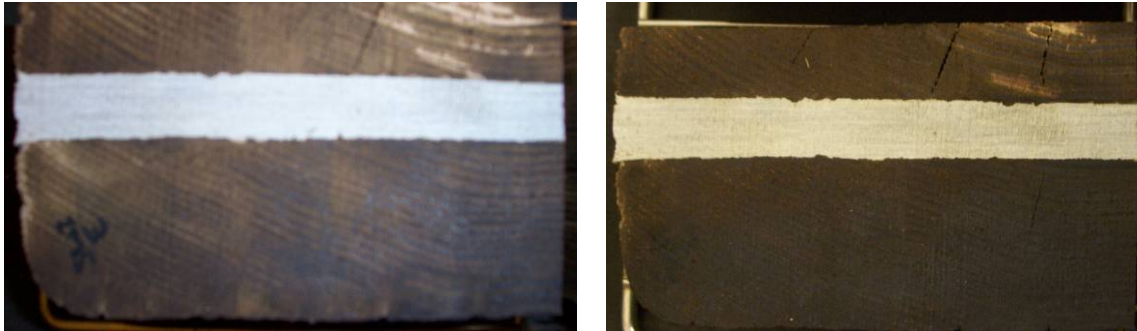
In the specimens that used the epoxy resin, there is evidence that the adhesive was bonded more completely. Figure 5.13 shows photographs of one specimen. The picture on the left shows the specimen before the drying. No cracks were evident between the spikes and the wood. Some checking can be seen on the surface of the specimen. It is possible that in the time between the cutting of the specimen and the drying test, the specimen may have started to dry. If there is a good bond between the spike and the wood, the spike will resist the shrinkage of the wood caused by drying. This would cause the checking that is seen. Also, the end of the specimen is smooth which indicates that there is still a complete bond. The picture on the right below shows the specimen after the drying cycle. No major change is observable between these two specimens except that the checking cracks appear to be larger. This would have resulted from the specimen drying more and the shrinkage being resisted by the spikes. It is concluded that in this specimen the epoxy held well initially and maintained its bond through the drying process.

Figure 5.13 Epoxy resin drying specimen (left: before drying; right: after drying)

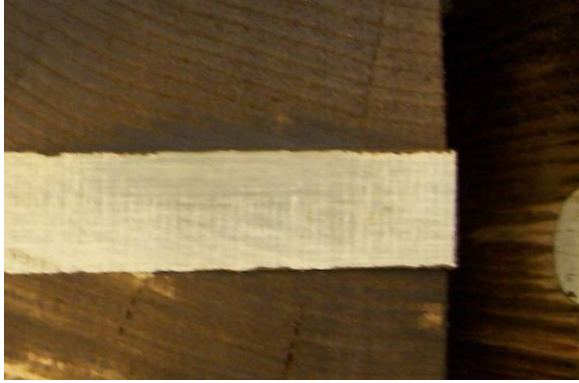
Not all epoxy resin specimens performed as well as the first one discussed. Two of the four specimens tested exhibited some cracking of the adhesive near the ends of the specimens. This allowed separation between the spikes and wood, and the wood was able to contract a little, meaning that there was less visible checking. As seen in Figure 5.14, there is some overhang in the epoxy specimen. However, the checking cracks were still present indicating that the epoxy was still maintaining its bond along most of the specimen in question.

Figure 5.14 End view of epoxy specimen after drying

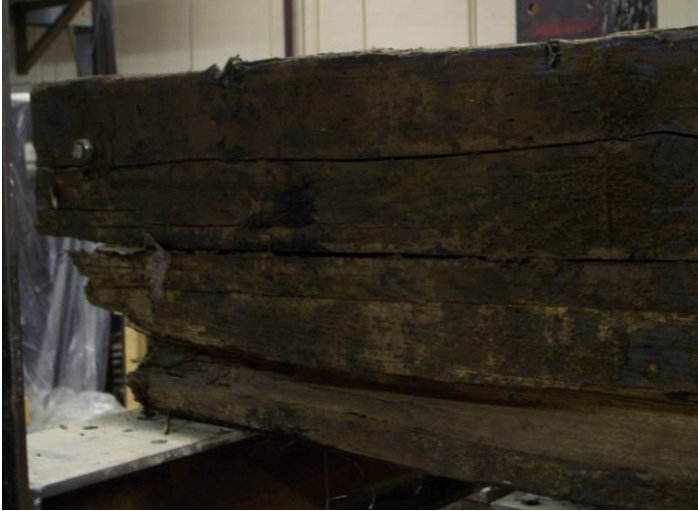
Lastly, Specimen 3 was tested. This chord had substantial damage. There were large cracks on the sides of the chord and splitting in all stringers in the chord could be seen from the ends of the chord. Representative damage to the chord can be seen in Figures 5.15 and 5.16. Being the most damaged chord, this specimen was expected to have the most to gain from the spiking process.

Figure 5.15 Splits and checking visible on side of Specimen 3

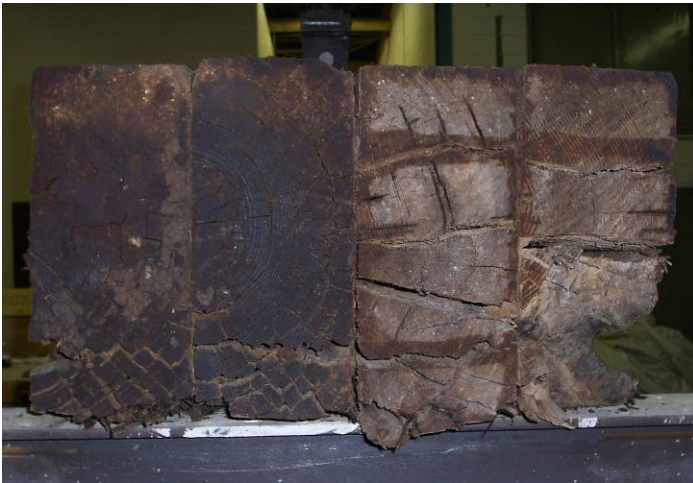
Figure 5.16 Damage to one end of Specimen 3
