Implementing Traffic Safety Evaluations to Enhance Roadway Safety

Upper Great Plains Transportation Institute
North Dakota State University
Fargo, ND 58108

May 2010

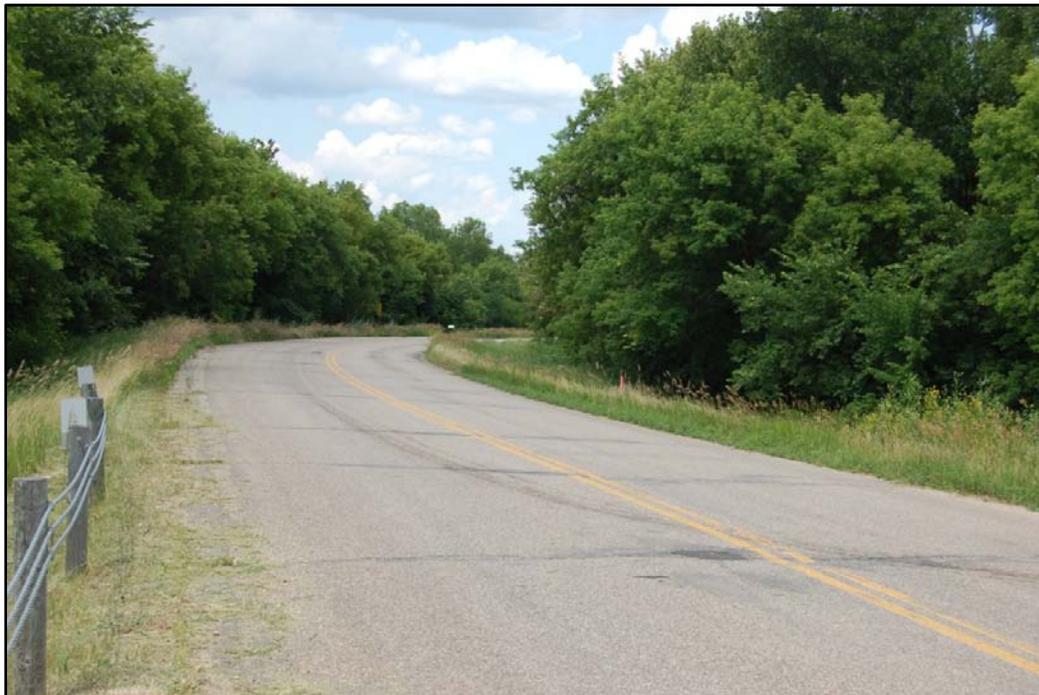
This roadway is also classified as a Scenic Byway, and is part of the Sheyenne River Valley Scenic Byway. This section of roadway was identified by Barnes County personnel due to perceived safety issues at several locations. The scenic byway portion of Highway 21 has several horizontal and vertical curves, most of which are located south of Valley City. In addition to the curvature, there are several locations which have limited clear-zone distances due to vegetation (Figure 3.3).

Figure 3.3 Roadway Curvature and Limited Clear Zone

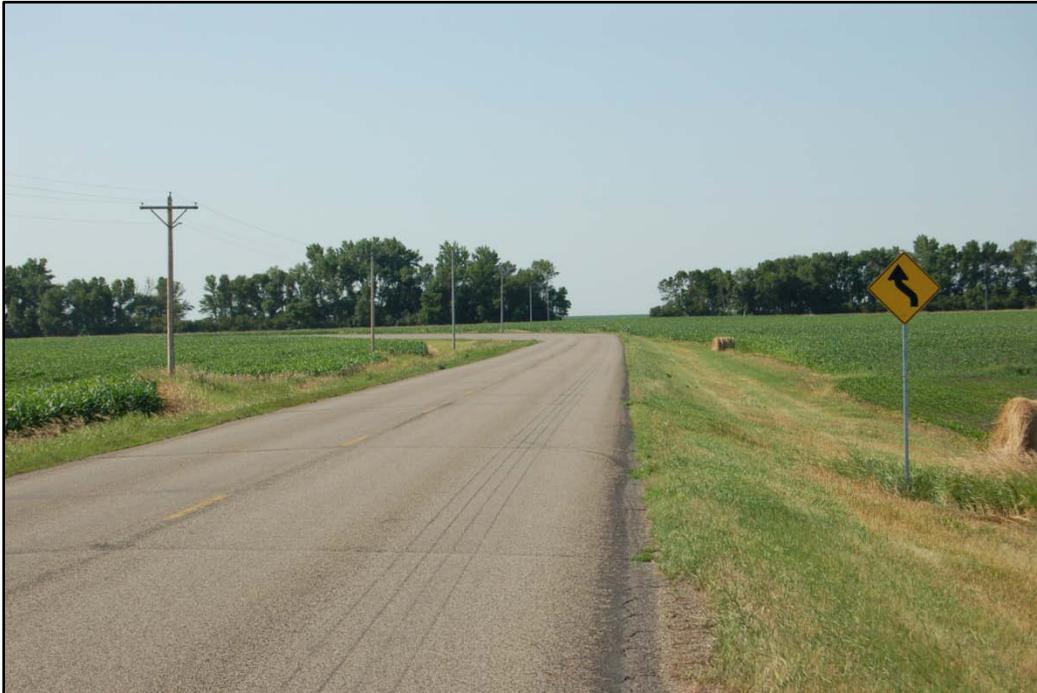
The first site evaluated was a large horizontal curve approximately three miles north of Valley City (Figures 5.1-5.2). It was noted that several run-off-the-road crashes have occurred at this location, with one resulting in a fatality. In addition to the roadway curvature, there are other characteristics which contributed to the safety issues at this location. An intersection with a gravel road, which isn't aligned perpendicular to the highway, is located at the midway point between the two horizontal curves. This alignment may potentially cause some sight-distance issues and driver confusion. In addition, several trees are located in the vicinity of the southern edge of the curve (Figure 5.2).

Figure 5.1 Horizontal curve north of Valley City

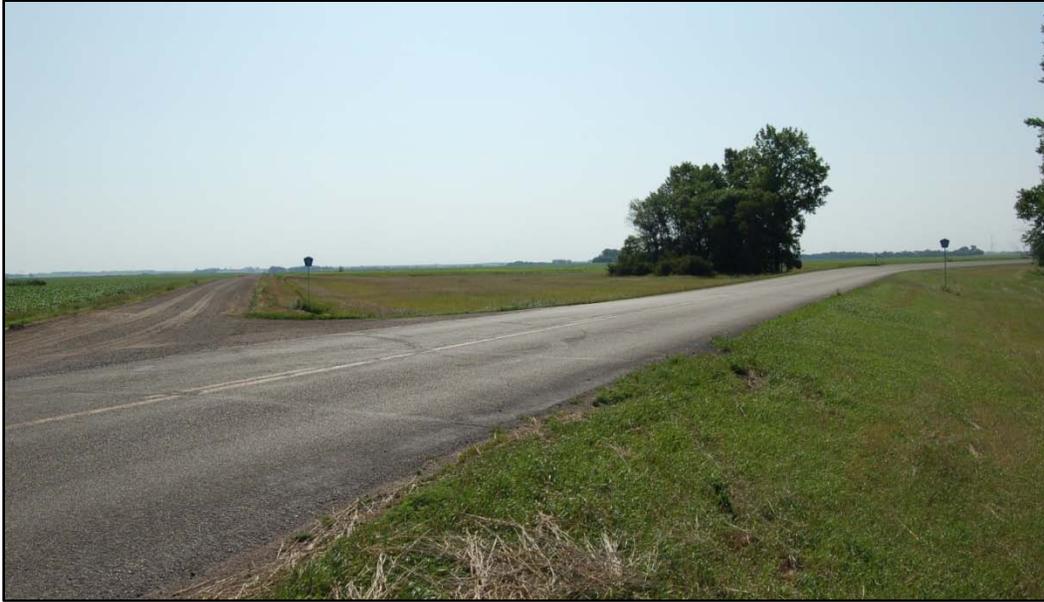
Figure 5.2 Intersection in the middle of the horizontal curve
Note: photo was taken facing to the southeast

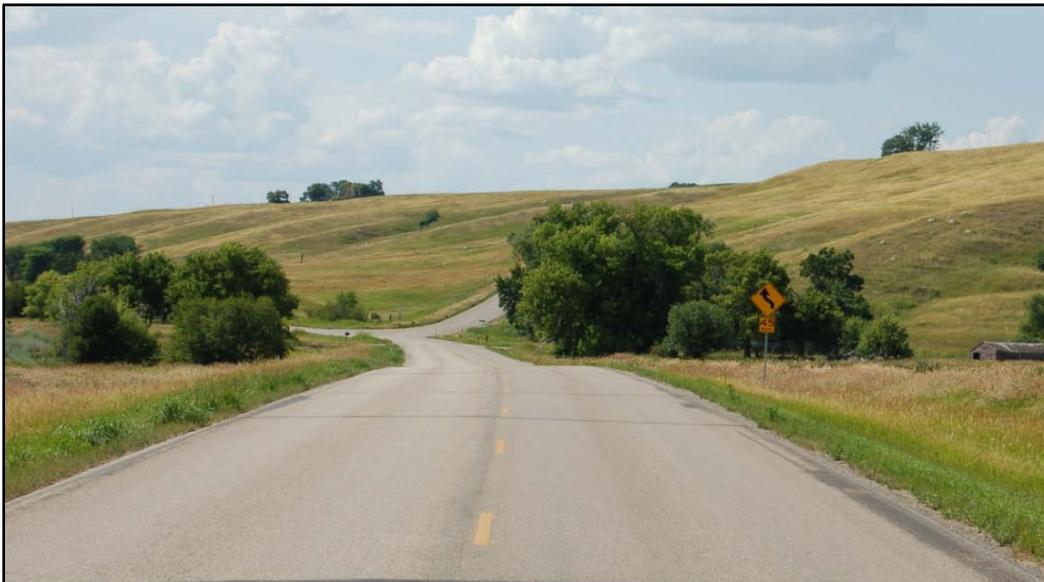
The second site which was evaluated was located to the northwest of Valley City and consisted of an intersection on a horizontal and vertical curve (Figure 5.3). There were several characteristics about this intersection which cause safety issues such as, intersection alignment, approach grade and roadway material, and sight distance.

Figure 5.3 Approaching the Bloomberg Hill intersection from the southeast

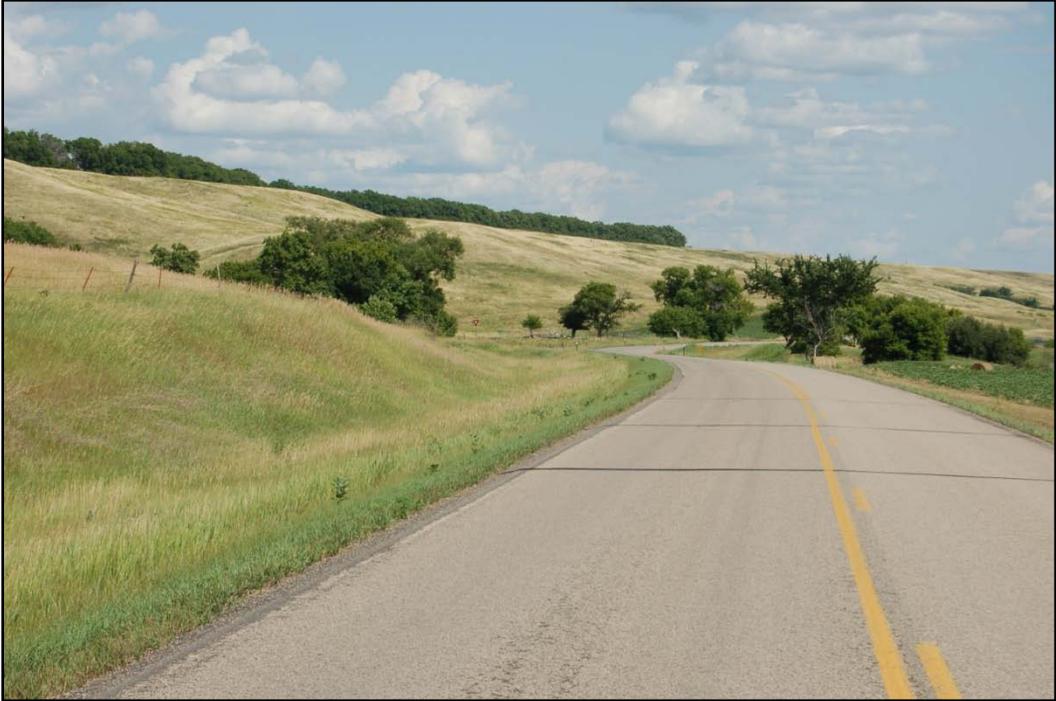
The paved highway intersects with a gravel road, which approaches the intersection at a significant downgrade. Due to the alignment of the intersection and orientation of the gravel road, it is extremely difficult to see the intersection and gravel road when approaching from the north on the paved roadway (Figure 5.4).

Figure 5.4 Approaching the Bloomberg Hill intersection from the northwest.

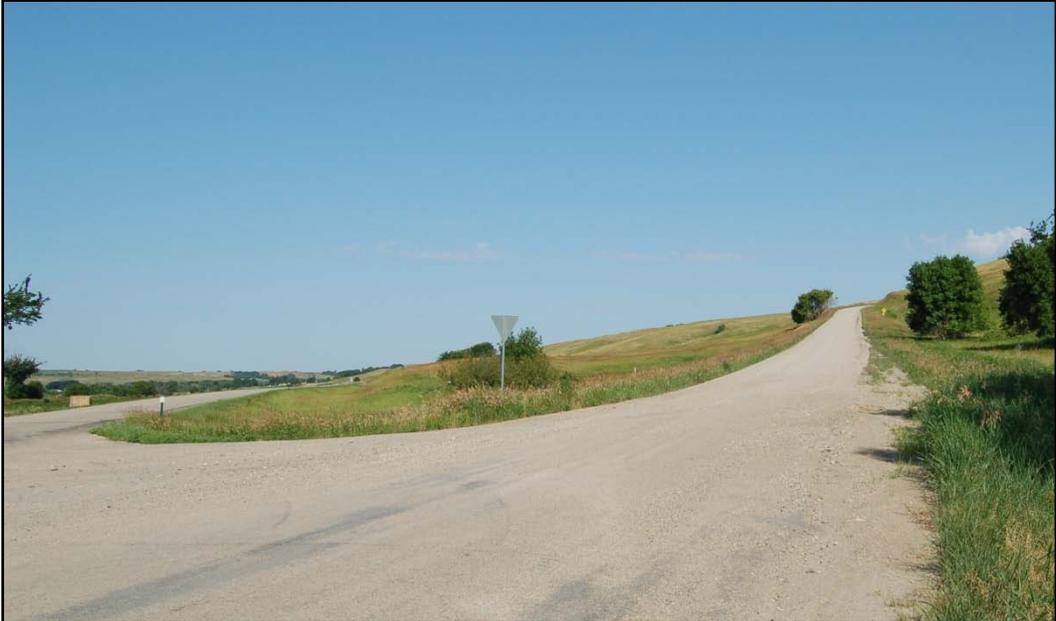
Several small trees and shrubs are located in the northwest quadrant of the intersection and block the view to the northwest for vehicles approaching the intersection on the gravel road. This is compounded by the fact that the intersection alignment already makes the view of oncoming traffic difficult (Figure 5.5).

Figure 5.5 Obstruction and alignment issues at the Bloomberg Hill intersection

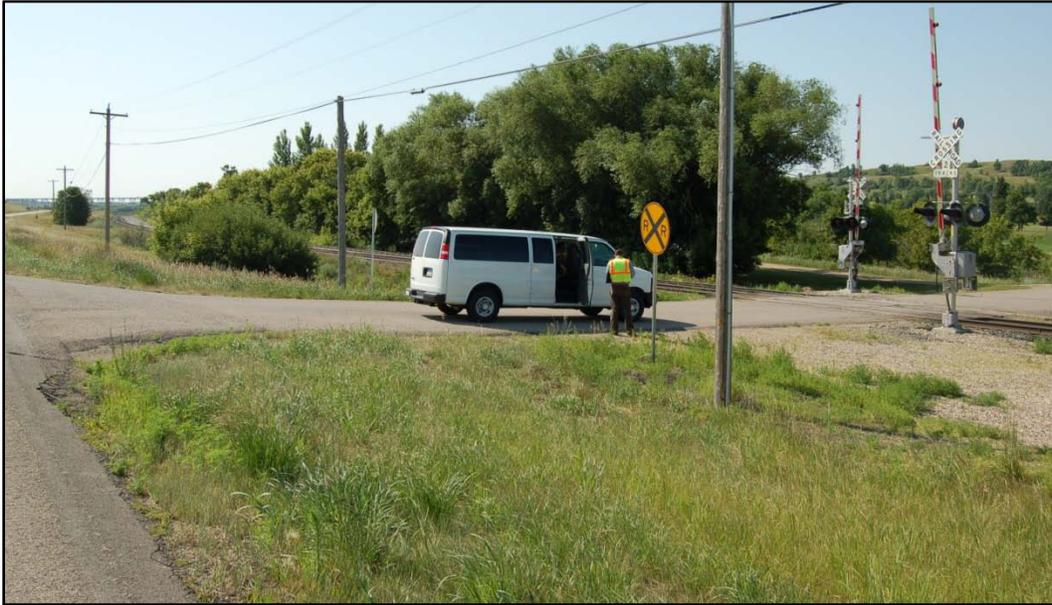
A railroad runs parallel to the highway northwest of Valley City (in the vicinity of Bloomberg Hill), and has access roads crossing at certain locations. One of these crossings was examined during the site visit. It was noted that when a train was present, the storage of the approach to the crossing may be insufficient in preventing spillback onto the highway (Figure 5.6).

Figure 5.6 Railroad crossing northwest of Valley City, N.D.

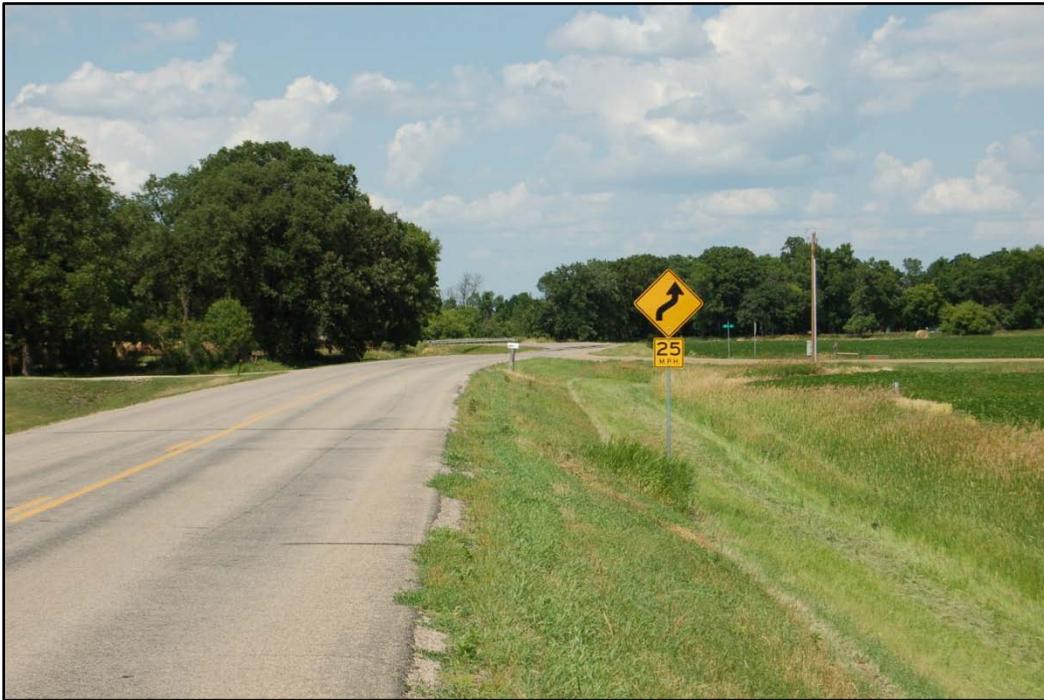
Approximately three miles south of Valley City, the evaluation team examined a bridge located on a horizontal curve along Highway 21 (Figure 5.7). Comments from this location regarded excessive speed and the narrowness of the bridge. Past observations have shown that due to the narrowness of the bridge, drivers tend to track along the center of the road when crossing. Proactive measures have been taken to improve the safety of this location through the addition of a speed advisory plate on the curve sign and updated guardrails at the bridge.

Figure 5.7 Bridge and horizontal curve south of Valley City, N.D.

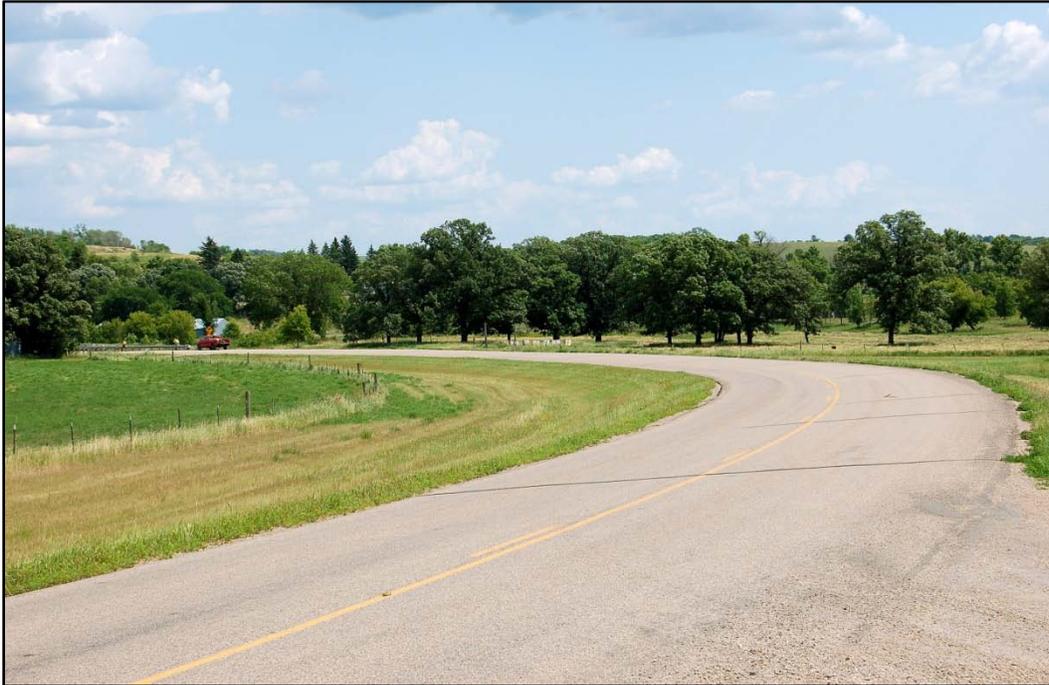
One of the most significant safety issues was observed approximately halfway between Valley City and Kathryn. This location is referred to as Skorpen Curve, and has been the site of several crashes. Skorpen Curve consists of a large reverse curve, with a bridge crossing the Sheyenne River at the midpoint. The north end of the curve includes an intersection with a gravel road (Figure 5.8).

Figure 5.8 North end of Skorpen Curve
Note: Photo was taken facing to the southeast

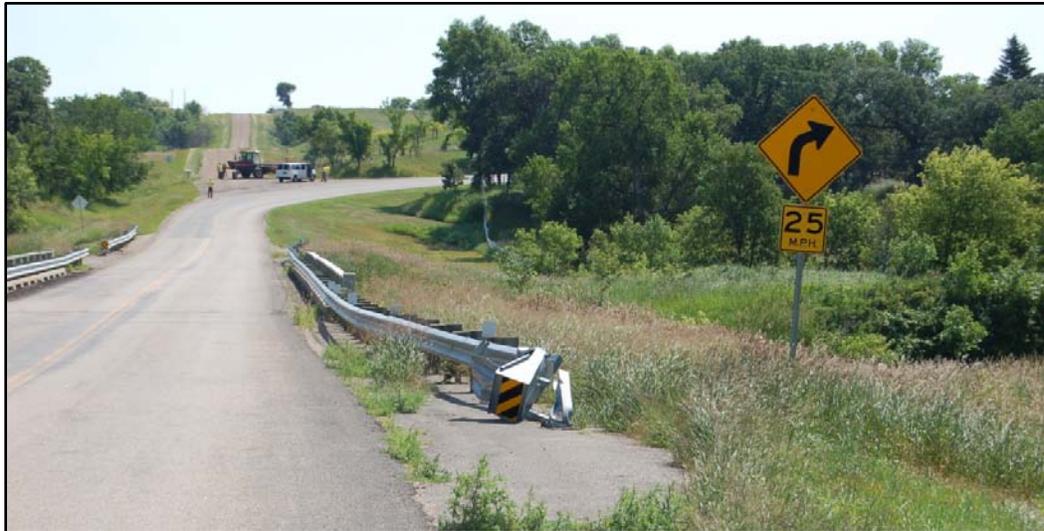
The bridge at the midpoint of the reverse curve is relatively narrow in comparison to the roadway, which results in the road having no shoulder on the bridge (Figure 5.9). It was observed during the site visit that the southbound guardrail attenuator was damaged, indicating that it had been struck by a vehicle. It should be noted that a road crew was repairing the guardrail at the time of the field visit.

Figure 5.9 Bridge at Skorpen Curve
Note: Photo was taken facing to the east

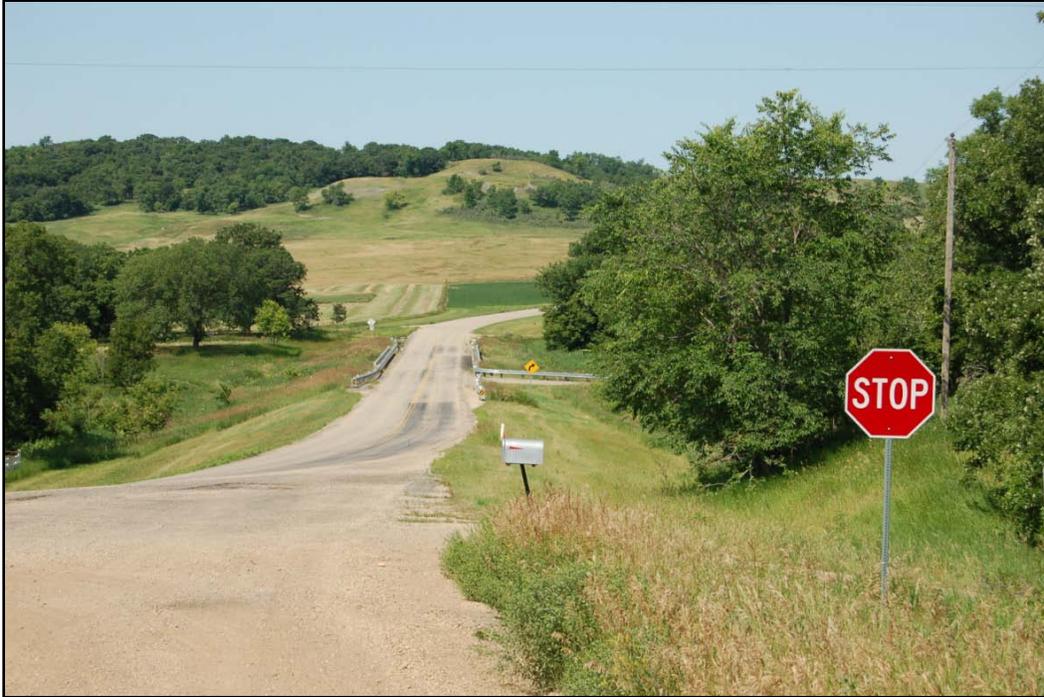
The south end of Skorpen Curve also intersects with a gravel road (Figures 5.10-5.11). This intersection had several safety issues, which were noted by the evaluation team. Due to the alignment of the intersection, vehicles travelling southbound on Highway 21 may think that the roadway continues straight, especially in low-light or inclement weather conditions (Figure 5.9). This alignment may cause drivers to inadvertently run off the road.

Vehicles approaching Highway 21 on the gravel road from the east have several factors to consider. The approach to the intersection with Highway 21 is on a downgrade and controlled by a stop sign (Figures 5.10-5.11). This may be hazardous for drivers unfamiliar with the roadway (especially if they don't see the stop sign and think the road continues straight).

Figure 5.10 Westbound approach at the south end of Skorpen Curve

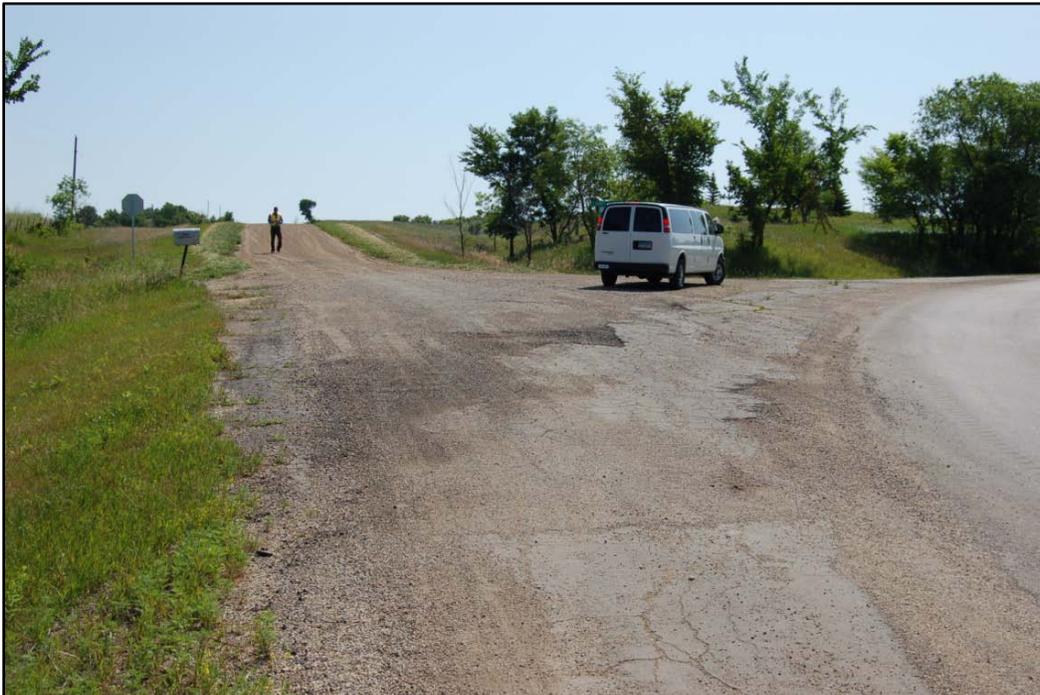
Figure 5.11 Westbound approach at Skorpen Curve
Note: Photo was taken facing to the east

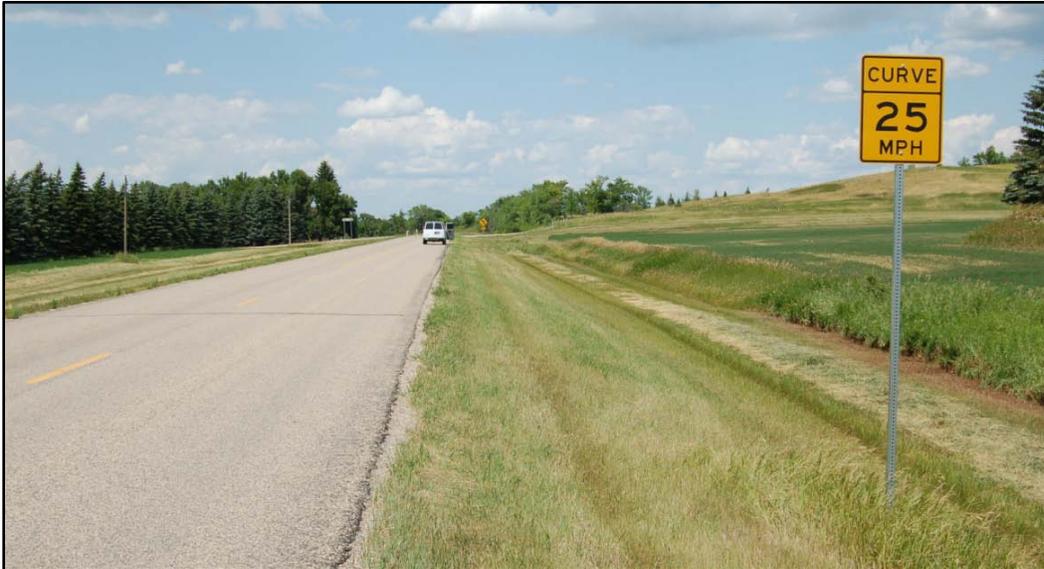
Vehicles approaching Skorpen Curve from the south have two speed advisory signs warning of the roadway curve (Figures 5.12-5.13). It was noted that the northbound direction at this location had a history of safety issues, primarily related to speeding. The advanced speed advisory sign was added in 2007 to encourage drivers to reduce their speed.

Figure 5.12 Advanced speed advisory sign (northbound at Skorpen Curve)

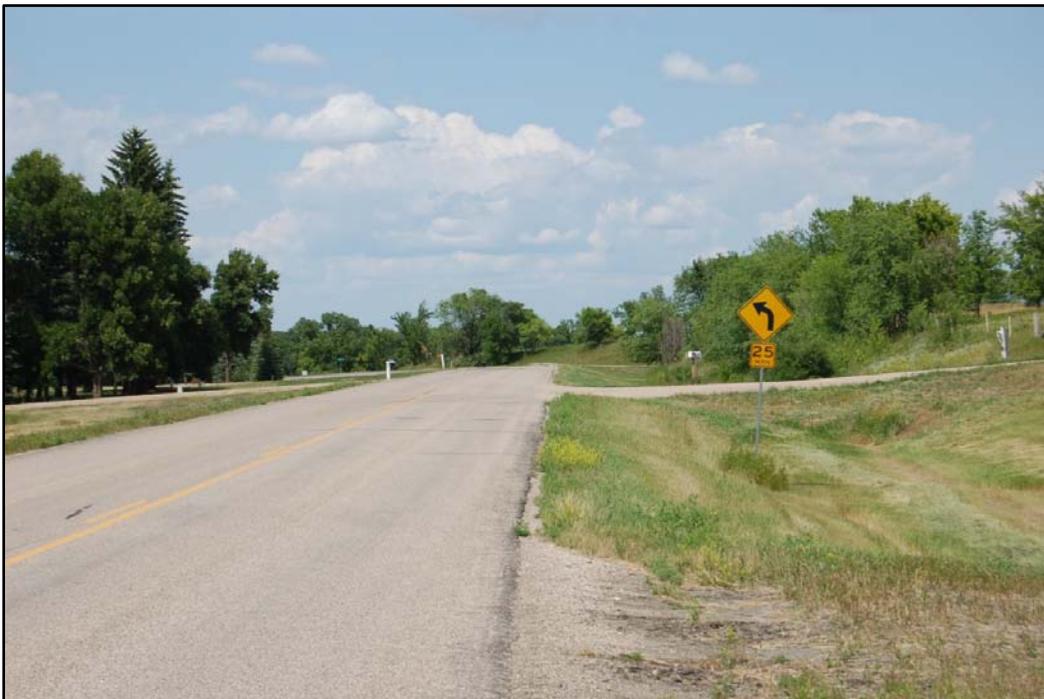
Figure 5.13 Curve advisory sign and speed limit sign at Skorpen Curve

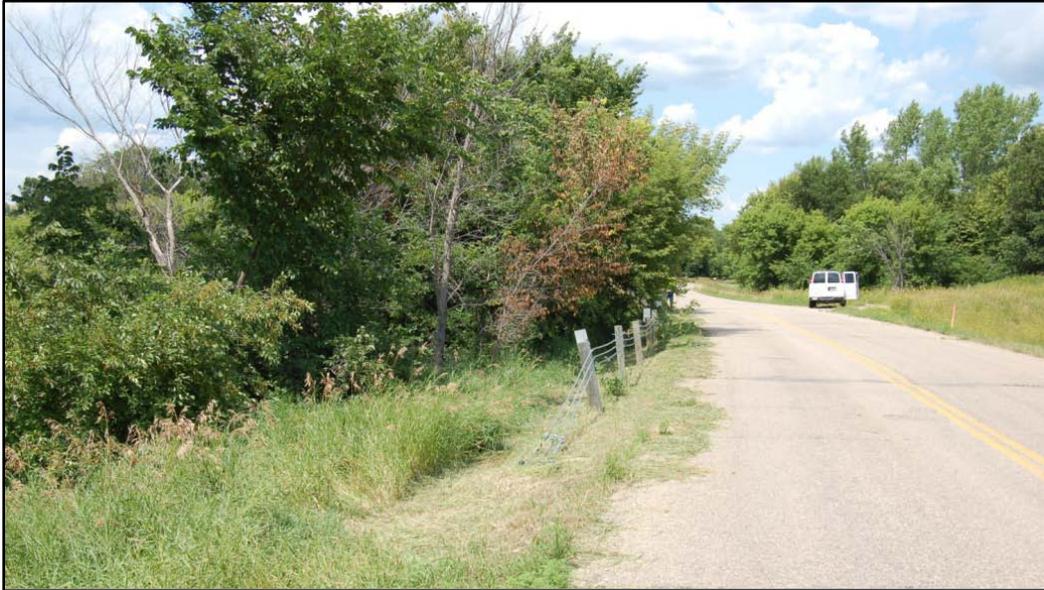
It was observed during the site visit that several horizontal curves were located on a section of road approximately five miles north of Kathryn (Figures 5.14-5.16). The safety issues observed at this location were primarily due to the close proximity of vegetation to the roadway. This results in limited sight distance at the curves, and requires drivers to reduce speed. It should be noted that the Sheyenne River is adjacent to Highway 21 at this location, and road crews have difficulty trimming vegetation close to the river. Guardrails have been placed at locations where the road is close to the river and locations where trees are adjacent to the road.

Figure 5.14 Vegetation growth along the road shoulder
Note: Sheyenne River is located on the left side of the photo

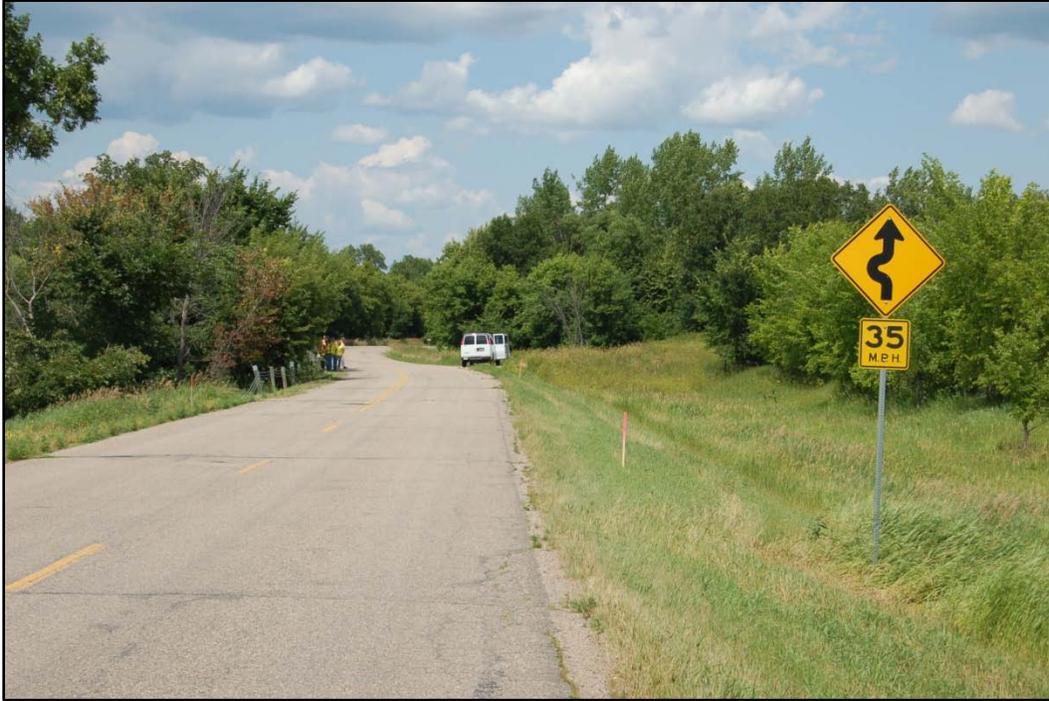
Figure 5.15 Speed advisory sign and horizontal curves

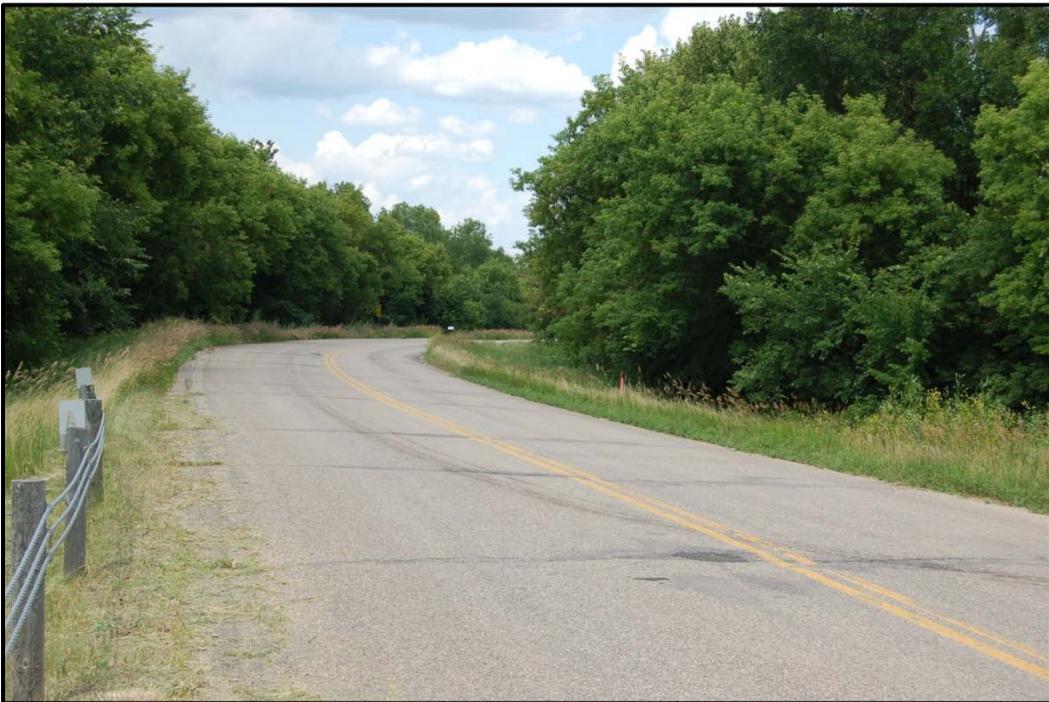
Figure 5.16 Clear zone encroachment due to vegetation

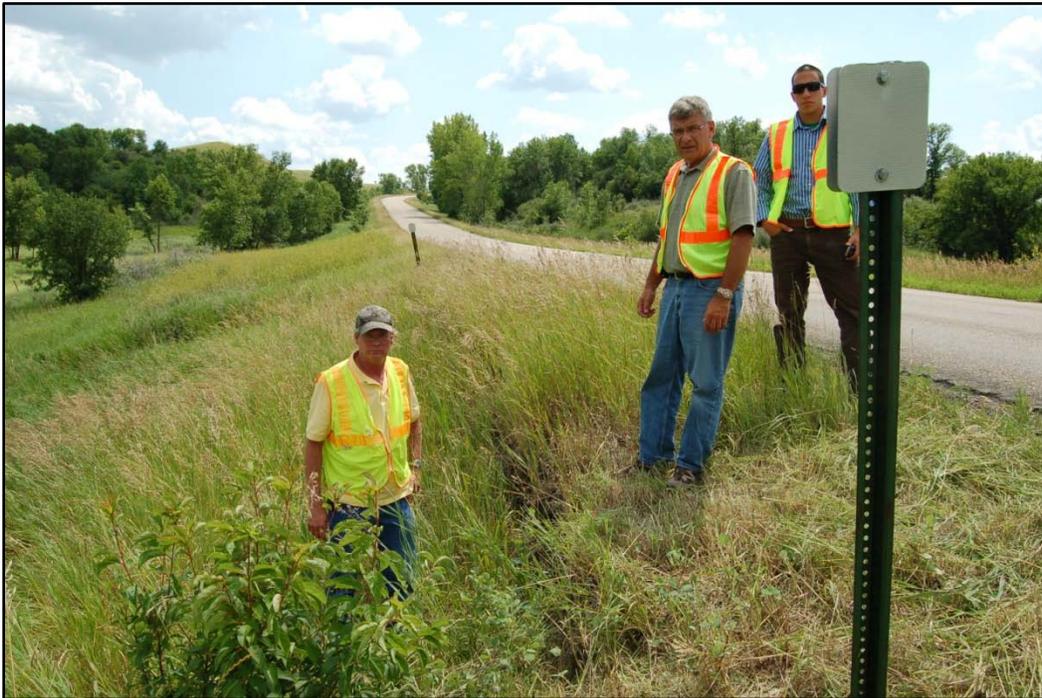
The evaluation team examined a location at which the roadway in-slope is unstable (Figures 5.17-5.18). This instability is causing the in-slope to slide (slough) approximately eight feet from the edge of the road shoulder. At the time of the site visit, the slough was approximately four feet deep (in comparison to the existing grade). In addition to the slough, the in-slope itself is considerably steep at this location. It was noted that a previous repair of the in-slope slough only lasted a few weeks before it began sliding again. There were no safety devices at this location except for two posts delineating the edges of the slough.

Figure 5.17 Roadway in-slope slough

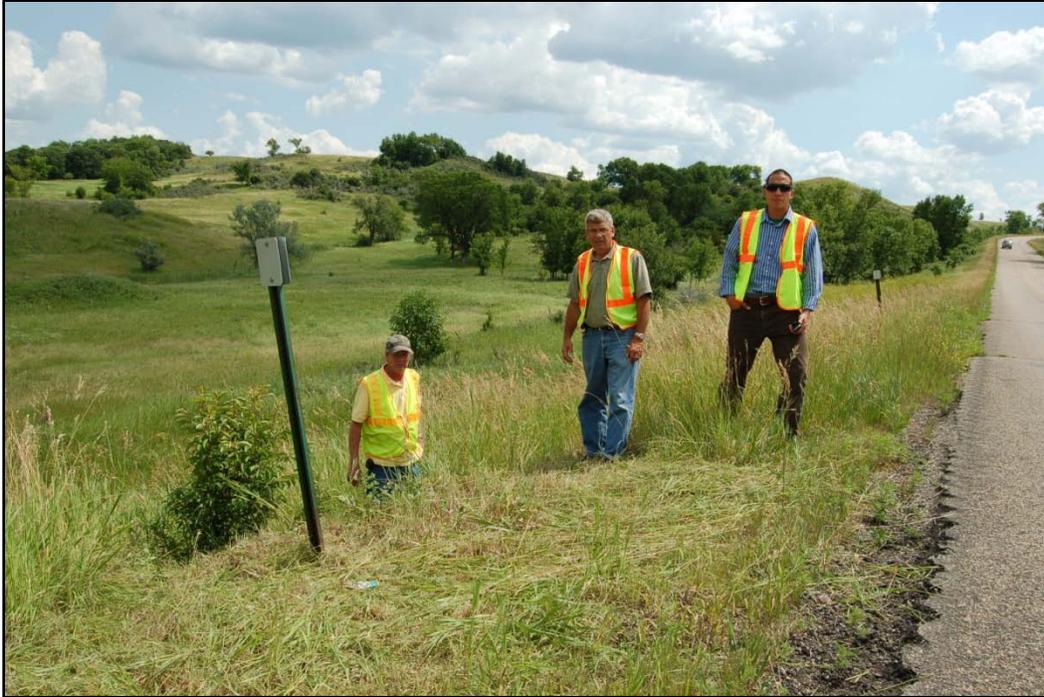
Figure 5.18 Roadway in-slope slough

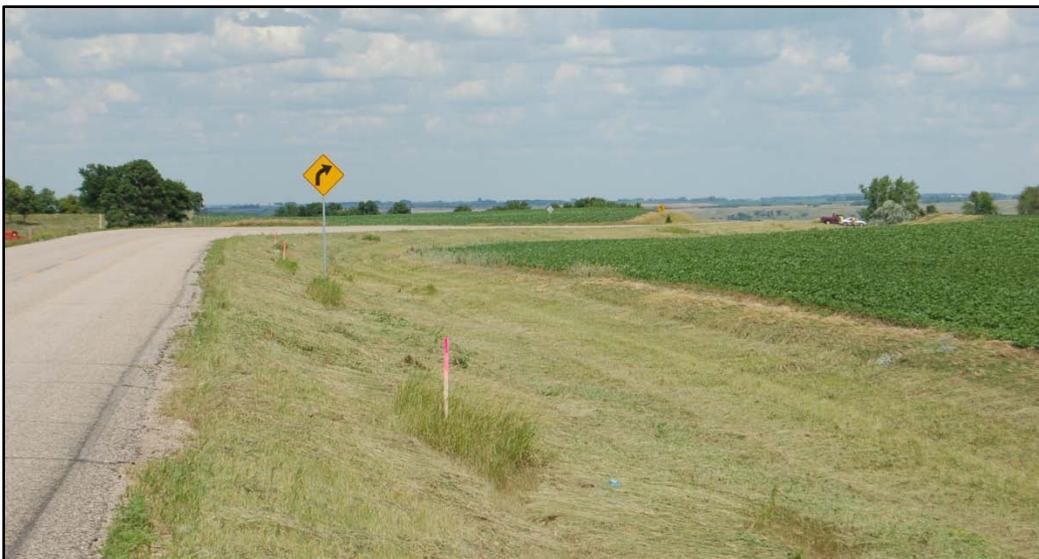
Several curves were observed on Highway 21 southwest of Kathryn (Figures 5.19-5.21). Although there were no obvious sight-distance issues caused by vegetation, some of the curves had relatively small radii due to the landscape, which required speed reductions to 35 mph.

Figure 5.19 Large horizontal curve on Highway 21

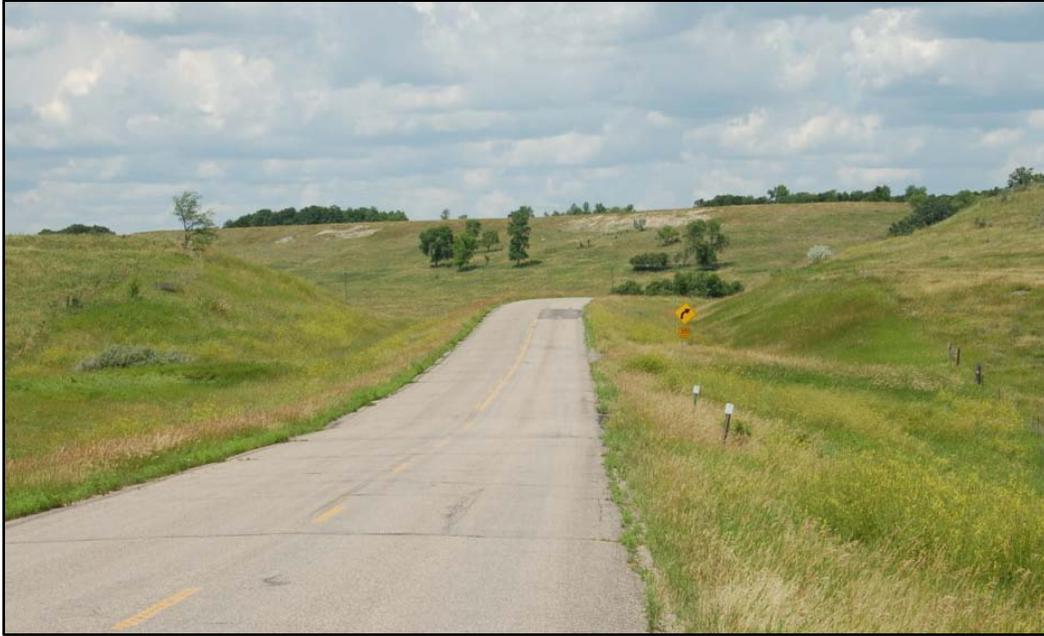
Figure 5.20 Horizontal curve with speed reduction

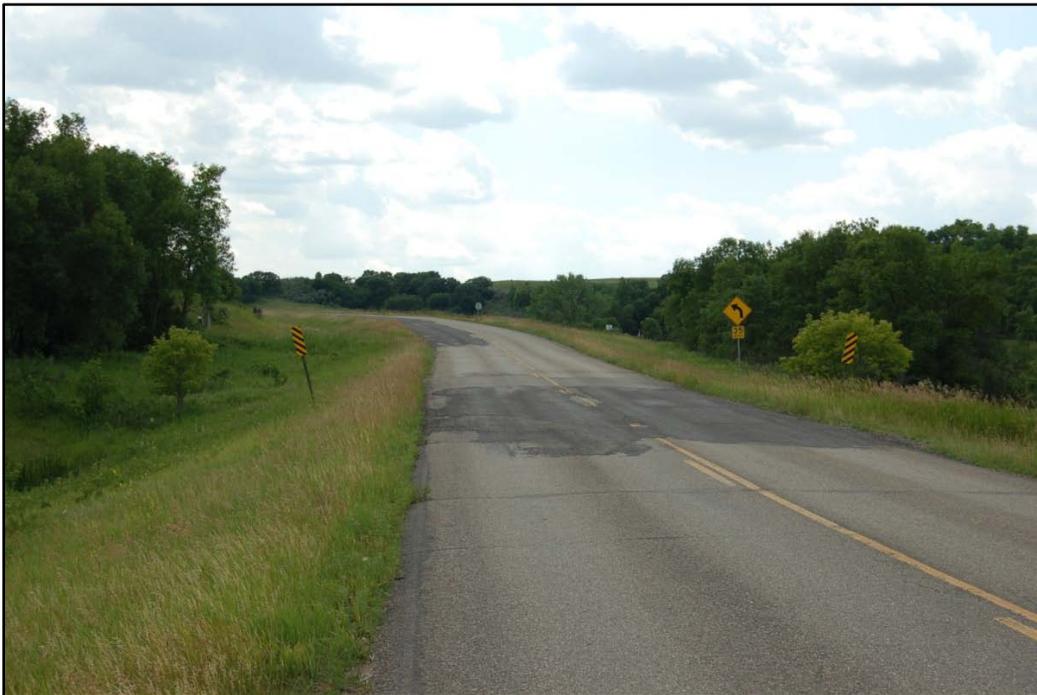
Figure 5.21 Horizontal curve with speed reduction and culvert delineators

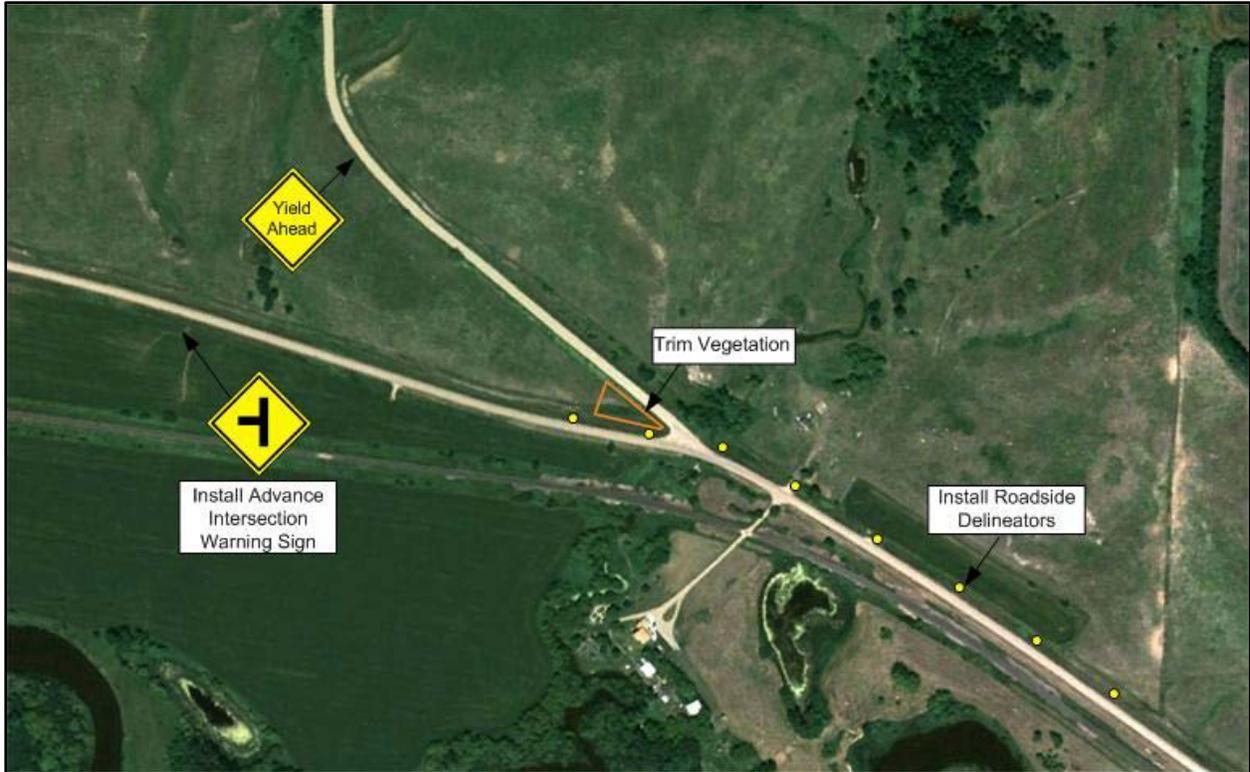
Figure 6.1 Improvement suggestions for Bloomberg Hill

This location was perceived to have the highest safety issue as noted by the ranking done by members of the evaluation team. There are several recommended suggestions for improvement at this location (Figure 6.1). The various improvement strategies are listed as follows:

- Install edgeline rumble strips
- Install centerline rumble stripes
- Re-align the intersection so the gravel road is perpendicular to the highway
- Widen the shoulders on the curve

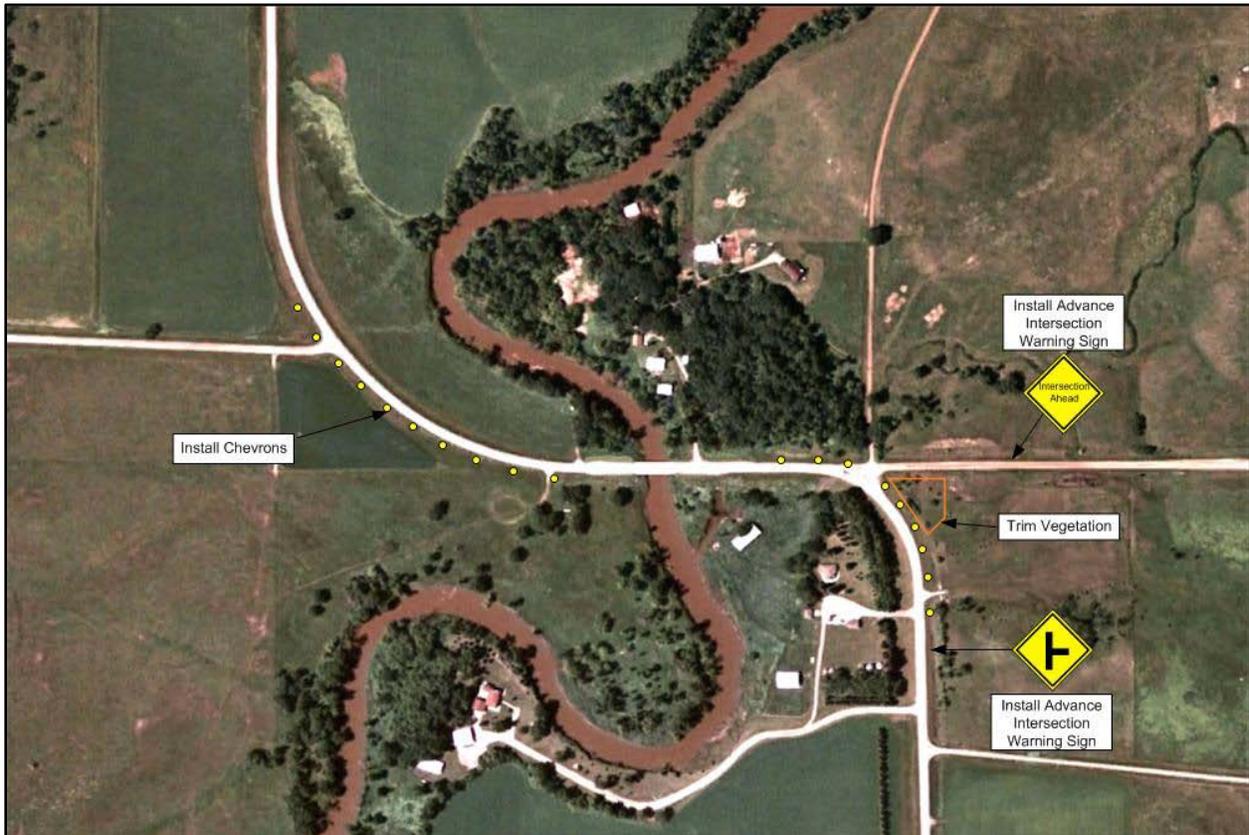
Figure 6.2 Short-term improvements for Skorpen Curve

Although this location was not ranked as high as the previous two, the ranking was only lower by .25, which illustrates the importance of evaluating the safety of this curve. It should be noted that two of the respondents ranked this location as having the worst safety issues (see Appendix B). The general layout and safety issues at Skorpen Curve are relatively similar in nature to the issues encountered at Bloomberg Hill, with a few exceptions. As a result, the strategies for improving the safety at this location are similar (Figure 6.2). The improvement strategies for Skorpen Curve are listed at follows:

- Install edgeline rumble strips
- Install centerline rumble strips
- Install dynamic speed advisory signs to alert drivers to their speed
- Widen the shoulders on the curves and bridge

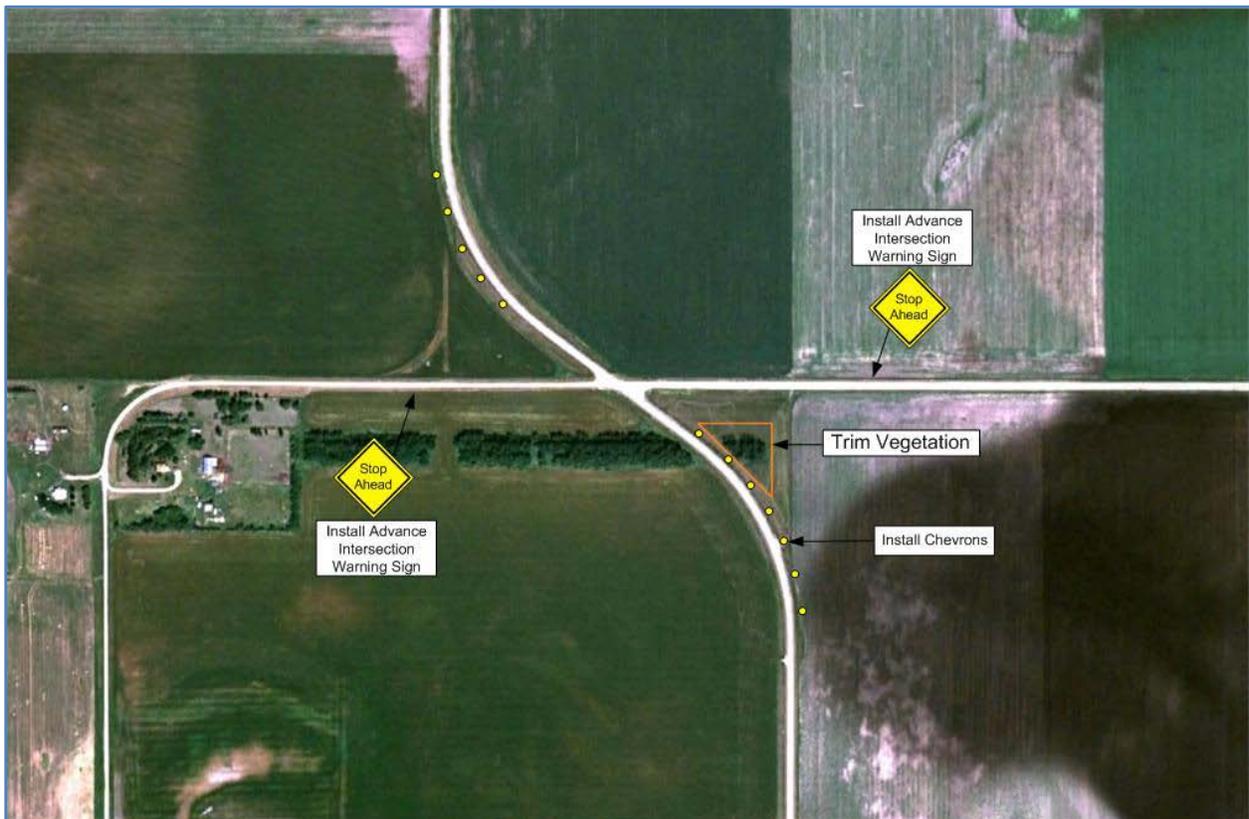
Figure 6.3 Short-term improvement suggestions for the curve north of Valley City

This location was examined by the evaluation team due to concerns resulting from previous crashes (one of which resulted in a fatality). This location is a reverse curve having similar safety issues as the others, such as vegetation/trees blocking the view and an intersection at the center of the curve. This location had a ranking of 3.5, with the highest respondent ranking of 2 (Appendix B). The recommended safety improvements for this location are listed as follows:

- Install edgeline rumble strips
- Install centerline rumble stripes
- Widen the shoulders on the curves
- Install dynamic speed advisory signs to alert drivers to their speed
- Re-align the gravel road (30th St. SE) so it is perpendicular to Highway 21
