**FIELD APPLICATION OF Z-SPIKE REJUVENATION
TO SALVAGE TIMBER RAILROAD BRIDGES**

Richard M. Gutkowski, Ph.D., P.E.
Nathan J. Miller, M.S.
Dept. of Civil and Environmental Engineering
Colorado State University
Fort Collins, Colorado

December 2011

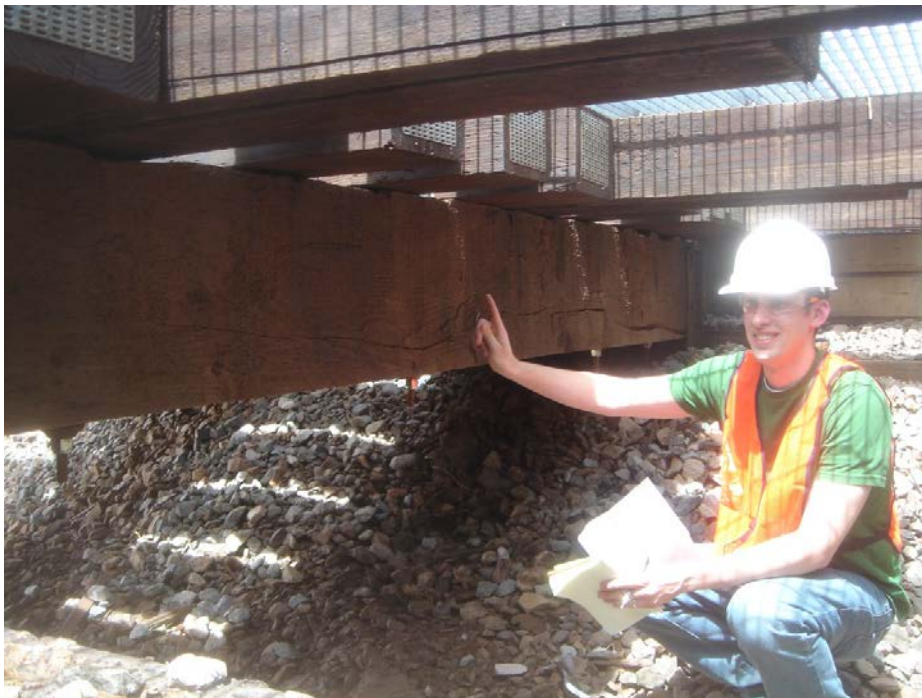
Figure C.2 Close up of crack in stringer 1, span 1. Coded 2A

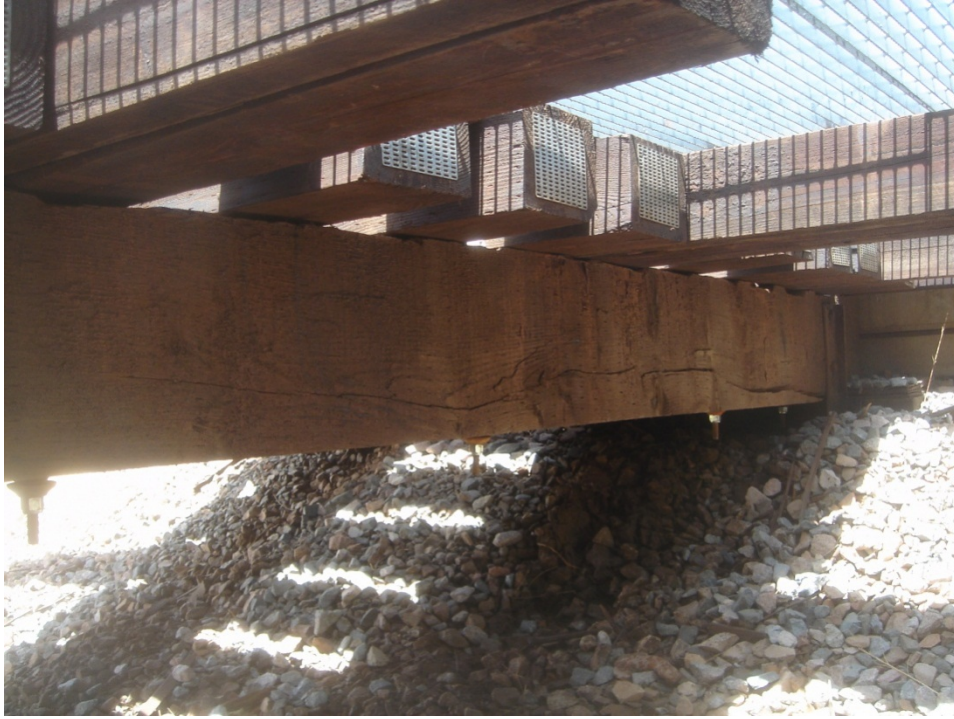
Figure C.3 Span 1, Stringer 1, badly cracked due to large knots and split near abutment.

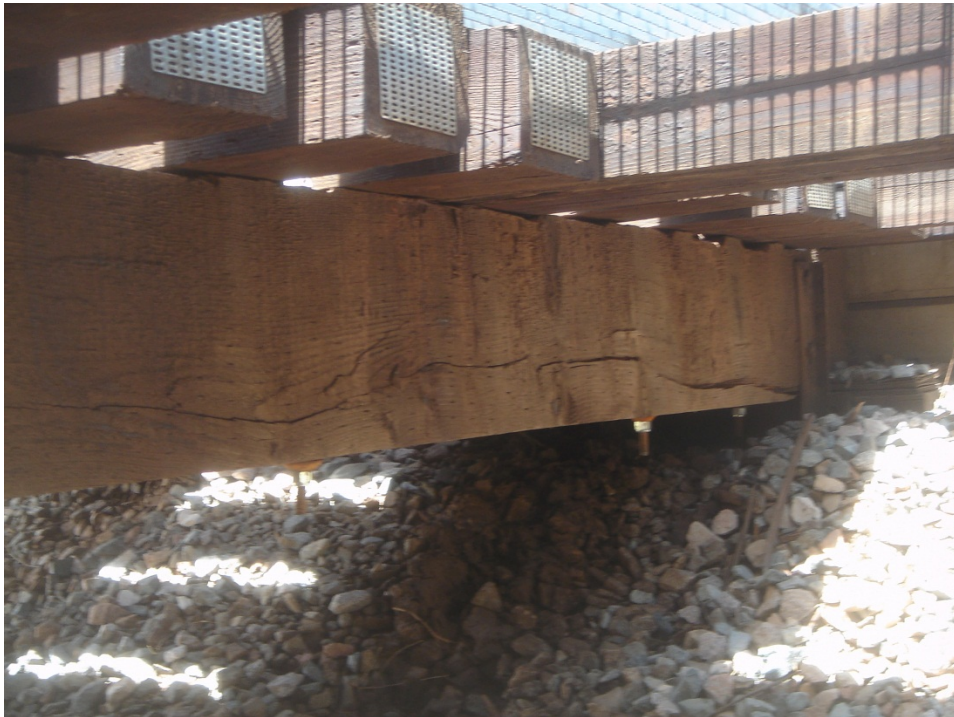
Figure C.4 Span 1, Stringer 1, badly cracked due to large knots and split near the abutment.

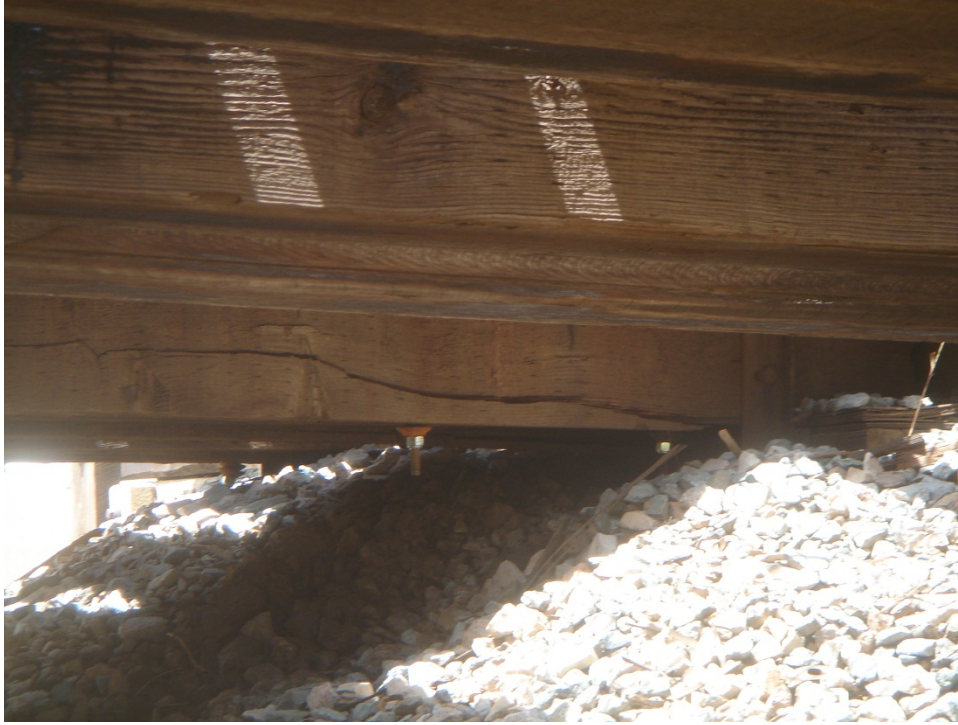
Figure C.5 Span 1, Stringer 1, badly cracked due to large knots and split near the abutment.

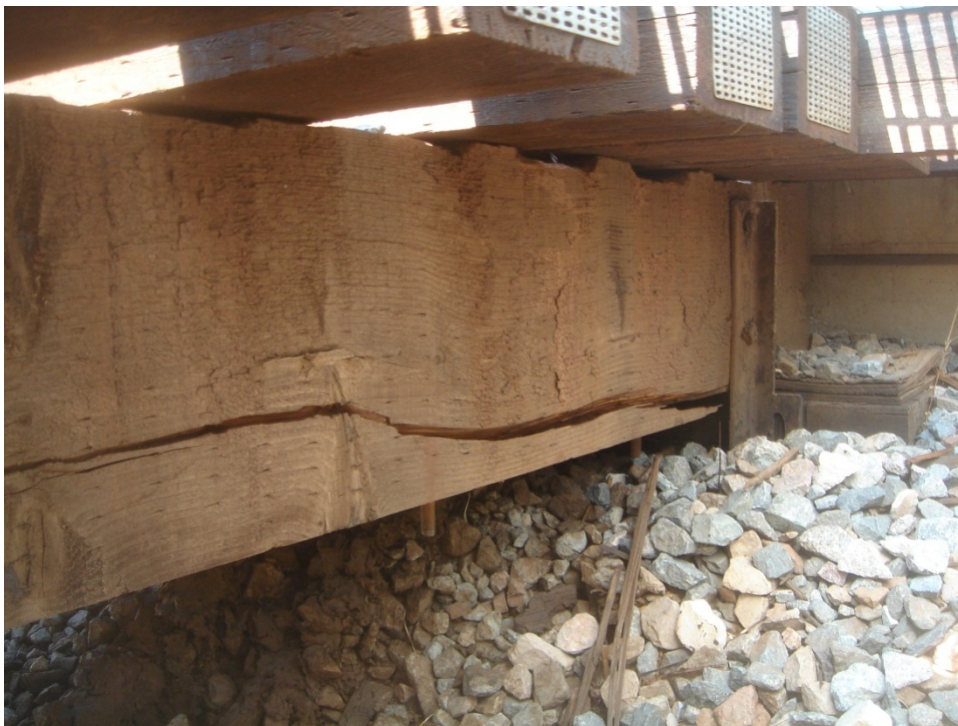
Figure C.6 Bad knots, flexural cracks - Span 1, abutment end of Stringer 1.

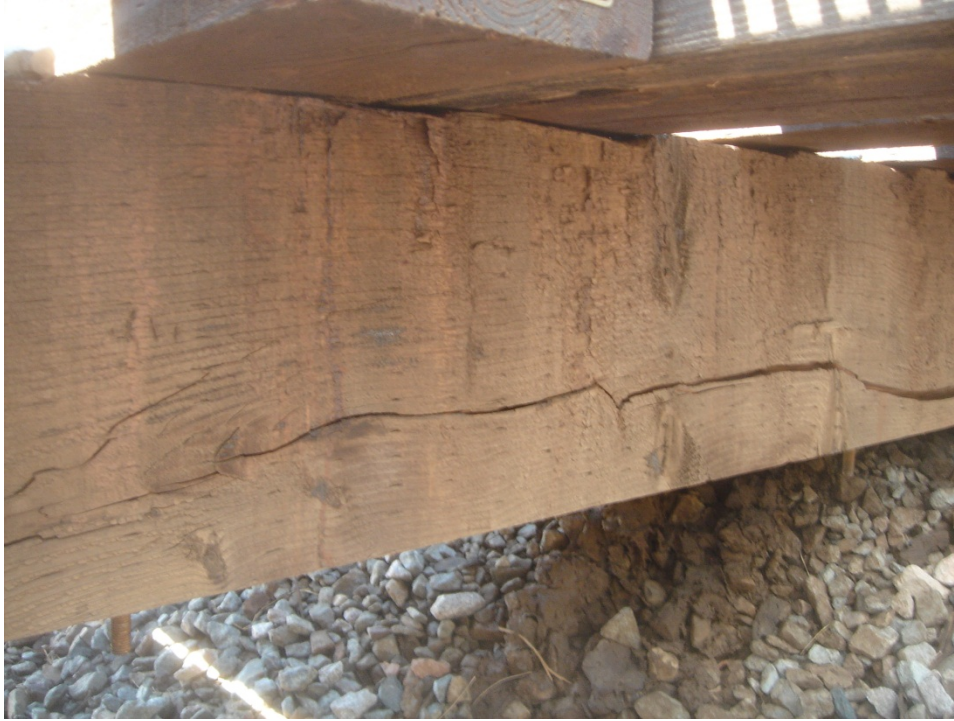
Figure C.7 Bad knots, flexural cracks - Span 1, mid span of Stringer 1.

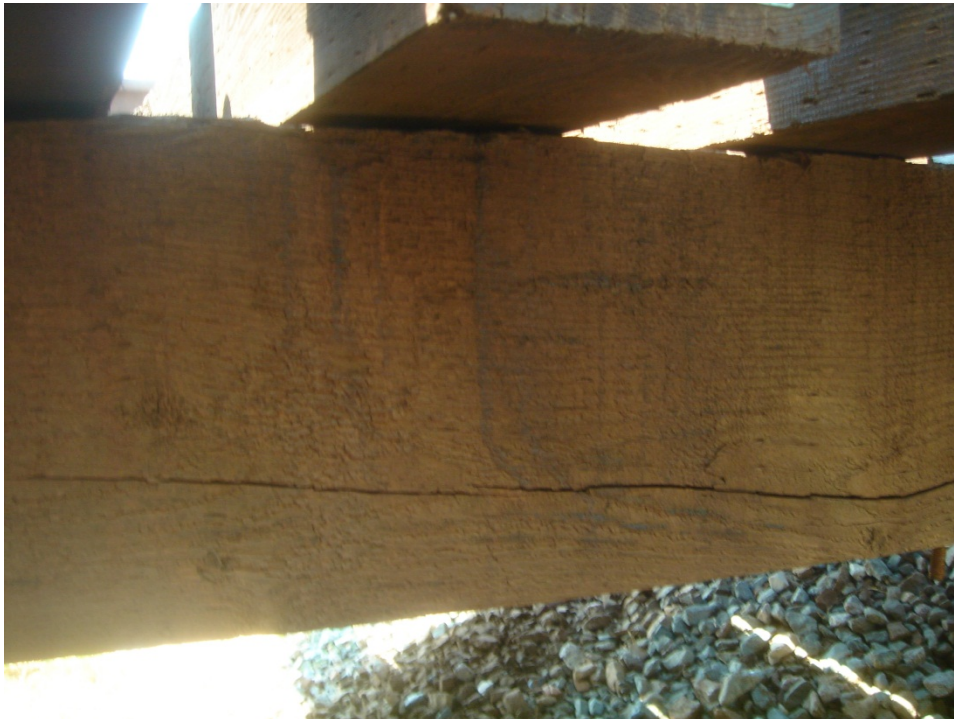
Figure C.8 Bad knots, flexural cracks - Span 1, mid span of Stringer 1.

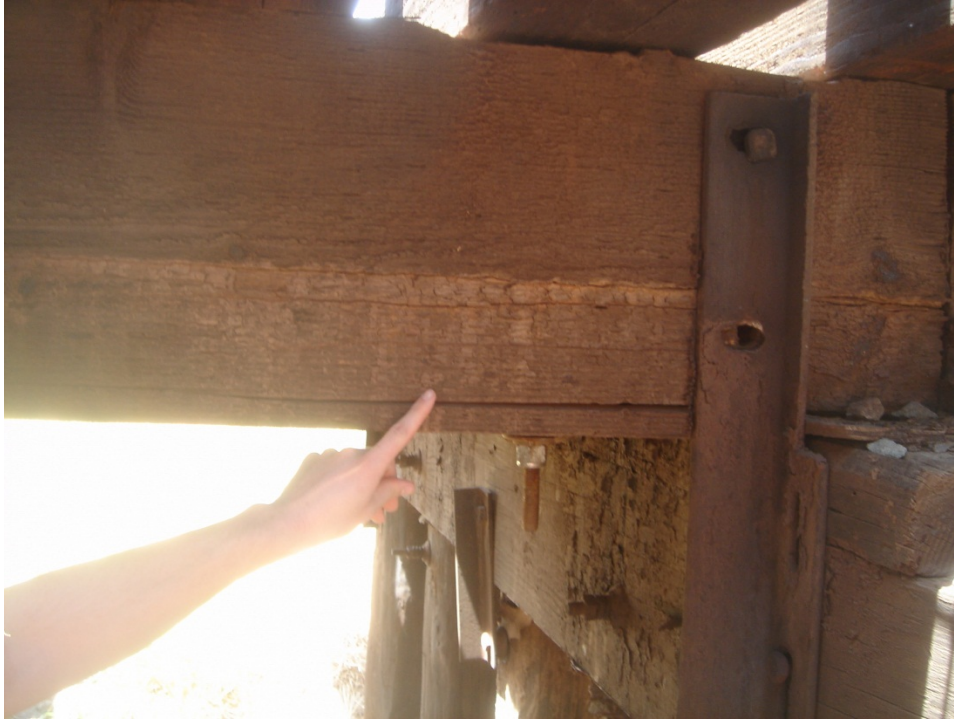
Figure C.9 Stringer 1, Span 2 - split in bottom of beam emanating from right end, notched bottom of beam at shimmed cap.

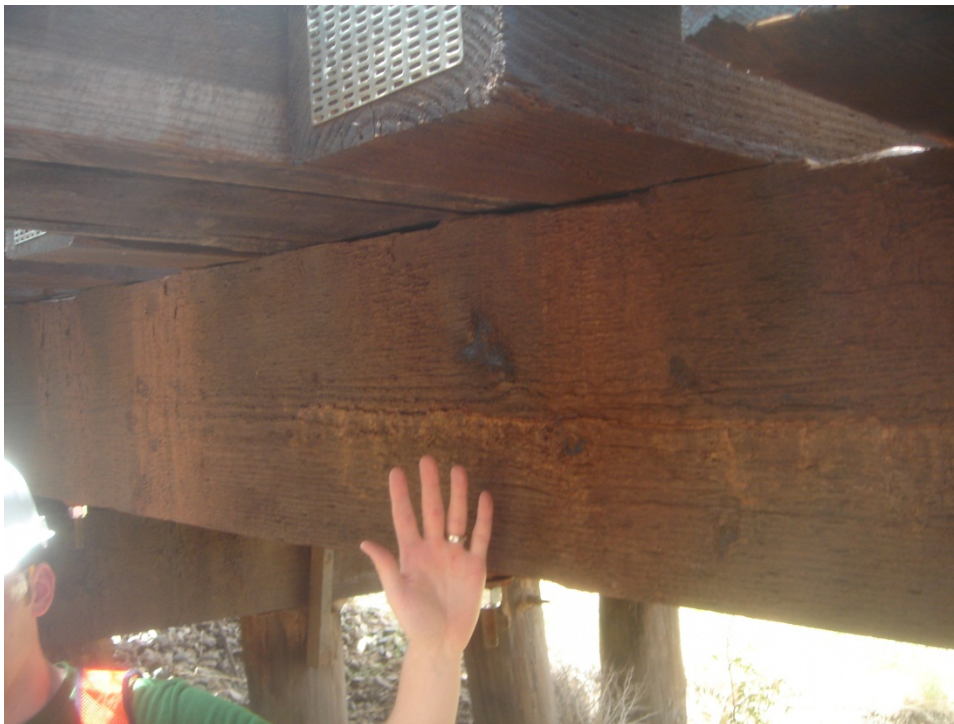
Figure C.10 Horizontal Shear Crack in Stringer 1, Span 2. Coded 4A

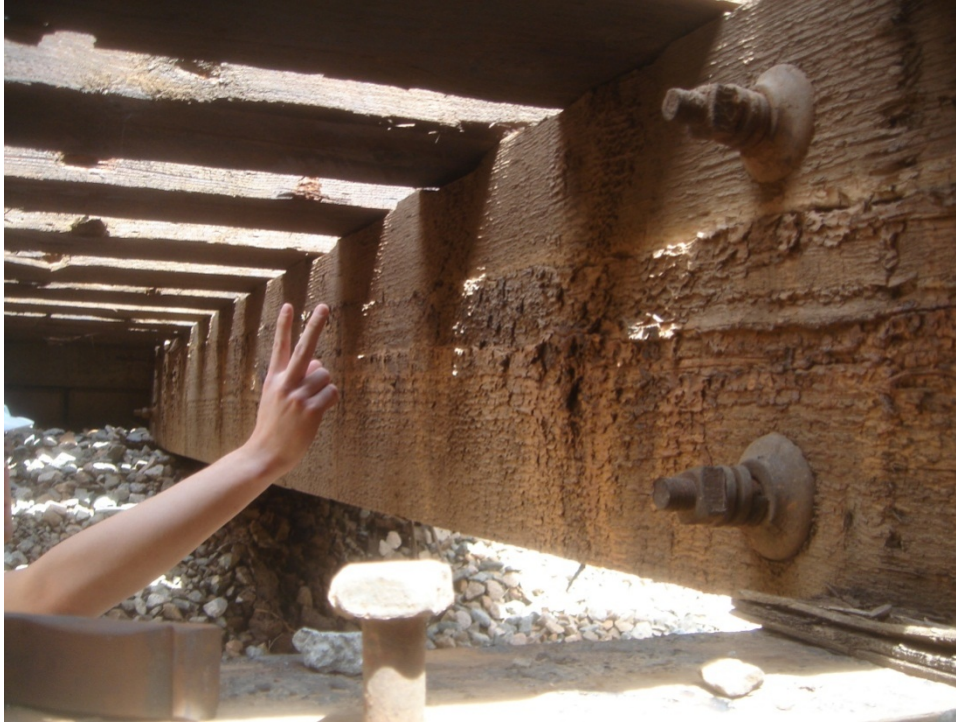
Figure C.11 Nathan pointing (2 fingers) to shear crack in stringer 4 , Span 1. Coded 4A

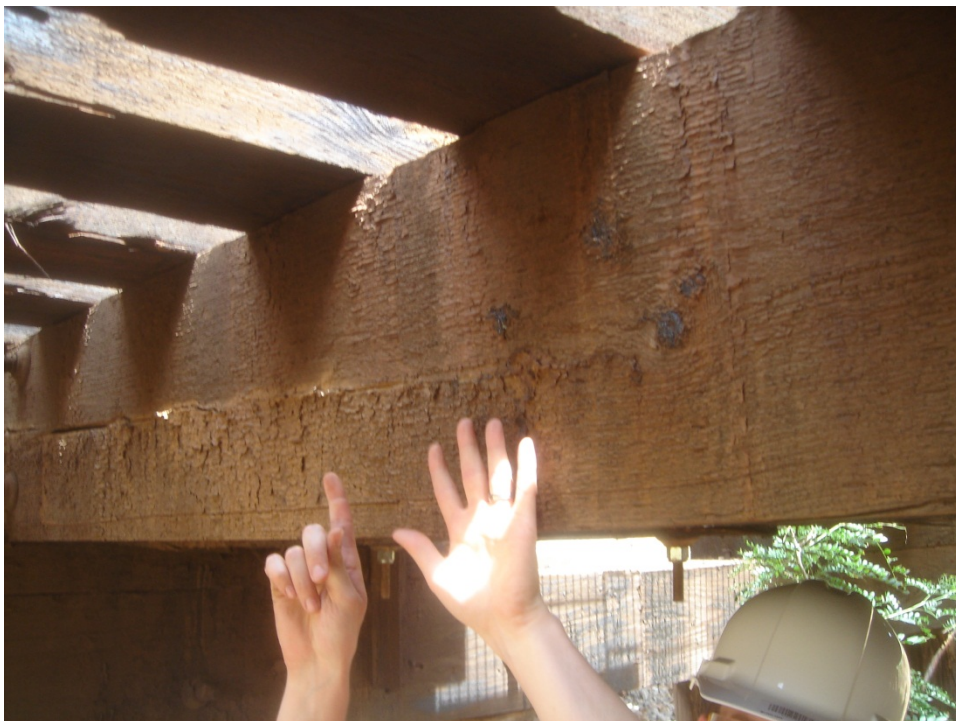
Figure C.12 Shear Crack in Stringer 4, Span 2. Coded 4A

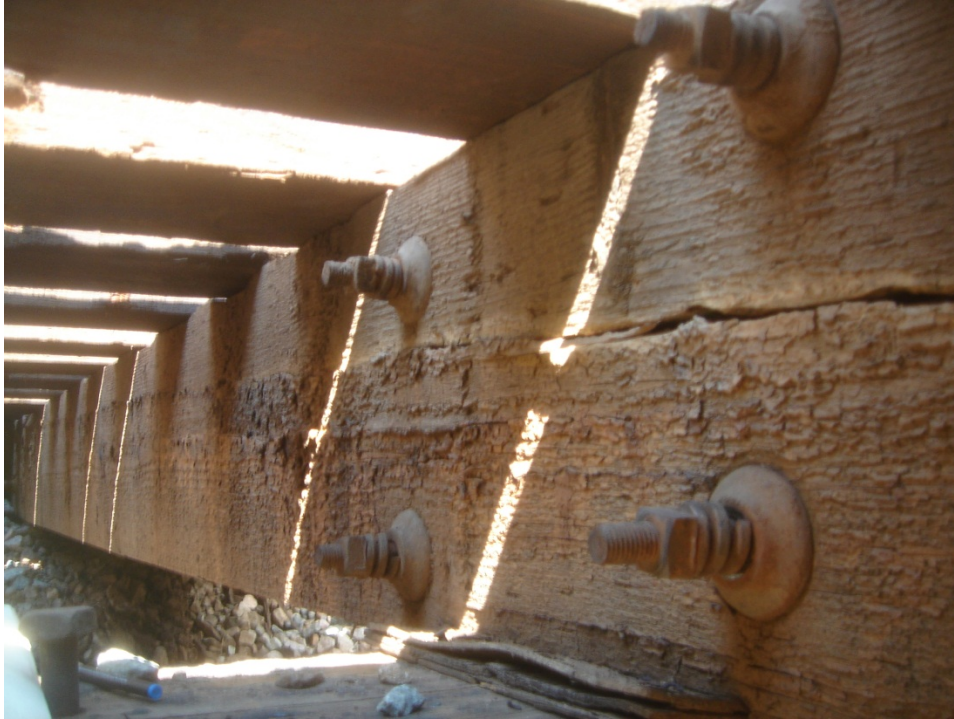
Figure C.13 Split at mid depth between lateral tie rods at Pier 2, stringer 4, spans 1 and 2.

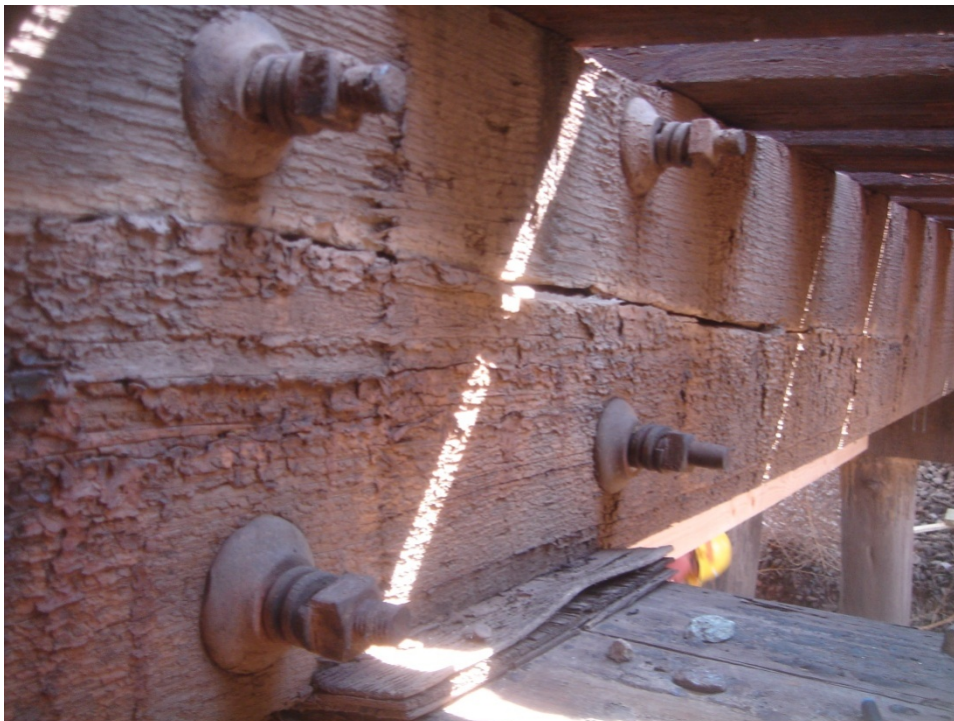
Figure C.14 Split at mid depth between lateral tie rods at Pier 2, stringer 4, spans 1 and 2.

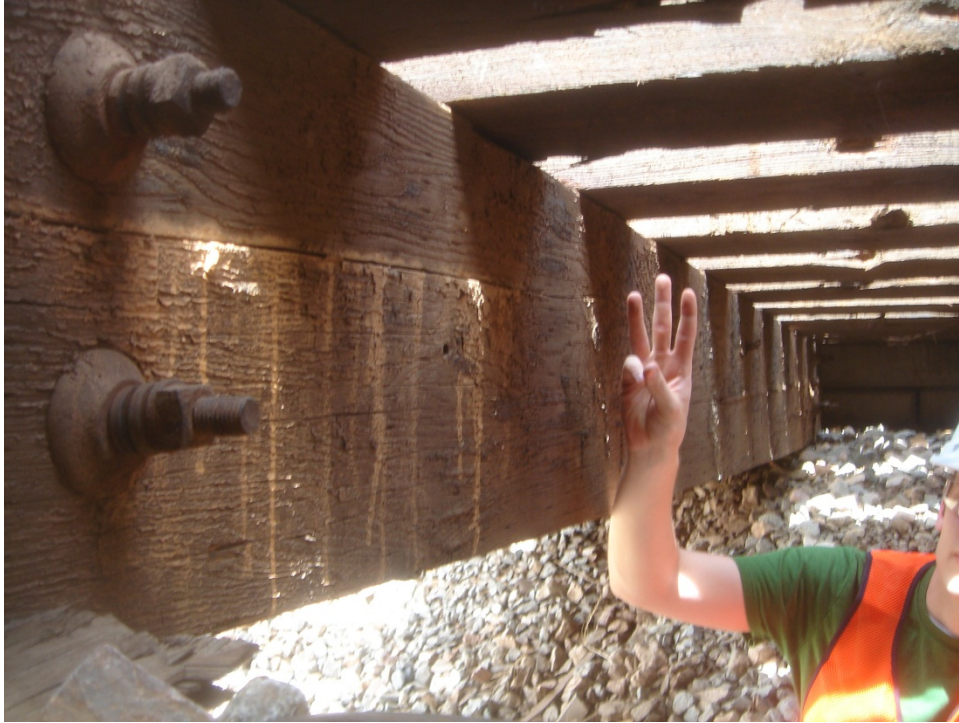
(Figure C.15 and Figure C.16) Similar to stringer 4, stringer 5 had a horizontal crack (about 1/8 inch wide) extending from above the intermediate pier about six feet into the far end of span 1 and about 12

Figure C.15 Stringer 5, Span 1 - Split between tie rods at interior pier. Coded 4A

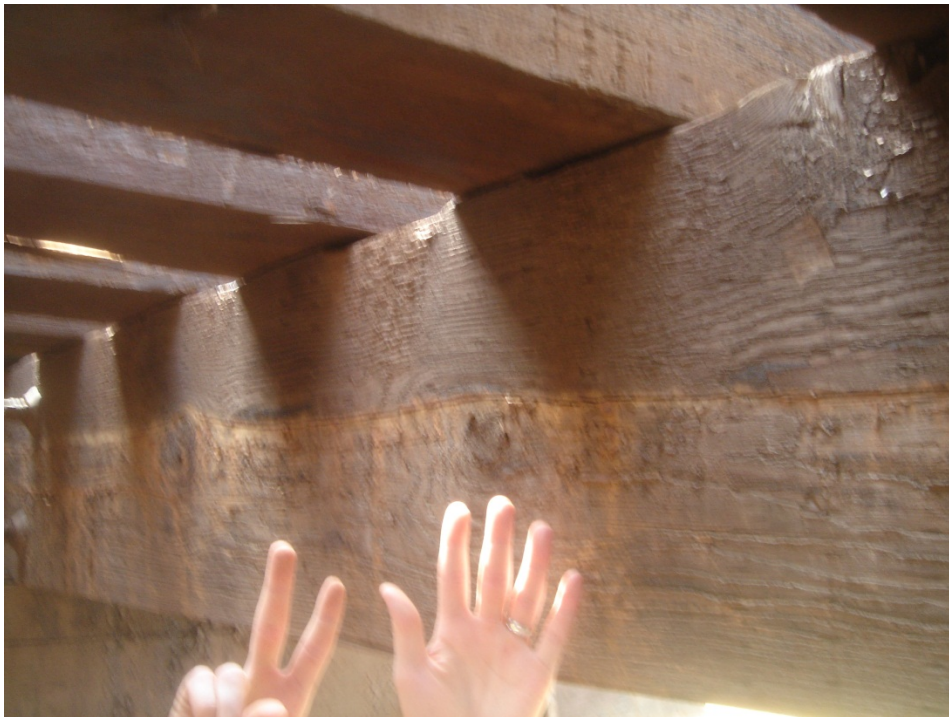
Figure C.16 Shear crack in Stringer 5, Span 2

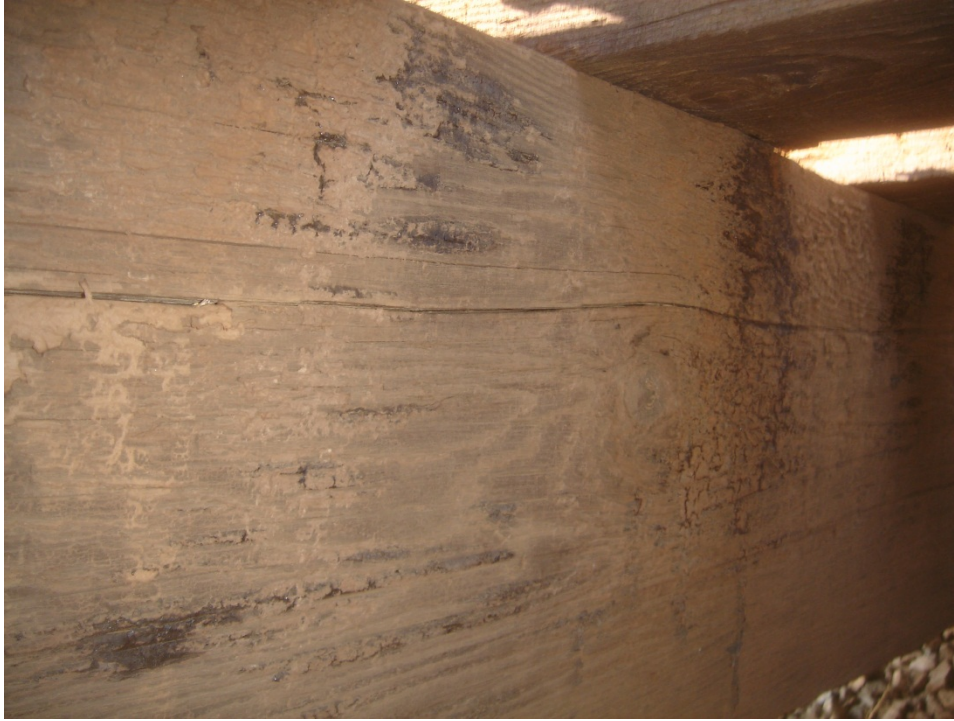
Figure C.17 Stringer 5, Span 1 – Horizontal crack looking away from the pier toward the abutment.

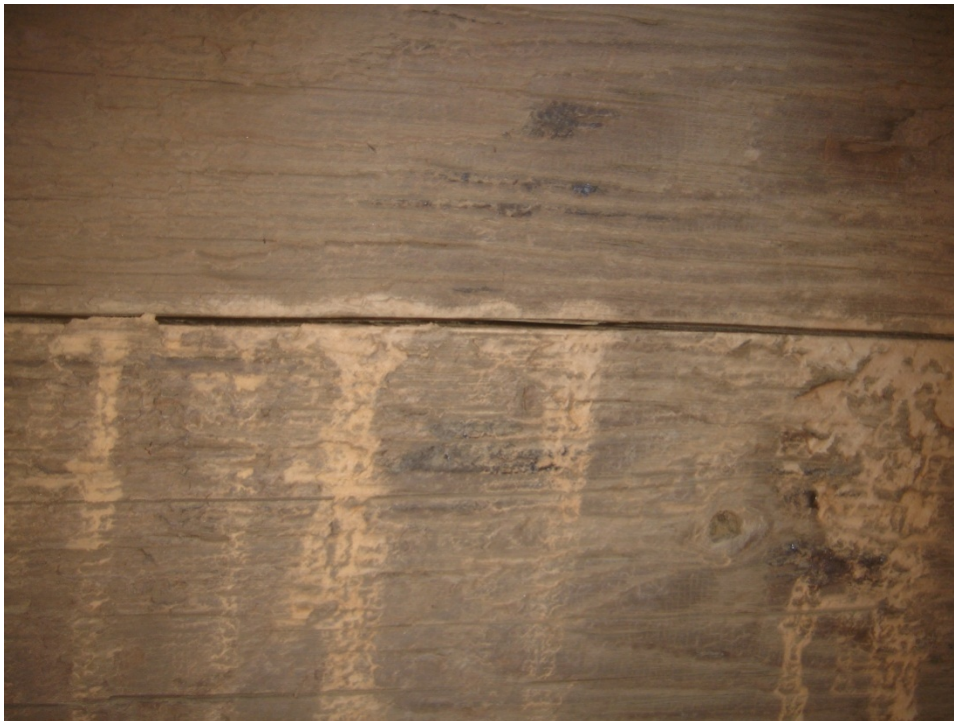
Figure C.18 Stringer 5, Span 1 – close up of horizontal crack.

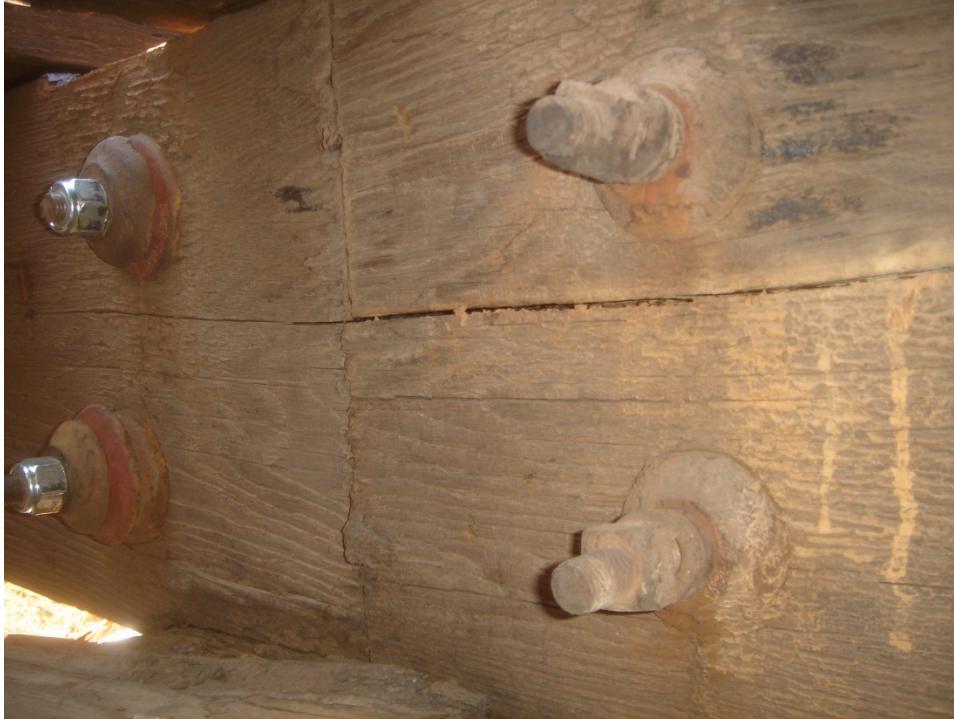
Figure C.19 Stringer 5 – Two members butted together over pier.

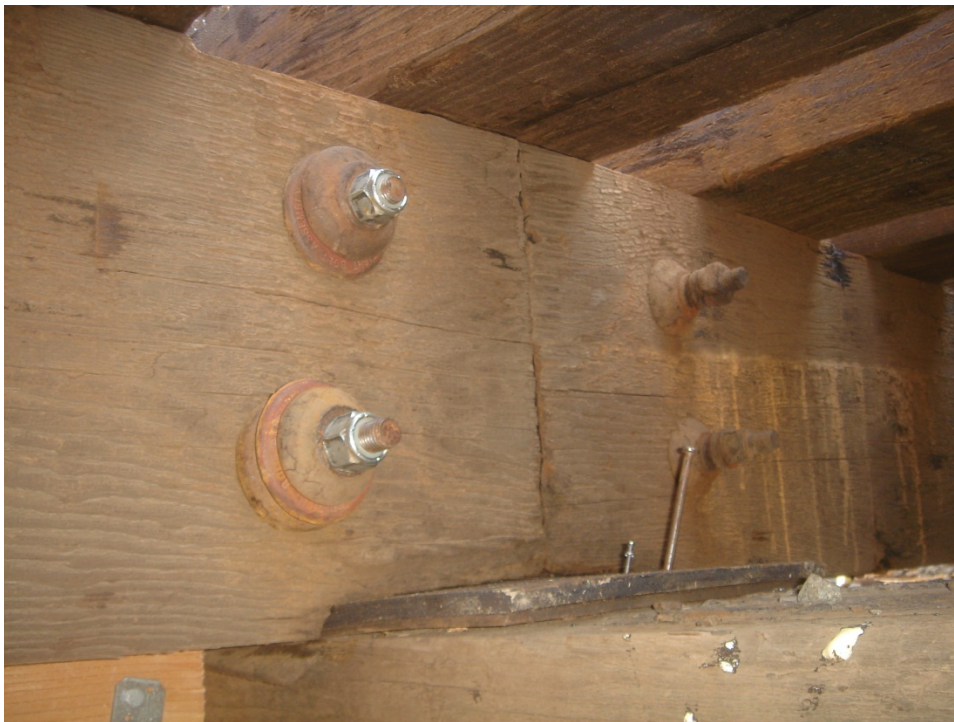
Figure C.20 Stringer 5, Spans 1 and 2 – Two members butted together over pier.

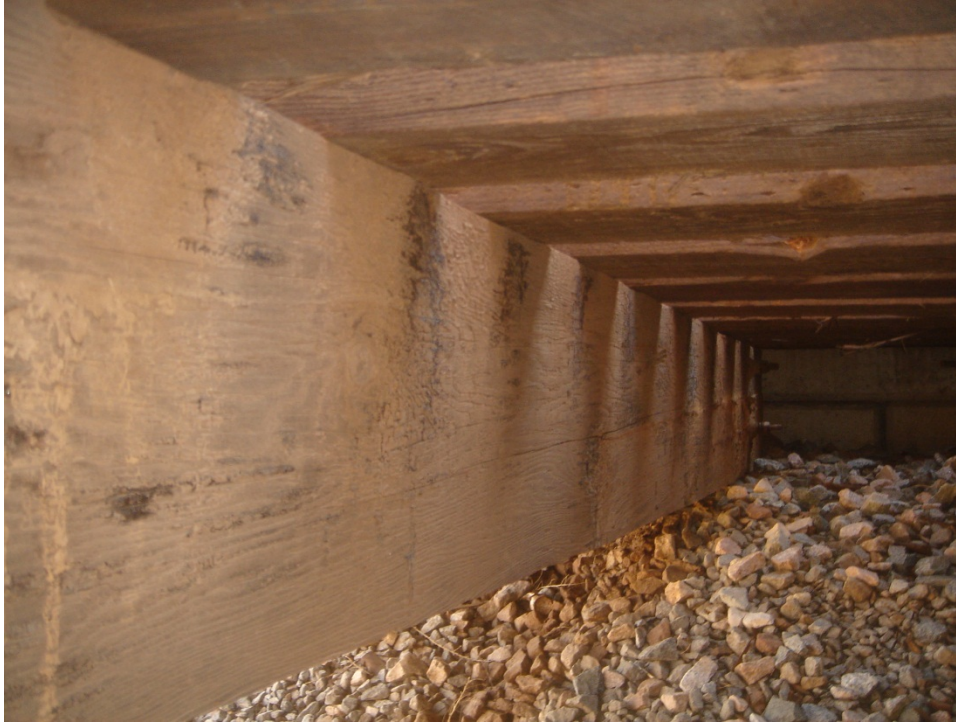
Figure C.21 Stringer 5, Span 1 – Horizontal Crack

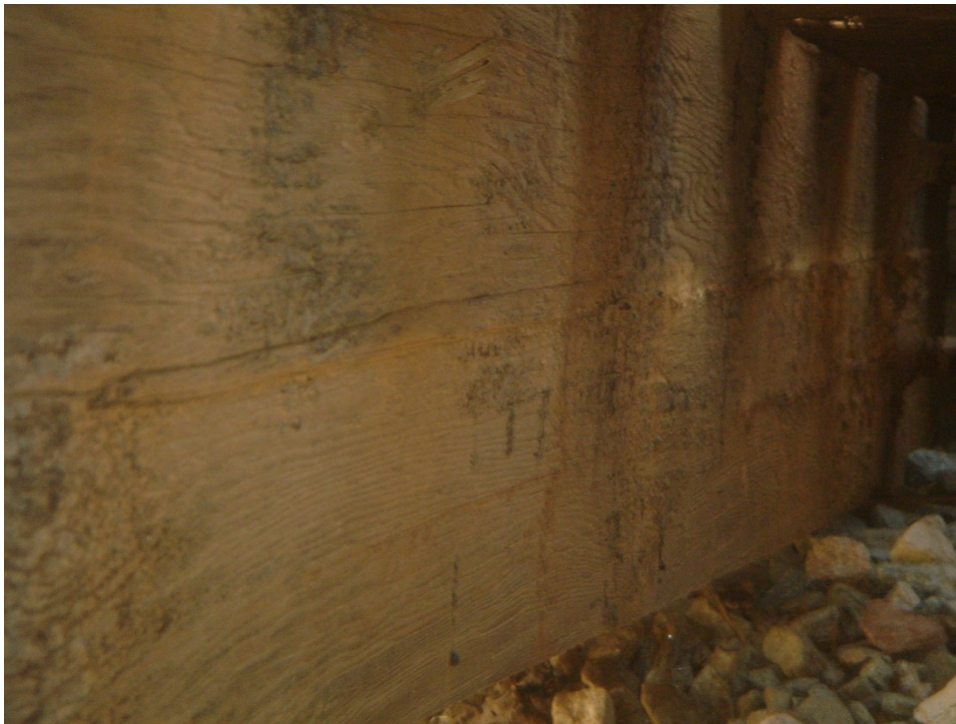
Figure C.22 Stringer 5, Span 1 – Horizontal Crack by abutment

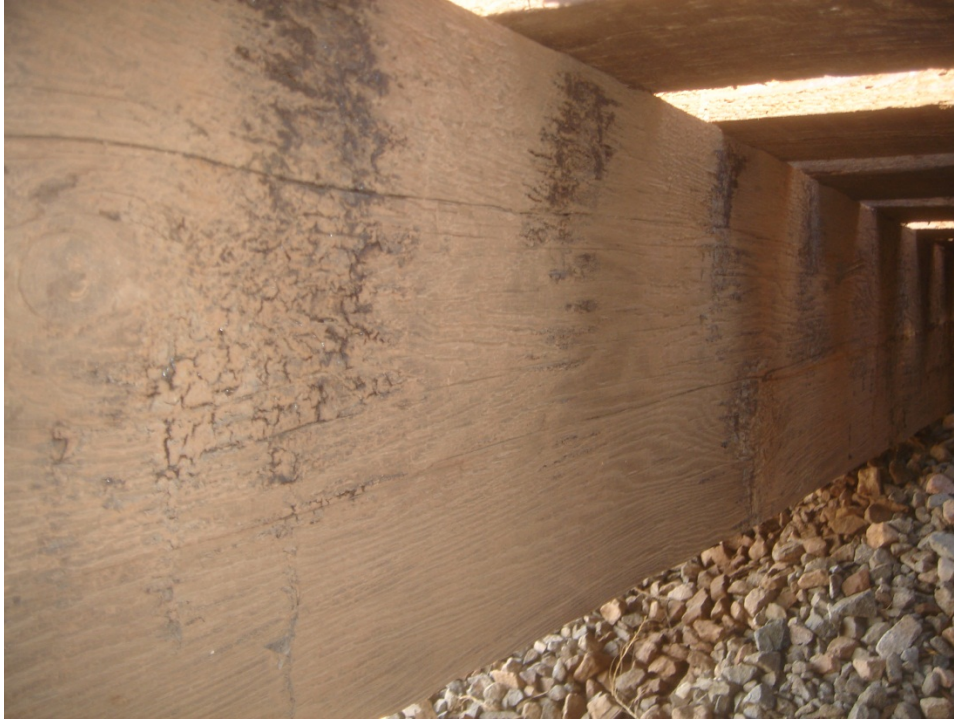
Figure C.23 Stringer 5, Span 1 – Horizontal crack near abutment

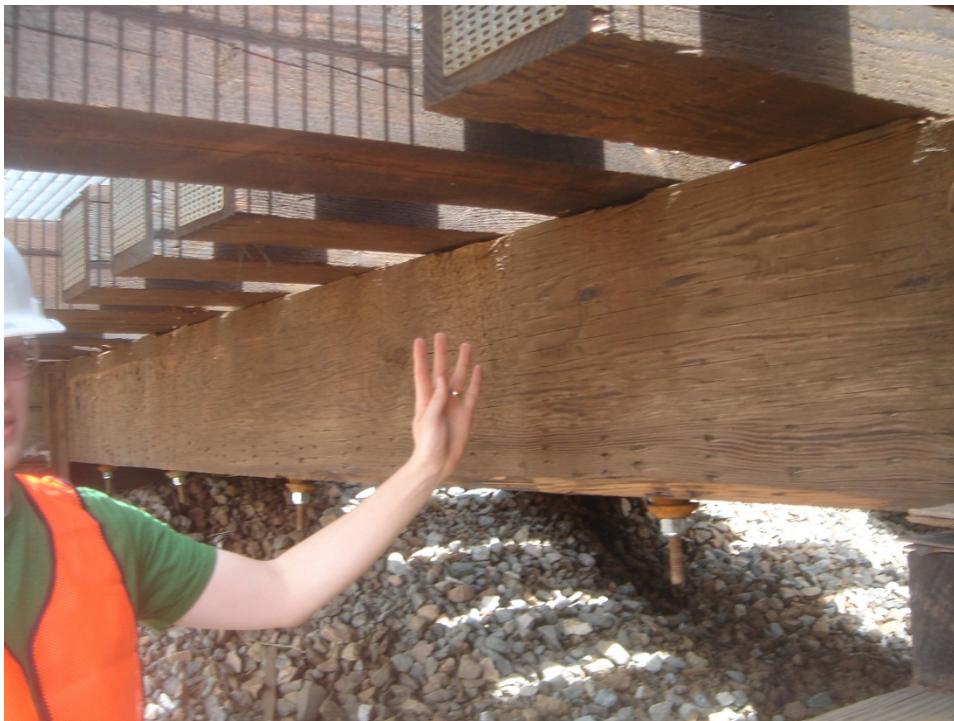
Figure C.24 Stringer 8, Span 1 – Minimal damage, despite 4A coding in inspection report.

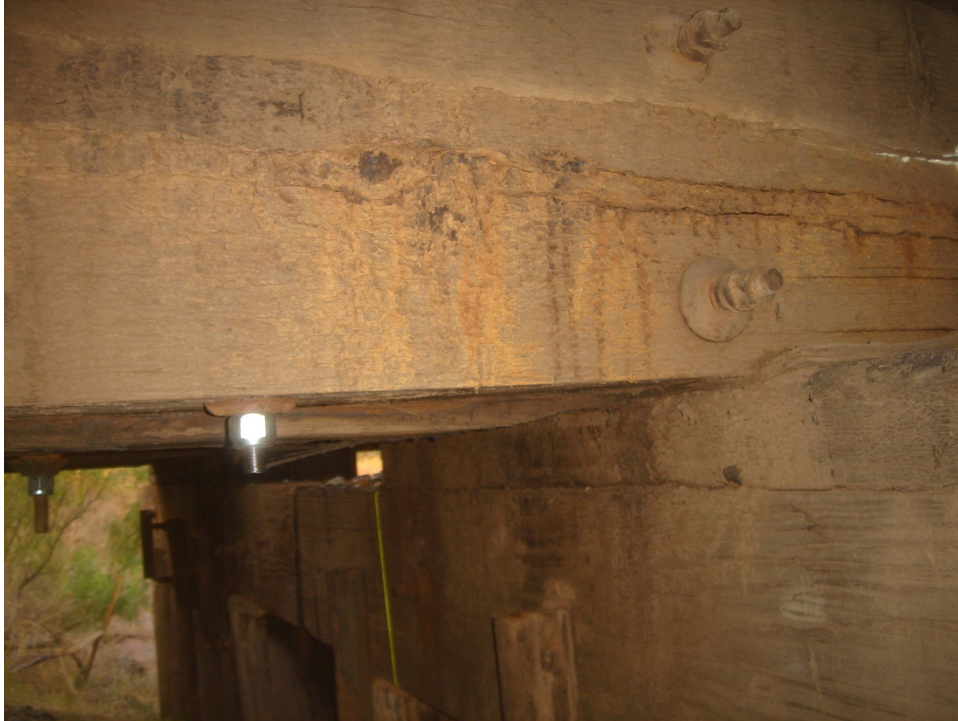
Figure C.25 View showing compressed Stringer 3, Span 1

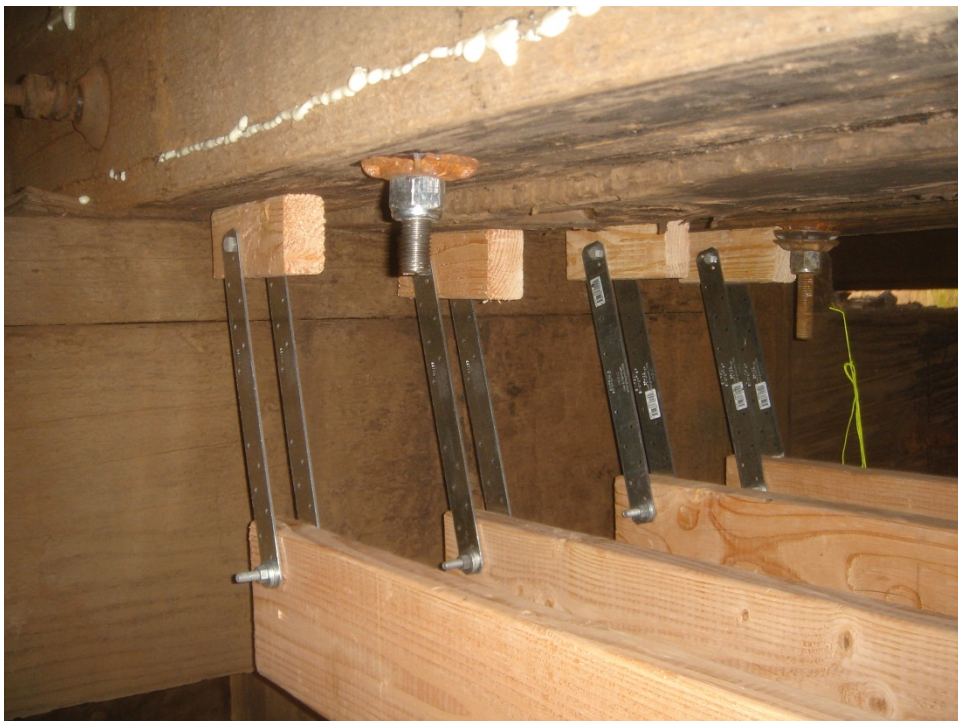
Figure C.26 View of showing compressed Stringer 3, Span 2

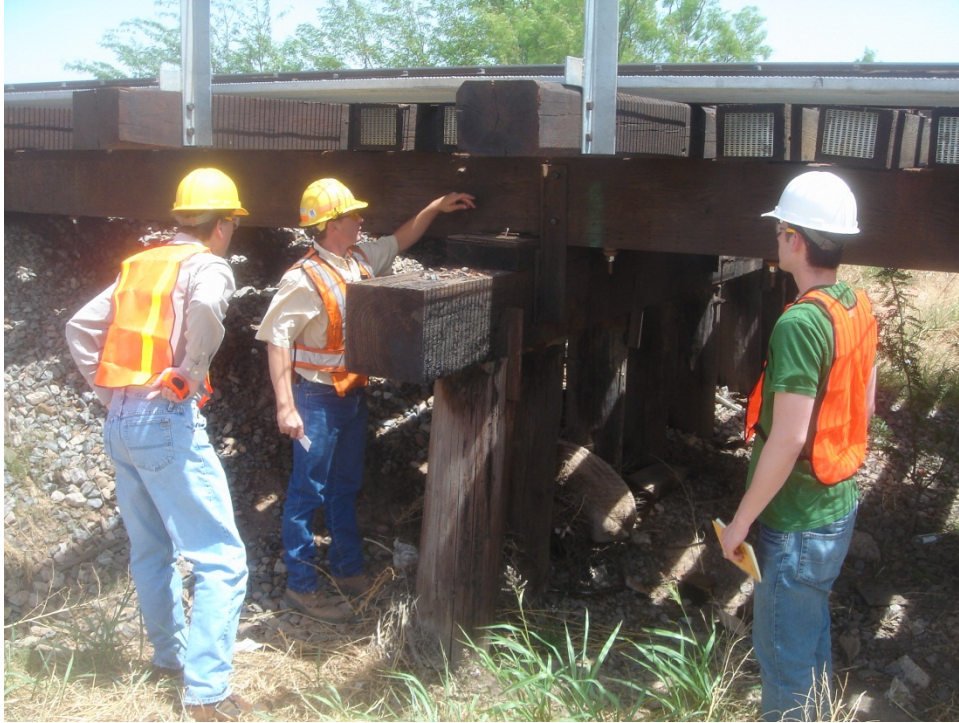
Figure C.31 Stringer 8 – Gap over pier between Span 1 and Span 2

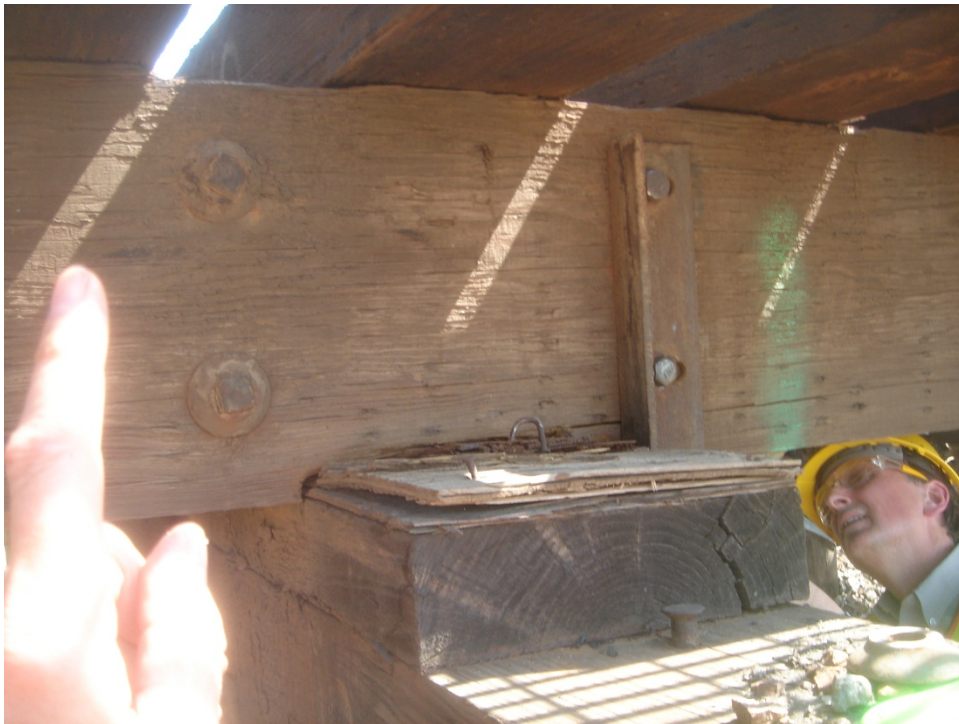
Figure C.32 Stringer 8 – Close up of damage over pier

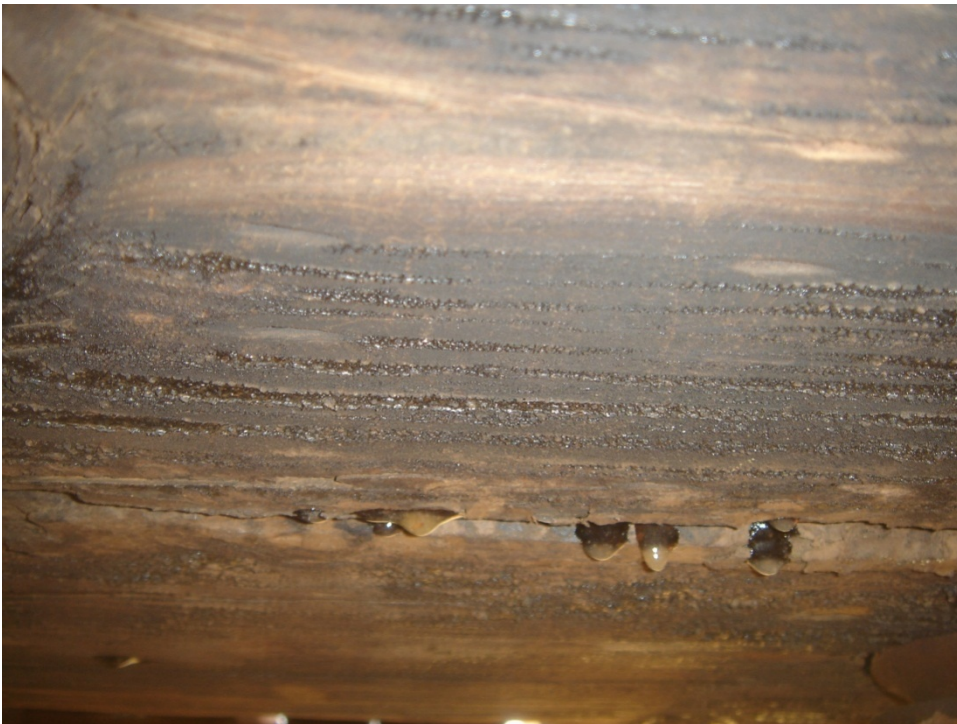
Figure C.40 Epoxy pushed out of cracks in beams

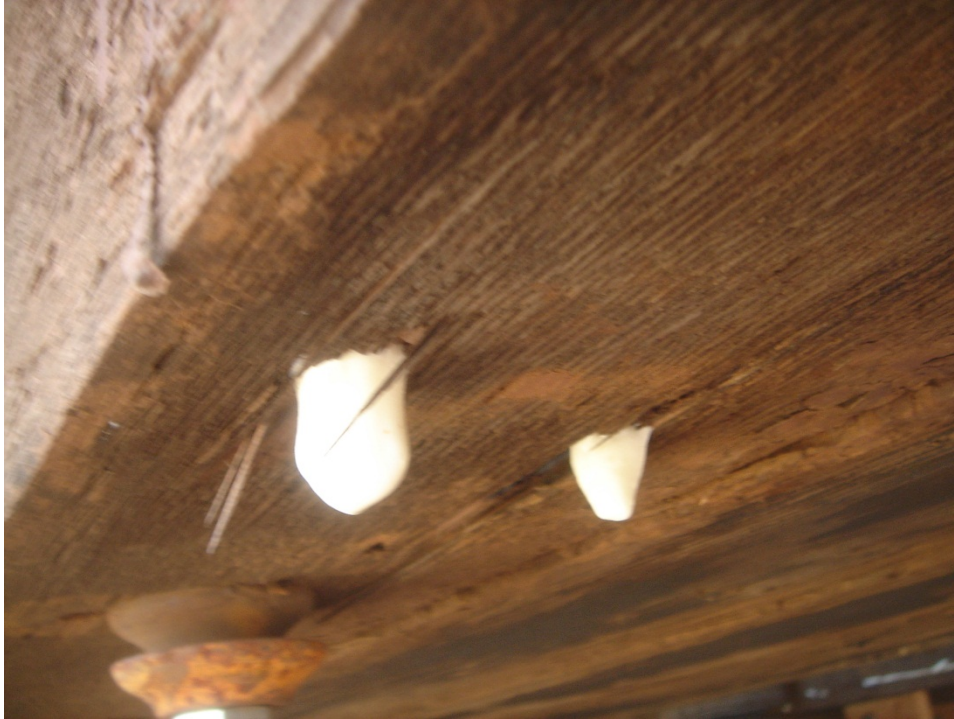
Figure C.41 Epoxy flowing through hole in bottom of beam.

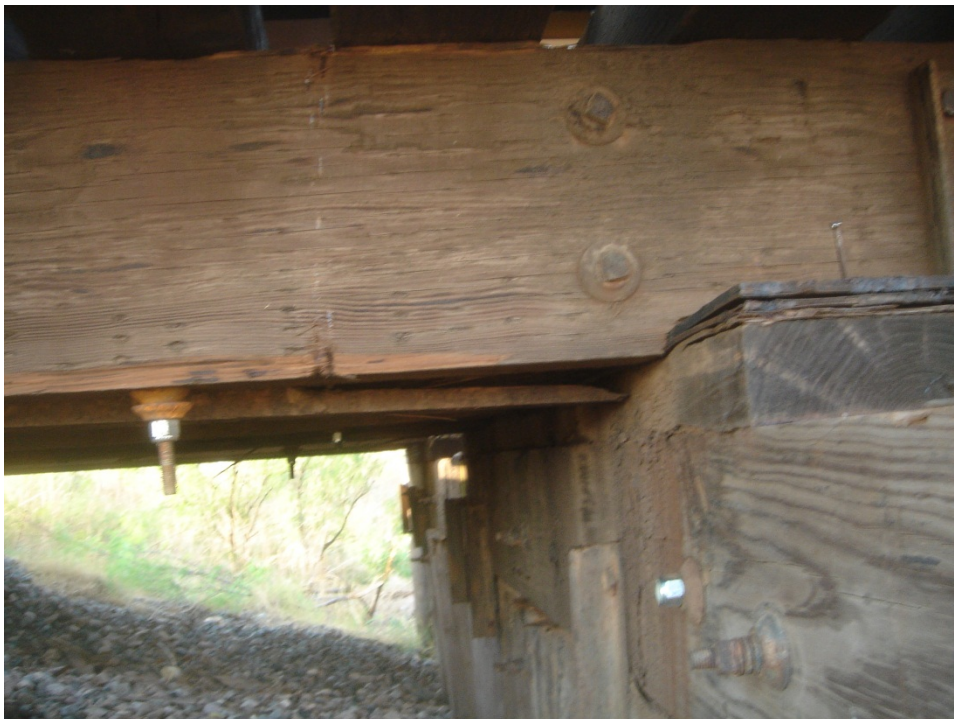
Figure C.54 Shimmed chord with stringer hanging below pier cap.
