MPC 19-389 | S. Rimal, B. Kidd, M. Tazarv, J. Seo, and N. Wehbe

Methodology for Load Rating Double-Tee Bridges

Department of Civil and Environmental Engineering
South Dakota State University
Brookings, South Dakota

July 2019

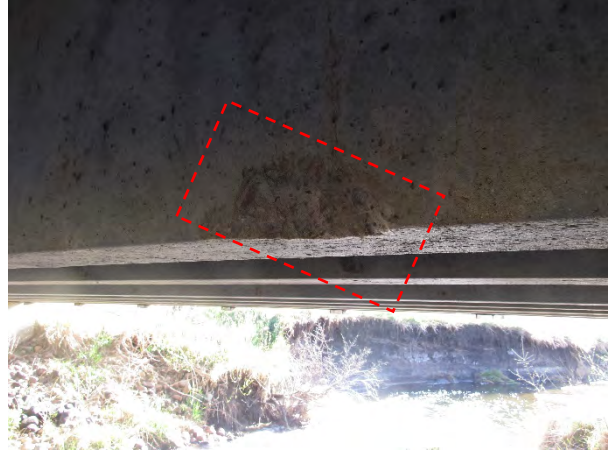
(b) Spalling at bottom of Stem, G4

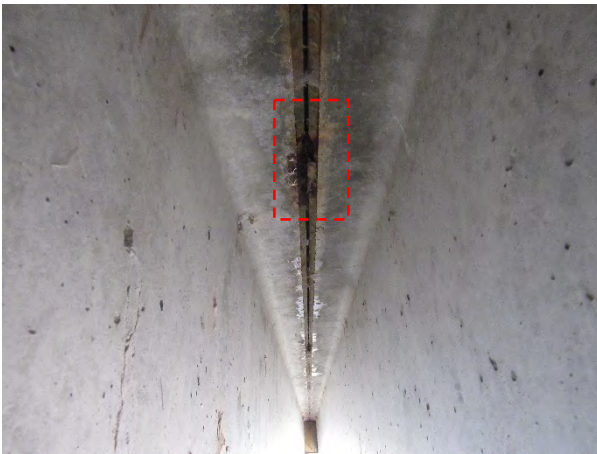
(c) Corrosion of Steel Plate

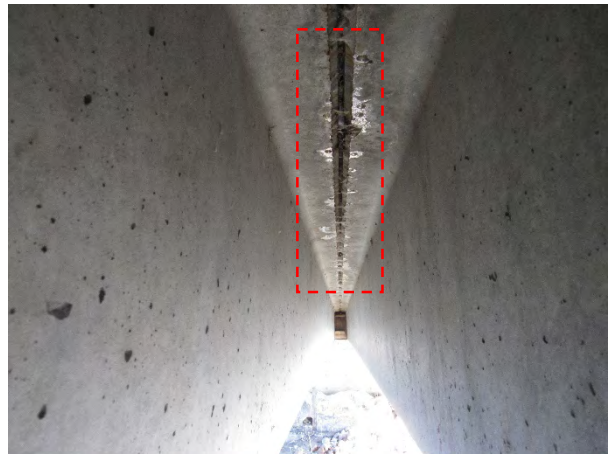
(d) Leakage in Joint

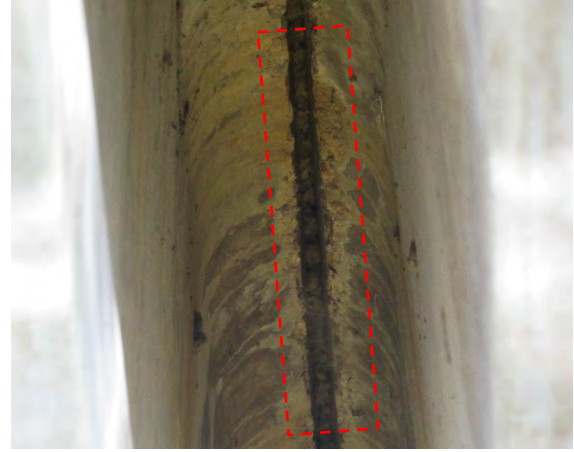
(b) Stains from Minor Corrosion of Steel Plates

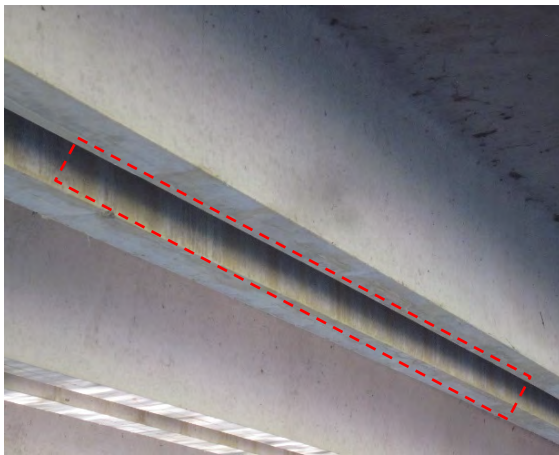
(c) Sign of Water Leak b/w Deck Units

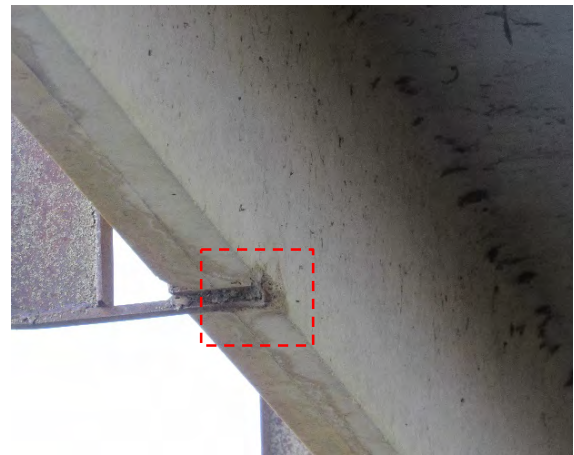
(d) Concrete Spalling at Railing

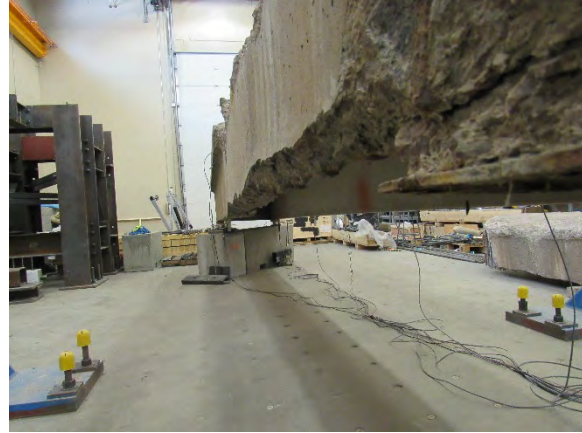
(b) Stem Cover Deterioration for 50-ft (15.24-m) Girder

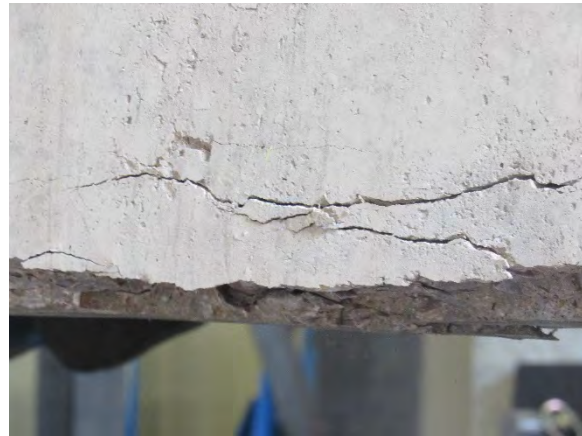
(d) Damage of 50-ft (15.24-m) Girder during Unloading

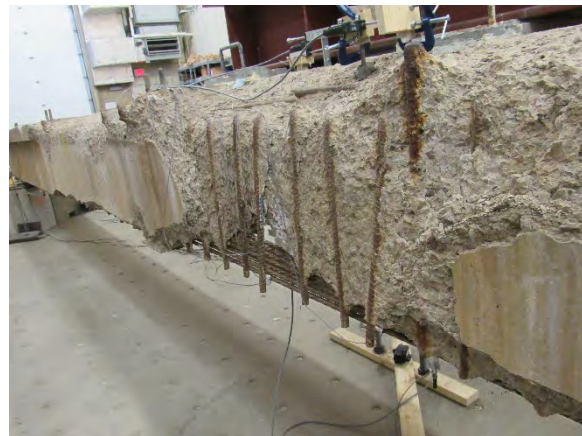
(f) Exposure of Strands and Transverse Bars on Stem of 50-ft (15.24-m) Girder

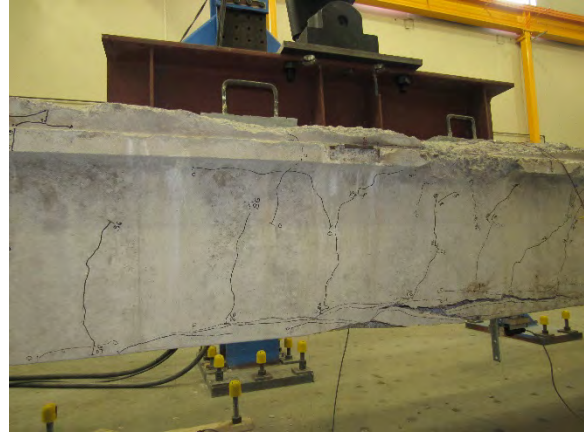
(b) Extension of Flexural cracks

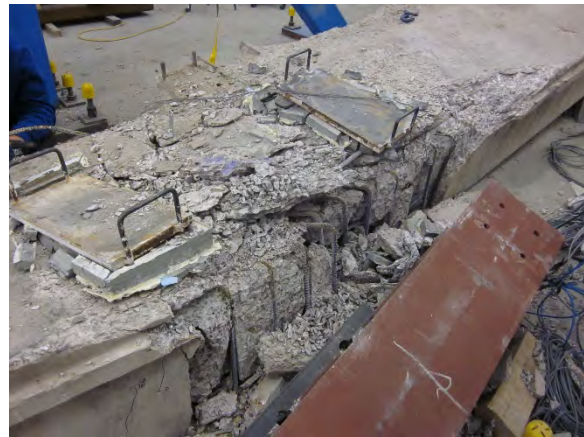
(d) Brittle Failure at Midspan

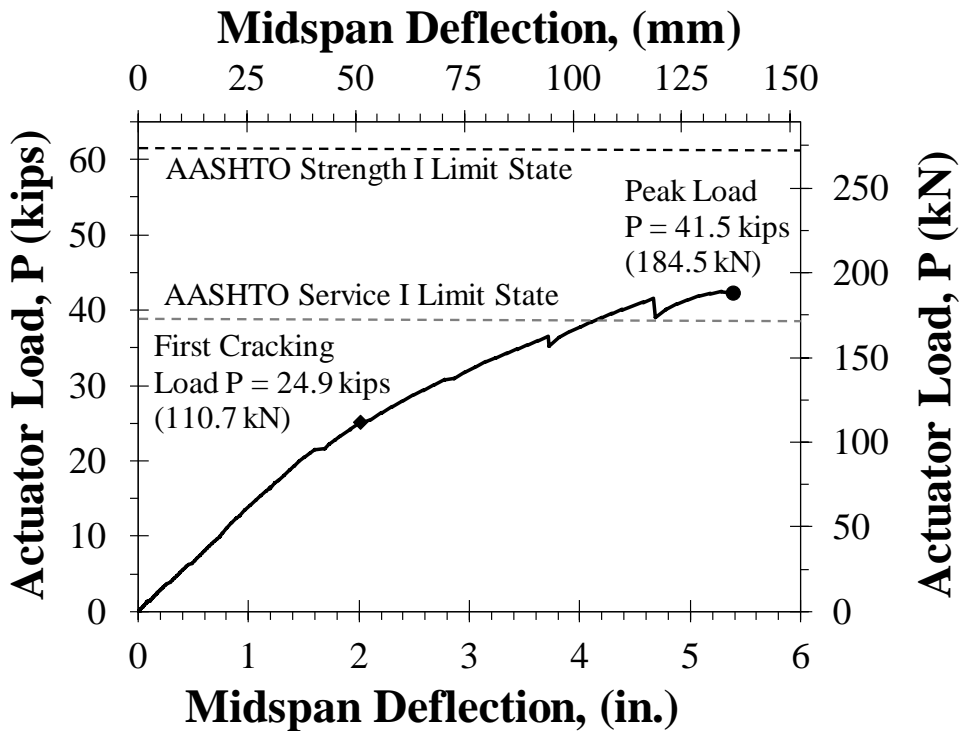
Figure 6.27 Measured Force-Deflection Relationship for 50-ft (15.24-m) Long Girder

Figure 6.27 shows the measured force-deflection relationship for the 50-ft (15.24-m) long double-tee girder. Loads equivalent to the AASHTO Service I Limit State and the AASHTO Strength I Limit State are also included in the figure. The first crack of the girder was at an actuator force of 24.9 kips (110.7 kN), which was 35% lower than the load equivalent to the AASHTO Service I Limit State. Failure mode of this girder was the compressive failure of the flange concrete at the midspan at a 5.4 in. (137 mm) of deflection. It was a brittle failure with no sign or warning while the girder was designed as a flexural member. It is clear that the girder did not meet the AASHTO requirements.

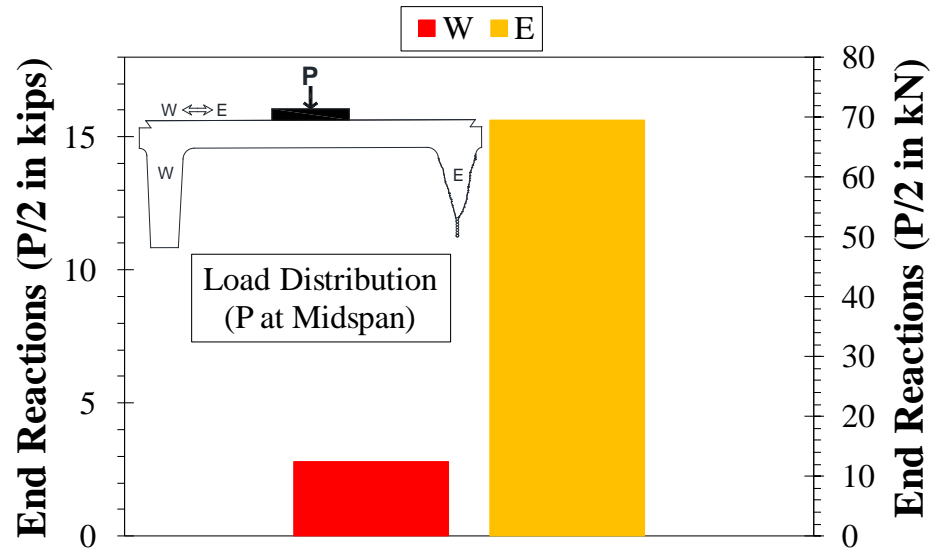
Figure 6.28 South End Support Reactions for 50-ft (15.24-m) Long Girder at Peak Load

Figure 6.28 shows the measured south end stem reactions of the 50-ft (15.24-m) long girder at the peak load. It can be seen that the east stem resisted 81% more load than the west stem. The east stem was severely damaged (exposure of steel tendons) prior to delivery to the test lab.

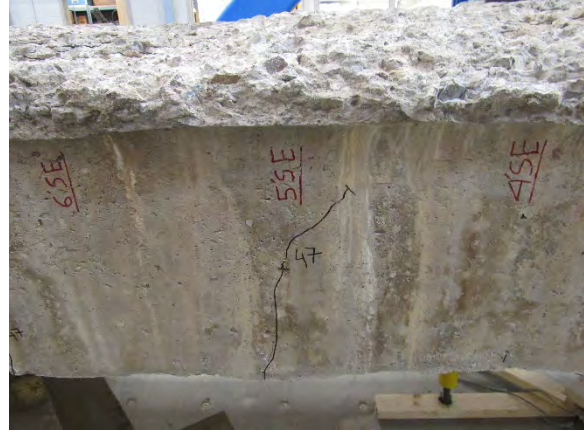
(b) Flexural Crack Near to Midspan

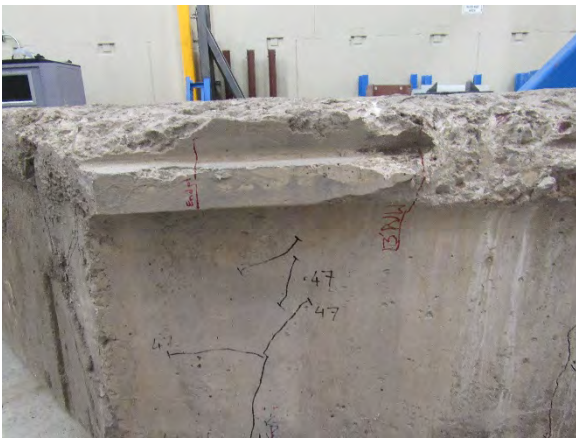
(c) Shear Crack Near North End

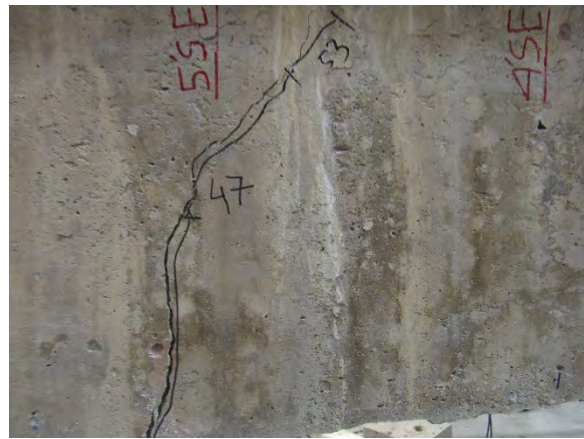
(d) Extension of Crack Width

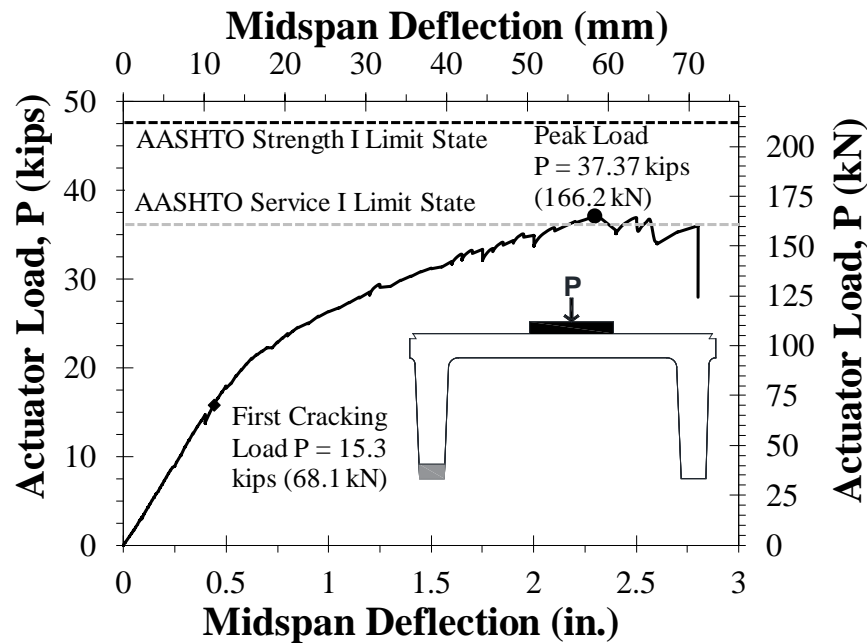
Figure 6.33 Measured Force-Deflection Relationship for 30-ft (9.14-m) Long Girder

Figure 6.33 shows the measured force-deflection relationship for the 30-ft (9.14-m) long double-tee girder. Loads equivalent to the AASHTO Service I and Strength I Limit States were also included in the figure. The first crack of the girder was at a force of 15.3 kips (68.1 kN), which was 44% lower than the load equivalent to the AASHTO Service I Limit State. This girder failed at a 2.3-in. (58-mm) deflection with a major flexural crack at the midspan. It is clear that the girder did not meet the AASHTO requirements.

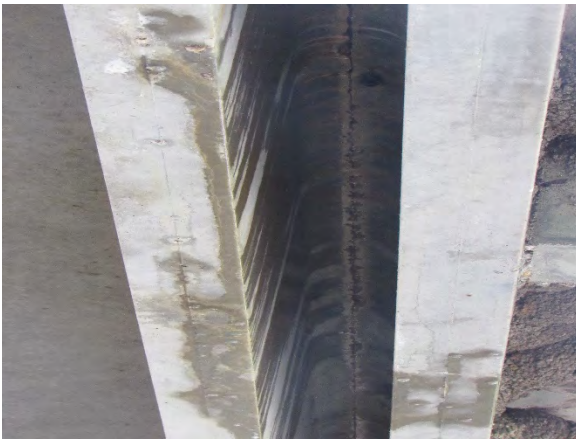
(c) Leakage from joint

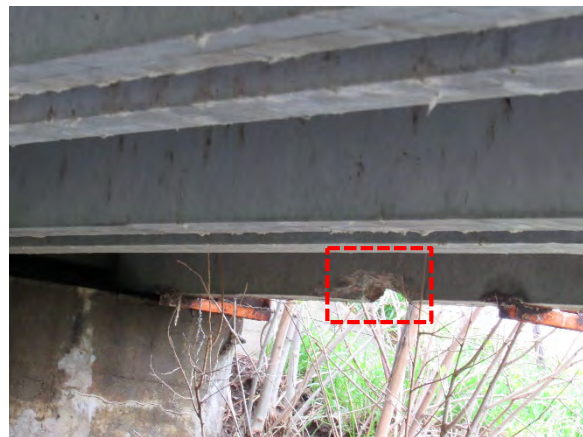
(d) Deterioration at bottom of stem

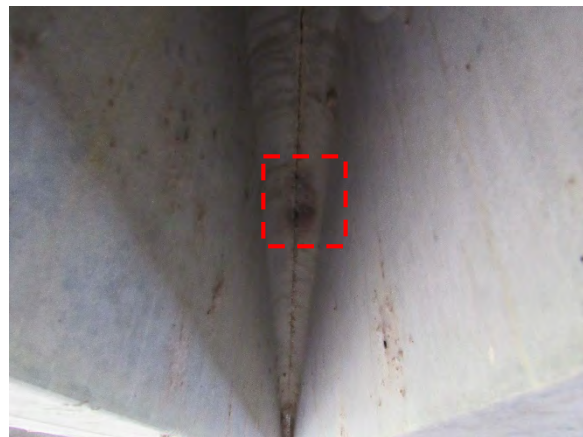
(f) Reddish color, sign of corrosion

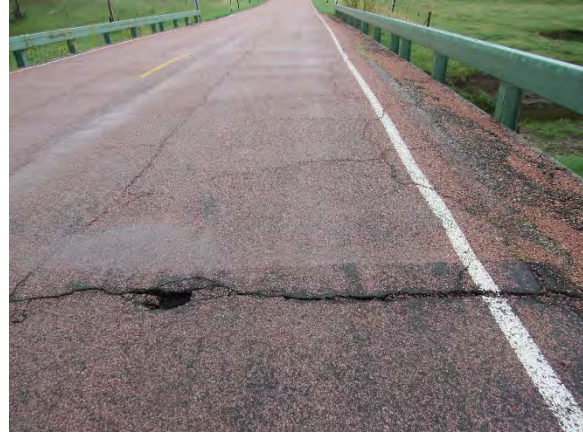
(b) Cracking on pavement over the bridge

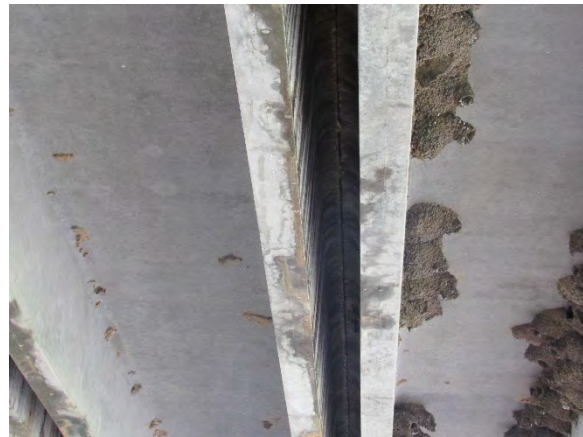
(d) Leakage from joint

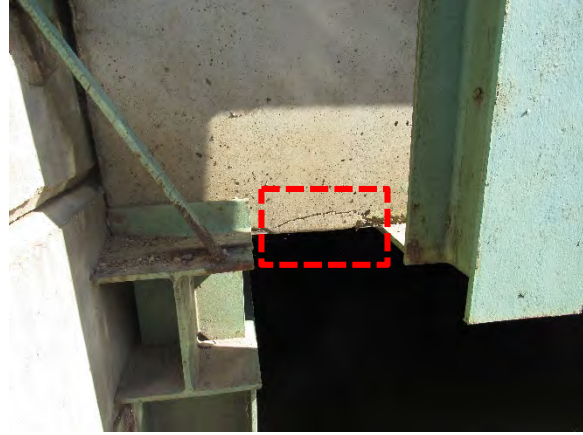
(b) Cracking at bottom of exterior girder

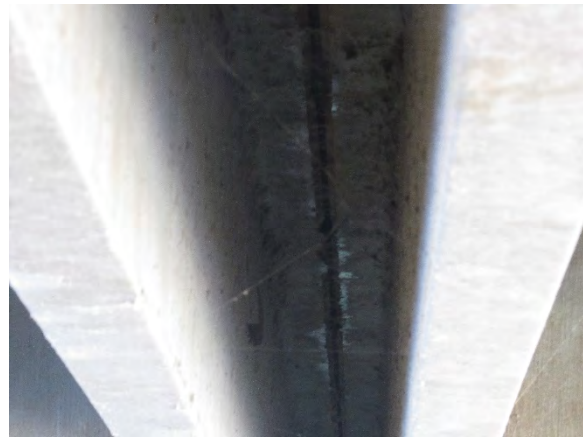
(d) Efflorescence in joint

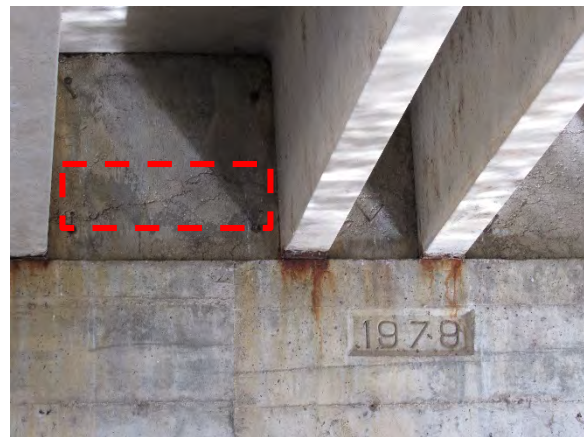
(d) Cracking in diaphragm

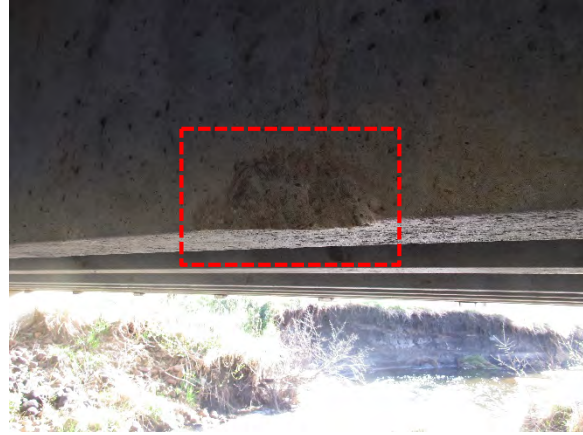
(b) Spalling at stem of bridge

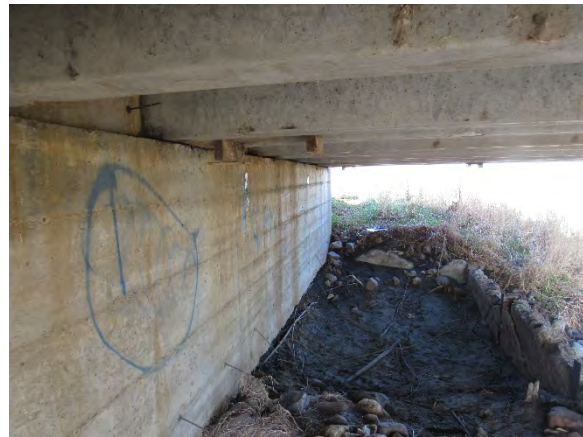
(d) Scouring at abutment of bridge

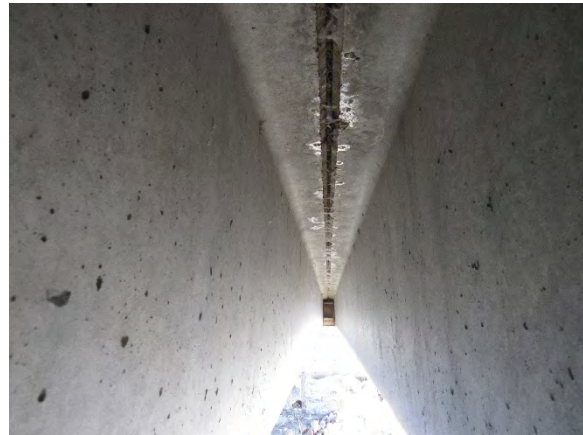
(f) Leakage from joint

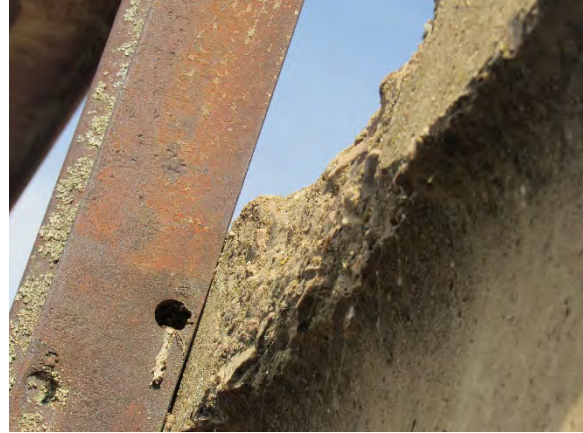
(b) Deterioration at side of bridge

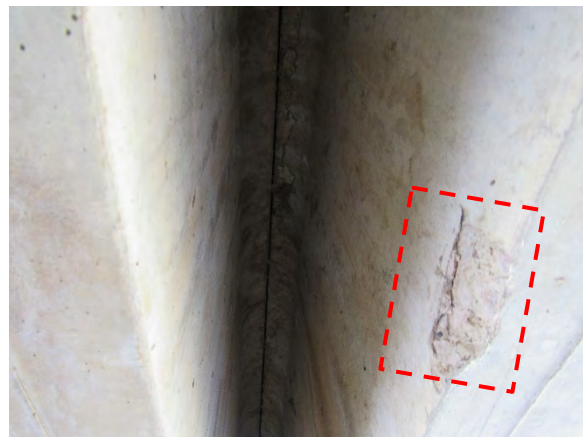
(d) Deterioration at bottom of stem

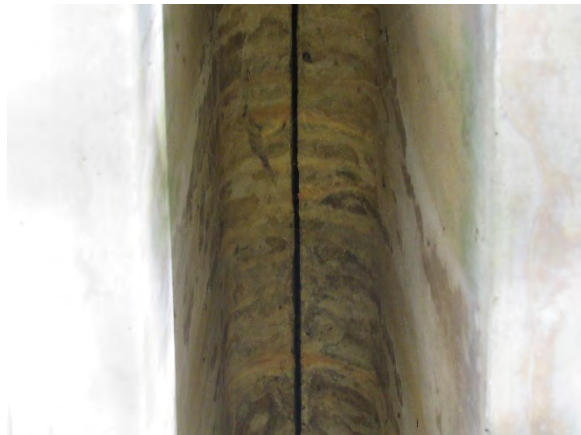
(d) Leakage from joint

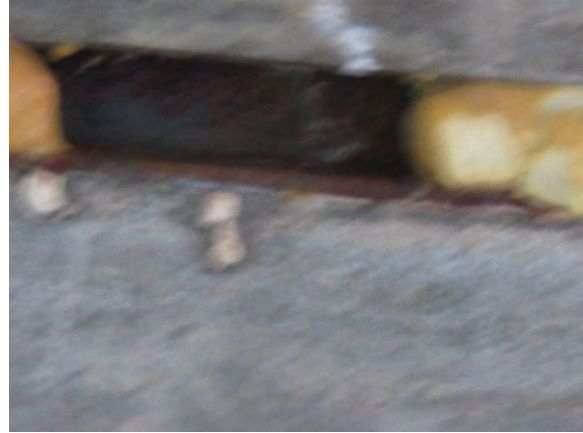
(b) Corrosion of plate of joint

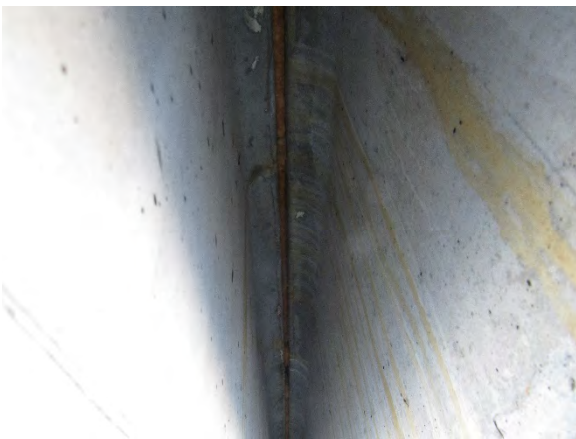
(c) Sign of leakage

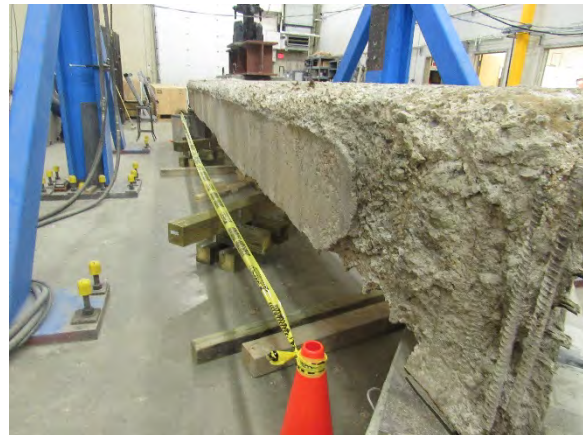
(b) Stem Cover Deterioration

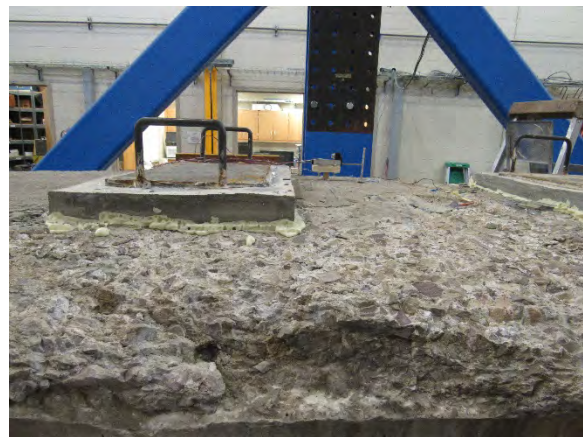
(d) Flange Cover Deterioration

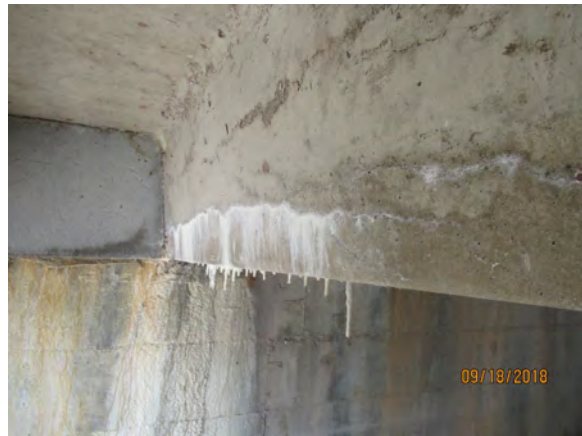
(d) Longitudinal Cracking and Severe Efflorescence-
North End of Deck Unit 1

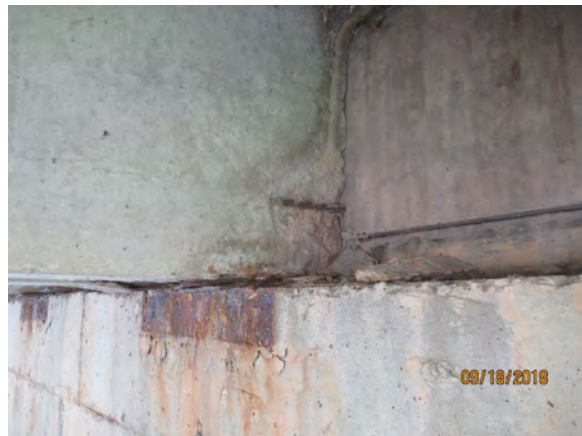
(e) Spall with Prestressing Strand Exposed – South
End of East Stem of Deck Unit 3

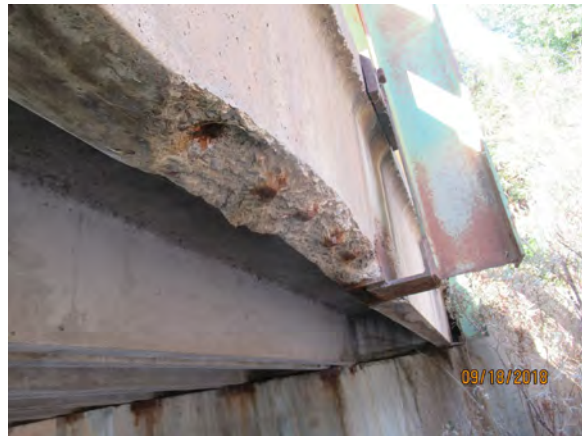
(i) Spall Near Rail Post 5 – Deck Unit 7
