# NTSB TRB Truck and Bus Update

Robert Molloy, PhD

January 8, 2025

# Pittsburgh Bridge Collapse

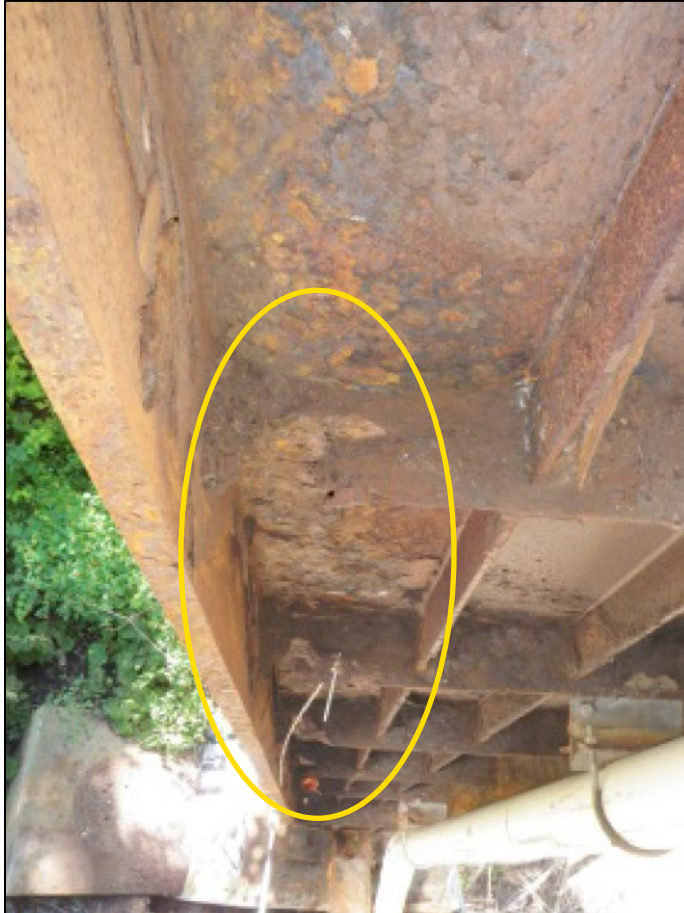
2013

# Stiffeners on Southwest Leg

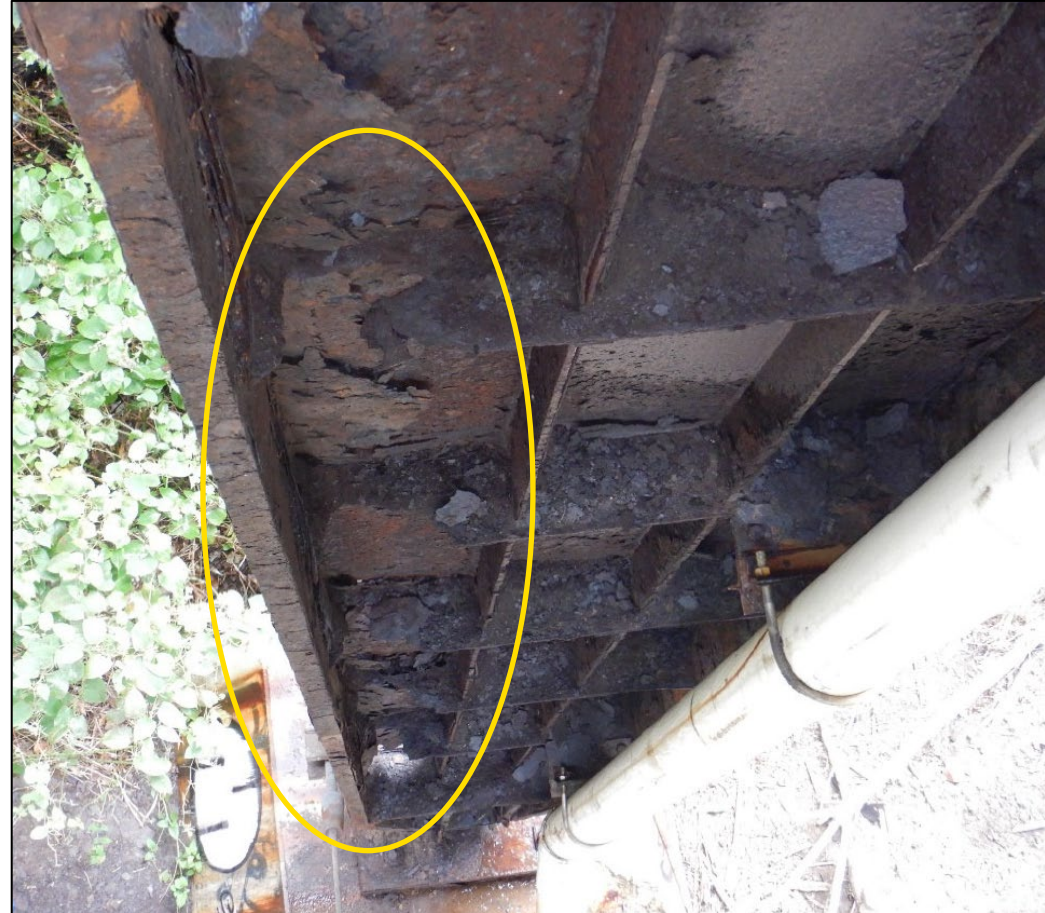
2021

1. The failure of the transverse tie plate on the southwest leg of the bridge, a fracture-critical member (nonredundant steel tension member), due to corrosion and section loss
2. Resulting from the City of Pittsburgh's failure to act on repeated maintenance and repair recommendations from inspection reports.
3. Contributing to the collapse were:
  1. the poor quality of inspections,
  2. the incomplete identification of the bridge's fracture-critical members (nonredundant steel tension members), and
  3. The incorrect load rating calculations for the bridge.
  4. Insufficient oversight by the Pennsylvania Department of Transportation of the City of Pittsburgh's bridge inspection program.

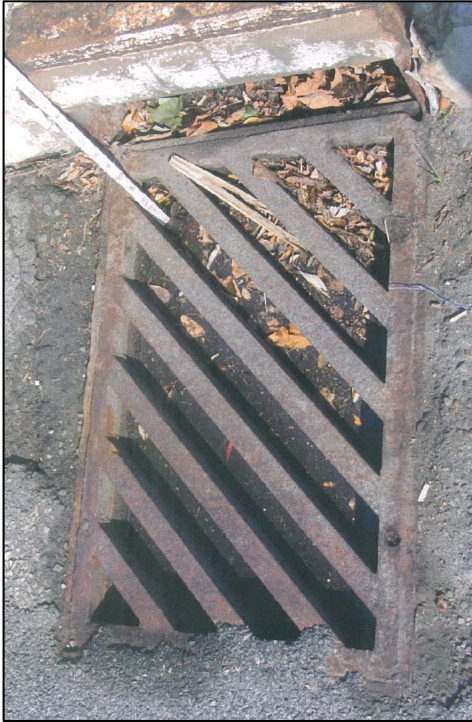
2005

# Clogged Drainage Inlets

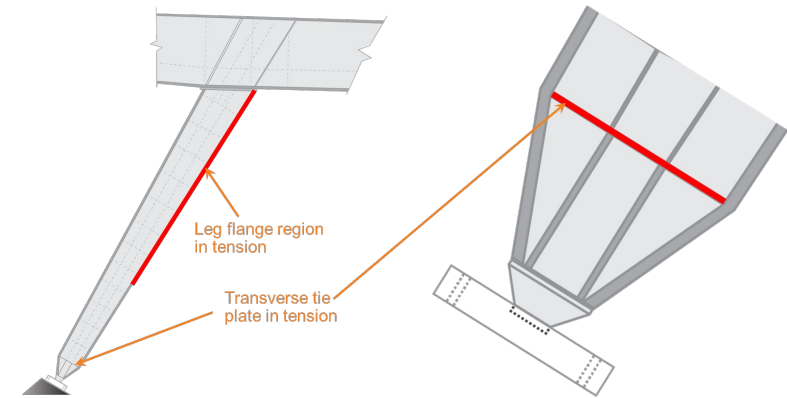
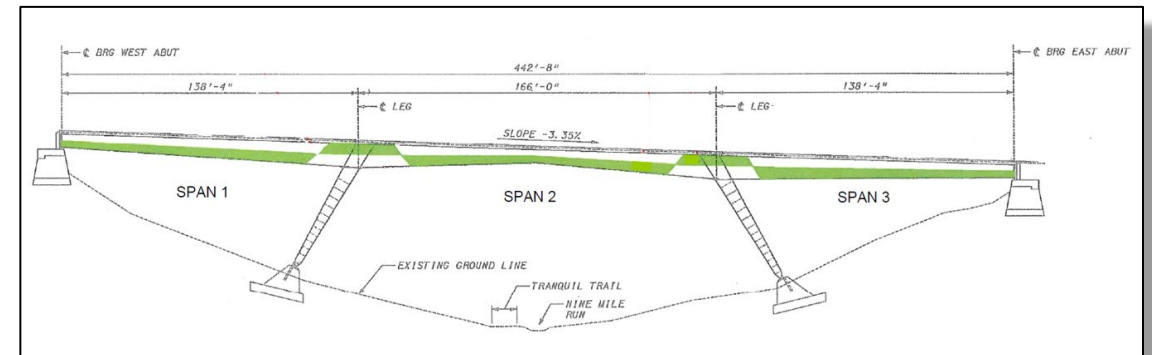
Bridge legs were not properly identified as fracture-critical

Bridge legs did not consistently undergo an in-depth FCM inspection

Maintenance and repair recommendations for the bridge legs were not assigned appropriate priority codes

Repairing the bridge legs could have prevented the collapse

The correct identification of FCMs is crucial

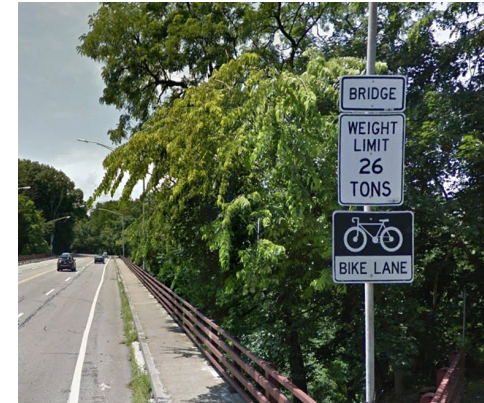
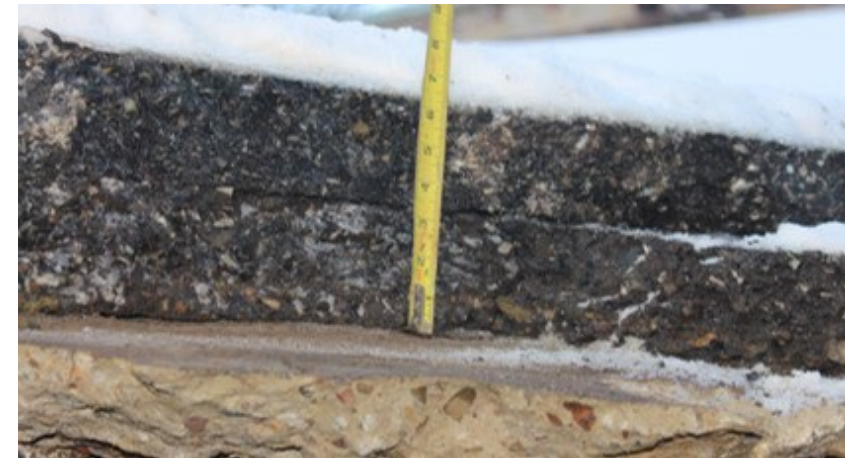
- The calculations and assumptions used in the 2014 load rating analysis overestimated the Fern Hollow Bridge's capacity
  - Wearing Surface Thickness
  - Load rating assumed an incorrect  $k$ -factor (Cross bracing not intact)
  - Distributed section loss length of the leg
- Had the correct calculations and assumptions been used, the bridge would have been closed
