**COMPOSITE REPAIR OF FULL-SCALE
TIMBER BRIDGE CHORD MEMBERS
THROUGH THE PROCESS OF SHEAR SPIKING**

Travis A. Burgers
Richard M. Gutkowski, Ph.D., P.E.
Donald W. Radford, Ph.D.
Jeno Balogh, Ph.D.

December 2005

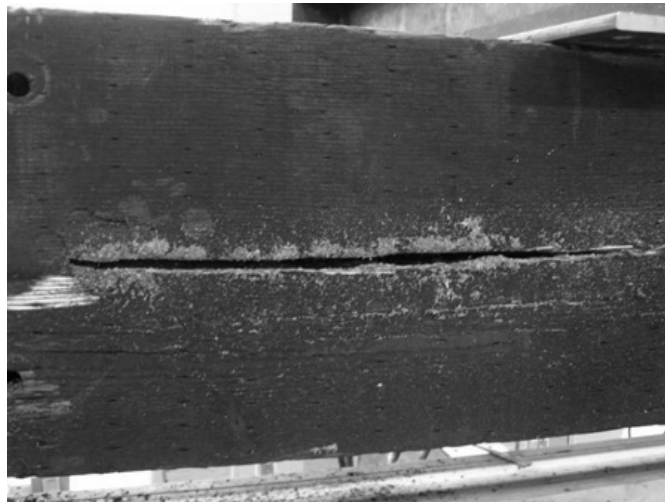
Figure 4.9: Chainsaw damage

Finally, a chainsaw was used to inflict the damage, creating a much larger width of cut than originally intended. The chainsaw damage and shimming can be seen in Figures 4.9 and 4.10. The cut was shimmed so the gap would not close when load was applied to the specimen.

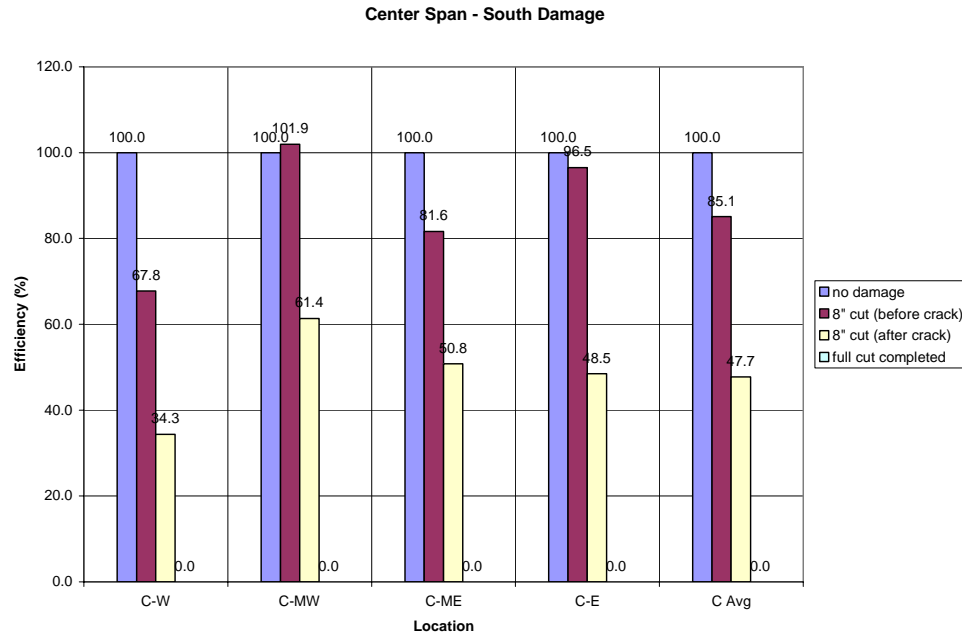
Figure 5.4: Efficiencies of the center span due to south end damage

Table 5.3 is a listing of the decreases in efficiency caused by the progression of damage and these are graphically shown in Figure 5.4. The “no damage” state is used as ST_k and the “full cut completed” state is used as ST_i in calculating efficiency from Equation 5.2. The efficiency equation and states ST_i , ST_j , and ST_k are used, but the definition of efficiency does not hold, because the data shown is for progression of damage and not repair. Instead these data show how

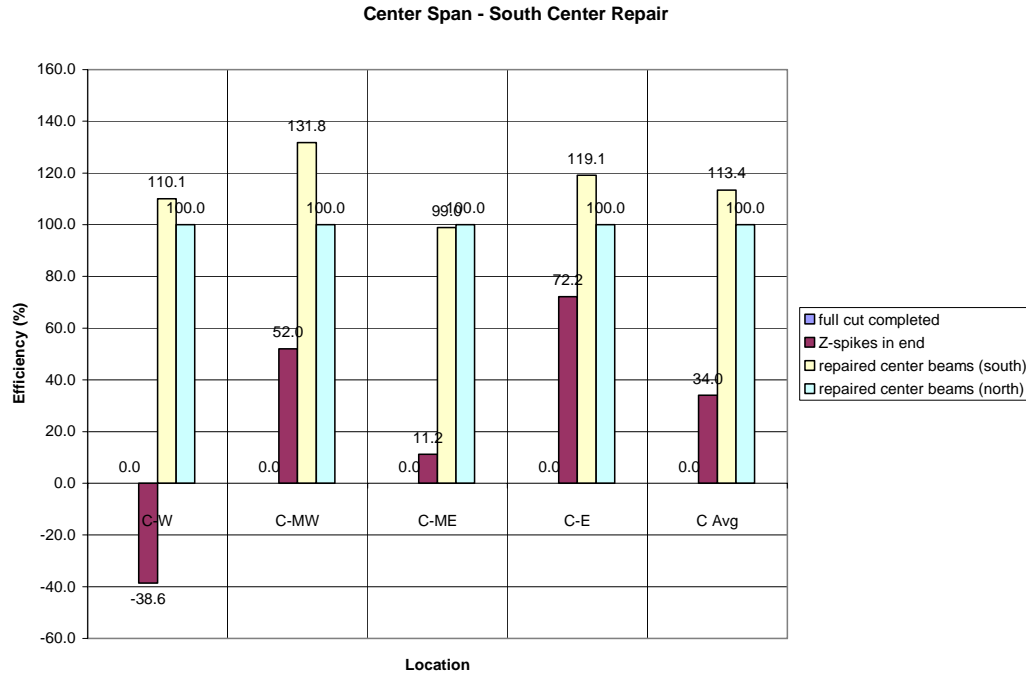
Figure 5.5: Efficiencies of the center span due to south end center repair

It is evident from the data that the installation of Z-spikes in the middle of the center span increased the effective stiffness. The effective stiffness was higher after the south half the center of the span was repaired than when both the south and the north halves were repaired. A possible explanation for this could be that the loss of the “sound” timber due to the drilling of the holes for the Z-spikes had more of a negative effect than the positive effect of the insertion of the Z-spikes. Note that in the west stringer, the efficiency decreased with the addition of the shear spikes near the end of the damage. This interesting phenomenon was also observed by both Radford et al. [38] and Schilling et al. [41].

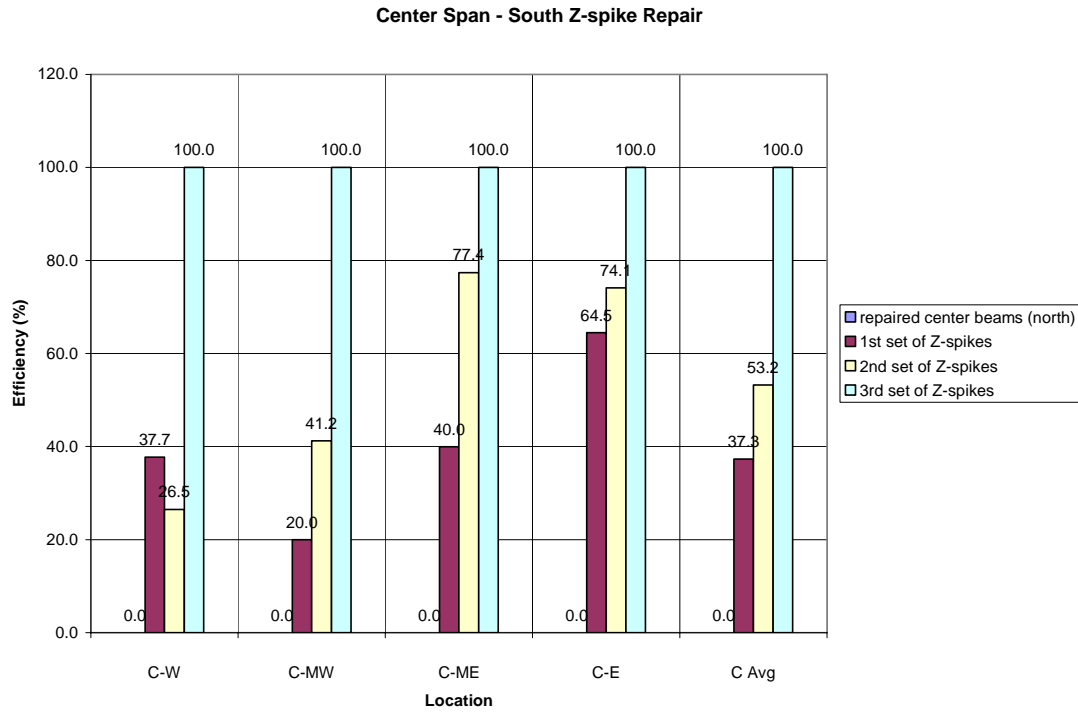
Figure 5.6: Efficiencies of the center span due to south end Z-spike repair

From the data in Table 5.6 and Figure 5.6, it is evident that the installation of Z-spikes to repair the cut increased the effective stiffness. On average, the last set of Z-spikes (inserted at the quarter point of the damage) had more effect than either of the other two sets. On average, the second set (inserted at the three-quarters point of the damage) had less effect than the other two sets.
