DURABILITY AND ULTIMATE FLEXURAL LOADING OF SHEAR SPIKE REPAIRED, LARGE–SCALE TIMBER RAILROAD BRIDGE MEMBERS

R. Gutkowski H. Forsling Department of Civil Engineering

December 2007

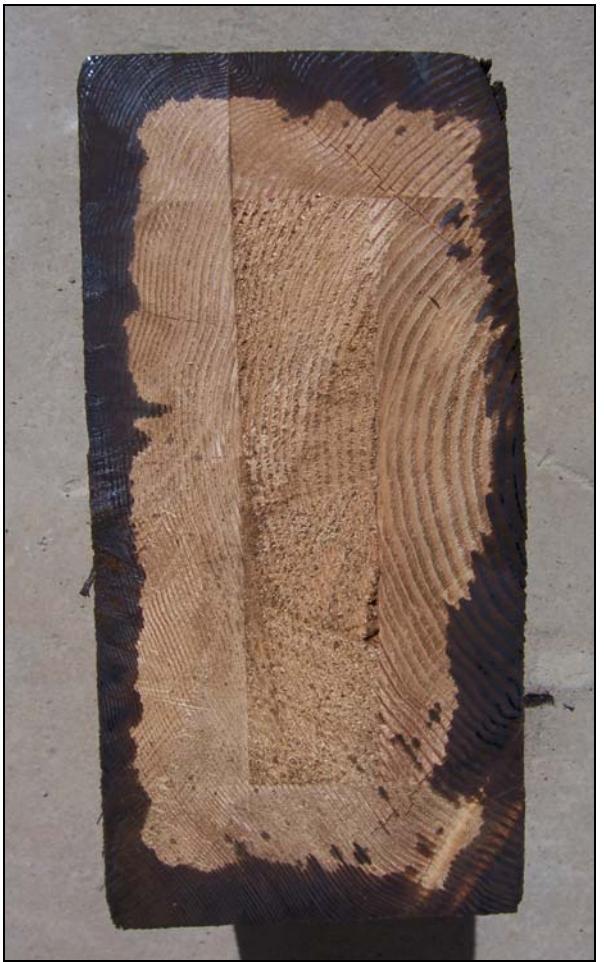
Figure 1.1 Cross-section of creosote treated, large-size timber.

Since the preservative treatment prevents decay of the surface and near-surface wood fibers, and because splitting and mechanical fasteners provide access for fungi to the inner regions, the decay process in treated timbers starts in the untreated core. Consequently, loss of mechanical properties in treated structural members is usually attributed to a loss of sound wood in the section's interior regions. This loss of sound wood may contribute to a loss of flexural strength and stiffness and a decrease in horizontal shear performance. According to Radford et al. [49], this loss of shear capacity is of particular significance to wood members of relatively low aspect ratio (length to depth), such as bridge stringers, where the flexural stiffness is strongly related to shear performance.

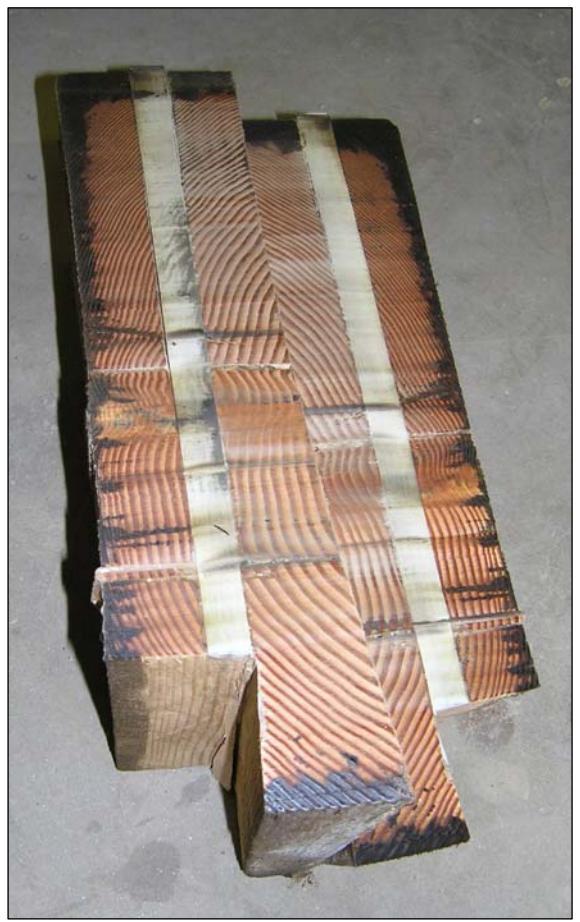
Figure 5.24 Dissected cross-sections with shear spikes in place.

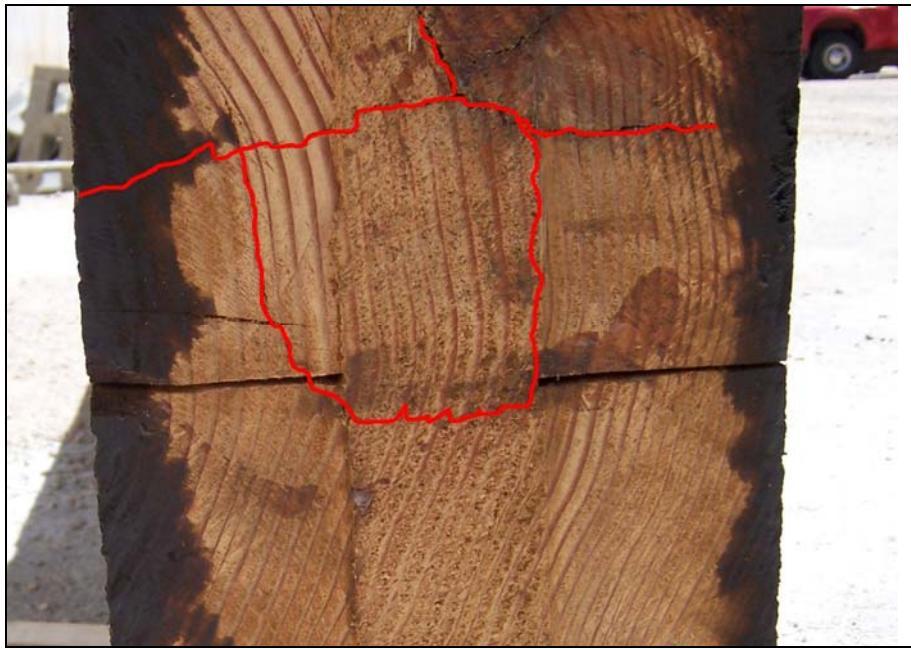
Figure 5.26 Shear crack (traced) at north end of specimen 1P-A.

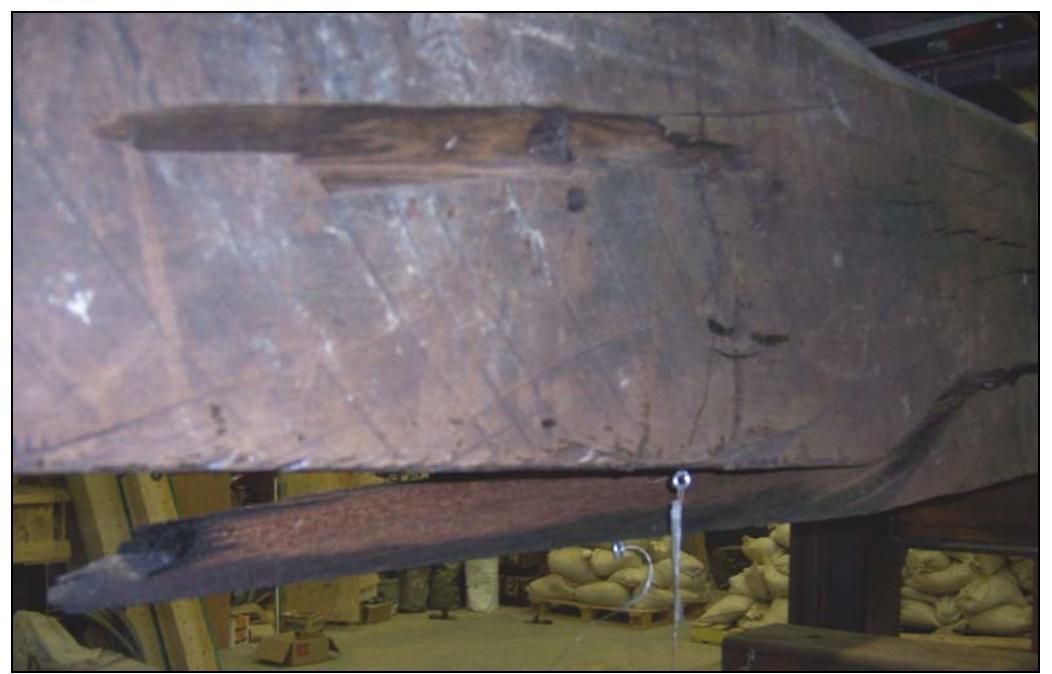
Figure 5.28 Diagonal flexure crack at tension face of stringer 1P-B.

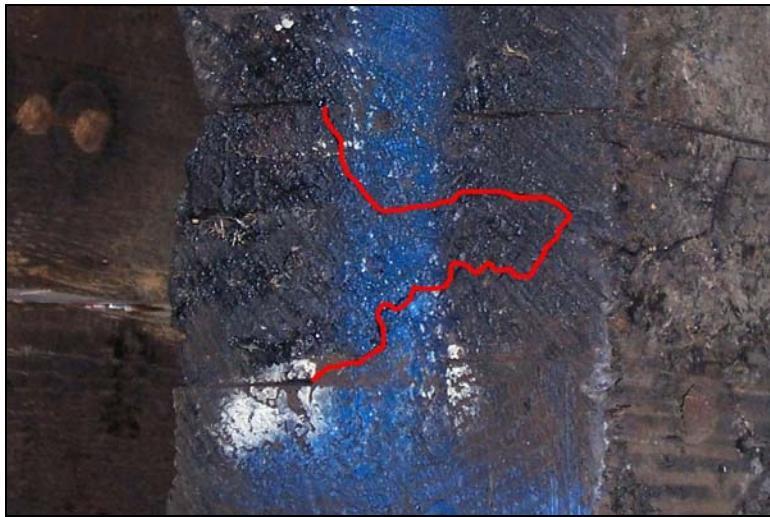
Figure 5.30 Traced shear crack at south end of stringer 2P-A.

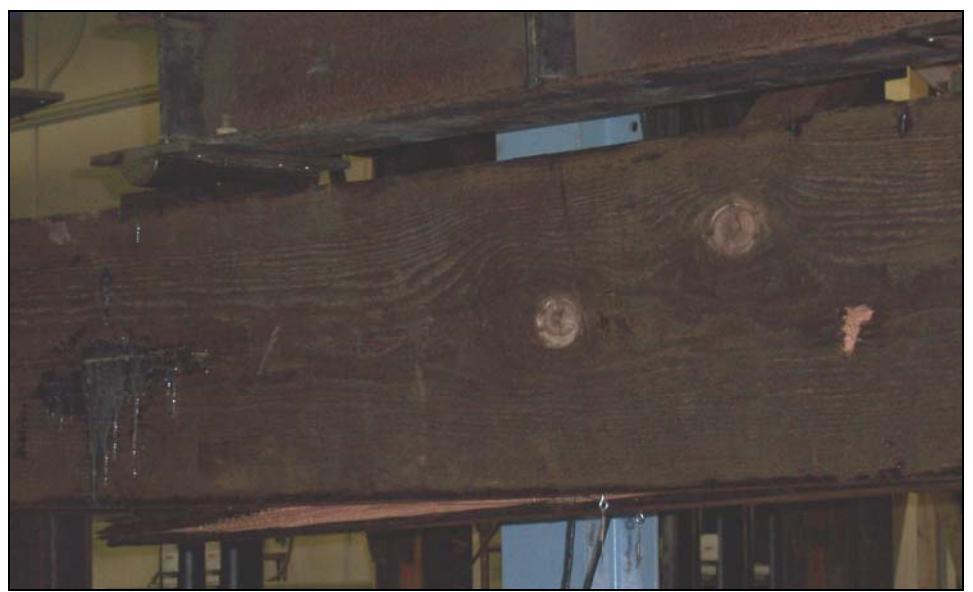
Figure 5.32 Flexural crack at tension face of stringer 1F-A.
