### Long Term Monitoring of Mechanical Properties of FRP Repair Materials

Rebecca A. Atadero, Assistant Professor Douglas G. Allen, Graduate Research Assistant Oscar R. Mata, Graduate Research Assistant Department of Civil & Environmental Engineering Colorado State University Fort Collins, CO

Mountain-Plains Consortium and Colorado Department of Transportation DTD Applied Research and Innovation Branch Denver, CO

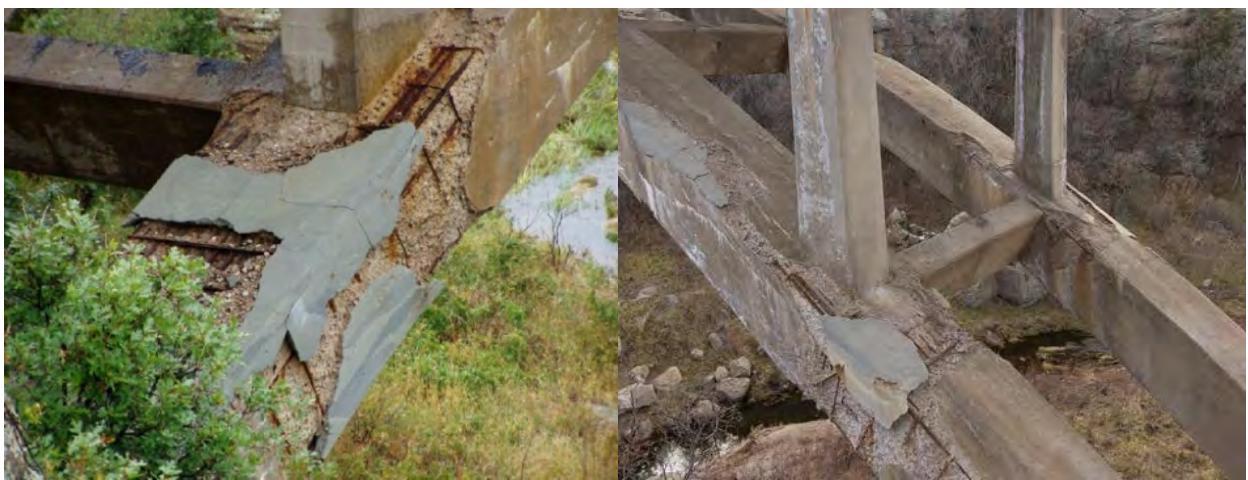
Prior to repair, the concrete arches had severe spalling due to the corrosion of the internal steel reinforcement as seen in the photographs in Figure 2.8.

Figure 2.8 Concrete spalling on arch section prior to repair (Mohseni, CDOT)

Loose concrete, typically no more than the few inches of concrete cover, was removed with 6.8 kg (15 lb.) jack hammers and the exposed steel reinforcement was sandblasted free of rust. As seen below, the cross-section was restored with shotcrete, which included a corrosion inhibitor, Sika FerroGard 903, to prevent further corrosion of the steel reinforcement.

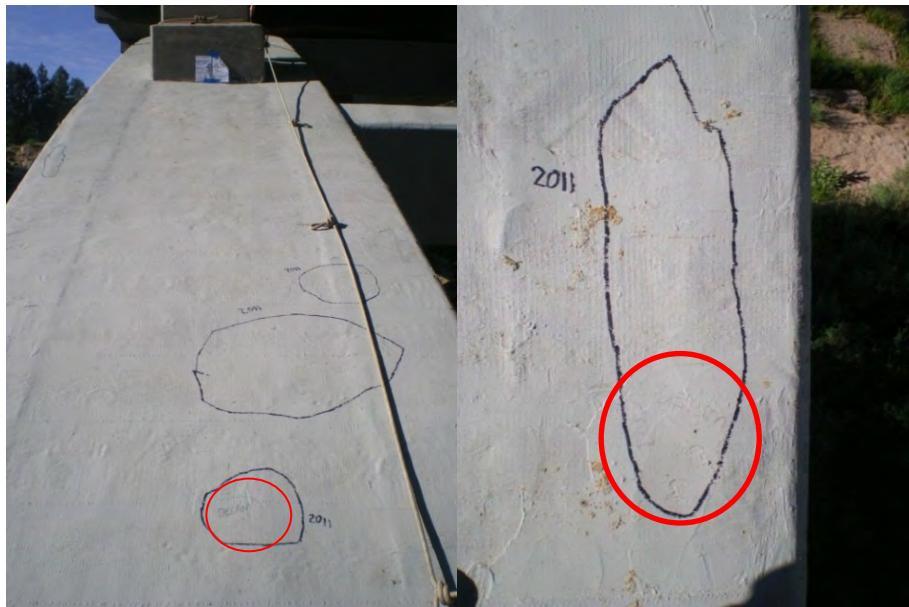
**Figure 2.14** Outlined in permanent marker are identified areas of debonding between the FRP and the substrate developed in the structure between inspections in 2007 and 2011. Faintly denoted in the bottom of the photographs (enclosed in red circles) are previously found voids identified with "DELAM 07" and lines distinguishing the boundaries of the voids.

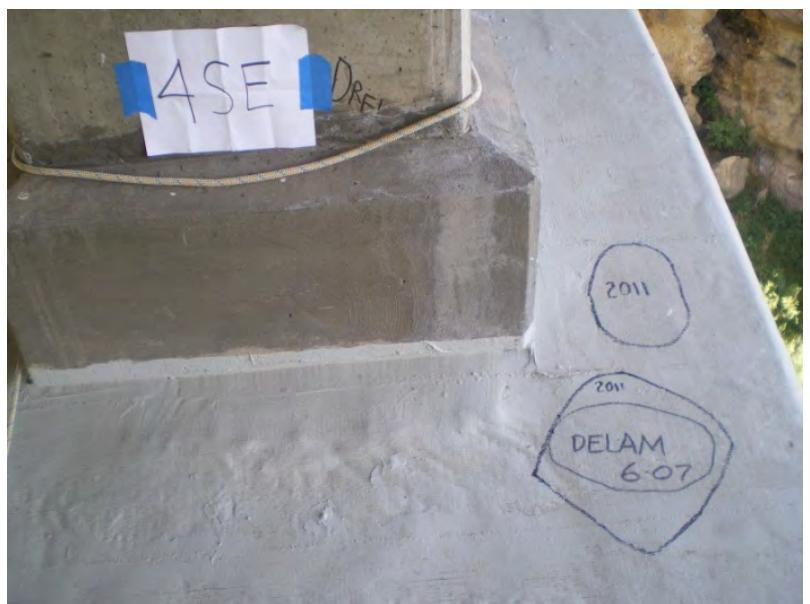
**Figure 2.15** Enclosed in permanent marker are identified areas of debonded areas between the FRP and the substrate from 2011 and June, 2007. Notice in this more protected bay of the structure the markings from 2007 are more clearly visible.

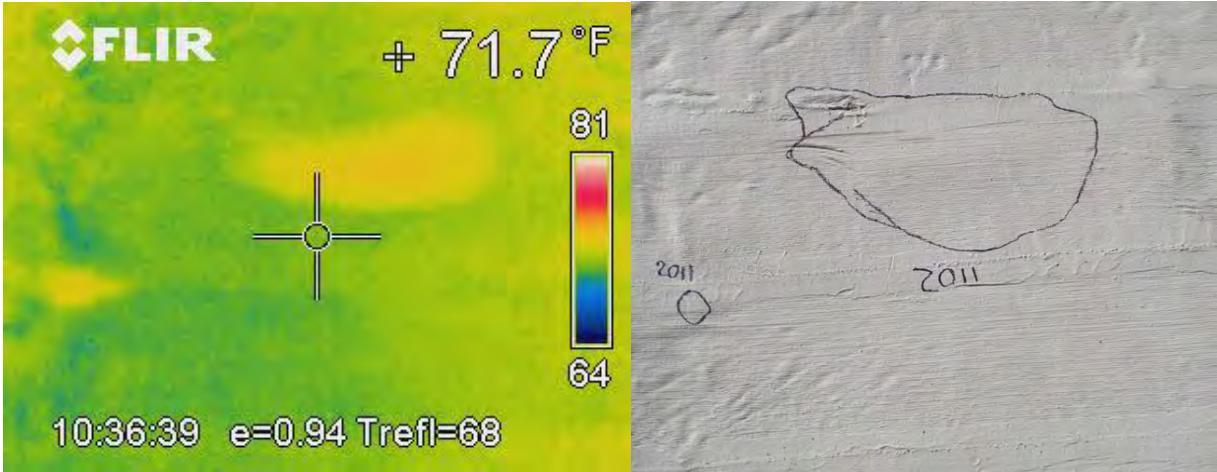
**Figure 3.1** Photograph and thermal image from an infrared camera of two voids, (appearing yellow), found in 2011 on the first bay on the north side of the east arch

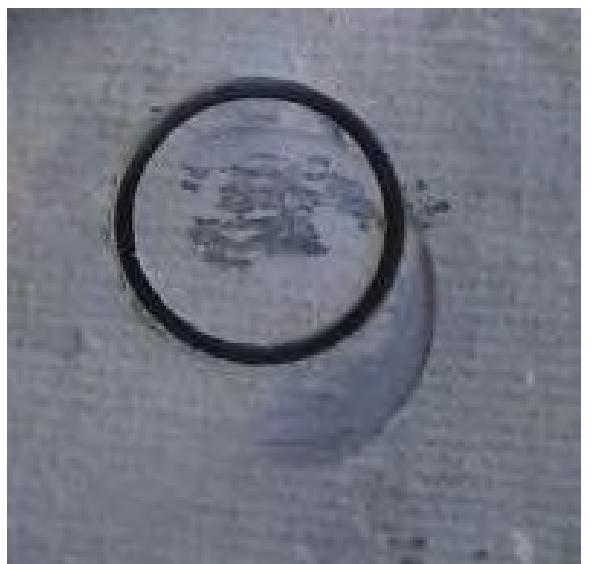
Figure 3.4 Damage caused by core bit without the use of the jig

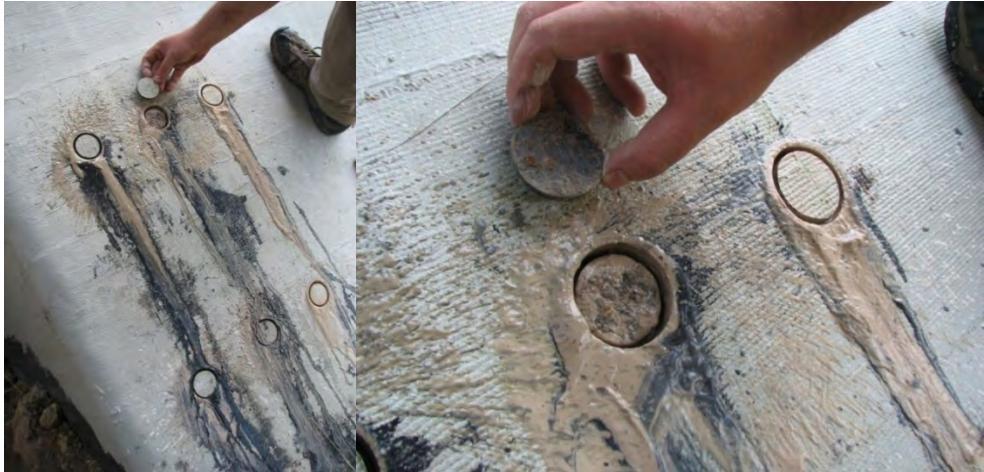
Figure 3.6 The core drilling location that failed due to torsional stresses during the core drilling process, bay 1NW

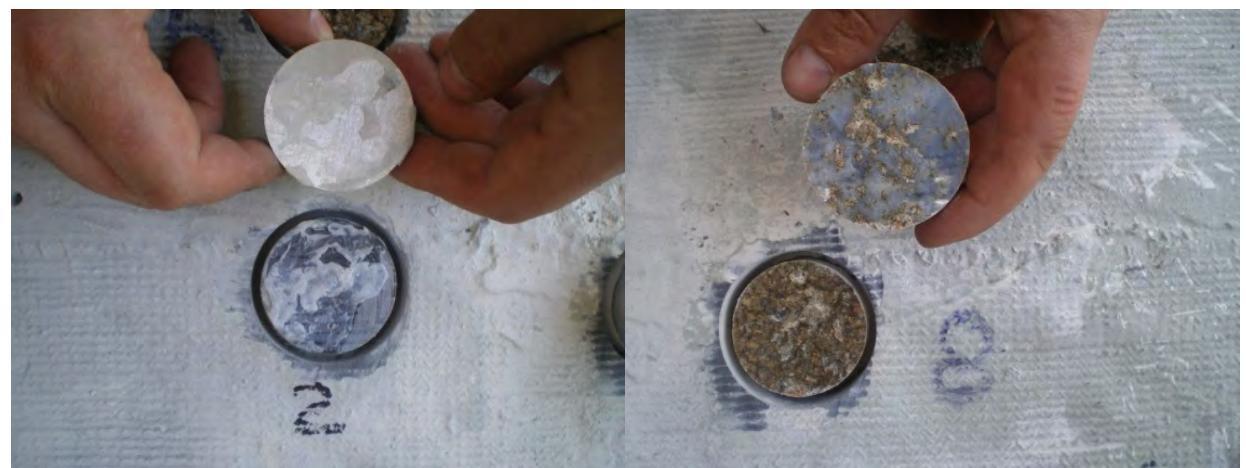
**Figure 3.14** Failure Mode A: bonding adhesive failure at loading fixture (on left), Failure Mode E: Adhesive failure at CFRP/substrate adhesive interface (on right)

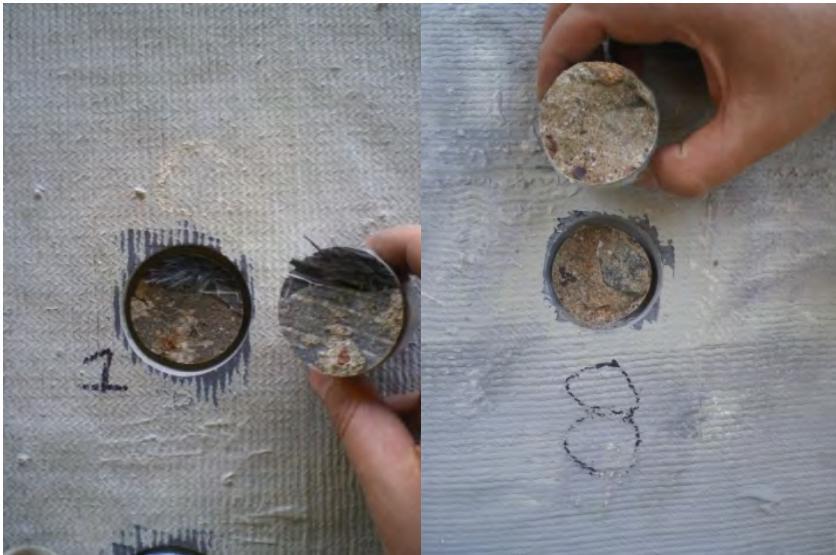
**Figure 3.15** Failure Modes B and F: cohesive failure in FRP laminate, and mixed cohesive failure in substrate and adhesive failure at the adhesive/substrate interface, respectively (on left), Failure Mode G: cohesive failure in concrete substrate (on right)

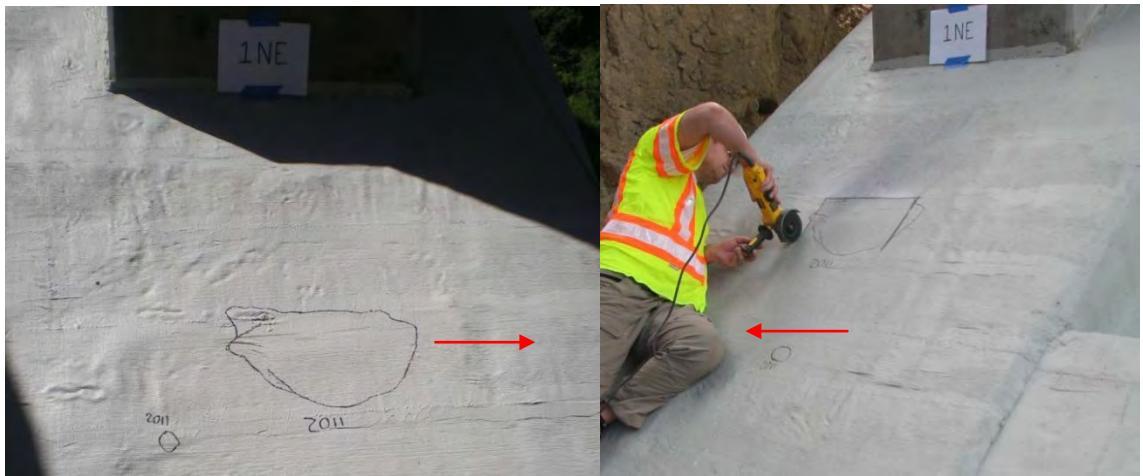
Upon cutting the lower edge of the CFRP rectangle, water exited the cut at the bottom of the void, revealing standing water at the interface between the CFRP and substrate. Photographs of the void and the removal of the CFRP layer are shown in Figures 3.20, 3.21, and 3.22.

Figure 3.20 Void in CFRP with transverse crack identified with red arrows and Cutting the perimeter of the void in the CFRP

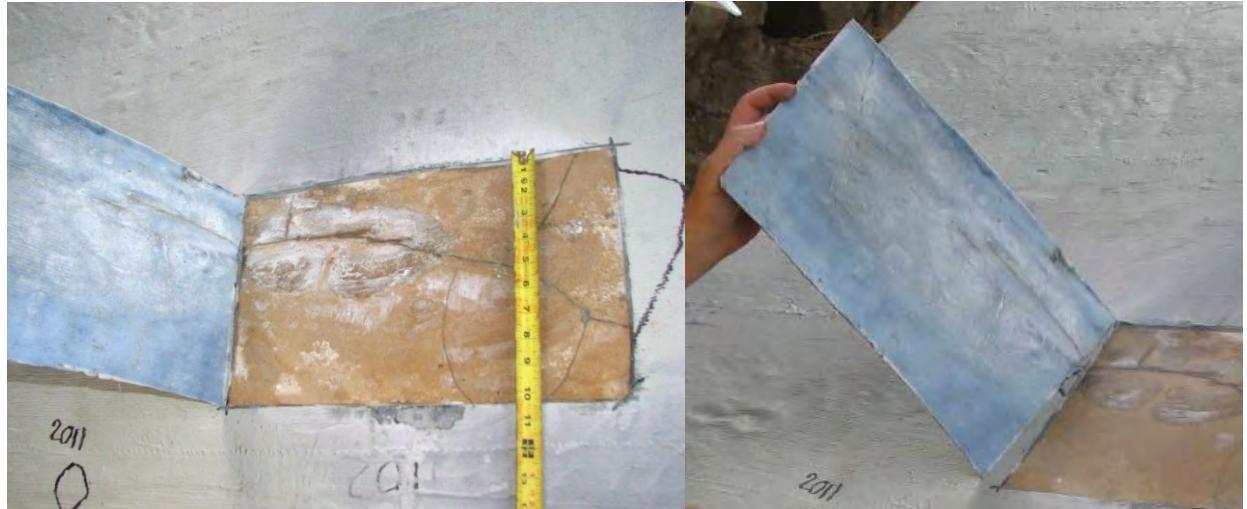
Figure 3.22 Cracks in the substrate were transmitted through the CFRP and notice the smooth texture and blue and white color of the underside of the CFRP

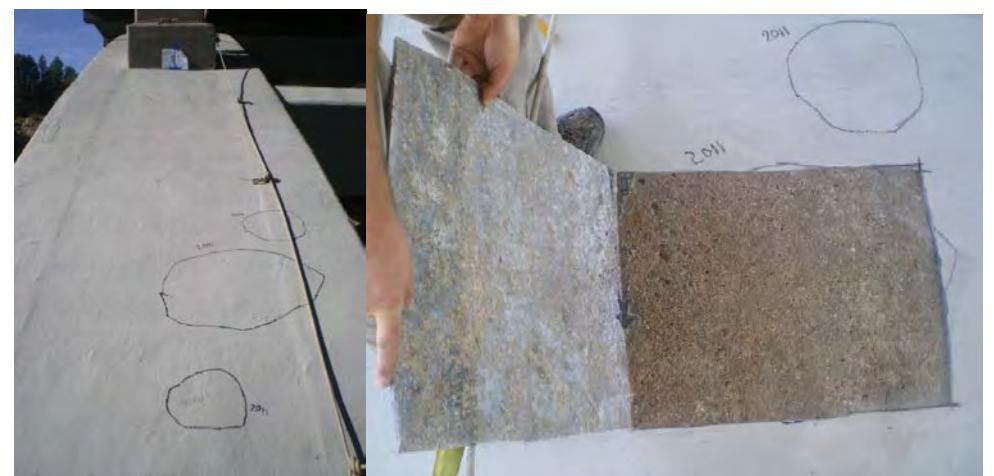
The second void was removed from the third bay on the north end of the east arch. A rectangular section of the CFRP was removed with the same procedure previously described. Photographs of the area of the void and the removal of the CFRP rectangle are in Figure 3.23. There was no standing water or evident moisture in this larger void area, but there was significant pieces of the substrate adhered to the underside of the CFRP patch removed.

Figure 3.23 Voids found in the third bay on the north end of the east arch and removal of the CFRP of the largest void

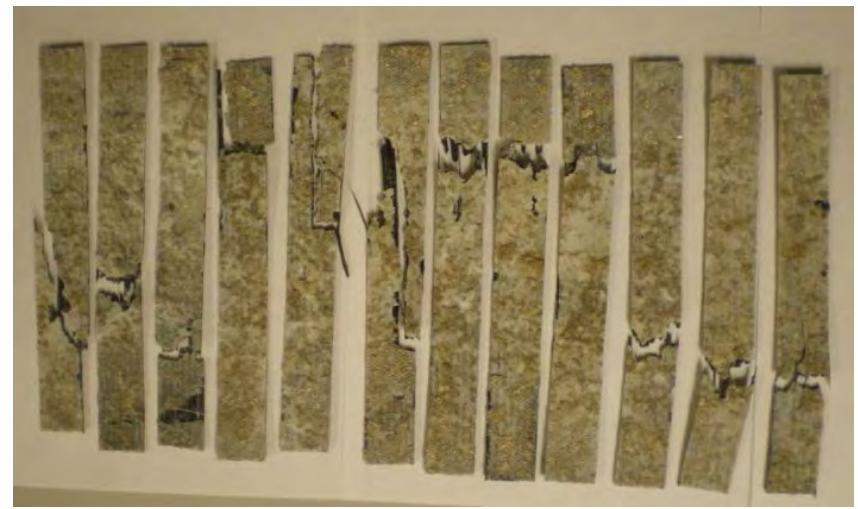
**Figure 4.2** Failed tensile test specimens from the large void removed from bay 3NE. Note the oatmeal appearance

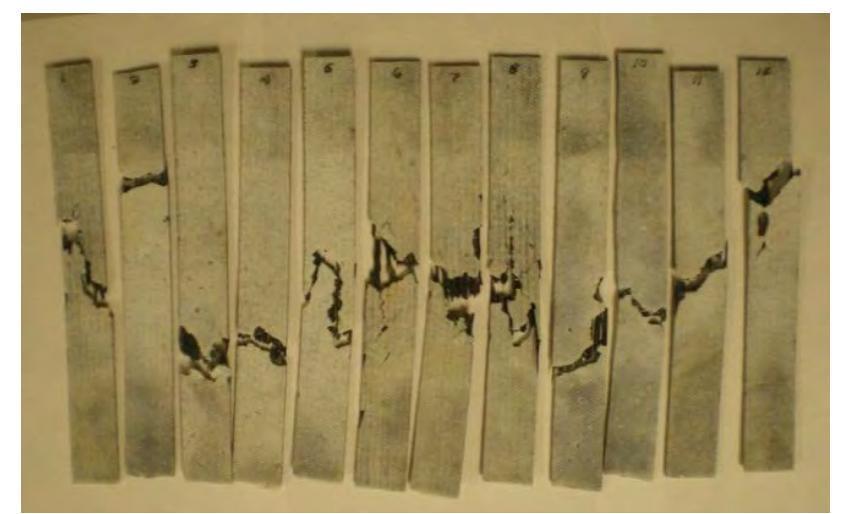
**Figure 4.3** Failed tensile test specimens from the small void removed from bay 1NE. Note the milky appearance.

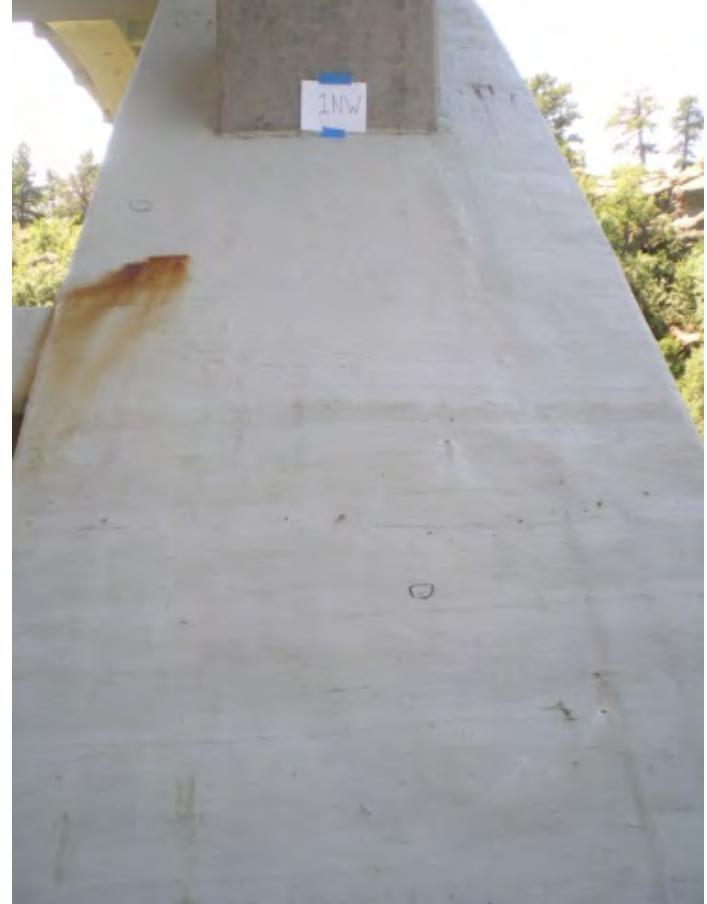
Figure A1. Bay 1NW, 2 of the 3 small voids and rust spot

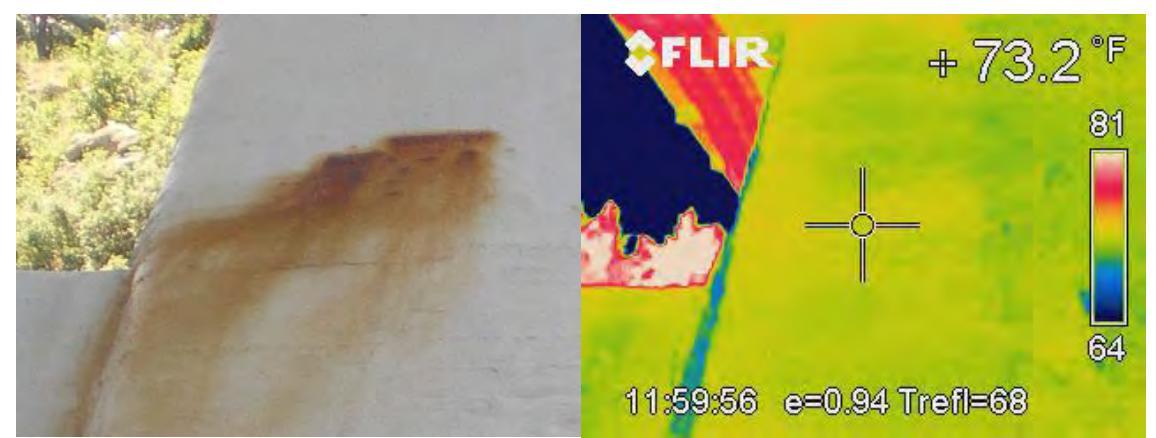
Figure A2. Photograph and thermal image of rust spot

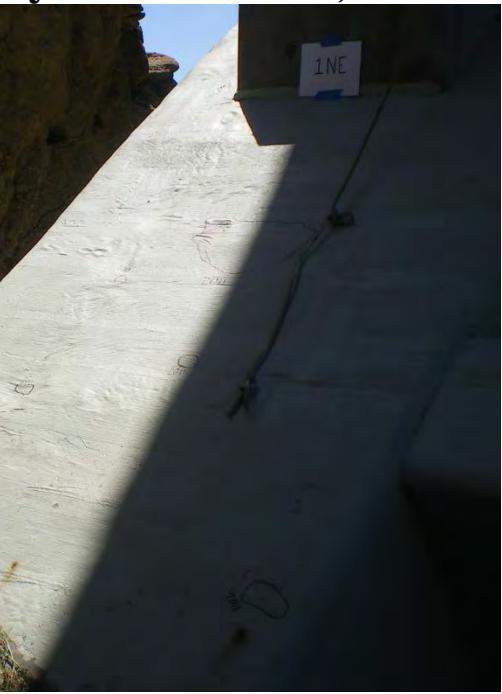
Figure A3. Bay 1NE, 5 voids

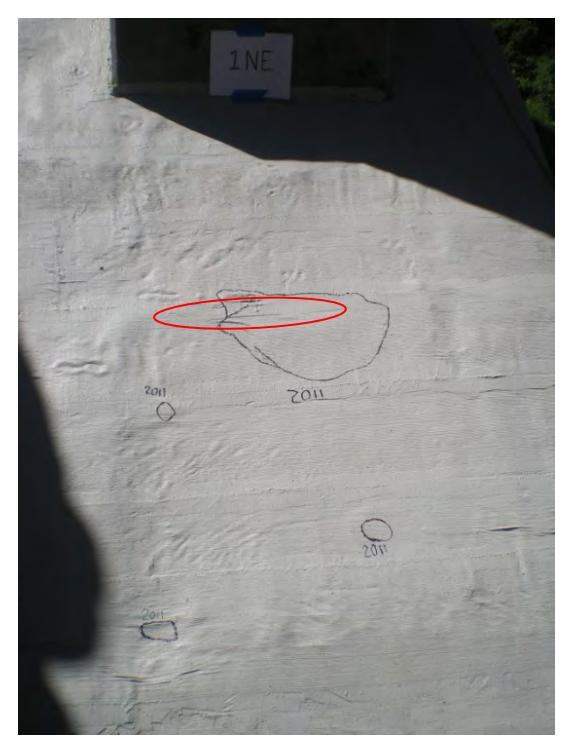
Figure A4. Bay 1NE, 4 of the 5 voids; Crack exists, enclosed in red oval, in the top of the largest void

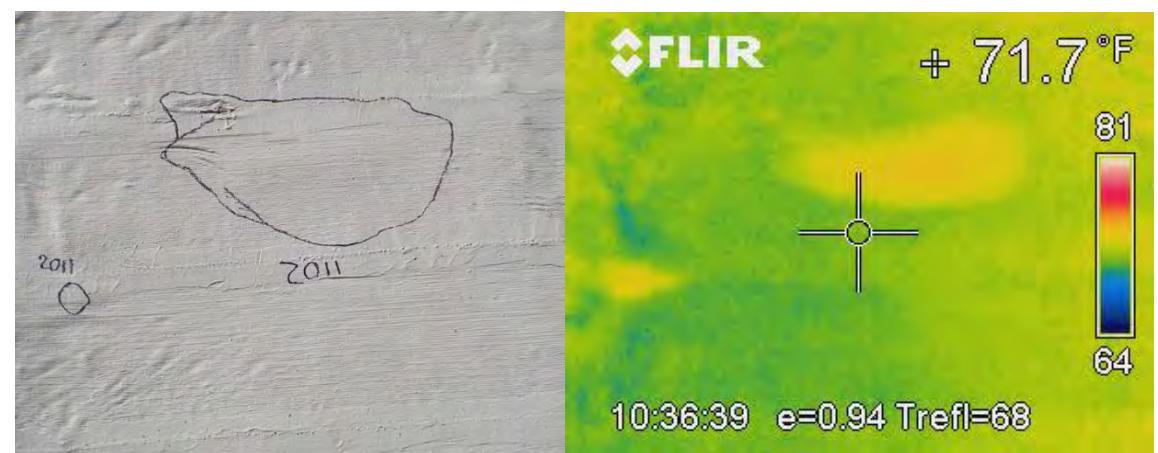
Figure A5. Photograph and thermal image of two voids in Bay 1NE

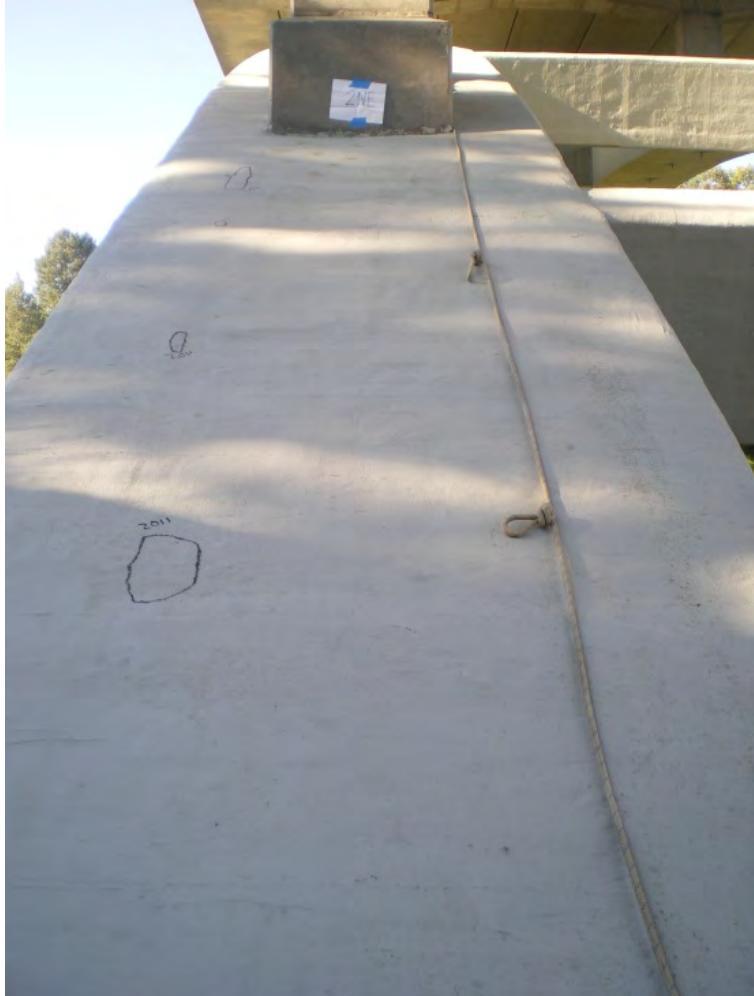
Figure A6. Bay 2NE, 3 Voids

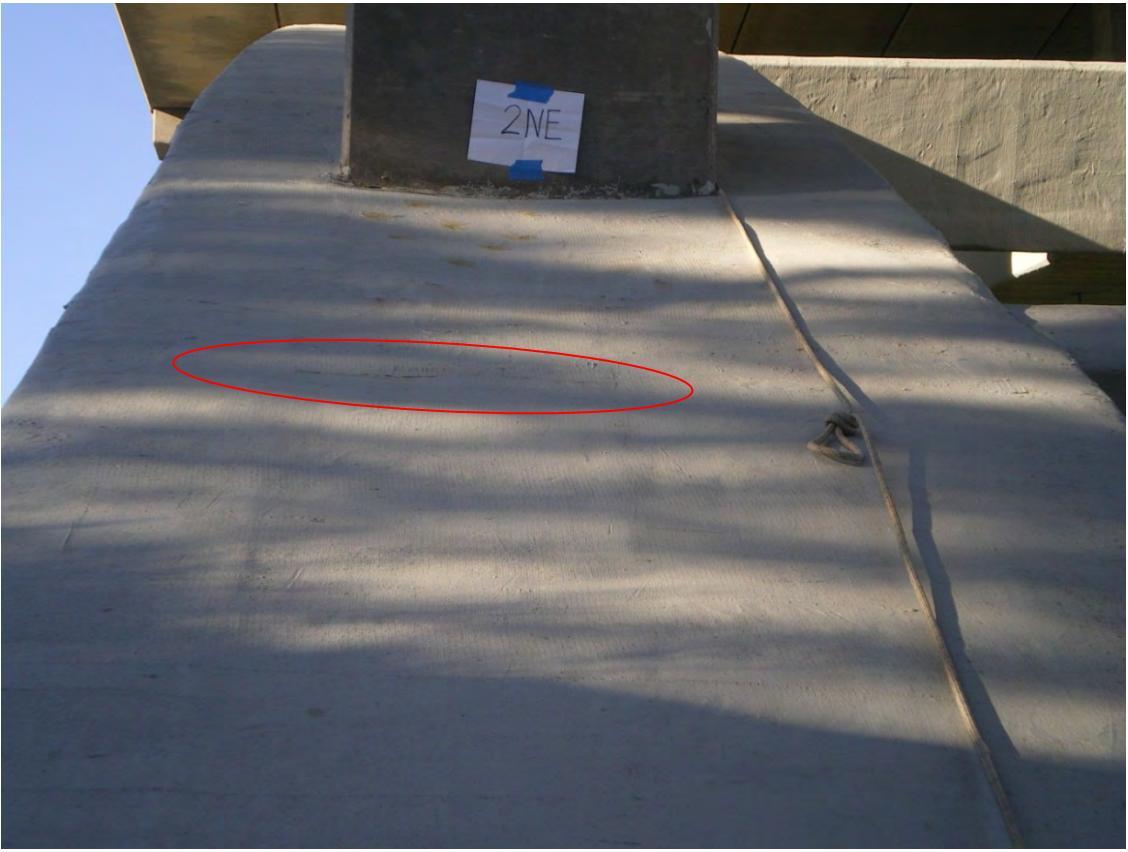
Figure A7. Bay 2NE, Crack enclosed in red oval was identified in 2007

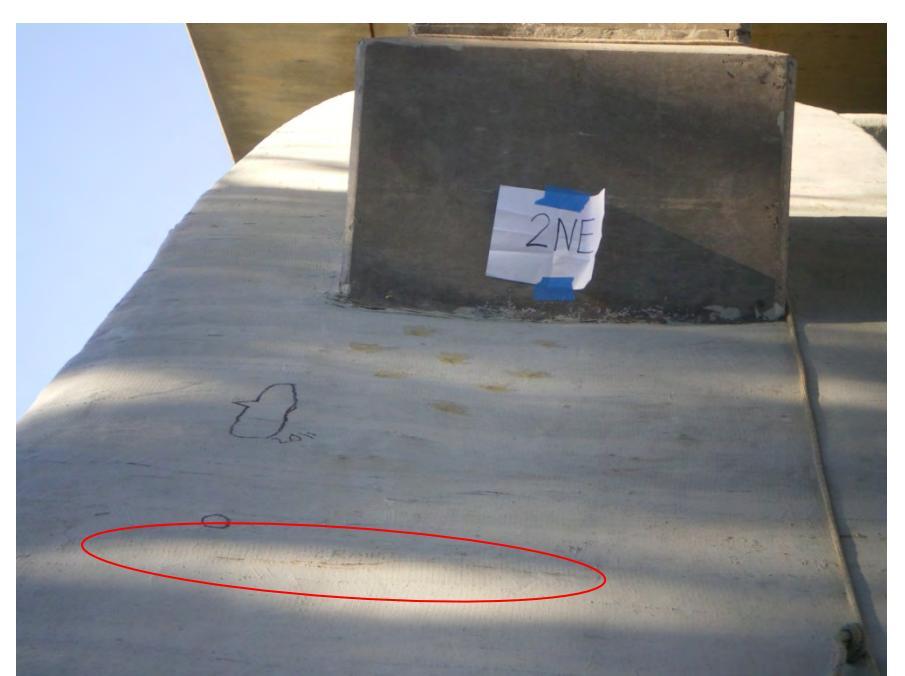
Figure A8. Previously identified in 2007, a crack enclosed in the red oval, no debonding at the location of the crack

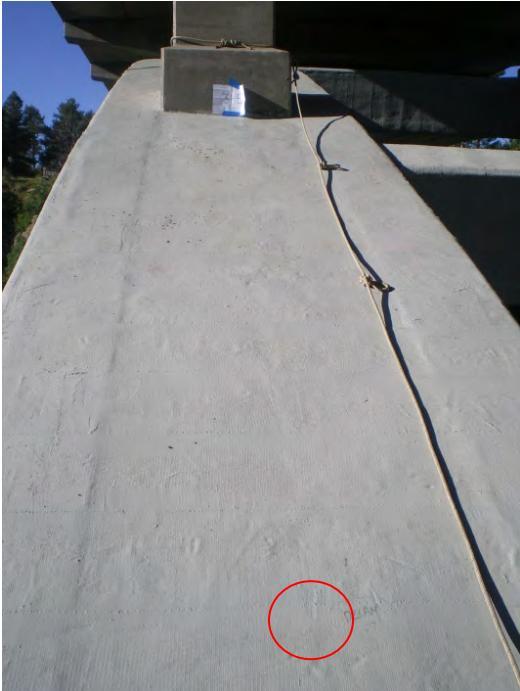
Figure A9. Bay 3NE with 1 of the 2 defects found in 2007 shown

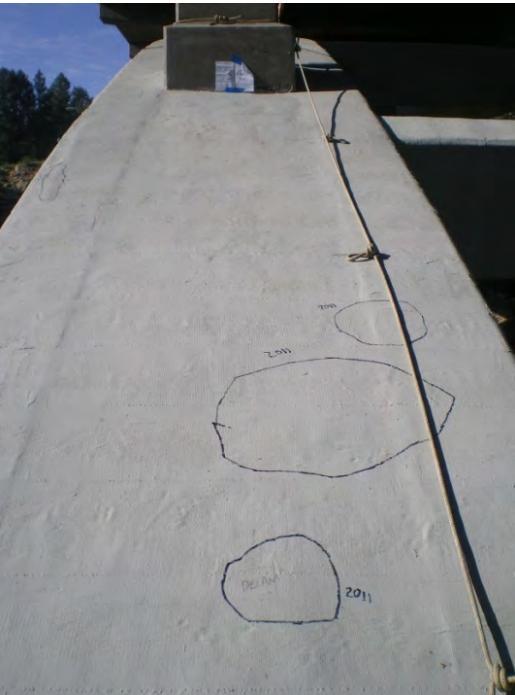
Figure A10. 4 of the 5 voids found in 2011

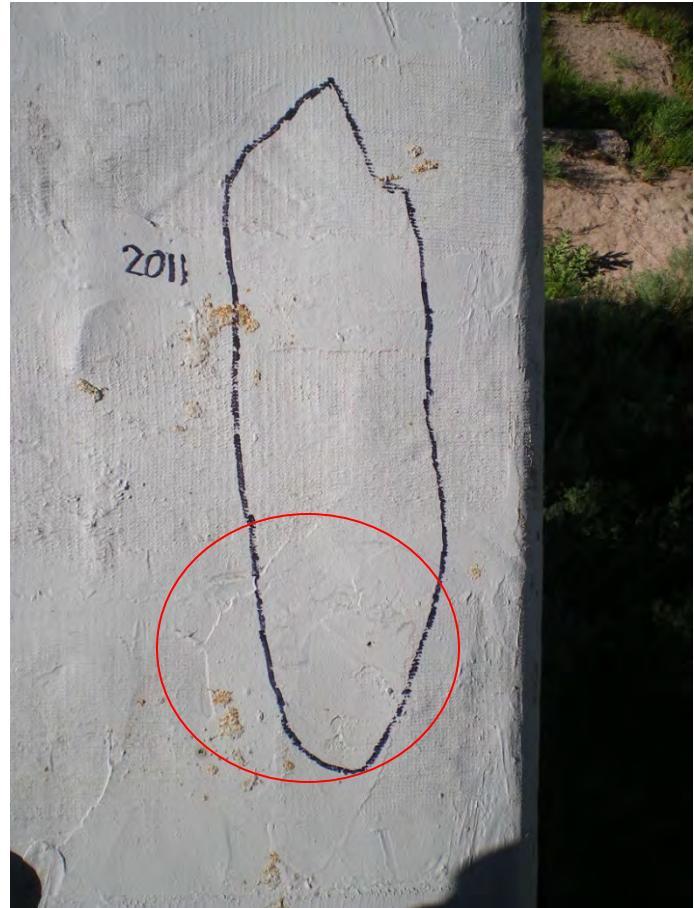
Figure A11. Enclosed in the red circle is 1 of the 2 voids found in 2007

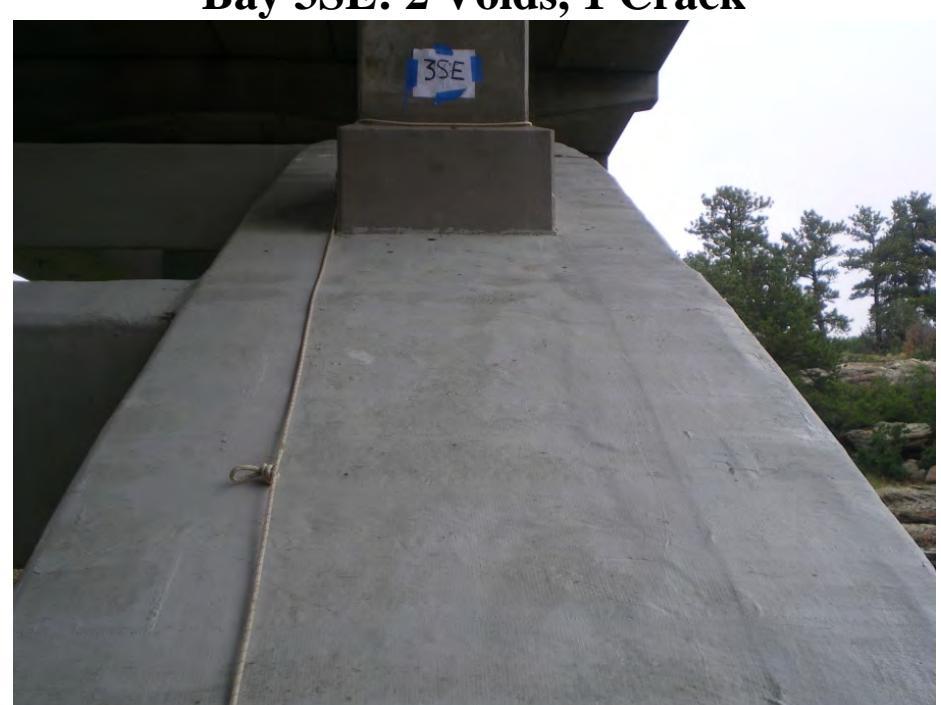
# Bay 3SE: 2 Voids, 1 Crack

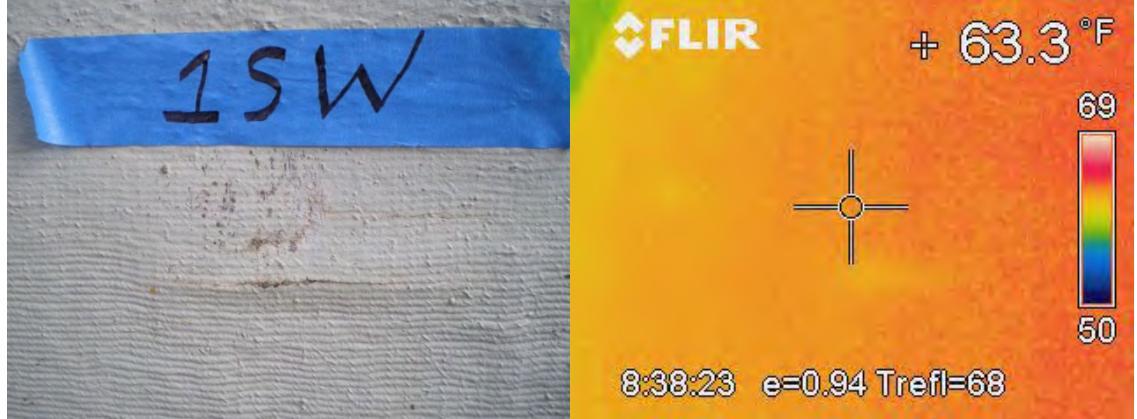
Figure A24. Photograph and thermal image of a defect found in Bay 1SW

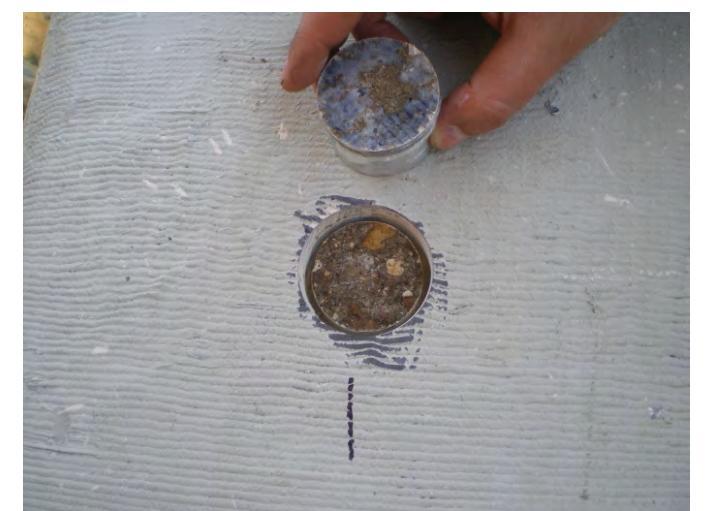
Bay 1NW

**Figure B9.** Test No.10, weak bond strength, and Test No.11 not available, cored area failed during drilling

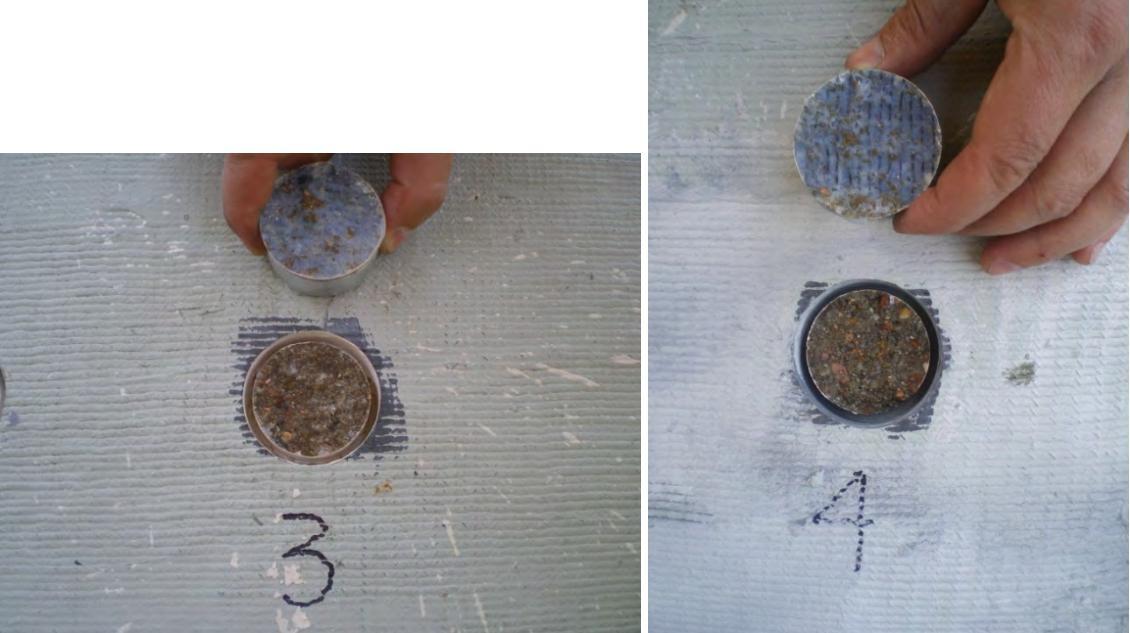
Figures B10 and B11. Test No.12, weak bond strength, and Test No.13, weak bond strength
