MPC 19-404 | P. Romero, S. Bao, and D. Sudbury

Evaluation of the Durability of Thin Lift Surface Treatments

Department of Civil and Environmental Engineering The University of Utah Salt Lake City, Utah

November 2019

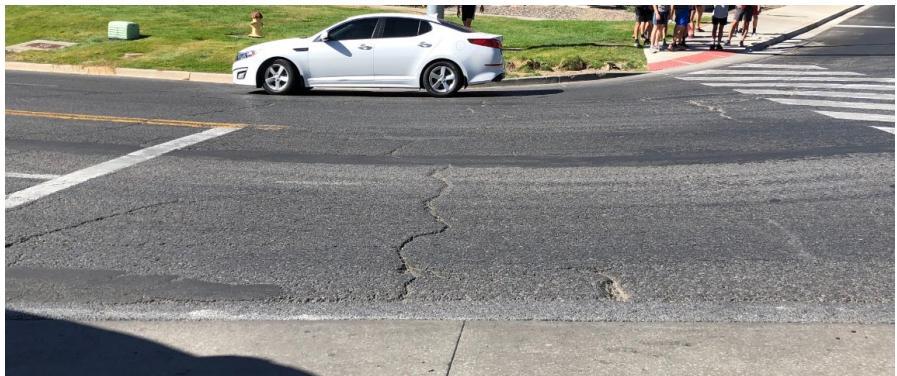
Figure 2.2 Transverse Crack

Transverse cracks, also known as low temperature cracking, are predominantly perpendicular to the pavement centerline. It is caused by the shrinkage of the mixture due to temperature changes. This kind of crack is recorded as the count number of transverse cracks on the section at each severity level. Figure 2.2 shows an example of a typical transverse crack. The transverse crack maximum allowable extent (MAE) for the low severity is one for every ten feet, or 53 cracks for a 528-foot sample section, for medium severity it is 75%, and for high severity it is 50%.

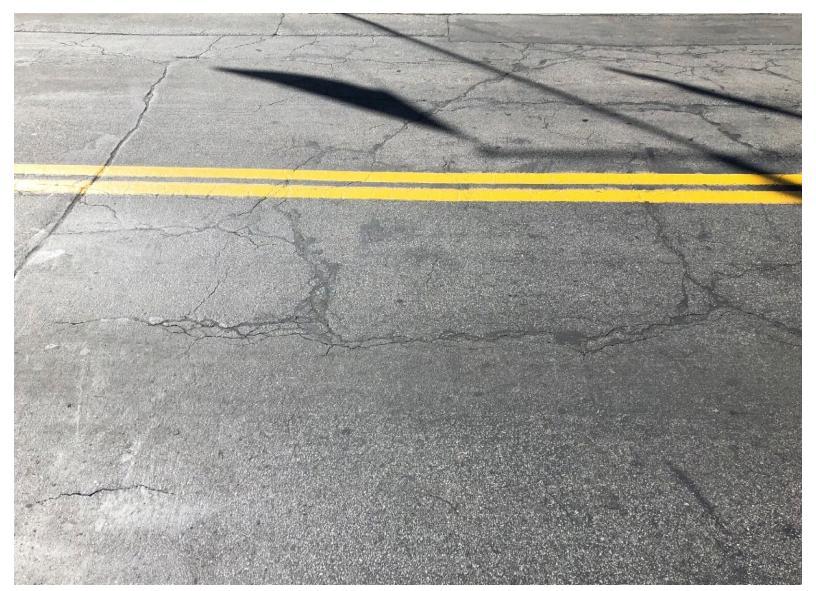
Figure 2.3 Block Crack

Block cracking is the pattern of cracks that divides the pavement into approximately rectangular pieces, with sizes ranging between 0.1 and 10 m^2 (Federal Highway Administration). The MAE of the block crack for a 528 feet sample section at the low severity is 528 feet in total, at the medium severity level is 75%, and the high severity is 50%. Figure 2.3 shows an example of block cracks.

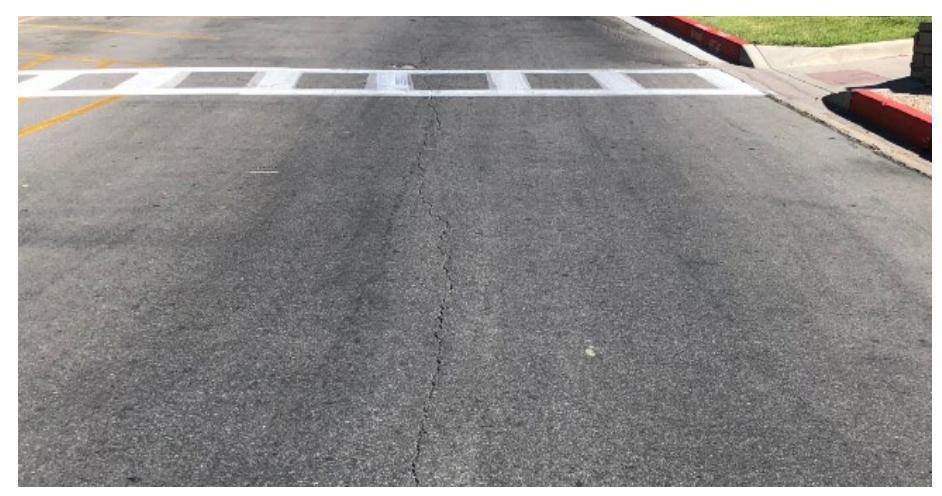
Figure 2.4 Longitudinal Crack

Cracks predominantly parallel to the pavement centerline and located within the lane, but not on the wheel path, are classified as longitudinal non-wheel path (LNWP) cracks, while longitudinal cracking in the wheel path area is considered as the wheel path (WP) cracking. The LNWP crack is recorded as the length with sealant in good condition at each severity level. The MAE for the low severity LNWP is 528 feet of one, 528 feet sample sections, which is 100% of the section. The medium and high severity level are 75% and 50% of the surveyed section respectively. Figure 2.4 shows a picture of longitudinal cracking.

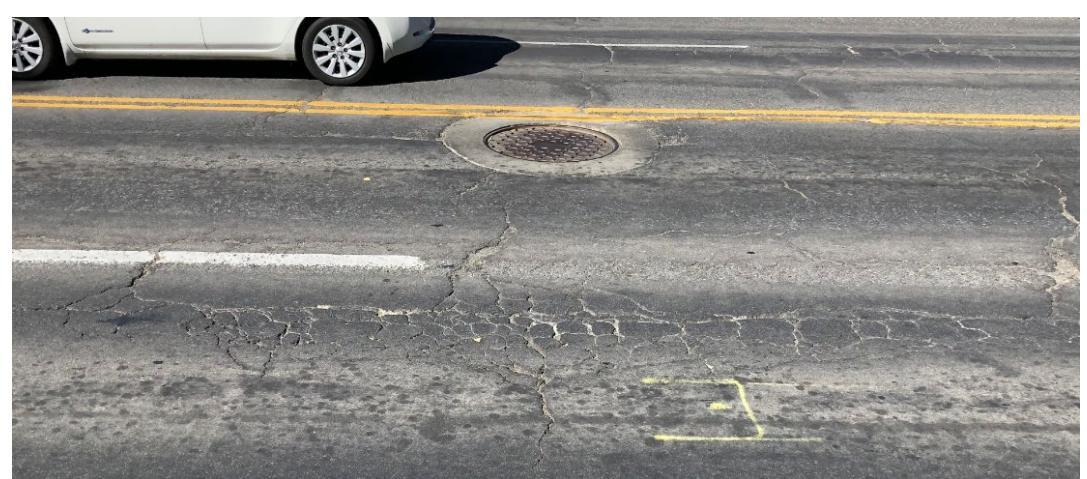
Figure 2.5 Wheel Path Crack

WP cracking is also known as alligator cracking or fatigue cracking. The crack is mainly caused by the repeated traffic loadings in the wheel path area and some minor longitudinal crack on the construction joint. The WP crack is recorded as length but calculated as area, since it considers the WP as 1.5 feet wide in both wheel paths for the 528 feet sample section. The maximum allowable extent for a 528 feet long sample section is 40% of 1,584 square feet for the low severity level, 20% for medium severity, and 10% for high severity.

Low severity WP cracks are longitudinal cracks in the wheel path with few secondary cracks. Medium severity has interconnected cracks resembling an alligator's back. High severity is interconnected cracks with moderate to high severity spalling between them. WP cracking is primarily considered loading related (Miller and Bellinger 2014; UDOT 2009A). The normal longitudinal crack on the wheel path is counted as low-level WP cracking. A picture of this type of distress is shown on Figure 2.5.

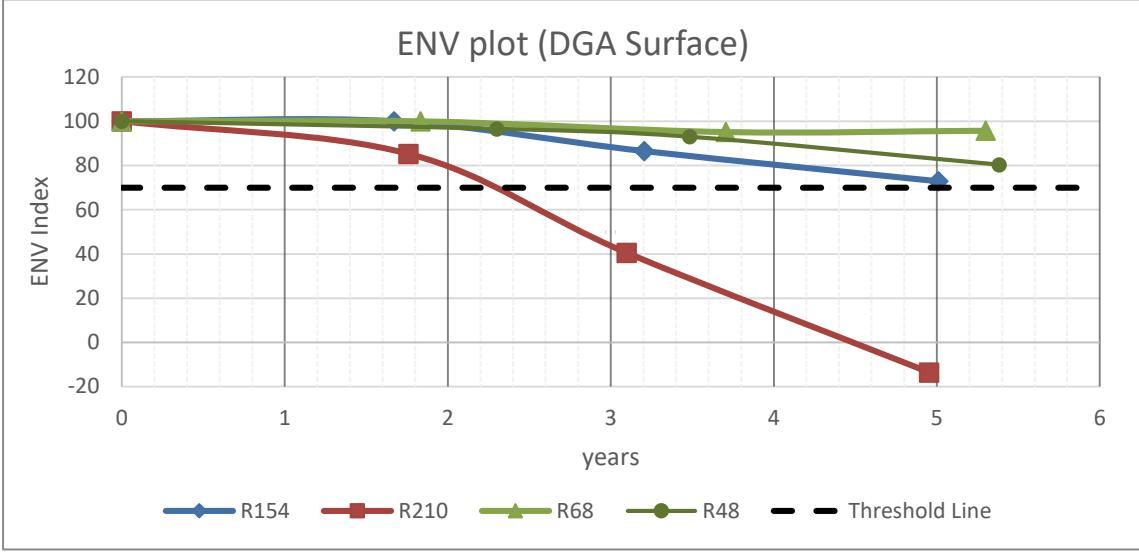
Figure 5.2 DGA TLTs ENV plot

In order to better understand the performance of each type of TLT, the data was separated into treatment types. Figure 5.2 shows the ENV index of the DGA surface only. SR-154, SR-68, and SR-48 have a fairly constant deterioration rate after two-and-half years, but SR-210 did not follow this pattern, and instead deteriorated much more quickly over the same timeframe.

As was discussed in Section 4.3.3, SR-210 is the route going to Alta and the Snowbird Mountain Resort, thus it is subjected to harsh winter conditions. The average elevation of SR-210 is 8000 feet from the sea level, which is 3800 feet higher than Salt Lake City. As shown in Table 5.1, this higher elevation leads to an average temperature for SR-210 section that is about 10 degrees lower than greater Salt Lake area (NOAA Data), and the snowfall in the Alta area is ten times more than that in the Great Salt Lake area. This environment is believed to be a critical issue for the SR-210 TLT section as it led the surface to start rapidly deteriorating before 2015. As a result, this route has the worst performance score out of the 14 treatments evaluated; however, it can be argued that the observed performance is an outlier and not representative of DGAs.

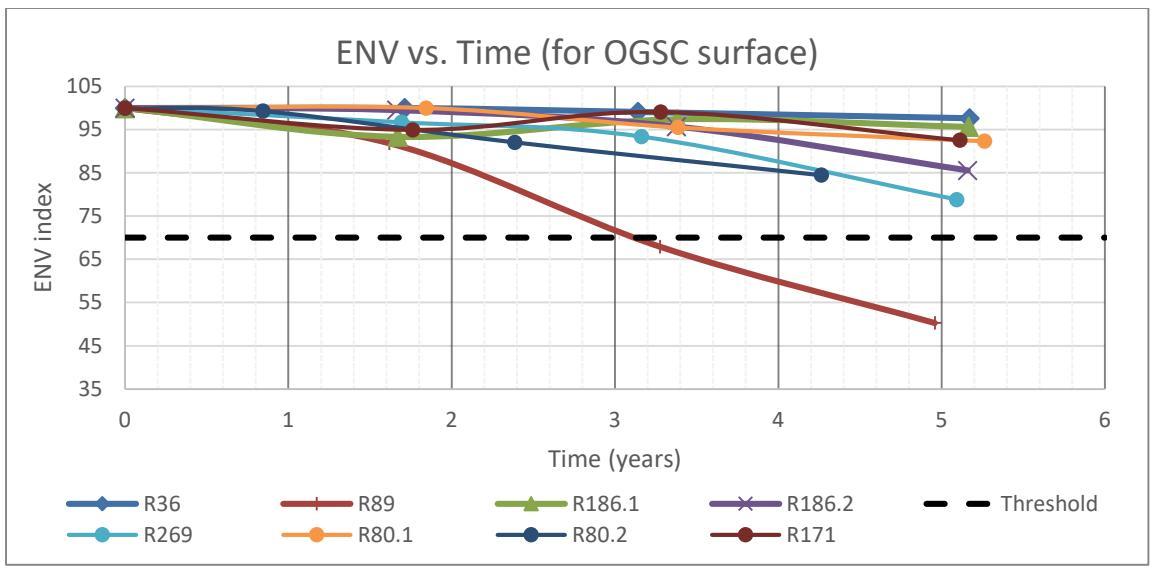
Figure 5.3 OGSC TLTs ENV Index Plot

The OGSC surface treatment comprised the largest sample group in this study. The ENV indexes for all of the OGSCs are shown in Figure 5.3. Seven sections had reasonable decreasing trends, but SR-89 stands out from the group. The estimated life ranges for OGSC surface treatment due to the ENV index condition is between six and 11 years, with the average of being 7.2 years, SR-89 being the exception since it failed at 3.3 years.

After five years, the ENV index for a majority of the OGSC surface treatments ranged from 78 to 97 (SR-89 was out of range). As Figure 5-3 shows, the ENV index value of SR-171, SR-186, and I-80 increased moderately from 2014 to 2015. Physically this is unlikely, although the "self-healing" of asphalt pavement has been reported. Self-healing is still a challenging issue for pavement engineering because it is a complicated mechanism that is not well understood and was not considered for this study. Thus "self-healing" will not be discussed or evaluated under this performance evaluation section. Instead, the increase will be considered an anomaly observation.

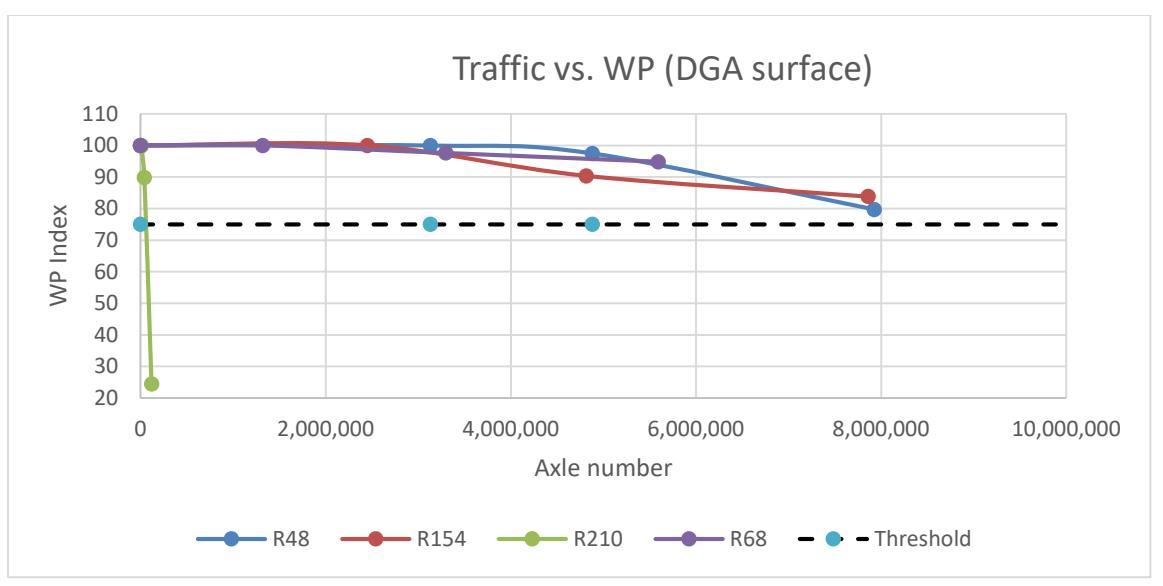
Figure 5.7 DGA WP Index Plot

The dense graded asphalt (DGA) surface treatment wheel path result shows that SR-154, SR-68, and SR-48 are still above the threshold value, but that SR-210 has failed. The value for the first three sections starts decreasing after three million load repetitions. SR-210 has the most unique situation in DGA study group as it has the most extreme environmental conditions out of all 14 sections. It is believed that the negative ENV score influenced the WP performance. This is shown in Figure 5.7.

The average failure point for the DGA TLT is at about 8 million load repetitions, which is approximately 8.5 years, depending on the specific traffic (without SR-210). Table 5.6 shows the life predictions for the DGA treatment.
