MOUNTAIN-PLAINS CONSORTIUM

MPC 17-320 | C.P. Pantelides, M.J. Ameli and L.D. Reaveley

Evaluation of Grouted Splice Sleeve Connections for Precast Reinforced Concrete Bridge Piers

April 2017

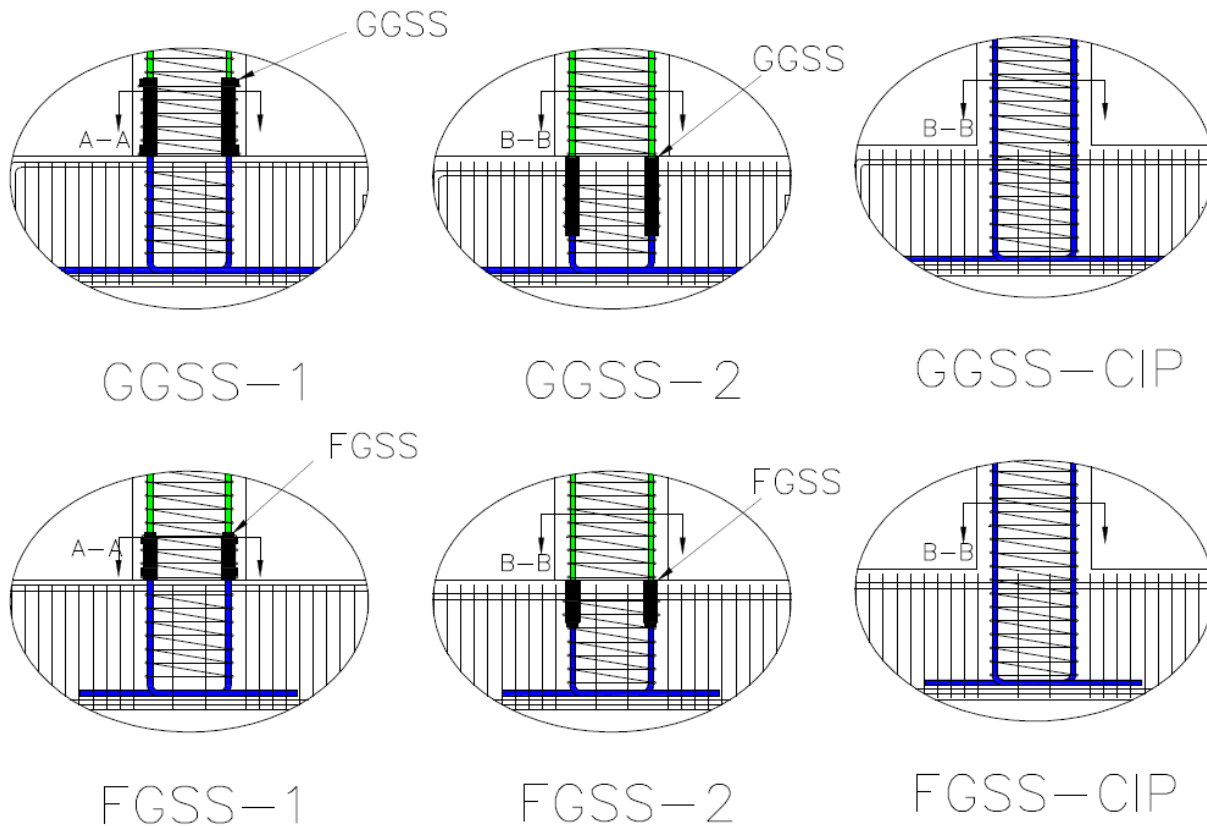
Figure 1.7 Configuration of test specimen alternatives.

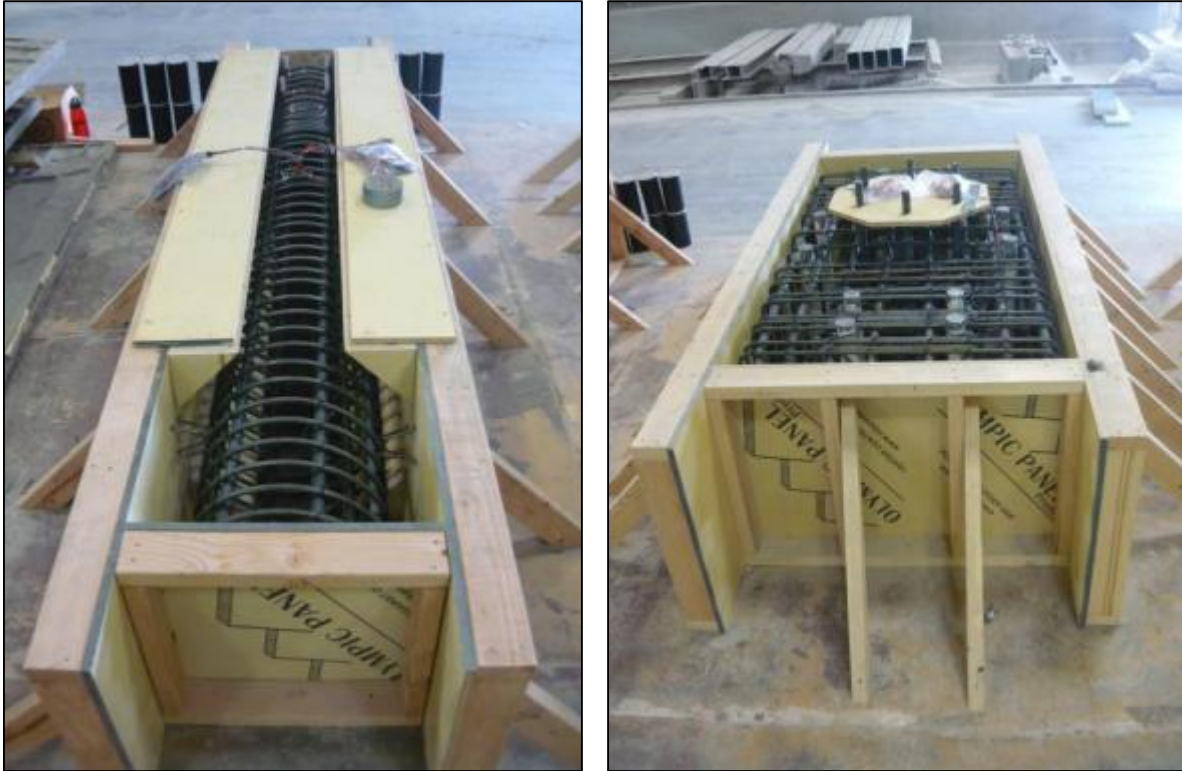
Figure 2.6 GGSS-1 precast components inside forms.

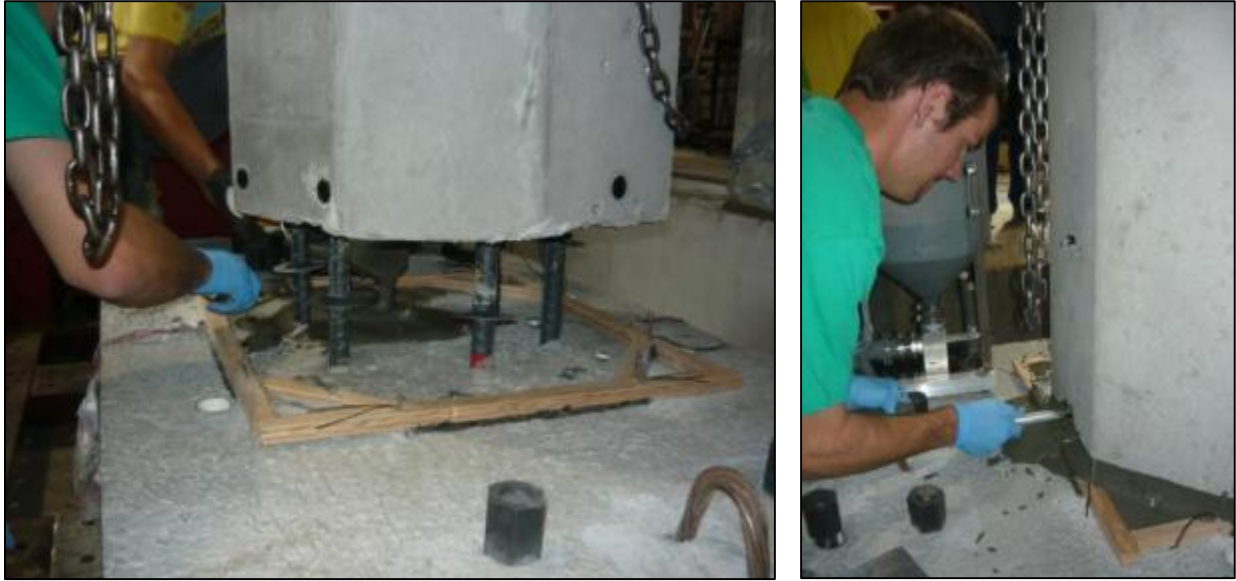
Figure 2.7 Grouting operation for GGSS-1.

The specimen remained attached to the testing frame for a minimum of 28 days before testing for the grout to cure completely. In the meantime, test preparation and external instrumentation were carried out. The average compressive strength of the grout at 28 days was found to be 14.4 ksi. Figure 2.8 displays specimen GGSS-1 in the final testing position at the end of the grouting operation.

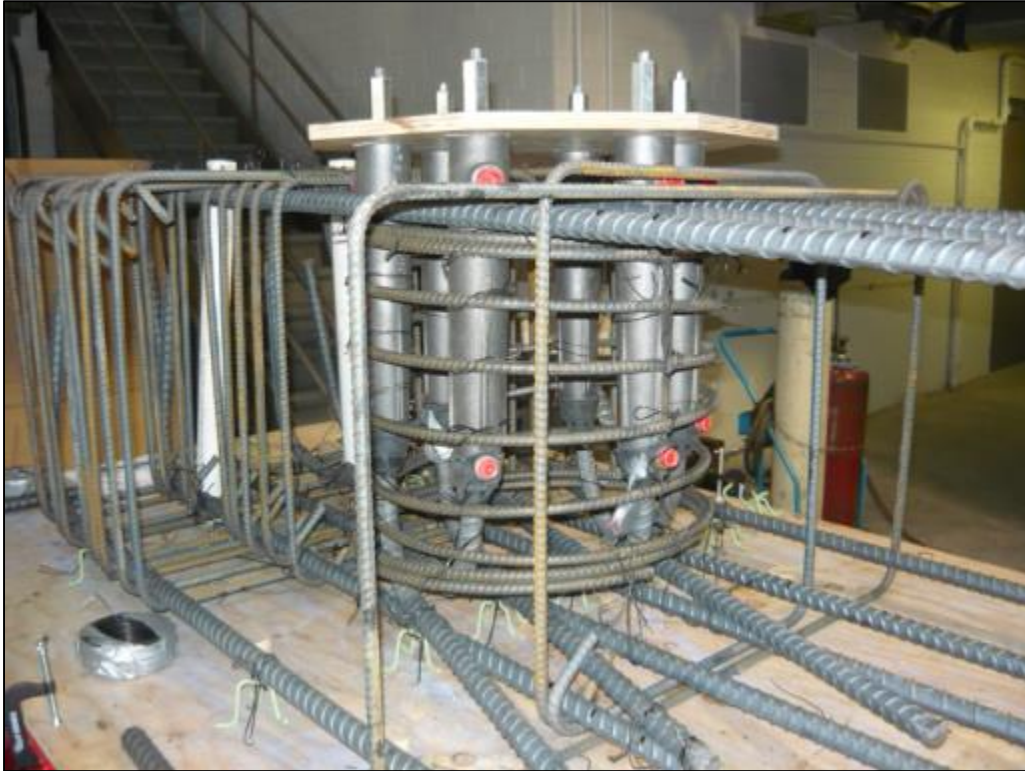
Figure 2.10 GGSS-2 precast footing core rebar cage.

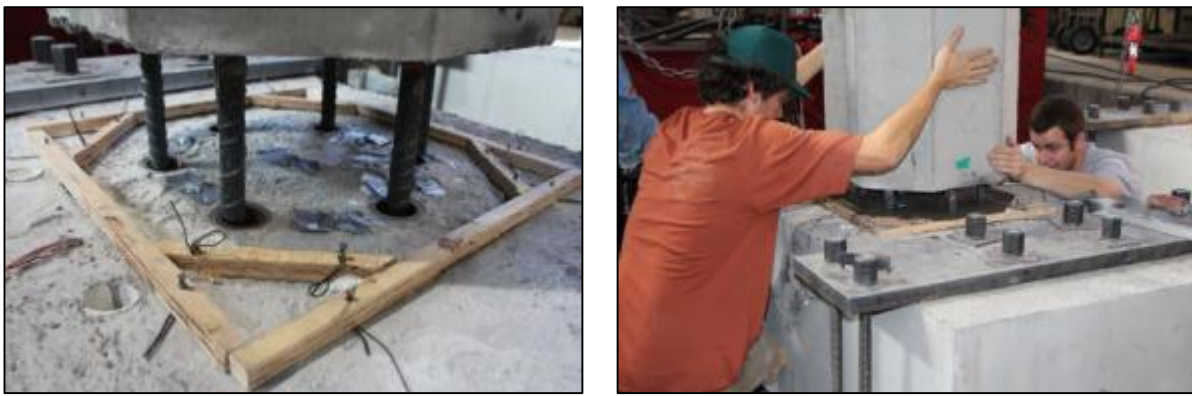
Figure 2.14 Grouting operation for GGSS-2.

A ¼-in. bed grout was incorporated at the column-to-footing interface by placing proper size spacers at the interface between the column and footing. A square wooden dam was made to pour the bed grout, as demonstrated in Figure 2.14. The column was lowered into position gradually and slowly, making sure that it rested plumb and level on the footing.

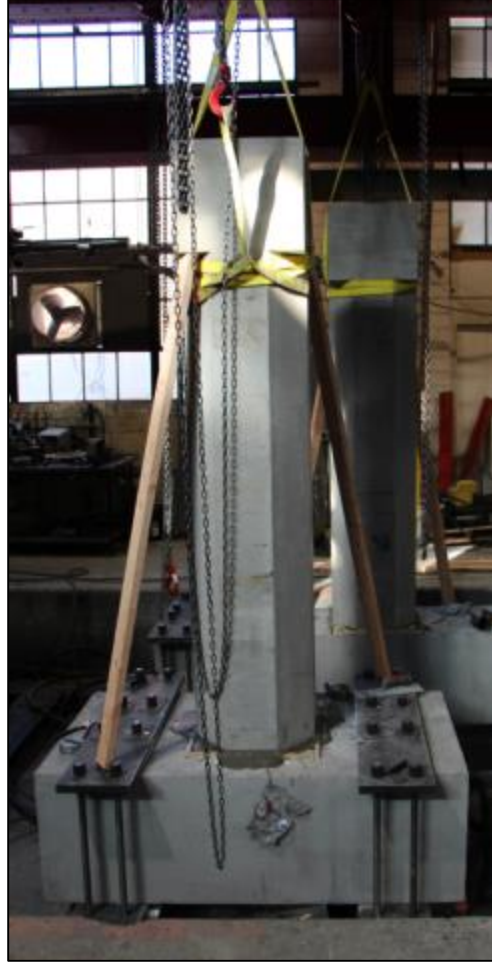
Figure 2.15 GGSS-2 in final position.

Temporary wood bracing was used to prevent movement of the GGSS-2 column until the grout developed sufficient strength. This specimen remained attached to the test frame for a minimum of 28 days before testing for the grout to cure completely. In the meantime, test preparation and external instrumentation were carried out. The average compressive strength of the grout at 28 days was found to be 11.1 ksi. Figure 2.15 displays specimen GGSS-2 in the final testing position, at the end of the grouting operation.

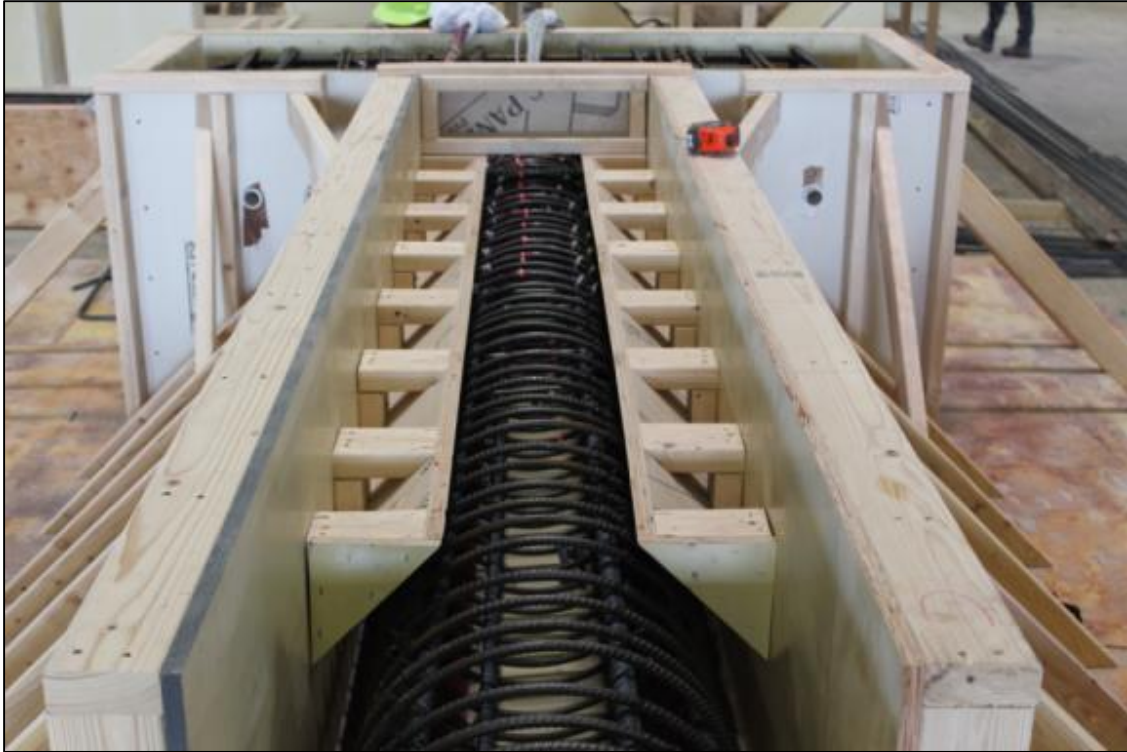
Figure 2.18 GGSS-CIP rebar cage inside form.

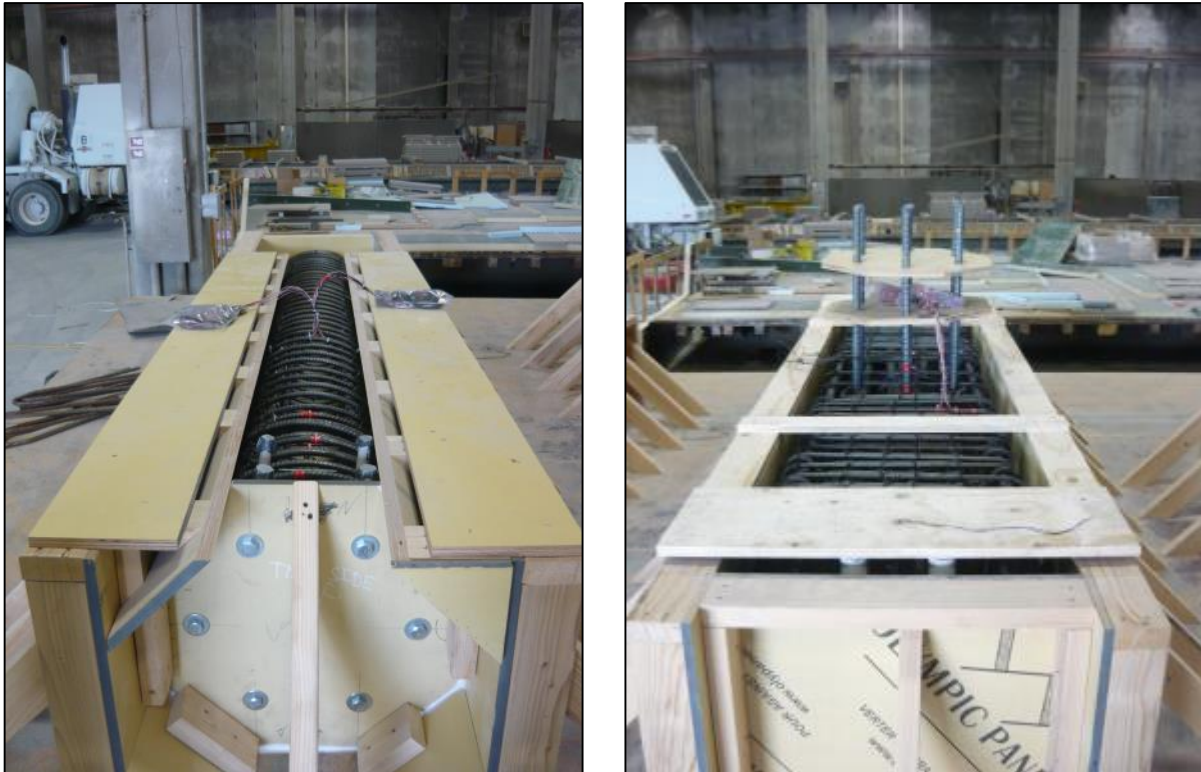
Figure 2.23 FGSS-1 precast components inside concrete forms.

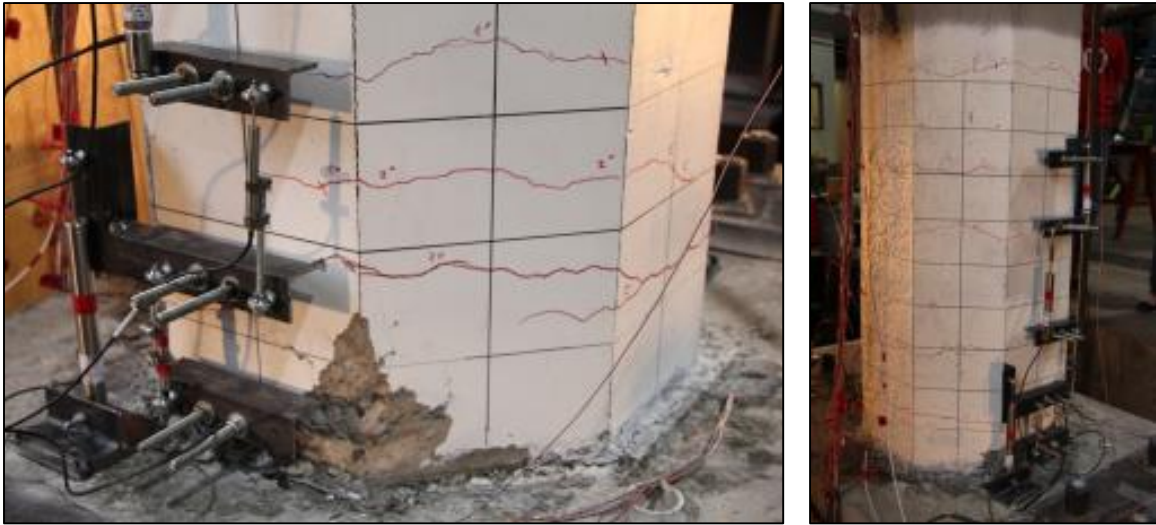
(a) Damage state at 3% drift ratio: cracks and spalling.

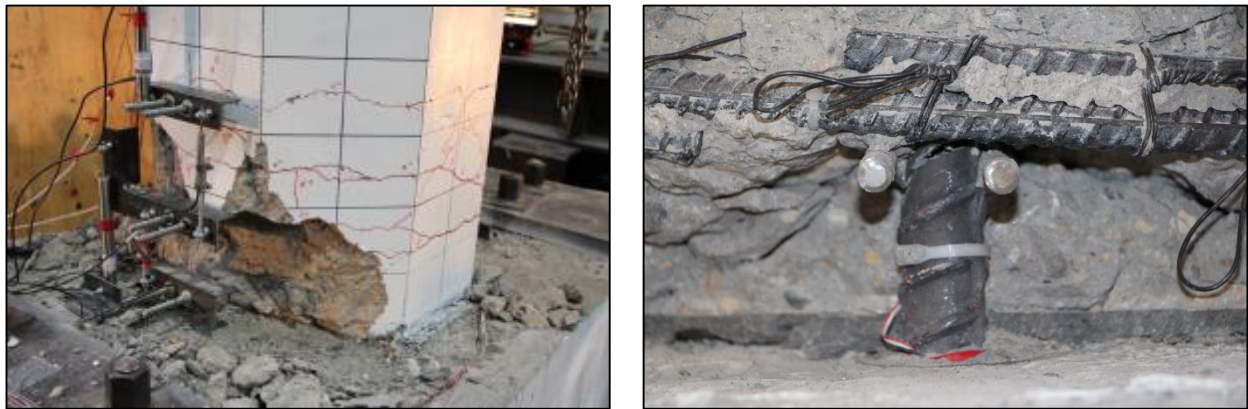
(b) Damage state at 7% drift ratio: cracks, spalling, fractured bar, and exposed rebar cage.

The crack, which had developed at the column-to-footing interface during the previous drift ratios, became a 0.0625-in. permanent gap when the test was terminated. Figure 4.10(b) depicts the damaged area at the column base, including major cracks, spalled region, and the fractured column bar.

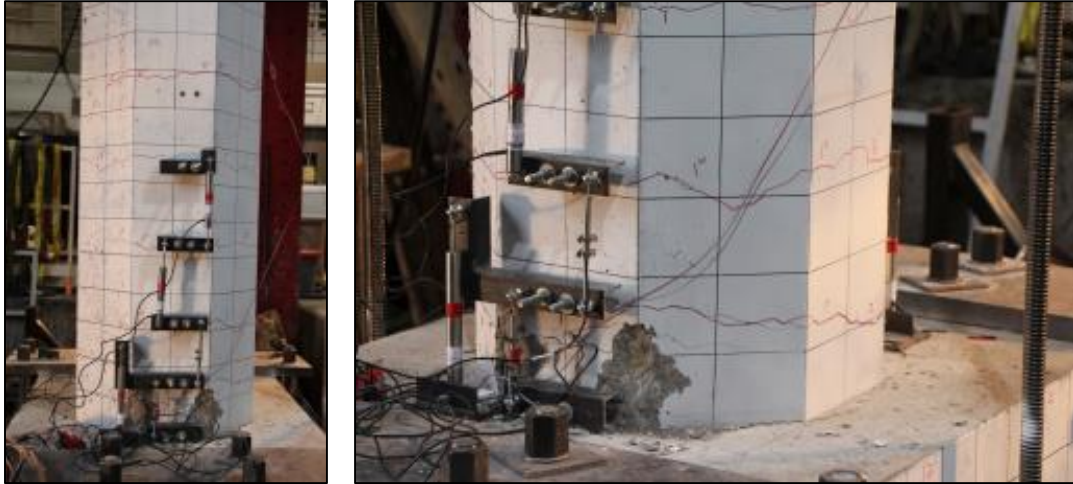
(a) Damage state at 3% drift ratio: cracks and spalling.

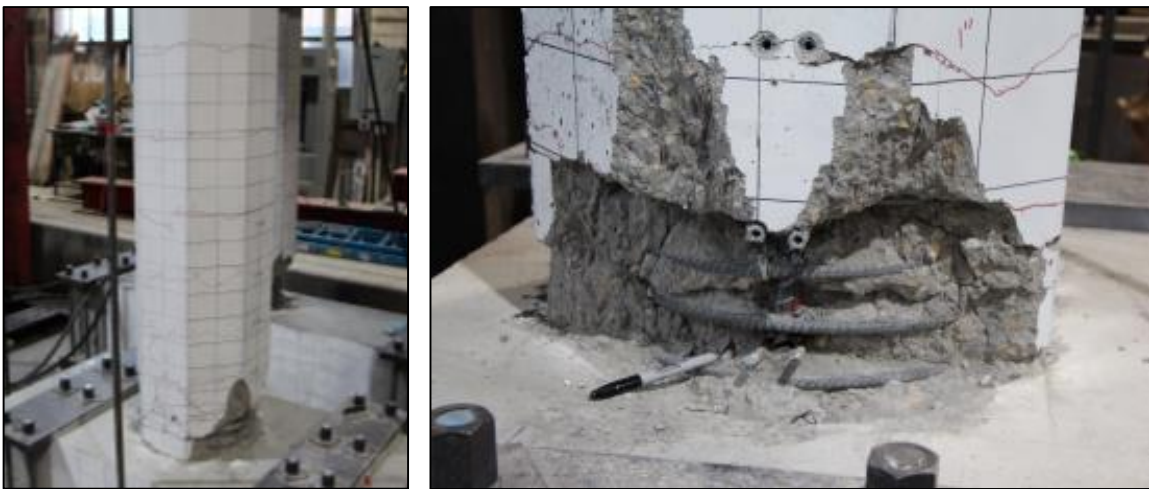
(c) Damage state at end of test: cracks, spalling, concrete delamination, and fractured rebar.

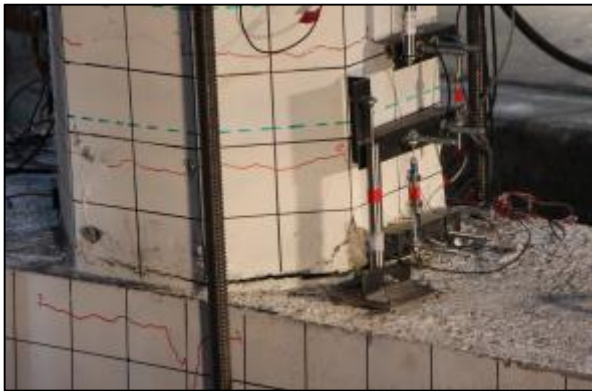
(a) Bed grout opening at 3% drift ratio (peak).

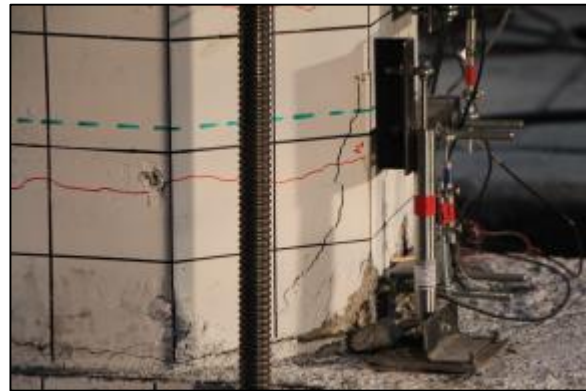
(b) Damage state at 3% drift ratio.

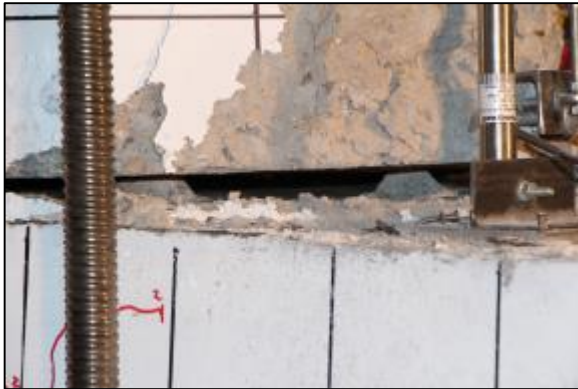
(c) Bar pull-out during 6% drift ratio.

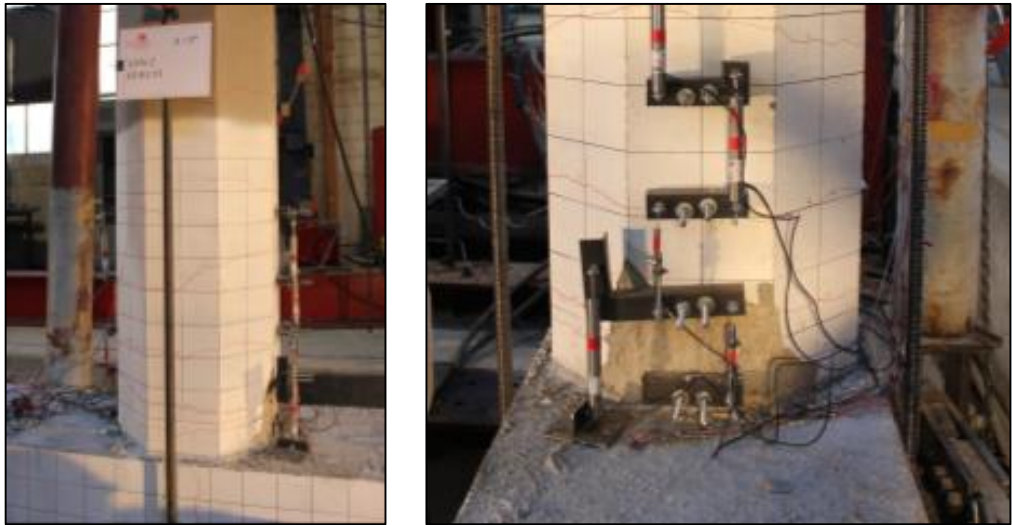
(a) Damage state at 3% drift ratio: cracks and spalling.

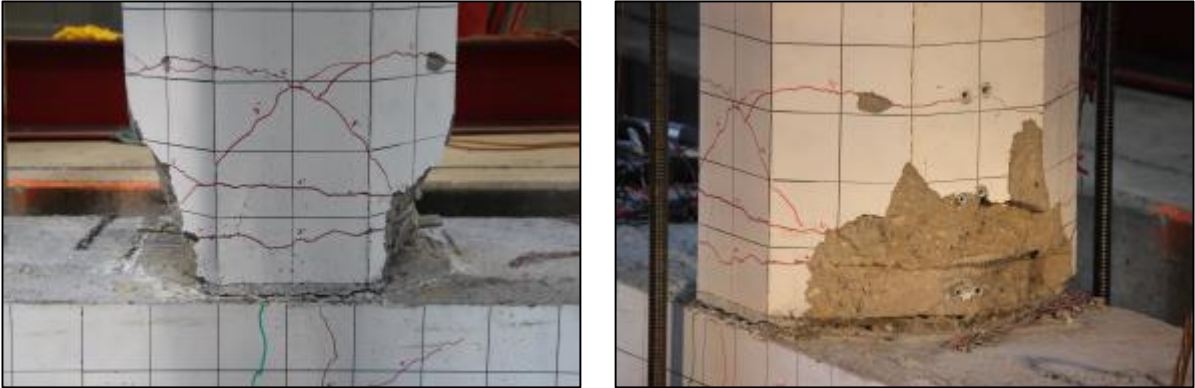
(b) Damage state at 7% drift ratio: cracks, spalling, and exposed spiral.

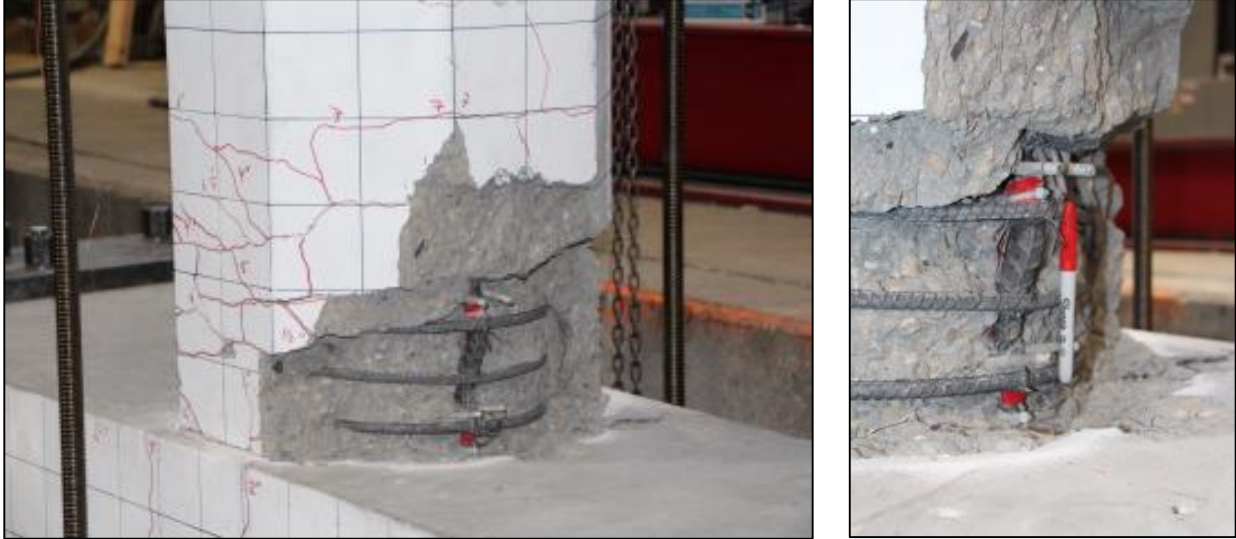
Figure 4.41 Damage state for FGSS-CIP: cracks and spalling, rebar buckling and fracture.

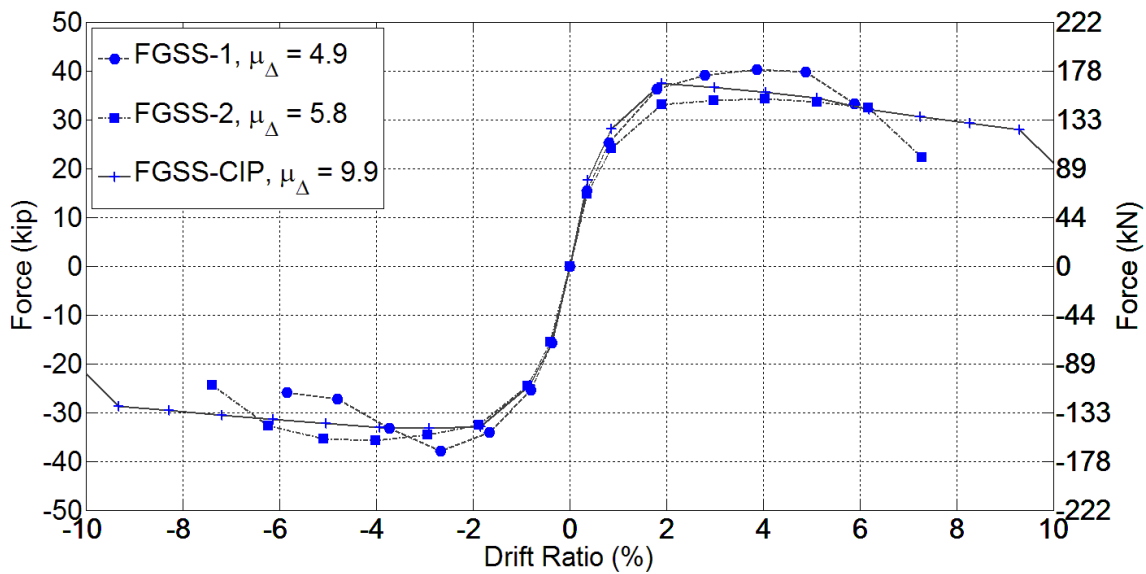
Figure 4.46 Force-displacement response of column-to-cap beam specimens.
