# Traffic Safety Evaluations: Stark County

Issue brief: Summer 2011

**Background/Observations** A location was identified for a TSE in Dickinson, ND at the intersection of 10th Ave East and E. Villard Street. The intersection was chosen for a TSE because of the complexity that exists for drivers. The number of access points to E Villard St. at the 10th Ave intersection cause drivers to have to look in a number of directions before deciding if it is safe to enter (Figure 2). Problems identified in this TSE included:

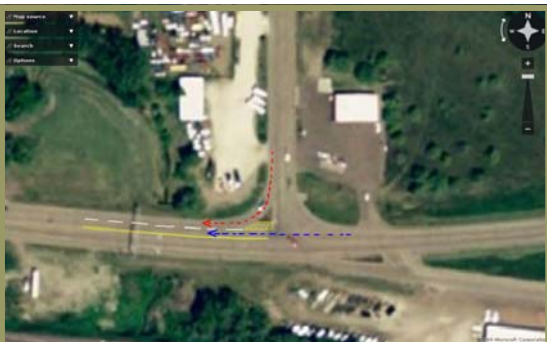
**Figure 5: Example of Suggested Lane Striping**

The east approach to the intersection is one lane which changes to two lanes on the west side of the intersection (Figure 5 - shown in blue). Additional striping and pavement markings to create a separate lane on Villard for vehicles to turn into from 10th Ave E. is recommended (shown in red). Removal of parking and adding left and right turn lanes on 10th Ave E. may also be useful (Figure 6).

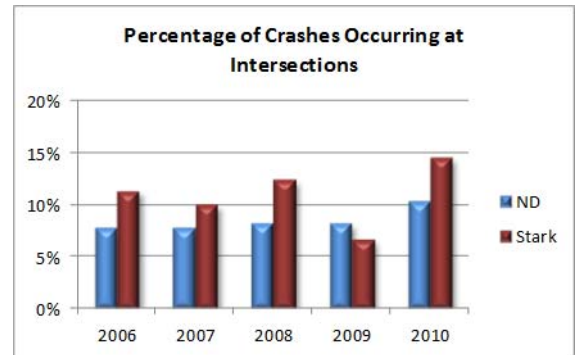
**Figure 7: Percentage of Crashes Occurring at Intersections**

Focusing on this intersection is important to enhancing roadway safety. Thirty crashes occurred at or within 75 meters of the 10th Ave East and E. Villard Street site from 2002 to 2010. Twenty five of the crashes were within 25 meters of the intersection (North Dakota Crash Statistics,). One crash reported injuries while the rest were property damage only. This is a great example of a city and county being productive before a serious injury or fatal crash occurs. Stark County has an intersection crash history that is higher than North Dakota. In 2010, 14.6% of all accidents in Stark County happened at intersections. This is above the average in North Dakota (10.4% in 2010) (Figure 7).
