# *Fort Totten Walkability Assessment*

## Final Report

Prepared for:  
Spirit Lake Nation  
Fort Totten, ND

Prepared by:  
Advanced Traffic Analysis Center  
Upper Great Plains Transportation Institute  
North Dakota State University  
Fargo, North Dakota

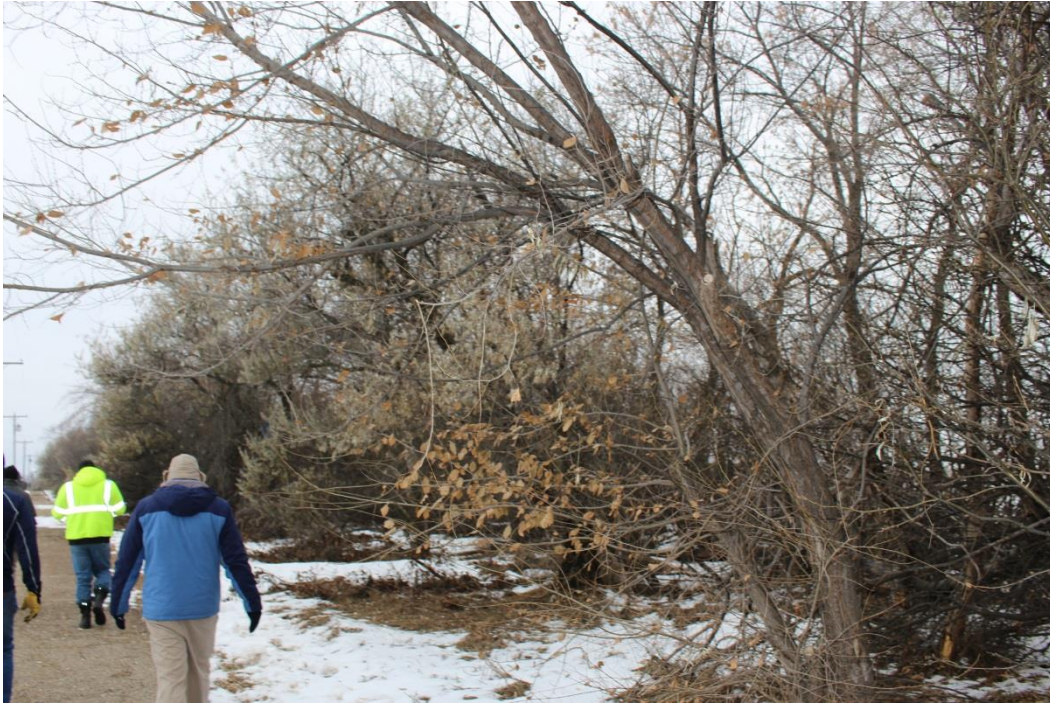
Figure 2. Overhanging trees along ND57

The team observed an overgrowth of trees and shrubs along the sidewalks. The overgrowth encroached upon the walkable areas of the sidewalk as can be seen in Figure 2. Note that the assessment was completed during the fall. During spring, summer and early fall, the overhanging branches can be expected to drop further and encroach on the sidewalk even more. This overgrowth is not only a sidewalk-constricting nuisance, but is a hazard with the potential of injuring the sidewalk users, especially during low-light hours of the day.

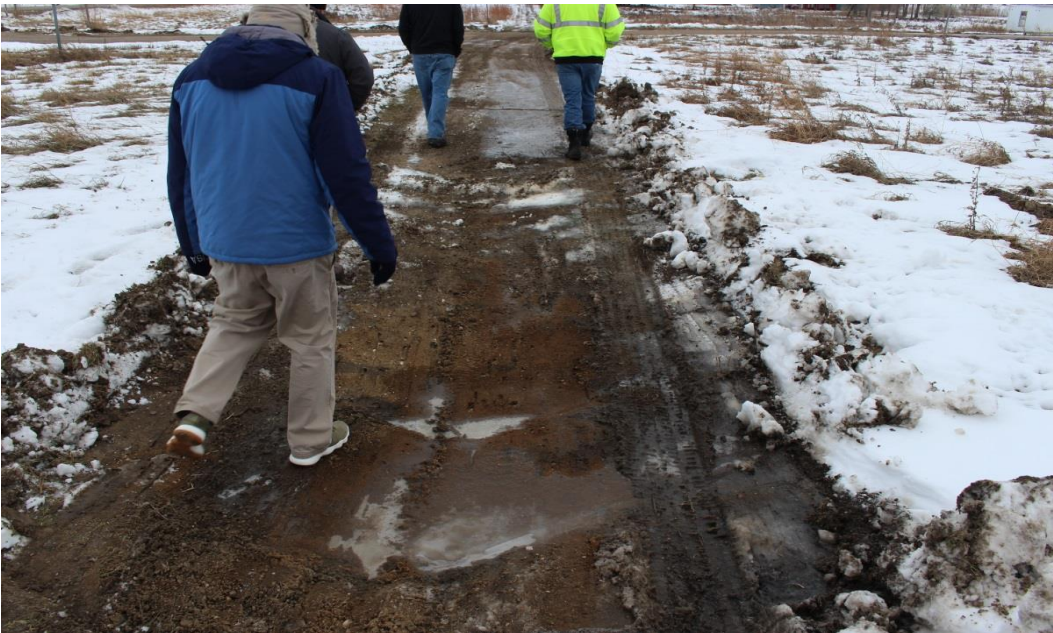
Figure 3. Discontinuity in sidewalk

At several locations, as can be seen in Figure 3, the sidewalk had deteriorated, leading to the substantial loss of the wearing course and allowing the subgrade to surface. In these locations, the sidewalk had the appearance of a gravel path. Such conditions, especially during wet weather, are not conducive to walking or running. The issue is particularly precarious for those using wheelchairs and strollers.

Sections of the sidewalks that are in poor condition should be rebuilt to current standards. In doing so, there be no discontinuities across driveways or along parking lots. It would likely be beneficial to complete several smaller related work items at the same time, including:

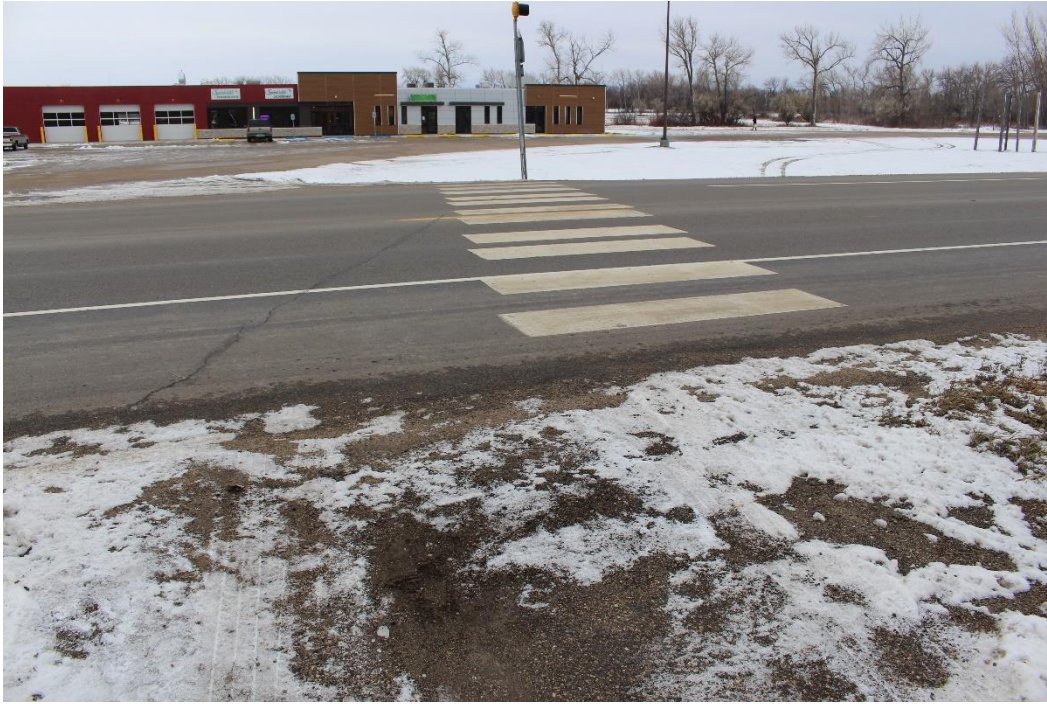
Figure 4. Missing ramp near Four Winds High School

At some locations, as seen in Figure 4, ramps connecting the sidewalk to the crosswalk were missing. They appear to have never been constructed.

- installation of missing ramps
- pavement marking updates
- missing sign installation
- damaged sign replacement

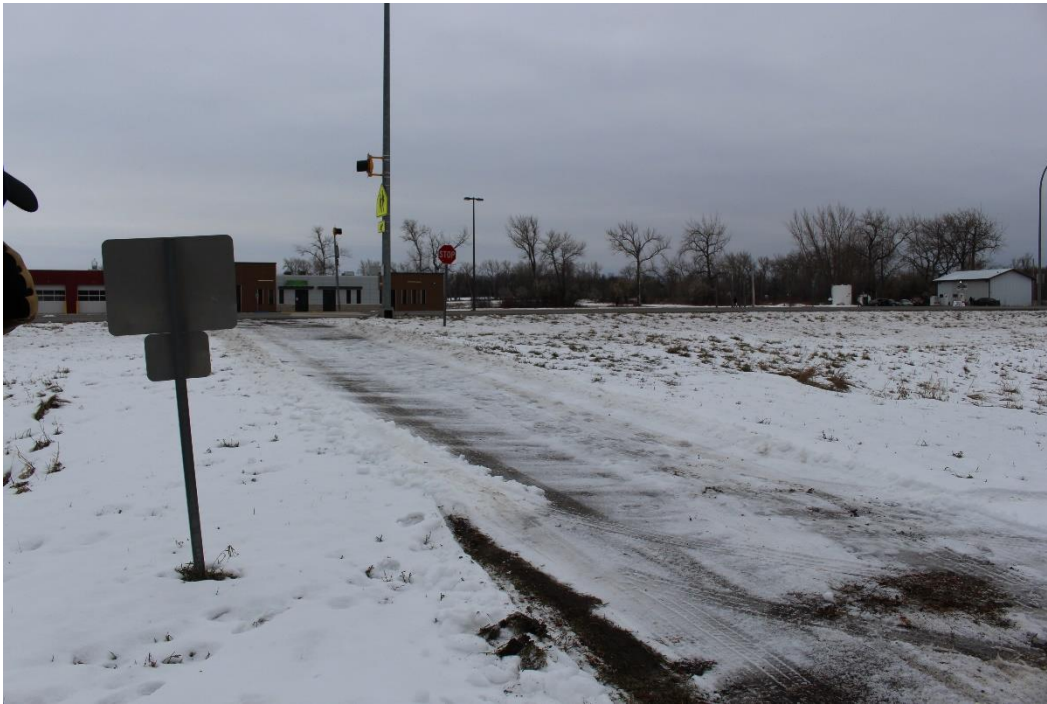
Figure 5. Slippery road condition

At several locations, as seen in Figure 5, the sidewalk was icy.

A review of maintenance practices should be completed. In addition to using plows, brushing of snow away from the walking surface should be considered. De-icing and traction improvement strategies should be instituted to maintain sidewalks and shared-use paths in safe walking conditions. Other considerations include regular maintenance of nearby trees/shrubbery and weed control. Trash receptacles could be installed at regular intervals along the entire path to encourage users to keep the area clear of any garbage.

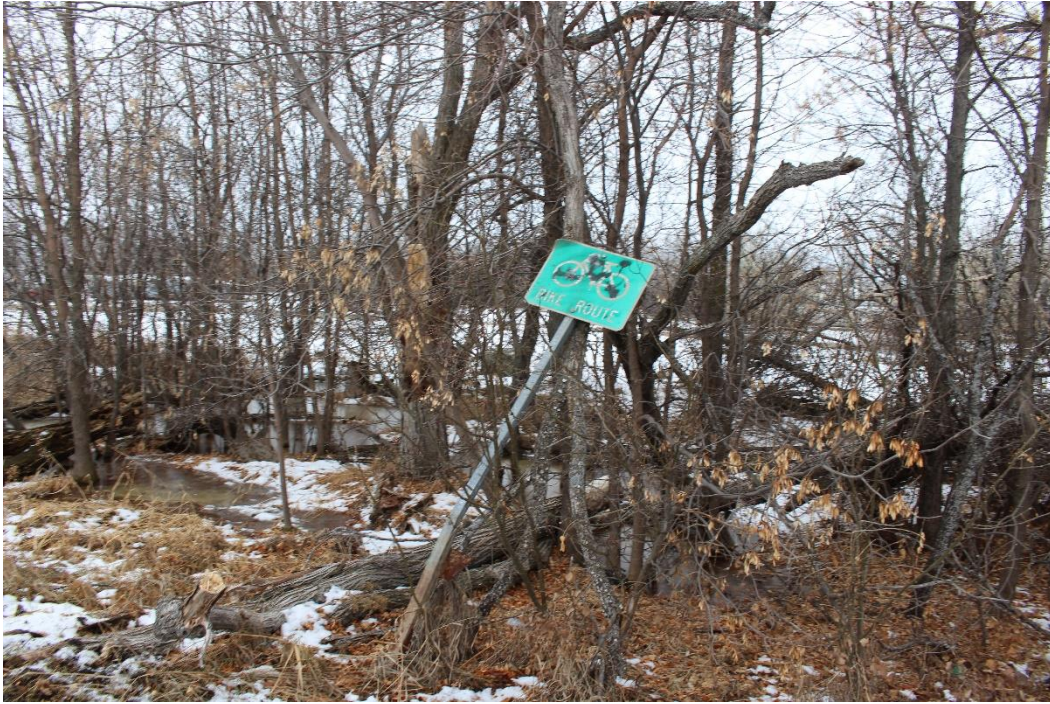
Figure 6. Damaged bike route sign

At multiple locations, signs were missing, graffiti-covered or otherwise vandalized as can be seen figures 6 and 7.

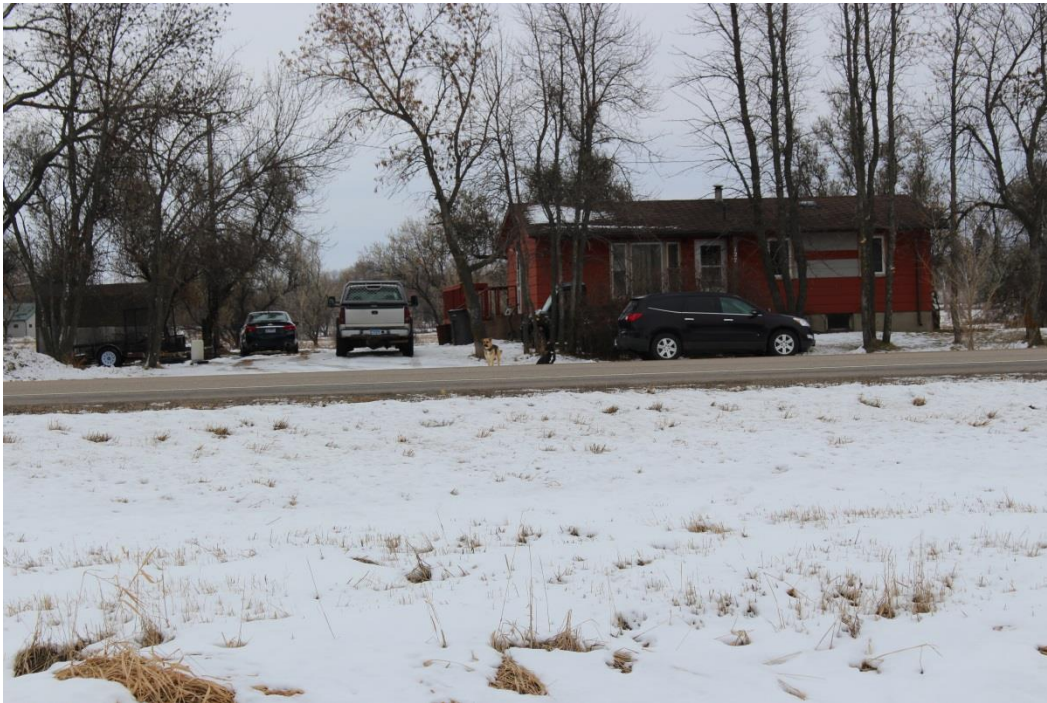
**Figure 8. Unleashed pet dog**

The team observed pet dogs unleashed in the vicinity of the apparent owner's house. This creates an uninviting walking environment that is further exacerbated by a lack of lighting at night or during low-light hours.

A local ordinance be considered to assure that pets that many assessment participants considered scary (e.g. unleashed pets) are kept away from the walking area at all times unless leashed.

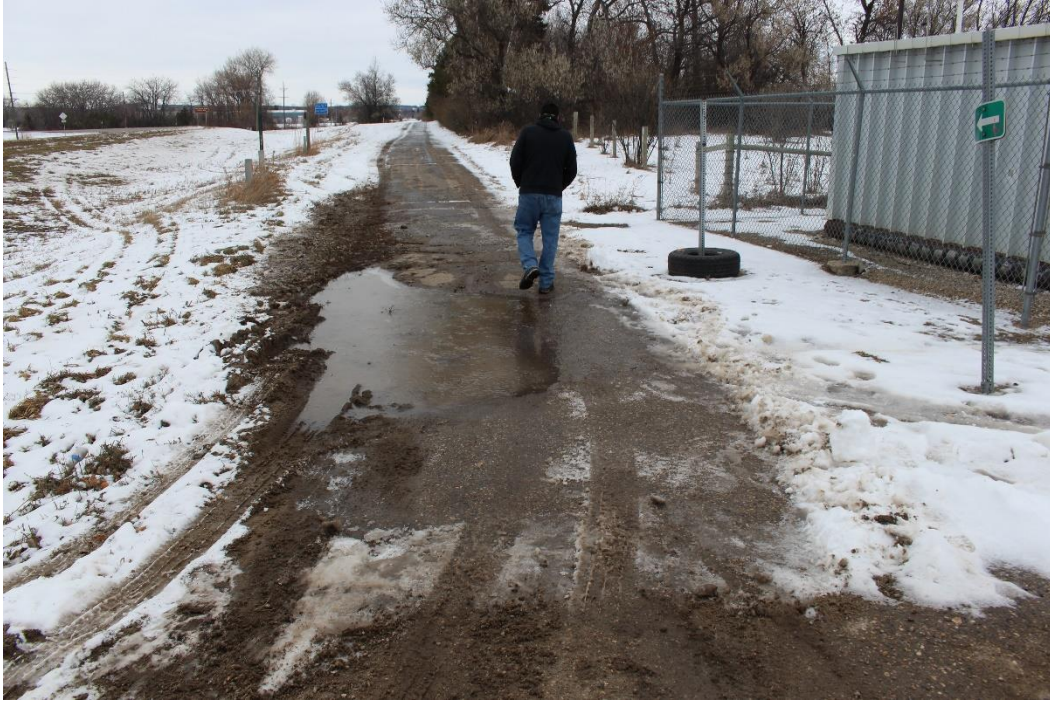
**Figure 9. Puddle of water on damaged sidewalk**

In some places, puddles of water were on the sidewalk. The area under water in Figure 9 appears to have been damaged/cracked. Also, note the missing sign on the post to the right.

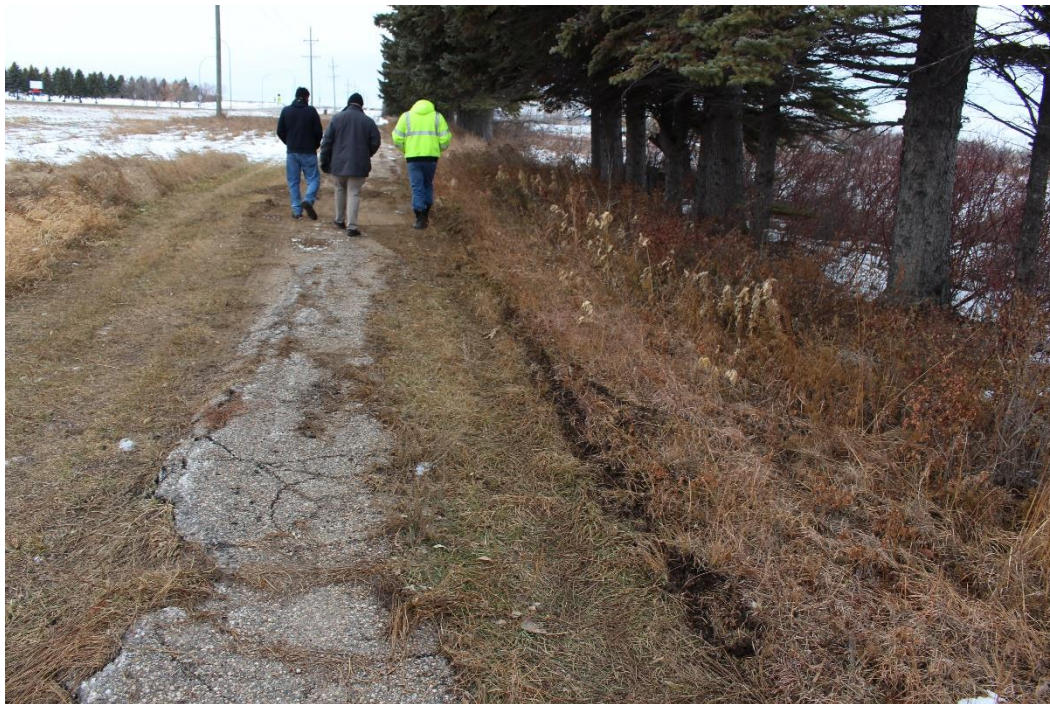
**Figure 10. Weathered sidewalk and weeds**

At other locations, most of the walking surface had weathered and weeds were seen growing where the sidewalk used to be.

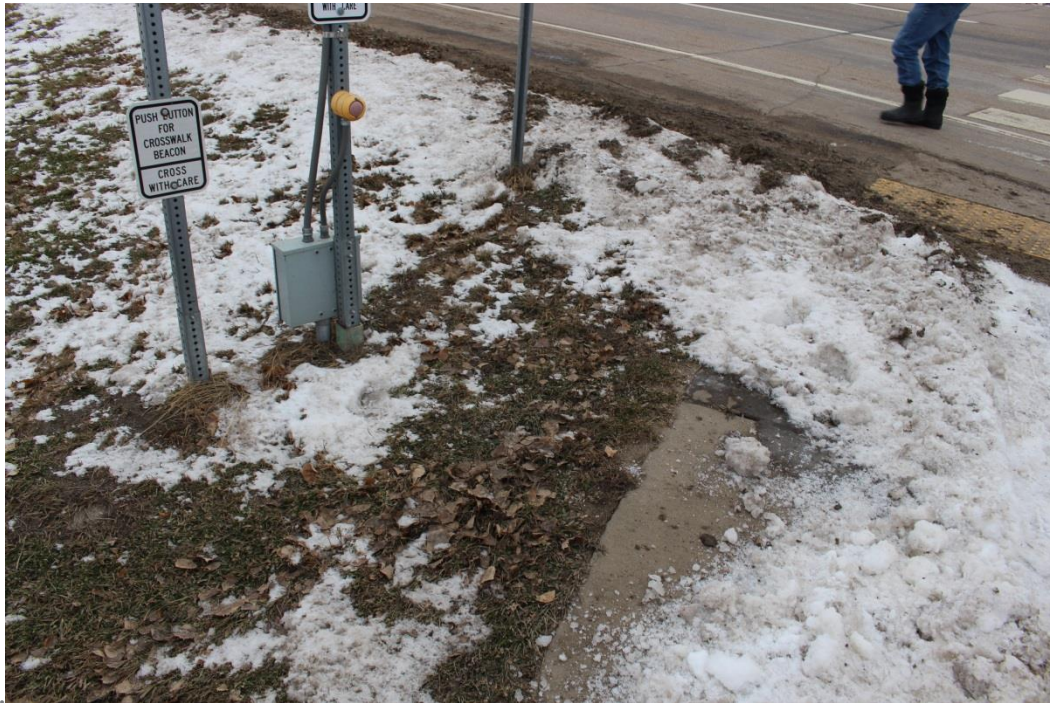
Figure 11. A location missing landing for the pedestrian push button

At some locations, landings were missing next to the pedestrian push buttons as can be seen in Figures 11 and 12. At such locations, it can be very difficult to reach the push button especially for children and other vulnerable members of the community. The landings appear to have never been built.

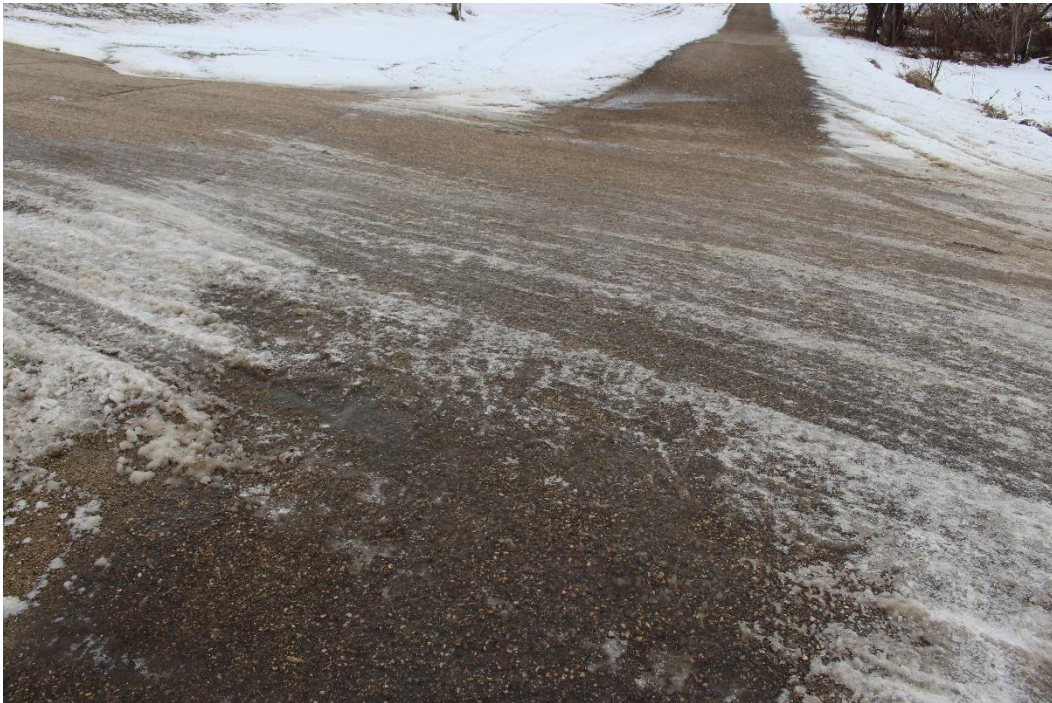
Figure 13. Discontinuous sidewalk

At several locations, the team found the sidewalk to be discontinuous, especially across driveways. Another location of discontinuity was where the sidewalk led into a parking lot and the difference in the parking lot and the sidewalk was not discernible.

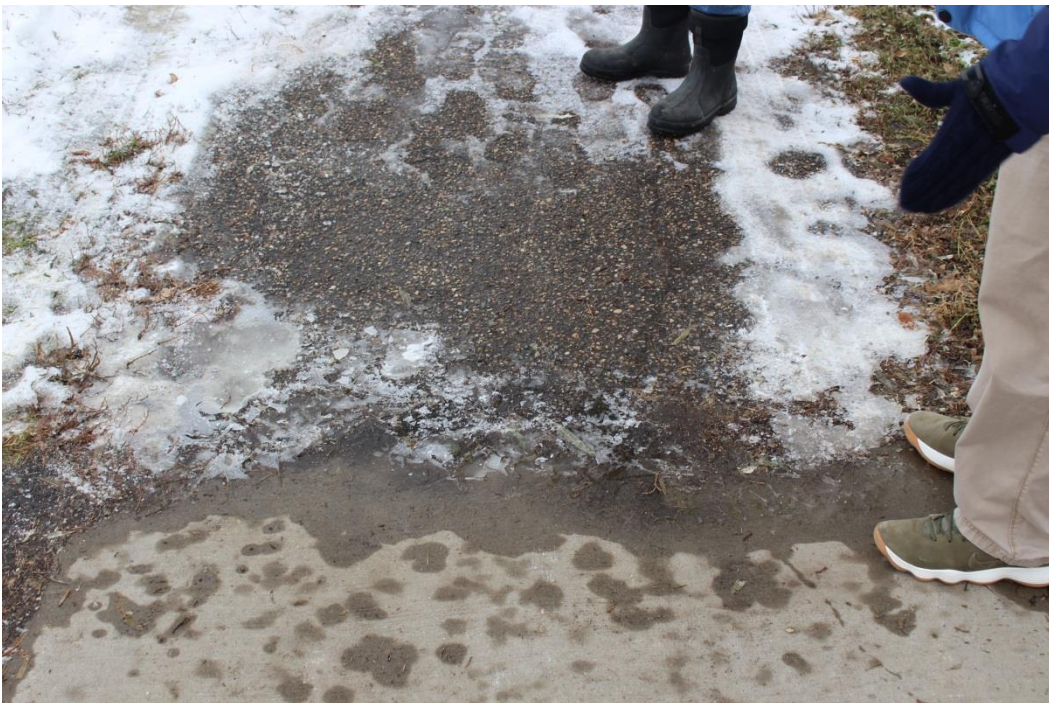
Figure 14. Different top layers used for sidewalk

In some locations, different top layers (asphalt and concrete) were observed on the sidewalk. A mix of materials as seen in Figure 14 may present challenges for repair and maintenance.
