# Vision Camera Data Collection & Traffic Analysis Enhancements

**Final Report**

Prepared for: Grand Forks-East Grand Forks MPO

Prepared by: Kshitij Sharma Bradley Wentz Advanced Traffic Analysis Center Upper Great Plains Transportation Institute North Dakota State University Fargo, North Dakota

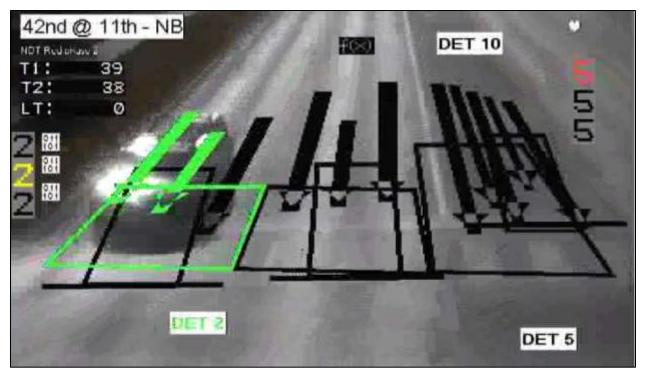
Figure 1. View of older model camera with detection and data collection overlays

Prior to this project, the Grand Forks-East Grand Forks MPO and the City of Grand Forks were using approximately 183 (45 intersections) of the city's existing traffic detection cameras for traffic data collection. These cameras were set up during Phases I, II, IIIa and IIIb of the study. Models of cameras at these intersections included Encore, Terra and Duo. Figure 1 shows an example of the view provided by these cameras.

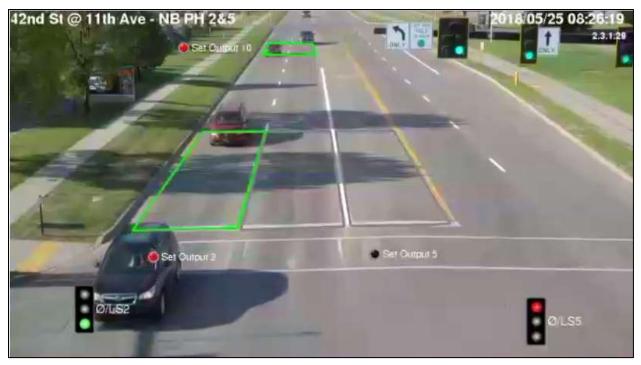
Figure 2. View of newer model VISION camera with detection and data collection overlays

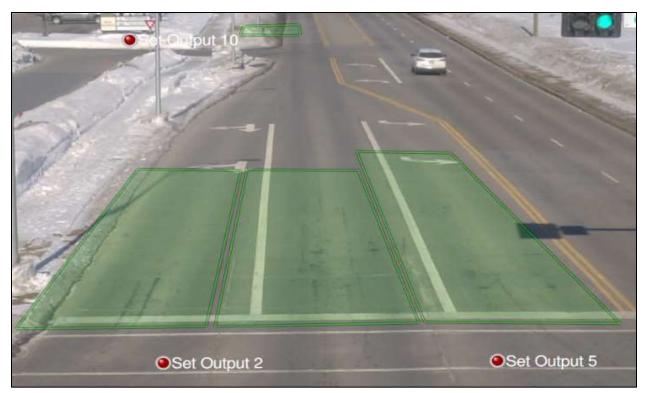
Figure 3 shows the existing zone setup at the southbound approach at the intersection of N 42<sup>nd</sup> St. and University Ave. At this location, the zones were off center from their corresponding lanes. Figure 4 shows the adjustments made to the zone locations to better accommodate the lanes. This adjustment should reduce double-counting because of the mismatch between the pavement markings and the zone setup.

Figure 3. Existing zone setup for N 42nd St. at University Ave. southbound

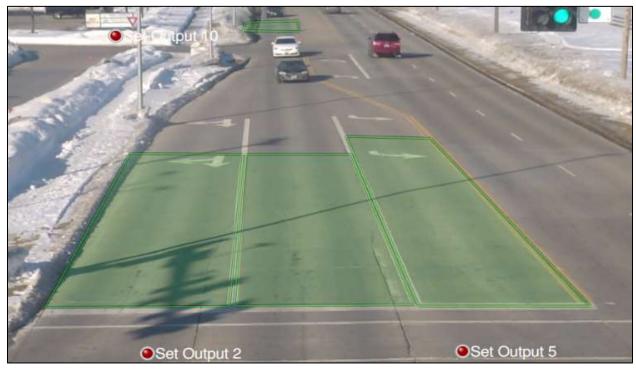
Figure 4. Updated zone setup for N 42nd St. at University Ave. southbound

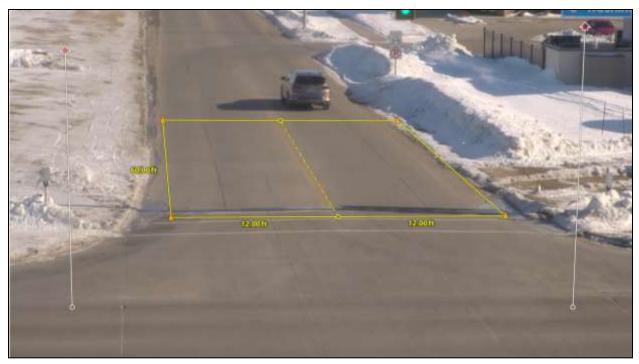
Figure 5 shows the existing calibration setup at the westbound approach at the intersection of Washington St. and 44th Ave. S. At this particular location, the calibrated lane widths were found to be incorrect. Figure 6 below shows the updated calibration at the same location. The improved calibration of these cameras is expected to improve the traffic counts as well as vehicle presence and passage detection.

Figure 5. Existing calibration setup at Washington S.t at 44th Ave. S WB approach

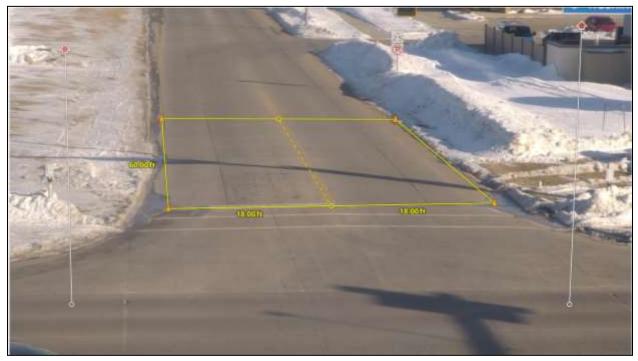
Figure 6. Updated calibration setup at Washington St. at 44th Ave. S WB approach

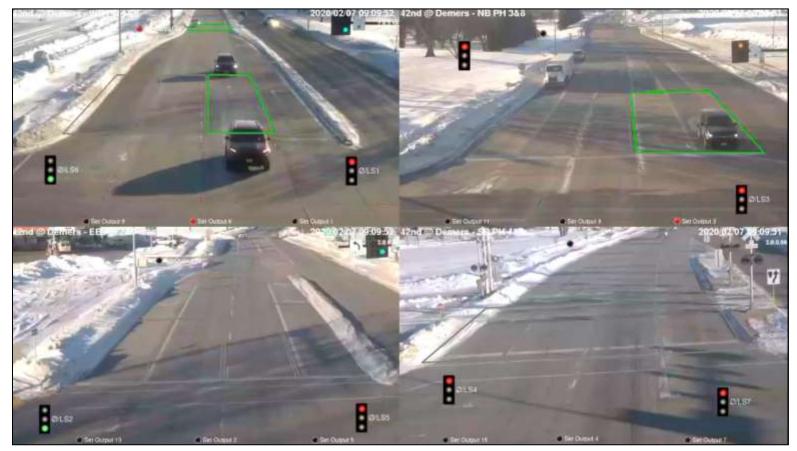
Upon further investigation, it was found that the traffic data quality began to deteriorate during the mid- to late-winter months. This seemed to coincide with certain camera contrast-loss events registered in the operations log following the software/firmware update. These events are not considered severe errors and are marked as informational (e.g., entering/leaving low-detail mode). Figure 7 shows a typical intersection that may be entering low-detail mode. The specific intersection shown is S 42<sup>nd</sup> St. and Demers Ave. Five

Figure 7. S 42nd St. at Demers Ave. EB camera in-and-out of low detail mode

out of the thirteen intersections audited thus far appear to have been impacted by the low-detail mode events. At these intersections, not every turning movement and not every camera was affected. Note that the direction of the camera did not appear to play a significant role. Figure 8 shows the operational log of the system entering low-detail mode. Note that vehicle detection for signal operations was not impacted by such events. Also, all of the data reported during the rest of the year is of exceptional quality. Further scrutiny is necessary in this matter. Recommendations and next steps in this regard are outlined in the corresponding section of the report.

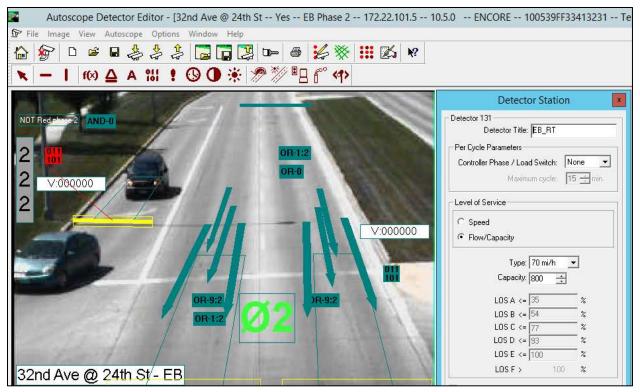
Figure 9. Level of service parameter settings as observed at eastbound 32nd Ave. S at 24th St. S

The persistent data collection especially at the non-VISION intersections allows level of service estimation. Parameters for such estimation can be set to suggested or custom thresholds. However, during our investigation it was found that the setup at all of the cameras is not consistent as illustrated in Figures 9 and 10. Note that the level-of-service estimation criteria as well as threshold is different, rendering the level-of-service estimate data collected at these intersections unusable. Apparently, the estimation has wide applications as the criteria can be set to either speed or volume/capacity ratio. The speed criteria may be considered for freeway mainlines whereas the volume/capacity ratio criteria are more suited for signalized intersection approaches or midblock arterial locations. Consequently, it was determined that it is feasible to collect level-of-service estimate data from the signalized intersections outfitted with older-model cameras in Grand Forks. However, doing so would require resetting of the parameters of more than 180 devices.

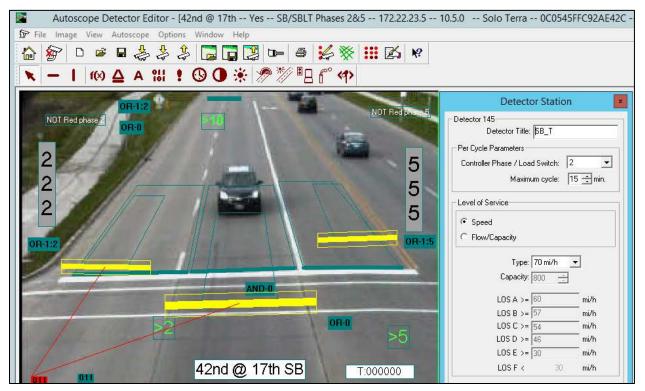
Figure 10. Level of service parameter settings as observed at southbound 42nd St. S at 17th Ave. S

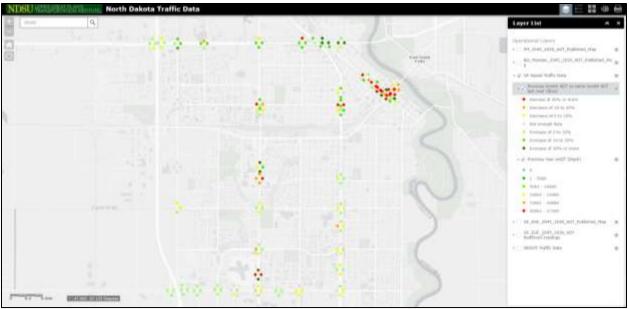
The ability to compare data in a timely and ongoing fashion affords stakeholders the ability to react to changes in travel demand and patterns in a much more appropriate manner. Currently, annual average daily traffic (AADT) values of the previous year can be compared to those of 2+ years ago. It is anticipated that soon the growth factor recalculation and web portal update will be carried out weekly, ensuring that weekly average daily traffic can be compared as well. The weekly factors will likely be divided into "weekday" and "weekend" categories. Figures 11 and 12 show a view of the web portal displaying MADT comparisons. Note that the colors and their shades depict growth (green) and decay (red) of traffic. The corresponding categories are:

- Dark green increase of 30% or more
- Medium green increase of 10% 20%
- Light green increase of 0% 10%
- Yellow decrease of 0% 10%
- Orange decrease of 20% 30%
- Red decrease of 30% or more

Figure 11. Sample of color-coded traffic changes at Grand Forks intersections on ND Traffic Data Portal

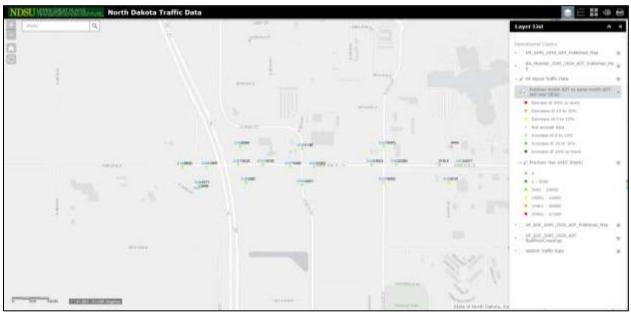
Figure 12. ND Traffic Data Portal showing last year's AADT and growth factors on selected Grand Forks intersections

The North Dakota Traffic Data Portal was created using the previous month's annual daily traffic (MADT) which can be compared to the same month of last year. This traffic growth factor calculation/comparison is done for all four (three – in case of T-intersections) legs of the Grand Forks intersections reporting traffic data.

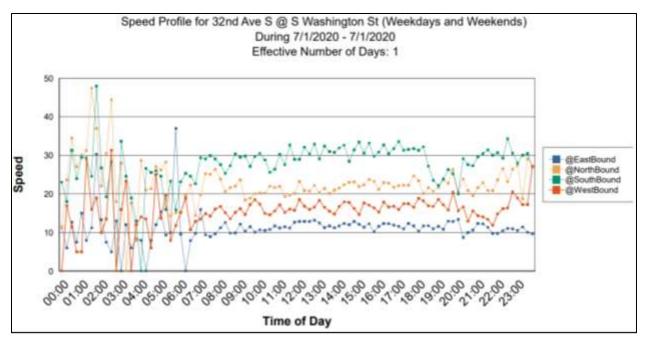
Figures 13, 14, and 15 show the three plots that constitute this report. The first plot has trend lines for all approaches of the intersection followed by the individual plots for the intersecting streets.

Figure 13. First plot of Speed Profile report showing trend lines for all approaches of the intersection

A new graph named Speed Profile was added to the traffic analysis website. As the name suggests, it is very similar to the existing Volume Profile in that it plots 15-minute average speed over a 24-hour period. When multiple days are selected for analysis, the speeds for individual 15-minute periods are averaged over the days.

In addition, to quantify network, intersection, and approach operations, this report can also be used to identify potential problem spots and/or times within the system. For example, Figure 15 presents a potential speeding issue along Washington St. during overnight hours around closing time for bars. Such instances warrant further investigation and coordinated efforts between multiple departments including law-enforcement and engineering. Note that the time periods with no traffic show up with a zero average speed on the graph.

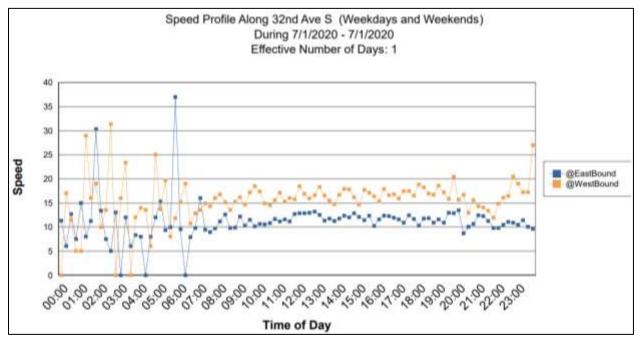
Figure 14. Second plot of Speed Profile showing trend lines for the east-west corridor

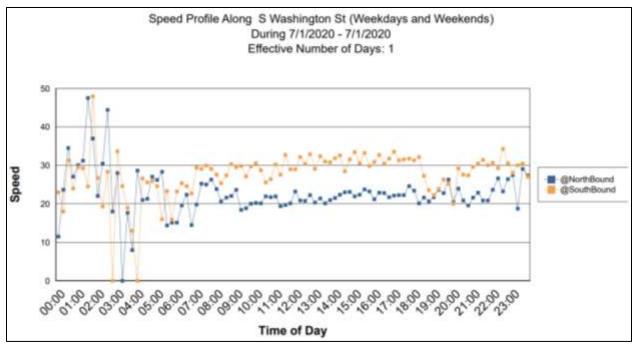
Figure 15. Third plot of Speed Profile report showing trend lines for the north-south corridor
