SIMPLIFIED IMPACT TESTING OF TRAFFIC BARRIER SYSTEMS

(Phase 1)

Richard M. Gutkowski, Ph.D., P.E.
and
Derek J. Winkler
Department of Civil Engineering
Colorado State University
Fort Collins, Colorado 80523

June 2003

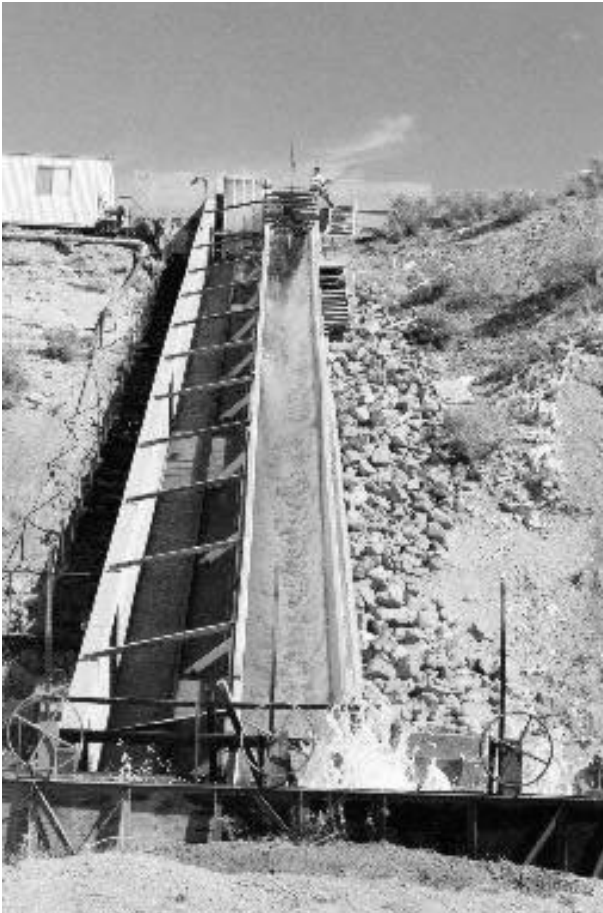
Figure 3.3: Flume during typical hydraulic testing: a. East view of the flume, looking from the west wall. b. North view of the flume base, looking from the south end of the west wall.

In its normal configuration, the flume structure actually consists of two separate channels: one on the south side, in which the hydraulic testing is actually performed, and another on the north side, which gives worker access to the flume while providing a foundation for lateral bracing that supports the adjacent flume wall during testing. The vehicle track for the simplified impact test was installed on the north side. Photographs of the flume during hydraulic testing are shown in Figure 3.3.

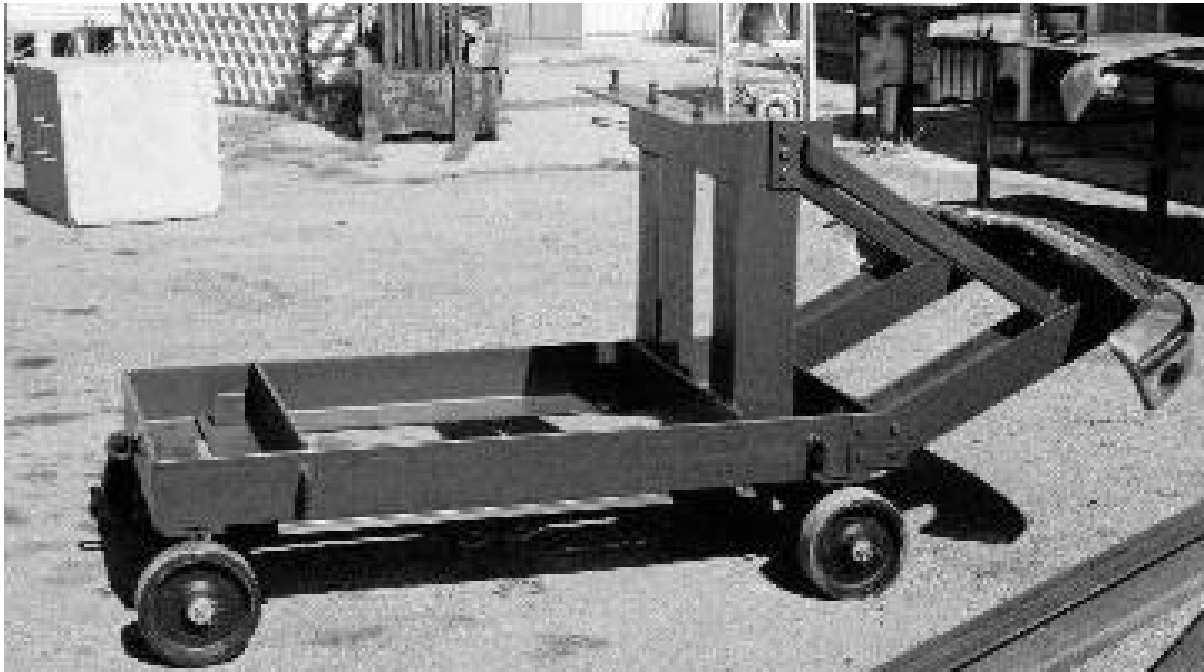
Figure 3.5: a. Side elevation, test vehicle design. b. Cart, as built, with concrete block in upper left corner.

In keeping with the need for minimal cost, the test vehicle frame was constructed entirely of readily available steel angles, channels, wide flange sections, and hollow tubes, as shown in Figures 3.5 and 3.6. Bolted connections were used for most of the frame to ensure that any parts damaged during a test could be quickly and inexpensively removed and replaced. The primary load-bearing portion of the frame consisted of half-inch plate angles, with six-inch legs to provide restraint to the concrete block.

This frame was then mounted to wide-flange sections, to which one-inch axles and inexpensive, 10-inch iron-hub wheels with roller bearings were mounted. The use of 10-inch wheels then dictated dimensions of the guide rail and the wide-flange members that connected the main vehicle frame to the axles. Use of larger wheels, had they been available at reasonable cost, would have dictated using a taller, more expensive wide-flange section for the guide rail than the W6 x 12 that was used.

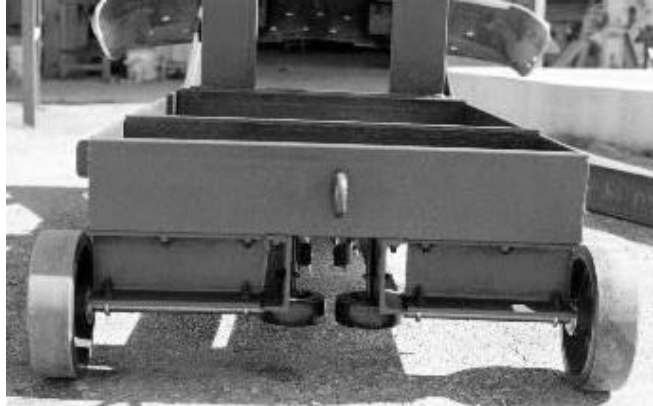
Figure 3.6: a. Section A-A, showing the trolley. b. Section B-B, showing the lateral restraint wheels. c. Rear view of the test vehicle, as fabricated, showing the lateral restraint wheels and the trolley.

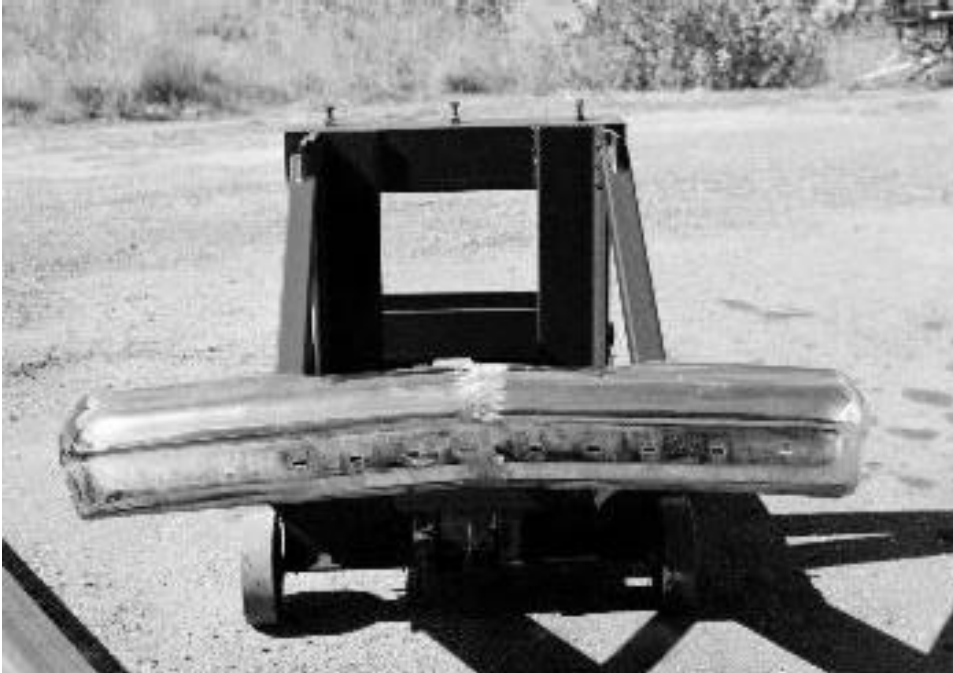
Figure 3.7: Ford light truck bumper installed on surrogate test vehicle.

To give the test vehicle a realistic frontal impacting surface, a used, undamaged five-mile-per-hour bumper was purchased and bolted to the test vehicle frame in a manner similar to that used on the original vehicle. The bumper was taken from a 1991 Ford full-size van, which is mounted on a light-truck chassis. To make the bumper fit in the flume, a 20-inch segment was cut from its center, and the two remaining pieces were welded together. The installed bumper is shown in Figure 3.7. The steel frame members, which connected the bumper to the main vehicle frame, were dimensioned in such a way that the bumper would be vertically aligned, in spite of the 25-degree pitch of the flume, and at a realistic height above the ground upon impacting the barrier specimens placed at the flume's base.

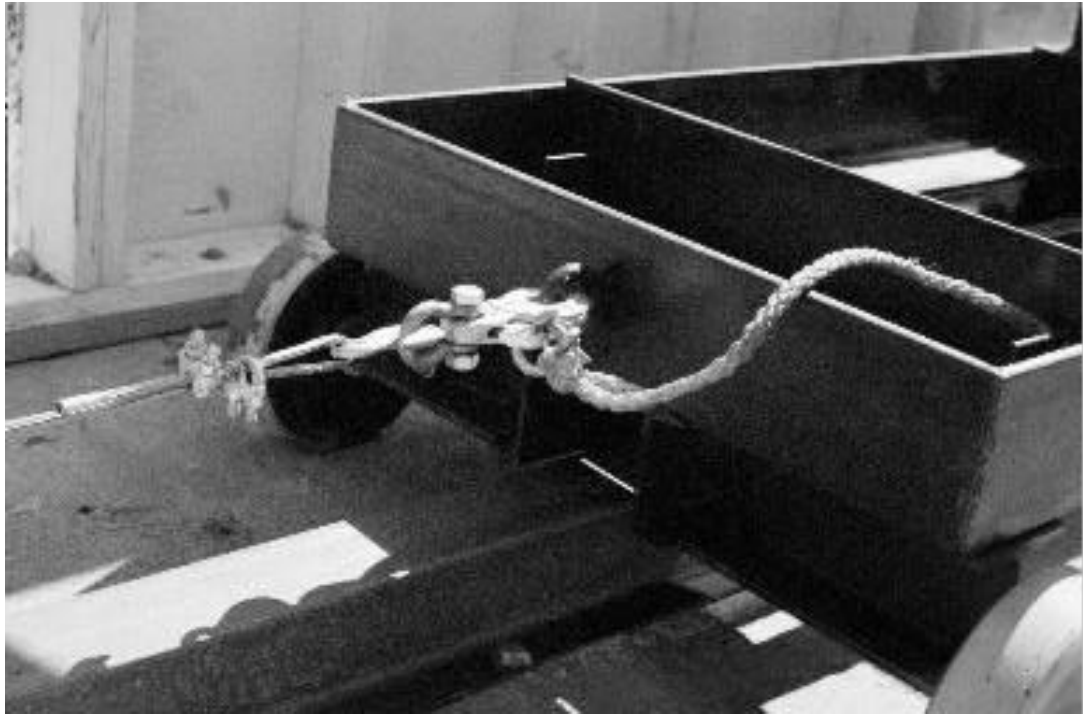
Figure 3.9: Quick-release connecting the winch cable to the surrogate test vehicle.

The final details of interest on the surrogate test vehicle frame include four tiedown points attached at the four corners of the frame and the eyebolt attached at its rear. Each tiedown point, which entailed a two-inch square plate with a 1.5-inch hole cut in its center, was positioned to permit strapping the concrete block in position on the test vehicle. The eyebolt was attached to the vehicle as a connection point for the winch cable, and was of adequate diameter to permit connection of a quick-release. The quick-release was to be operated by the pull of an attached rope, which permitted the operator to stand clear of the potential recoil of the winch cable. Figure 3.9 illustrates the connection of the quick release to the test vehicle and winch cable.

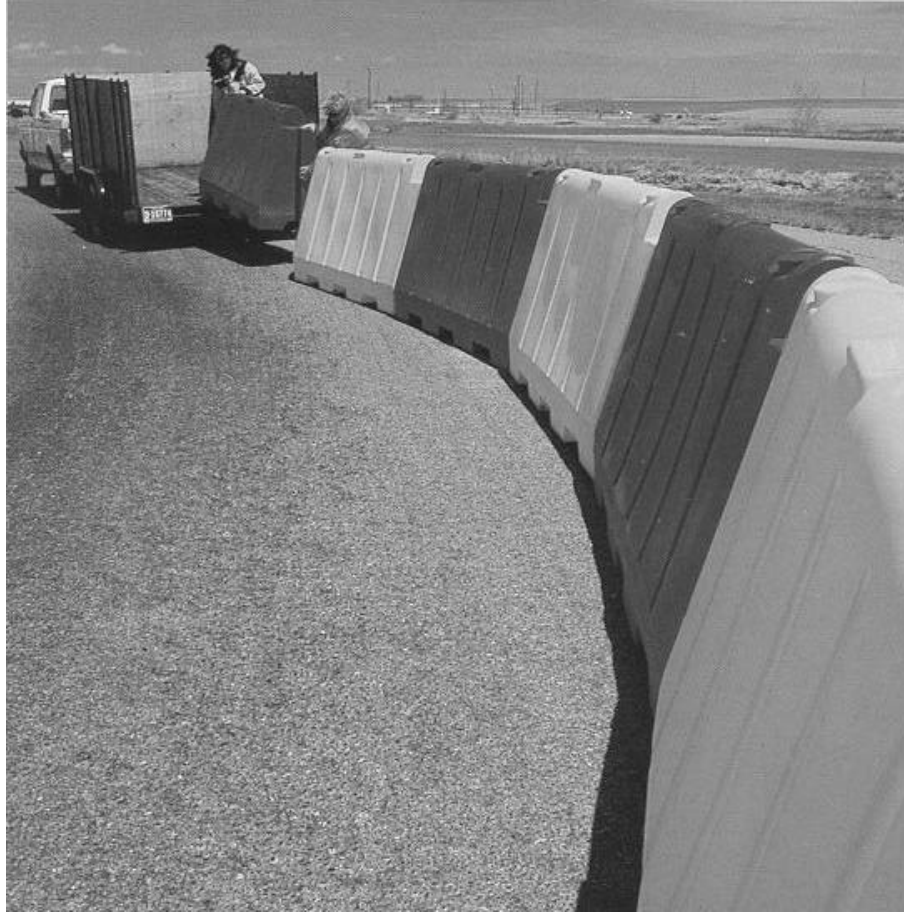
Figure 3.11: Assembly of an interconnected line of barrier specimens in the field.

To provide a reasonably fair assessment of this barrier system, installation of at least three interconnected barriers at the base of the flume were deemed necessary. This required utilization of additional space created by opening the gate in the flume base's north wall, as previously described. Recognizing that a system of only three barriers still was not fully representative of a typical application, consideration was given to installing a steel cable through the three barriers and connecting its ends to the north and south flume walls. This initially was not seen as entirely unrealistic, as the barrier manufacturer previously had considered strengthening the connectivity of the barriers with a cable. Nevertheless, the decision ultimately was made not to install a steel cable, in light of safety concerns. In terms of the test environment, it was considered possible that the resultant tensile force in the cable, due to the normal impact force, might be in excess of a typical cable's tensile strength, depending on the initial tension in

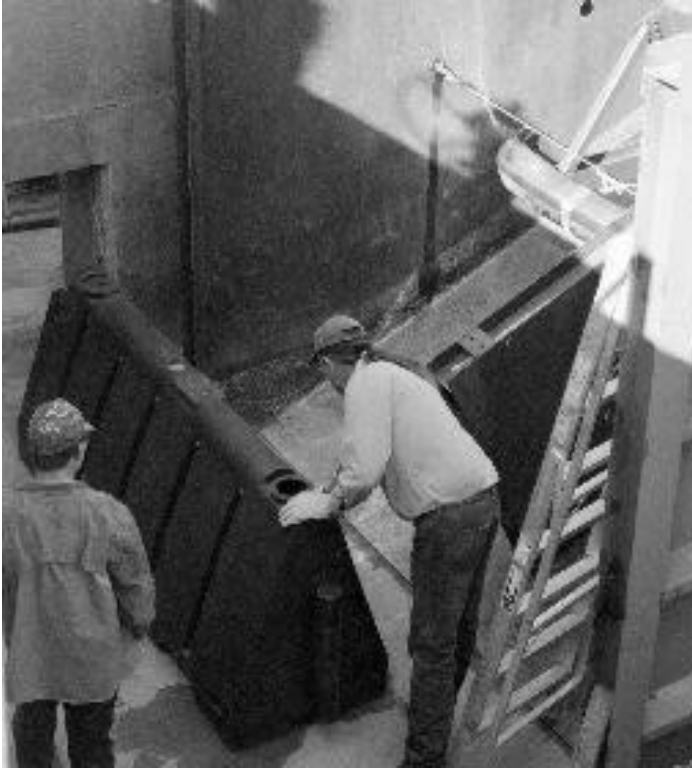
Figure 4.1: Placement of a single test specimen at the base of the flume prior to the trial run.

Since only one-quarter of the design surrogate test vehicle weight was to be involved in the impact for the trial run, a single barrier filled to capacity with water (2,525 pounds total weight) was expected to provide adequate resistance. This barrier was placed in the position that was to be used in the first actual test, which was perpendicular to the test vehicle path with the leading edge 20 inches from the end of the inclined track, as shown in Figure 3.8. The barrier's center of mass was aligned with the centerline of the test vehicle path to produce a direct impact. Positioning of the barrier is shown in Figure 4.1.

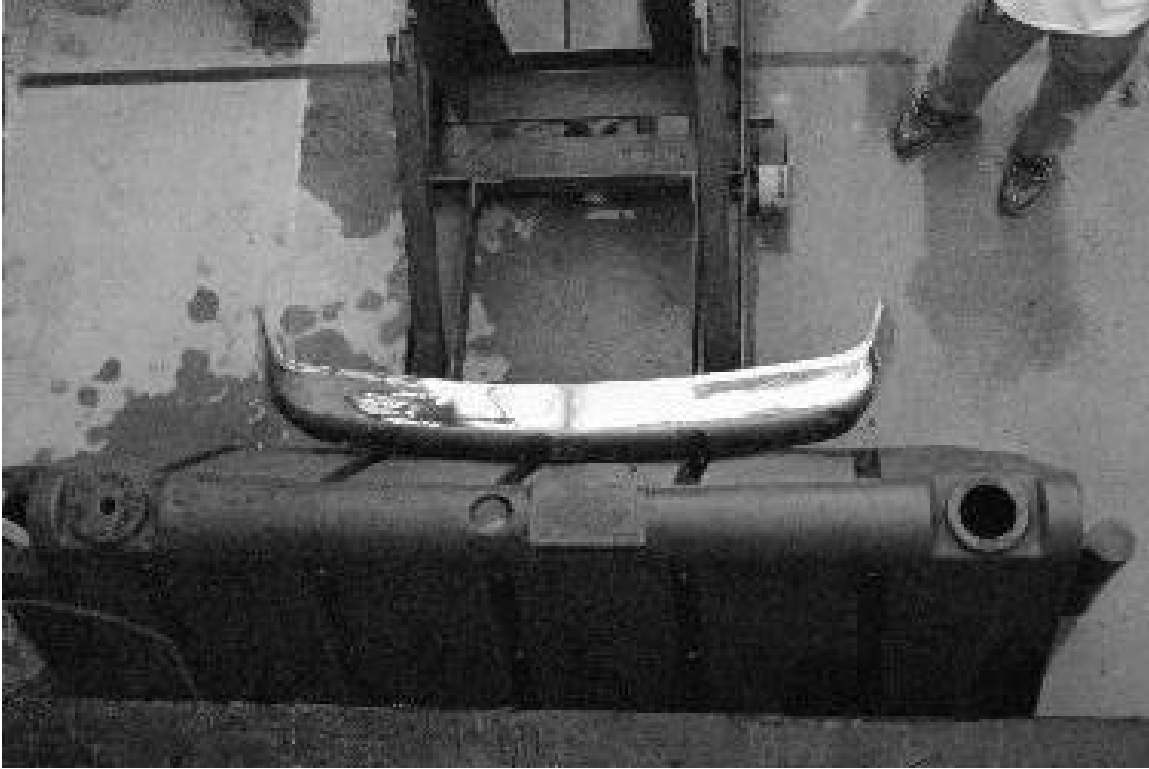
Figure 4.2: Position of the unloaded surrogate test vehicle and single test specimen following the trial run.

The test vehicle impacted the test specimen in the manner intended by the vehicle design, with the bumper striking the barrier at a realistic height of approximately 18 inches above the ground. Perhaps the most important observation drawn from the trial run was the tremendous magnification of force resulting from the test vehicle's motion. Since the test vehicle was not loaded to its design weight, the impact condition was not anticipated to be especially remarkable. The effect of the impact force on the single test specimen, however, was quite impressive. Several gallons of water were spouted through the specimen's top fill hole 10 to 15 feet into the air upon impact, and the 2,500-pound mass was instantly pushed the entire available width across the base of the flume (4.5 feet), as shown in Figure 4.2. These conditions were not fully anticipated, and lead to more careful consideration of the progression of test levels to be pursued in actual testing with the fully loaded test vehicle.

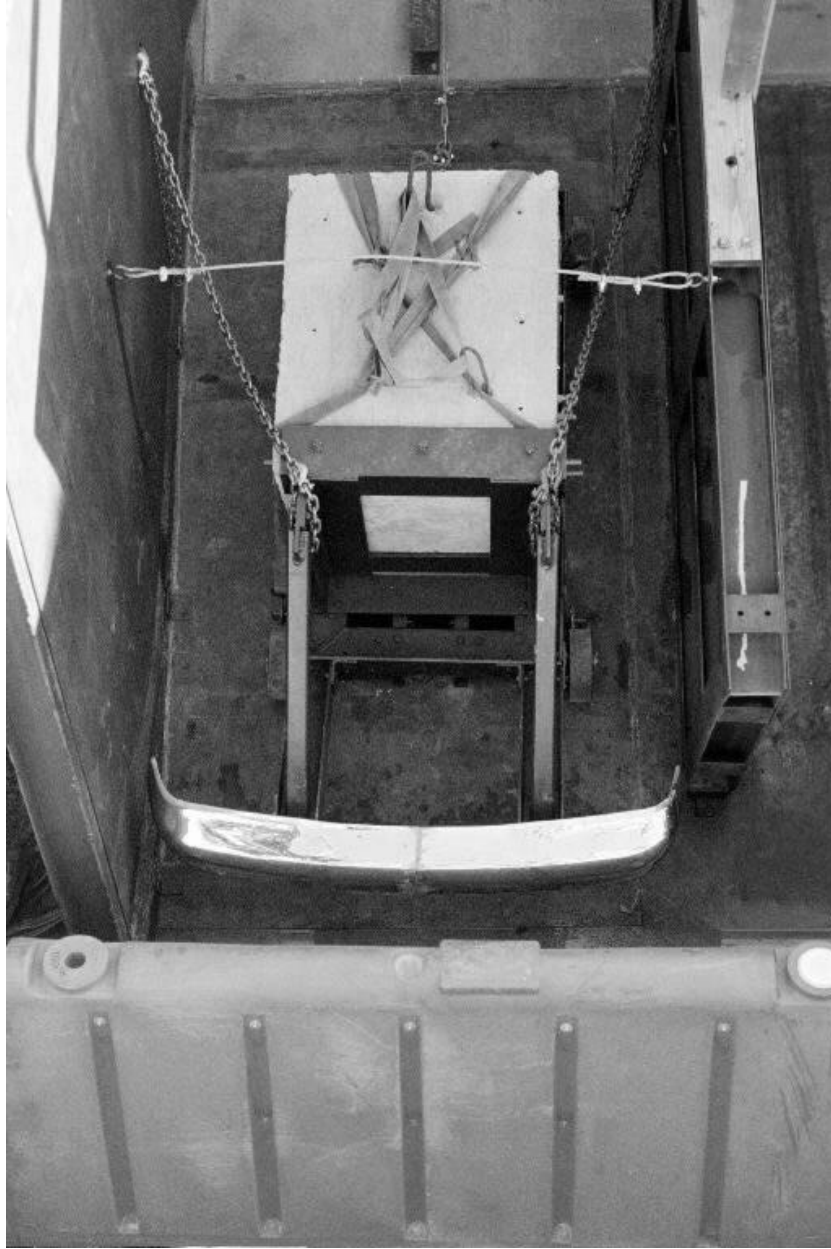
Figure 4.3: Surrogate test vehicle loaded with the concrete block and chained to the flume to permit safe barrier placement. Also visible are the safety cable, tiedown straps, and the end of the guide rail.

To ensure safety for the individuals who were to position test specimens at the base of the flume, the loaded surrogate test vehicle was hoisted partway onto the flume incline and chained in place, as shown in Figure 4.3. Three interconnected barriers were then positioned according to the design test configuration, as shown in Figure 4.4. The right barrier was positioned with approximately 3.5 feet of its width protruding through the gate in the north flume base wall, to permit a direct impact of the test vehicle on the center barrier. In an attempt to provide similar translational restraint to the left barrier as imparted by the concrete gate to the right barrier, a fourth barrier was placed six inches behind the left barrier. Once positioned properly, the barriers were filled to capacity with water, and were photographed in their initial position. After all personnel were clear of the flume base, the test vehicle was hoisted onto the guide rail and then to the 3.53-meter height necessary for development of the 67.6-kilojoule impact severity for test level 2. The test vehicle is shown in Figure 4.5 in its initial position.

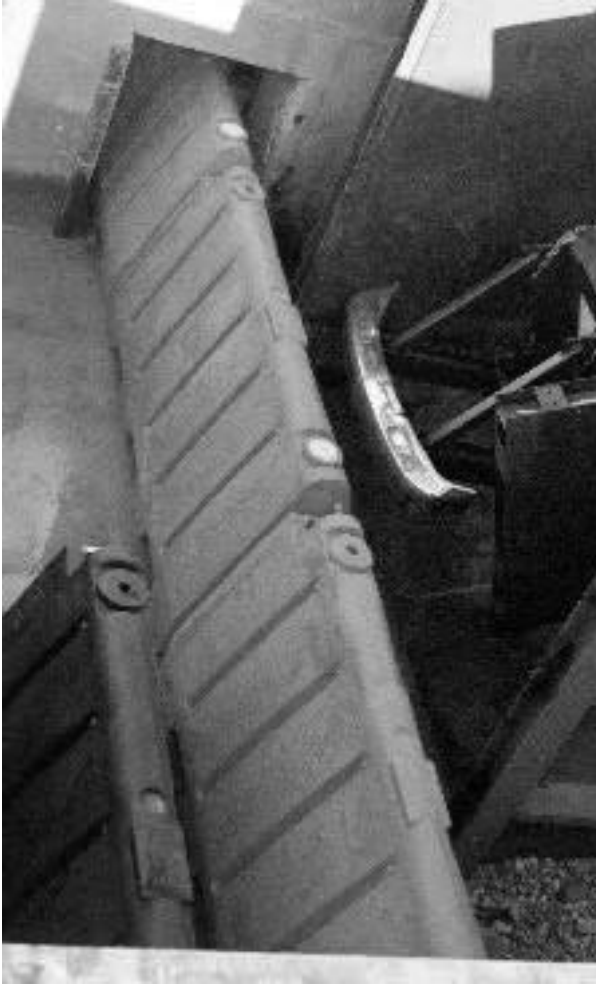
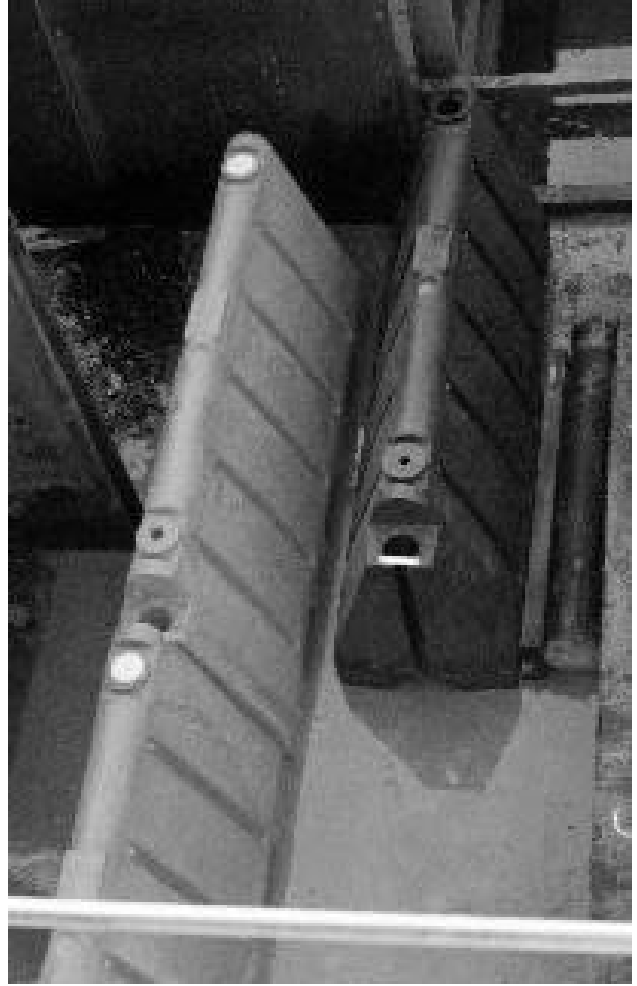
Figure 4.4: Initial position of test specimens for the first test. a. North view, showing the gate in the north wall. b. South view, showing the position of the fourth barrier.

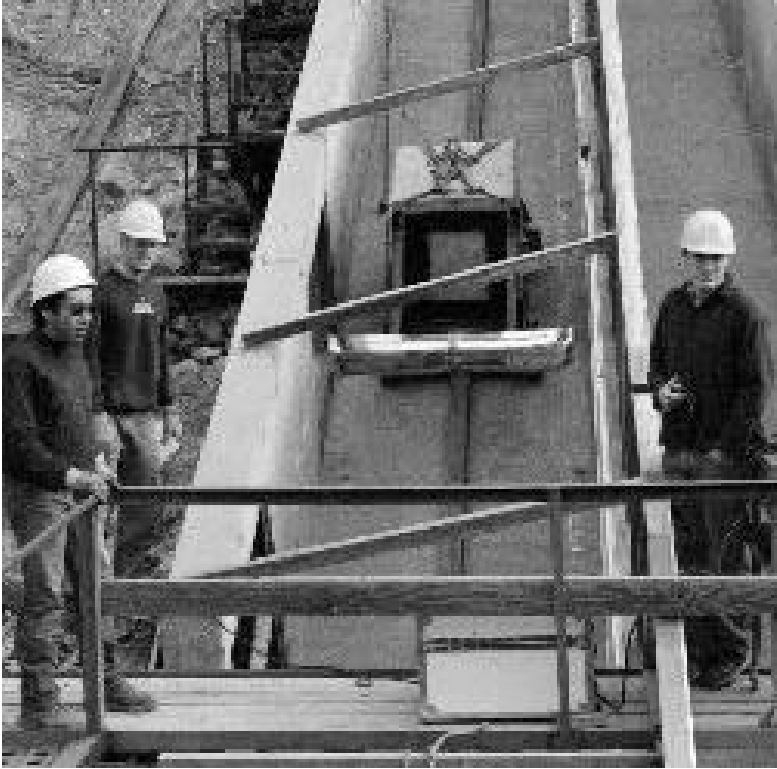
Figure 4.5: Surrogate test vehicle hoisted to the release height for test level 2.

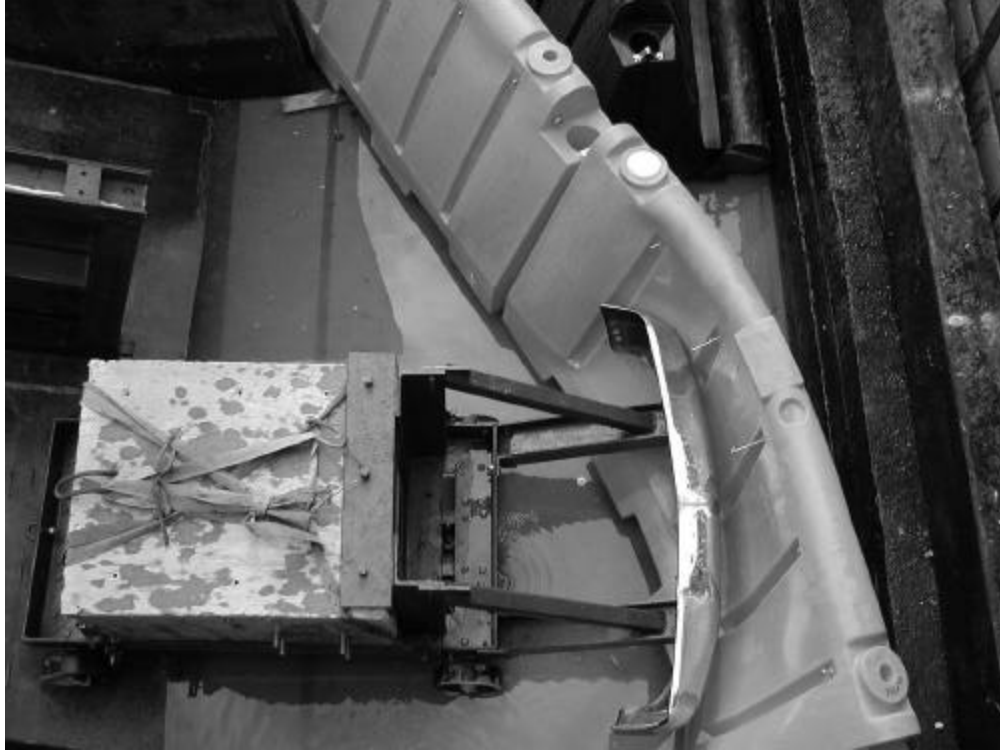
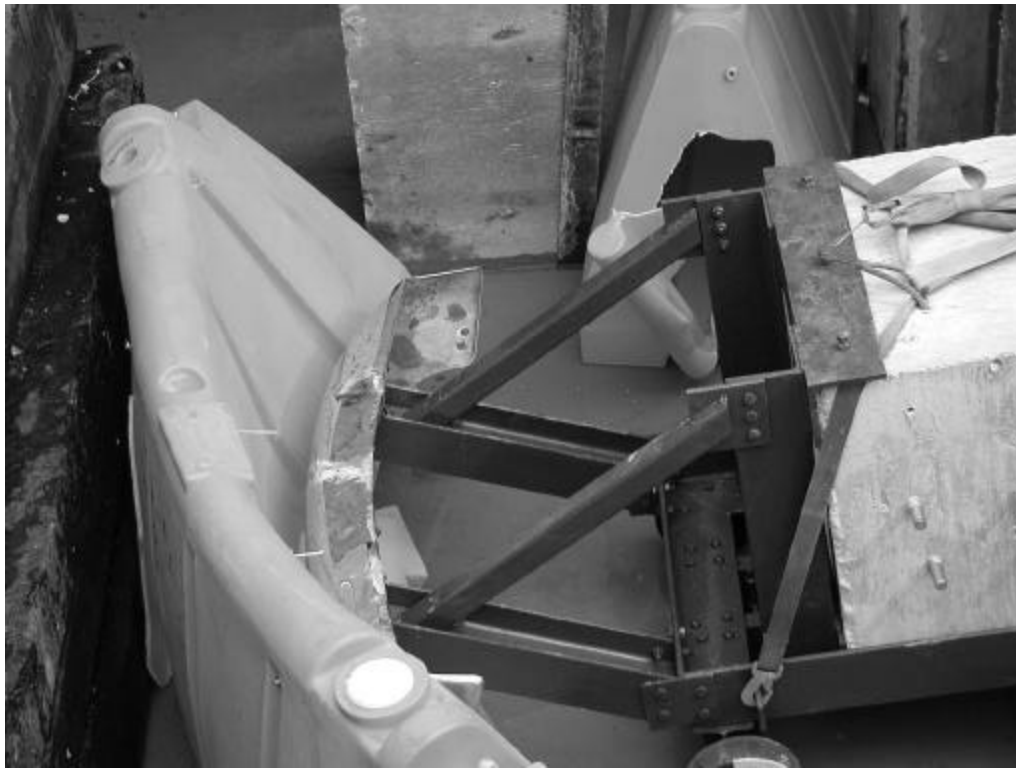
Figure 4.7: Deflected position of test specimens and final position of the test vehicle following the first test. a. Overhead view. b. North view, showing tearing of the right barrier's connector bar.

The first test was successful in many respects, as it effectively illustrated the mode of the barrier specimen's structural response and features of the test configuration that were in need of improvement. In accordance with NCHRP reporting procedures, several frames from the contact phase of the impact were extracted from high-speed photography, and are presented in Figure 4.6a and b. Photographs of the barrier specimens and the surrogate test vehicle in their final positions after impact are shown in Figure 4.7.

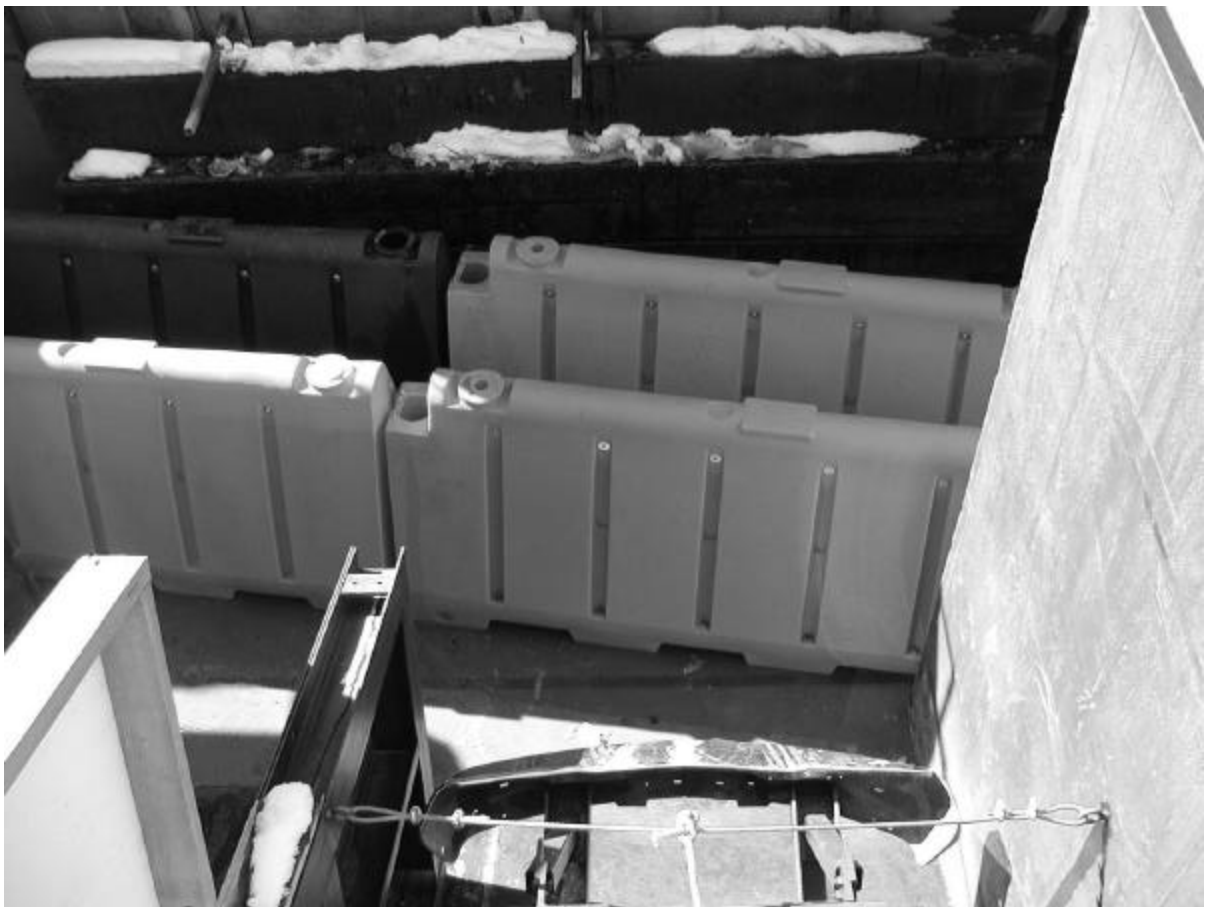
Figure 4.9: Barrier specimen configuration for the second test.

The simplified impact test developed here accommodated a barrier specimen configuration appropriate for modeling a typical roadblock or facility protection type of application. For this test, a roadblock specimen configuration was modeled with two rows of two barriers placed at the bottom of the flume. The barrier manufacturer indicated that this configuration had been used at the end of racetrack straight-aways and in facility protection applications. To explore the effect of an angled impact to the extent possible in the flume test configuration, barriers were angled at approximately eight degrees to the perpendicular position used in the first test. Thus, the impact angle was approximately 82 degrees. A smaller angle of impact was not possible in the constrained space of the test site. Orientation of the barriers for the second test is illustrated in Figure 4.9 and Figure 4.10.

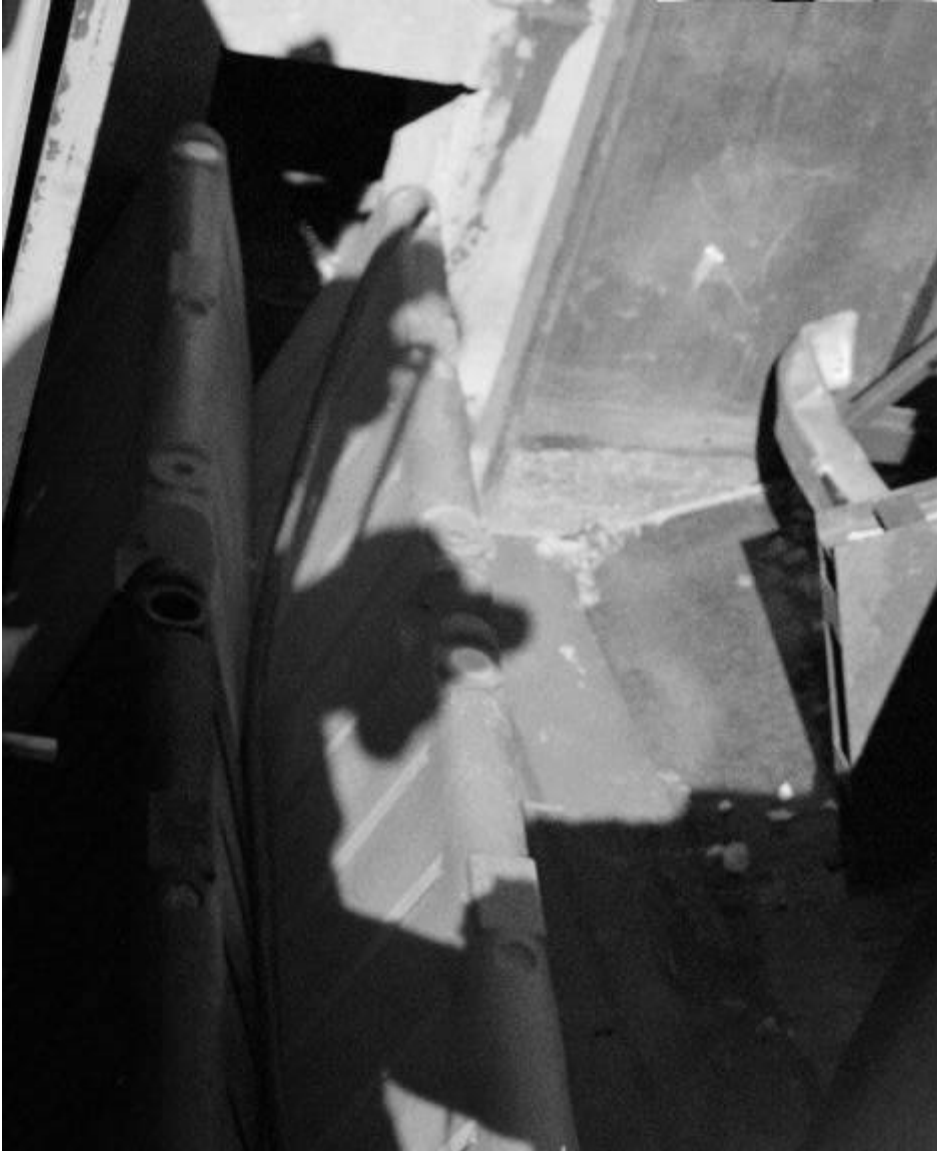
Figure 4.10: Test specimen configuration for the second test. Note that no barrier is positioned within the concrete gate as in the first test.

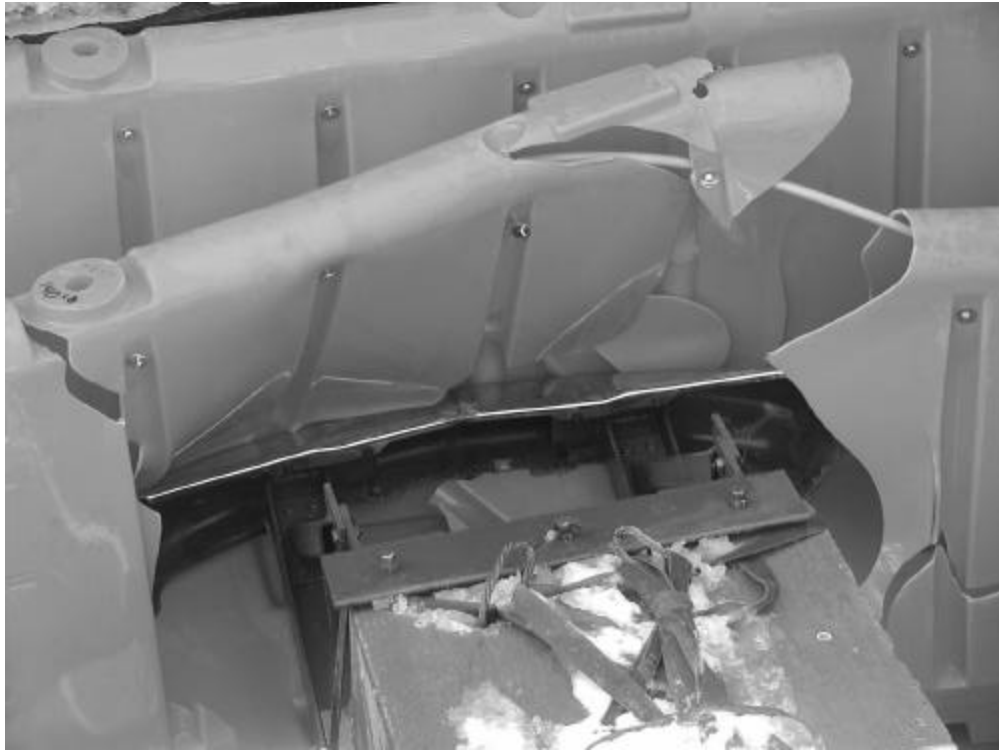
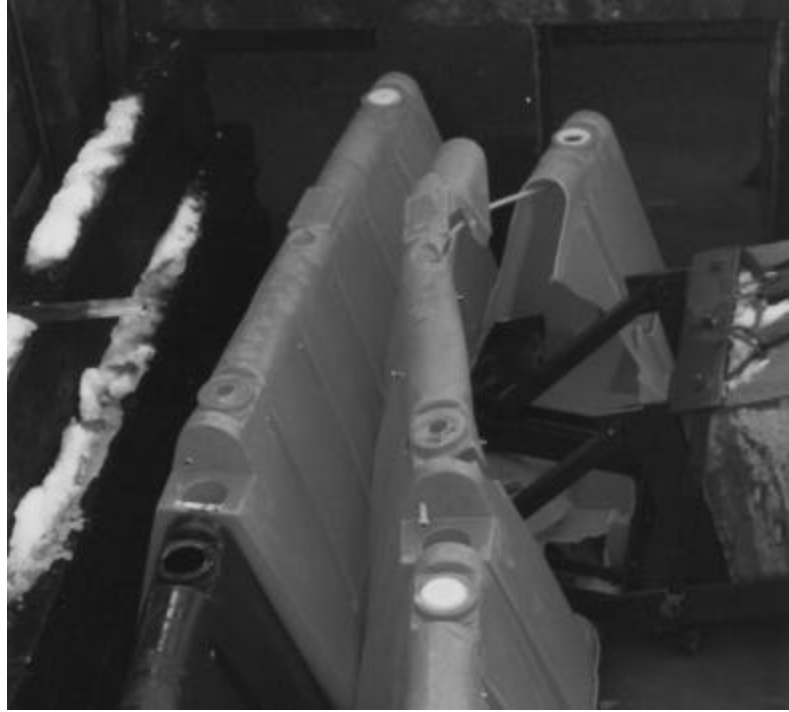
Figure 4.11: Final condition of the barrier specimen and test vehicle after the second test.

Unfortunately, the high-speed camera used to document the dynamic deformation of the impacted specimen in the first test was not available for use during the second test. Nevertheless, the final condition of the specimen struck by the test vehicle, as shown in Figure 4.11, is somewhat indicative of the difference in response during the second test. During the impact, this barrier was observed to experience sudden fracture when struck by the test vehicle. Several large fragments of the barrier's front sidewall were thrown into the air at onset of the impact event as the test vehicle bumper punched through the surface. Therefore, it is believed that the extent of dynamic lateral displacement observed during the first test was prohibited during the second test. This can be explained primarily by the prevention of lateral movement imparted initially by the rear line of barriers, and also by the rear wall of the flume after only one to two feet of lateral displacement of the entire system. The degree of fracturing witnessed also draws into question the effect of cold temperature on low-density polyethylene material of which the barriers were constructed. It is possible that the material was considerably more brittle during the second test as a result of the colder temperatures.

Variance from the design test configuration in terms of location of the test specimens relative to the end of the inclined flume resulted in much more significant damage to the test vehicle than was experienced in the first test. Since the barriers were angled away from the impacting bumper, considerably less energy was transferred to the barriers before the test vehicle's front wheels reached the abrupt change in grade at the bottom of the flume. As a result, the axle of the front left wheel was fractured in shear at its connection to the wheel, and the web of the wide-flange section connecting this axle to the frame was buckled approximately 60 degrees out of its original plane, as is visible in the lower right corner of Figure 4.11b. Importantly, some of this damage had been initiated in the first test, which

had not been repaired prior to the second test. The altered test configuration was nevertheless responsible for considerably more damage to the test vehicle.
