**EFFECTS OF ENVIRONMENTAL EXPOSURE
ON TIMBER RAILROAD BRIDGE/TRACK
MEMBERS AND CONNECTORS**

Travis Burgers
Jeno Balogh, Ph.D
Richard Gutkowski, Ph.D., P.E.

December 2004

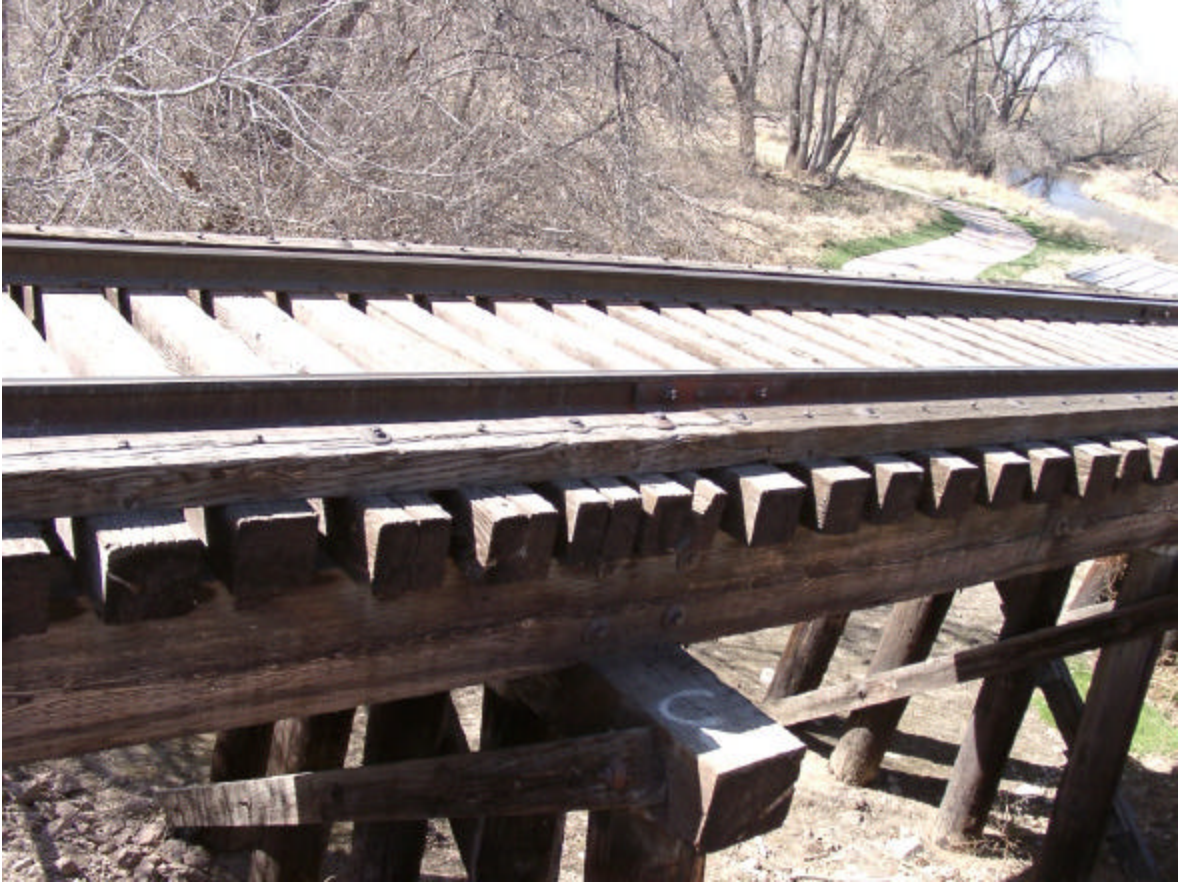
Figure 2. Standard open-deck timber trestle railroad bridge

The major components of the bridge in Figure 2 consist of creosote-treated, Douglas fir solid sawn timbers. This 31-span bridge has two chords consisting of four spaced plies. Each span is 15' long. In both chords, 30' plies are continuous over two spans, but their ends are staggered one span. In the end span, alternate plies are 15' supported members.

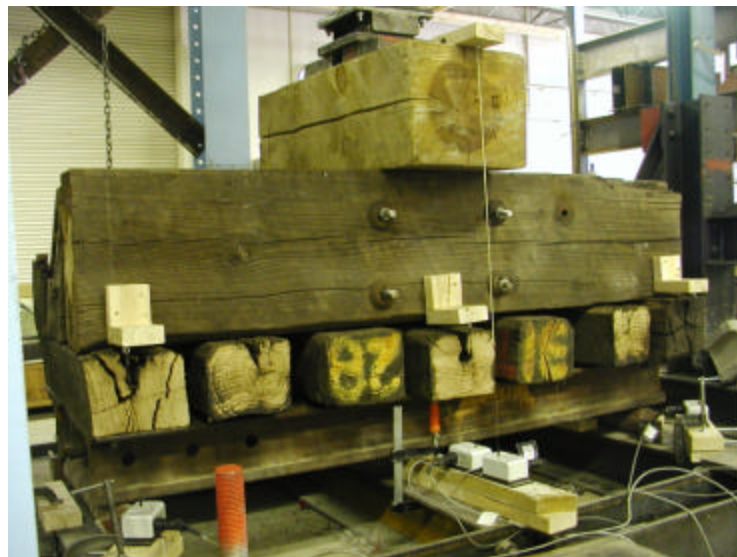
Figure 4. Side view of the (upside down) specimen load test setup

Figure 4 shows the test setup of the specimen.

After construction, the cap was removed from the specimen so that a load could be applied to each individual ply rather than the three plies simultaneously through the cap.

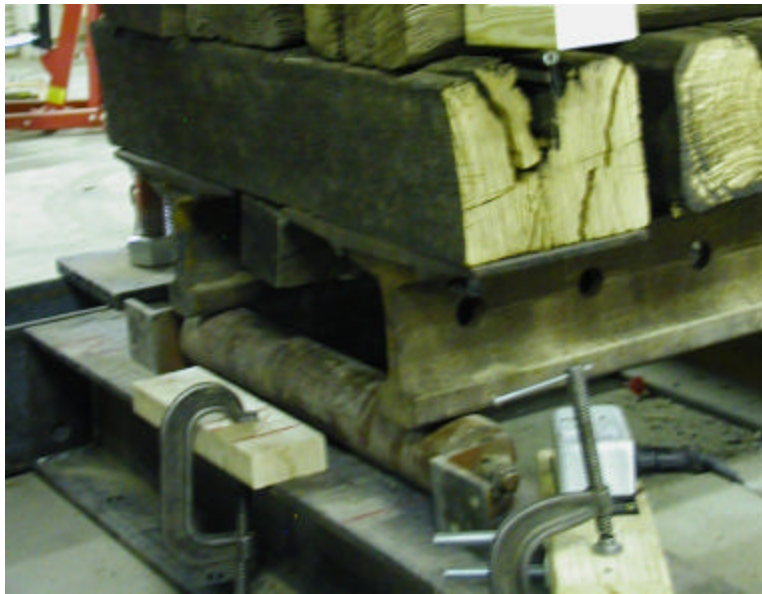
Figure 5. End supports for the test specimen

The test specimen was load tested after its construction. It was placed upside down (rails down) on two roller supports placed 3" from the edge of the rails. A photo of one of these roller supports can be seen in Figure 5.

The end supports were spaced 67" apart to simulate the longitudinal distance between the two front or rear axles of a railroad car. This dimension is approximate because there are many types of railroad cars with differing axle spacings. This is also the approximate distance between the zero moment (inflection) points on either side of the cap. The load was applied through the underside of the bridge so that the two point loads from the train axles would be uniform and the test specimen would be more stable in the frame during loading than if the specimen were right-side up and two loads of the same magnitude were applied simultaneously.

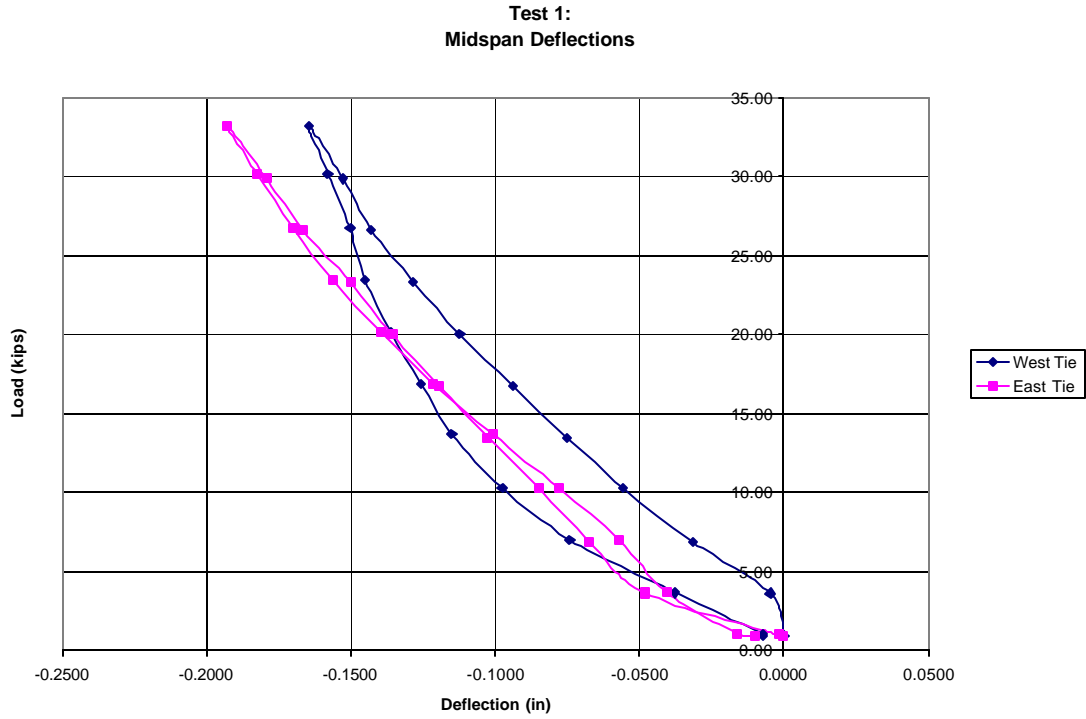
Figure 7. Midspan deflections due to loading on center ply (Test 1)

The measured load versus deflection plots for the midspan of the plies are shown in Figures 7 through 12. A negative deflection is vertically downward. Test 1 in these figures corresponds to the initial test after the initial exposure period (55.5 hours over 20 days) and Test 2 corresponds to the test after the specimen was exposed in the environmental chamber the second time (for 134 hours over 41 days).

For the first test, the measured load versus deflection graph shows that the 27 kip load on the center ply causes a vertical downward deflection of 0.1700 and 0.1475 inches in the east and west plies respectively (Figure 7). When the load is applied to the east ply, 2.7 kips are required to make it deflect downward 0.1700 inches, the same deflection that occurs when the 27 kip load is applied to the center ply (Figure 9). When the load is applied to the west ply, 2.5 kips are required to make it deflect downward 0.1475 inches, the same deflection that occurs when the 27 kip load is applied to the center ply (Figure 8).

From the comparison of the midspan deflections because of center ply loading in Figures 7 and 10, the test specimen showed significant degradation in the east ply but little in the west. In the first test, the east ply deflected 0.17 inches and the west ply 0.15 inches at a load of 27 kips. In the second test, the east deflected 0.31 inches and the west 0.16 inches under the same load. This corresponds to an 82 percent deflection increase in the east ply and a 7 percent increase in the west ply.

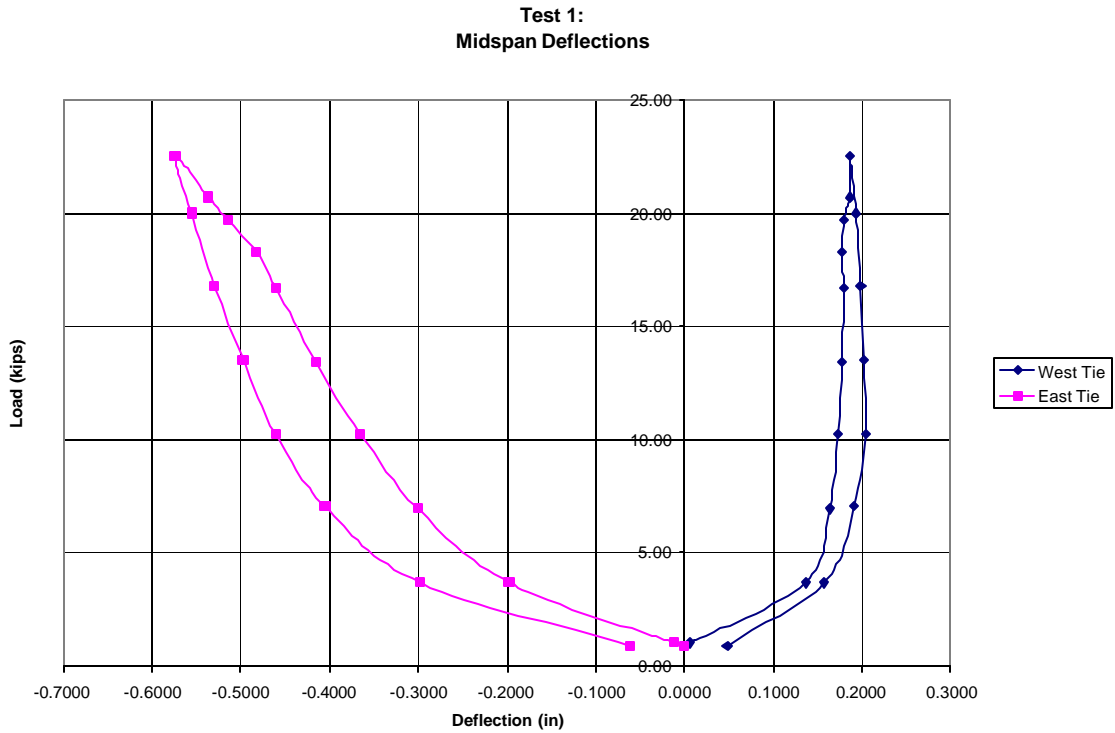
Figure 9. Midspan deflections due to loading on east ply (Test 1)

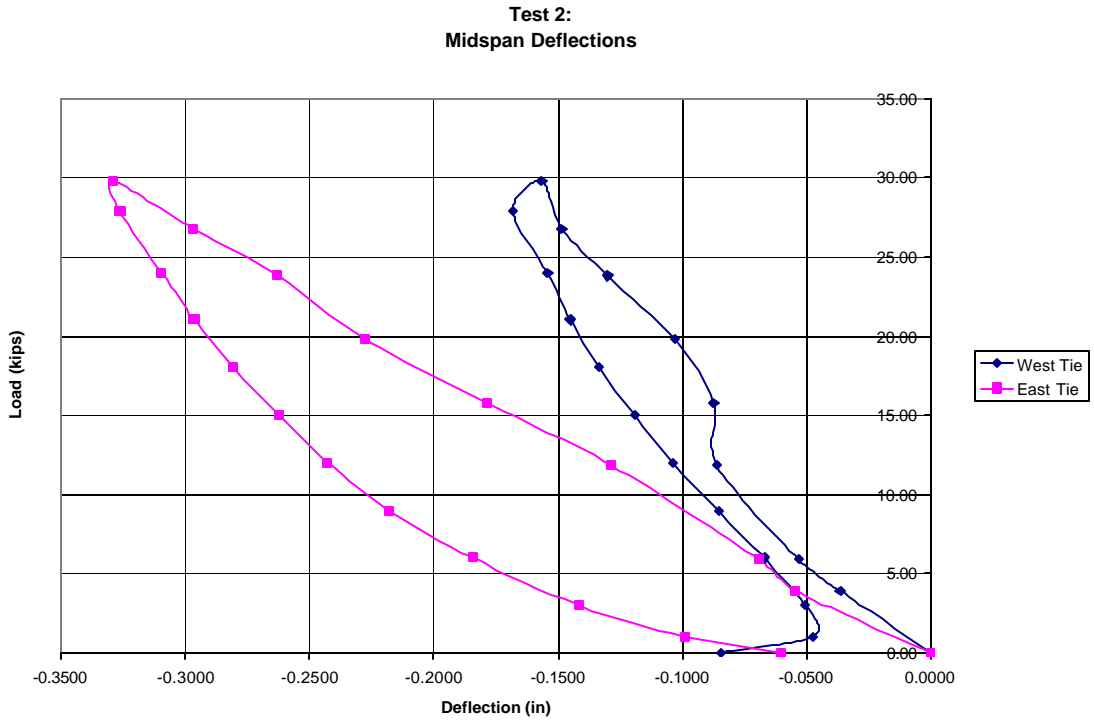
Figure 10. Midspan deflections due to loading on center ply (Test 2)

The same load share analysis was done after the specimen was exposed to the changing temperature and humidity in the environmental chamber. Figures 10 through 12 were used to find the displacements. The deflections of the east and west plies for the second test were 0.3100 and 0.1575 inches downward for 27 kips. At this load the east, west and center plies carried 3.0 (11.1% of the total), 2.3 (8.5%) and 21.7 (80.4%) kips respectively. At the 25 kip load the deflections were 0.2950 and 0.1500 inches for the east and west plies, corresponding to 2.7 (10.8% of the total), 2.1 (8.4%) and 20.2 (80.8%) kips to the east, west and center plies respectively. When the load was 20 kips, the deflection was 0.2675 and 0.1225 inches in the east and west plies. These deflections cause loads of 2.3 (11.5% of the total), 1.7 (8.5%) and 16.0 (80.0%) kips in the east, west and center plies.

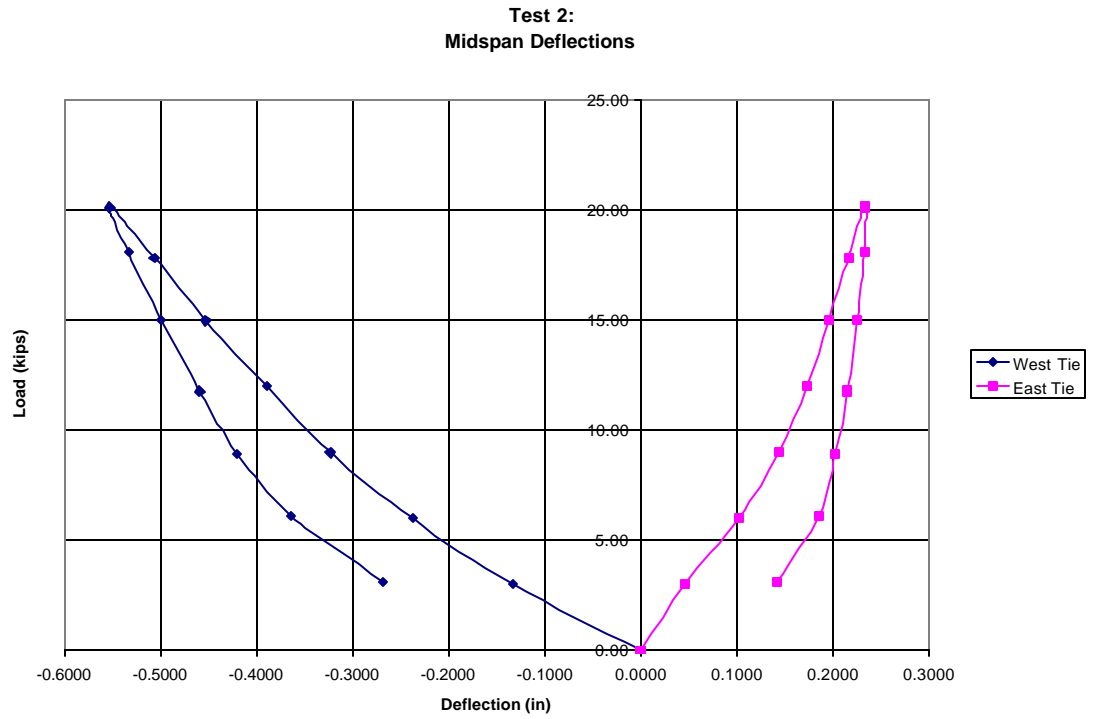
Figure 11. Midspan deflections due to loading on west ply (Test 2)

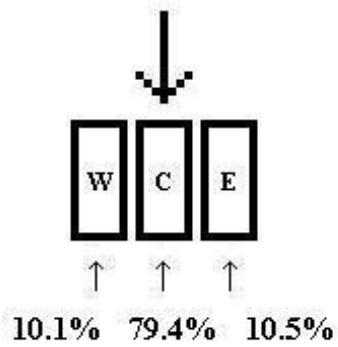
Figure 19. Average load distribution (Test 1)

The diagrams of the load sharing are shown in the following figures. The two 20 kip tests are shown in Figures 13 and 14; the two 25 kip tests in Figures 15 and 16; and the two 27 kips tests in Figures 17 and 18. In each pair, the second test occurred after 41 days of exposure in the environmental chamber. The average percentages of the load sharing in the first and second tests are shown in Figure 19 and 20 respectively. The calculations can be found in Appendix C.

By comparing Figures 19 and 20, the average load distribution percentages, there was an increase in the load distributed to the east and center plies but a decrease in the load that went to the west ply. The load on the east and center plies increased from 10.5 percent to 11.1 percent and 79.4 percent to 80.4 percent respectively while the west ply decreased from 10.1 percent to 8.5 percent. This shows that the load sharing through the transverse connector rods remained nearly the same before and after the chamber exposure.
