Dynamic Impact Load Tests of a Bridge Guardrail System

R. Gutkowski
A. Shigidi
M. Peterson

September 2007

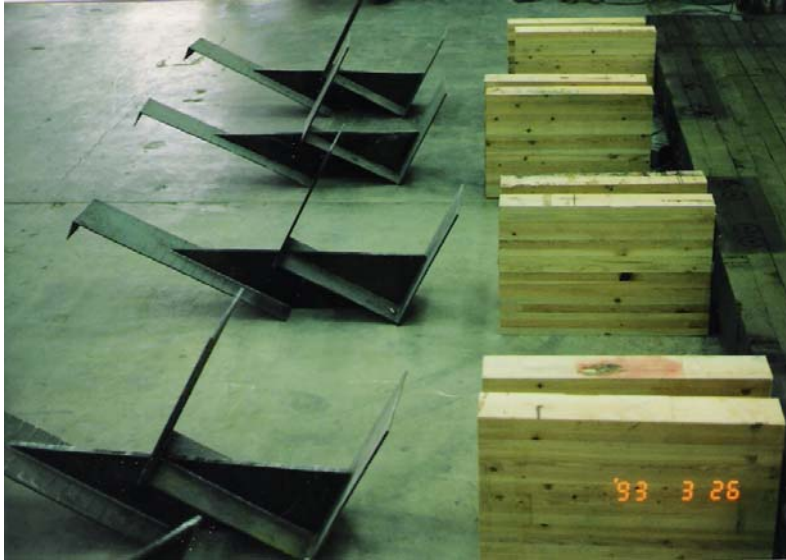
Figure 3 Steel hangers

The cross-section of the glulam through girder was 12 in. x 60 in. (305 mm x 1520 mm). Steel hangers (see Figure 3) were nailed to the side of the through girder (see Figures 4 and 5), with the center-lines of these hangers being spaced 5 ft. (1.524 m) apart along the length. Paired transverse glulam members, with a 2-in. (51 mm) space between them, were attached to the top and bottom plate of each hanger by masonry nails (see Figure 5). Each of the transverse members was 3 x 24 in. (7.6 mm x 610 mm) in cross-section and 3 ft. (0.92 m) long. All timber elements were Douglas Fir Grade #1.

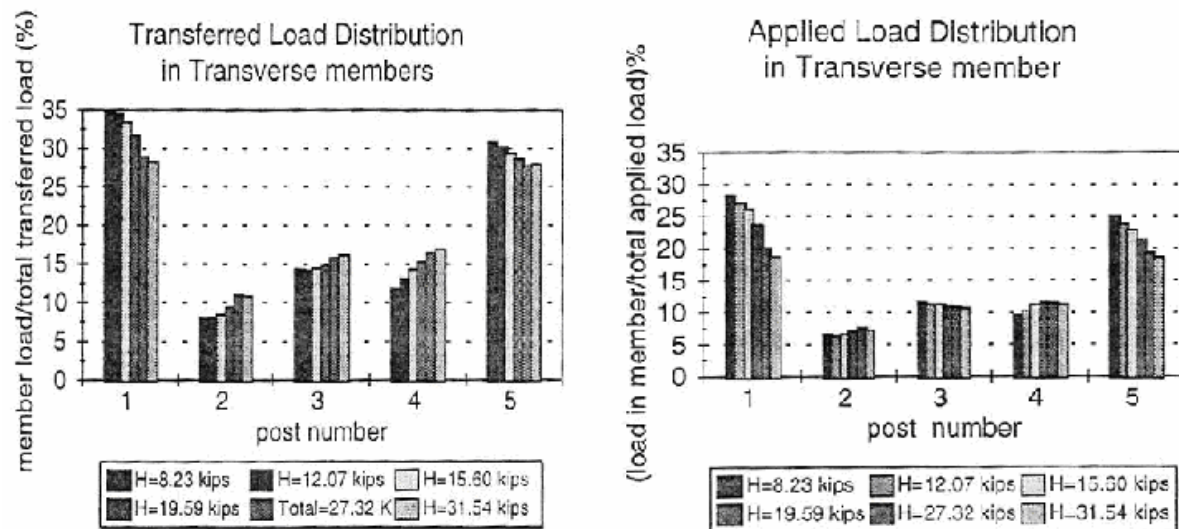
Figure 14 Load distribution in transverse members

Bar charts shown in Figure 14 depict the percentage distribution of the total applied and of the loads transferred to the transverse members. A degree of symmetry is evident in the distribution of the transferred loads. The two outermost pairs of members together had to accommodate more than 35% of the applied load and more than 50% of the transferred load. The percentage of the load resisted by the outermost pairs of transverse members decreased with increasing applied loads.

Also, the load shares resisted by members at the locations of posts #2, #3, and #4 increased slightly. The load distribution observed in the transverse members can be explained to a great extent by considering the measured pattern of the rail deflection (Figure 15) relative to the transverse members. For any applied load, post #3 experienced the highest deflection, followed by post #4, then post #2, while the two outer most posts experienced minimal relative deflection.

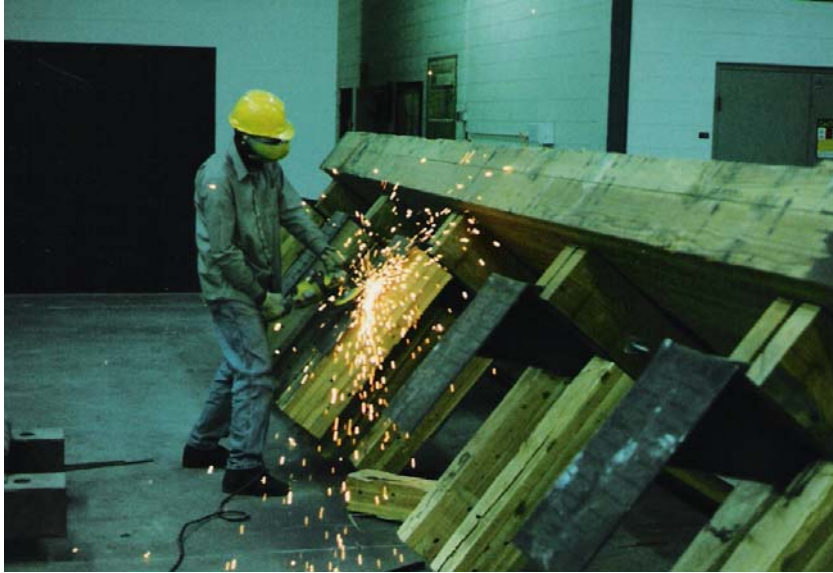
Figure 18 Removal of flange nails

Because the load capacity of the original specimen was so much higher (evident from the static load test) than the then required AASHTO static design load factored to the ultimate load level, two significant changes were made. First, the outer side rows of nails were removed from the top and bottom flanges of the steel hanger (see Figure 18). Second, approximately 12 in. (300 mm) of the depth of the main girder of the specimen was sawn off the top of that member (see Figure 19). These changes were intended to be major downgrades in the specimen resistance. Also, as the lever arm of the transverse members was longer, the restraint to overturning of the main girder under lateral load was significantly higher. This led to a much more rigid specimen at impact compared with the original specimen used in the ramp load tests. Presumably, a much higher impact force would result over a shorter impact time than would have occurred for the original specimen, which had been sized in accordance with the geometry intended for an actual bridge application.

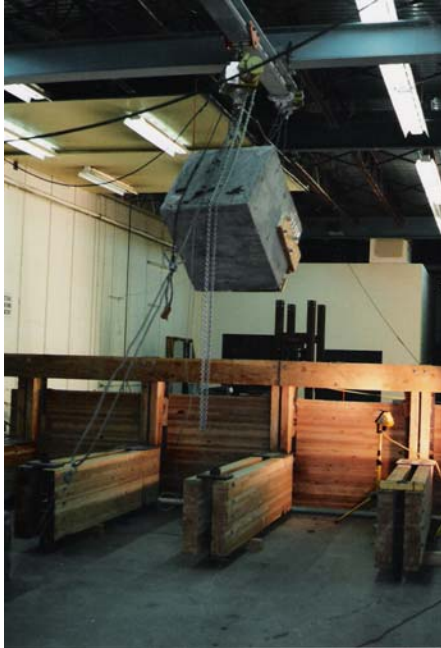
Figure 20 Pendulum test set-up

After positioning the modified specimen into its new location, the pendulum (concrete block) was then raised to the position shown in Figure 20. It was set to swing over impact the rail when the concrete block was horizontal. For safety reasons, an actual initial elevated position was not measured. The center of the concrete block was later estimated (from photographs) to be 4 ft. 1.5 in. (1.26 m) above the impact elevation. Upon release, the block swung downward and impacted the specimen at the rail opposite a post and hanger more or less on center. It then rebounded and hit the specimen again a few times but at substantially reduced speed. The initial impact velocity for the estimated position of the concrete block was 11.1 mph (5.0 m/s). The corresponding impact severity (kinetic energy) is 12.8 kip-ft. (17.4 kN-m).

The exploratory pendulum test with the massive concrete block, suggests good performance of the specimen. The impact severity was about 12.8 kip-ft. (17.4 kN-m). This is comparable to a test Level 2 requirement (13.3 kip-ft. [18.0 kN-m]) if conducted with a small sedan 1807 (820 kg) based on federal recommended test procedures (Transportation Research Board 1993). Impact severities required for a 4400-lb. (2000 kg) single unit truck for Test Levels 1, 2, and 3 are 25.4 kip-ft. (34.5 kN-m), 49.9 kip-ft. (67.6 kN-m), and 102 kip-ft. (138 kN-m) respectively.

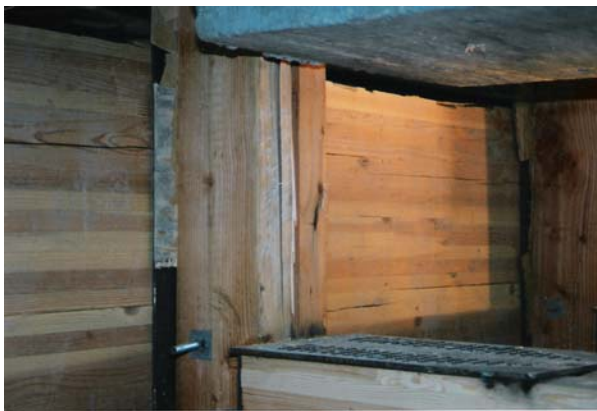
Figure 21 Horizontal cracks in through girder

The main damage was to the through girder, and was comprised of several discontinuous, perpendicular-to-grain cracks (appearing almost like opened seasoning checks) horizontally at various locations on the impact side of the member (see Figure 21). This is logical as the through girder tended to rotate (torque) outward away from the concrete block upon impact and flex about the essentially rigid base somewhat like a cantilever plate. Moving the specimen into position also involved considerable lifting and rotation of it, as shown in Figures 22 and 23. It is possible this handling created some initial unseen micro-damage prior to the pendulum test itself. However, after the impact of the pendulum, the specimen had no overall catastrophic failure. High speed film also revealed it resisted the impact load more or less like an immovable mass absorbing a shock effect. However, the wood rail did flex oscillate in a wave form for a short time. Had the overall specimen been able to rotate more flexibly, as in a real bridge, the impact duration would have been lengthened in time, and the impact force would have been reduced in magnitude. Thus, the effect of impact effect is considered to be much more intense than in an actual bridge hit by the same magnitude of impact.

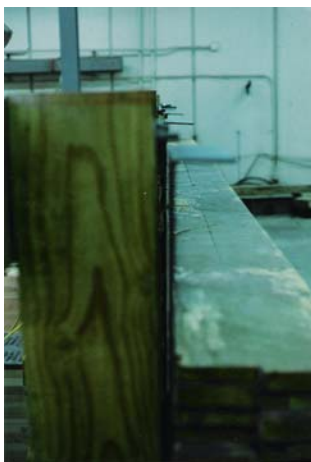
Figure 24 Permanent deformation of protruding hangers

Most of the other physical damage was minor and due to features and components of the test set-up that would not be present in an actual bridge. Primarily, the portion of the steel hanger protruding above the cut main girder was plastically deformed by flexure (see Figure 24). This was an oversight, and the hanger should have been blocked in some way locally at the hanger locations to prevent such unrestrained deformation. In actuality, the hanger would be flush atop the girder. The concrete block left an imprint on and caused some minor breakage into the wood rail, but did not significantly damage it (see Figure 25).
