RELATING WILDLIFE CRASHES TO ROAD RECONSTRUCTION

Rhonda Young and Chris Vokurka

Department of Civil and Architectural Engineering
University of Wyoming
1000 E. University Avenue
Laramie, Wyoming 82071

July 2007

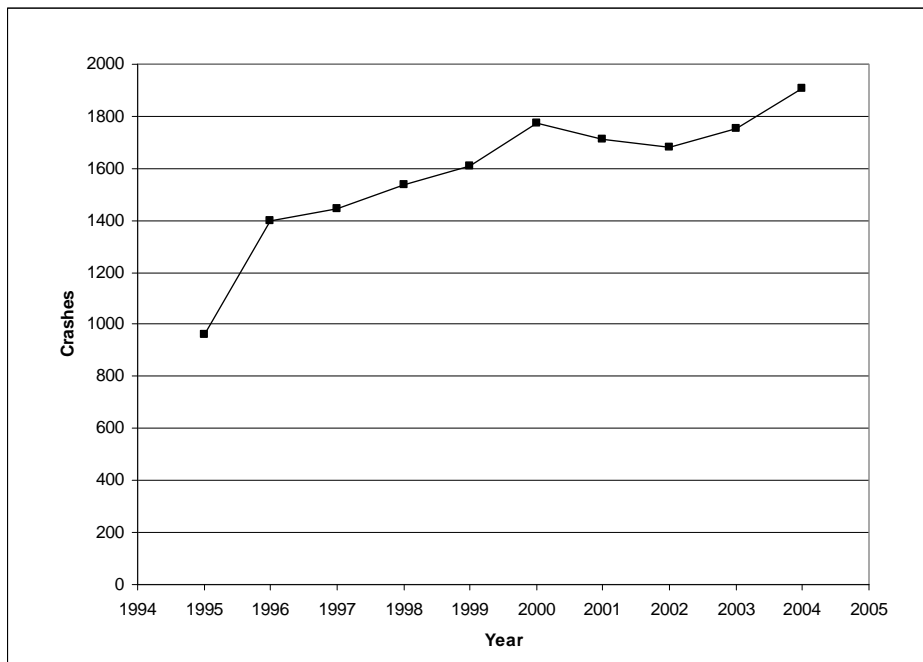
In rural areas, some of the most common types of vehicular accidents involve large animals. There are over 1.5 million impacts with deer every year, resulting in 150 human lives lost and more than one billion dollars in damage (IIHS, 2004). In Wyoming alone, there were more than 16,000 reported accidents involving wild animals between 1995 and 2005 according to data collected for this research effort. These collisions resulted in 14 human deaths. This same data indicate that this problem is increasing by the year. Figure 1.1 illustrates the increases that have occurred over the past decade.

Figure 1.1 Reported Wild Animal Collisions in Wyoming from 1995-2004
(Source: WYDOT Highway Safety Program)

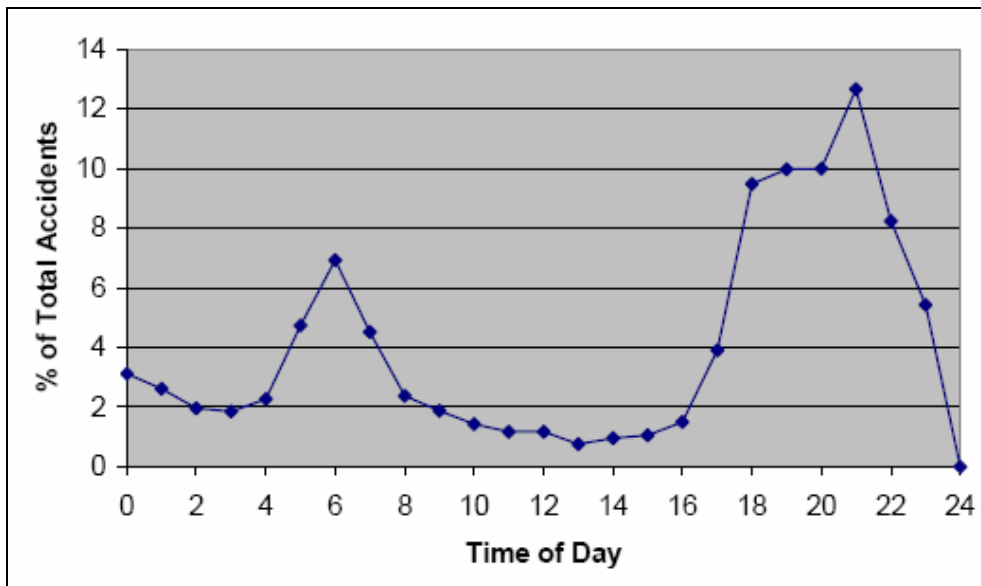
The time of day has a large effect on the probability that a driver will strike an animal. Most game animals tend to be more active during early morning, dusk, and evening hours and use these times to do a large portion of their feeding. A study of AVCs performed in Utah on data collected between 1999 and 2001 shows that the most likely times for impacts to occur were between 6 and 10 PM, with a smaller peak at around 6 AM. Figure 2.1 shows the distribution of animal impacts by the time of day (Perrin, 2003).

Figure 2.1 Animal Crashes by Time of Day
(Source: Utah Department of Transportation Research and Development Division)

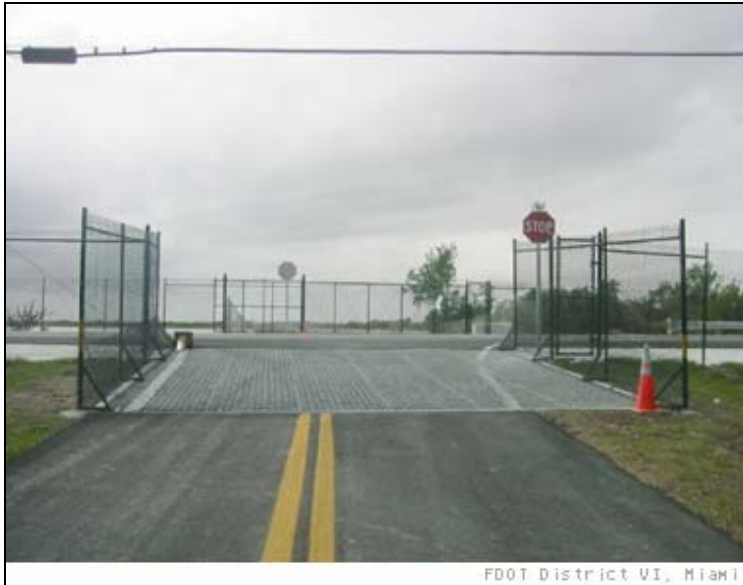
Deer guards have been implemented in Florida to protect the endangered key deer, but their effectiveness could not be determined (Braden et al., 2005). This research was able to show six of the eight total deer observed within the fenced portion after construction used the guards to enter, but no data prior to the construction of the guards was available to use for comparison. A picture of a deer guard used to protect the key deer in Florida can be seen Figure 2.3.

Figure 2.3 Deer Guard in the Florida Keys (Source: *Public Roads*, 2004)

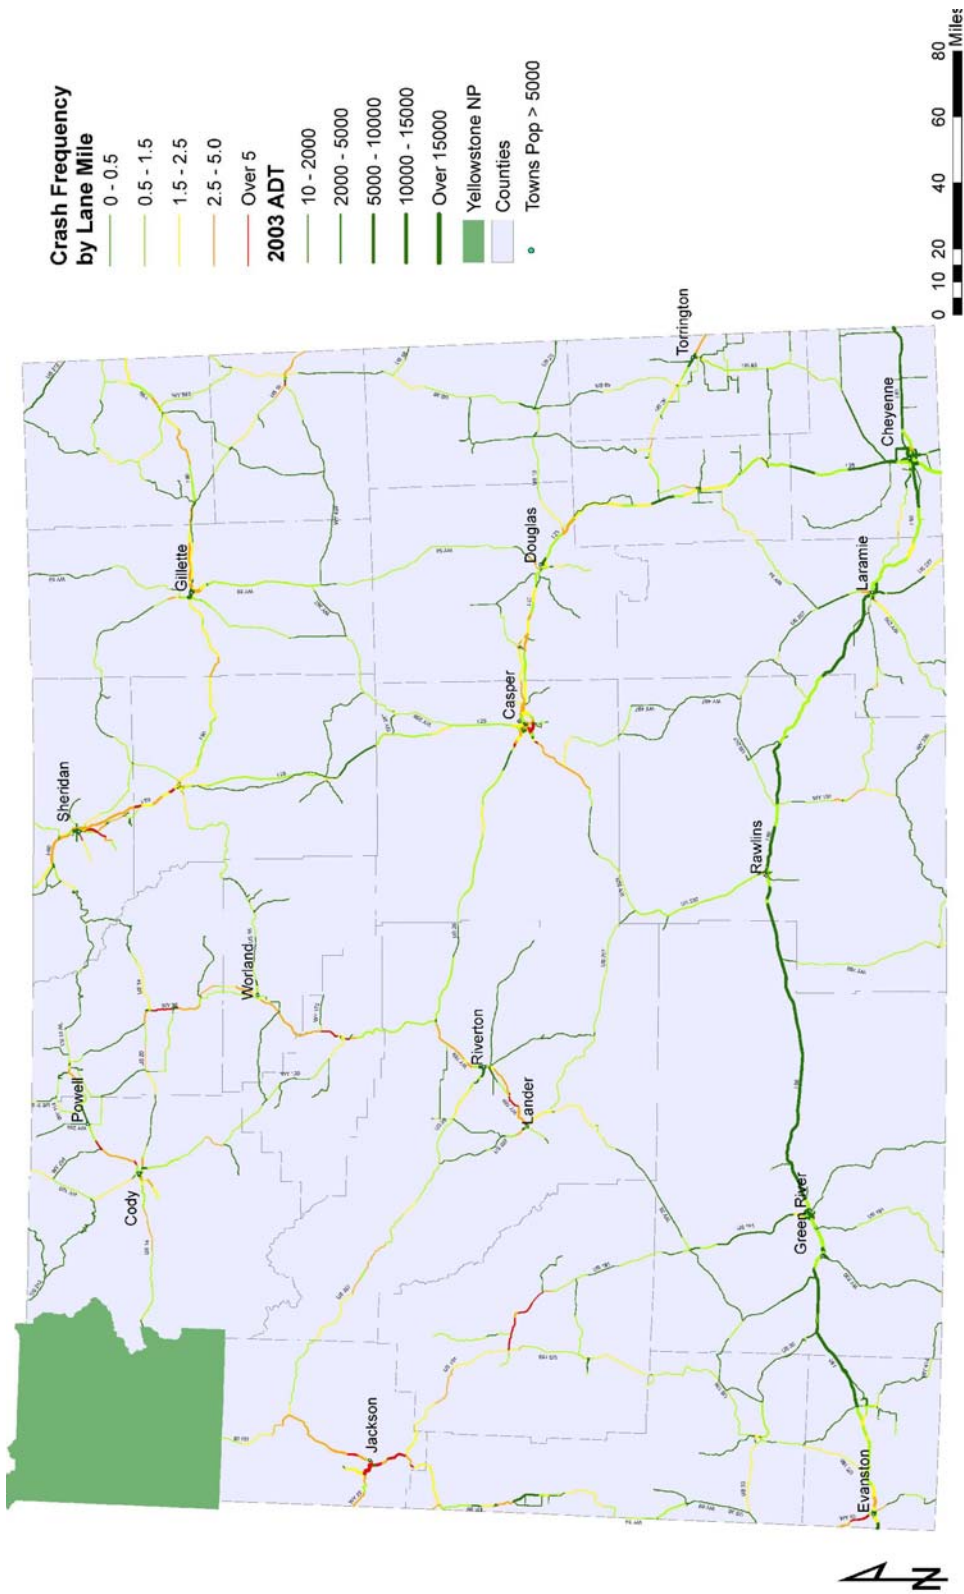
A map showing the state of Wyoming lane-mile AVC frequency broken down by VMT section can be seen in Figure 3.2. Several locations throughout the state show a propensity for AVCs. The areas surrounding Jackson and Pinedale in the western region of the state have many highway sections that show a high frequency of AVCs. Likewise, the Sheridan region in the northern part of Wyoming has high frequencies of wildlife crashes. Other regions throughout the state that have higher than average animal crash frequencies include the areas surrounding Casper, Worland, and the road between Lander and Riverton.

Figure 3.2 Wyoming Reported AVC Frequency by Lane Mile

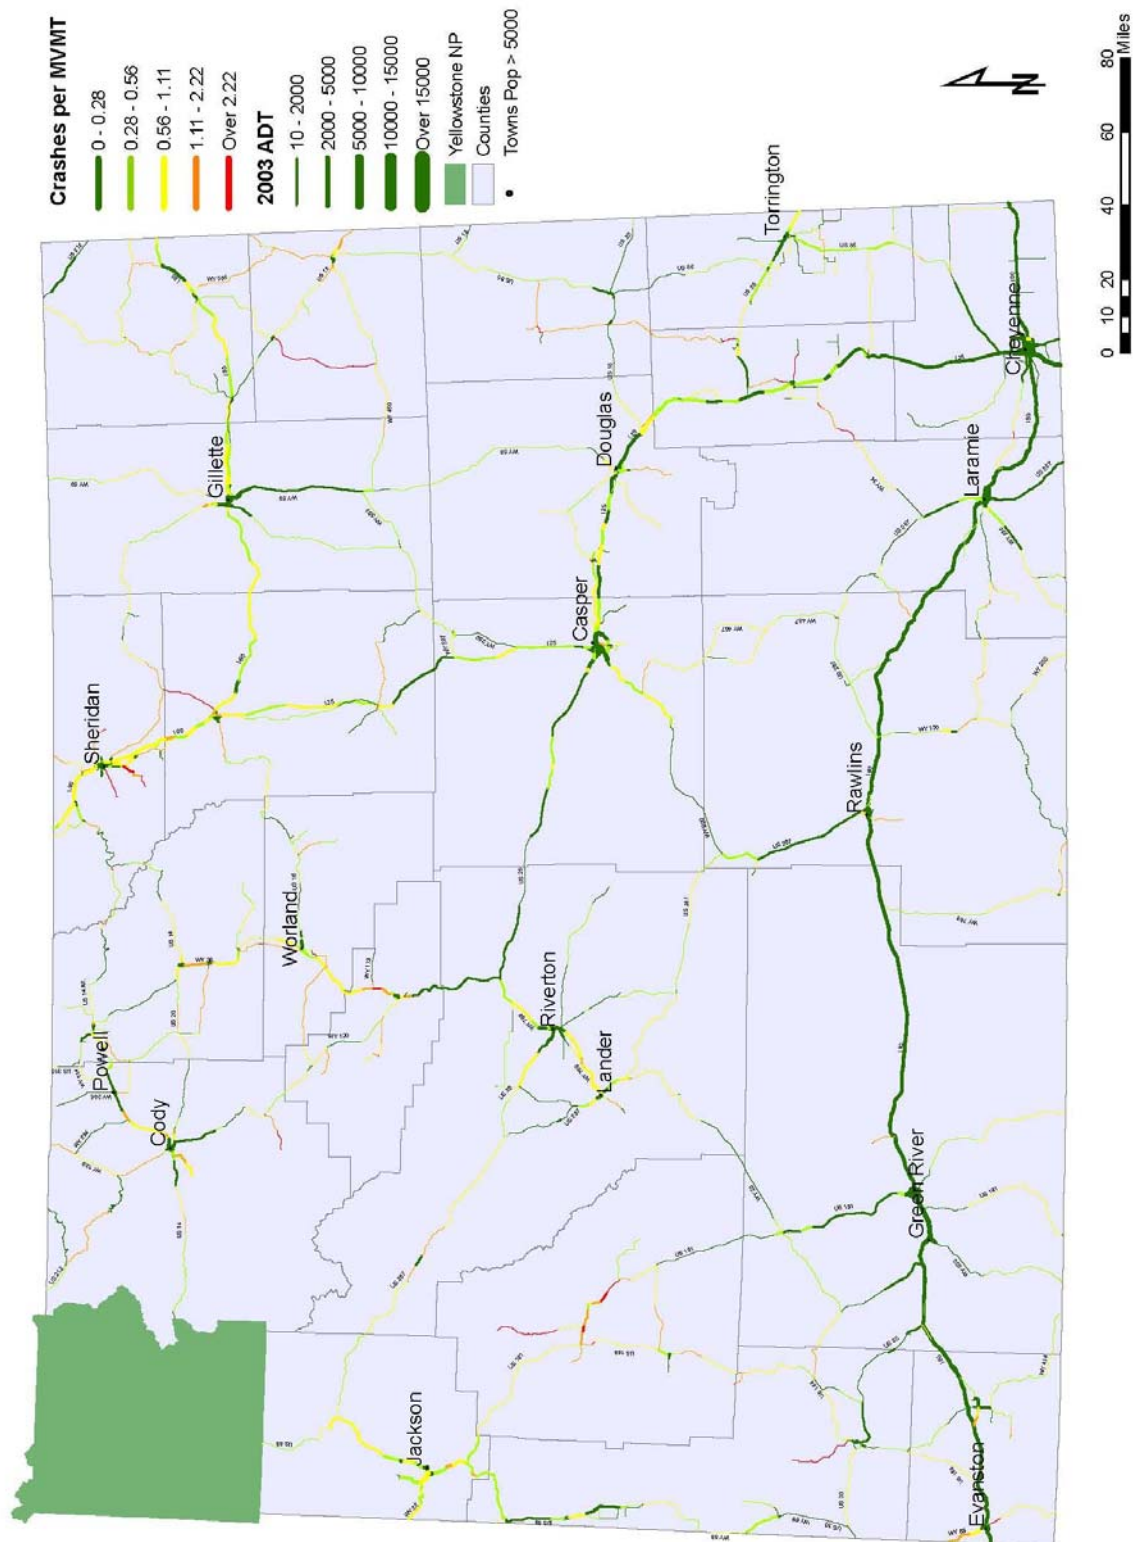
The use of VMT sections for the basis of both crash rates and frequencies allow for each section of road to be compared on a one-to-one basis for both criteria. Figure 3.3 shows the resulting AVC rates for each roadway in the Wyoming state highway system. As a crash rates analysis considers crash history by using the total vehicle miles traveled in a section, rather than just the section length, this analysis identifies many parts of the state traveled less frequently. As with the frequency analysis, the rate analysis singled out the areas near Pinedale and Sheridan as high AVC locations. Problem areas not identified through frequency analysis, but included within the rate analysis, include the areas surrounding Wheatland in the southeast part of the state, Kemmerer in the southwest part of the state, and large portions of northeastern Wyoming.

Figure 3.3 Wyoming Reported AVC Rate

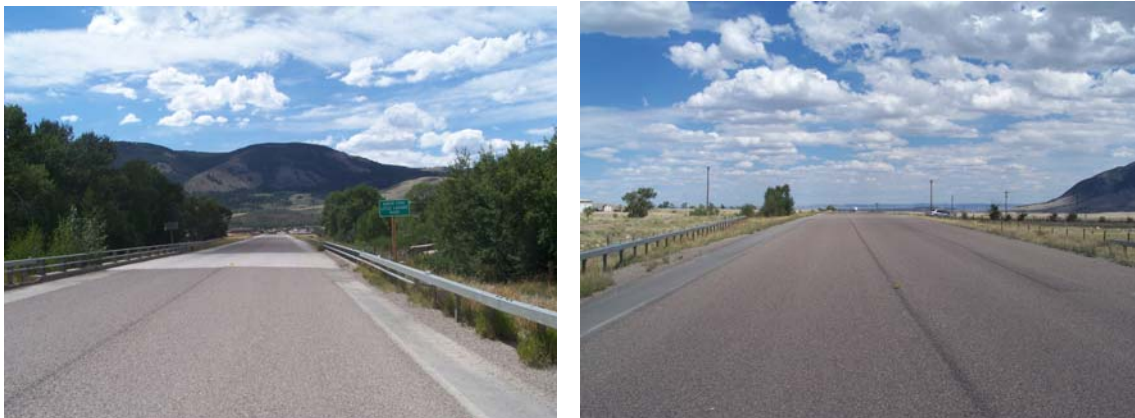
Figure 4.2 Centennial East View – North Fork Little Laramie River Looking West (L) and East (R)

Wyoming State Highway 130 (WYO 130) connects the town of Centennial to Laramie in the southeast corner of the state. The section of road being studied begins 6.1 miles to the east of Centennial, near the junction with WY 11, extending from milepost 21.320 to 27.431. The section ends at the eastern edge of Centennial. The vegetation in the region consists primarily of short-grass prairie, with riparian areas adjacent to the few permanent watercourses in the region. The Snowy Range Mountains begin immediately to the west and south of the area. A map of the area can be seen in Figure 4.1. Two typical views of this roadway section can be seen in Figure 4.2.

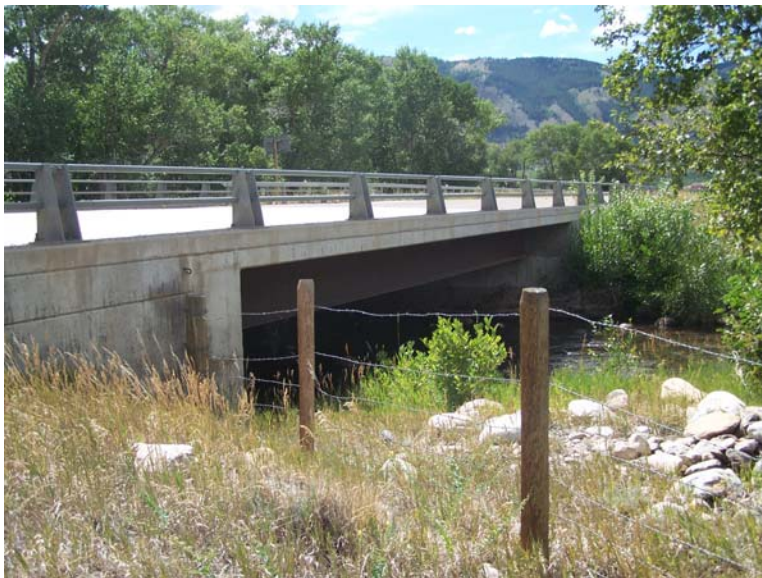
From the literature review on usability of bridges as wildlife structures, the bridge crossing the North Fork may be too short to be readily used by wildlife. The bottom of the bridge girder is only approximately five feet above the river bottom. Mule deer studies have demonstrated that bridge heights less than eight feet are unlikely to be used. A picture of this bridge structure can be seen in Figure 4.3.

Figure 4.3 North Fork Little Laramie Bridge

There are two bridges along this section of roadway. Crossing the Little Laramie River, there is a three-span girder bridge approximately 100 feet in length. The second structure is a single-span girder bridge that crosses the North Fork Little Laramie River that is approximately 60 feet in length. Both bridges were in existence prior to the reconstruction and were not changed as part of the construction. The bridge decks are 36-feet wide.

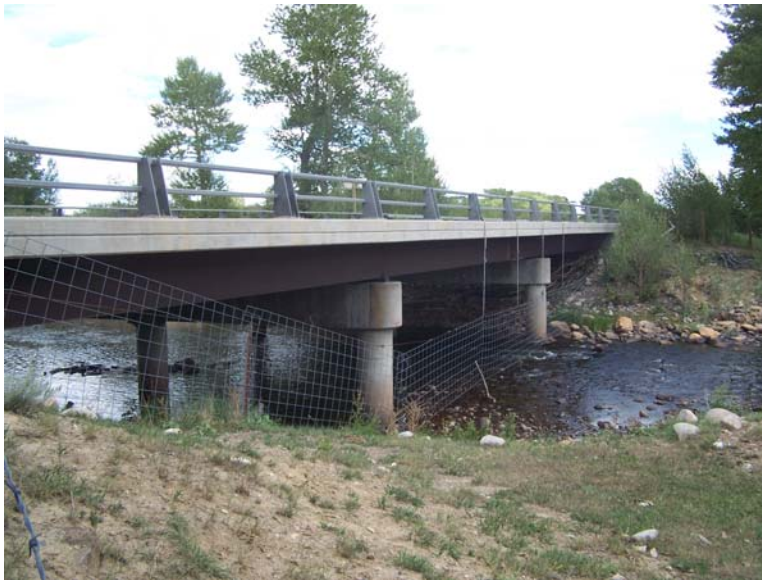
From initial inspection, the bridge crossing the main stem of the Little Laramie River appears to be much more hospitable to crossing game. However, the south side of the structure is fenced across the width of the river, as seen in Figure 4.4, presumably by a rancher in the area, since the adjacent land is used for ranching.

Figure 4.4 Little Laramie Bridge

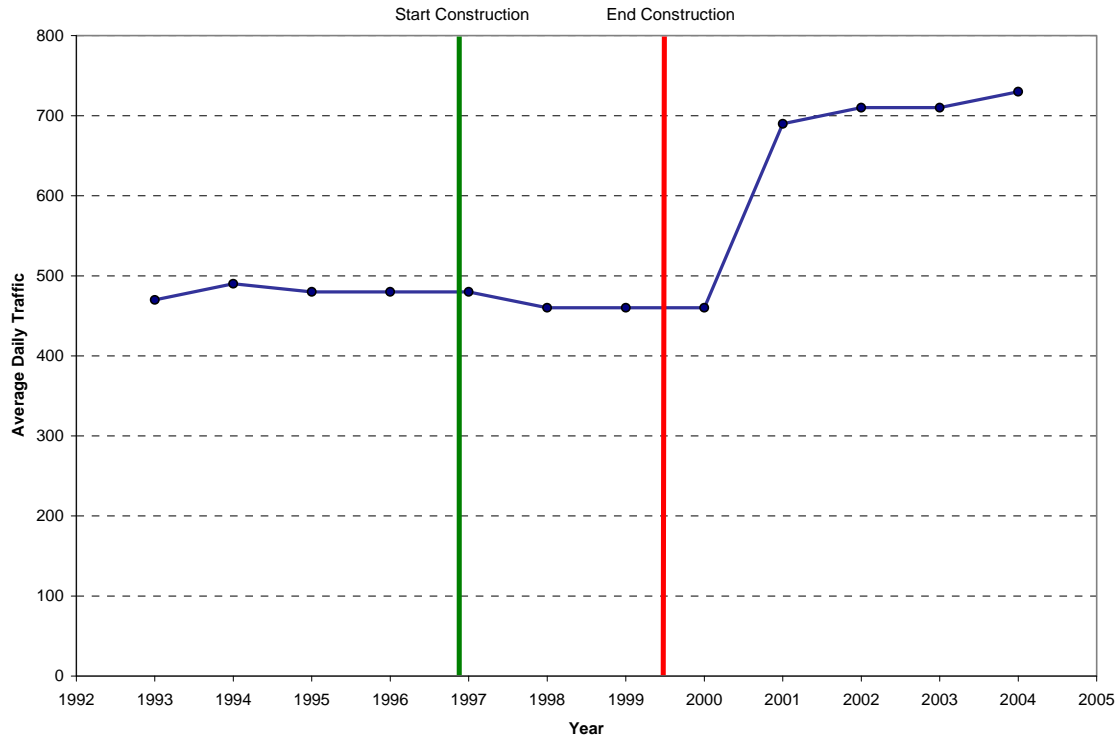
As seen in Figure 4.7, traffic on this section of road experienced a 40% increase following the reconstruction, rising from an ADT of 500 to 700.

Figure 4.7 Centennial ADT

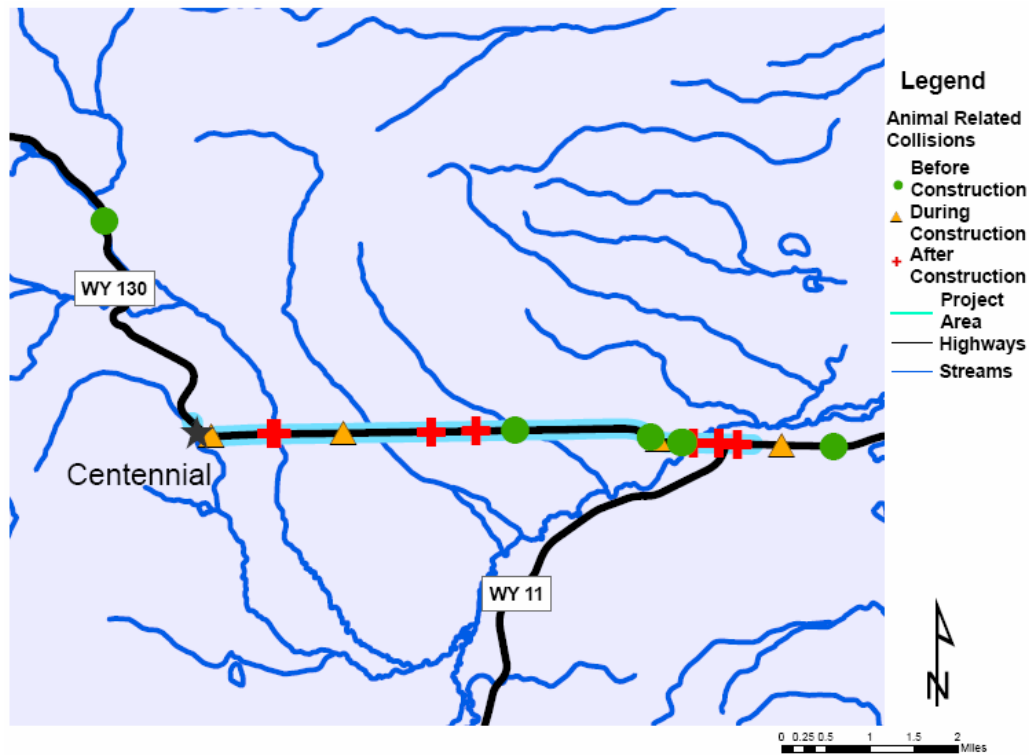
Roadway reconstruction started in November of 1996, and WYDOT's current crash record database only goes back to the start of 1995. Therefore, the full three years of crash data prior to reconstruction is not available for this project. In this case the post-construction time period is adjusted to match the pre-construction time period. In the 23 months prior to reconstruction, there were a total of 12 crashes, four related to wild animals. During the 2.5 years of construction, there were a total of 10 crashes, two involving wild animals. In the two years after the new road was accepted, there were 10 crashes, seven related to hitting wild animals. The animal-vehicle crash data is summarized in Figure 4.8. A summary of the crash data can be found in Appendix B.

Figure 4.8 Centennial East Animal-Vehicle Crashes

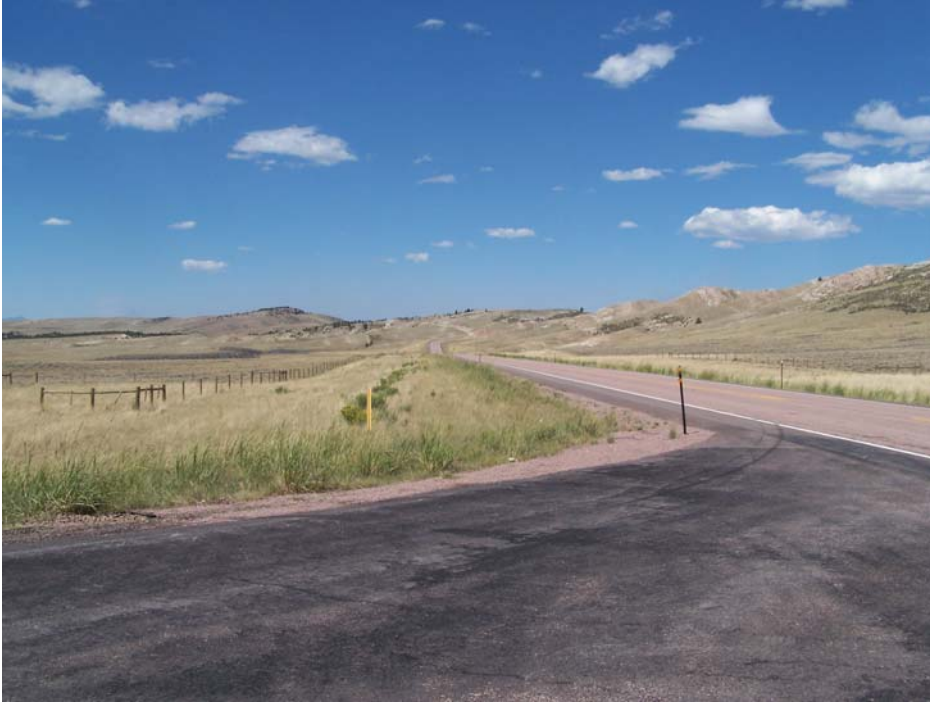
Figure 4.10 Morton Pass from the West

Vegetation in this area is largely sagebrush, with some patches of coniferous forest cover to the east of Morton Pass. A map of the region surrounding this section can be seen in Figure 4.9. A picture taken west of Morton Pass can be seen in Figure 4.10.

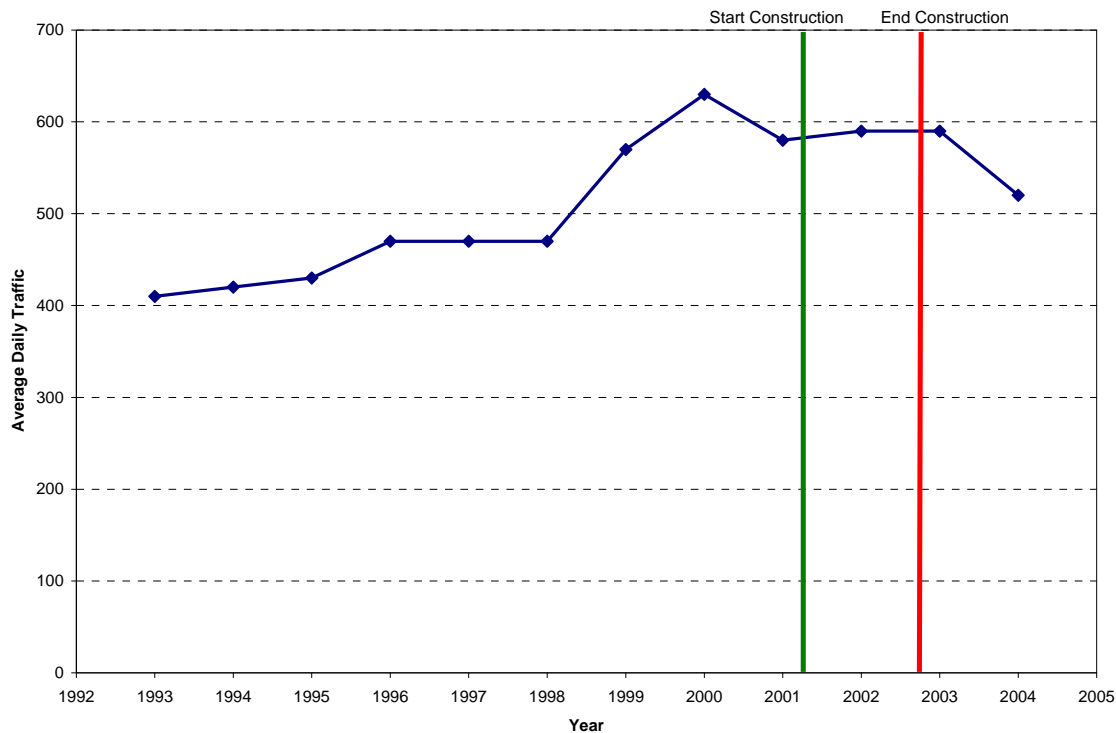
Traffic seems to be increasing on this section, but, as can be seen in Figure 4.13, it is somewhat erratic over the course of the last ten years. The last five years of data show traffic volumes dropping from their high of 630 ADT in 2000 to 520 in 2004.

Figure 4.13 Morton Pass ADT

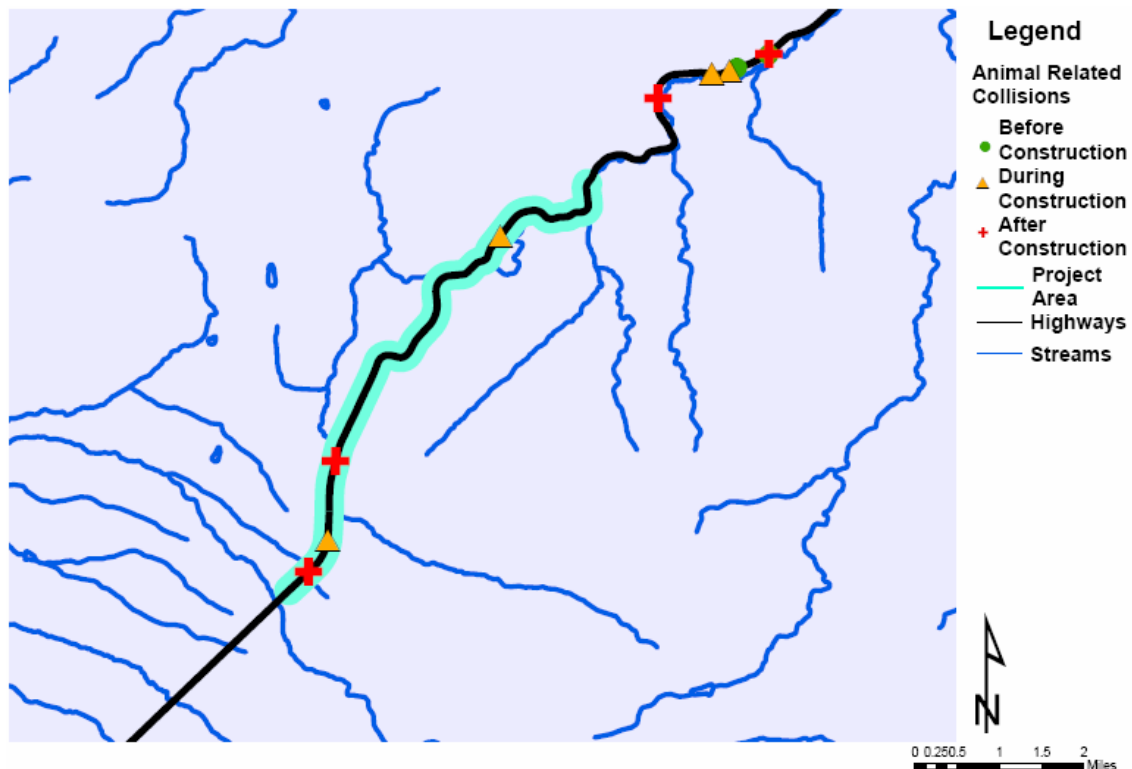
Within this section in the three years prior to reconstruction, there were a total of 19 crashes, but none of these was related to wild animals. During the year and a half of construction there were five total reported crashes, two involving wild animals. In the three years following the acceptance of the section, there were seven crashes, and two list a wild animal as the first harmful event. The wild animal related crashes can be viewed in Figure 4.14. A summary of the crash data can be found in Appendix B.

Figure 4.14 Morton Pass Animal-Vehicle Crashes

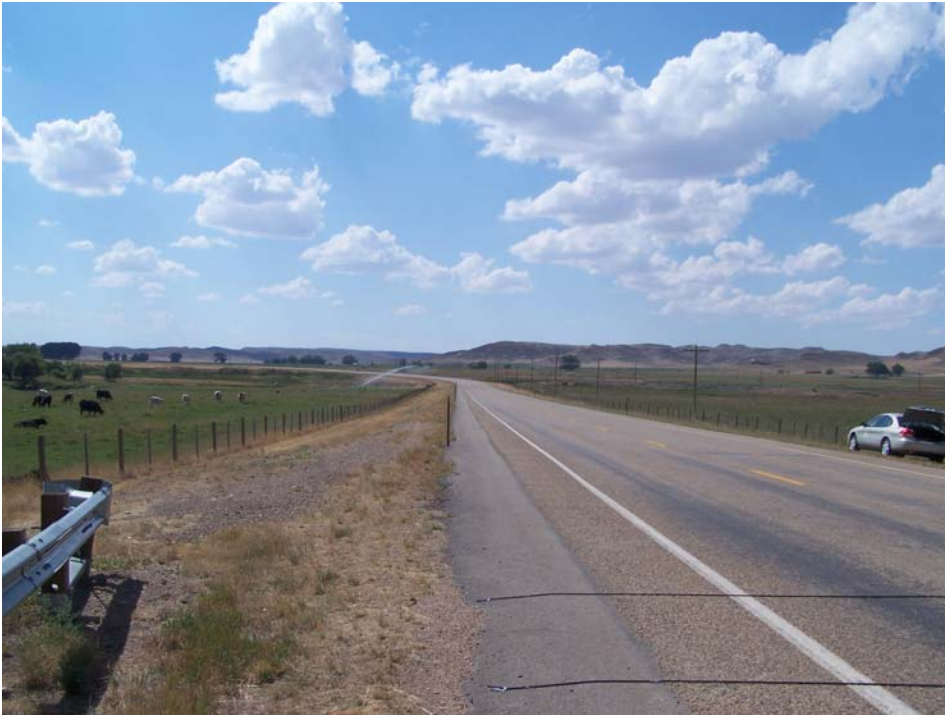
The terrain in this area contains sagebrush on either side of the Clear Creek Valley. Within the valley, there are large areas of irrigated hay fields. A picture showing the general terrain of the section, as viewed from Leiter looking west, can be seen in Figure 4.16.

Figure 4.16 Clearmont North View

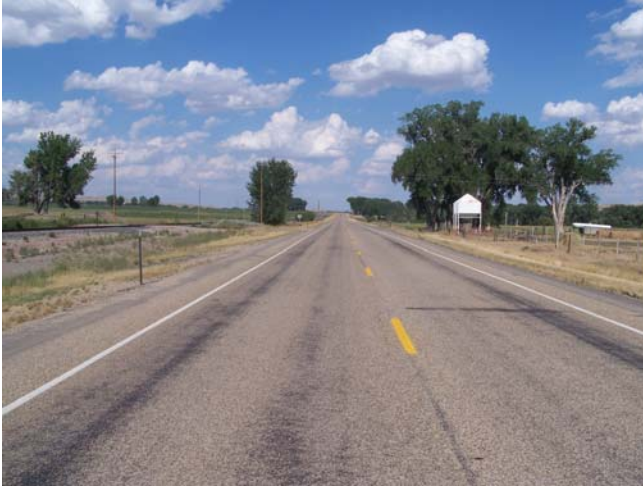
The first tenth of a mile and last two-tenths of a mile of this section already had 12-foot lanes and 4-foot shoulders, and the reconstruction project matched this cross section. The remainder of the project had 11-foot lanes and no shoulders prior to reconstruction. A view of the current lane design can be seen in Figure 4.17.

Figure 4.17 Clearmont North View

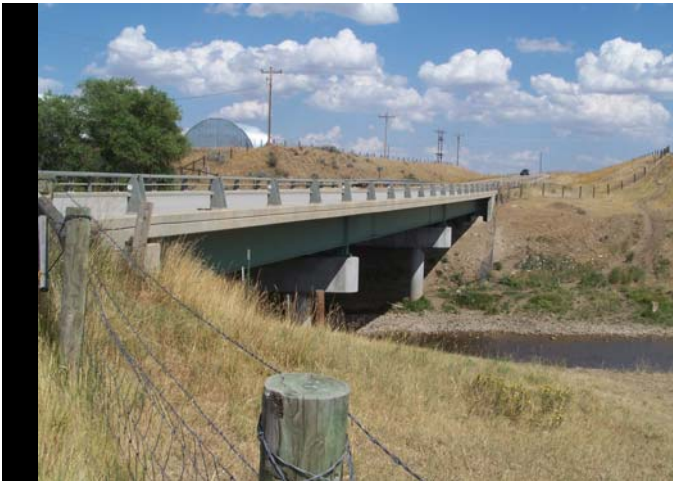
Several large culverts are in the section and one three-span bridge is located just outside the project section, immediately adjacent to the east end. This structure crosses Clear Creek, and the study section roughly parallels the creek to the west. The Clear Creek bridge has a center span in excess of 30 feet, and is approximately 12 feet above the surface of the water. This would make this structure a likely candidate for use as a game crossing structure and may already function as such. A view of this bridge can be seen in Figure 4.18.

Figure 4.18 Clear Creek Bridge

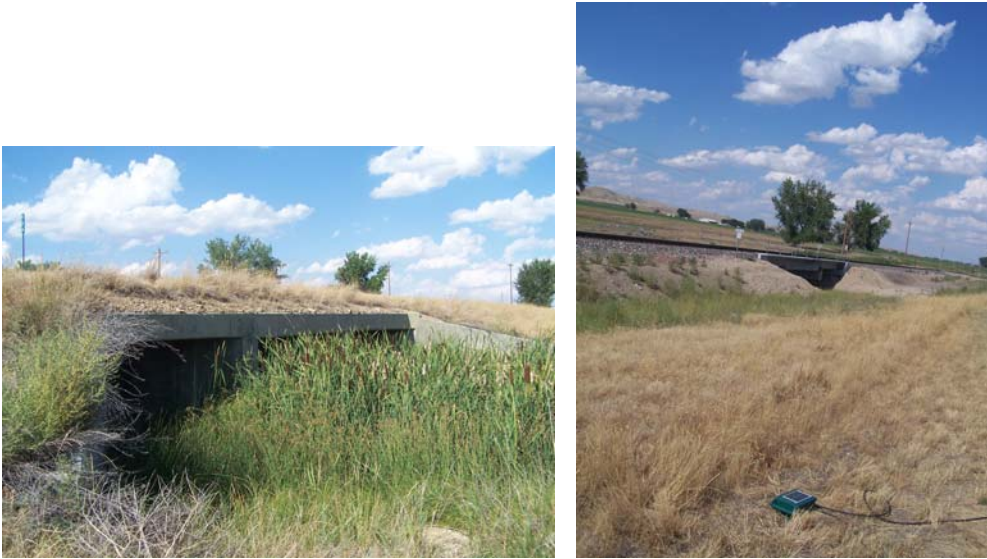
for more information.) It is possible that the combination of a natural drainage and the railroad bridge serve to funnel the deer to this location, where they are then forced to cross over the highway. Pictures of the culvert and railroad bridge can be seen in Figure 4.19.

Figure 4.19 Culvert and Railroad Bridge at Creek Crossing

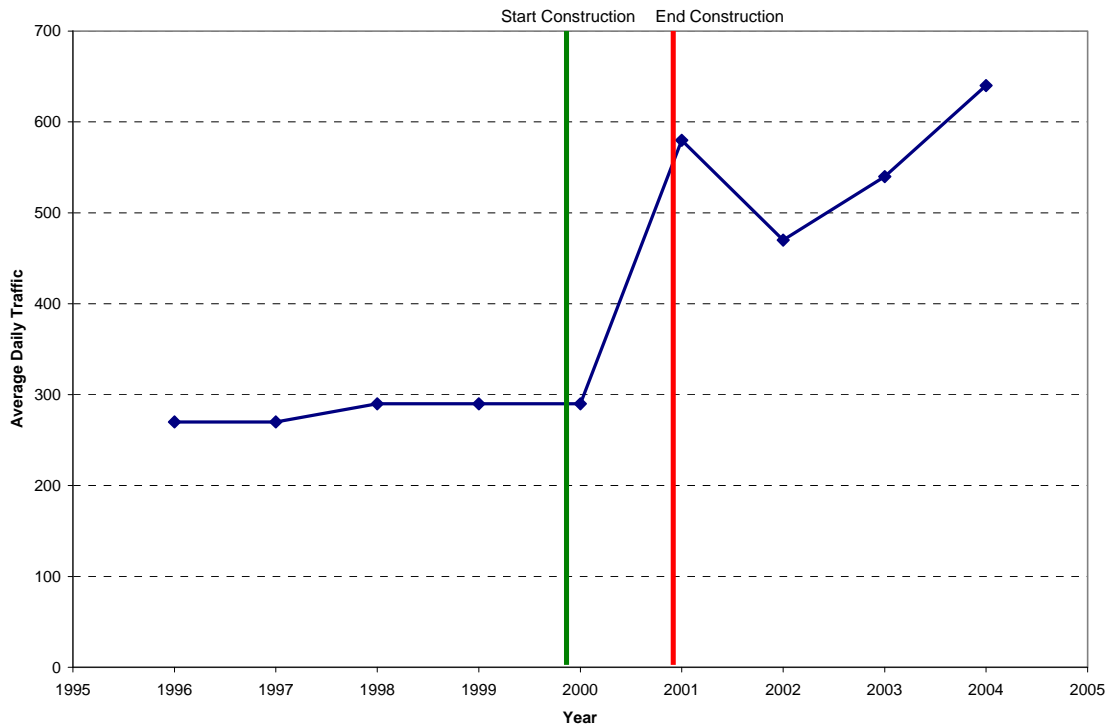
Traffic in this section experienced a large increase during the construction period, and then dropped slightly in the year following construction as can be seen in Figure 4.22. From there, traffic grew at a fairly steady rate of approximately 15% per year for the next two years.

Figure 4.22 Clearmont North ADT

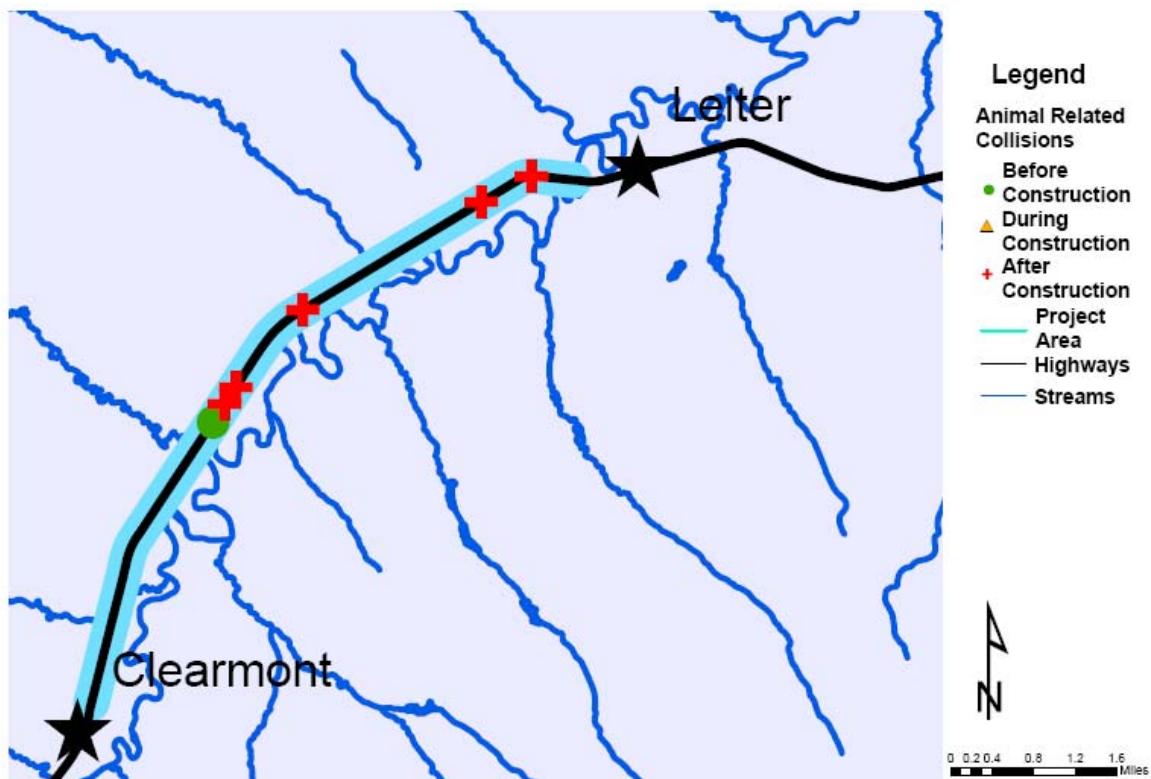
During the three years prior to reconstruction, there were a total of six crashes, and only one involved a wild animal. During construction there were a total of three crashes, none of them involving animals. In the three years following the reconstruction of the road, there were seven crashes, five involving a wild animal. The locations of each of the animal-vehicle crashes can be seen in Figure 4.23. A summary of the crash data can be found in Appendix B.

Figure 4.23 Clearmont North Animal-Vehicle Crashes

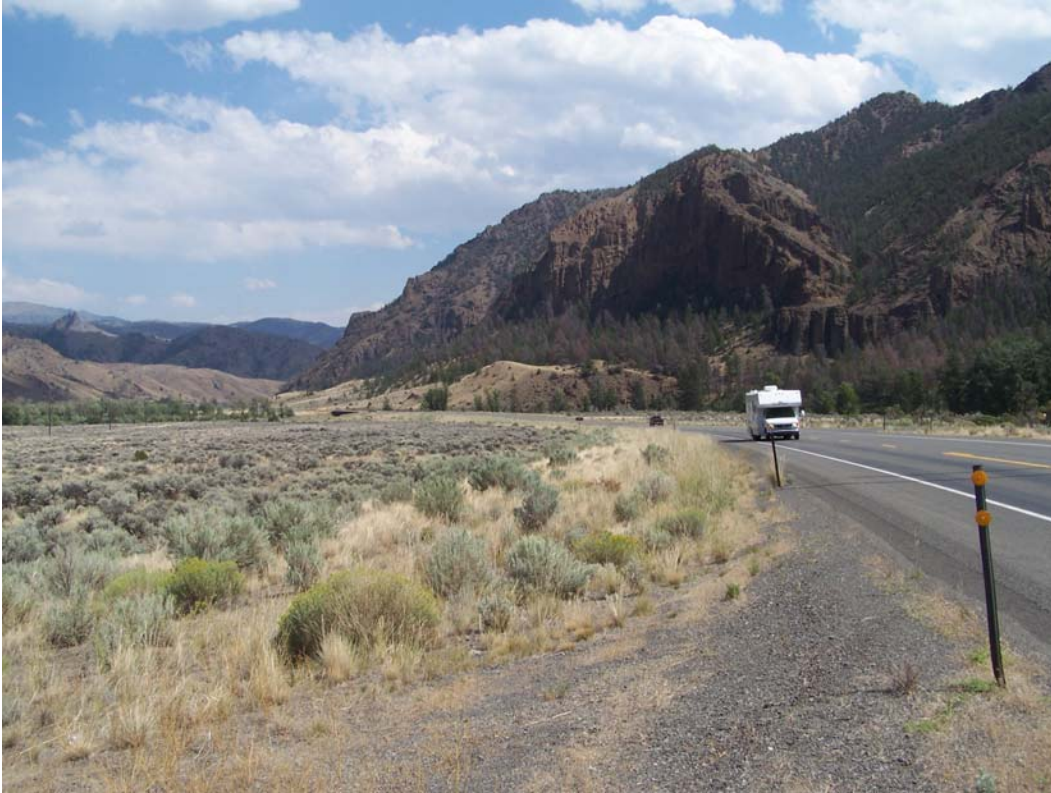
The road travels through United States Forest Service land, and coniferous forests start within a hundred yards of the highway in many locations. The valley itself is narrow and flat, with deciduous riparian habitat along the river and cliff faces on either side of the roadway. A typical view of the valley and the highway can be seen in Figure 4.25. This photograph is taken from the western end of the section looking east.

Figure 4.25 Hanging Rock View

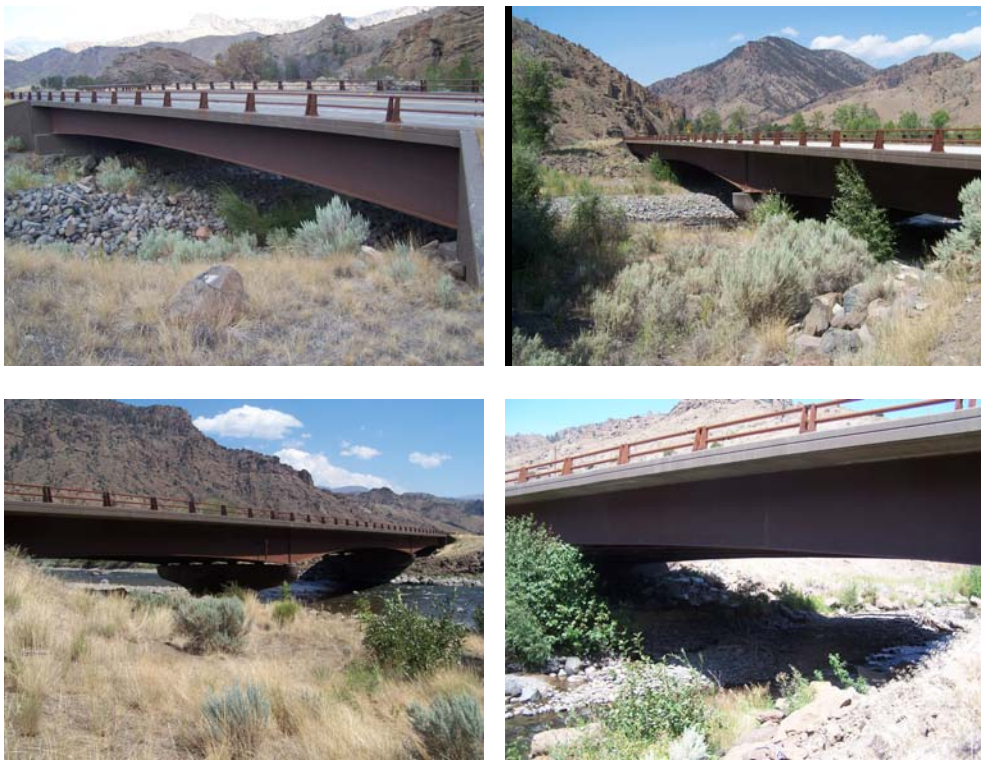
Four new bridge structures are within this section of highway (see Figure 4.26). One structure crosses the North Fork of the Shoshone River, while the other three cross tributaries of the river. All four of the bridges appear to be large enough to accommodate the crossing of game animals. Each of the bridges has end spans that are at least 20 feet in width, which, according to the literature reviewed, is the minimum recommended width for the passage of mule deer. The height of each of the spans over the water surface is greater than six feet, which was the limiting height in the same study.

Figure 4.26 Hanging Rock Section Bridges
Clockwise from upper left: Clocktower Creek (MP 24.84), Elk Fork (MP 22.05), North Fork Shoshone River (MP 20.31), Clearwater Creek (MP 19.74).

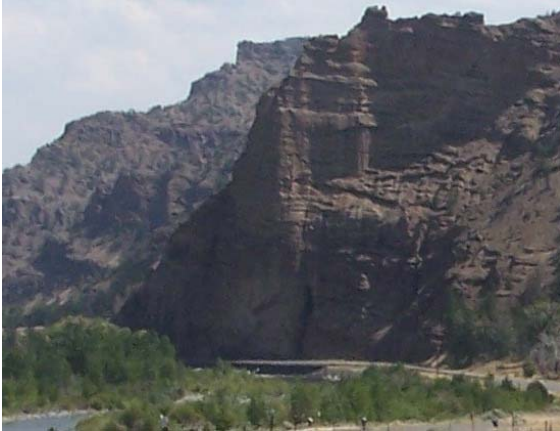
Several retaining walls are in this section, many over 20 feet tall, generally located in areas where the road is positioned between the river and a steep cut in the cliff. An example of this can be seen in Figure 4.27. These areas typically would not make good crossing points for game, as there is no approach to the roadway from either side.

Figure 4.27 Hanging Rock Section Retaining Wall

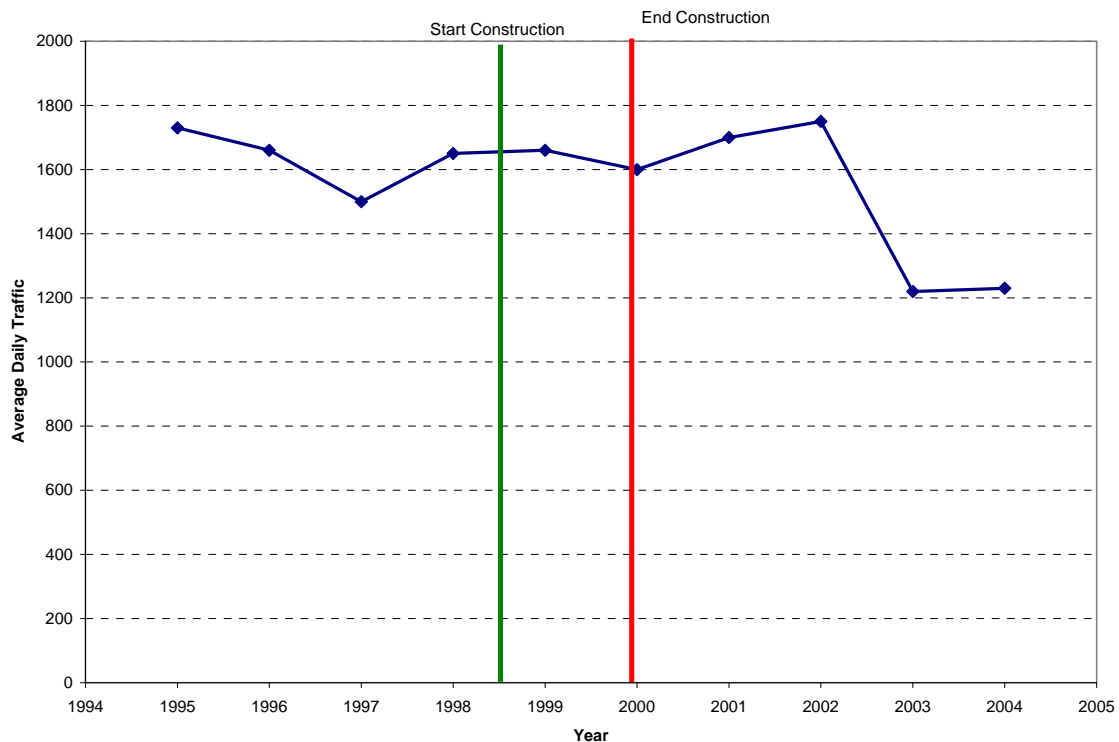
One thing that must be noted is that approximately 19 miles to the west of this section, within Yellowstone National Park, a major reconstruction project was undertaken during the summer of 2006, causing road closures of up to a half an hour. This forced much of the eastbound traffic to be grouped into large platoons. By the time they reached this section of roadway, they would likely be spread out, although it is possible that some platooning remained and might affect the collected vehicle speed data.

Figure 4.30 Hanging Rock ADT

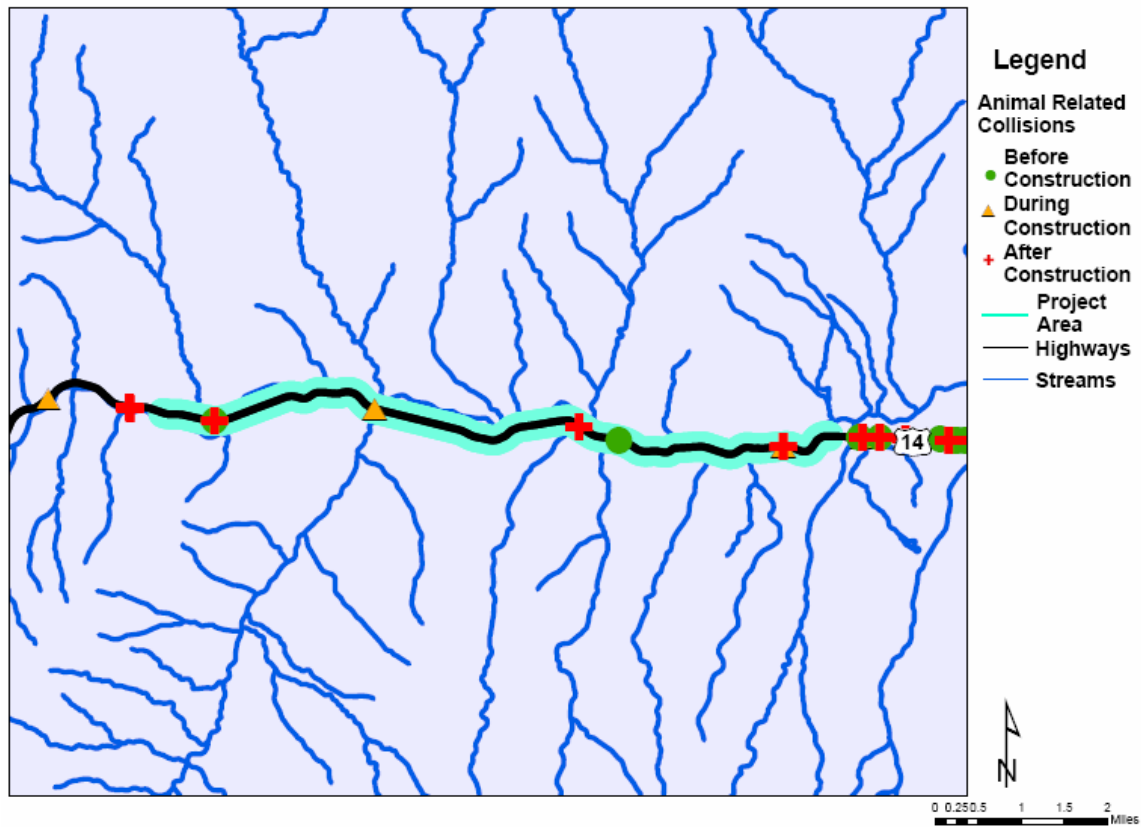
In the three years prior to construction, there were a total of 12 crashes in this section, with two related to wild animals. During construction, there were a total of eight crashes, two involving animals. In the three years after the project was completed, there were an additional eight crashes, four related to wild animals. The distribution of the animal related crashes can be seen in Figure 4.31. A summary of the crash data can be found in Appendix B.

Figure 4.31 Hanging Rock Animal-Vehicle Crashes

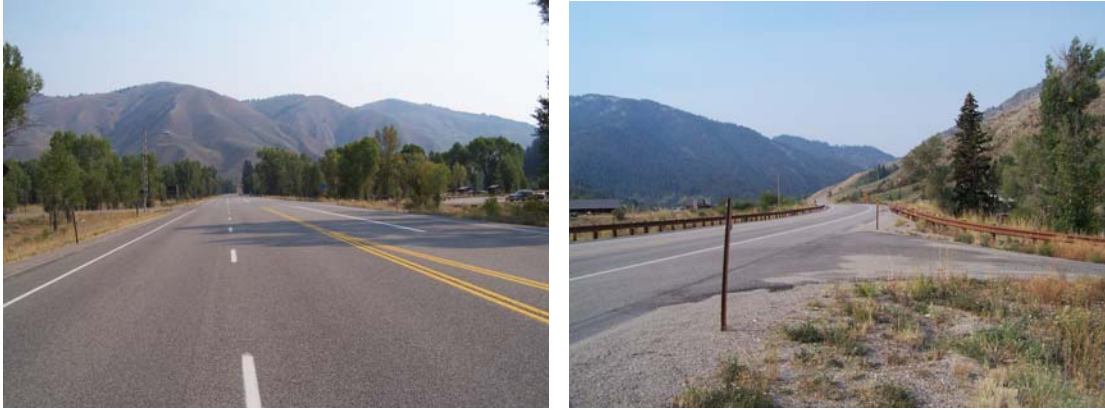
The first mile traveling north has mixed coniferous/deciduous forest on both sides of the road. There are passing lanes in both directions in this area. The rest of this section is located higher on the valley slopes above the river and has a more curved alignment. Several 10- to 20-foot high retaining walls are in this section, and most of this area has guardrail on the river side of the road. Throughout the section, the road parallels the west side of the Snake River. The characteristics of the two different sections are shown in Figure 4.33.

Figure 4.33 Astoria Views
Near the South End of the Section Looking North, (left) and Center of the Section Looking West (right)

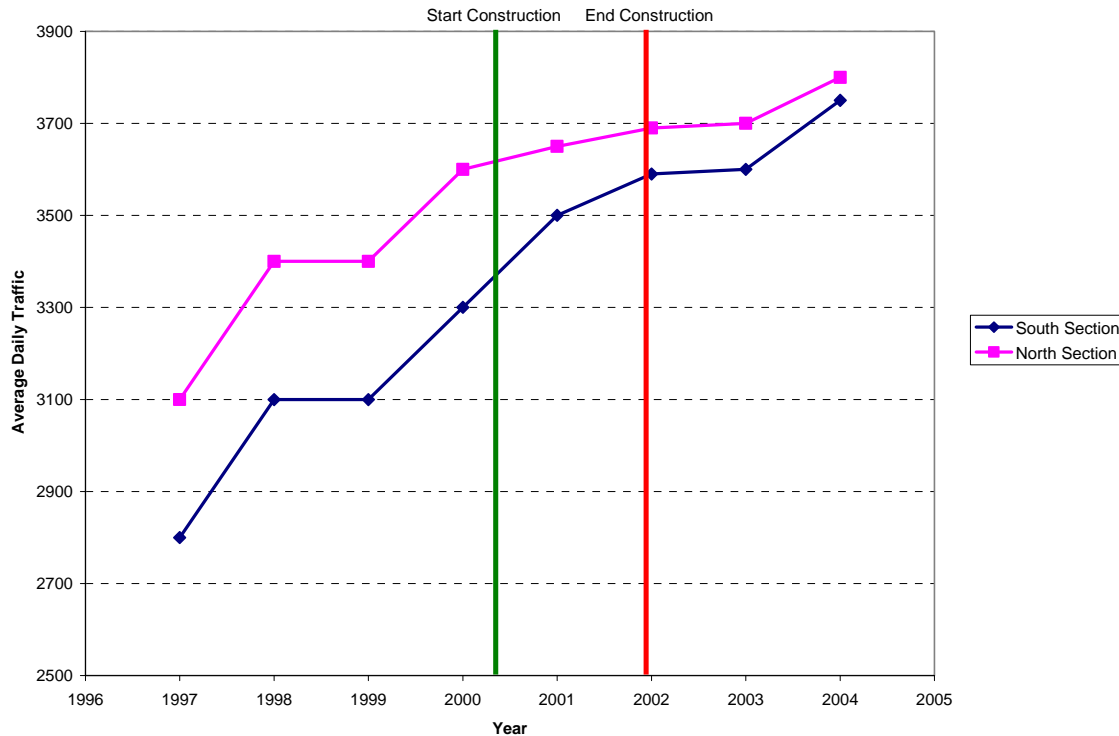
area with the most AVCs. The northern section covers the remainder of the project, as well as the rest of US 89 to Hoback Junction. Traffic on the two sections trend very similarly, with volumes on the southern section slightly lower than the northern. Traffic on the southern section grew slightly faster than the northern. By 2004, the difference between the two sections could be considered negligible. As is demonstrated in Figure 4.36, the two segments had consistent growth between 1997 and 2004, with a combined average yearly growth of nearly 4%.

Figure 4.36 Astoria ADT

WYDOT uses two different traffic volume zones in the area of this project. The south zone is valid for the southernmost 1.3 miles of the project. This includes the passing zone, as well as the
