RELATING WILDLIFE CRASHES TO ROAD RECONSTRUCTION

Rhonda Young and Chris Vokurka

Department of Civil and Architectural Engineering
University of Wyoming
1000 E. University Avenue
Laramie, Wyoming 82071

July 2007

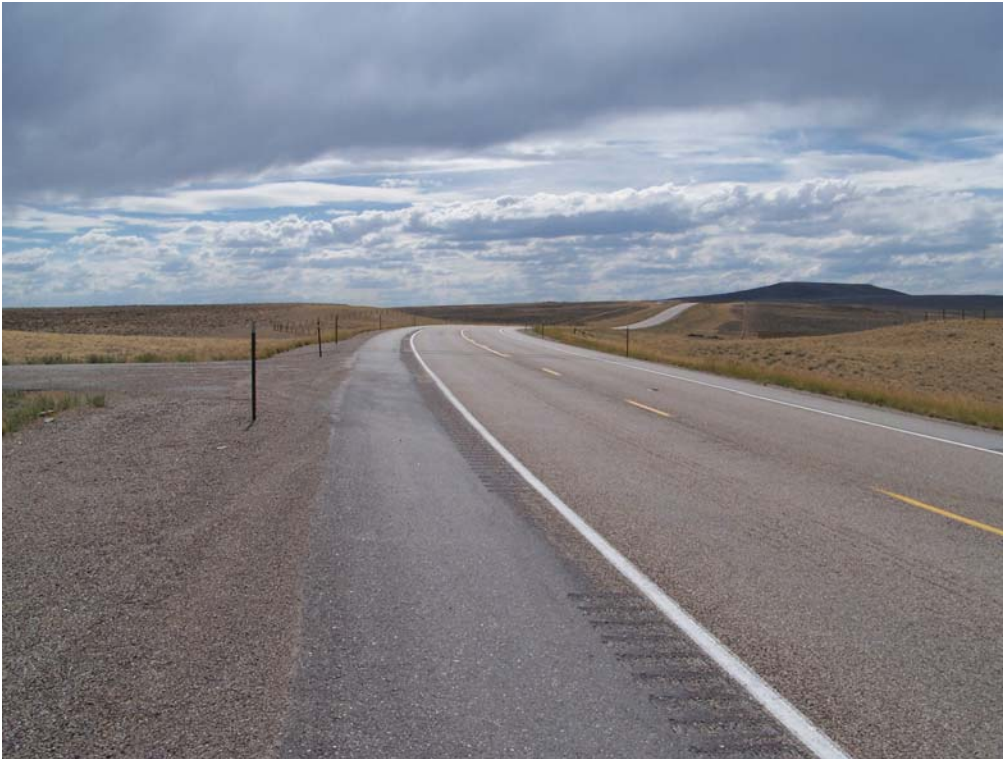
The terrain consists of rolling hills dominated by sagebrush. There is no visible cover within sight of the highway. No bodies of water were observed from the roadway in this section. A typical view of the area can be seen in Figure 4.39.

Figure 4.39 Round Mountain View

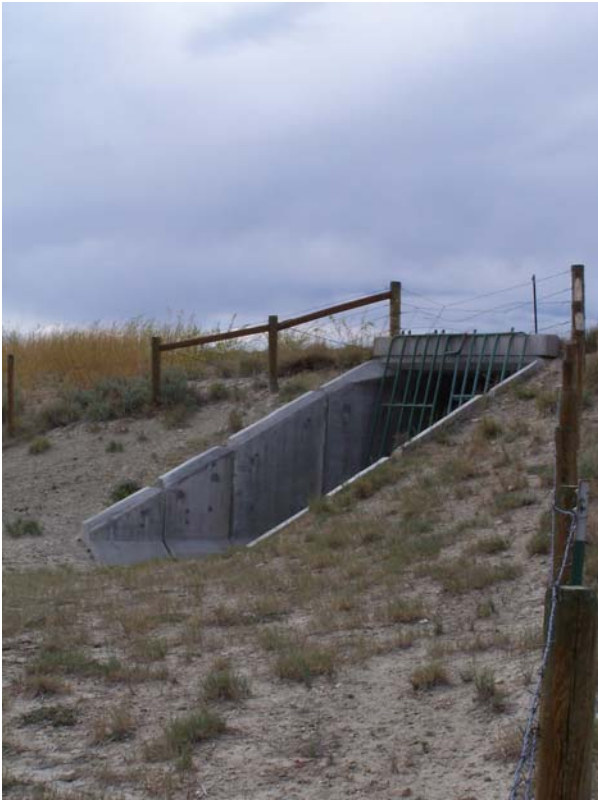
There was only one major drainage structure in the entire segment, a 10-foot by 10-foot box culvert crossing a dry wash. The primary use for this structure appears to be as a stock crossing. This structure would most likely discourage deer use, as it was much smaller than the 20-foot minimum width recommended in the literature review for the use of mule deer. This point may be unimportant, as the south entrance was blocked by two vertically hung metal gates. A picture of this culvert can be seen in Figure 4.40.

Figure 4.40 Round Mountain Crossing

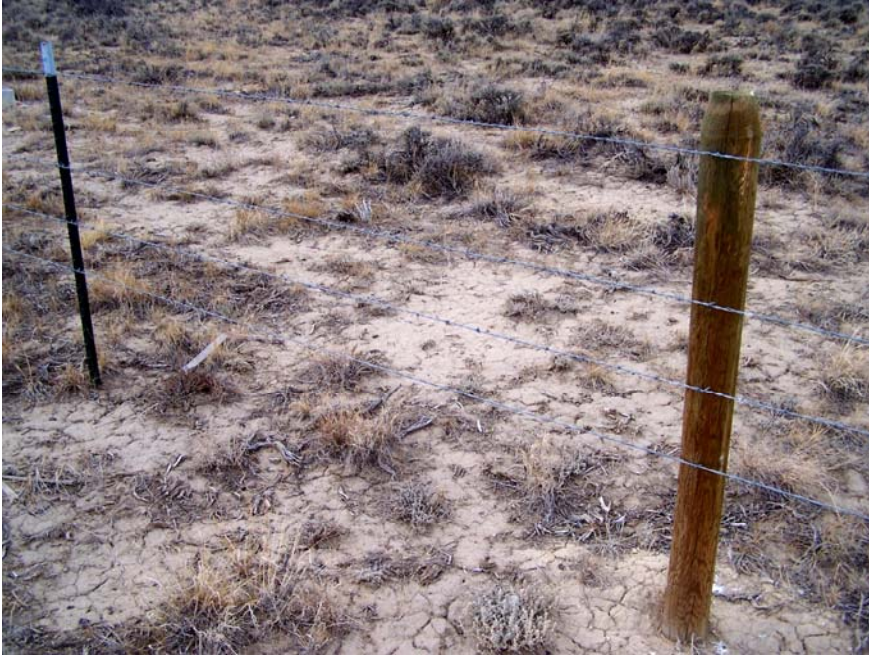
Figure 4.41 Round Mountain Fencing

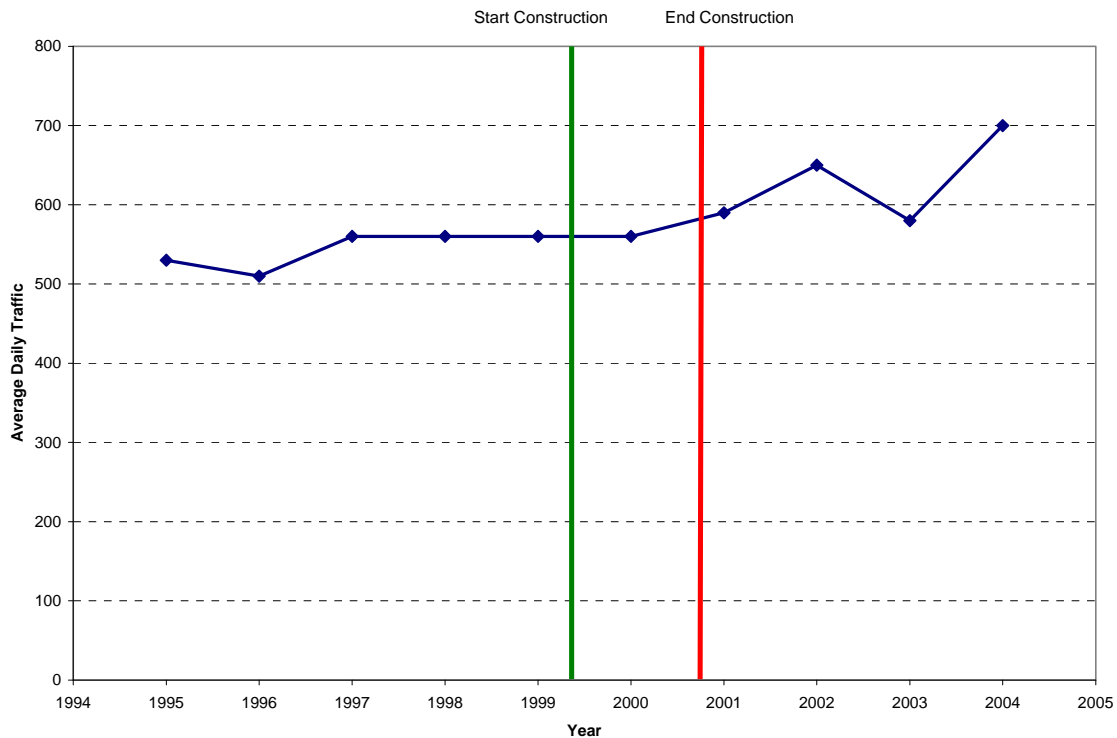
The years prior to and during construction saw almost constant traffic volumes, as can be seen in Figure 4.44. Following the reconstruction, traffic volumes were more variable, but showed a generally increasing trend.

Figure 4.44 Round Mountain ADT

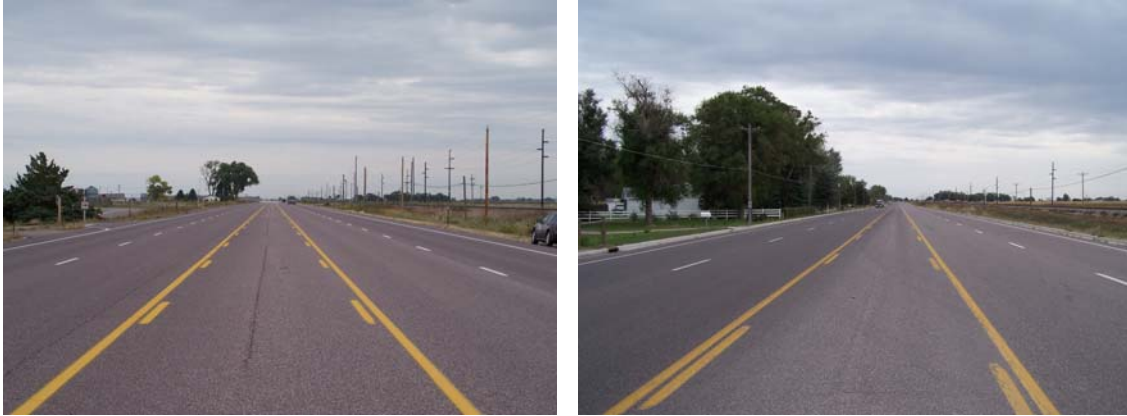
This section of highway is notable because it was rebuilt with two lanes in each direction. Throughout the segment, there is also a 12-foot wide, center, two-way left turn lane, making the roadway five lanes in width. The segment starts on the outskirts of Torrington at mile marker 94.6. The first two miles have a posted speed limit of 45 mph and contain a couple of larger radius sweeping turns. Following this, there are two miles posted with a 55 mph speed limit. This part of the highway is straight. Both the 45 and 55 mph sections of the highway contain curb and gutter. According to Buck Klemola, WYDOT resident engineer for the region, the 45 and 55 mph posted sections were chosen to decrease the probability for errant vehicles to “trip” when striking the curb and gutter. The remaining portion of the highway in question has a posted speed limit of 65 mph and is straight. Two typical views of this section can be seen in Figure 4.47.

Figure 4.47 Torrington West Views
US 85 Looking East 1 Mile East of Lingle (left) and US 85 Looking East within the
Curbed 55 mph Section (right)

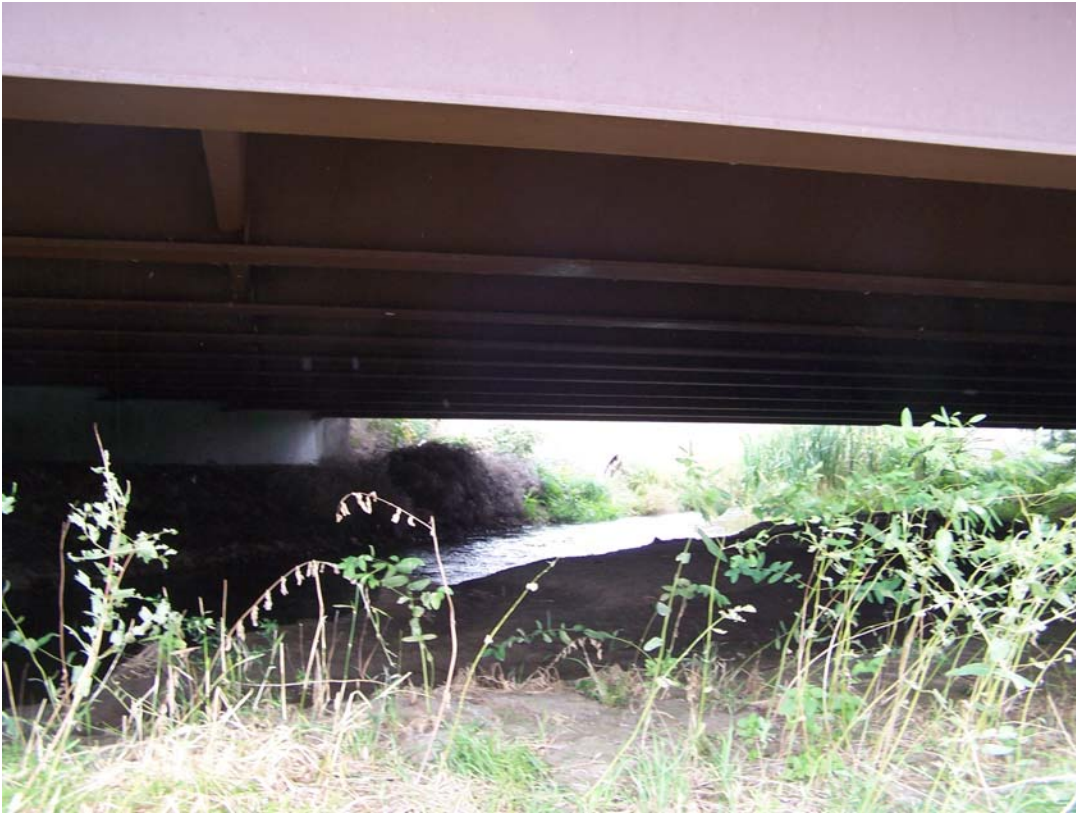
Figure 4.48 Rawhide Creek Bridge
