**LOAD TESTING OF WOOD-CONCRETE BEAMS INCORPORATING  
RECYCLED UTILITY POLES**

**Matthew R. LeBorgne**

**April 2008**

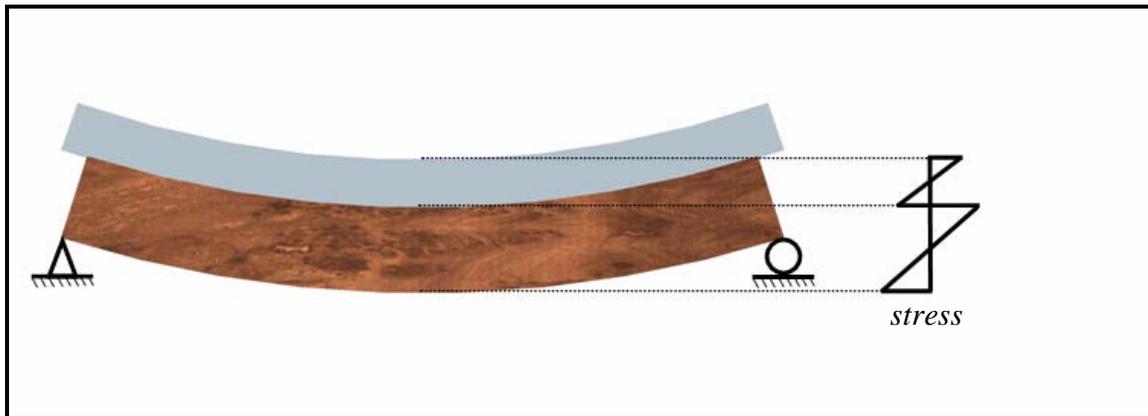
**Figure 2.1** No Composite Action

Wood-concrete construction first began in the United States when a bridge spanning the canal between the cities of Houghton and Hancock in Michigan was rebuilt in 1929.<sup>6</sup> The bridge was constructed by using 6" x 6" timber cross ties with a precast concrete slab placed on top. This type of construction was chosen because it provided a hardwearing surface and allowed efficient use of the wood. There was no interconnection of the concrete deck to the wood crossties. Thus, this bridge is a "non-composite" system as depicted in Figure 2.1.

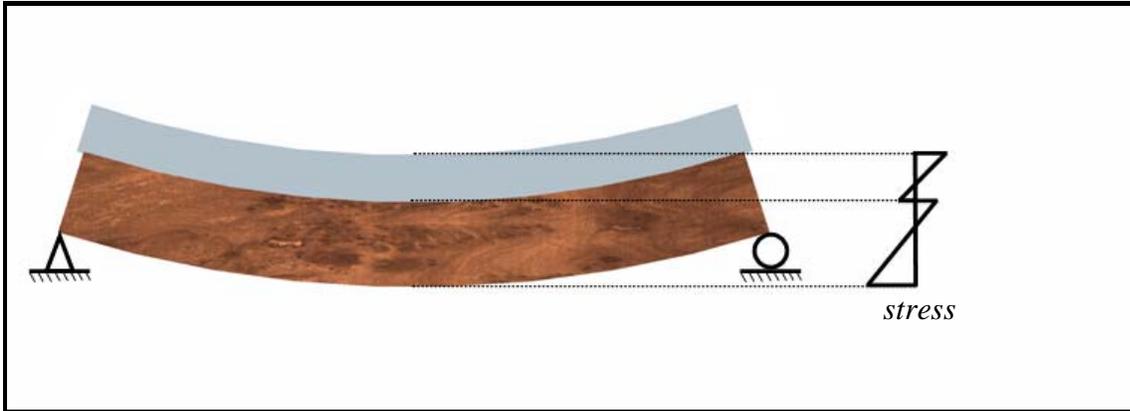
**Figure 2.2** Partial Composite Action

As mentioned earlier, in 1932, the Oregon State Highway Department constructed the first wood-concrete composite bridge.<sup>7</sup> The bridge was constructed by using creosote-treated timber stringers topped with concrete to form a T-beam girder.<sup>8</sup> Interlocking connectors were used between the wood and concrete to provide partial composite action as shown in Figure 2.2. The partially composite system moves the two neutral axes closer together relative to the non-composite case. This transfers more axial tension force to the wood while increasing the axial compression load in the concrete. Additionally, the stresses at the slip plane decrease.

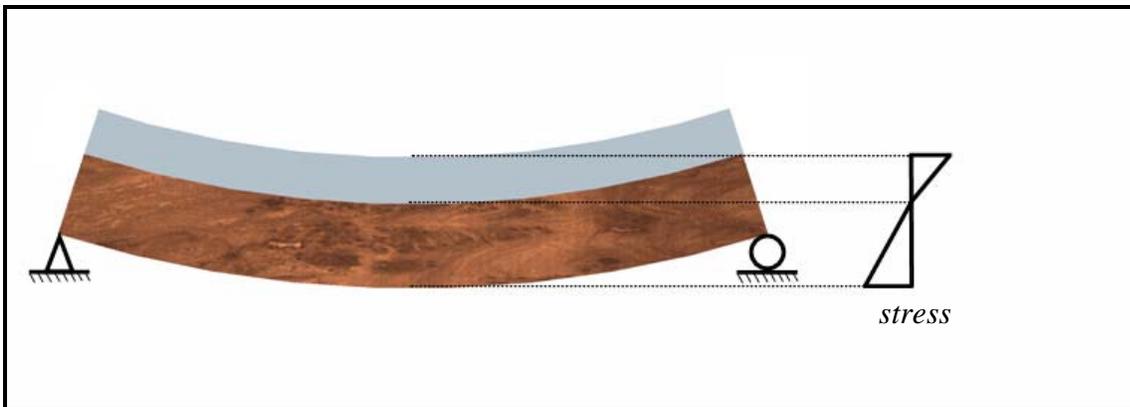
**Figure 2.3** Full Composite Action

If it were possible to rigidly bond the concrete layer to the wood layer, full composite action would result. A way to achieve this type of bond would be to cast and cure the slab separately, applying a “rigid adhesive” to the wood beam and then use a crane to place the slab on the wooden beams. However, due to the natural variability in the wood and the way the concrete is cast, there is no guarantee that the wood beam and the concrete slab will lie flat against the wood. Additionally, to move the slab would require flexural reinforcement to be purchased and installed to keep the slab from cracking under its own weight, and that could be cost prohibitive. Despite the problems with gluing the wood and concrete layers together, Pincus<sup>9</sup> was able to create a partially composite bond between the wood and concrete through the use of an epoxy. However, he encountered similar problems as described above with the bonding of the layers, moisture, and inability of the bond to withstand impact tests. At the University of Singapore, an epoxy resin was used to connect a concrete slab to wooden stems.<sup>10</sup> The wood-concrete composite beam exhibited nearly full composite action during ramp loading, however, the cost of the epoxy resin was so high that it made this connection method impractical. The idealized and highly sought after full composite action is shown in Figure 2.3.

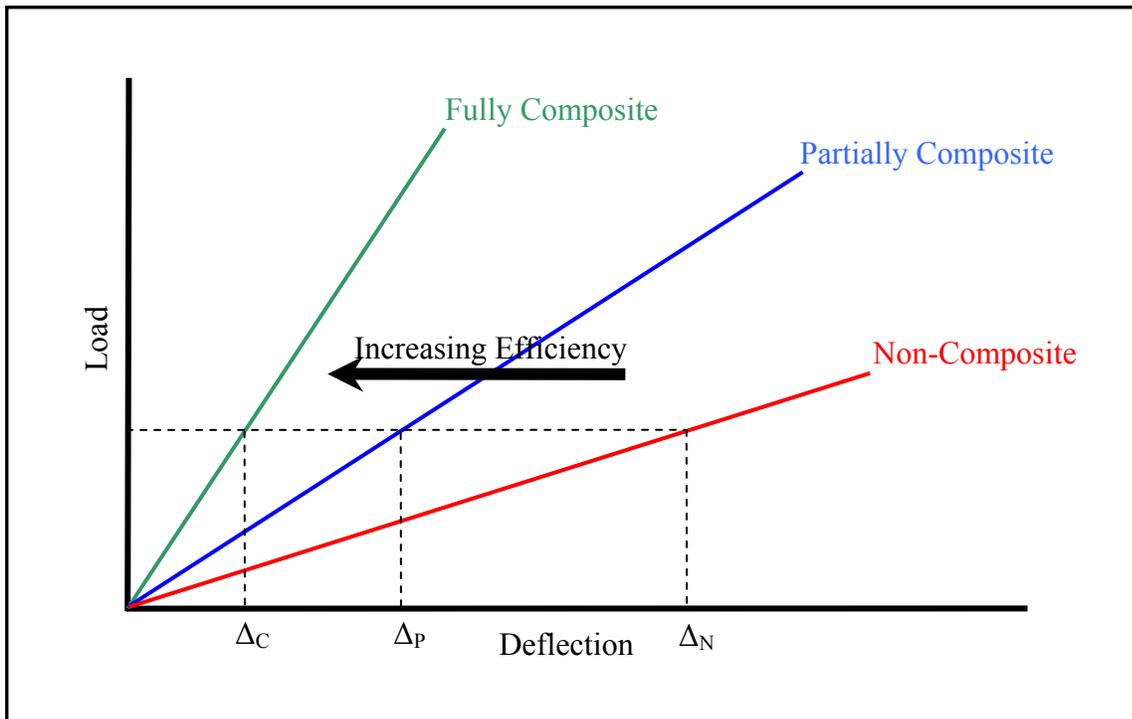
Figure 2.4 Efficiency Graph

Where  $\Delta_N$  is the theoretical non-composite deflection,  $\Delta_P$  is the measured composite deflection, and  $\Delta_C$  is the theoretical composite deflection. Efficiency quantifies the degree of composite action, where 100% efficiency is full composite action. The efficiency of a beam is inversely related to interlayer slip, which is the relative movement of the wood and concrete layers at the interface. As slip increases the composite efficiency decreases. However, the relation of slip to composite action changes with the beam configuration and span. Therefore, it is more convenient to use efficiency as a way to describe how close a beam is to achieving fully composite action over the slip measurement. Figure 2.4 illustrates the relationship between full, partial, and non-composite action.

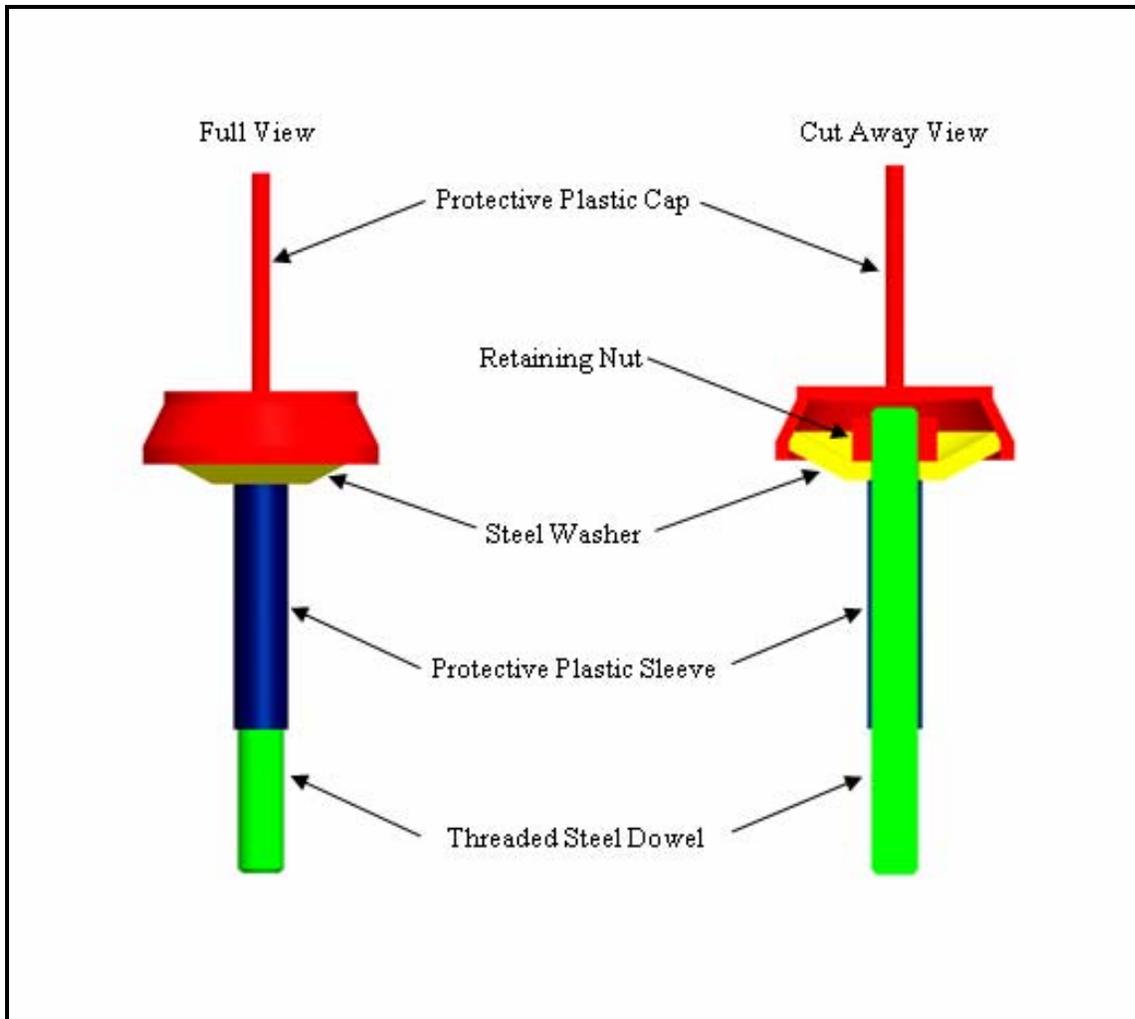
**Figure 2.5** Description of Hilti Dowel Components

A type of connection originally developed by Natterer et al.,<sup>12</sup> which uses a shear key and Hilti dowel anchor, was adapted to this research. The main advantage of this system is that the anchor can be post tensioned after the concrete has been cast and cured. The post tensioning forces the concrete up against the wood ensuring a positive connection and increasing friction between the wood and concrete layer. In a typical installation, there are five pieces to the dowel assembly as shown in Figure 2.5.

The first piece is the protective plastic cap that protects the retaining nut and upper dowel threads from being covered by concrete when the concrete slab is poured over the wood beam (see Figure 2.6). The plastic cap also has a breakaway tab on top attached to the marker so there is easy access to the retaining nut for post tensioning. The washer has an angular shape to help avoid air pockets while the concrete is filling around the dowel.

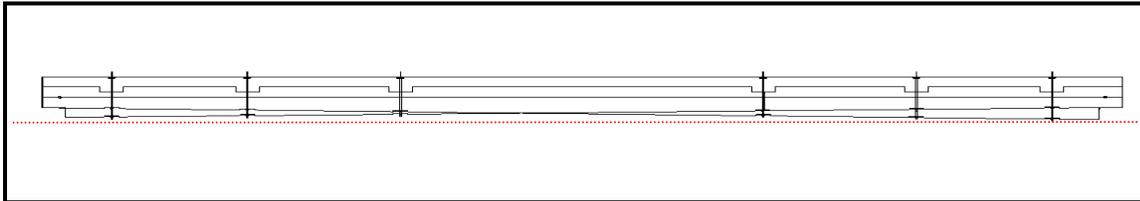
**Figure 3.1** Elevation View of the Wood-Concrete Beam

To overcome the dead load deflection of the beam due to the weight of the concrete and utility poles, it is critical to have camber in the beam. The camber on the underside of the wood-concrete composite beam is natural and comes from the tapered shape of the utility poles and their placement as shown in Figure 3.1.

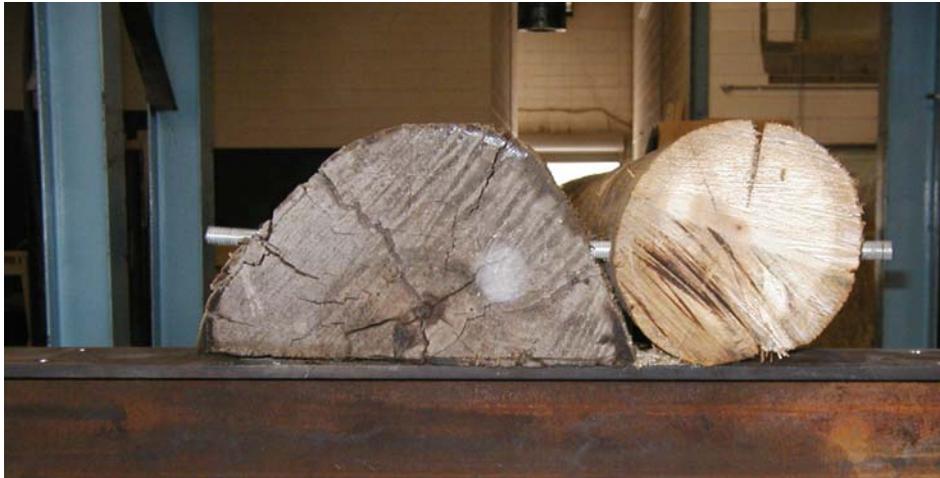
**Figure 3.2** Notch at the Support

To create camber, the tops of the logs are placed level relative to each other so that a natural arching occurs on the underside of the utility poles. However, since the utility poles are different diameters at the ends, a notch in the larger end of the utility poles is created as shown in Figure 3.2. The support notch depth is determined by measuring the difference between the end diameters and cutting the notch to that depth. Measure down from the top of the utility pole and place a mark at a distance equal to the difference in diameters on the end of the utility pole. Using a level, a horizontal line is drawn at the end of the beam. The width of the supports on the load frame is 8 inches, so with a 2-inch overhang at the end of the support a 10-inch long notch is cut. After the notch is cut, the utility pole is rolled over so that the 10-inch notch rests on the support as shown in Figure 3.2 and Figure 3.3.

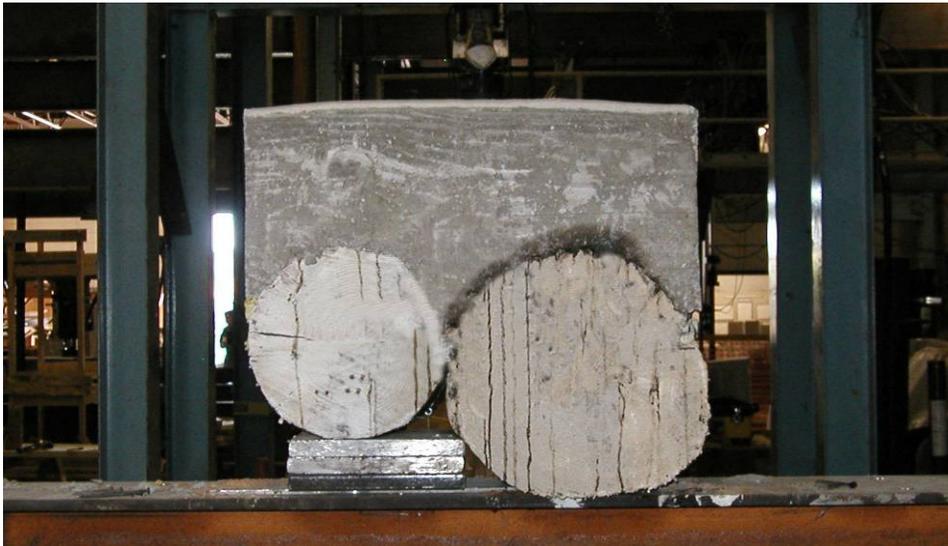
**Figure 3.4** Shim at the Support

Notching the utility poles at the end creates a uniform look, but it may not be the best choice if there are high vertical shear loads at the support. If high shear loads exist at the notch, a better solution is to shim the smaller log so that its top is level with the larger utility pole as shown in Figure 3.4.

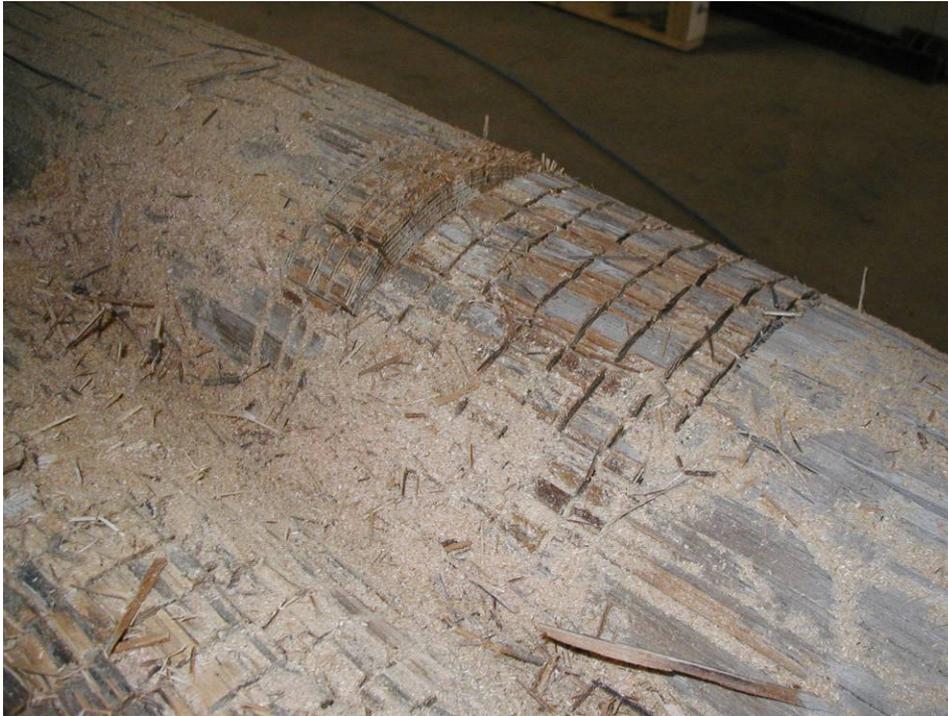
**Figure 3.5** Cutting the Shear Key Notch for the Connection

Next, the twelve shear key notches in the two utility poles are cut. The notch locations are marked at the crest of the utility pole by measuring from the end of the beam. Then a circular saw is set at the notch angle and depth of the notch. Two opposing cuts are made to create the outer dimensions of the notch for the shear key. Then a series of cuts are made between the two outer cuts as shown in Figure 3.5.

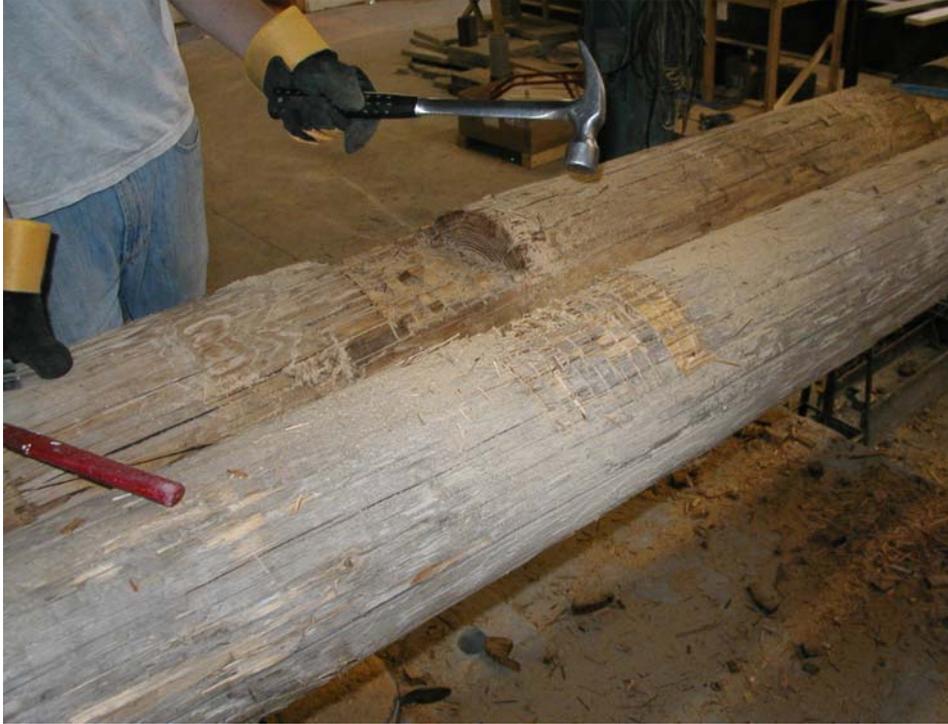
**Figure 3.6** Breaking the Fingers Out of the Notch with a Hammer

It is important to keep the saw level on the round utility pole so that a uniform depth is created along the width of the notch. The wood fingers left from the series of cuts are then being knocked out with a hammer to form the notch as shown in Figure 3.6. Using an air chisel, any remaining material should be removed from the notch (see Figure 3.7).

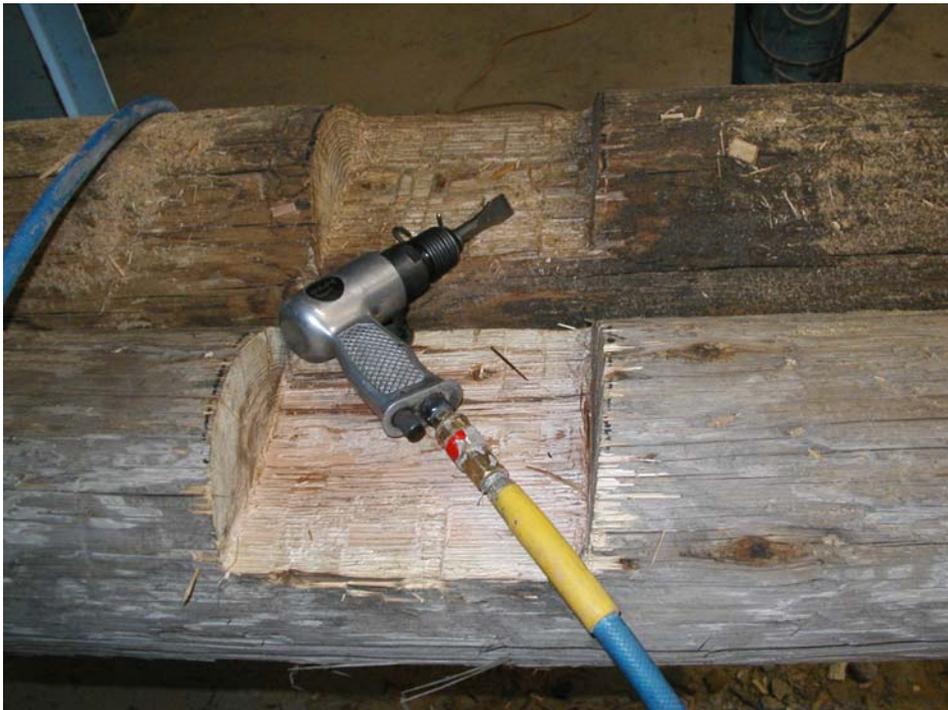
**Figure 3.7** The Finished Notch After Using the Air Chisel

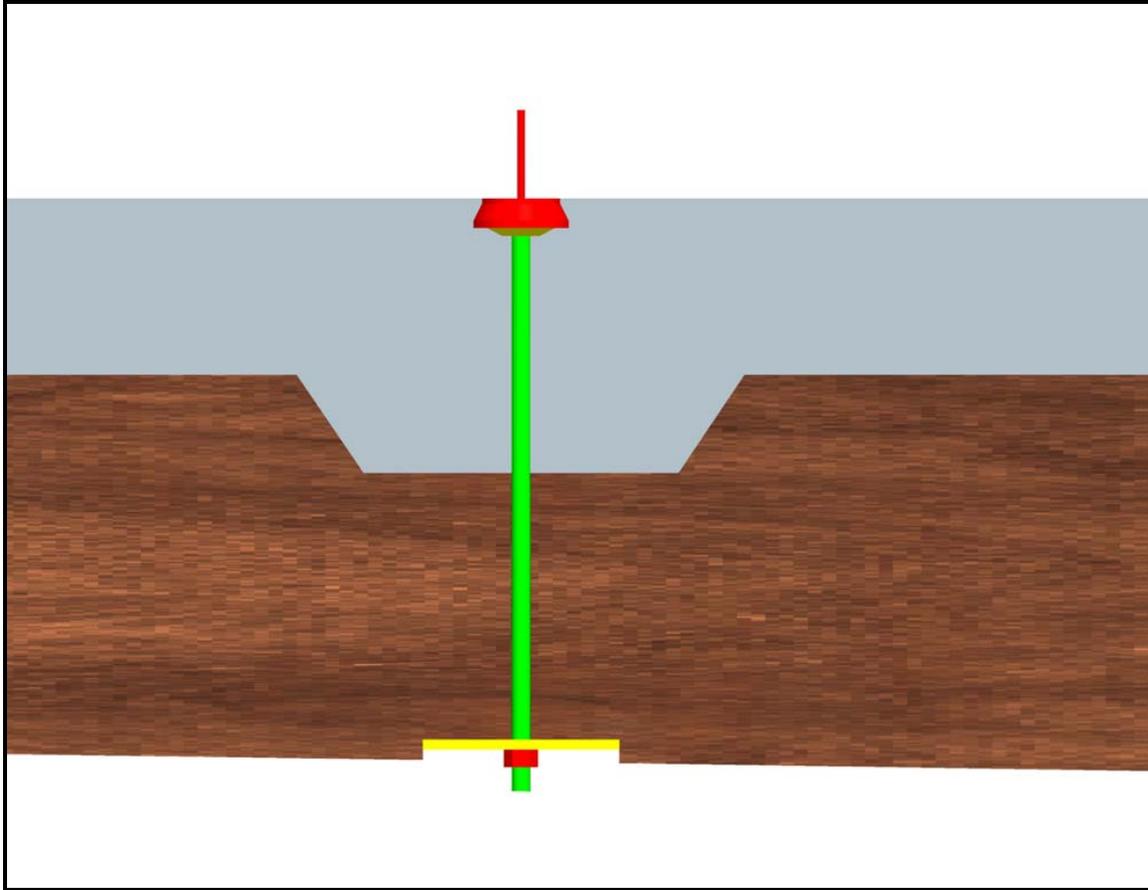
**Figure 3.8** Cross Section of the Shear Key

Next, a hole is drilled 1/16 of an inch greater than the nominal size of the threaded rod in the center of each notch so the Hilti dowel can pass through the center of the utility pole. Using this hole as a guide, a notch for the bearing plate is cut on the underside of the pole to provide a flat bearing surface using the same notching technique described earlier for the shear key notch. A cutaway schematic of the shear key, Hilti dowel, and bearing plate is shown in Figure 3.8.

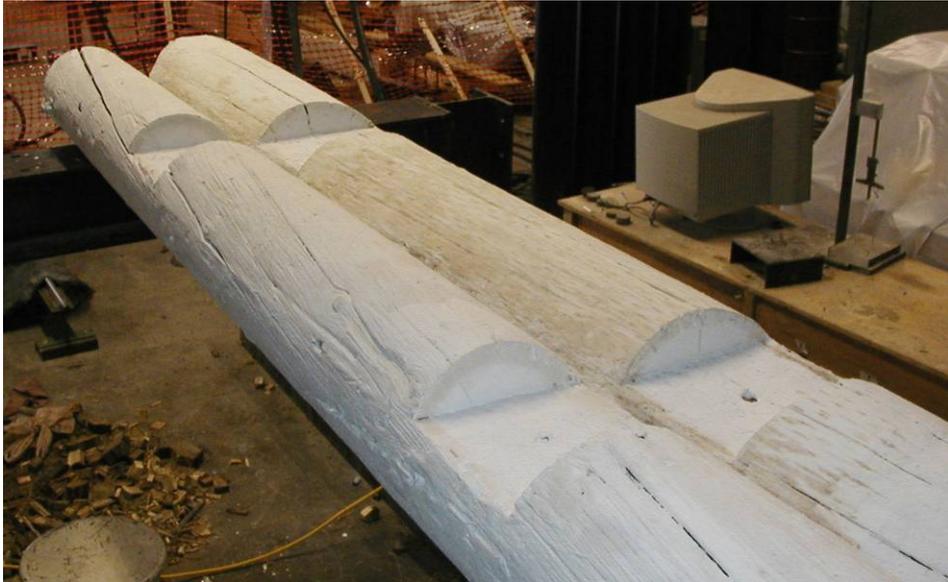
**Figure 3.9** Painted Utility Poles

If concrete was placed directly on the bare wood of the utility poles, the wood fibers would wick away moisture from the concrete causing the concrete to dry cure and the wood to swell. The swelling of the wood from water absorption works against the efficiency of the connection. The main problem occurs when the wood swells and compresses the uncured concrete. When the wood dries and reaches stable moisture content, there is a gap between the wood and the concrete, which adds an initial slip to the beam and a reduced stiffness. To keep the swelling of the wood from occurring, a waterproof paint is applied to the utility poles. UGL Drylock oil based waterproofer has been found to be effective for this situation. Traditionally, Drylock is used to prevent water seepage through basement walls, and it works equally well at preventing water from penetrating the wood. The paint is applied using a roller and brush. However, if a number of poles needed to be painted, an airless sprayer can be used to apply the paint more efficiently. Around the circumference of the utility poles, natural checking from the wood drying over the years caused deep gaps in the wood. If left unsealed, they would allow moisture to enter the utility poles. Therefore, on the top side of the utility poles where the concrete would be in direct contact with the wood, paint was forced into the cracks with a brush to ensure adequate coverage. The painted utility poles are

shown in Figure 3.9. The entire utility pole was painted in an attempt to stabilize the moisture content of the utility poles. This may or may not have been necessary.

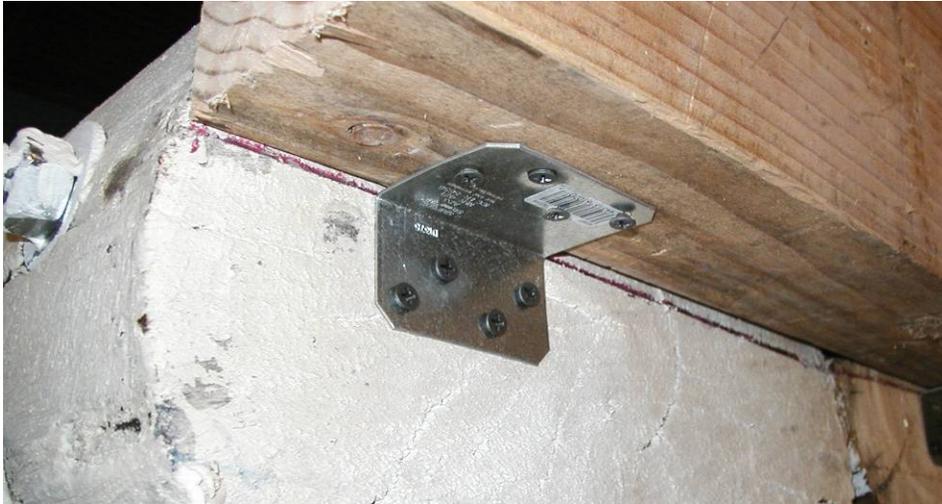
**Figure 3.10** Simpson Model A23

Brackets commercially available from Simpson Strong Tie were used to connect the formwork to the utility poles. Two of the Simpson model number A23 angle connectors were used at each end of the utility poles to hold up the ends of the formwork as shown in Figure 3.10. The forms were constructed of nominal 4" x 12" boards (3½" x 11¼" actual) since this allowed for an 8-inch slab with an 1¼-inch cover over the side of the utility pole. Three-inch long number eight drywall screws with a fine thread were used to attach the Simpson bracket to the utility pole, and 2-inch long number six drywall screws with a fine thread were used to attach the Simpson bracket to the form.

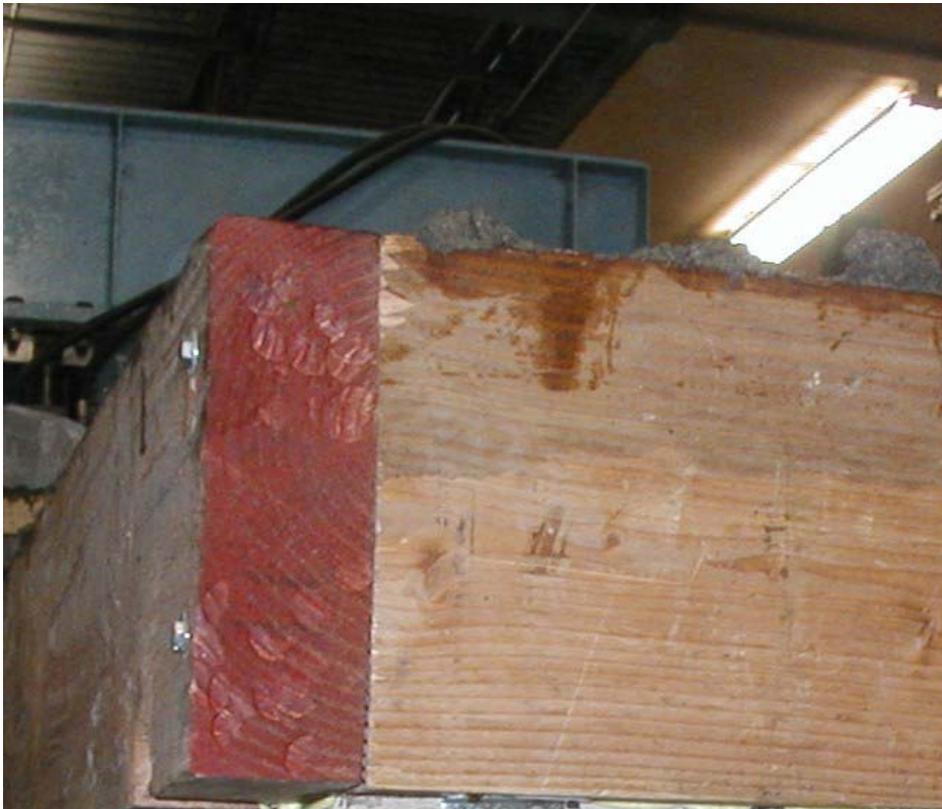
**Figure 3.11** Lag Bolts at the Corner of the Formwork

The corners of the forms were joined horizontally using 3/8" by 8-inch lag bolts. The corner connection of the formwork is shown in Figure 3.11. To keep the lag bolt from binding in the wood, a 3/8" clearance hole was first drilled through the longitudinal form and then a 3/16" pilot hole was drilled in the transverse end form. Two lag bolts were used at each corner spaced three inches from the top and bottom of the form. Angled support brackets were used to support the formwork along the length of the utility pole (see Figure 3.12). They are also manufactured by Simpson Strong Tie and have a model number of LS30. These brackets can be bent to conform to the round shape of the utility pole.

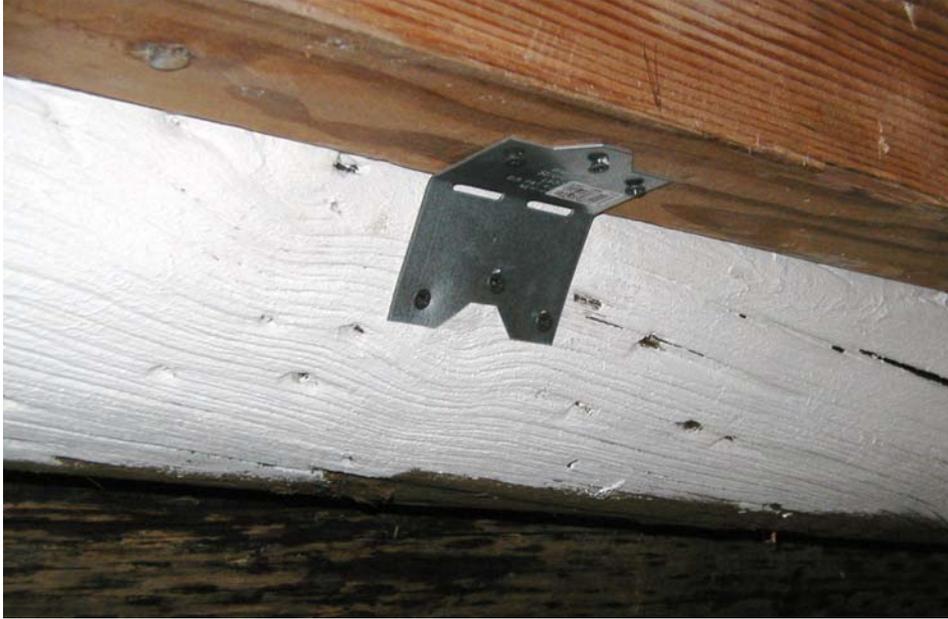
**Figure 3.12** Simpson Angle Bracket Model LS30

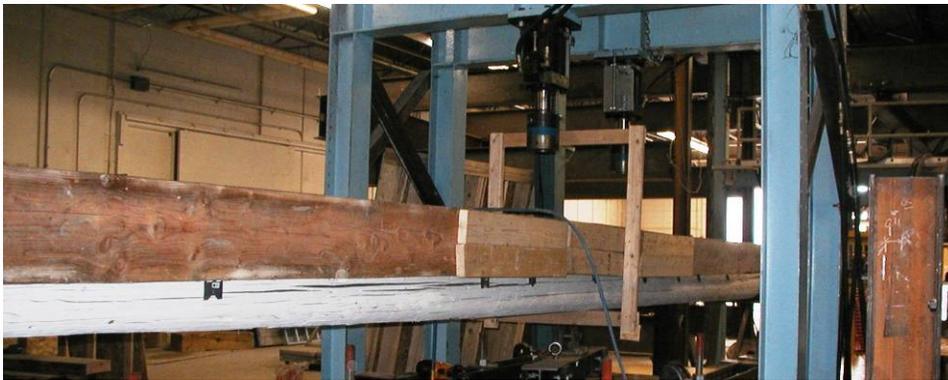
**Figure 3.13** Splice Along the Formwork

The wood boards used for the formwork are only 12 feet long so it was necessary to make splices along the length of the wood-concrete beam. The splices are created by nailing nominal 2X6 boards to the side of the beam. Then a flume brace is used to support the sides of the formwork (see Figure 3.13). Figure 3.14 shows a view inside the form before installing the rebar.

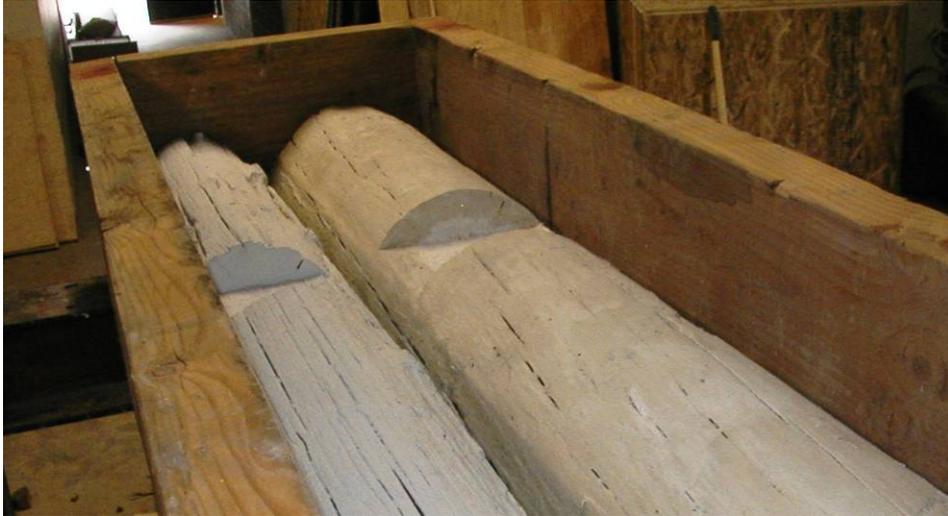
**Figure 3.14** View Inside the Form Before the Rebar is Installed

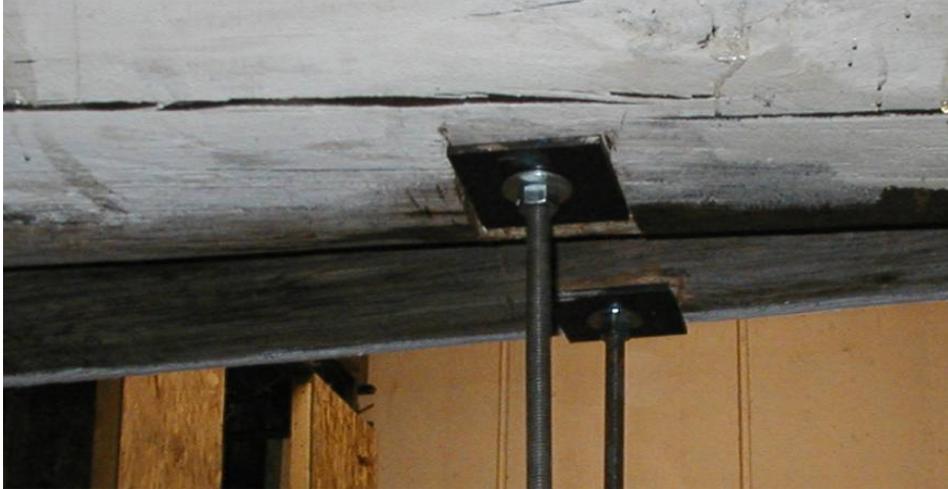
**Figure 3.15** Bearing Plate Assembly

The threaded rod used for the Hilti dowel is cut using an abrasive cutoff wheel, horizontal band saw, or hacksaw. The researchers found it easiest to cut all of the dowels at the same time to the longest required length and then trim any excess below the bearing plate after the concrete has cured. To keep the Hilti dowel's washer tight against the nut, a loop of rebar tie wire is tied to the dowel under the washer. This step keeps the washer and protective cap in the proper position while the concrete is placed in the form. The flat top of the red protective plastic cap should be flush with the top of the forms so that once the concrete has cured, the top of the cap can be removed and the nut torqued to 25 foot-pounds. The access hole is then grouted before the asphalt topping is applied. Once the washer, nut, and protective cap are secured to the threaded rod with rebar tie wire, the assembly is placed in the notch hole drilled earlier and the bearing plate, nut, and washer are secured as shown in Figure 3.15. To keep this entire Hilti dowel assembly from sliding through the hole, another loop of rebar tie wire is placed where the threaded rod enters the notch hole (see Fig. 3.16).

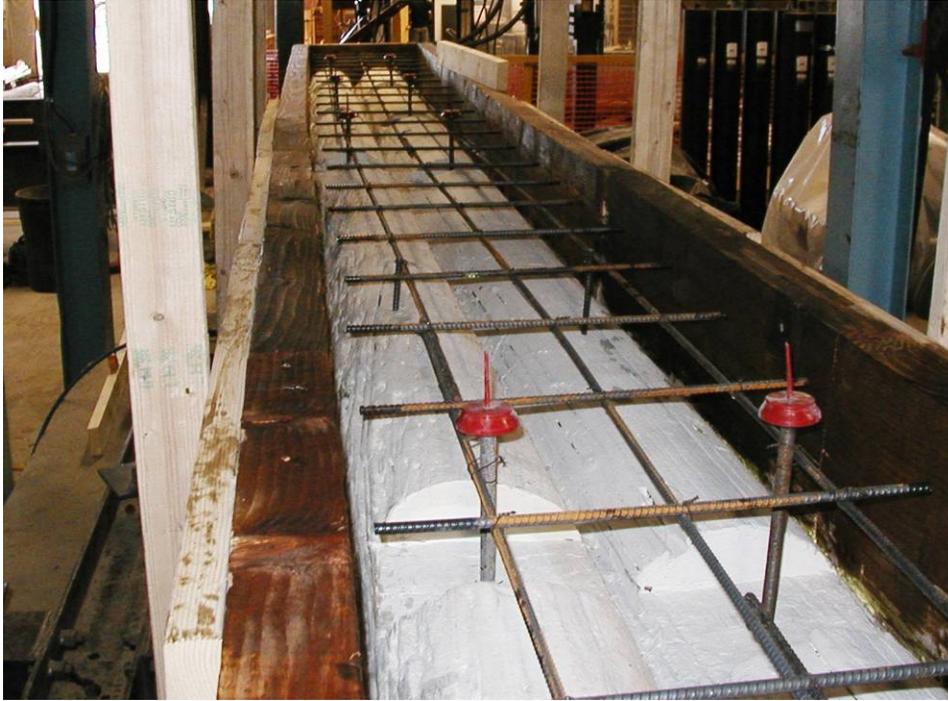
**Figure 3.17** Rebar Layout

In the beam shown in Figure 3.17 there are three longitudinal pieces of rebar shown as they are required to meet the minimum reinforcement requirements. Two pieces of rebar are tied to the Hilti dowels to provide 1.5 inches of cover for the transverse reinforcement that was tied on top of the longitudinal reinforcement. Then the third longitudinal bar is attached below the transverse reinforcement. The third longitudinal bar was placed in the center between the other two longitudinal pieces of rebar to ensure even distribution of the reinforcement. Then the transverse reinforcement is placed. The transverse reinforcement was spaced to meet the ACI design requirements for minimum reinforcement, which requires a #3 bar placed every 7.5 inches on center.

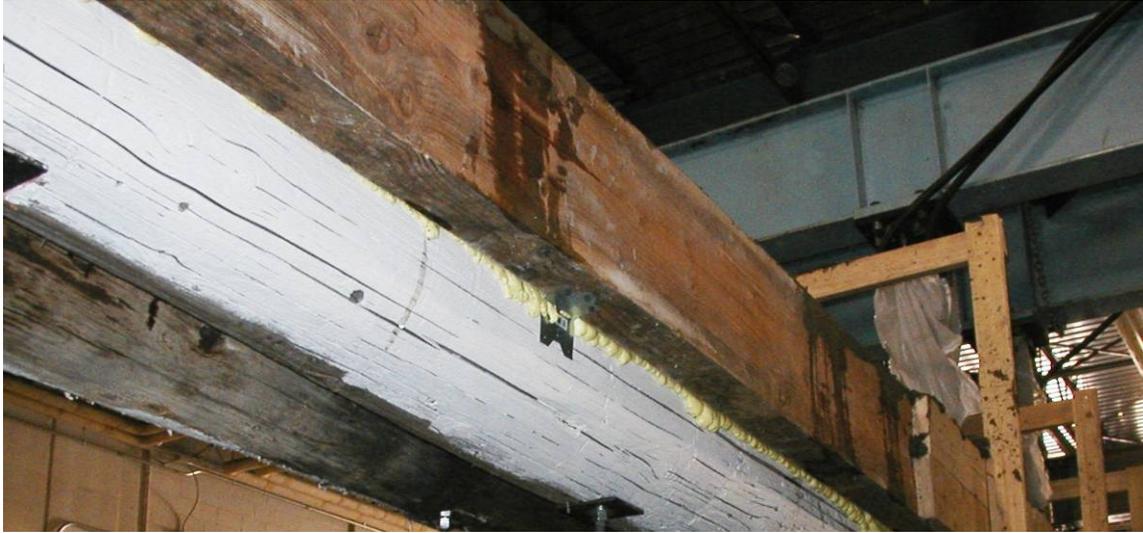
**Figure 3.18** Bottom of the Formwork Showing the Foam Gap Filler

With all of the reinforcement installed, any gaps between the formwork and the utility poles were filled with Great Stuff®, which is an expanding foam sealer used to fill gaps in houses. The foam is waterproof and bonds to anything, which makes it a great product for filling gaps in the forms. Bondo® should not be used to fill the gaps between the utility poles and the formwork since it creates a permanent bond, making the formwork more difficult to remove after the concrete has been placed. Figure 3.8 shows the sealed forms.

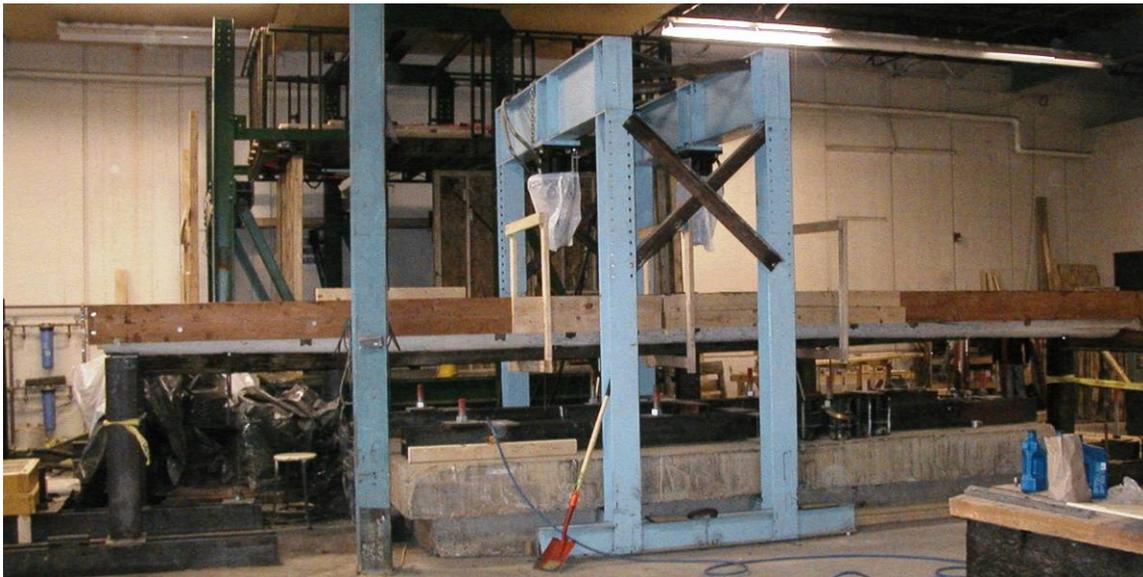
**Figure 3.19** Wood-Concrete Beam and Formwork

The forms were then covered with a release agent. Any commercial release agent will work, but simply spreading used motor oil on the forms worked well. The motor oil fills the pores of the wood to keep the wood from absorbing water from the concrete. Additionally, the oil prevents the concrete from sticking to the formwork, making form removal easy. Figure 3.19 shows the complete beam and formwork ready for concrete placement.

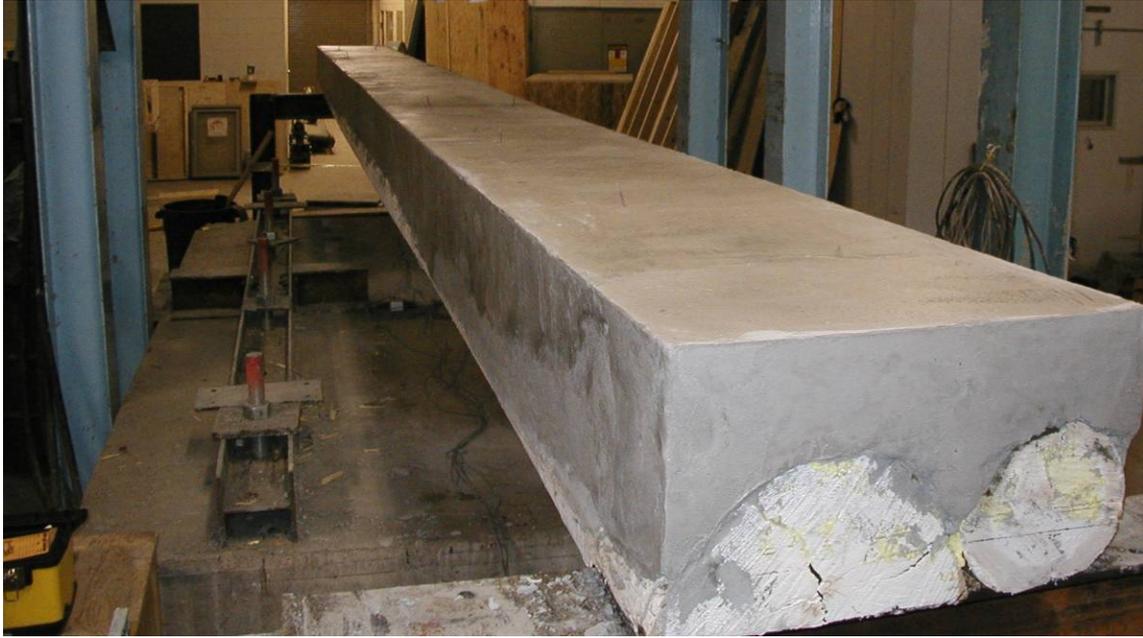
**Figure 3.20** Finished Wood-Concrete Beam

The concrete is placed into the forms with the aid of a Bobcat skid steer loader. After the concrete is cured for one day, the forms are removed to reveal the finished wood-concrete composite utility pole beam shown in Figure 3.20.

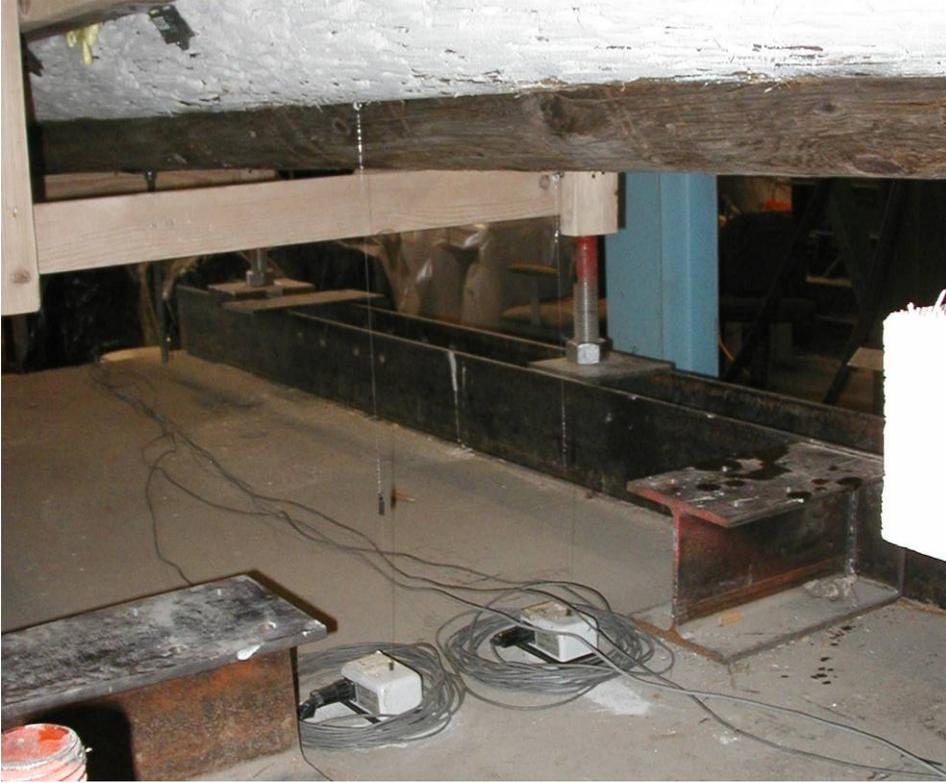
**Figure 3.21** Linear Transducers

It is important to measure the slip between the wood and concrete layer to determine the effectiveness of the shear key. The location of the most slip between the wood and concrete layer is at the end of the beam. Therefore, the researchers configured a fixture able to read the average slip of the two utility poles relative to the concrete. The fixture contains two pieces – the first piece is made of 3/8" plate and attaches directly to the concrete slab using plastic anchors and screws (see Figure 3.22).

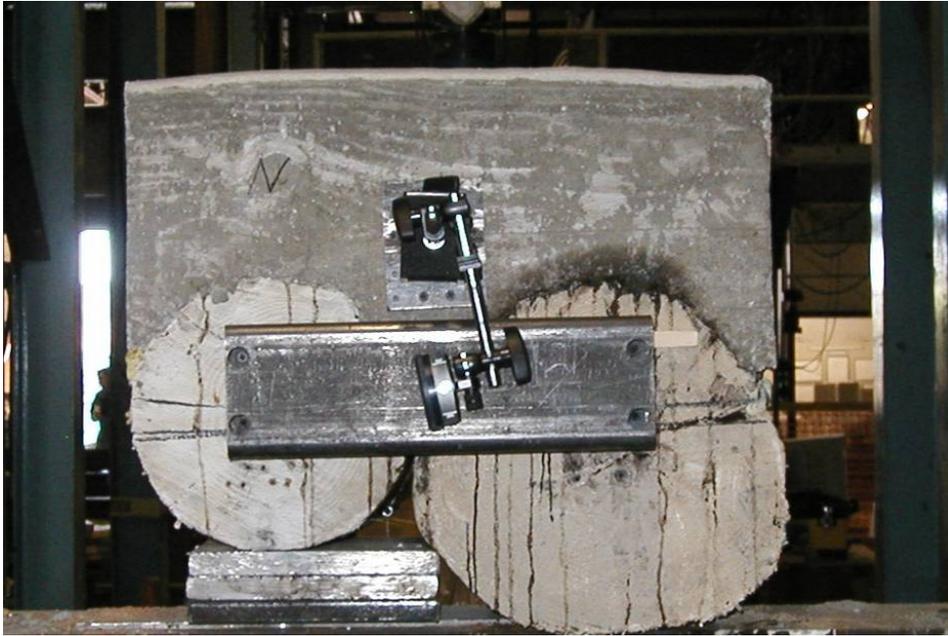
**Figure 3.22** Slip Measurement Fixture End View

The second piece of the fixture is a piece of two by four by quarter inch wall tubing that is welded to two one inch stand offs and is screwed to the back of the utility poles using three inch number eight drywall screws. Then a magnetic base is mounted to the steel plate attached to the concrete. This magnetic base was special-made to hold a dial indicator rigidly in any position. The Mitutoyo dial indicator used to take the relative measurements between the wood and concrete has an accuracy of 0.0001 inches and a range of one-half inch. With the indicator mounted to the magnetic base as shown in Figure 3.23, the indicator will read backwards since the concrete is moving away from the wood.

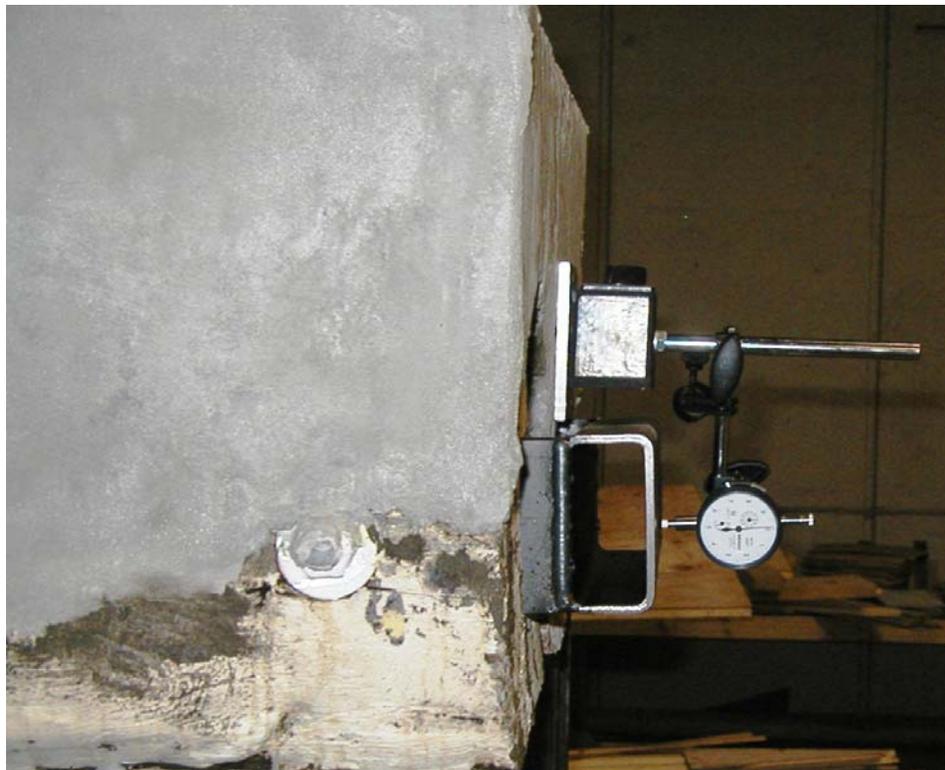
**Figure 3.23** Slip Measurement Fixture Side View

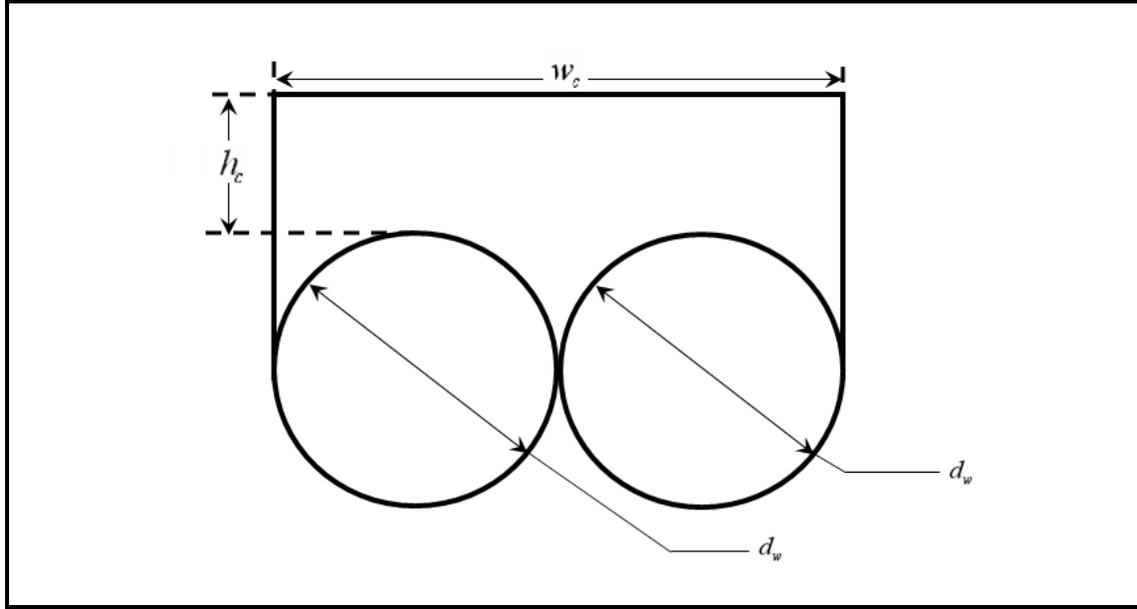
**Figure 4.1** Wood-Concrete Beam Cross Section

Two wood-concrete composite beams were constructed of utility poles and load tested to failure by placing the beam in three-point bending. The general cross section of the beams is shown in Figure 4.1 and the dimensions of Wood-Concrete Beam 1 and Wood Concrete Beam 2 are listed in Table 4.1. This cross-section represents a typical cut from a much wider complete longitudinal deck bridge.

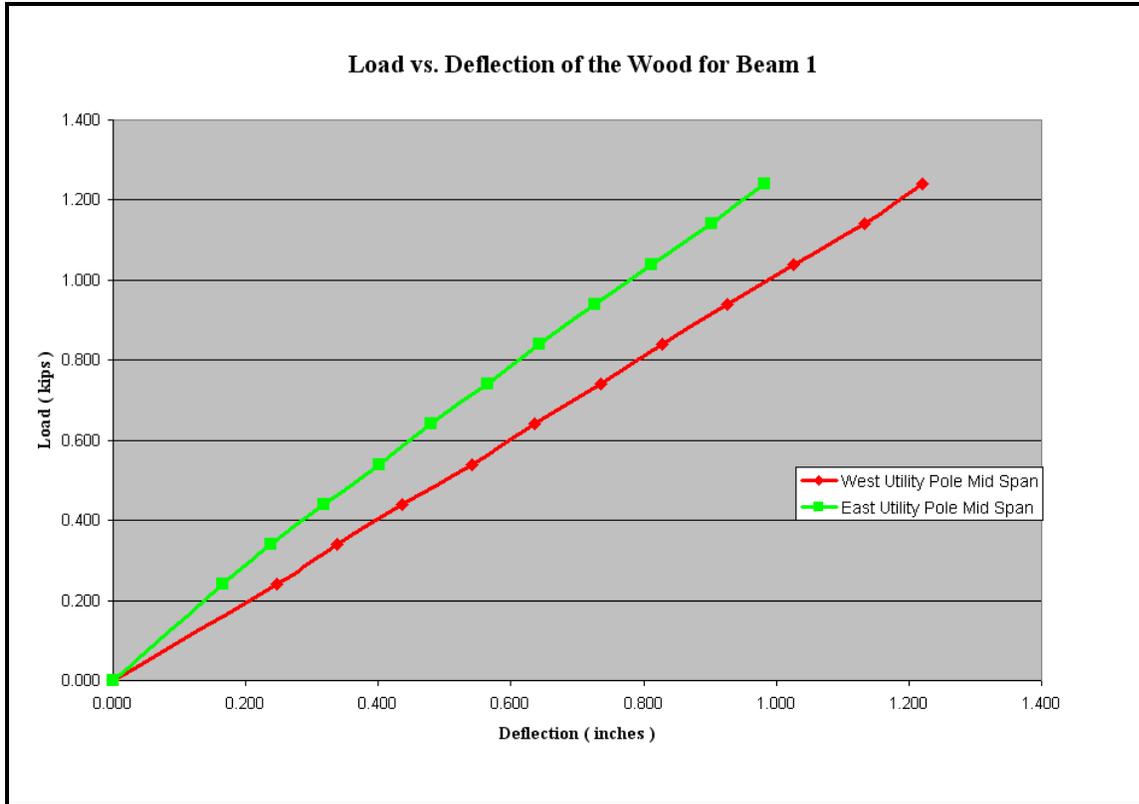
**Figure 4.2** Load vs. Deflection of the Wood – Beam 1

is Ponderosa Pine and the west utility pole is Western Red Cedar. It is evident from the load versus deflection curve in Figure 4.2 that there is a variance in the stiffness of the two utility poles. The modulus of elasticity values determined from the load tests were 1,255 ksi and 958 ksi for the east and west utility poles.
