**LOAD TESTING OF WOOD-CONCRETE BEAMS INCORPORATING  
RECYCLED UTILITY POLES**

**Matthew R. LeBorgne**

**April 2008**

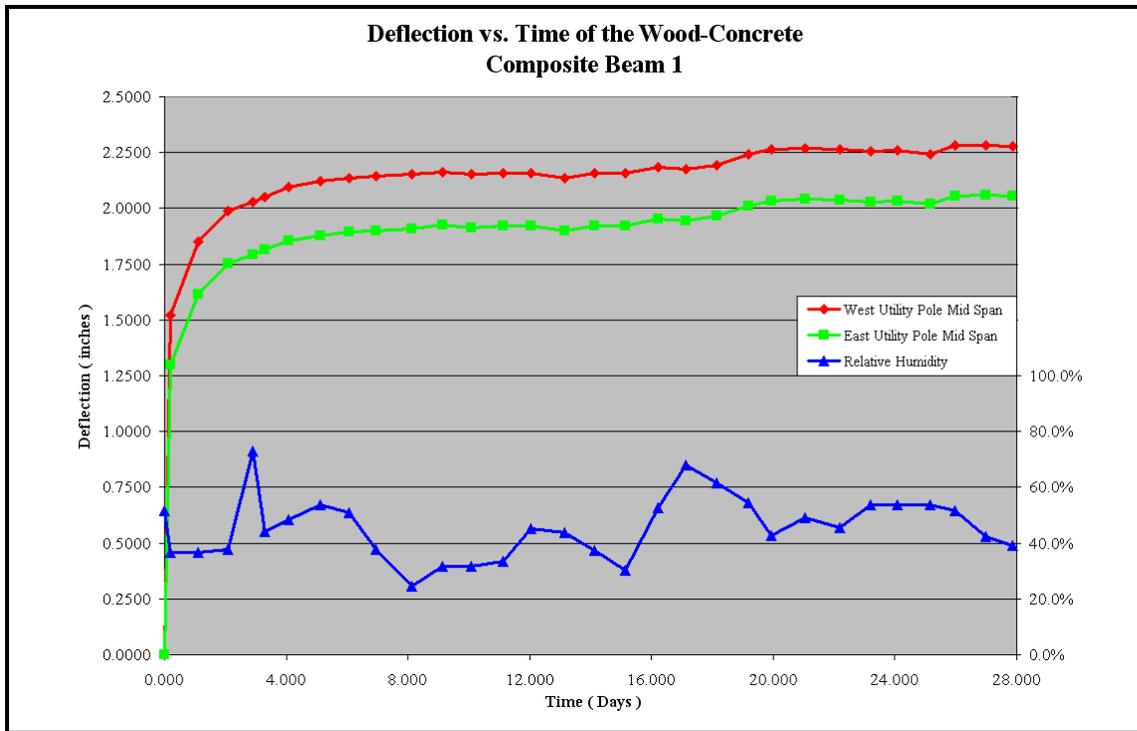
**Figure 4.3** Deflection vs. Time – Beam 1

After determining the modulus of elasticity of each utility pole, the concrete layer was placed. The support and mid-span deflections of the beam under its own dead weight were monitored over a 28-day period as the concrete cured. The relative humidity was also monitored using data from the Chrisman Field Weather Station, which is located a quarter mile from the laboratory where the load tests were performed. Figure 4.3 shows the resulting mid span deflection (adjusted for support effects) for the entire 28 day period of curing and the trend in relative humidity. In Fig. 4.3, the datum point at time zero is the point before any concrete was added to the beam. The next datum point at 0.2 days is the initial deflection more or less immediately after the concrete was added. The points up to the 28<sup>th</sup> day show the movement of the beam due to the time-dependent effects of shrinkage of the concrete, creep of the concrete, creep of the wood, and fluctuations in relative humidity. It is evident that at the time the concrete was placed in the formwork the west utility pole deflected more than the east utility pole. This is due to the lower modulus of elasticity of the west utility pole. Once the curing process began to harden the concrete, the two utility poles were bonded to the concrete slab and deflected in unison.

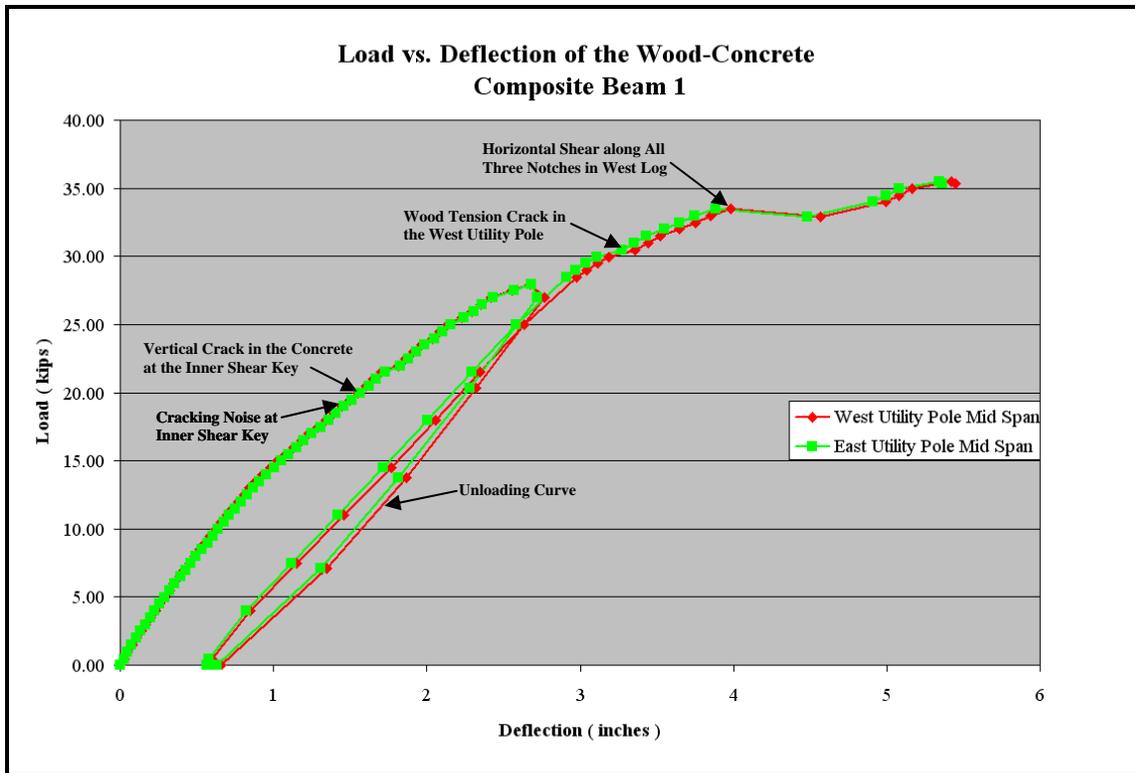
**Figure 4.4** Ultimate Strength Test – Beam 1

Immediately after the 28-day curing period, the wood-concrete beam was ramp loaded at mid span to observe the beam’s ultimate load capacity in a point load configuration. The load was applied at mid span using a spreader beam to distribute the load over the wood-concrete beam’s width. A pivot point was centered above the spreader beam so that if the utility poles deflected by different amounts, a uniform load distribution across the width of the beam could still be maintained. Figure 4.4 shows the results of the load test after adjusting for support effects. Graphs of load-deflection responses of the two wood-concrete beam specimens without adjustments for end support deflections are included in Appendix A. Hereafter, all graphs shown will have that adjustment already included.

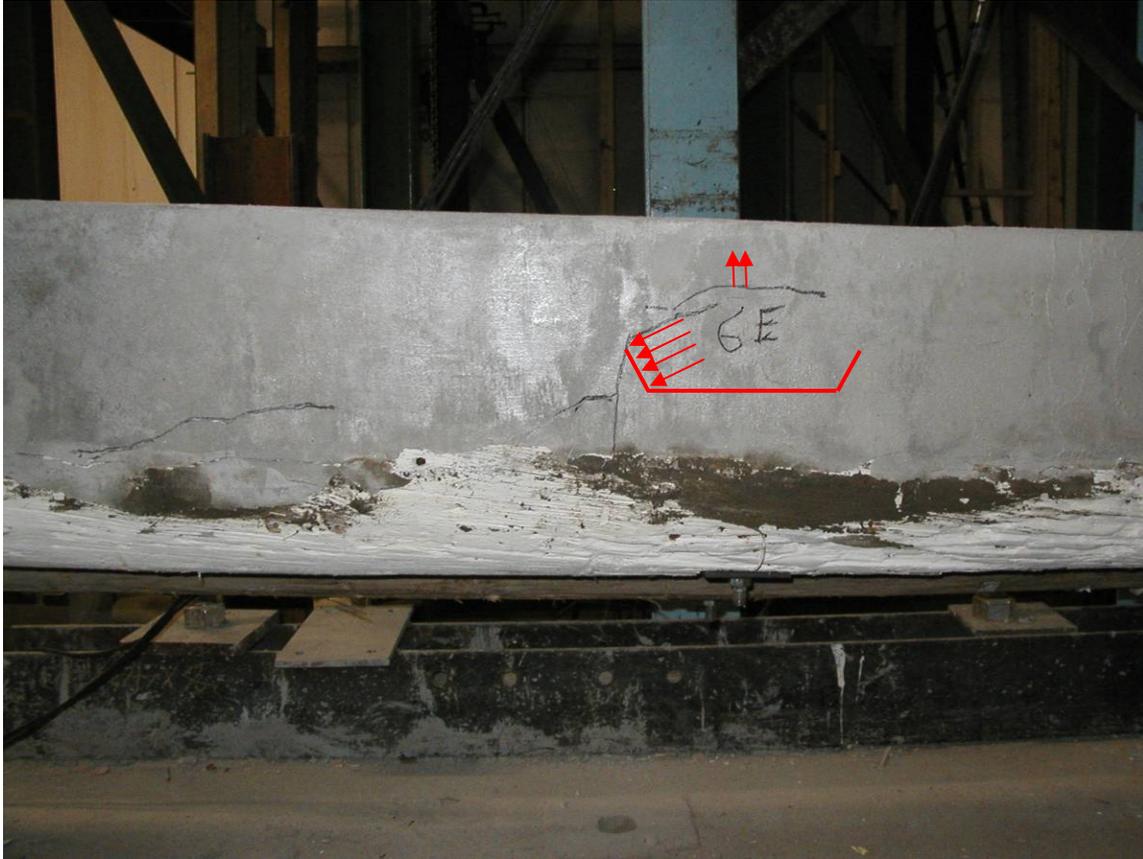
**Figure 4.5** Cracking on the Decompression Side of the Inner Notch – Beam 1

It is evident that once the concrete had cured, the two utility poles deflected together under load. The sequence of events that lead to the first noticeable failure of the beam began with flexural cracking at the inner most shear key. At 19.48 kips, there was an audible cracking noise coming from the wood at the inner shear key as shown in Figure 4.4. Then, at 20.55 kips, the concrete at the inner notch began cracking on the unloaded side of the shear key. This created the hooked flexural crack drawn in black and shown in Figure 4.5. For purposes of identification, the notch position and direction of forces acting on the shear key notch and Hilti dowel are drawn over the concrete.

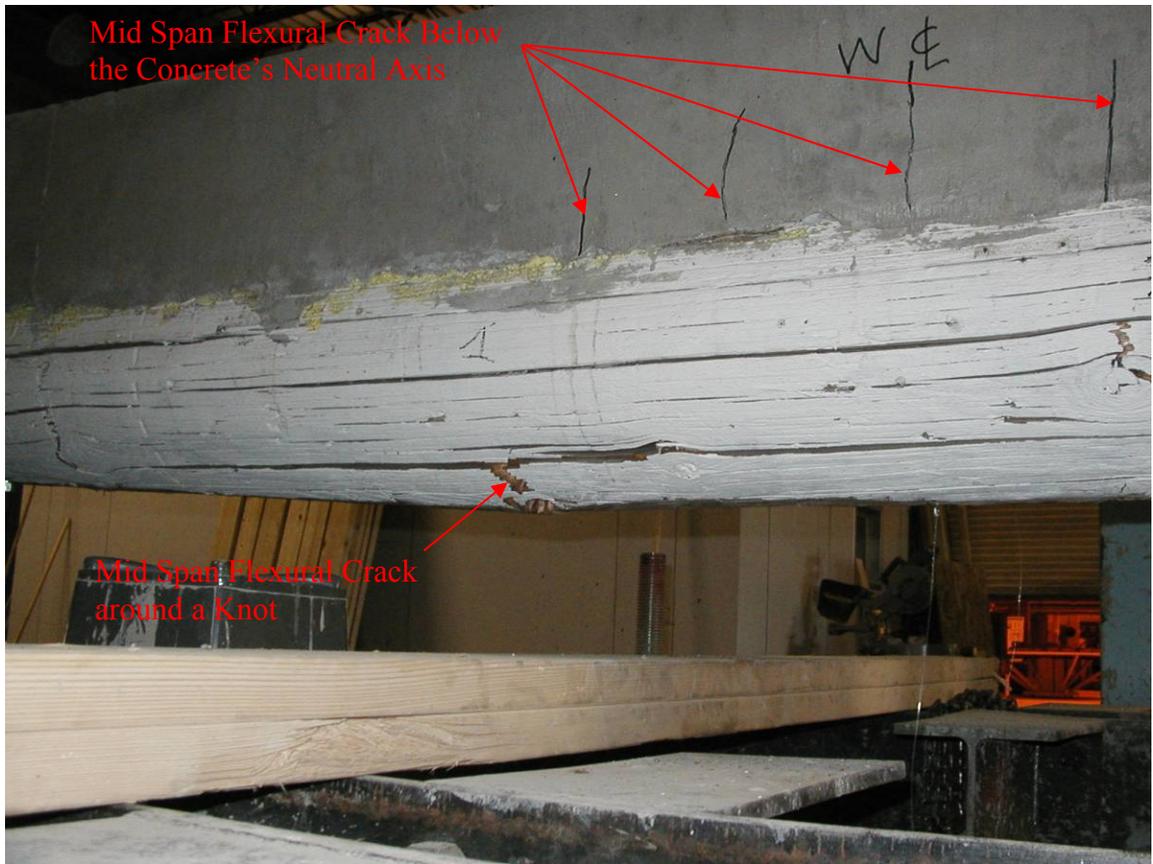
**Figure 4.6** Flexure Crack at Mid Span in the West Utility Pole – Beam 1

At 27.98 kips, the load was removed from the beam so that an unloading curve could be plotted, providing a graphical representation of how much stiffness the beam would have after being loaded to 1.7 times its factored design load capacity.<sup>19</sup> It can be seen that the beam had a residual deflection of 0.566 inches at mid span after having deflected 2.68 inches at the 27.98 kips load level. The ramp loading back up to 27.55 kips was uneventful. However, at 30.48 kips, a flexural crack in the lower tensile fiber of the beam formed around a knot 12 inches from the mid span of the beam (see Figure 4.6). Vertical flexural cracks also appeared at the mid span of the beam below the neutral axis of the concrete.

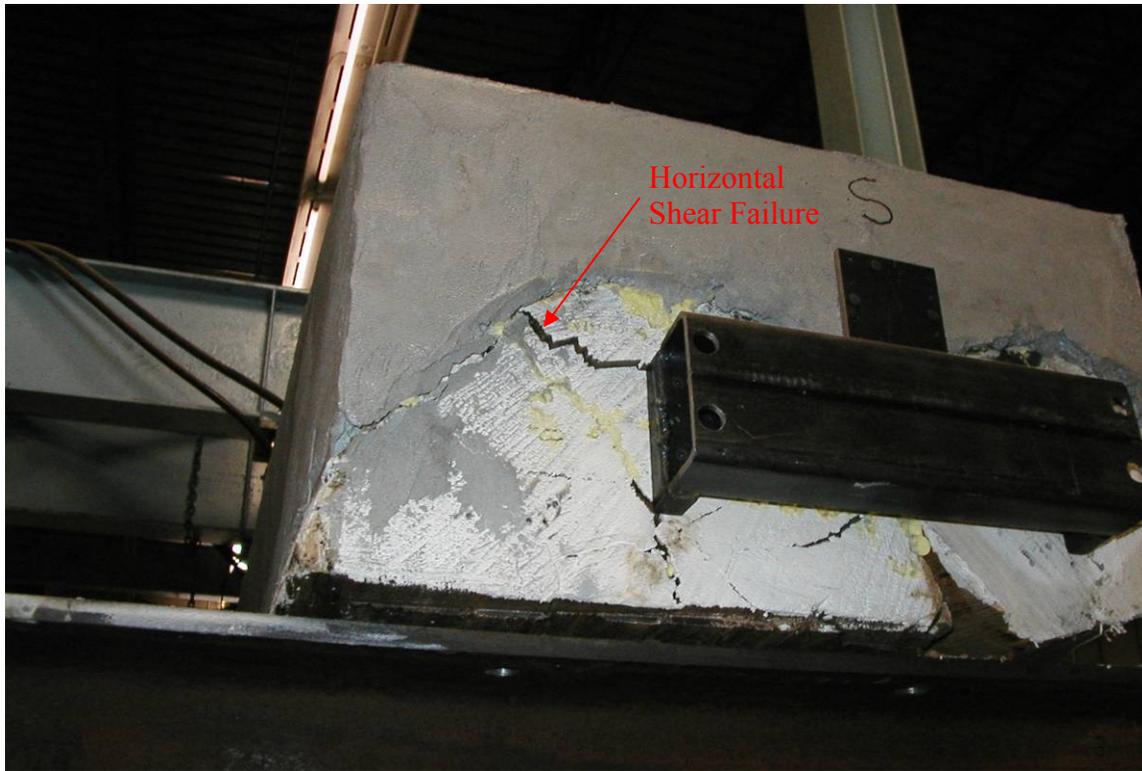
**Figure 4.7** Horizontal Shear Failure in the West Utility Pole – Beam 1

At 33.48 kips, the west utility pole experienced a block shear failure at the south end as shown in Fig. 4.7. As only the end of the utility pole was visible, it is not known if this crack extended only to the first notch or affected the other notches. When the shear failure occurred, the beam lost stiffness, causing the beam to deflect 1.48 inches with only a 2-kip increase in load. Once the beam reached a maximum deflection of 5.45 inches, the actuator travel was fully exhausted and the loading ceased.

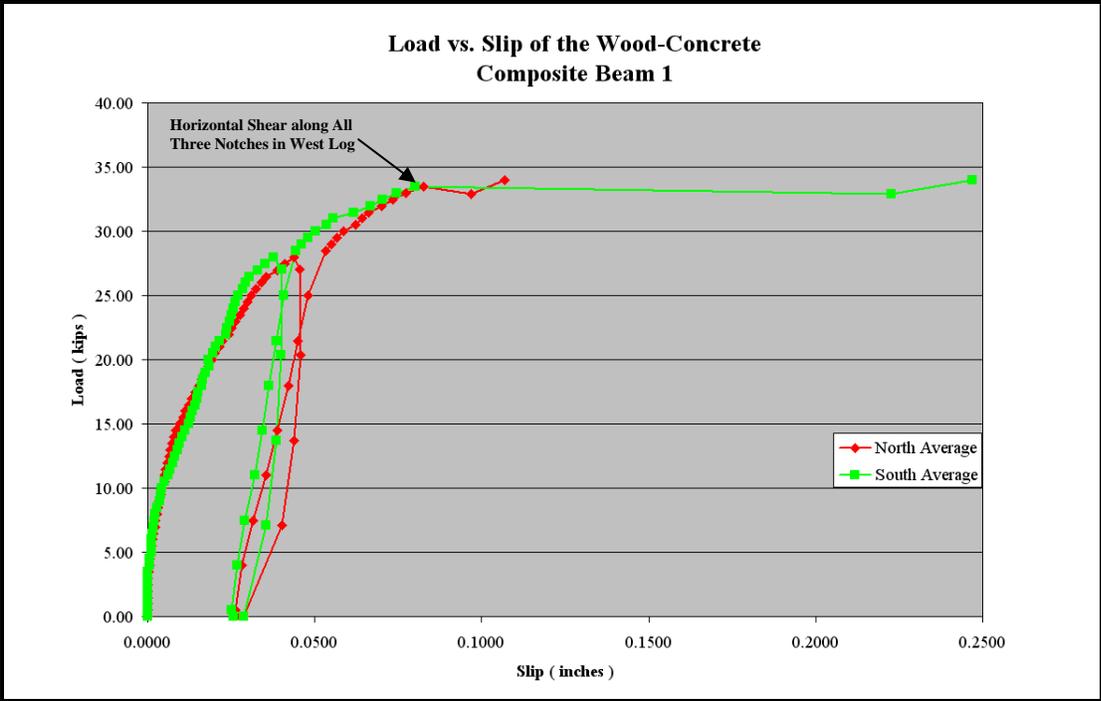
**Figure 4.8** Load vs. Slip for Ultimate Strength Test– Beam 1

Slip at each end of the wood-concrete beam was measured using the fixture discussed in Chapter 3 and was plotted versus load as shown in Figure 4.8. The behavior of the shear keys is more apparent by enlarging the left-most portion of the plot (see Figure 4.9). From Figure 4.9 it is seen that up to 10 kips of loading, the slip was essentially the same at both ends of the beam, but beyond this load level, the slip was different at each end. Between the 11 kip and 19 kip load levels, the south end slip was higher than that of the north end. Beyond 19 kips, the north end slip was higher than that of the south end.

Beyond 19 kips of loading, the north end slips at a greater rate than the south end. Then at 33.48 kips (see Fig. 4.8), just as the north and south end slips were converging, the shear failure of the west side utility pole occurred, causing the slip on the south side of the beam to jump from 0.0800 inches to 0.2468 inches.

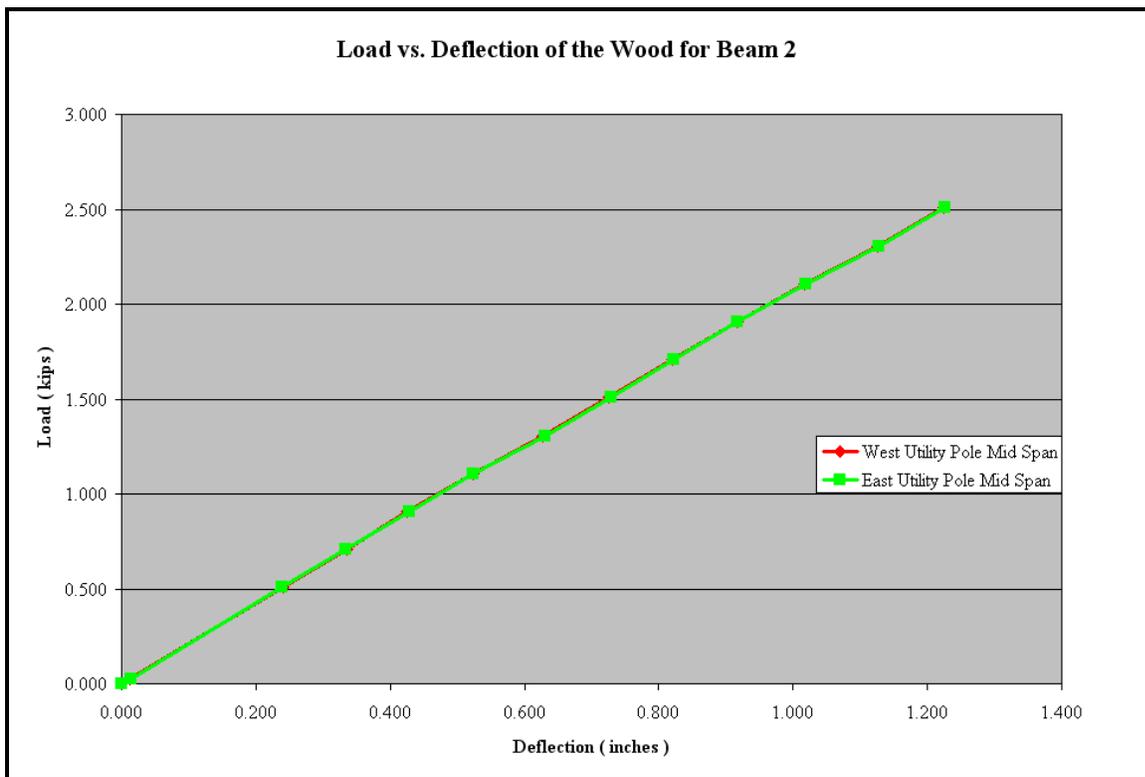
**Figure 4.10** Load vs. Deflection of the Wood – Beam 2

The modulus of elasticity of the second beam was determined in a similar manner to the first beam. After the ends were pinned, a single actuator load was applied to the beam at mid span to determine the modulus of elasticity of each utility pole. Again, at this time there were no shear key notches or support notches cut into the utility poles. Figure 4.10 shows the load versus deflection graphs for the mid span deflections of the two utility poles.

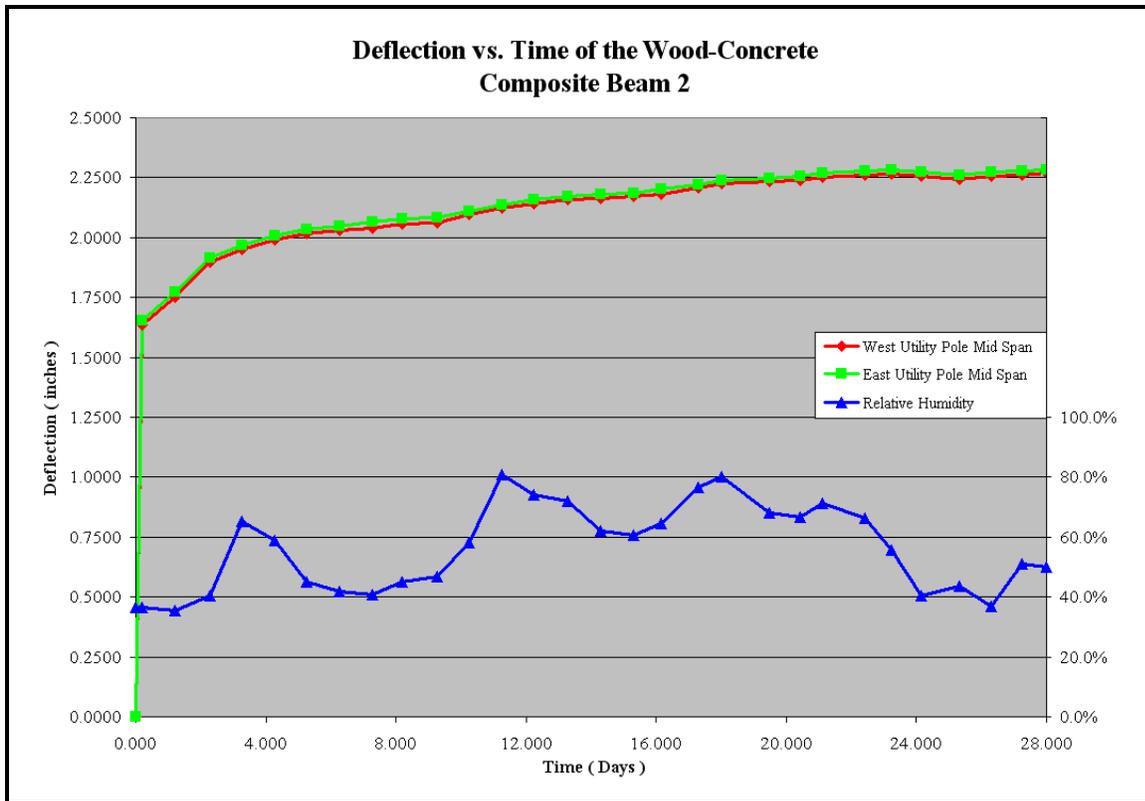
**Figure 4.11** Deflection vs. Time – Beam 2

It is evident from Figure 4.11 that between day 17 and day 22 the relative humidity (typically 40% or lower) was high for Fort Collins, Colorado, during the summer. This caused the beam to relax as evident by the increase in the rate of deflection over this period. Yet, when the relative humidity decreased to 40% on the twenty-fourth day, the beam began recovering stiffness. The rebound of the beam from the decrease in humidity was 0.0211 inches.

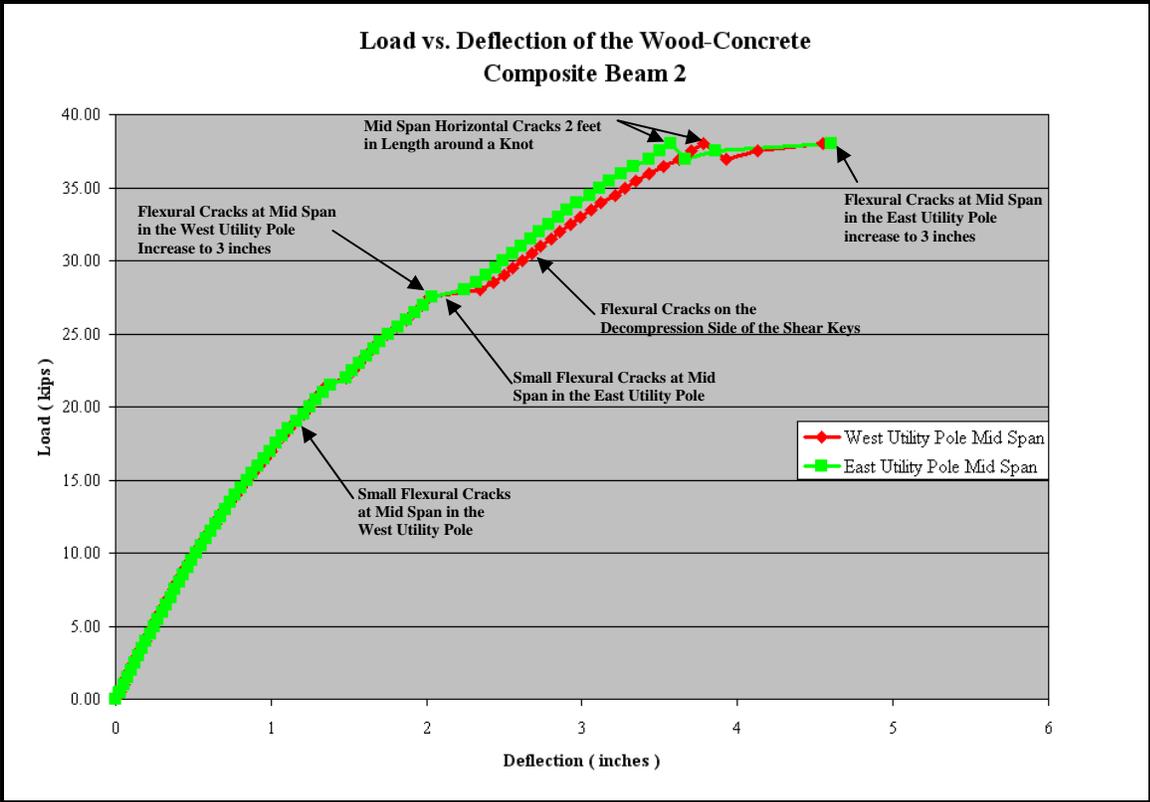
**Figure 4.12** Ultimate Strength Test – Beam 2

Wood-Concrete Composite Beam 2 was loaded with a point load at mid span to find its ultimate load capacity using the spreader beam to distribute the load across the width of the beam in the same way as Wood-Concrete Composite Beam 1. Figure 4.12 shows a graph of load versus mid span deflection. The first event that led to a noticeable failure event occurred at a load of 18.98 kips when a mid span flexural crack in the wood of the west utility pole occurred on the tension face near a two-inch knot, causing a small vertical crack. At a load of 27.48 kips, this mid span crack in the west utility pole suddenly grew to three inches in length, and a 14-inch horizontal crack began propagating as shown in Figure 4.13. Once the west utility pole deflected, it placed a higher stress on the east utility pole, causing a small vertical crack to form at mid span.

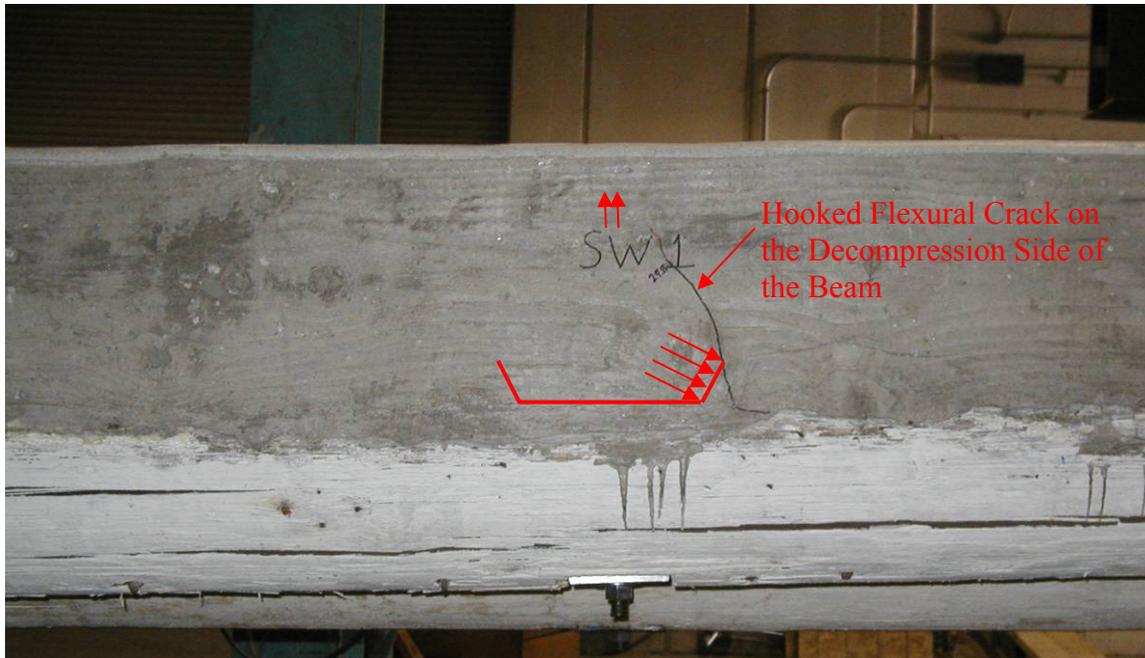
**Figure 4.14** Cracking on the Decompression Side of the Notch – Beam 2

At 30.48 kips, flexural cracks on the decompression side of the notches began to form as shown in Figure 4.14. The crack shape at all six shear keys was similar. Each crack formed a hooked shape that curved over the base of the notch. The general direction of the forces of the concrete bearing on the wood is drawn in Figure 4.14. In this image, mid span is toward the left of the figure and the south support is toward the right side. At these high loads, vertical cracks at mid span can also be seen (see Figure 4.15). The vertical cracks extended up to the neutral axis of the wood-concrete composite beam.

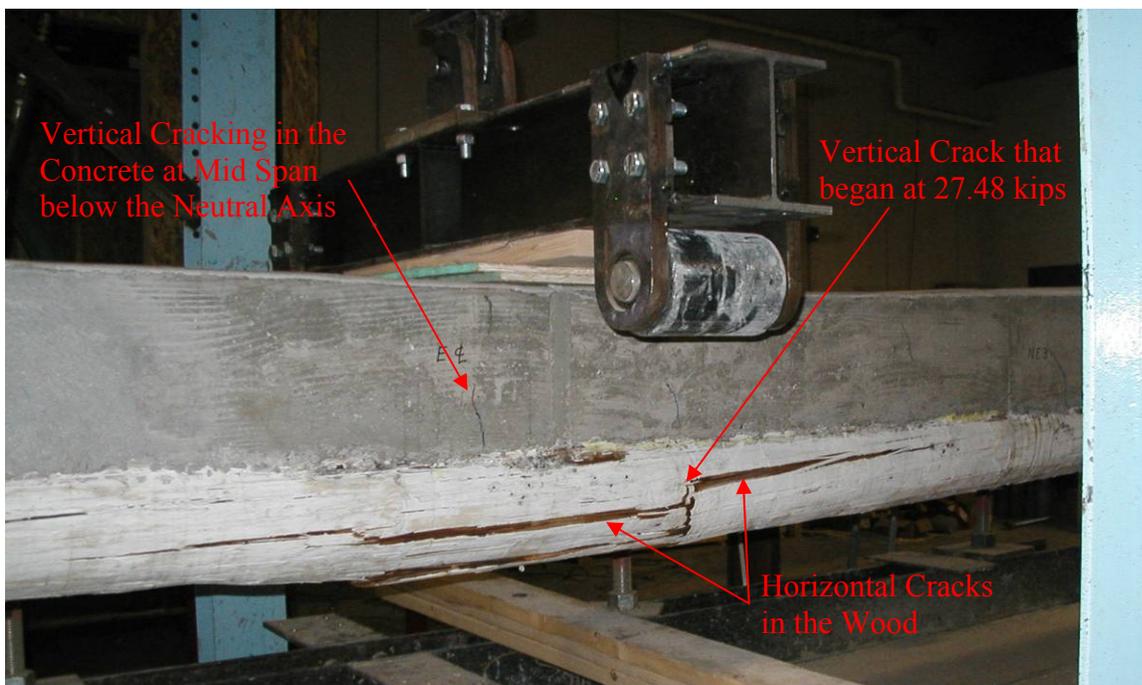
**Figure 4.15** Horizontal Cracks in the East Utility Pole at Mid Span

At 37.55 kips, the high tensile and flexure stress in the wood caused a two-foot horizontal crack at mid span on either side of the vertical crack (see Figure 4.15). These horizontal cracks weakened the specimen, causing 37.55 kips to be the maximum load that the second beam would accept. Additional attempts to apply more load to the beam resulted in an increased deflection of the beam with little increase in load as evident in Figure 4.12. The final failure was a three-inch vertical crack and tear out of the tensile face of the wood as shown in Figure 4.15.

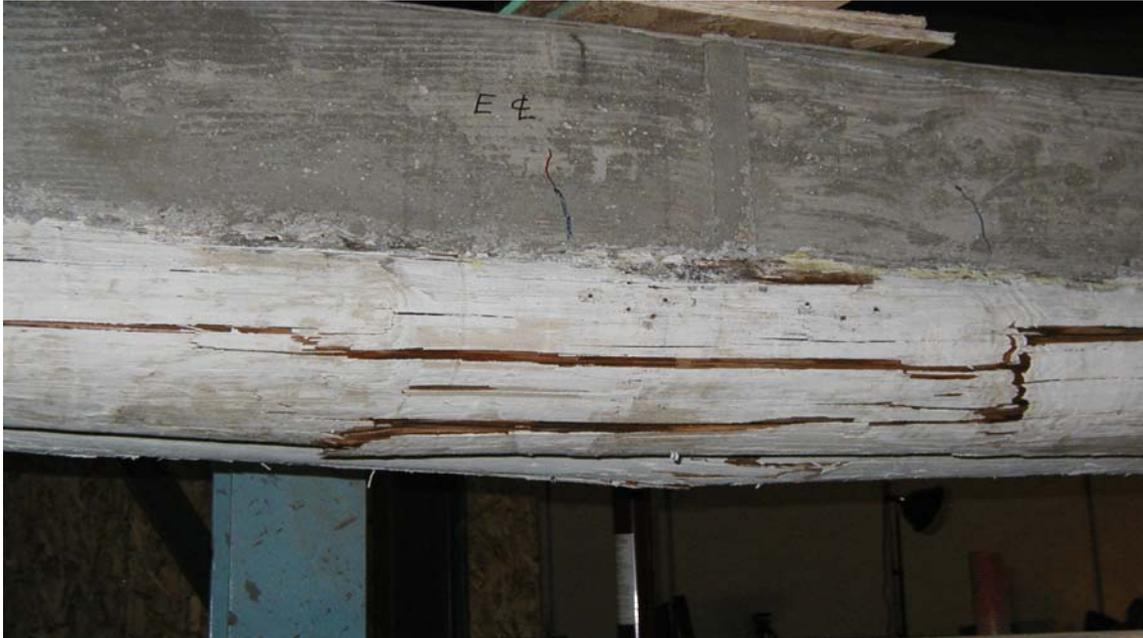
**Figure 4.16** Tear out of the Tension Face – Beam 2

to the north end. It should be noted that the specimen did not exhibit a block shear failure in wood along the notch plane as had occurred in Wood-Concrete Composite Beam 1.

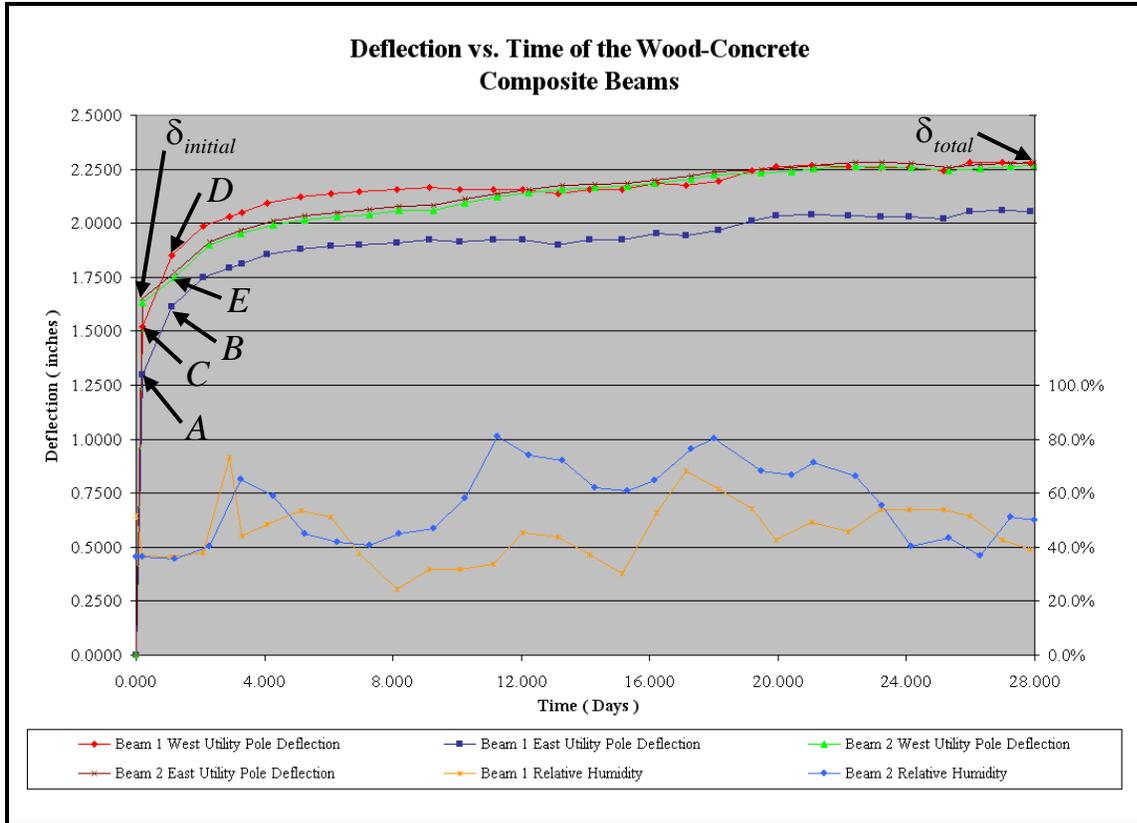
**Figure 5.1** Mid Span Deflection versus Time for Wood-Concrete Composite Beams 1 and 2

This section describes a simplified computational procedure developed to predict the deflection of a wood-concrete composite beam over its 28-day curing period. Figure 5.1 shows the data obtained in that period. The trend in relative humidity is also included.

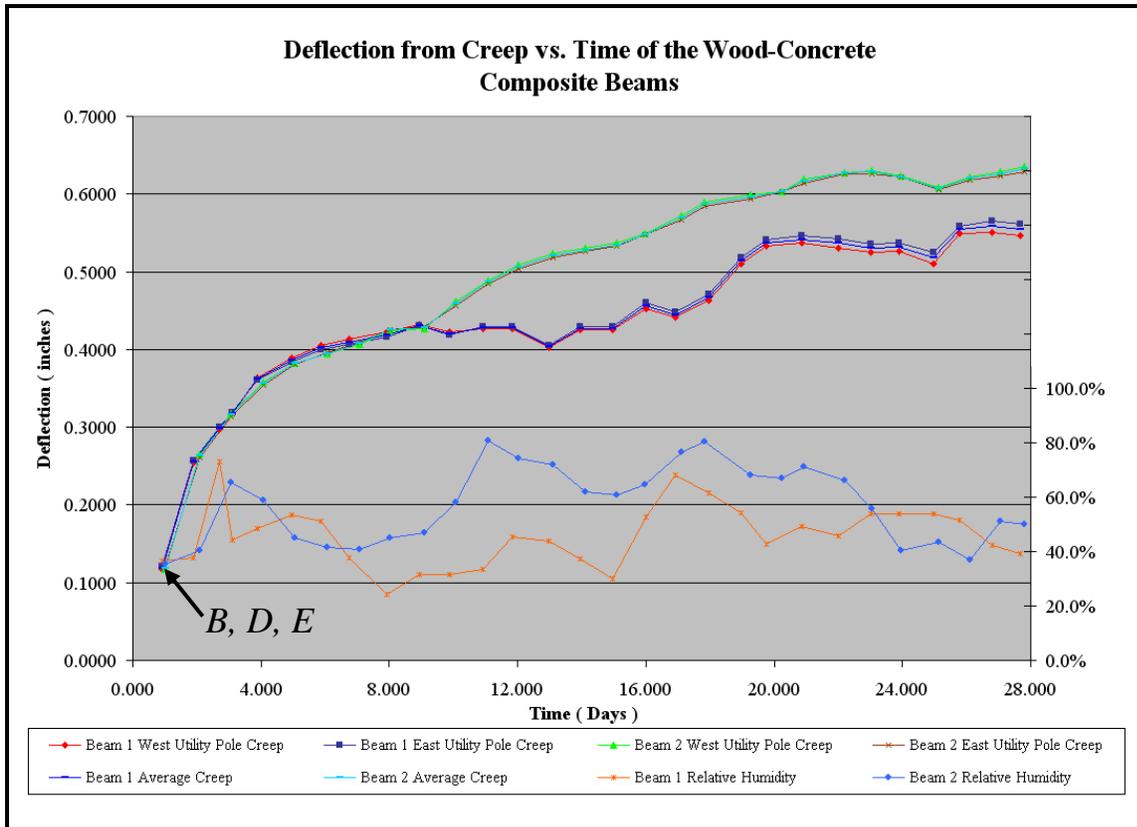
**Figure 5.2** Mid-Span Deflection from Creep versus Time

Recall that the two utility poles of Wood-Concrete Composite Beam 1 were of different species, which is primarily why they had different initial deflections. Once the concrete layer hardened enough, the resulting rigidity of the layer constrained the two utility poles to deflect in unison. Therefore, to account for that condition, the graph of the west utility pole was shifted downward toward the graph of the east utility pole so that points B and D coincide. Then the coincident points B and D of Fig. 5.1 were shifted up to point E of Fig. 5.1. The resulting point is the datum for the deflection versus time graphs shown in Figure 5.2. The reason for not using  $\delta_{initial}$  (i.e., point A of Fig. 5.1) as the datum in Fig. 5.2 is to remove the effect of the load sharing of the forms in Wood-Concrete Beam 1.

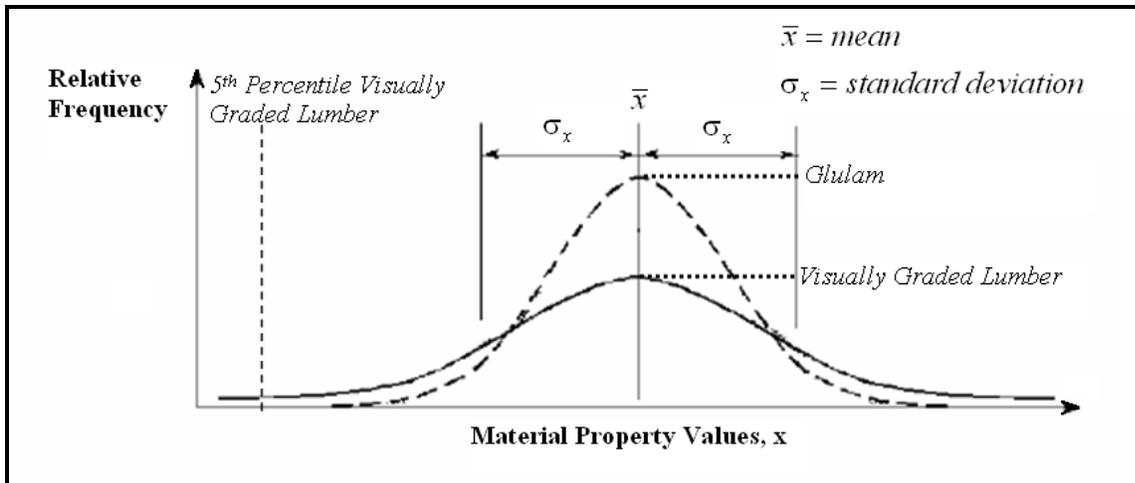
**Figure 5.6** Material Property Distribution<sup>26</sup>

For practical use, the observed ultimate capacity should be compared to a code-based design load requirement. For a structure to be mechanically adequate, the load capacity of the structure must be greater than or equal to the expected demand. Wood is a natural product and hence has variability in its mechanical properties. If a sample was taken from a group of boards and a particular property was measured, a normal probability distribution would be created<sup>15</sup> as shown qualitatively in Figure 5.6.

Figure 5.6 illustrates the qualitative material property distributions for glue-laminated lumber and visually graded lumber. The distribution for glue-laminated lumber is tighter with less variability since it is a manufactured wood product using tightly graded material. In contrast, visually graded lumber has a broader stress distribution, which indicates increased variability in the natural material. A utility pole would likely be in between these distributions. To account for this variability, the reference design values in the NDS are calculated using the material properties found below the 5<sup>th</sup> percentile.

To determine the ultimate load of a wood-concrete beam constructed using utility poles that had material properties at the wood's mean strength or  $\bar{x}$  as shown in Figure 5.6, the specifications in ASTM D245-06 are used. This standard specifies how to adjust the average clear wood stress for a species of wood based on the defects present within the wood. Defects that reduce the flexural and tensile capacity of the wood include knots and slope of grain, among other lesser factors. There are tables within ASTM D245-06 that show by what percentage the average clear wood strength is reduced by certain amounts, depending on the nature of the defect. The clear wood strength values used in the calculations are provided in ASTM D2555-06.<sup>18</sup>

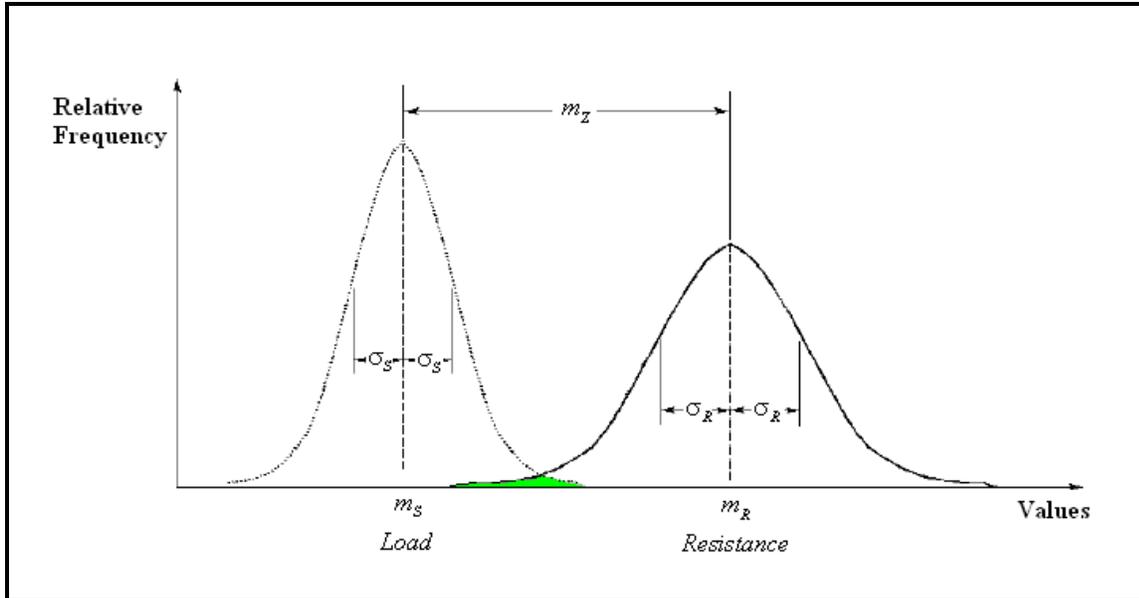
Figure 5.7 Sample Distributions of Load and Resistance<sup>26</sup>

Figure 5.7 illustrates the qualitative load and resistance distributions plots. There is an overlap, shown in shading, between the load and resistance distribution where load level might exceed the resistance level. Subtracting the load distribution from the resistance distribution yields the performance distribution shown in Figure 5.8. The performance values which fall below the reliability index ( $\beta$ ) multiplied by one standard deviation are considered a failure for design purposes. To minimize the number of performance values that are less than the quantity  $\beta \cdot \sigma_z$ , while still maintaining an economically feasible structure, the reliability index typically is set between 5.6 and 5.9.<sup>26</sup>

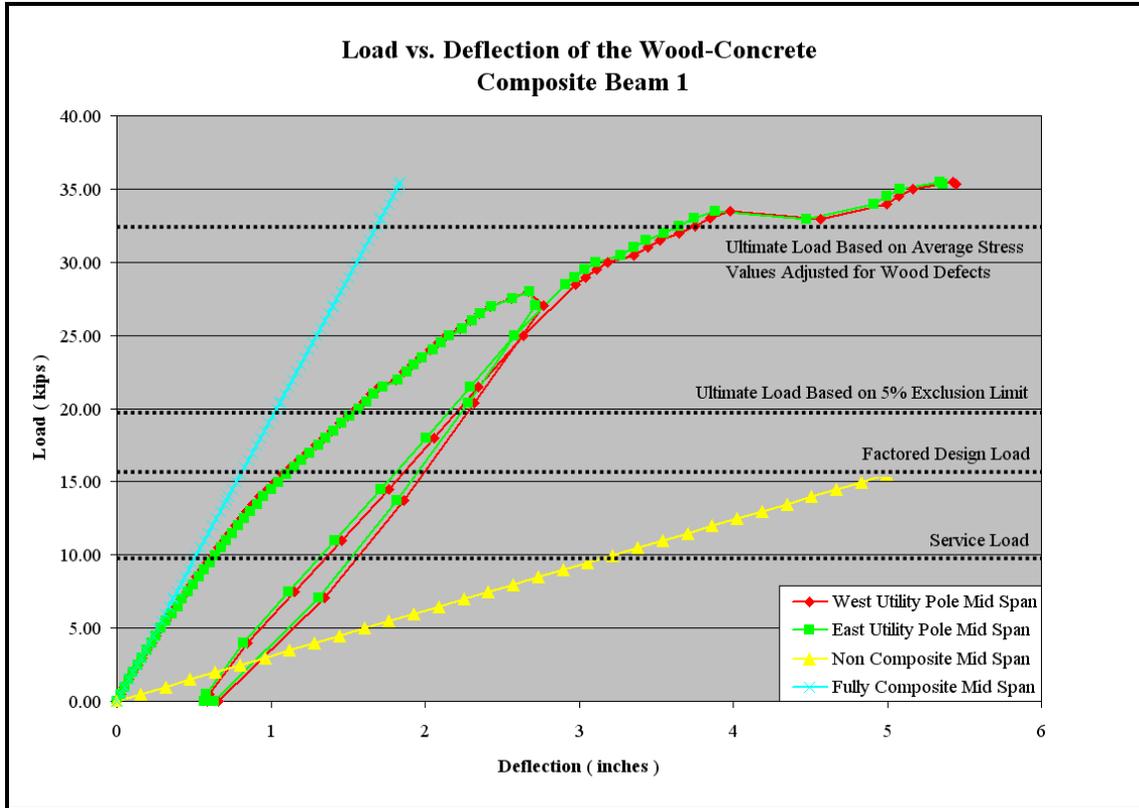
**Figure 5.9** Ultimate Loads for Wood-Concrete Composite Beam 1

The plot shown in Figure 5.9 indicates that Wood-Concrete Composite Beam 1 has an ultimate load,  $P_{ultimate} = 35.48$  kips, which is 2.96 kips above the clear wood mean ultimate load corrected for defects in the wood,  $P_{\bar{x}}$ . Additionally, the ultimate load based upon the 5% exclusion limit,  $P_{5\%} = 19.80$  kips is 15.68 kips below the ultimate strength of Wood-Concrete Composite Beam 1. The factored design load of  $P_u = 15.55$  kips is 19.93 kips below the ultimate strength. The service load of  $P_a = 9.72$  kips is 25.76 kips below the ultimate strength of the Wood-Concrete Composite Beam 1. This suggests that the utility poles used to design Wood-Concrete Composite Beam 1 were near the average strength of the applicable wood species.

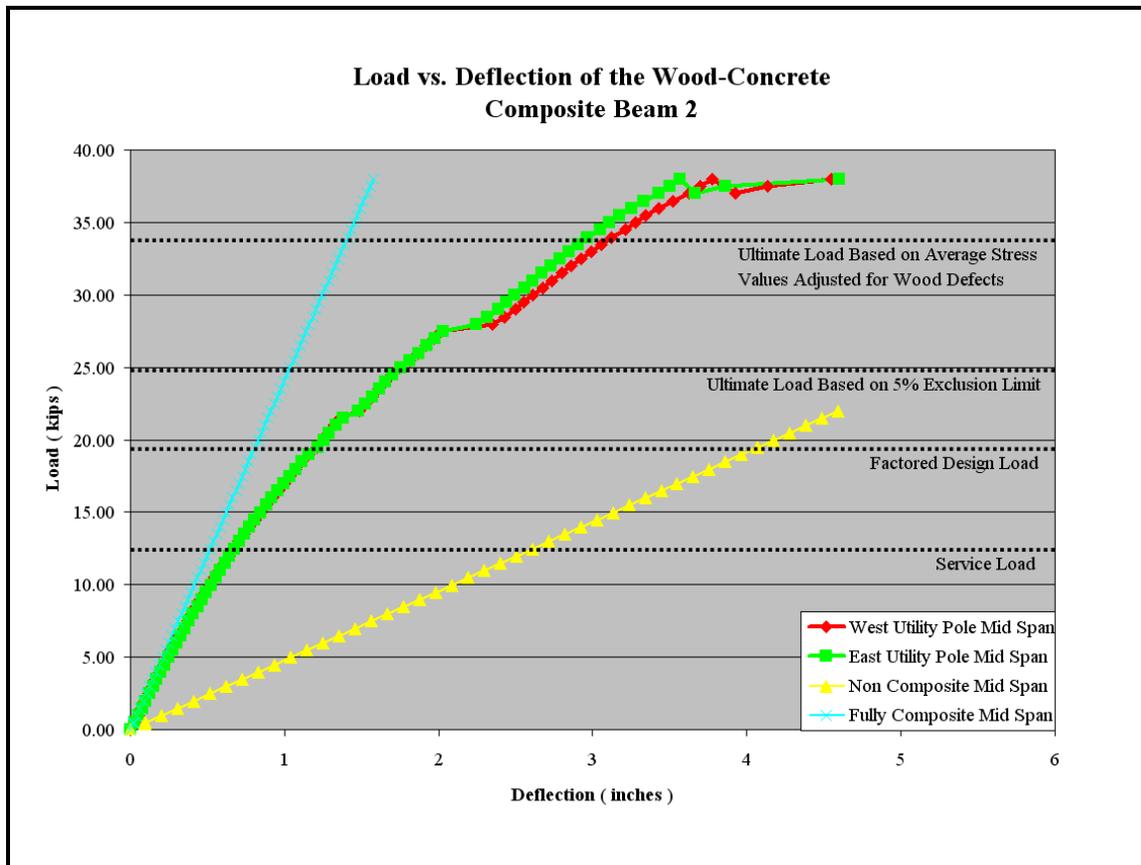
**Figure 5.10** Ultimate Loads for Wood-Concrete Composite Beam 2

The plot shown in Figure 5.10 indicates that the Wood-Concrete Composite Beam 2 has an ultimate load of  $P_{ultimate} = 37.98$  kips, which is 4.35 kips above the clear wood mean ultimate load corrected for defects in the wood ( $P_{\bar{x}}$ ). Additionally, the ultimate load based upon the 5% exclusion limit of  $P_{5\%} = 24.64$  kips is 13.34 kips below the ultimate strength of Wood-Concrete Composite Beam 2. The factored design load of  $P_u = 19.55$  kips is 18.43 kips below the ultimate strength of the beam, and the service load of  $P_a = 12.22$  kips is 25.76 kips below the ultimate strength of the Wood-Concrete Composite Beam 2. This shows that the utility poles used to design Wood-Concrete Composite Beam 2 were near the average strength of the wood's species. The data for the two wood-concrete composite beams are summarized in Table 5.2.

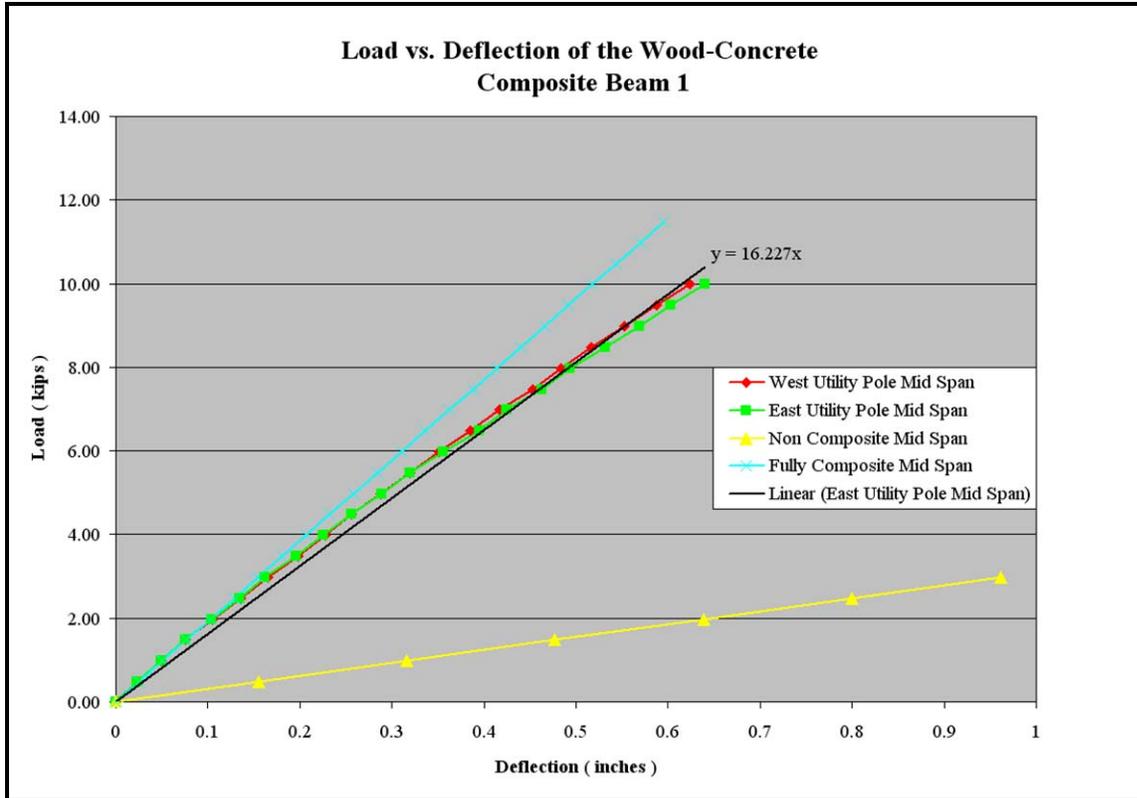
**Figure 5.11** Load vs. Deflection Plot Below the Service Load – Beam 1

Like all beams, the wood-concrete-composite beam will generally see the majority of its loads below the service load capacity. Therefore, when fitting trend lines, only the data below the service load capacity is used to calculate the beam's efficiency. Using the trend line fitted to the west utility pole deflection data for the first beam, the average slope of the data is as shown in Figure 5.11. Using the service load of 9.72 kips, the partially composite deflection can be found by dividing 9.72 by the slope of the trend line, which is 16.23. This equals an average deflection of 0.599 inches. Assuming that the beam is fully composite, the deflection at a load of 9.72 kips is 0.504 inches. Similarly, if the beam is non-composite, the deflection at a load of 9.72 kips is 3.136 inches. Using Equation 5.12, the resulting composite efficiency of Wood-Concrete Composite Beam 1 in the service load range is obtained as:
