Performance of Reclaimed Asphalt Pavement on Unpaved Roads

Scott Koch
George Huntington, P.E.
Khaled Ksaibati, PhD., P.E.

Wyoming Technology Transfer Center
University of Wyoming
Laramie, Wyoming

May 2013

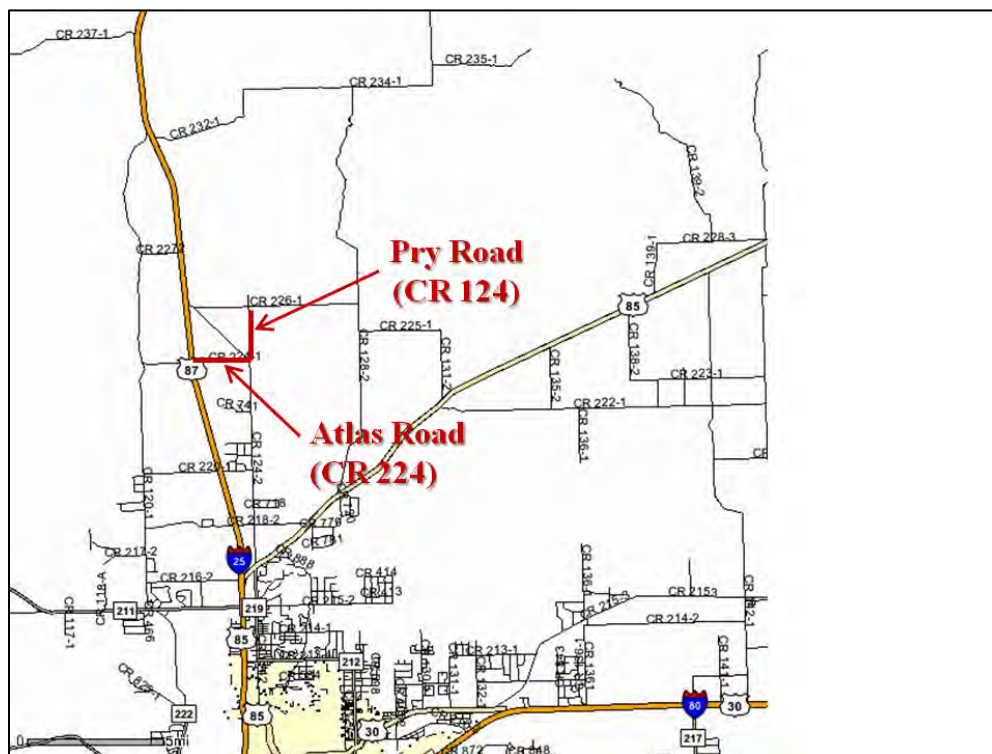
Figure 3.1 Laramie County test sites

Sections of Laramie County's Atlas Road [CR 224] and Pry Road [CR 124] (see Figure 3.1) north of Cheyenne; Johnson County's Schoonover Road [CR 204B] (see Figure 3.2) east of Buffalo; and Sweetwater County's Crooks Gap Road [CR 23] (see Figure 3.3) just north of Wamsutter were constructed and evaluated. Figure 3.4 shows that each of these sections are located near an interstate highway, which was each section's RAP source, as well as the source of much of their traffic. Abbreviations used to describe the sections are in Appendix E.

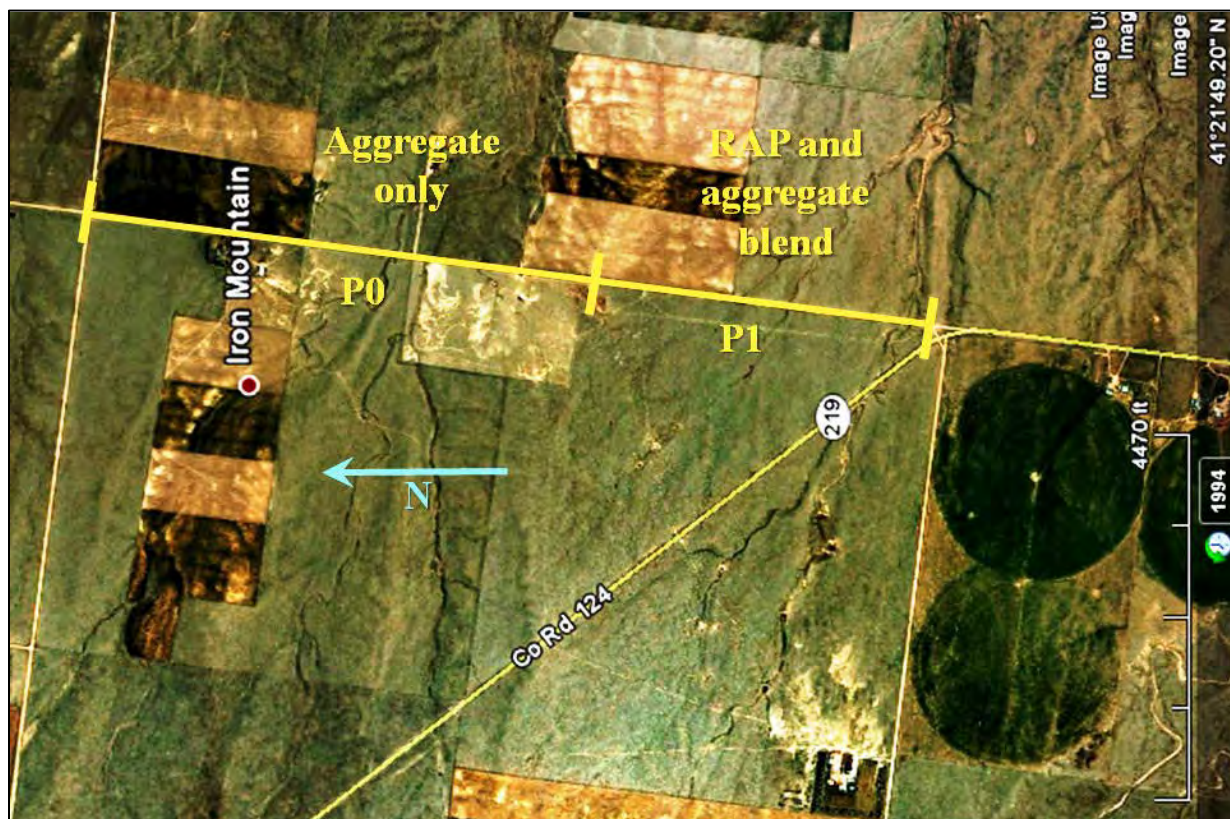
Figure 3.6 Laramie County Pry Road test sections.

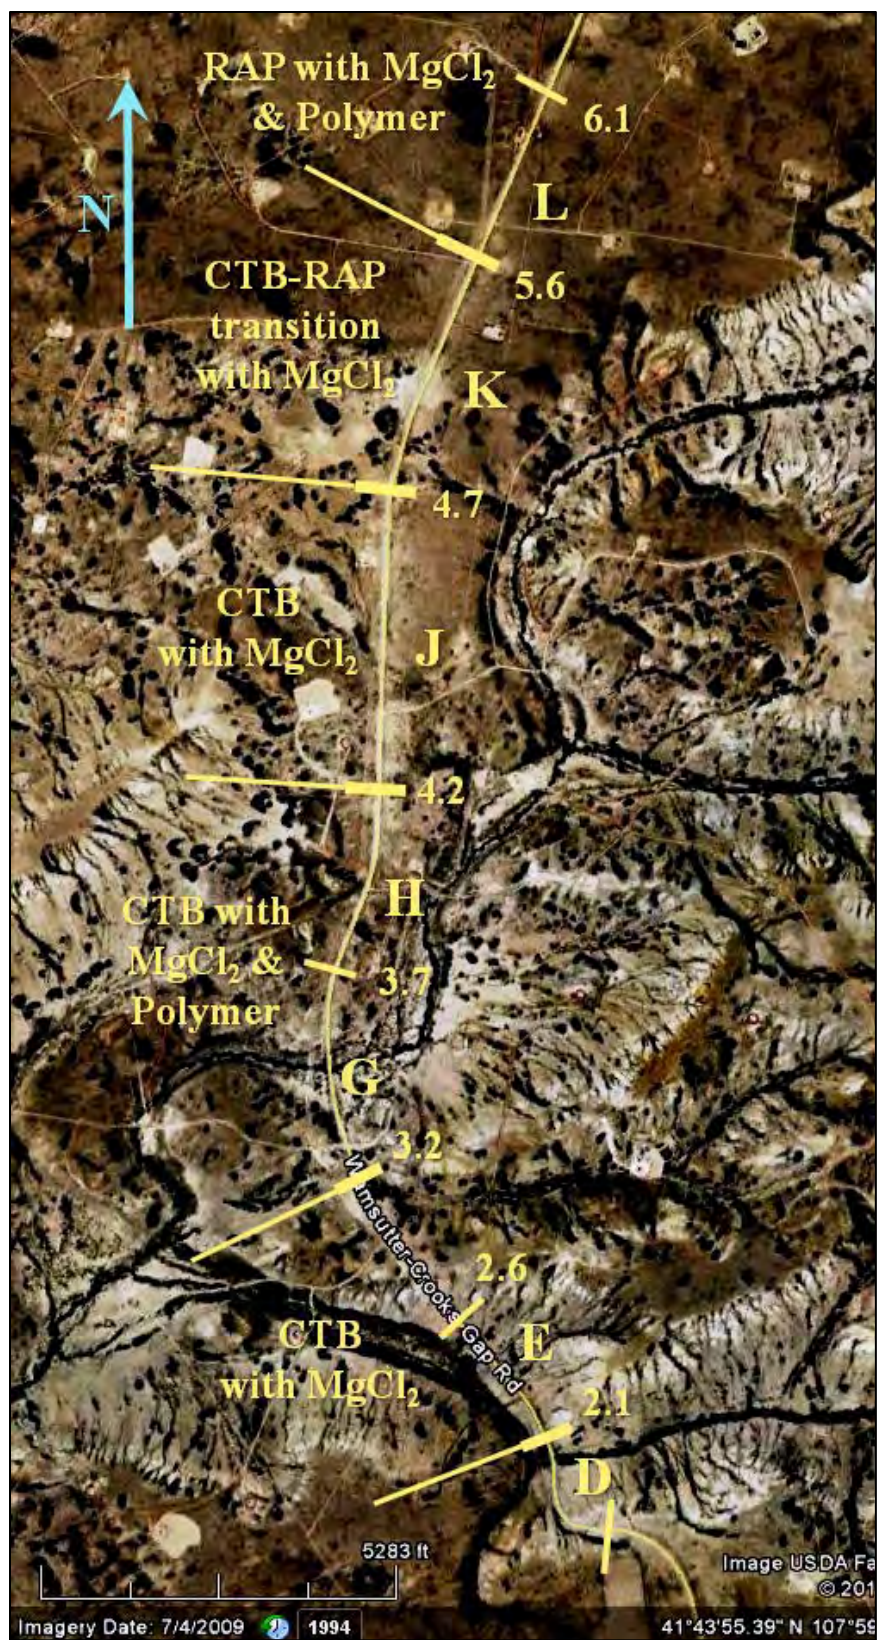
Figure 3.9 Sweetwater County test segments on Crooks Gap Road, SW CR 23, center.

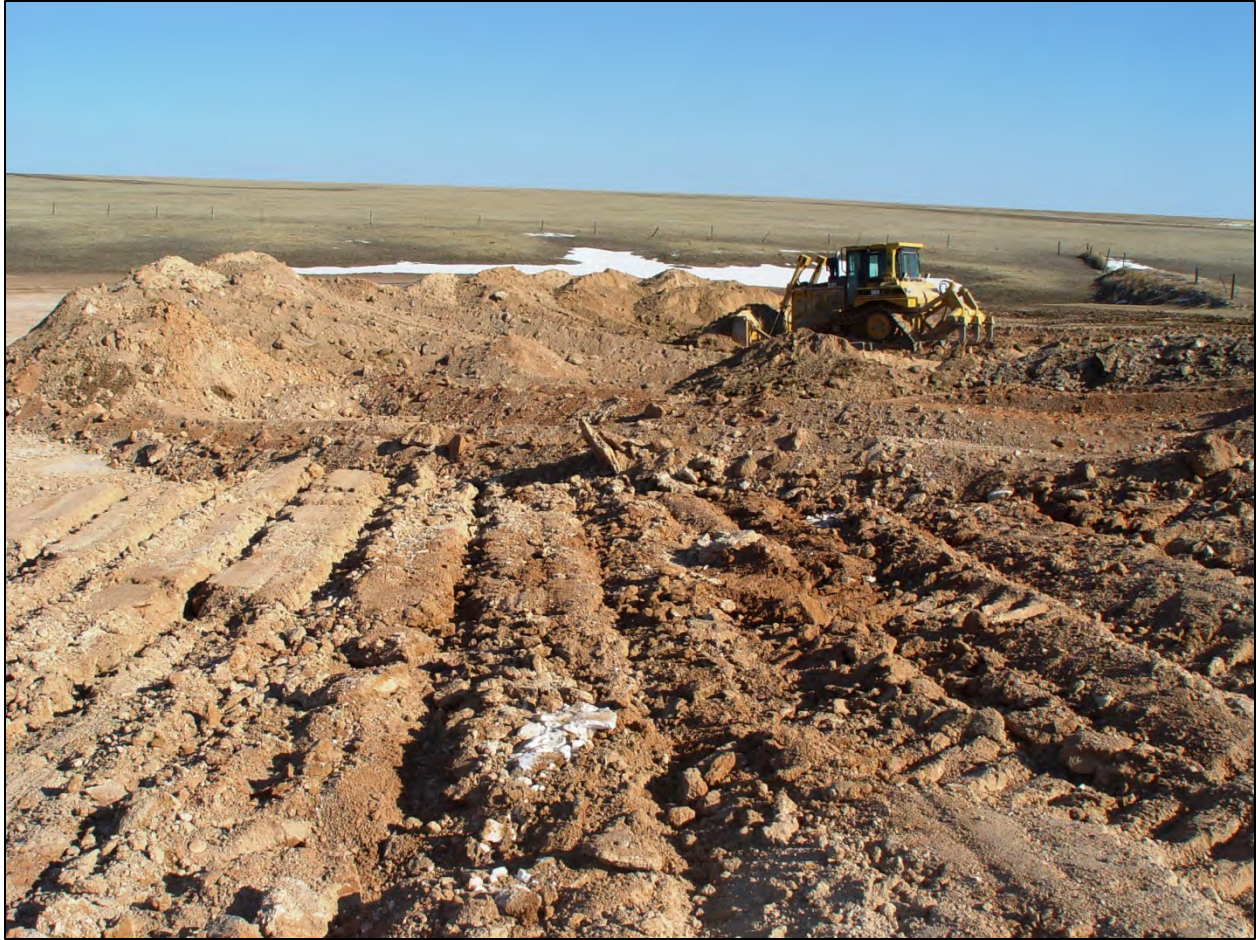
Figure 3.12 Blending of aggregate at Laramie County scoria pit near Atlas Road.

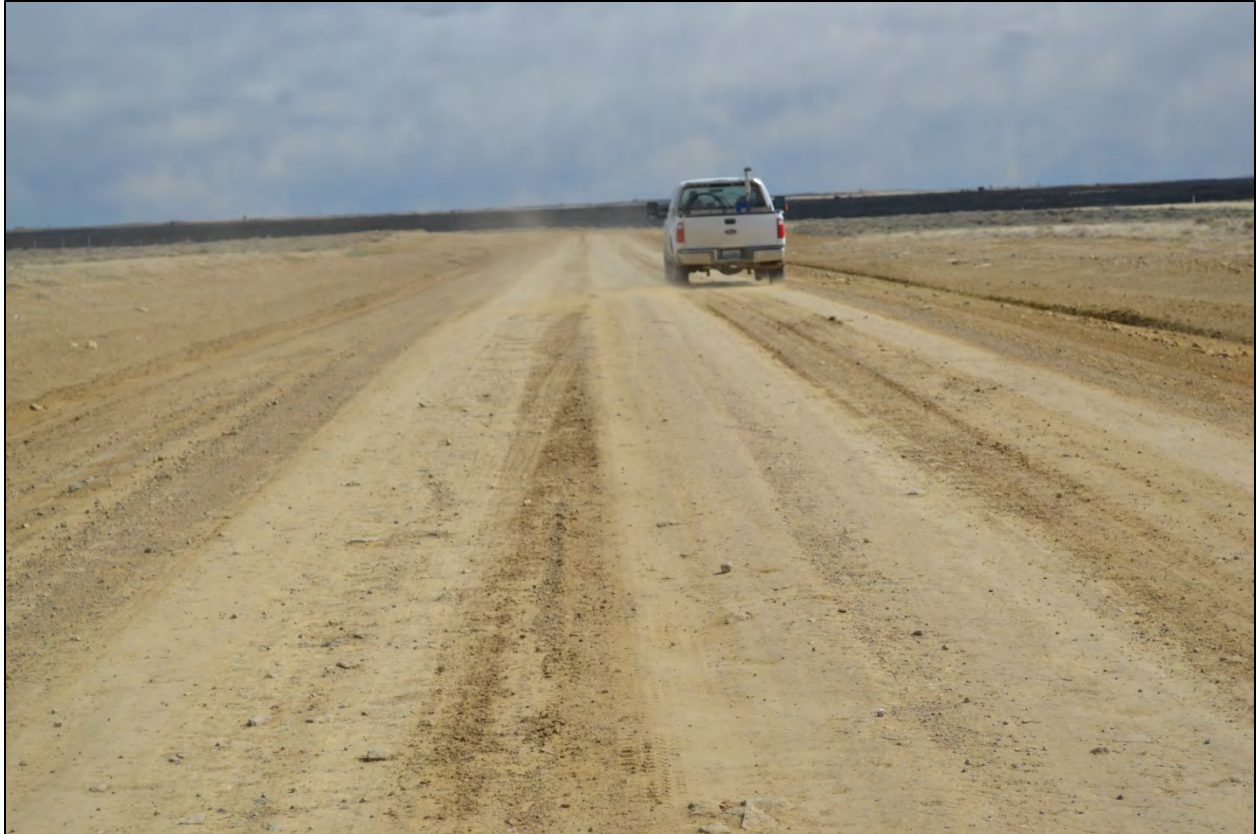
Figure 3.13 Crooks Gap Road north of the test sections showing the surfacing material typical of that which was blended with RAP or CTB on the Sweetwater County test sections.

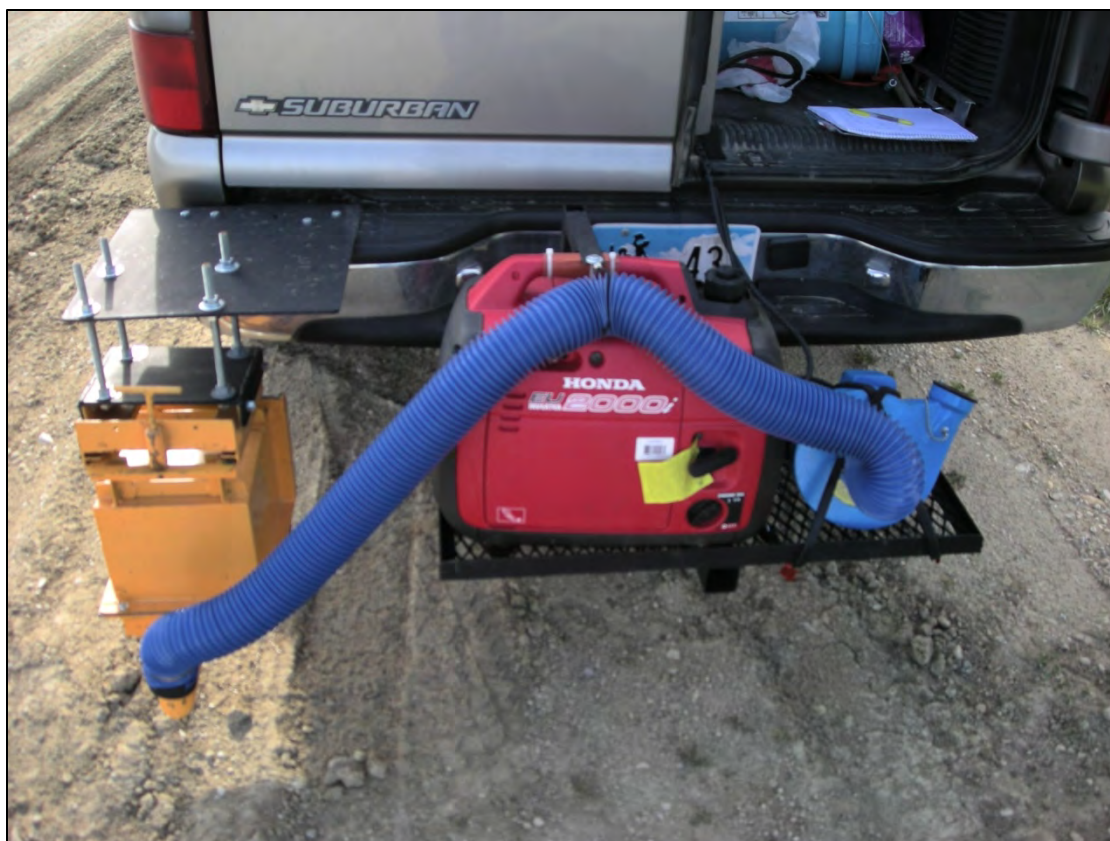
Figure 3.15 Dustometer setup with, left to right, the dustometer, generator, and vacuum.

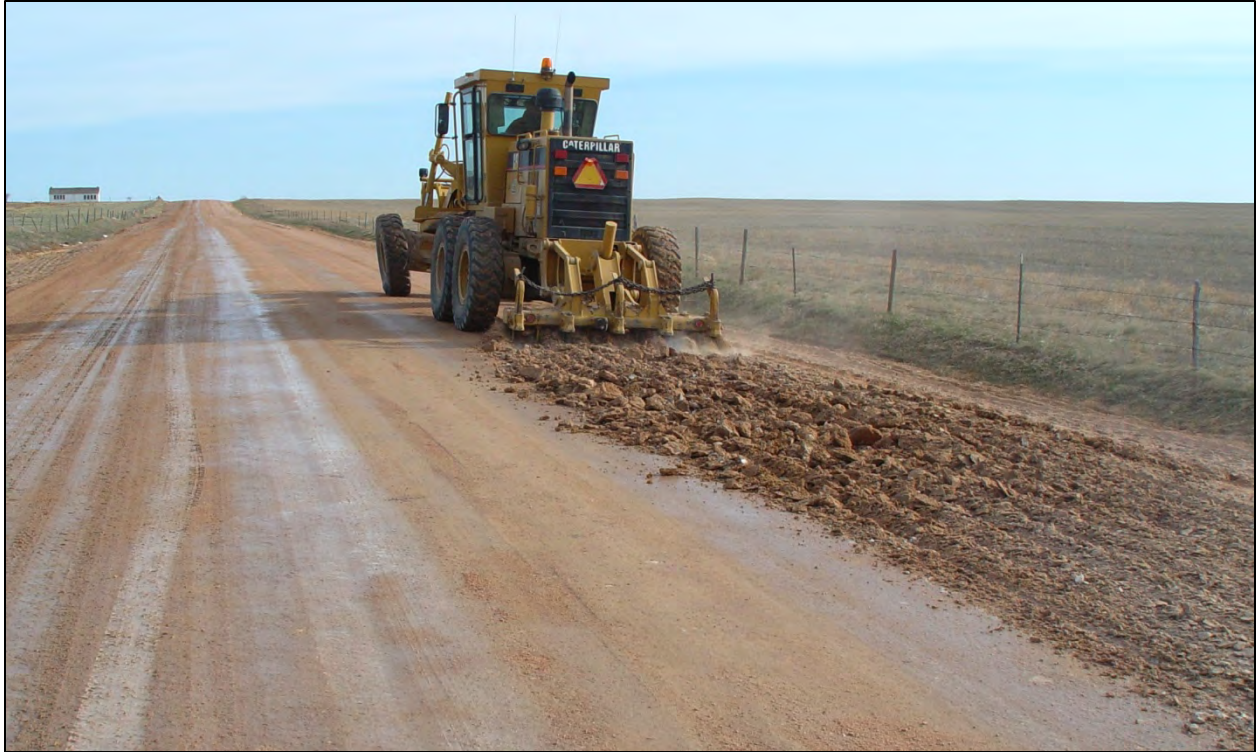
Figure 3.16 Scarifying Laramie County's Atlas Road prior to placement and blending of RAP.

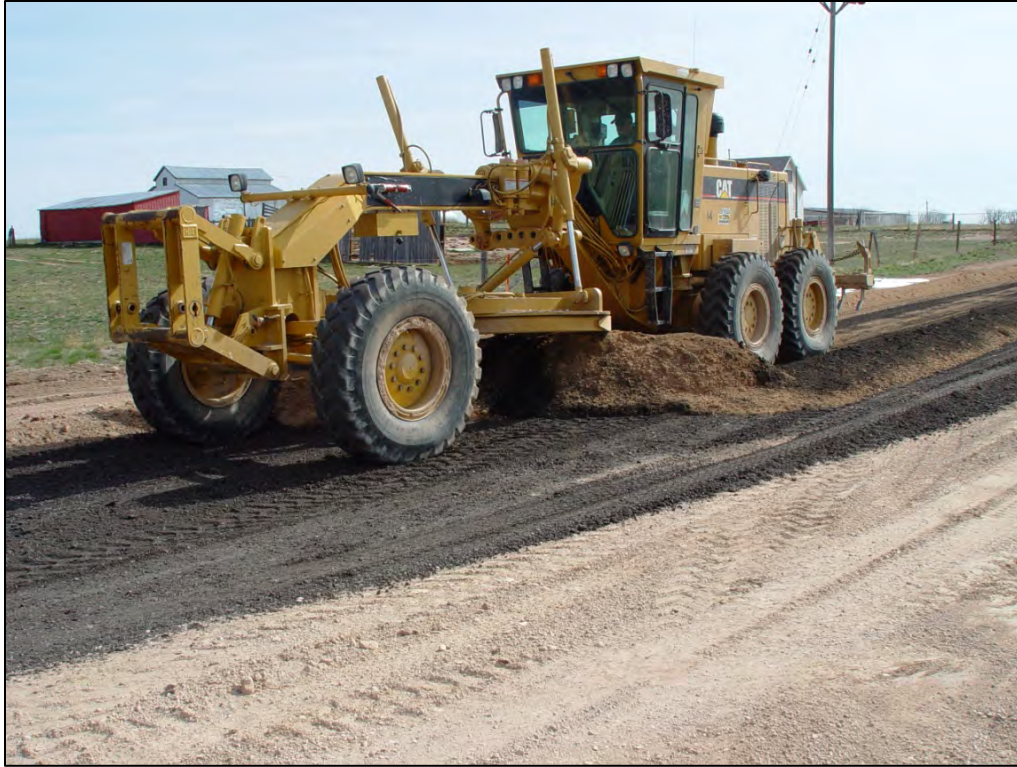
Figure 3.18 Blending RAP and existing, scarified aggregate on Laramie County's Atlas Road.

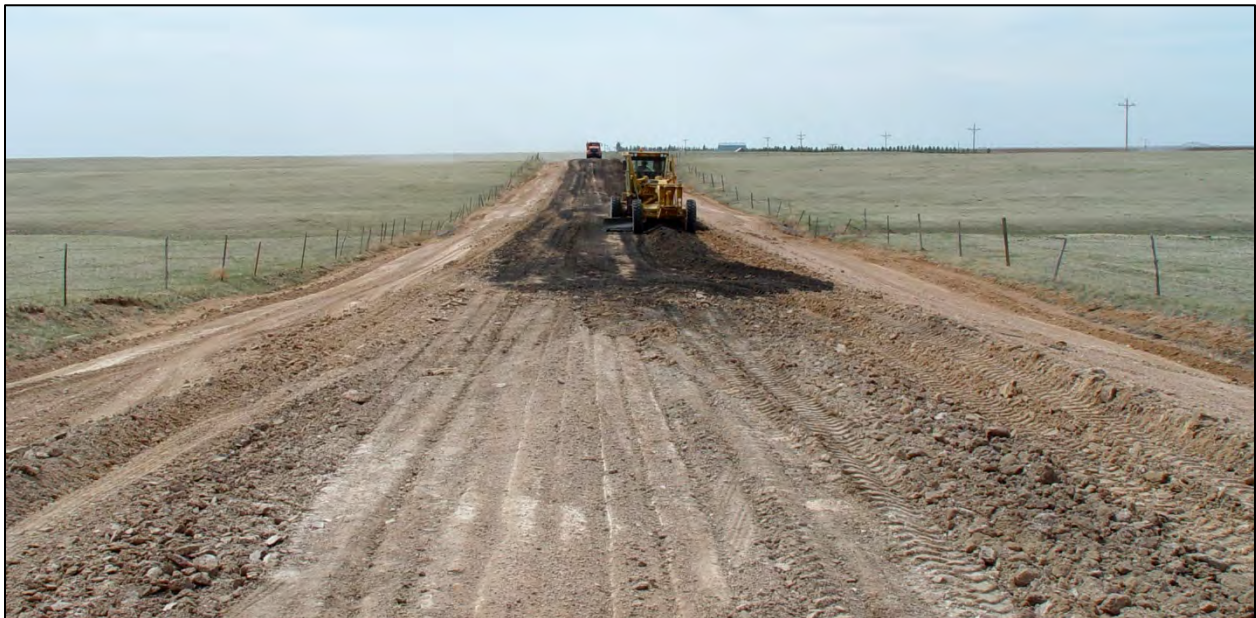
Figure 3.19 Blending and shaping RAP and existing, scarified aggregate on Laramie County's Atlas Road.

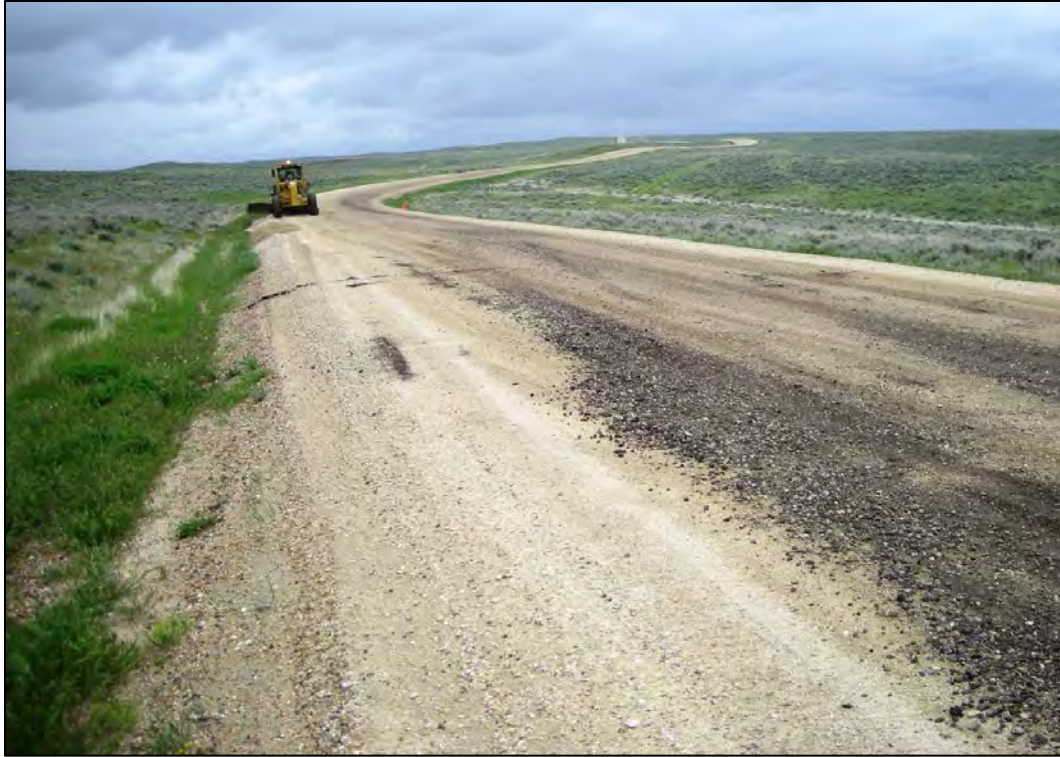
Figure 3.21 Initial shaping of Johnson County's Schoonover Road prior to placement of the blended RAP and aggregate, June 2008.

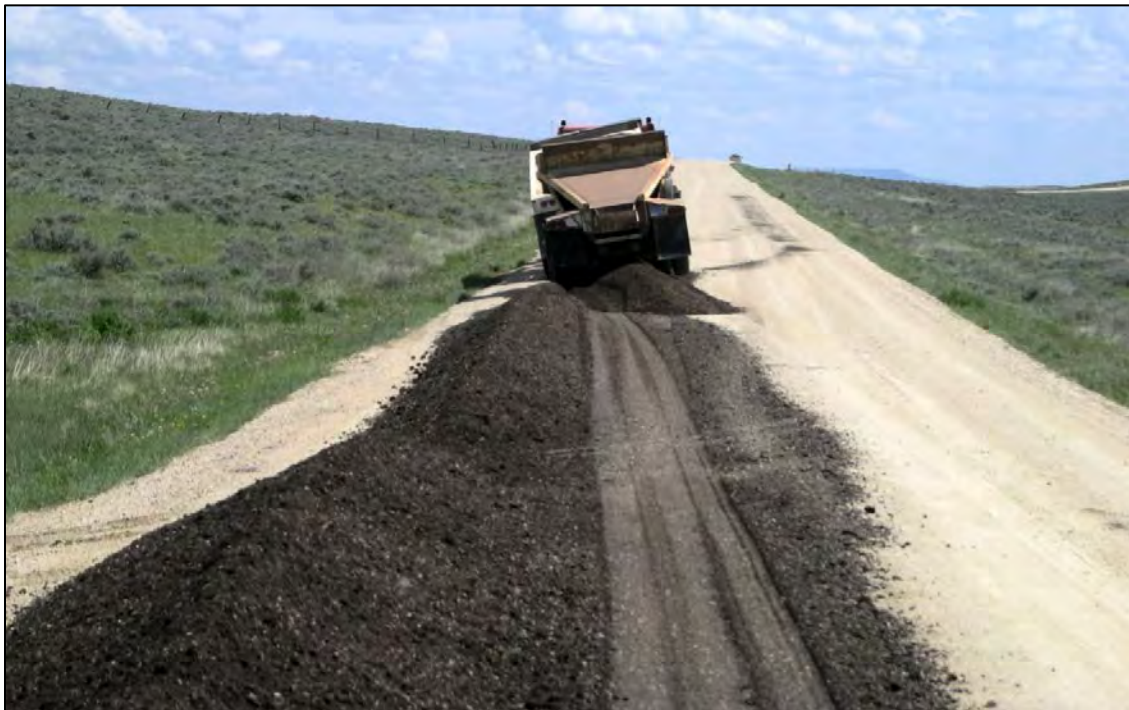
Figure 3.22 Placing RAP and aggregate blend on Johnson County's Schoonover Road, June 2008.

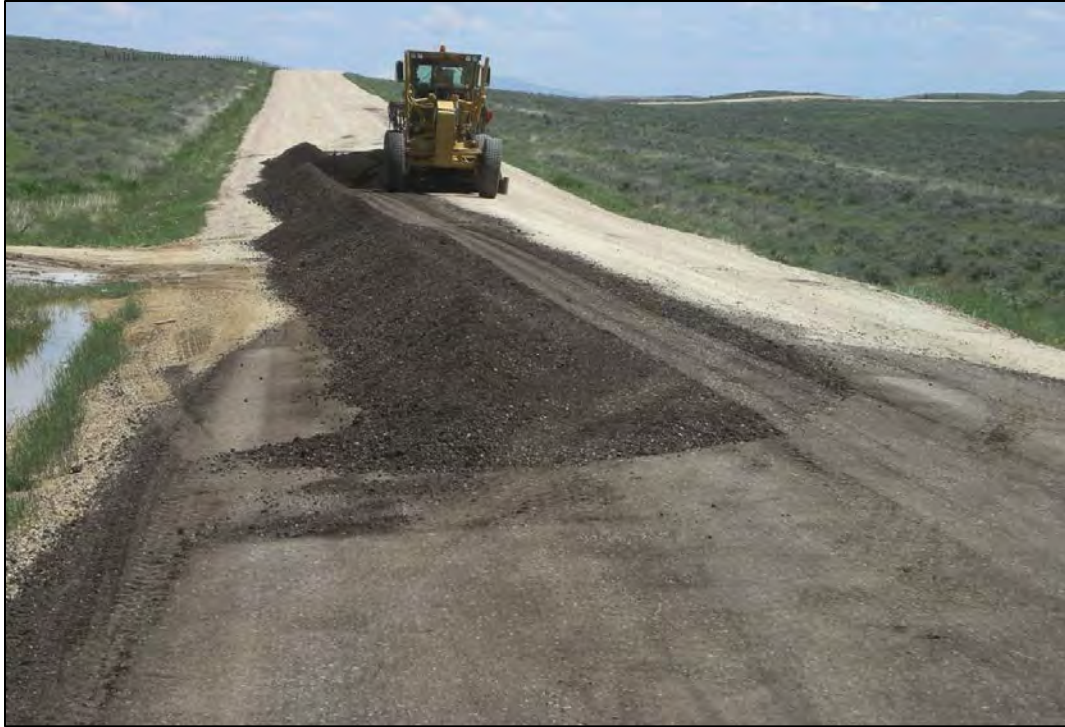
Figure 3.23 Shaping RAP and aggregate blend on Johnson County's Schoonover Road, June 2008.

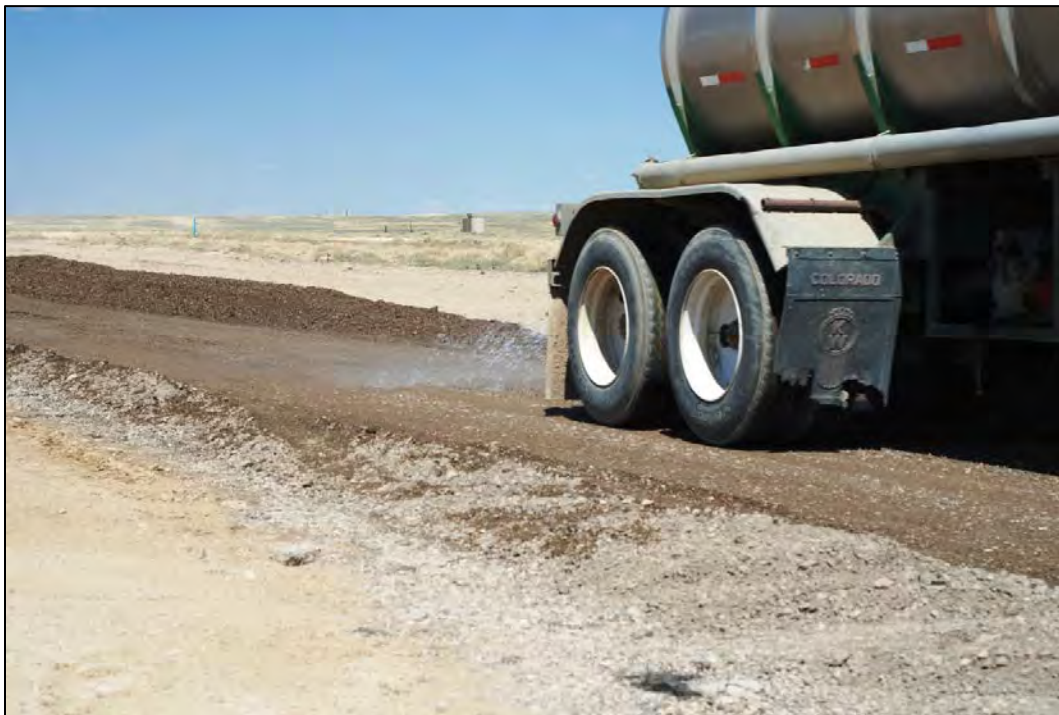
Figure 3.31 Applying water to the CTB and aggregate blend prior to final shaping and compaction on Sweetwater County's Crooks Gap Road, August 2010.

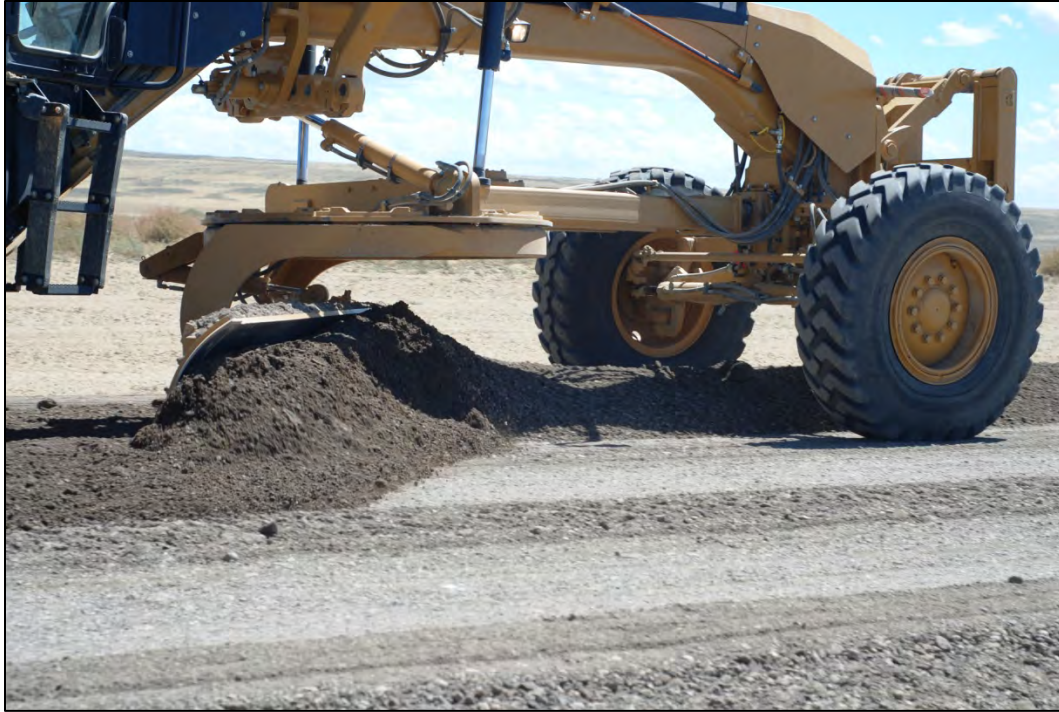
Figure 3.32 Blending and shaping the existing aggregate and CTB blend on Sweetwater County's Crooks Gap Road, August 2010.

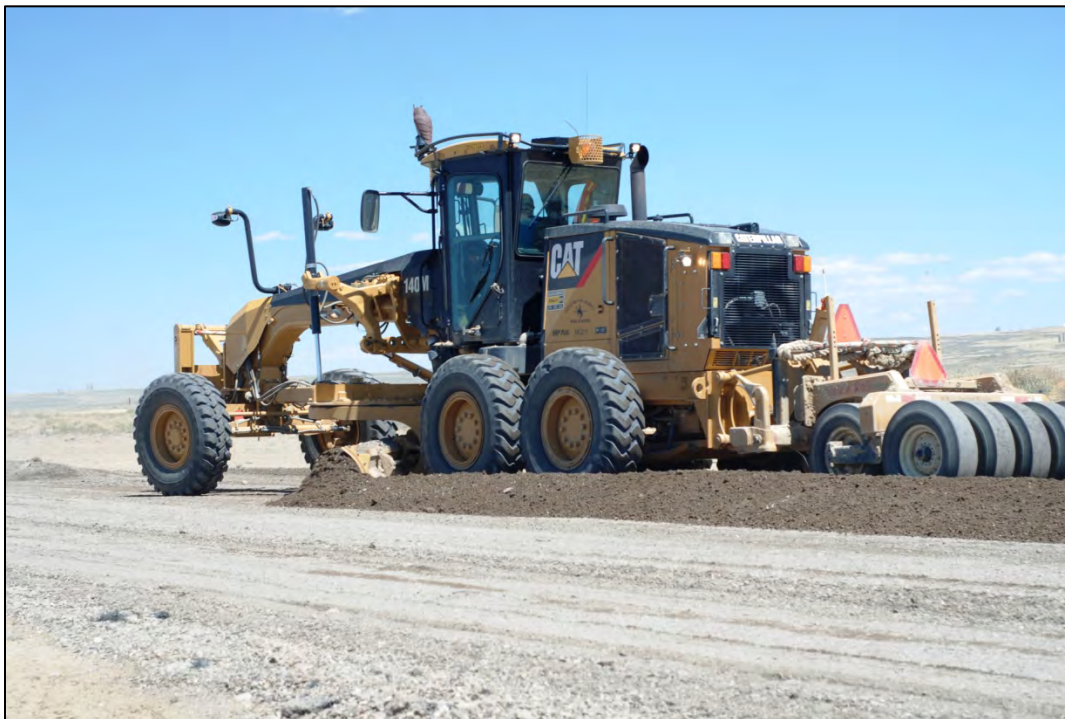
Figure 3.33 Final shaping and compaction of CTB and aggregate blend using a motor grader with pneumatic tire compactors mounted to its ripper hydraulics on Sweetwater County's Crooks Gap Road, August 2010.

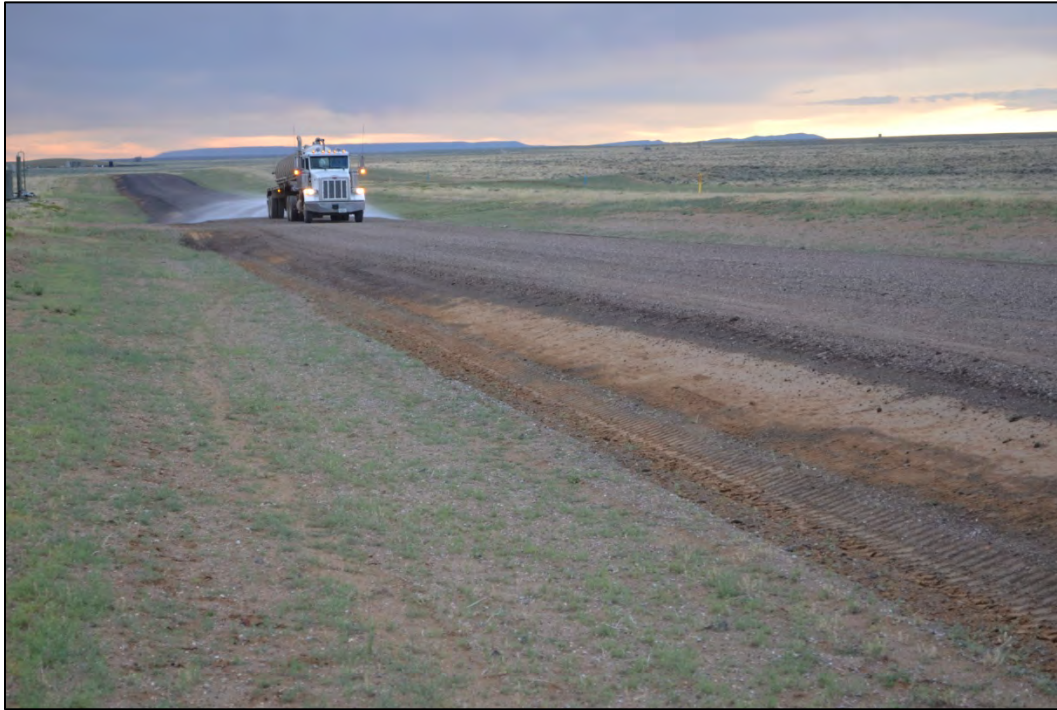
Figure 3.34 Pre-wetting RAP and aggregate blend at dawn prior to application of dust suppressants on Sweetwater County's Crooks Gap Road, July 2011.

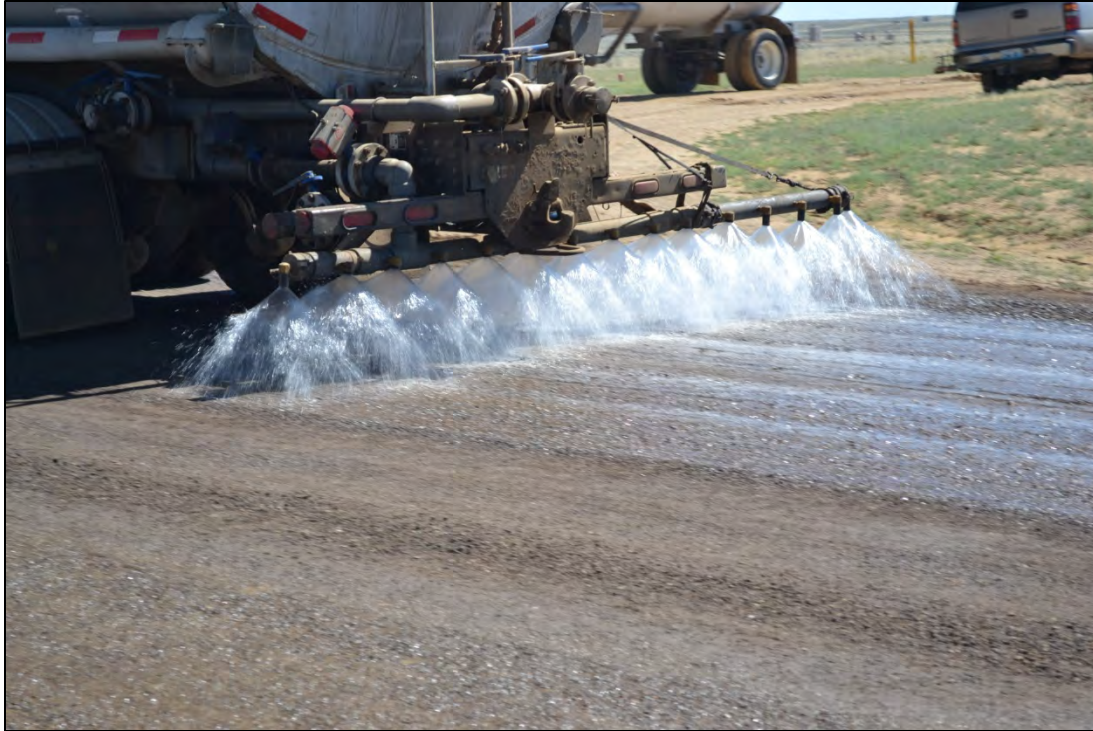
Figure 3.37 Applying dust suppressant brine to aggregate and RAP blend on Sweetwater County's Crooks Gap Road, July 2011.

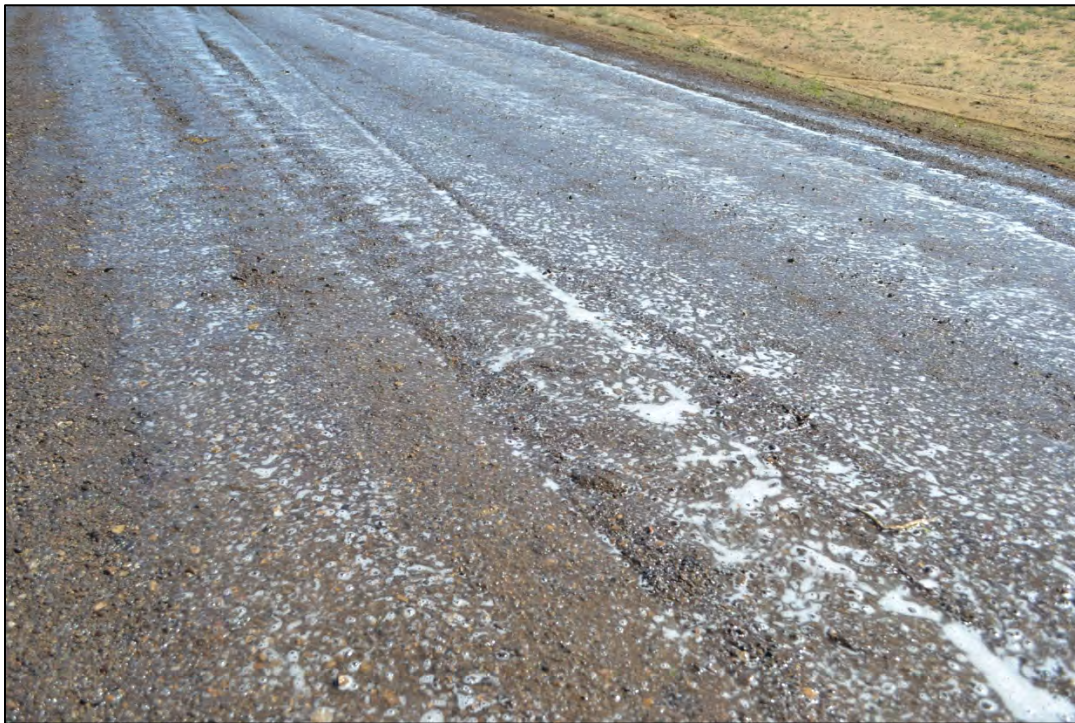
Figure 3.38 Recently applied magnesium chloride on the RAP and aggregate blend on Sweetwater County's Crooks Gap Road, July 2011.

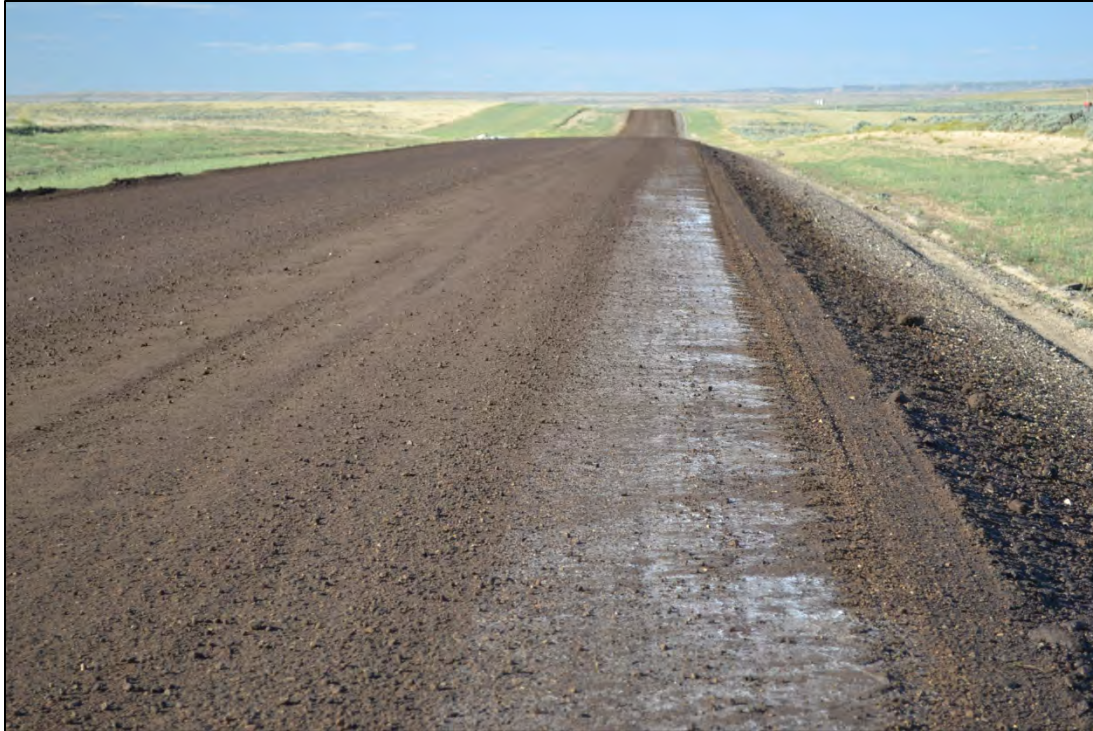
Figure 3.39 Magnesium chloride almost completely absorbed into the RAP and aggregate blend on Sweetwater County's Crooks Gap Road, July 2011.

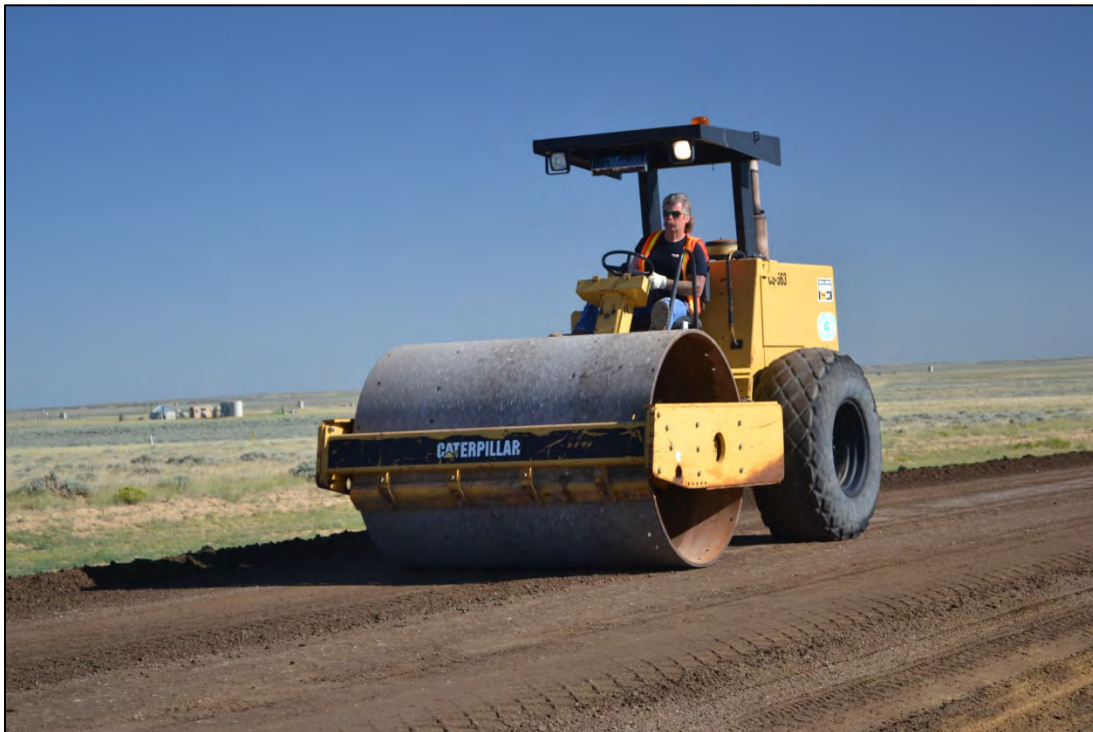
Figure 3.40 Compaction of the magnesium chloride-treated RAP and aggregate blend on Sweetwater County's Crooks Gap Road, July 2011.

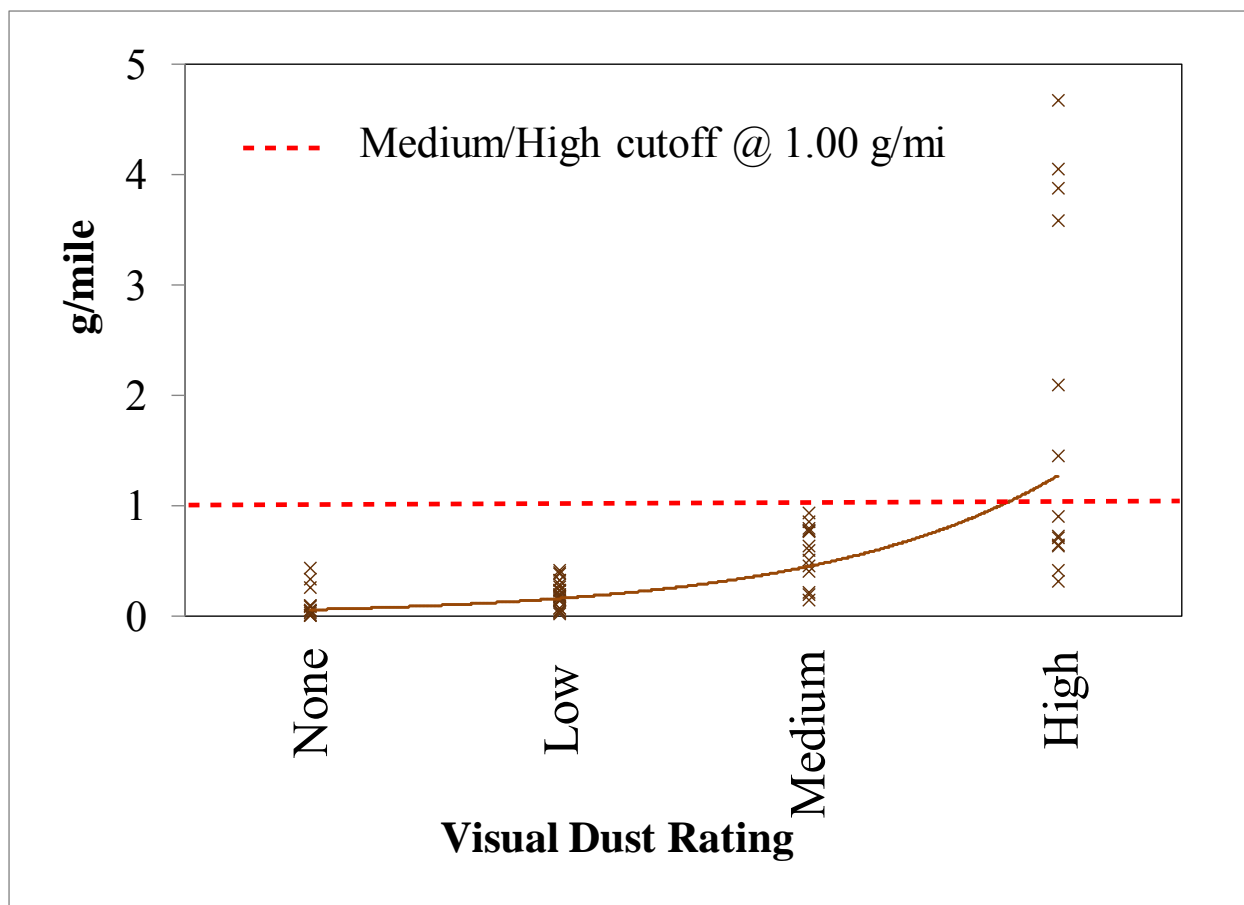
Figure 4.1 Dust measured with the dustometer as a function of subjective visual dust ratings, with a suggested numerical cutoff between Medium and High dust severity at 1.00 grams per mile.

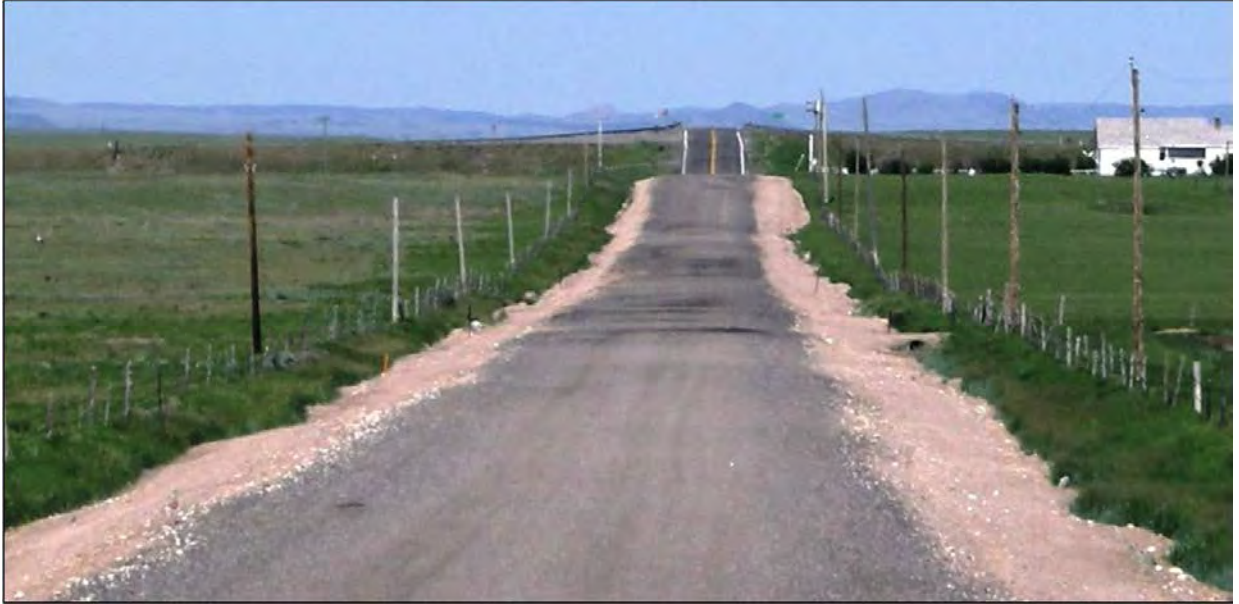
Figure 4.10 Segregation of RAP on Laramie County's Atlas Road in June 2008, two months after initial RAP application.

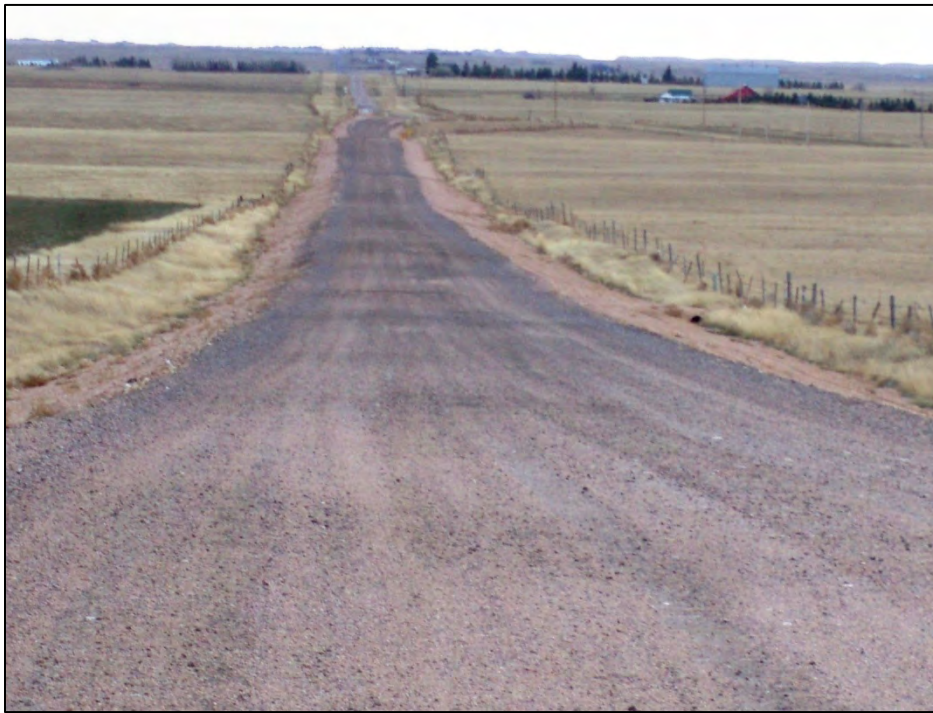
Figure 4.11 Segregation bands attributed to inadequate spreading of the windrows placed by the bottom-discharge haul trucks on Laramie County's Pry Road in November 2008, six months after initial application.

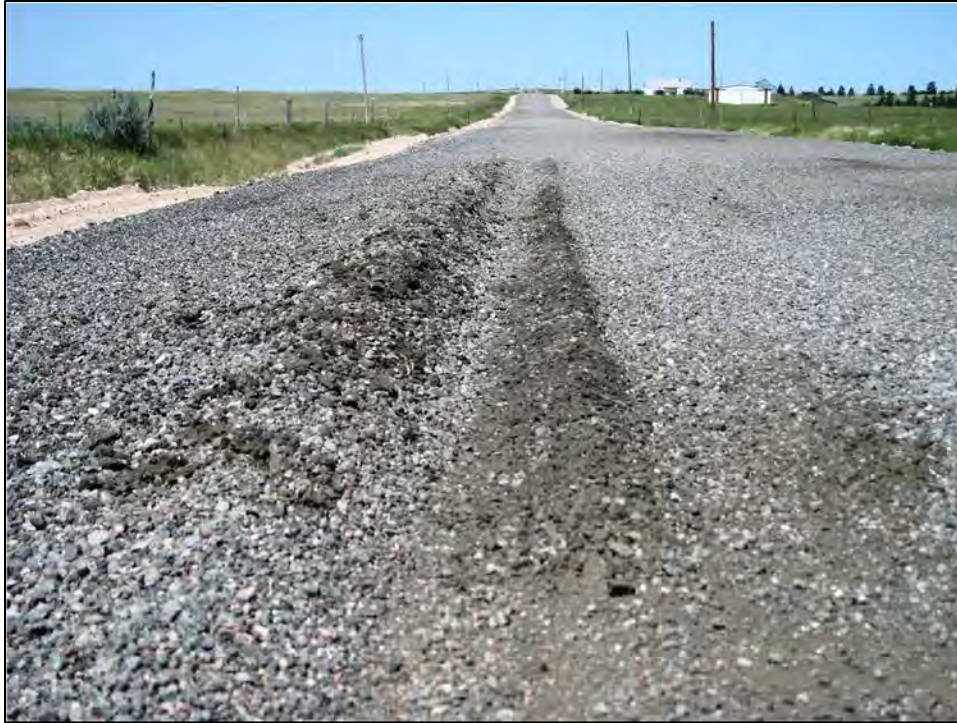
Figure 4.12 Nearly 100% RAP resulting in excessive loose aggregate on Laramie County's Atlas Road in June 2008, about two months after initial application.

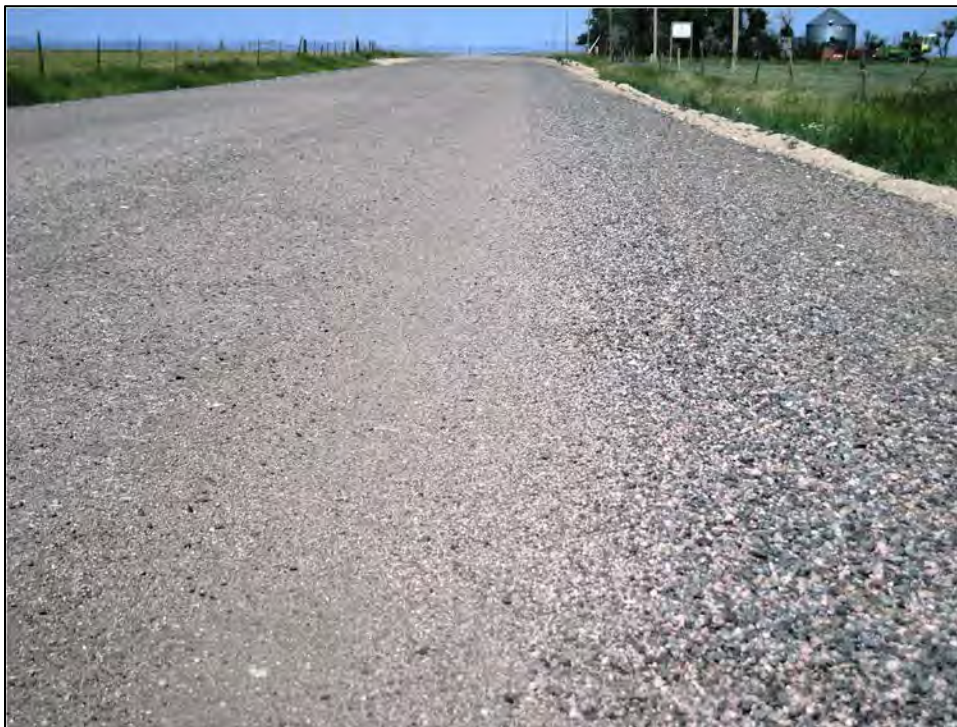
Figure 4.13 Well compacted, tight surface due to good blending on Laramie County's Atlas Road in June 2008, about two months after initial application.
