Performance of Reclaimed Asphalt Pavement on Unpaved Roads

Scott Koch
George Huntington, P.E.
Khaled Ksaibati, PhD., P.E.

Wyoming Technology Transfer Center
University of Wyoming
Laramie, Wyoming

May 2013

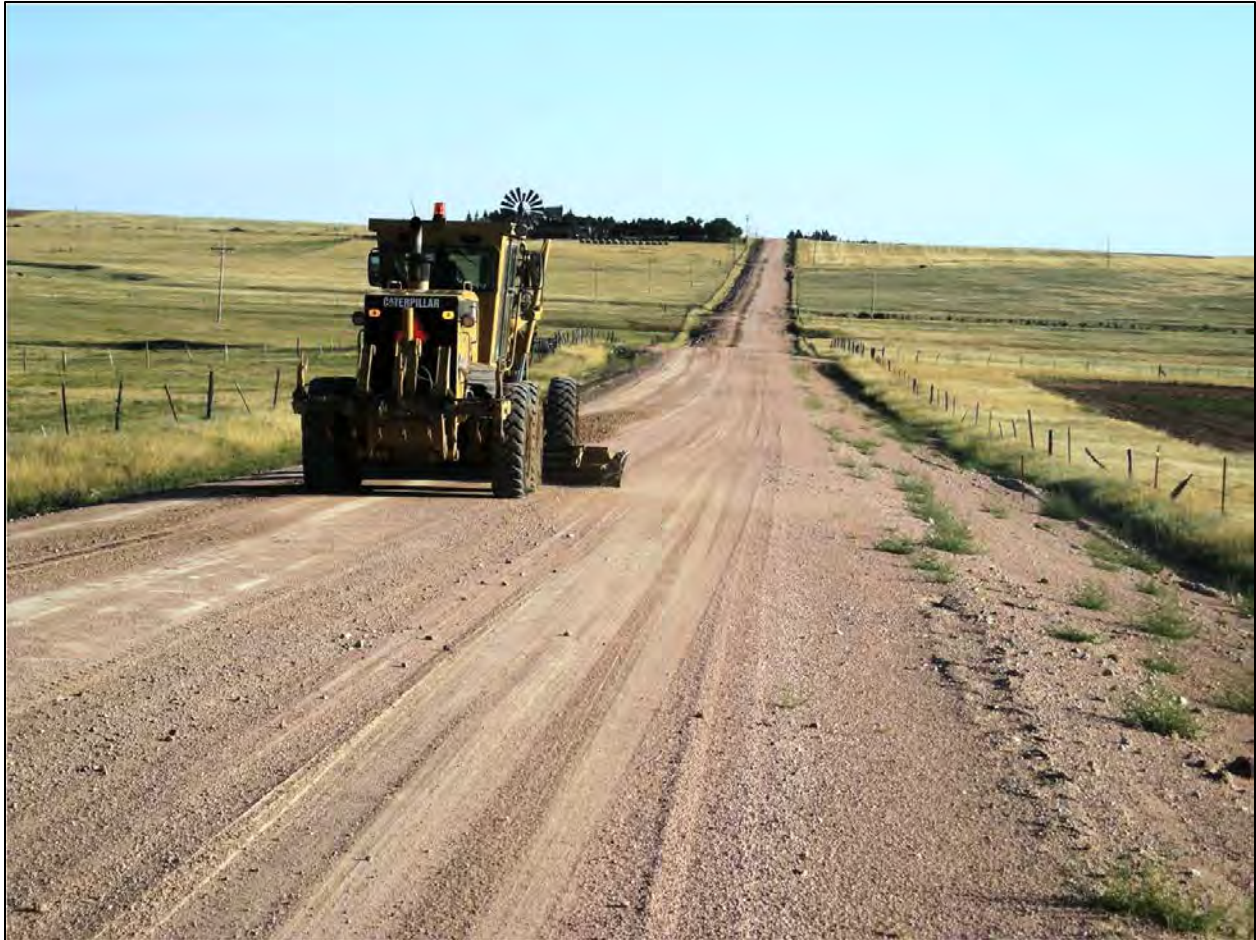
Figure 4.14 Re-working Laramie County's Pry Road in August 2008, four months after initial application, to correct segregation with additional blending and spreading.

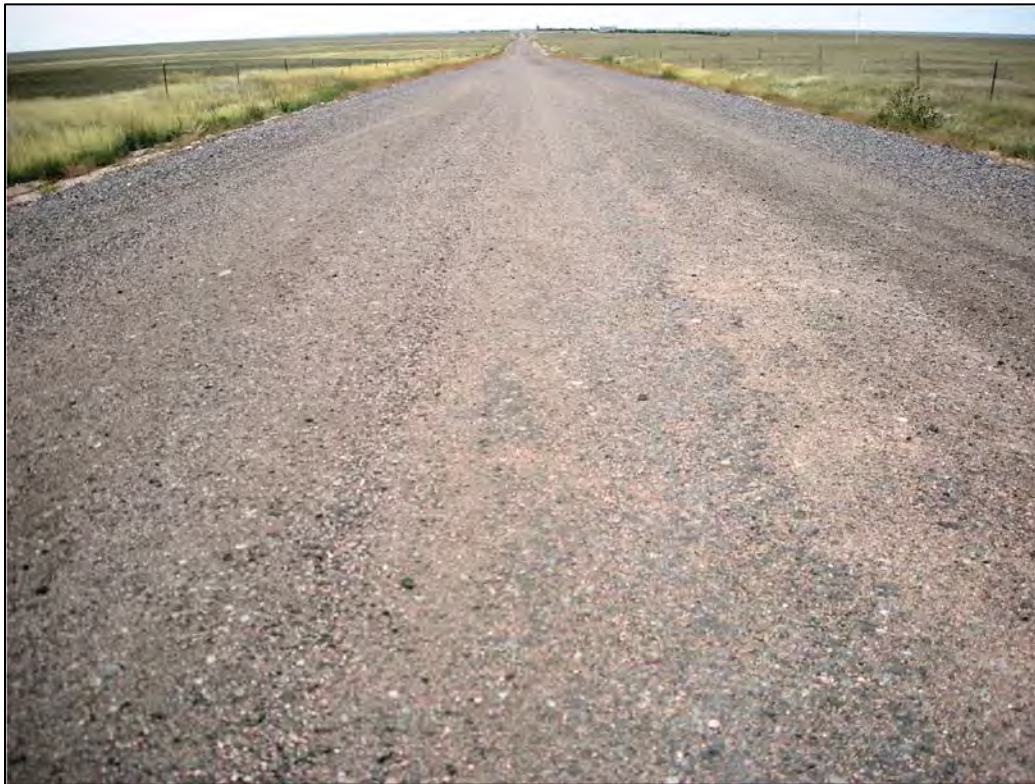
Figure 4.15 Good, tight surface on Laramie County's Atlas Road in October 2008, five months after initial application and two months after re-blending with motor grader.

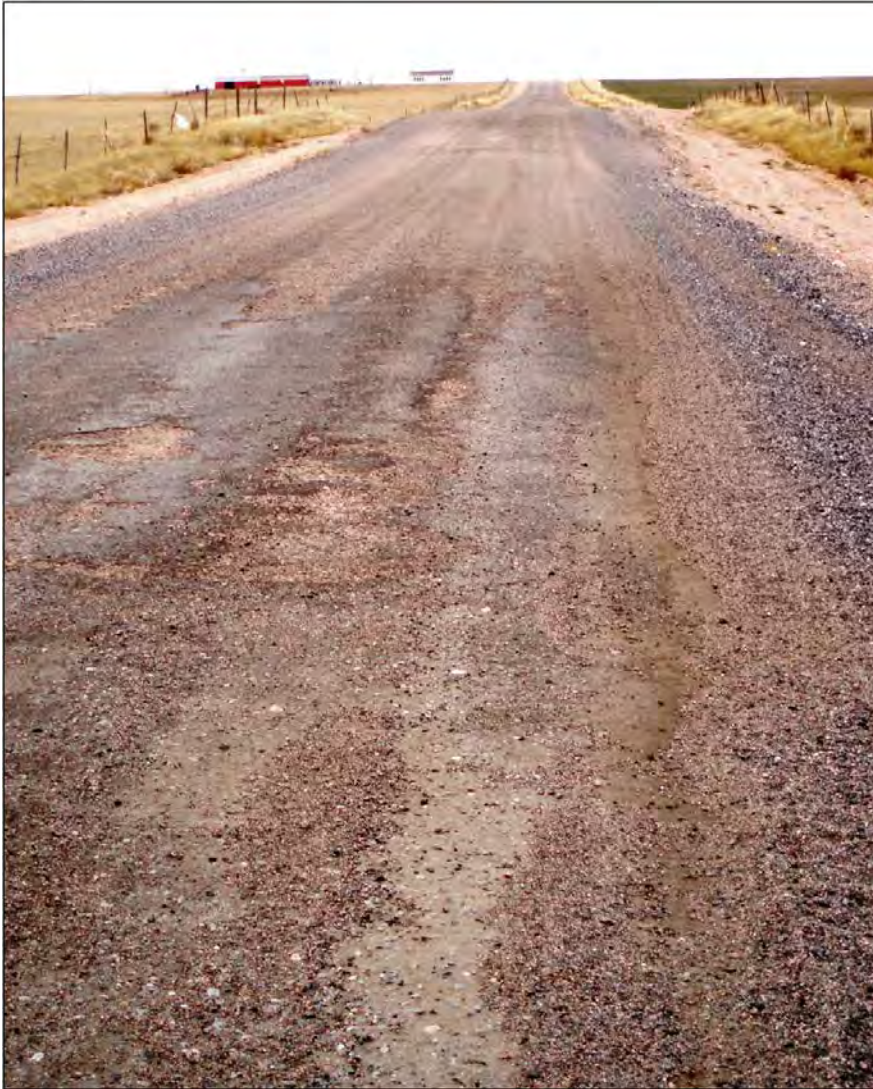
Figure 4.16 Variable densification under traffic due to incomplete blending and segregation of RAP and aggregate on Laramie County's Pry Road in November 2008, six months after initial compaction and three months after re-working.

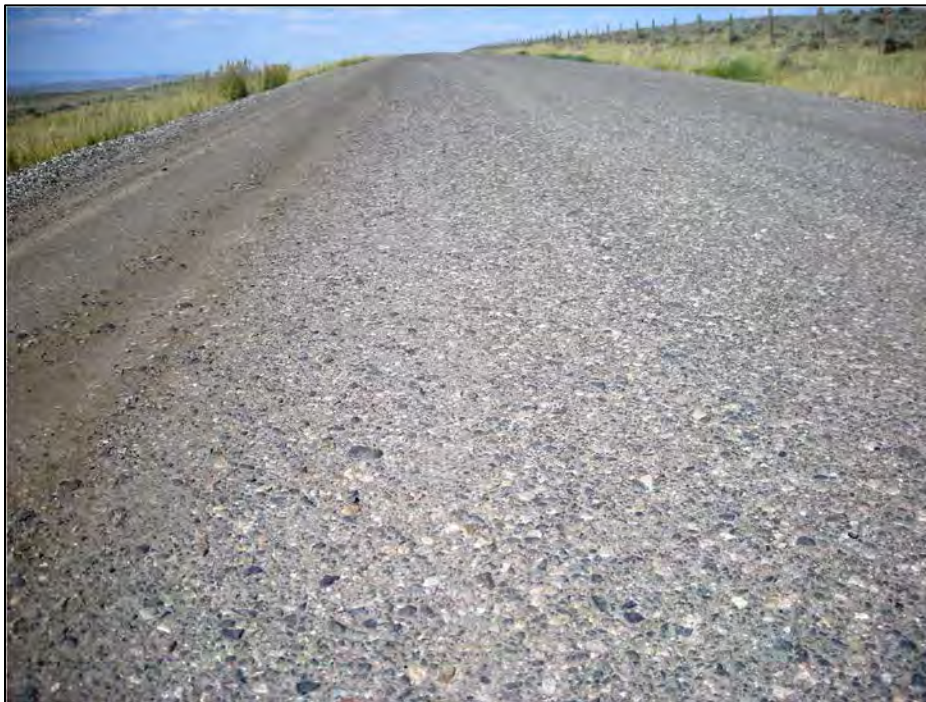
Figure 4.21 Road surface with some rutting on Johnson County's Schoonover Road, segment S1 with RAP and calcium chloride in August 2008, two months after RAP placement and one month after calcium chloride application.

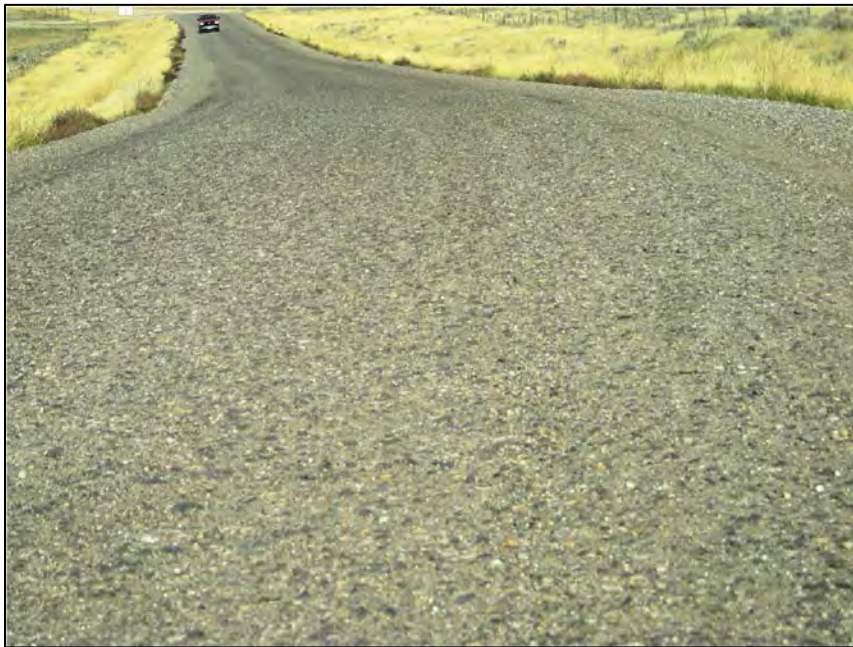
Figure 4.25 Road surface on Johnson County's Schoonover Road, segment S2 with RAP but no calcium chloride in October 2008, four months after RAP placement.

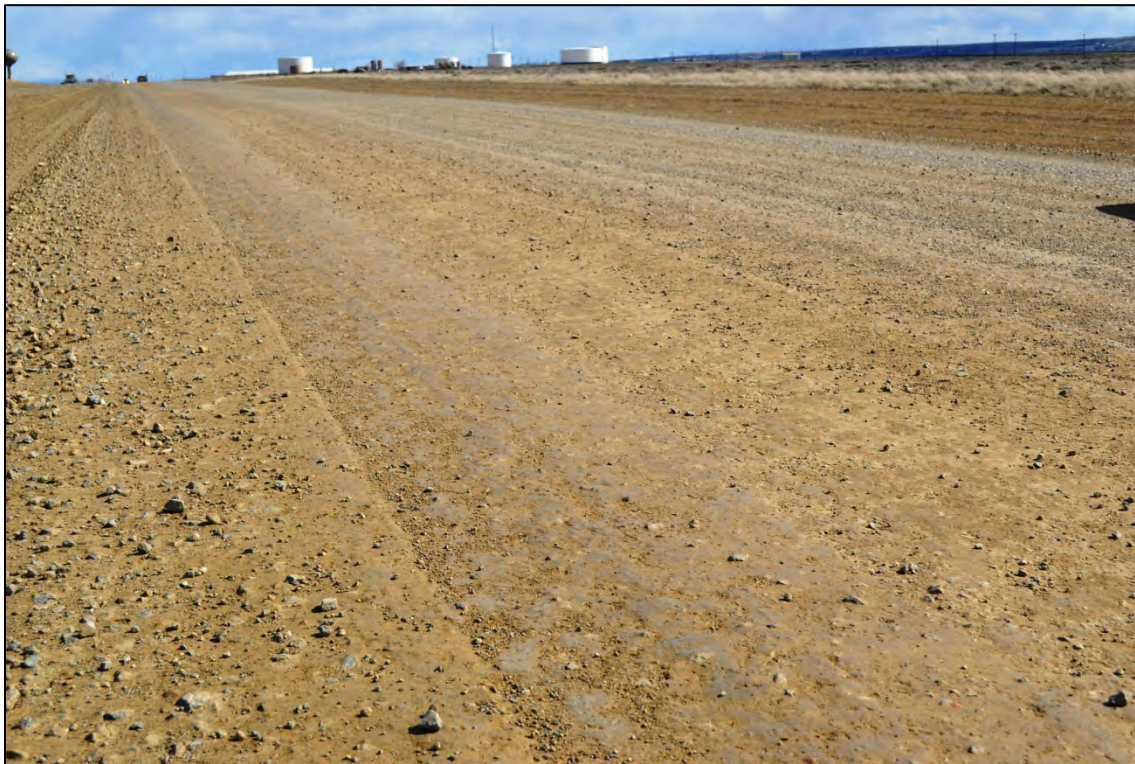
Figure 4.32 Road surface made of limestone crushed base treated with magnesium chloride on Sweetwater County's Crooks Gap Road.

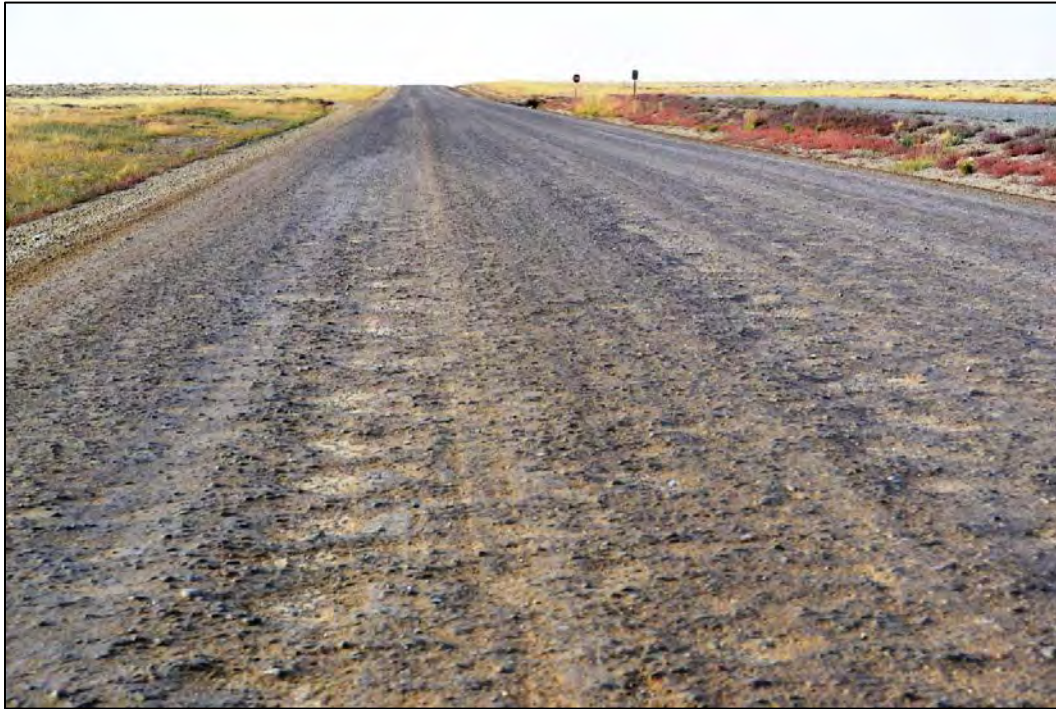
Figure 4.33 Road surface made of limestone crushed base treated with magnesium chloride on Sweetwater County's Crooks Gap Road showing small scale roughness.

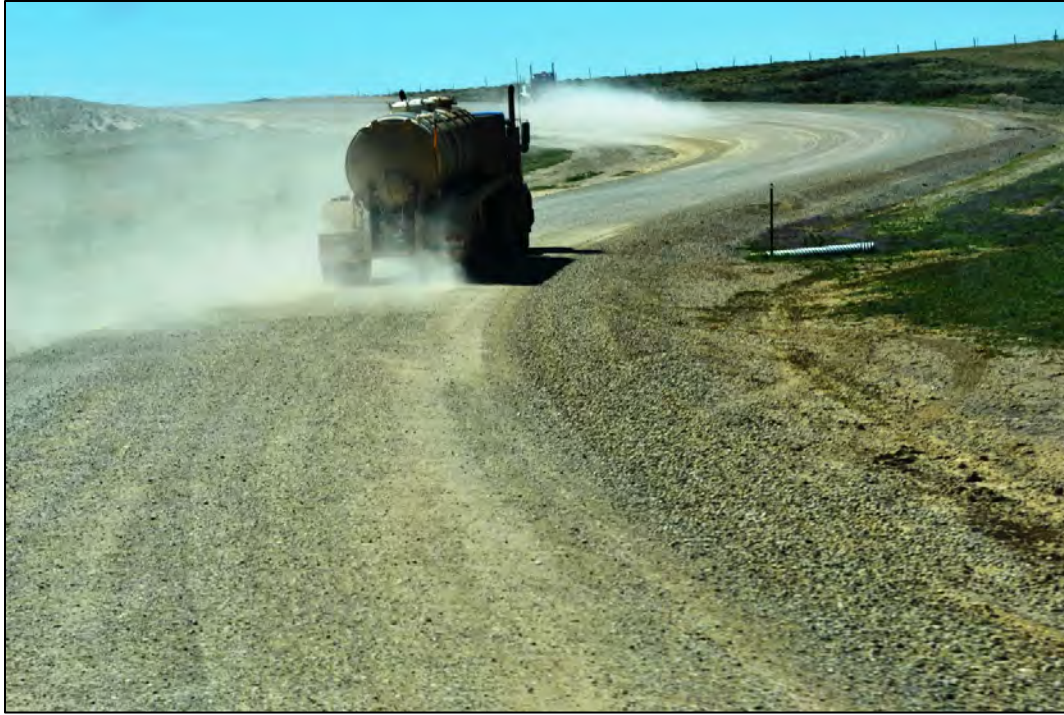
Figure 4.34 Dust from limestone crushed base before dust suppressant application on uphill, curved segment D of Sweetwater County's Crooks Gap Road in June 2011.

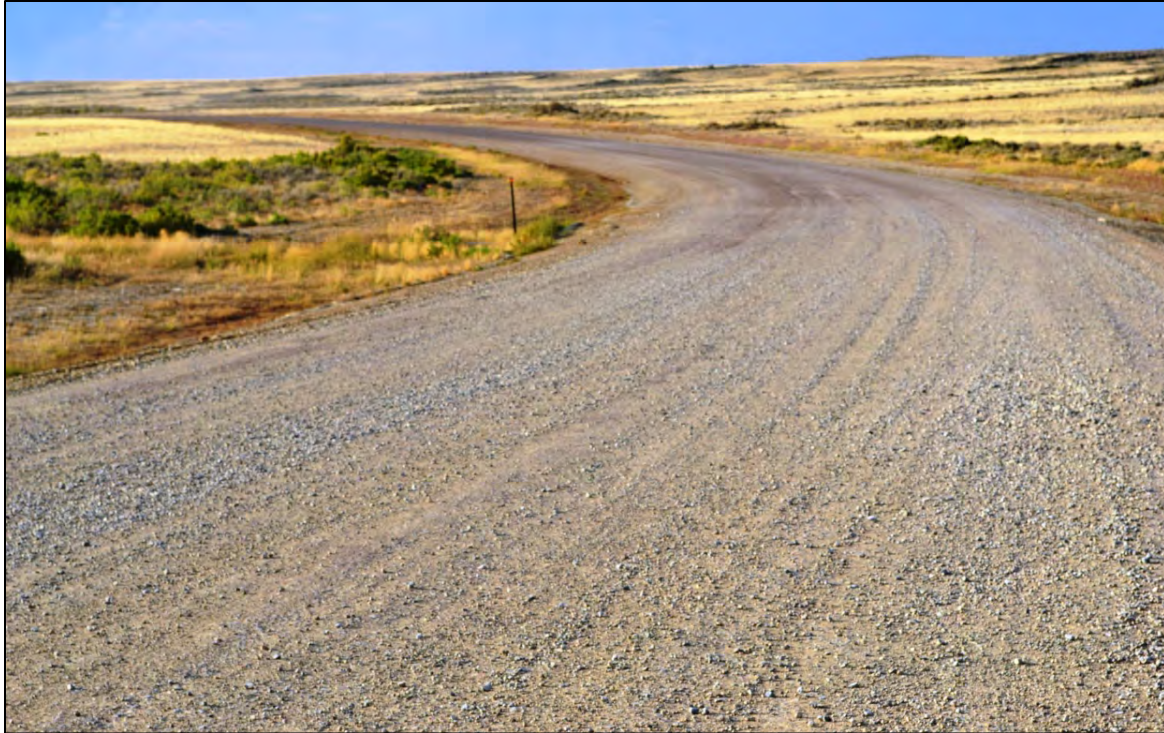
Figure 4.38 Broken up crust of limestone crushed base, foreground, and still intact crust, background, both treated with lignin and magnesium chloride on uphill, curved segment D of Sweetwater County’s Crooks Gap Road in September 2011, eight weeks after application of dust suppressant.

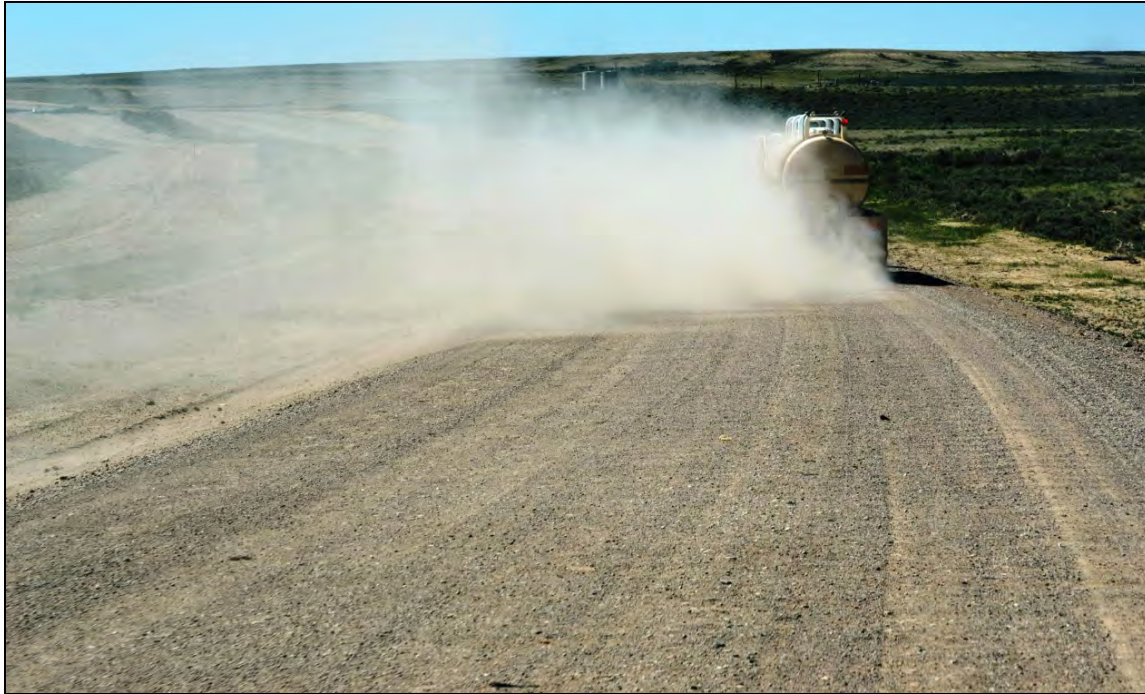
Figure 4.39 Dust from road surfaced with finer reclaimed cement-treated base on segment G of Sweetwater County's Crooks Gap Road in June 2011 before application of dust suppressant.

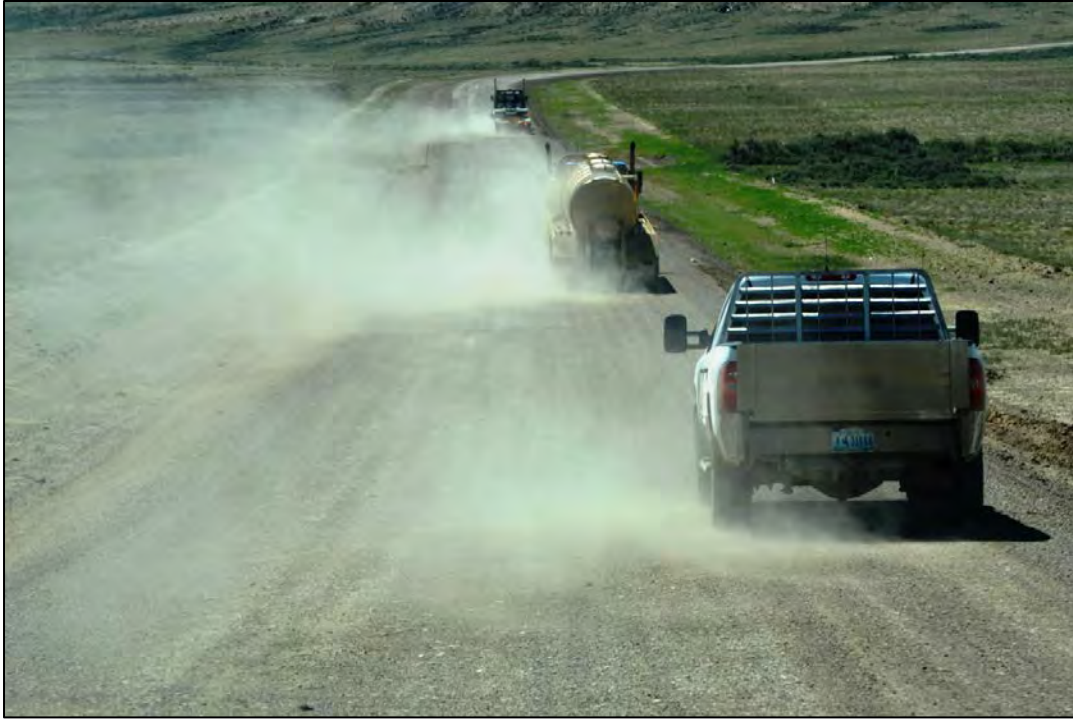
Figure 4.40 Dust from road surfaced with coarser reclaimed cement-treated base on segment E of Sweetwater County's Crooks Gap Road in June 2011 before application of dust suppressants.

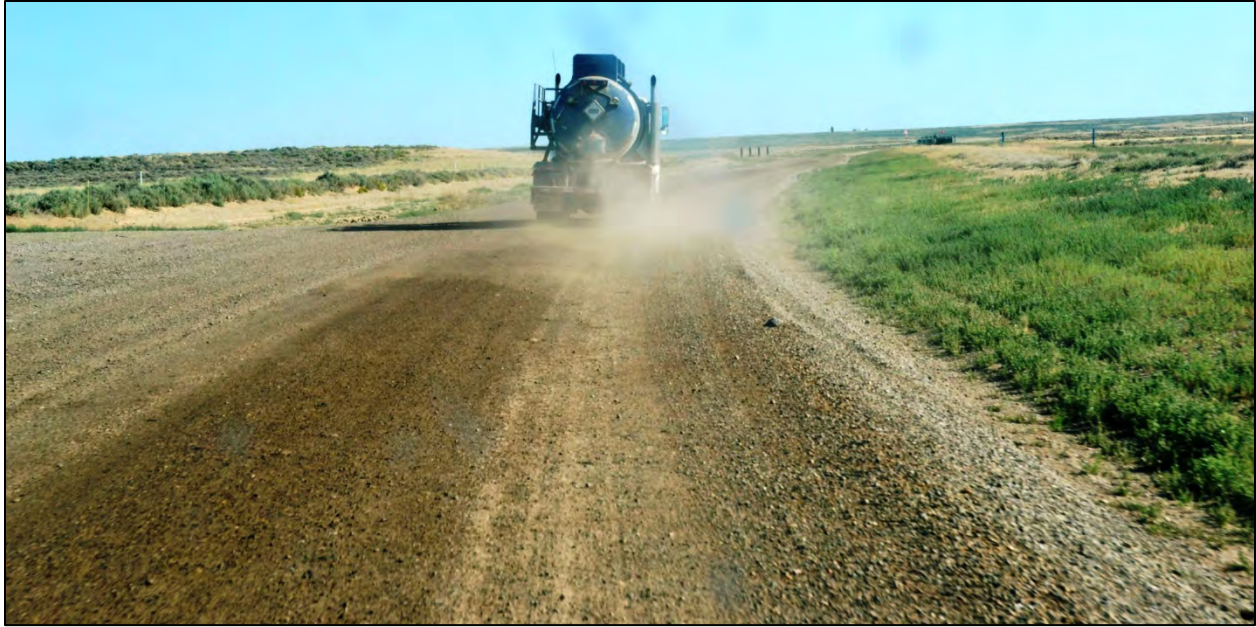
Figure 4.42 Road surface with good crust made of reclaimed cement-treated base treated with polymer and magnesium chloride on segment G of Sweetwater County's Crooks Gap Road in August 2011, three weeks after application of dust suppressant.

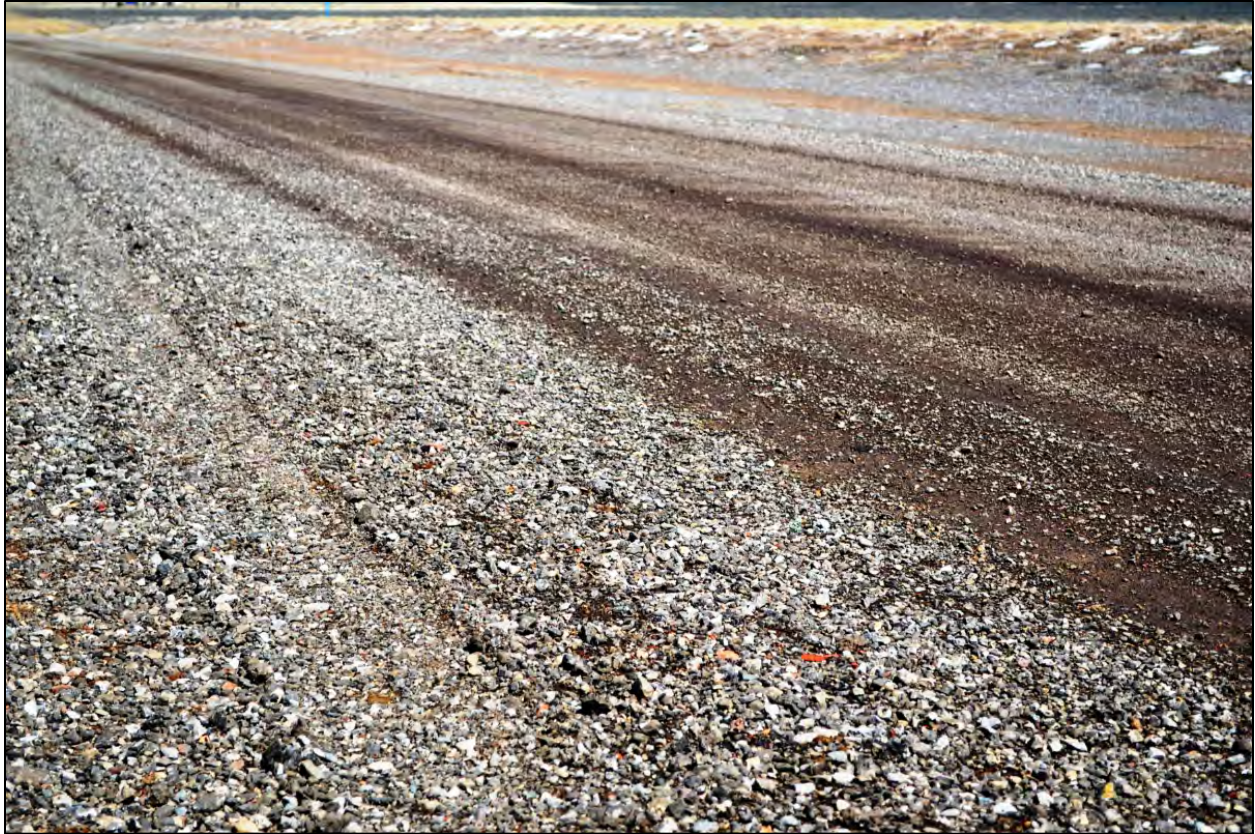
Figure 4.46 Road surface made from RAP blended with existing aggregate on segment Q of Sweetwater County’s Crooks Gap Road in April 2011 without dust suppression agents.

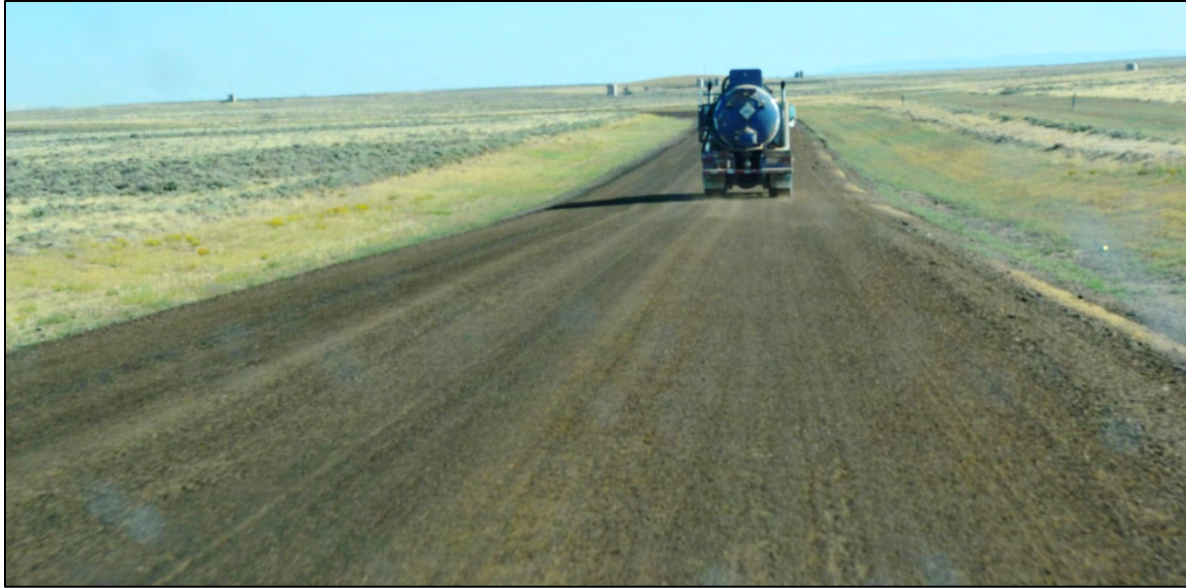
Figure 4.47 Road surface made from RAP blended with existing aggregate treated with magnesium chloride and polymer on segment M of Sweetwater County's Crooks Gap Road in August 2011, three weeks after application of dust suppressant.

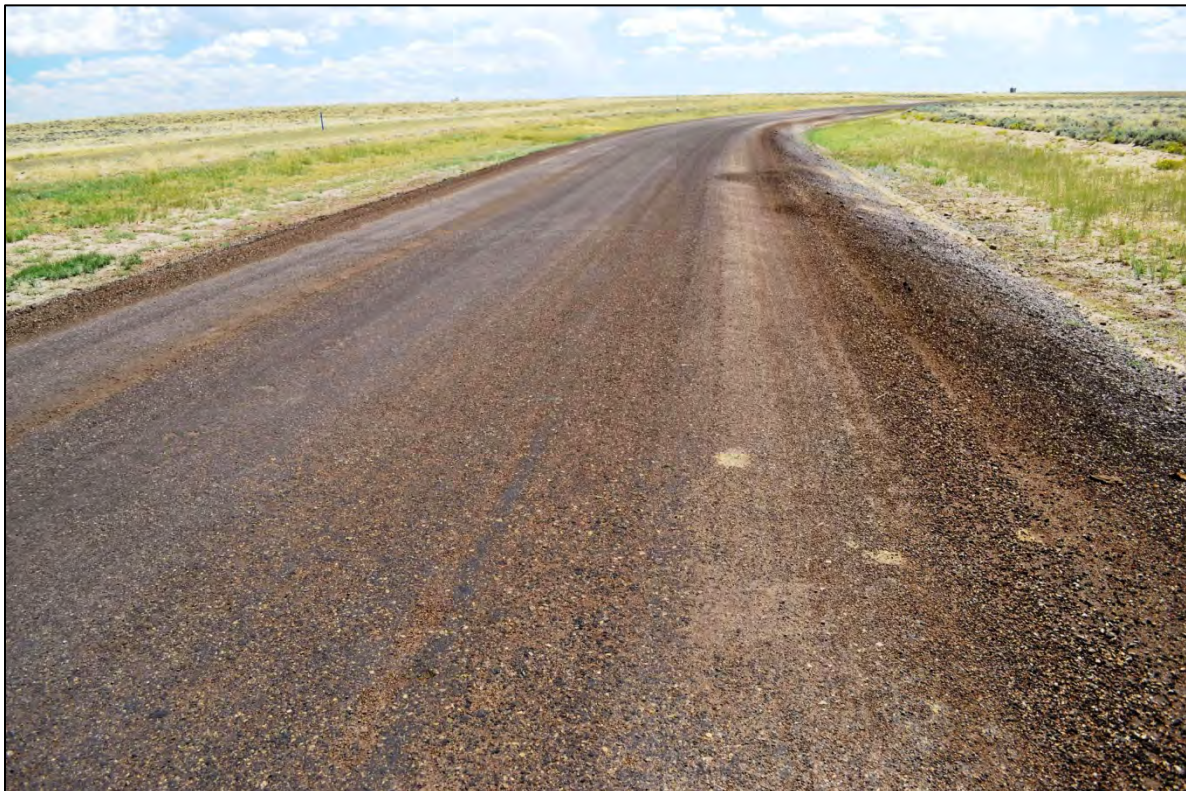
Figure 4.48 Road surface made from RAP blended with existing aggregate and treated with magnesium chloride on segment of Sweetwater County's Crooks Gap Road in August 2011, three weeks after application of dust suppressant.

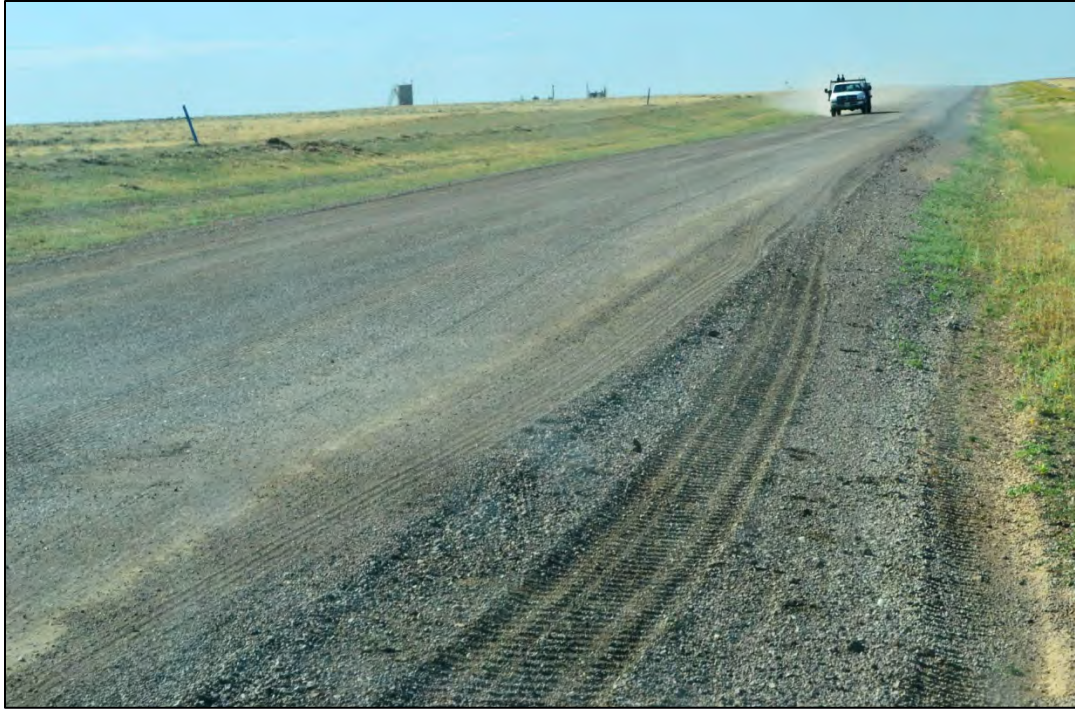
Figure 4.49 Road surface made from RAP blended with existing aggregate on segment P of Sweetwater County's Crooks Gap Road in August 2011.

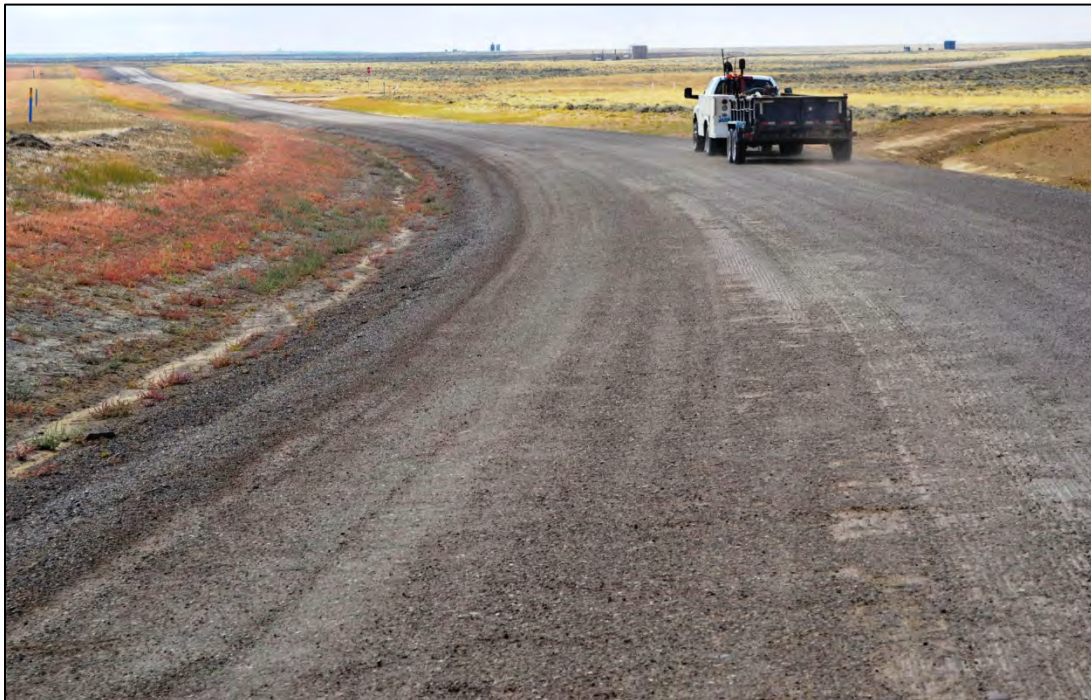
Figure 4.50 Road surface made with RAP blended with existing aggregate and treated with magnesium chloride on segment N of Sweetwater County's Crooks Gap Road in September 2011, eight weeks after application of dust suppressant.

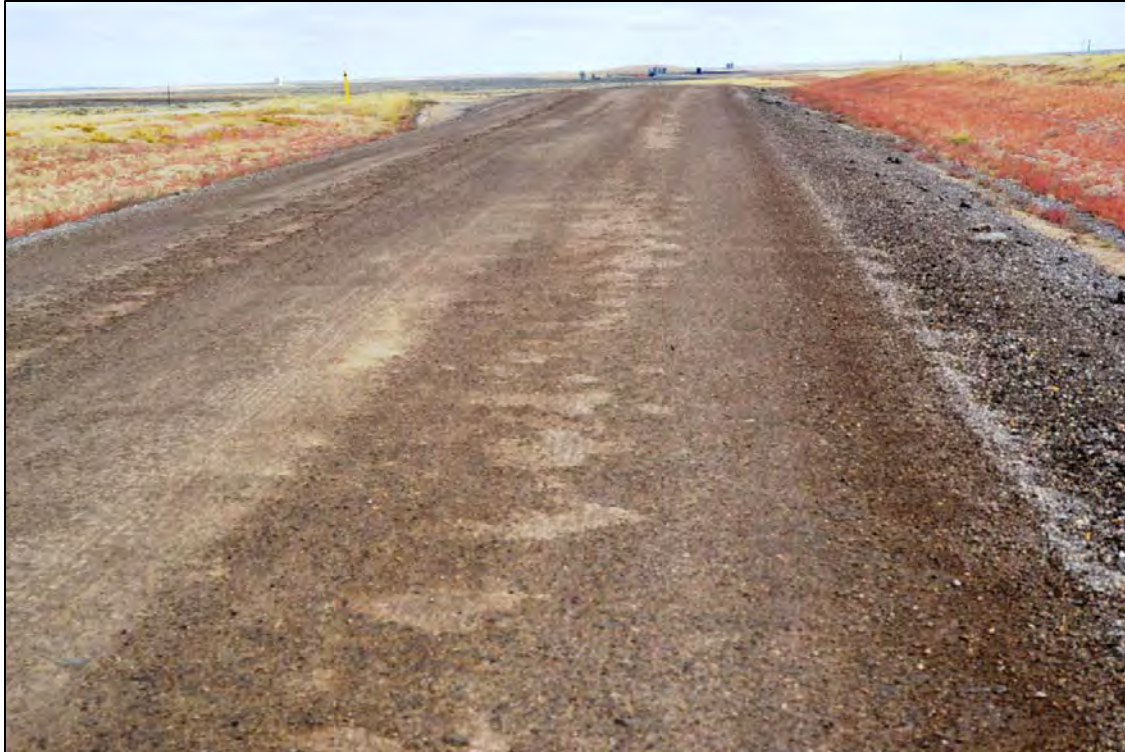
Figure 4.51 Road surface made with RAP blended with existing aggregate and treated with magnesium chloride and polymer on segment L of Sweetwater County's Crooks Gap Road in September 2011, eight weeks after application of dust suppressant.

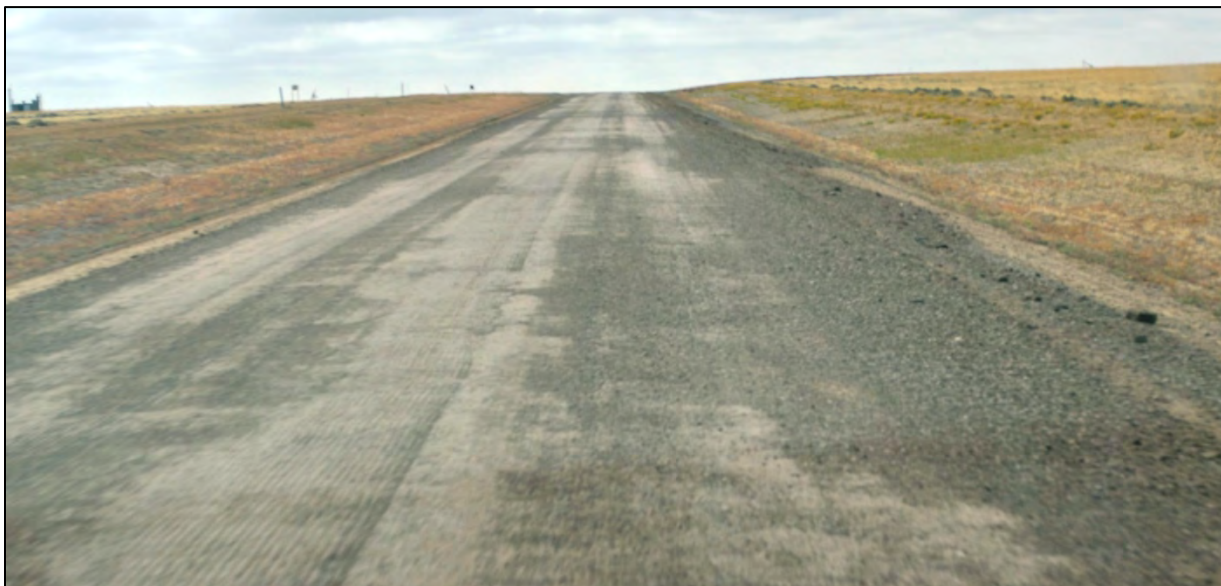
Figure 4.52 Road surface made with RAP blended with existing aggregate on segment P of Sweetwater County's Crooks Gap Road in September 2011.
