MPC 17-325 | Y. J. Kim

Performance of Steel Girders Repaired with Advanced Composite Sheets in a Corrosive Environment

**PERFORMANCE OF STEEL GIRDERS REPAIRED WITH
ADVANCED COMPOSITE SHEETS IN A CORROSIVE ENVIRONMENT**

June 2017

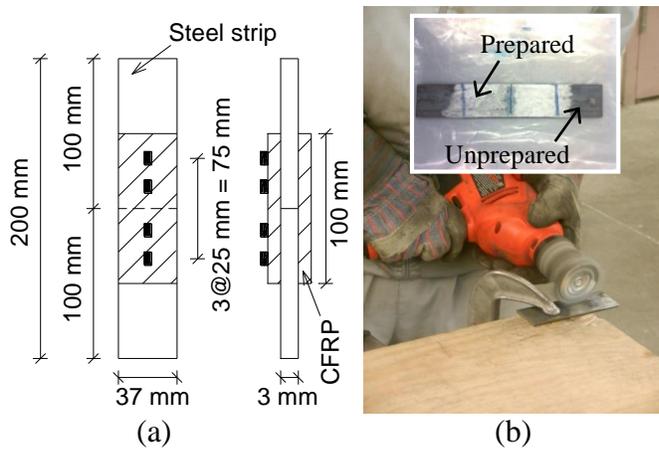
Figure I.1 Specimen details: (a) dimension; (b) surface preparation

Double-lap interface test coupons were prepared with two steel strips (100-mm long by 37-mm wide by 3-mm thick per strip) to be bonded with one layer of CFRP sheet (100-mm long by 37-mm wide by 0.165-mm thick per sheet) on each side, as shown in Figure I.1(a). Surface grinding was performed to enhance adhesion between the CFRP and steel [Figure I.1(b)]. A resin-hardener-mixed epoxy adhesive was employed to bond the sheet to the steel substrate. Table I.1 summarizes the mechanical properties (nominal) of these constituents. After evenly pasting the adhesive along the strips, precut CFRP sheets were positioned and softly pressed to squeeze out epoxy residues. In compliance with the manufacturer’s recommendation, the bonded specimens were cured for a minimum of one week at room temperature and their mass was measured. Seven test categories were planned to evaluate the effect of galvanic current on the performance of the CFRP-steel interface, as listed in Table I.2. The electrochemical-processing time varied from 0 hours to 72 hours and five specimens were used per category, including 35 specimens total.

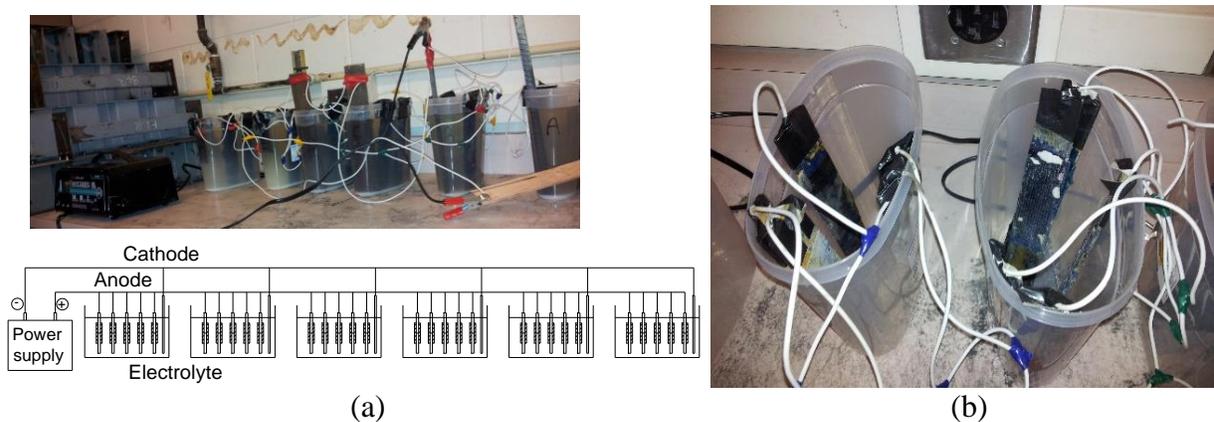
Figure I.2 Galvanic current generating protocol for electrochemical reactions: (a) schematic; (b) close-up view of anodes

Galvanic corrosion cells were fabricated with plastic containers, anodes, cathodes, and electrolytes, as shown in Figure I.2. The cured strips served as anodes where oxidation would take place, while additional metallic strips worked as cathodes experiencing reduction; in other words, the anode produced electrons ($\text{Fe} \rightarrow \text{Fe}^{2+} + 2\text{e}^{-}$) that were consumed by the cathode ($1/2\text{O}_2 + \text{H}_2\text{O} + 2\text{e}^{-} \rightarrow 2\text{OH}^{-}$). These two corrosion components were connected by conductive wires to facilitate electrochemical reactions, including an external direct current (DC) power supply (2A). A 3.5% sodium chloride solution was used as the electrolyte conducting a current and transferring the ions for hydrated ferric oxide at room temperature (the temperature in the galvanic cell was not measured). The electrode potential and current of each specimen were measured. It is worth noting that the maximum galvanic current exposure time of 72 hours was determined based on a preliminary test that resulted in a considerable amount of corrosion in the steel strips, whose corrosion rates converged (to be discussed). When the predetermined electrochemical processing time was achieved (Table I.2), all the specimens were retrieved and cleaned as guided by ASTM G1-03 (ASTM 2011).

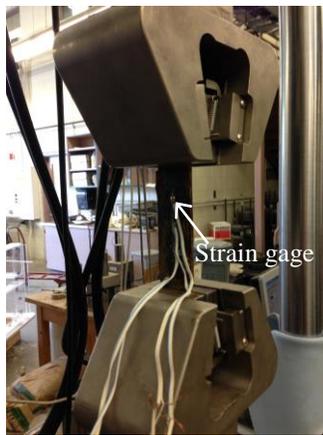
Figure I.3 Post-corrosion monotonic tension test

The interface test specimens were monotonically loaded at a rate of 0.5 mm/min using a 90 kN capacity universal testing machine, as shown in Figure I.3. To monitor the initiation and progression of CFRP debonding along the interface, strain gages were bonded at a typical spacing of 25 mm on center [Figure I.1(a)]. The applied load and corresponding displacement were recorded by a load cell and a loading-head stroke, respectively.

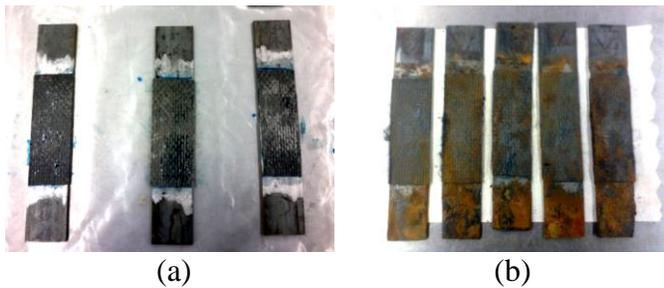
Figure I.4 Effect of galvanic current: (a) control; (b) specimens exposed to 36 hours

Figure I.4 compares the state of the specimens before and after the galvanic current processing. Hydrated ferric oxide, $\text{Fe}(\text{OH})_2$, formed along the steel strips (brown rust) because of the coupled reactions between the anodes and cathode in conjunction with passing of the iron ions into the electrolyte. The corroded steel surface was heterogeneous, and the edge of the specimens tended to exhibit more corrosion damage than other regions. Such an irreversible process resulted in a physical change in the specimens, as shown in Figure I.5. The surface area of the steel strips gradually decreased with an increase in electrochemical reaction time [Figure I.5(a)]. The surface area of the corroded specimens normalized by the average area of the 0-hour counterparts indicated that 18.7% of the surface area was lost at 72 hours, while the normalized area was reasonably maintained up to 60 hours. These observations can be explained by the fact that the progression of corrosion damage was relatively uniform over the steel strips, whereas localized corrosion was accelerated near the corner of the specimens as the effect of galvanic current augmented. The relationship between the variation of mass and corrosion time is available in Figure I.5(b). Although some scatter was noticed in all cases, it is apparent that the electrochemical reaction entailed a noticeable decrease in specimen mass up to 19.0% of the initial mass, on average, at 72 hours.

- The coupled reactions between the anodes and cathodes resulted in hydrated ferric oxide along the CFRP-steel interface, while the edge of the specimens attracted more corrosion damage in conjunction with a noticeable loss in their surface area and mass.

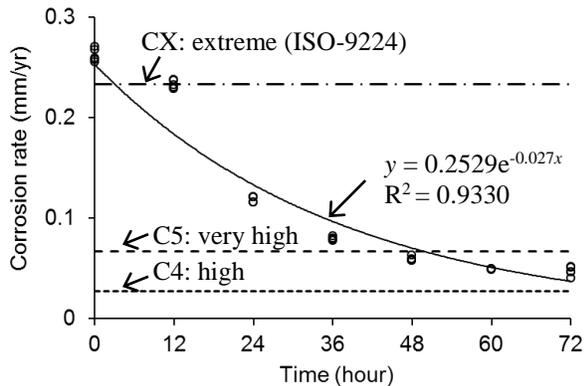
Figure I.6 Corrosion propagation with time

Figure I.6 shows the rate of corrosion (Eq. I.1) depending upon reaction hours. A propensity for an exponentially decreasing rate was observed, while the variation beyond 48 hours was not significant (i.e., the average corrosion rate from 48 hours to 72 hours was 0.05 mm/yr). This fact implies that electrochemical reaction was active when corrosion initiated; however, it tended to dwindle with an increase in time. Similar observations were reported by others (Yalcyn and Ergun 1996; Liu and Weyers 1998). Vu and Stewart (2000) noted that the diffusion of iron ions can be affected by the rust formed over a steel surface so that the progression of corrosion slows down as time increases due to the accumulated rust amount. Figure I.6 also compares the corrosivity of steel members exposed to various exposure conditions specified by ISO-9224 (ISO 2012): High (C4), Very high (C5), and Extreme (CX). The average experimental corrosion rate of 0.12 mm/yr was positioned between the C5 and CX categories, which is reasonable because the electrochemical reaction with galvanic current imposed on the CFRP-steel interface resulted in an accelerated corrosion environment that could represent aggressive service conditions.

- The variation of the corrosion rate clarified that the electrochemical reaction in the CFRP-steel interface decayed exponentially as a galvanic current exposure time increased. The diffusion process of iron ions appeared to slow down because of the accumulated rust along the test specimens.

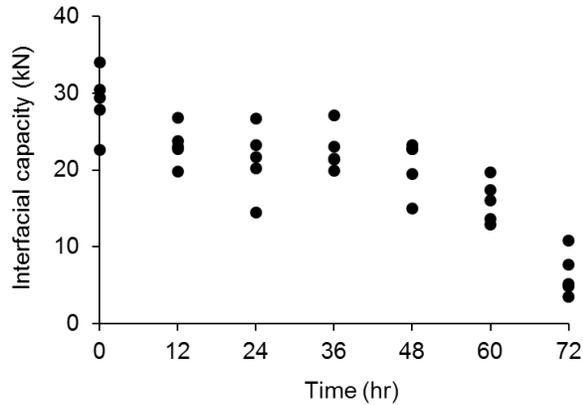
Figure I.7 Interfacial capacity of specimens

Figure I.7 reveals the interfacial capacity of the individual specimens. The initiation of corrosion damage within the CFRP-steel interface was apparent due to the galvanic current flowed, entailing the 19.5% average capacity drop between the reaction time of 0 and 12 hours. With an increase in corrosion-processing time from 12 hours to 24 hours, the percentage of the capacity drop was reduced down to 8.4%. In between 24 hours and 48 hours, the interfacial capacity remained virtually unchanged. A significant capacity reduction was noticed beyond 48 hours, including an average drop of 77.7% for the specimens exposed to 72 hours in comparison with the strength of the un-corroded specimens (0 hours). Irrespective of the extent of electrochemical reactions, all interface specimens failed by CFRP-debonding when mechanically loaded (Figure I.8). Disintegration of the CFRP composite itself was not observed in the corroded specimens from a macro-scale standpoint. In other words, the galvanic current primarily deteriorated the steel substrate (and the CFRP-steel interface), rather than the CFRP. It is thought that the adhesive layer has impeded galvanic interaction between the steel and the conductive carbon fibers. This finding clarifies that an additional protection layer between the CFRP and steel is not necessary (e.g., glass FRP sheets may be positioned in between the steel substrate and CFRP to

mitigate the occurrence of galvanic corrosion as used in some experimental programs, Mertz and Gillespie 1996; Shaat and Fam 2008), as long as the bonding agent is properly applied along the steel substrate.

- The load-carrying capacity of the interface was influenced by the rate of corrosion in such a sense that the capacity drop when corrosion damage initiated was 232% greater, on average, than the drop within a steady-state corrosion progression period. Some load-softening was noticed due to the formation of hydrated ferric oxide that partially degraded the steel surface (a mix of bonded and unbonded CFRP regions). A protection layer between the steel substrate and the CFRP for the sake of mitigating galvanic interaction was found to be unnecessary.

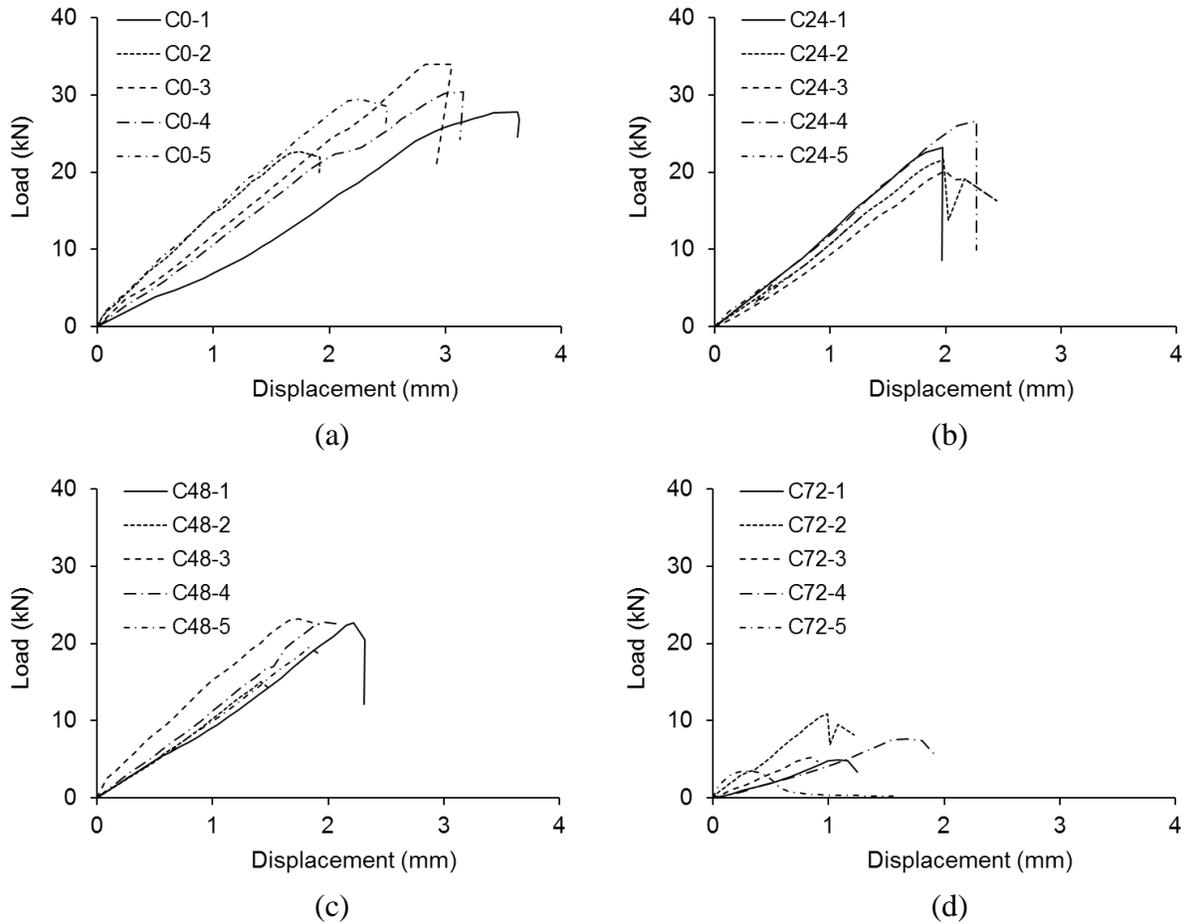
Figure I.9 Load-displacement behavior: (a) 0 hours; (b) 24 hours; (c) 48 hours; (d) 72 hours

The load and displacement behavior of selected interfacial specimens is depicted in Figure I.9. The displacement of the specimens increased linearly with the load until abrupt failure took place. As discussed in the previous sections, some scatter was noticed in capacity and stiffness because of uneven corrosion progression along the interface. Although all the responses were intrinsically brittle, some specimens in the 72-hour exposure category [Figure I.9(d)] demonstrated gradual load-softening after their peak loads were achieved. Such a fact points out that the bonded steel surface was partially damaged by the formation of the hydrated ferric oxide; hence, the mechanical failure of the interface occurred in a progressive manner. Figure I.10 describes the variation of the stiffness depending upon the level of electrochemical processing time. It was unlikely to characterize the effect of galvanic current on the response of the interfacial stiffness; nonetheless, the average stiffness of all the specimens (10.2 kN/mm) could be a reference value for the CFRP-steel interface exposed to a corrosive environment. Figure I.11 provides the strain development of the CFRP-steel interface with respect to the

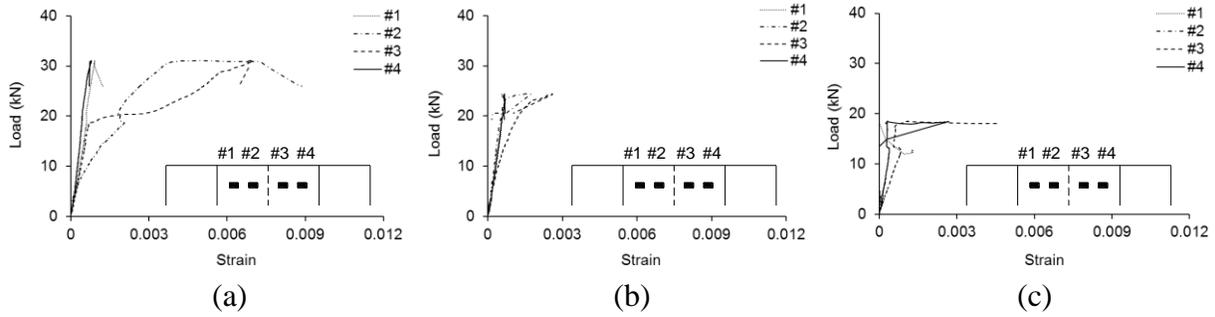
Figure I.11 Load-strain behavior: (a) 0 hours; (b) 24 hours; (c) 48 hours

applied load. A general trend found was that strain gages bonded near the middle of the specimen (Gages 2 and 3) showed early CFRP-debonding, which was indicated by a bifurcation from the ascending linear load-strain branch. This is because the gap between the two steel strips [Figure I.1(a)] caused stress singularity. Such premature local debonding may be observed in full-scale steel girders strengthened with CFRP sheets when geometric discontinuity occurs (e.g., fatigue cracking).

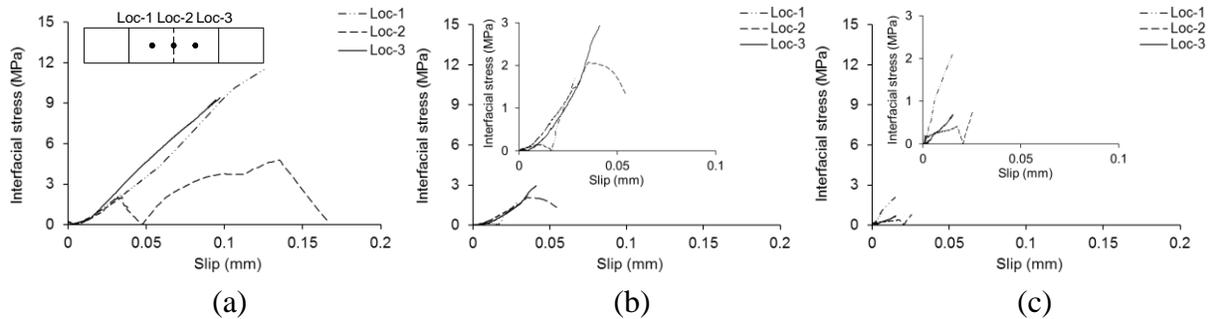
Figure I.12 Interfacial stress-slip behavior: (a) 0 hours; (b) 24 hours; (c) 48 hours

where τ is the average interfacial stress between two arbitrary spatial locations (x_2 and x_1) exhibiting a strain gradient $\Delta \varepsilon(x)$; Δx is the distance between the two locations; E_F and t_F are the elastic modulus and thickness of the CFRP, respectively; s is the slip of the CFRP over the steel substrate. For the un-corroded 0-hour interface [Figure I.12(a)], the middle of the specimen (Location 2) where a geometric discontinuity existed showed multiple ascending and descending stress-slip responses; on the other hand, the interfacial stresses at locations 1 and 3 (outside the discontinuity) continuously developed up to their peak along with an increase in slip. These

observations illustrate that i) the propagation of local CFRP-debonding was gradational in the vicinity of the discontinuity (possibly accompanying complex interaction between the bonded and partially-debonded regions), and ii) the behavior of the CFRP-steel interface outside the stress singularity zone was preserved until the gradational debonding progressed. The electrochemical reaction induced by the galvanic current altered the stress-slip behavior of the interface, as revealed in Figure I.12(b) and (c). The aforementioned stress development pattern was maintained even though the extent was reduced noticeably. Figure I.13 demonstrates the influence of reaction time on the maximum interfacial stresses of the specimens. As mentioned earlier, the stress significantly decreased when electrochemical damage was initiated and was gradually reduced as the galvanic current propagated. The increased stresses at 60 and 72 hours could be explained by the fact that corrosion-induced impurities on the steel substrate augmented frictional resistance in conjunction with CFRP slip, which resulted in an increase in strain gradient (Eq. I.2).

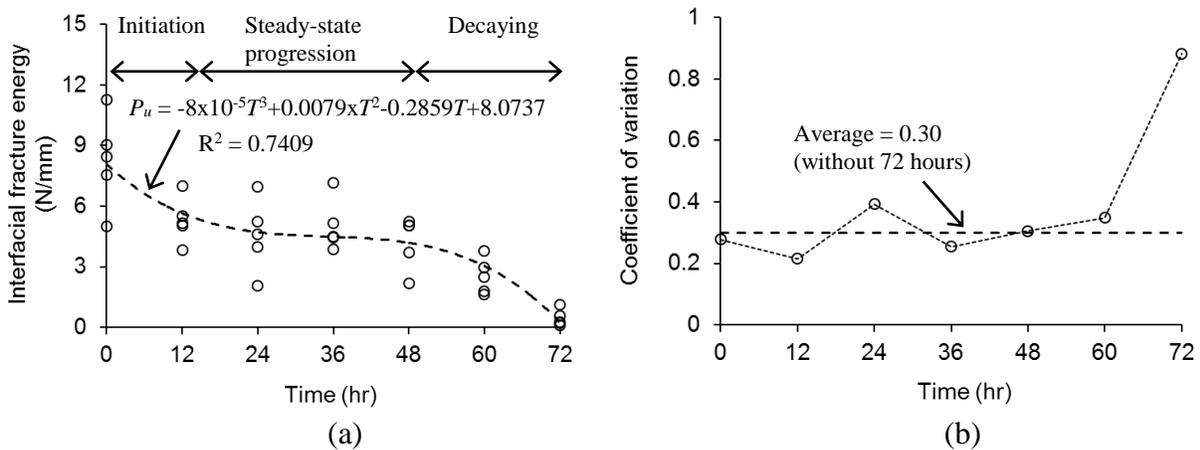
Figure I.14 Interfacial fracture energy: (a) variation with exposure time; (b) coefficient of variation

Figure I.14(a) summarizes the variation of the interfacial fracture energy with respect to exposure time (Eq. I.8). Three performance stages linked with corrosion damage were noticed: initiation, steady-state progression, and decaying. The interfacial fracture energy within the first stage was rapidly reduced from 8.3 N/mm to 5.3 N/mm at 0 hours and 12 hours (0.25 N/mm per hour), on average; on the other hand, the average fracture energy drop in the steady-state progression zone was 0.03 N/mm per hour from 12 hours to 48 hours. Within an exposure period between 60 and 72 hours, the degradation of the interfacial fracture energy was accelerated to 0.17 N/mm per hour. From a practical perspective, the initiation and steady-state progression stages can typically occur during the service life of a CFRP-strengthened steel member; however, the decaying stage may be observed at discrete locations where corrosion damage is concentrated, rather than along the entire interface. The coefficient of variation (COV) of the fracture energy was almost constant up to 60 hours with an average value of 0.30, as shown in Figure I.14(b), whereas the COV of 72 hours was much higher than others, possibly because of the unstable interfacial bond associated with substantial corrosion on the steel substrate (i.e., a mix of bonded and unbonded regions as previously explained).

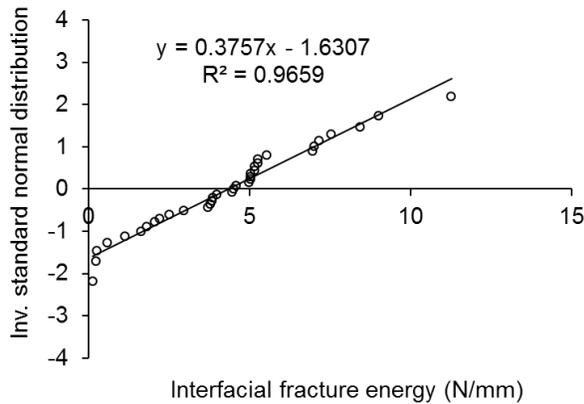
Figure I.15 Normality check for test specimens

where Φ is the standard normal quantile function, G_{fi} is the sorted interfacial fracture energy, k is the total specimen number, and a is a constant ($a = 0.375$ and 0.5 for $k \leq 10$ and $k > 10$, respectively). The relationship between the inverse standard normal distribution and the interfacial fracture energy is provided in Figure I.15. Significant linearity was observed with a coefficient of determination of $R^2 = 0.9659$. It is, therefore, concluded that the corrosion-dependent fracture energy of the CFRP-steel interface had a normal probability distribution. Figure I.16(a) reveals the transition of the inferred probability distributions, depending upon galvanic current exposure time, in accordance with the best-fit fracture energy formula and the average COV of 0.30 as shown in Figure I.14. The phase transition of the interfacial fracture energy was obvious with an increase in exposure hour (i.e., the most probable fracture energy became pronounced). The distribution of 72-hour exposure was not available because the interface was predicted to fail (i.e., complete deterioration, $D = 1$ and $n_f = 72$ hours). The probability of interface deterioration (Eq. I.6) is available in Figure I.16(b). A deterioration probability of 0.42 was noticed at 12 hours, which implies that the CFRP-steel interface was susceptible to damage when corrosion initiated, while the progression of the deterioration probability was relatively consistent until 72 hours was reached.

- The probability distribution of the corrosion-dependent interfacial fracture energy was found to be normal, with an average coefficient of variation of 0.30. The probability-based theoretical framework predicted the degree of interface deterioration subjected to an aggressive service environment, in particular, corrosive circumstances.

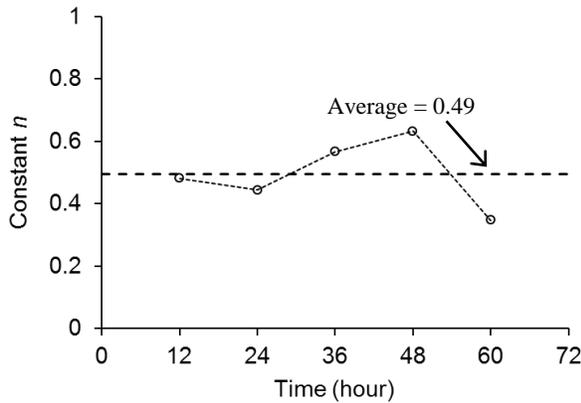
Figure I.17 Determination of deterioration constant

The empirical constant n of Eq. I.5 was acquired by Figure I.17 (individual n values for 0 hours and 72 hours were not obtainable by definition), including an average value of $n = 0.49$. All the empirical constants determined previously were substituted into Eq. I.4, and the level of interface deterioration was predicted, as shown in Figure I.18(a). It was estimated that deterioration levels of 0.25 and 0.5 could take place at 7% and 25% of the failure time ($t_i/t_f = 0.7$ and 0.25), respectively. Figure I.18(b) illustrates the rate of interface deterioration. A rapid increase in deterioration rate was observed at the beginning of CFRP-strengthening, followed by an exponentially decreasing trend with time. Such a predicted deterioration rate was aligned with the corrosion rate presented in Figure I.6, and theoretically corroborates the aforementioned assertion concerning the interrupted diffusion process of iron ions as the amount of surface rust augmented.

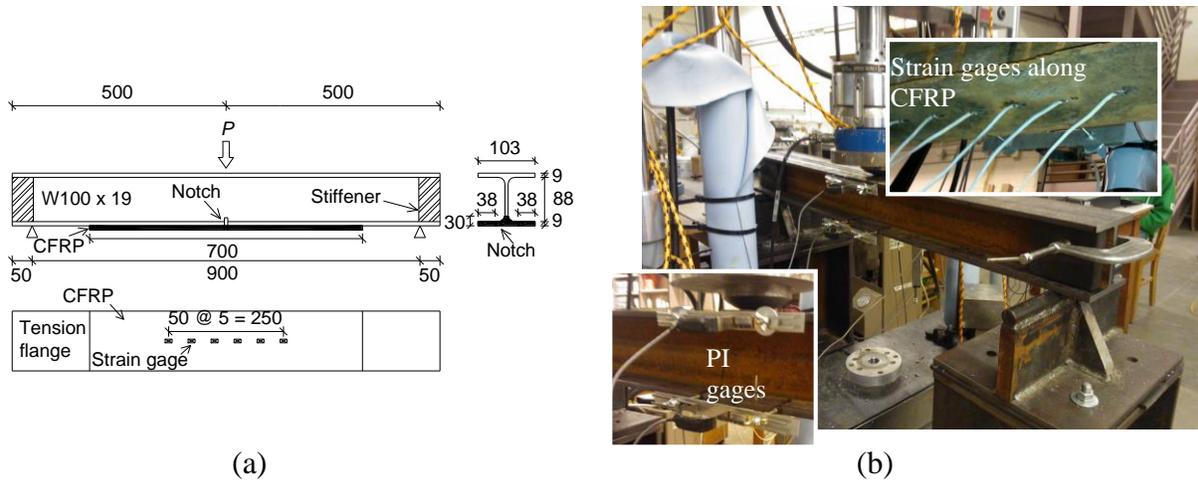
Figure II.1 Beam details: (a) dimensions (unit in mm); (b) flexural test and instrumentation

A total of 22 beams were prepared, including one un-strengthened, three un-corroded, and 18 corroded beams. W100×19 steel beams were precut to a length of 1,000 mm. A notch of 30 mm at midspan was created using a blade saw to simulate structural damage (e.g., fatigue cracking), as shown in Figure II.1(a). Such a damage configuration is often used when examining the flexural behavior of CFRP-strengthened steel beams (Nozaka et al. 2005; Shaat and Fam 2008; Nakamura et al. 2009). Another purpose of the notch was to initiate CFRP-debonding at midspan for observing a consistent failure pattern, regardless of test configurations. Before bonding the CFRP sheet, the steel substrate was ground using an electric steel brush to enhance bond between the steel and the CFRP and was cleansed with an air compressor. Other surface preparation methods, such as grit-blasting, are also available, while according to the authors' previous experience, the performance of adhesively bonded CFRP was virtually independent of preparation techniques as long as the surface is sufficiently roughened and the robust chemical bonding of polymeric adhesives controls the interfacial behavior. The mixed epoxy was pasted on the prepared steel surface and one layer of CFRP sheet (100 mm wide×0.165 mm thick×700 mm long) was impregnated. To squeeze out excessive epoxy residues, the CFRP surface was softly rubbed with a spatula (an adhesive thickness of about 1 mm was achieved along the bond-line). All the CFRP-bonded beams were cured for seven days at room temperature prior to commencing an electrochemical process.

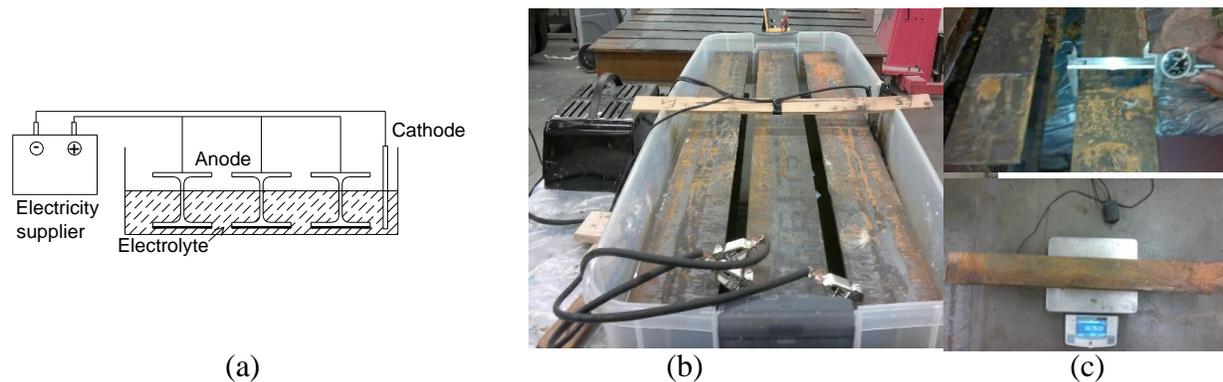
Figure II.2 Electrochemical reaction: (a) schematic; (b) test in progress; (c) measuring surface area and mass loss

An electrochemical reaction cell was exploited for accelerated corrosion testing, as schematically shown in Figure II.2(a). The corrosion cell consisted of an external power supply (2A direct current), anodes (steel beams), a cathode (a metallic strip), an electrolyte (3.5% NaCl solution that is commonly used in accelerated corrosion test programs), and connecting wires between the cathode and anodes. Upon generating electricity, the anode beams lost electrons ($\text{Fe} \rightarrow \text{Fe}^{2+} + 2\text{e}^-$) and the electrolyte expedited oxidation ($4\text{Fe}^{2+} + \text{O}_2 \rightarrow 4\text{Fe}^{3+} + 2\text{O}^{2-}$) associated with a reduction reaction at the cathode ($\text{O}_2 + 2\text{H}_2\text{O} + 4\text{e}^- \rightarrow 4\text{OH}^-$). Brown rust then formed around the steel beams with increasing time [Figure II.2(b)]. During this electrochemical process, the electrical potential and current of the beams were monitored. The CFRP-strengthened beams submerged in the electrolyte were subjected to a simulation period from 12 hours to 72 hours at a typical interval of 12 hours (the electrochemical responses of the beams approached zero at 72 hours, and this was determined from a preliminary test), as listed in Table II.1: three beams were simultaneously exposed to each corrosion environment.

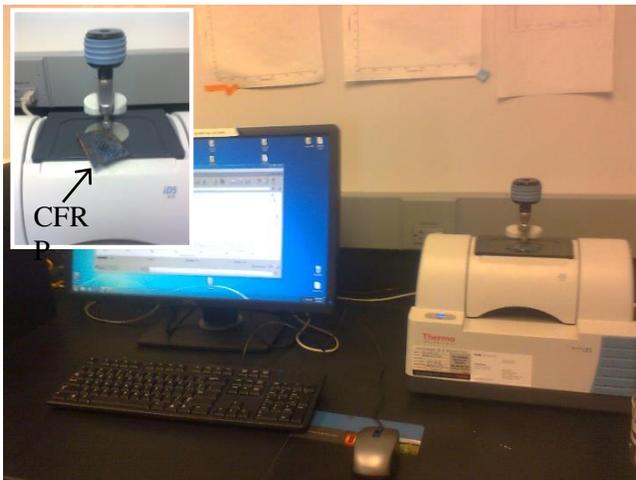
Figure II.3 Fourier transform infrared spectroscopy

Fourier transform infrared spectroscopy (FTIR) was conducted to investigate the consequence of the electrochemical reaction on the composition of the strengthening system. An attenuated total reflectance (ATR) technique was employed with a typical penetration depth of 2 mm and an incidence angle of 45° . Upon completion of the mechanical test described above, the failed CFRP sheet was cut to length, 20 mm by 30 mm, and exposed to infrared, as shown in Figure II.3. The absorbance of each specimen was detected within a range of 4000 cm^{-1} to 550 cm^{-1} , including an increment of 0.48 cm^{-1} . Response spectra were recorded to analyze the functional groups of the strengthening system subjected to electrochemical distress.

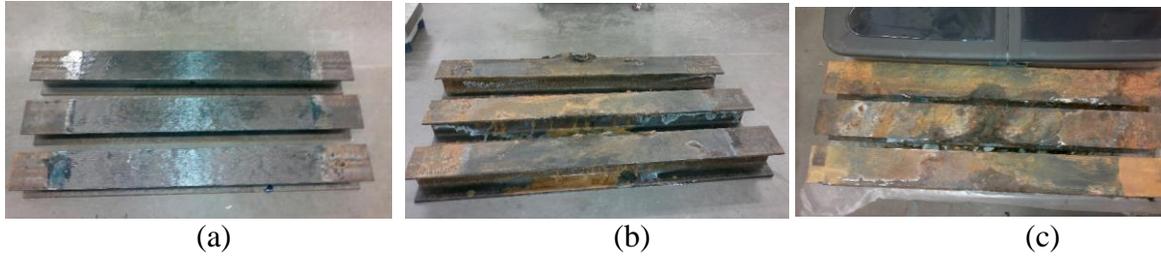
Figure II.4 Propagation of corrosion with time: (a) 12 hours; (b) 36 hours; (c) 72 hours

A qualitative assessment of the strengthened beams subjected to the electrochemical reaction is provided in Figure II.4. It is apparent to note that corrosion has initiated near both ends of the beams at 12 hours, as shown in Figure II.4(a); however, the CFRP-strengthened region appeared to be intact. With a 36-hour increase in corrosion-processing time [Figure II.4(b)], dispersed surface-pitting was observed in the uncovered areas (i.e., outside the CFRP) of the beams, and partial brown rust was also noticed along the CFRP sheet. For the beams at 72 hours [Figure II.4(c)], the extent of corrosion became severe and rust formed in the steel spread widely and deeply with some localized crevice corrosion. The CFRP sheets were covered by rust-generated impurities; nonetheless, premature bond failure was not detected by visual inspection. Figure II.5 exhibits the corrosion-dependent properties of the strengthened beams. The measured surface area of the beams was virtually constant [Figure II.5(a)] even though an average drop of 2% was noticed when corrosion time increased from 0 hours to 72 hours. This observation implies that the surface area of the strengthened beams was not a contributing factor to the rate of corrosion. The average coefficient of variation (COV_{average} hereafter) of the surface area was approximately 6×10^{-4} . The loss of mass varied linearly with time, which can be categorized into three stages, as shown in Figure II.5(b): gradual (0 hours to 36 hours), steady (36 hours to 60 hours), and rapid (60 hours to 72 hours) increases. The first stage describes corrosion initiation and propagation due to irreversible oxidation. The second stage is concerned with serviceability based on the steady-state electrochemical reaction, while the last stage encompassed unstable dissolution. The transition from the second to the last stages might indicate serviceability concerns for the CFRP-strengthened steel beams. Figure II.5(c) reveals a decrease in electric potential, which can characterize the likelihood of corrosion. A slight downward gradient in potential was observed with an increase in time from 0 hours to 12 hours (0.04 V/hr on average), which implies that the strengthened beams experienced ion migration (from the anode to the cathode) and corrosion initiated accordingly. The decrease rate in potential became more pronounced between 12 hours and 24 hours (0.35 V/hr on average), beyond which a relatively stable decrease rate was observed up to 60 hours. The average potential at 72 hours was 8% compared with that of the 0-hour beams, while the average potential rate was 0.22 V/hr. This fact indicates that the potential difference between the anode and cathode became insignificant, thereby minimizing the flow of electric current or galvanic current between them. The variation of corrosion current density (i_{corr}) with time is provided in Figure II.5(d). Similar to the potential shown in Figure II.5(c), the current density was noticeably reduced up to 24 hours and exhibited a stable decrease rate until an exposure time of 72 hours was achieved. It is thought that the brown rust formed on the steel surface tended to impede the interaction between the anode and the electrolyte to a certain extent (i.e., less diffusion of iron ions), and hence the measured electric properties decreased with time.

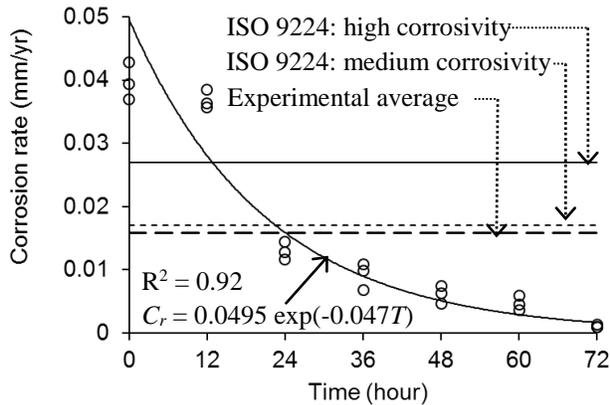
Figure II.6 Variation of corrosion rate based on Faraday’s law

Figure II.6 displays the corrosion rate of the strengthened beams determined by Faraday's law (Eq. II.1). The rate was maintained up to 12 hours with an average of 0.038 mm/year, followed by a noticeable drop until an exposure time of 72 hours was reached. This fact indicates that the development of corrosion was rapid at an early stage, while it had a propensity for slowing down when rust formed on the steel substrate due to less diffusion of iron ions, as explained earlier. The experimentally obtained average corrosion rate was 0.016 mm/year, which was close to the 10-year corrosion rate of ISO 9224 (ISO 2012) in the C3 category (medium corrosivity).

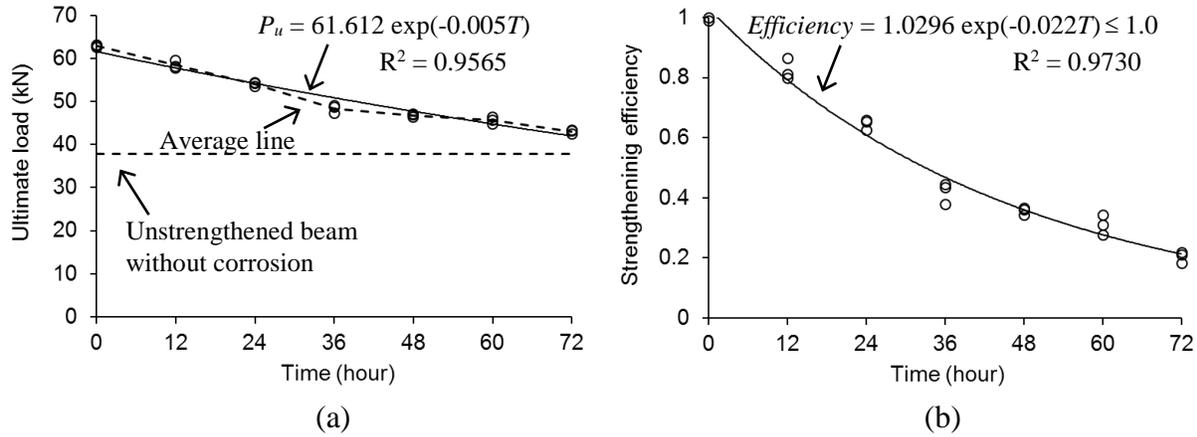
Figure II.7 Load-carrying capacity of the beams: (a) ultimate load; (b) efficiency of CFRP-strengthening

The failure load of the strengthened beams subjected to various levels of accelerated corrosion is provided in Figure II.7(a). Because of their relatively short span-length, lateral torsional buckling did not take place. The efficacy of CFRP-strengthening was significant without the occurrence of corrosion; in other words, the average load-carrying capacity of the strengthened beams at 0 hours was 66% greater than that of the un-strengthened case ($P_u = 37.9$ kN). The ultimate load of the beams was, however, reduced as the extent of corrosion augmented: a bilinear trend was observed before and after 36 hours of exposure according to the average line. The mean rates of load-drop from 0 hours to 36 hours and 48 hours to 72 hours were 0.40 kN/hr and 0.15 kN/hr, respectively. This indicates that the level of corrosion damage in the strengthened beams (specifically, damage of the CFRP-steel interface) had a transition period from an initiation-propagation phase to a steady-state-development phase. It was apparent that the bond between the CFRP and the steel substrate was influenced by the propagation of corrosion, thereby decreasing the effectiveness of CFRP-strengthening, as illustrated in Figure II.7(b), which is based on the strength efficiency factor Ω_{CFRP} (Eq. II.3). Such a long-term issue shall be considered when CFRP-strengthening for steel members is designed (further discussion is available in the Design Recommendations section). Figure II.8 depicts the load-displacement behavior of selected beams. The beams at 0 hours [Figure II.8(a)] showed an almost consistent response until their ultimate loads were reached at 62.9 kN on average (Table II.1), including yielding of the steel section followed by an abrupt load drop. The corrosion-damaged beams, on the other hand, exhibited somewhat scattered responses due to irregular corrosion damage along the CFRP-steel interface [Figure II.8(b) and (c)]. Nonetheless, the flexural stiffness of all the beams appeared to be more or less similar. Such a fact explains that synergetic damage (i.e., corrosion plus mechanical distress) on the interfacial bond was not obvious in a typical service stage beyond which the interfacial damage was accelerated by corrosion (lowering the load-carrying capacity of the beams).

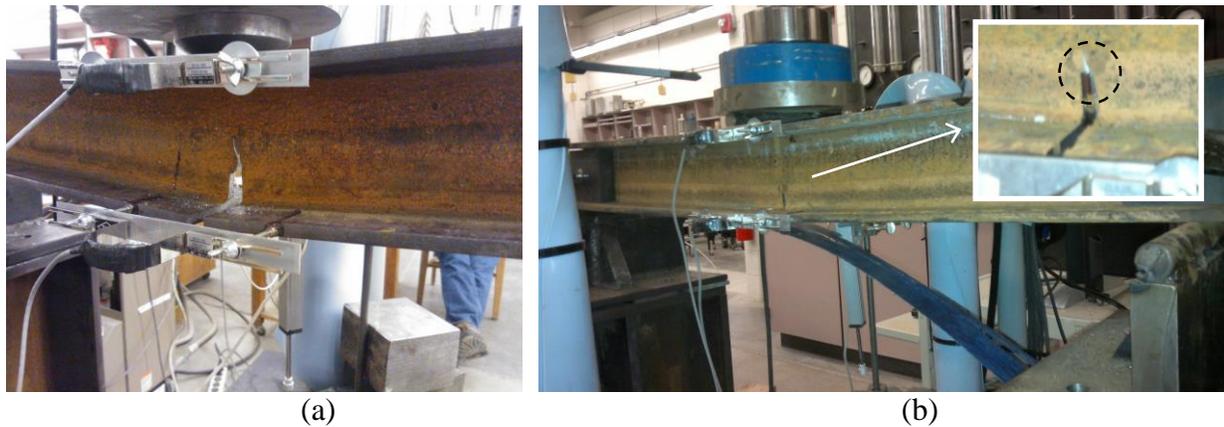
Figure II.9 Failure mode: (a) ductile fracture cracking; (b) CFRP-debonding

The unstrengthened beam failed by ductile fracture in the vicinity of the midspan notch where stress singularity was associated, as illustrated in Figure II.9(a). The web-crack may be regarded as an intergranular fracture engaged with the slip of the lattice structure, accompanying gradual crack-tip plasticity (Cooke et al. 1975). All the strengthened beams demonstrated CFRP-debonding failure [Figure II.9(b)] because the interfacial stresses exceeded the adhesion capacity of the epoxy, irrespective of corrosion-damage level. More specifically, partial CFRP-debonding was first observed near the notch because of a geometric discontinuity associated with stress concentrations, and propagated along the bond-line with a further increase in load. Such a failure sequence resulted in an abrupt drop in the load and displacement behavior, as shown in Figure II.8. Once complete CFRP-debonding occurred, a sharp crack developed at the tip of the notch [inset of Figure II.9(b)] and the loading process was terminated; the local plasticity limit of the steel was reached. The secondary failure of these strengthened beams was a ductile fracture of the web as in the un-strengthened beam. Provided that the adhesion failure of the CFRP was the primary failure mode, the following can be postulated: i) corrosion developed along the steel substrate even though it was covered by an epoxy layer (chemical characterization of corrosion

damage will be discussed later) and ii) moisture diffusion into the micro-pores of the bonding agent was not a concern because cohesion failure (i.e., material level failure) was not noticed. It is worth noting that the debonding failure occurred after yielding of the steel section, as evidenced by Figure II.8, which means that the CFRP-strengthening system continuously carried the applied load even after some local debonding occurred near midspan. This observation is crucial from a practice standpoint because the efficacy of CFRP-strengthening can be preserved in spite of local damage that may be linked with fatigue-cracked steel members on site.

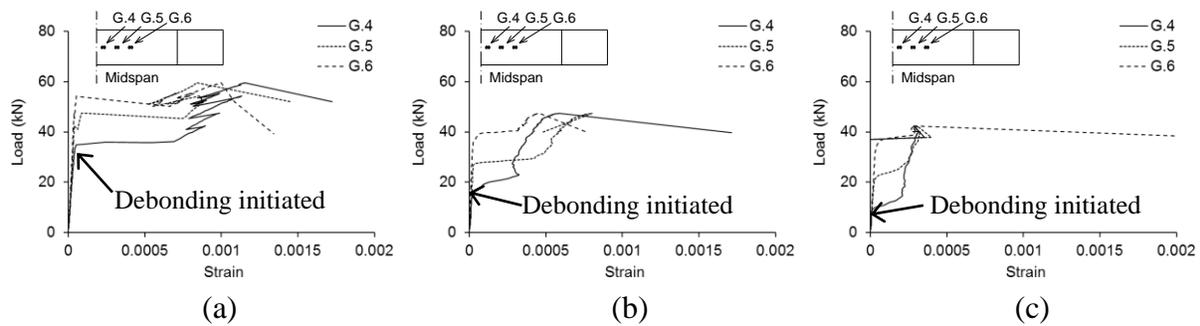
Figure II.10 CFRP strain development of corroded beams: (a) 12 hours; (b) 36 hours; (c) 72 hours

The load-strain behavior of the strengthened beams is given in Figure II.10. For the beam at 12 hours [Figure II.10(a)], all strains rapidly developed up to a load of 35 kN when local CFRP-debonding initiated at Gage 4 in the vicinity of the notch, followed by progressive debonding at Gages 5 and 6. Once the CFRP sheet was separated from the steel substrate, its strain development was unstable because of displacement incompatibility. With an increase in corrosion-exposure time, the debonding initiation load of the beams decreased. For instance, the debonding loads of the beams at 36 hours and 72 hours [Figure II.10(b) and (c)] were 63% and 76% lower than that of the beam at 12 hours [Figure II.10(a)], respectively. These observations confirm that corrosion damage has degraded the performance of the CFRP-steel interface. Other strengthened beams subjected to various corrosion-processing hours demonstrated similar responses (not shown for brevity). Figure II.11 presents strain profiles along the CFRP sheet of the beams at a typical interval of 25% of the ultimate loads (P_u). When the applied load level augmented, CFRP-debonding initiated and propagated along the bond-line supported by the increased strain values. Local damage (i.e., notch at midspan) attracted strain development, as mentioned earlier, and the usable CFRP strain at 100% P_u was reduced with an increase in corrosion damage. Another observation to note is that the breadth of CFRP-debonding was correlated with the degree of corrosion damage due to the deteriorated adhesion between the CFRP and the substrate.

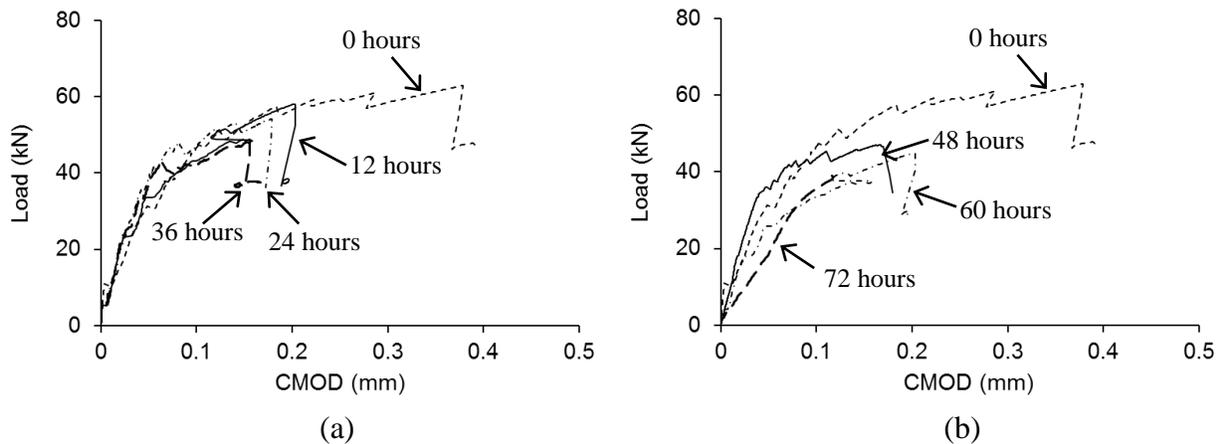
Figure II.12 Crack mouth opening displacement (CMOD) of strengthened beams: (a) up to 36 hours; (b) up to 72 hours

The crack mouth opening displacement (CMOD) of the beams measured by the lower-flange PI gage is depicted in Figure II.12. The CMOD of the 0-hour beam developed linearly within a service range, while load-softening accompanied by local spikes was noticed when a load level increased further. The presence of these local spikes denotes that the propagation of CFRP-debonding was not continuous along the interface so that a discrete debonding-progression pattern was recorded. It is interesting to note that the extent of such local spikes tended to diminish with an increase in corrosion-exposure hour, which indicates that the adhesion characteristics of the bonding agent were weakened (i.e., smooth debonding propagation). The slope of the load-CMOD behavior in an ascending branch tended to decay after 60 hours of corrosion exposure; in other words, the pseudo-confining or notch-closure effect by the bonded CFRP lessened because of the conditioned epoxy layer. The CMOD values at failure of the beams were reduced with increasing corrosion exposure. This can be explained by the fact that CFRP-debonding or interfacial failure was affected by the degree of the electrochemical reaction, and thus, the CMOD of the severely deteriorated beams did not sufficiently develop until their failure took place.

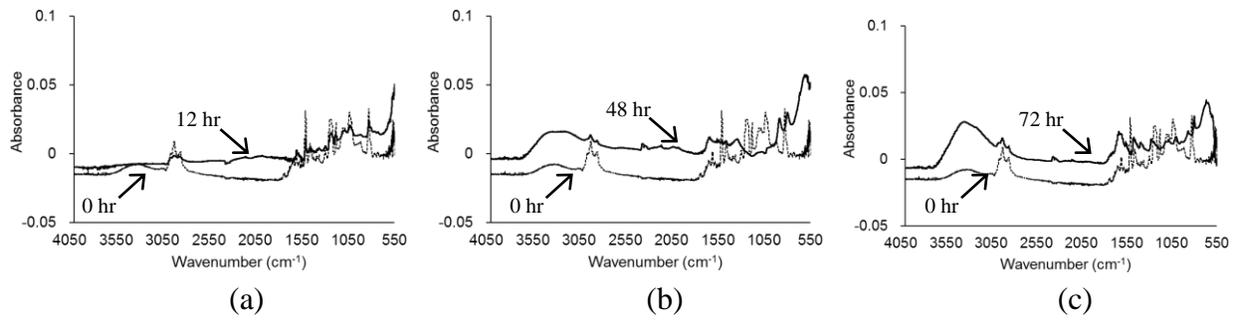
Figure II.13 Chemical response of the CFRP sheets: (a) 12 hours; (b) 48 hours; (c) 72 hours

Figure II.13 depicts the response spectra of selected CFRP specimens to characterize chemical changes caused by the corrosion exposure. A typical fingerprint region was noticed in between 550 cm^{-1} and 1500 cm^{-1} in conjunction with perplexing absorbance. The interpretation of the infrared spectra given below is available in organic chemistry texts such as McMurry (2012). For the 0-hr control specimen [Figure II.13(a)], the following was identified: The C-Br stretch of haloalkane and the $\text{-C}\equiv\text{C-H:C-H}$ bend of alkynes were first observed within wavenumber ranges from 550 cm^{-1} to 690 cm^{-1} and from 700 cm^{-1} to 610 cm^{-1} , respectively. The C-N stretch of the aliphatic amine functional group was noticed from 1020 cm^{-1} to 1250 cm^{-1} , followed by the N-O asymmetric stretch of nitro compounds in 1550 cm^{-1} to 1475 cm^{-1} . The last noticeable absorbance peak was the C-H stretch of the alkane functional group at a wavenumber of 2930 cm^{-1} . With an increase in corrosion exposure hour, the peak range from 550 cm^{-1} to 670 cm^{-1} arose; on the other hand, the peaks at a wavenumber-range from 1030 cm^{-1} to 1510 cm^{-1} decayed because most amine functional groups were eliminated due to the propagation of corrosion. The emerging peak at 3350 cm^{-1} of the corroded 48- and 72-hour specimens [Figure II.13(b) and (c)] illustrates a transition in functional group from alkane (C-H stretch) to amine (N-H stretch) by means of the electrochemical reaction. It may be reasonable to postulate that the specimens exposed to longer corrosion-simulation time included more active nitrogen atom responses than the un-corroded 0-hour specimen. The change of corrosion current density and corrosion rate [Figs. II.5(d) and 6] appears to have some relationship with the activation and deactivation of the aforementioned functional groups. Rigorous chemical analysis may be required to fully understand the exact structure alteration of the CFRP system, which is outside the scope of the present research.

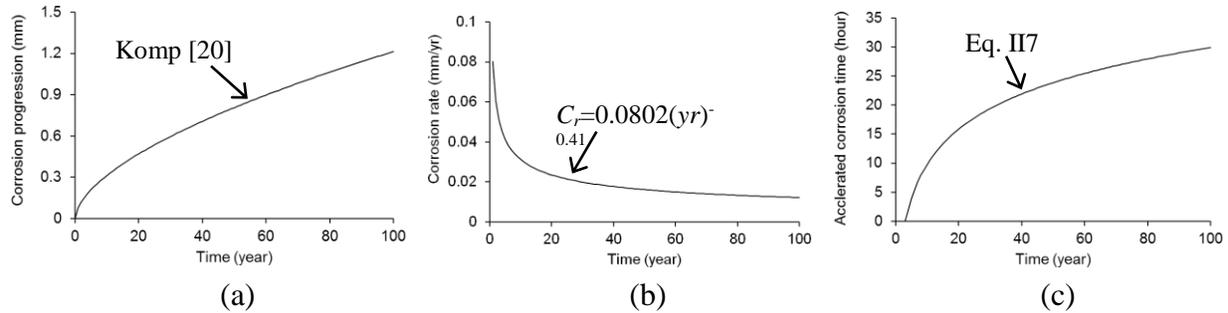
Figure II.14 Relationship between accelerated corrosion hour and equivalent service year:
 (a) predicted corrosion progression on site; (b) predicted corrosion rate on site;
 (c) proposed corrosion curve for time conversion

where $hr_{eq}(hr)$ is the equivalent laboratory hour hr to service year yr . It should be noted that a negative time cannot be predicted by Eq. II.7 due to the inequality condition and $hr_{eq}(hr) = 0$ along with newly constructed structural members (e.g., 1 or 2 years of service), indicating that corrosion has not occurred yet, which is valid in most existing steel bridges. Figure II.14(c) reveals the proposed parabola-like function of the equivalent service year against the accelerated laboratory time.

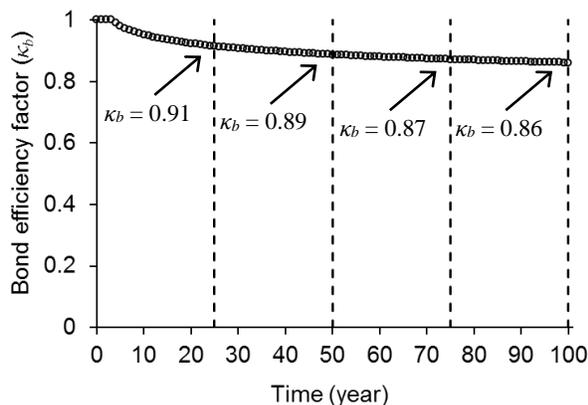
Figure II.15 Variation of bond efficiency factor

Figure II.15 presents the variation of the bond efficiency factor (κ_b) with respect to service time in years, which was acquired by the equivalent service hour (Eq. II.7) and the capacity change (Eq. II.9). For design convenience, the variable bond efficiency factors were simplified as listed in Table II.2.
