MPC 19-373 | Z. Carnahan, M. Mingo, M. Tazarv and N. Wehbe

Development of Alternative
Bridge Superstructures for
South Dakota Local Roads

Department of Civil and Environmental Engineering
South Dakota State University
Brookings, South Dakota

February 2019

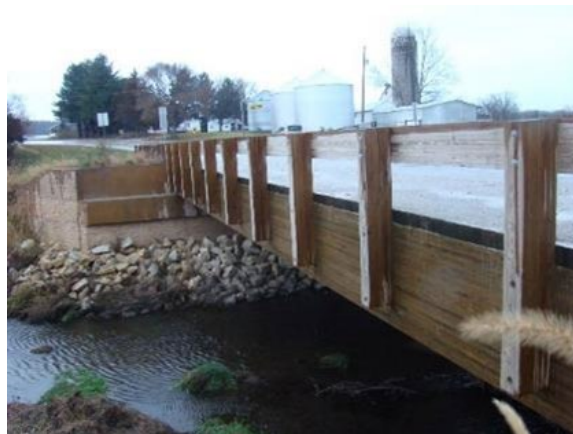
Glulam timber bridges (Fig. 3.16) are constructed of glulam members manufactured from lumber laminations bonded together on their wide faces with waterproof structural adhesives. According to Ritter (1990), glulam is the most common material used for the fabrication of timber bridges because glulam members can be manufactured to any size and shape. In general, the span length of glulam bridges ranges from 20 to 80 ft, but construction of longer bridges with span lengths of 140 ft or longer is possible (Ritter, 1990). Important design and construction considerations, such as design method, wearing surfaces, railing systems, and abutments, are discussed in the following sections.

Figure 3.16 Glulam Timber Bridge in Buchanan County, Iowa

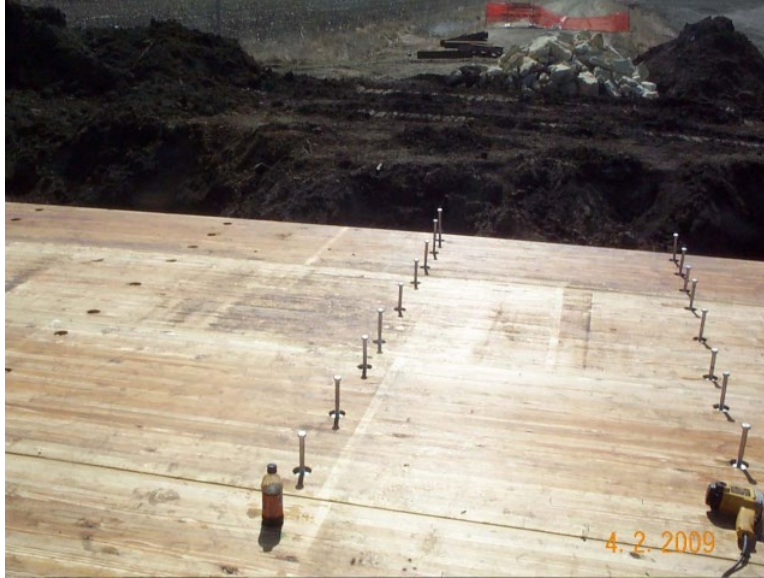
Currently, two methods are primarily used to connect deck panels to stringers. One method is to install lag bolts from the top of the deck through the entire panel into the top of the beam (Fig. 3.21). One of the disadvantages of using lag bolts is their large size, requiring field boring for installation. Since it is impractical to drill lag bolt holes before the pressure treatment of the lumber, the bridge is more susceptible to decay due to water penetration. Furthermore, it is not possible to retighten these bolts if they loosen since the wearing surface will cover them.

Figure 3.21 Lag Bolt Deck-to-Stringer Connection for Timber Bridges (Hosteng, 2013)

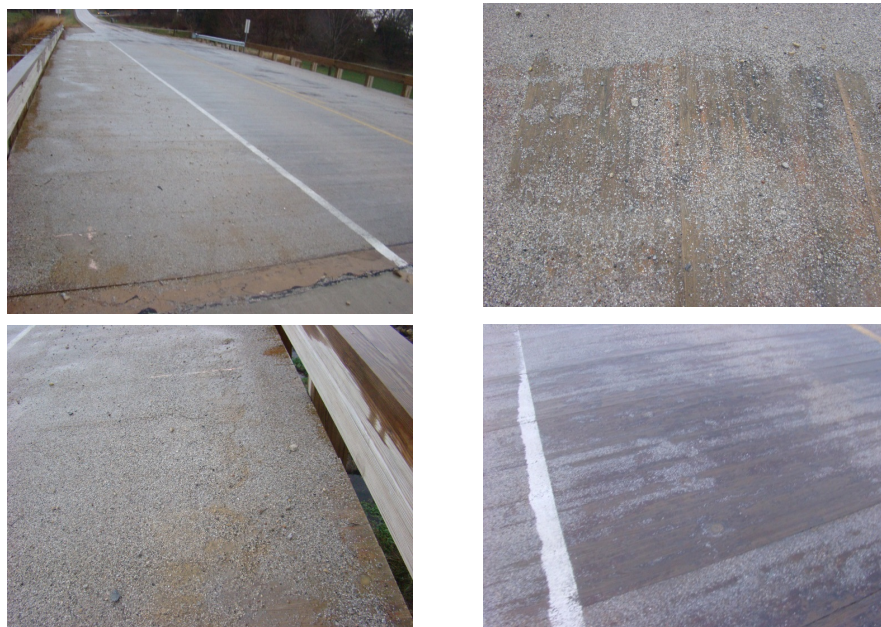
A new wearing surface was recently used on the Cedar Rock Bridge in Buchanan County, Iowa (Fig. 3.29). The bridge deck was flooded with epoxy to fill all the gaps in the wood. Then very small rocks were imbedded into the epoxy to improve traction. The epoxy is typically applied in three layers of 3/8-in thickness each. The life of the epoxy depends on its exposure. This wearing surface was applied in 2015, which is too recent for full performance evaluation.

Figure 3.29 Epoxy with Embedded Grit Wearing Surface for Glulam Timber Bridge in Buchanan County, Iowa

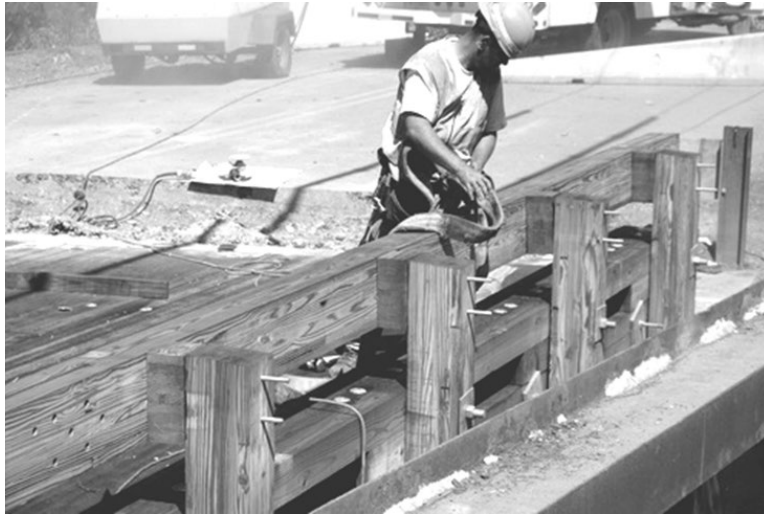
A bridge railing system must be positioned to safely contain an impacting vehicle without allowing it to pass over, under, or through the rail elements. A proper railing system must be free of features that may catch on the vehicle or cause it to overturn or decelerate too rapidly. Any crash-tested railing configuration or any railing designed according to Section 13.7 of AASHTO LRFD (2013) can be used for timber bridges. The connecting components should be designed adequately. The rail material can be timber, metal, or concrete. One example of a timber railing is shown in Fig. 3.30.

Figure 3.30 Railing on a Glulam Bridge (laminatedconcepts.com)

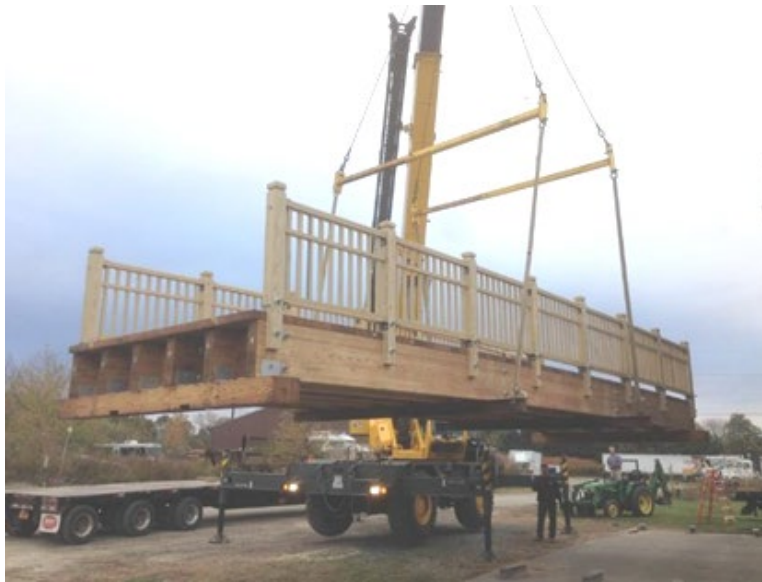
One of the advantages of glulam timber bridges is they can be completely prefabricated offsite and shipped to the project site for installation (Fig. 3.32). This feature is in line with Accelerated Bridge Construction (ABC), which has been recently emphasized in the United States. For wide timber bridges, the bridge can be prefabricated in segments of one or two lanes to be shipped and assembled onsite.

Figure 3.32 Erie Canal Bridge Being Placed in Port Byron, NY, in 2014 (laminatedconcepts.com)

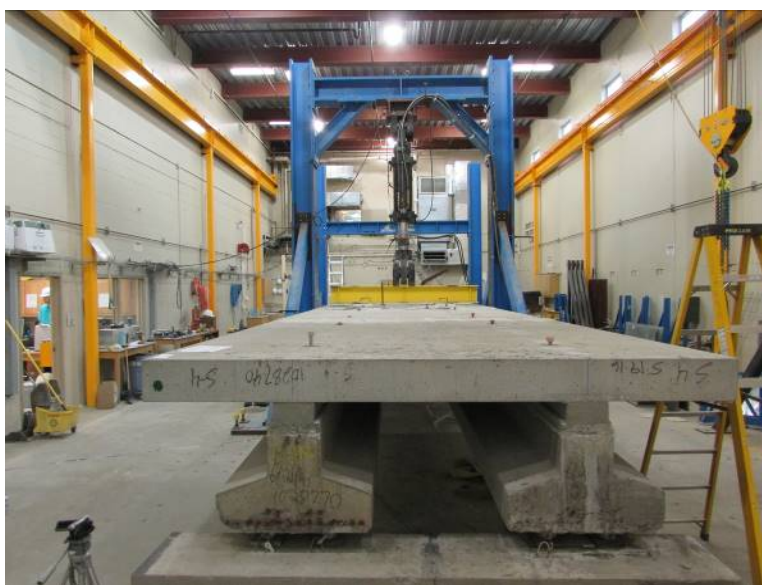
After the completion of the fatigue testing, an ultimate test was conducted using a 328-kip actuator. A W12x93 steel beam was used to spread the load over the two girder centerlines at the mid-span to avoid punching shear failure of the deck. Figure 4.16 shows the test setup for the strength test.

Figure 4.16 Ultimate Test Setup for the Precast Bridge Specimen

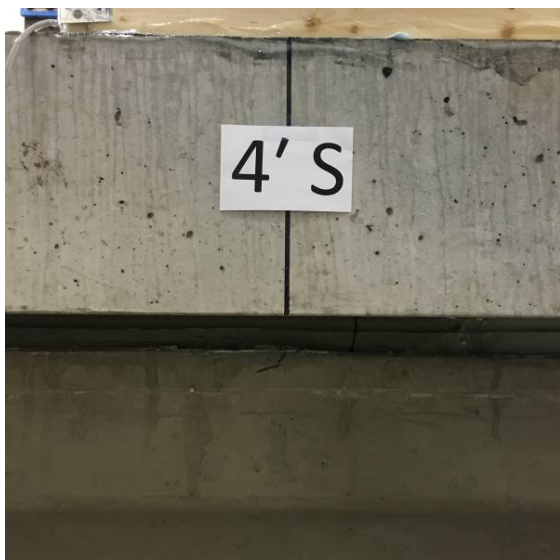
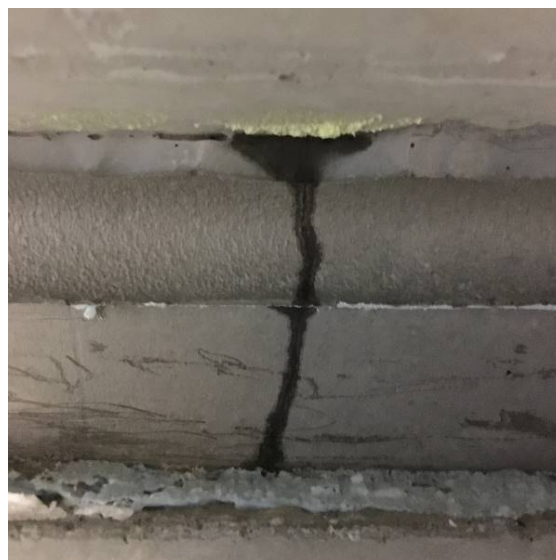
At 25,000 load cycles, which corresponds to 4.6 years of service, a vertical hairline crack was observed on the grouted haunch of Girder A, located approximately 4.2 ft south of the mid-span in one of the LMC joints. One of the water ponds was on top of this joint. Since (1) the crack width did not change over the entire fatigue test (Fig. 4.19), (2) the pond did not lose water from this leak, and (3) this joint was the last one filled with LMC (which sets in approximately 30 minutes), it was concluded that the leak was because of construction issues but not structural degradation due to fatigue. Furthermore, there was no change in bridge overall stiffness due to this crack.

(a) Observed Crack at 25,000-Load Cycle

(b) Close Up of Crack

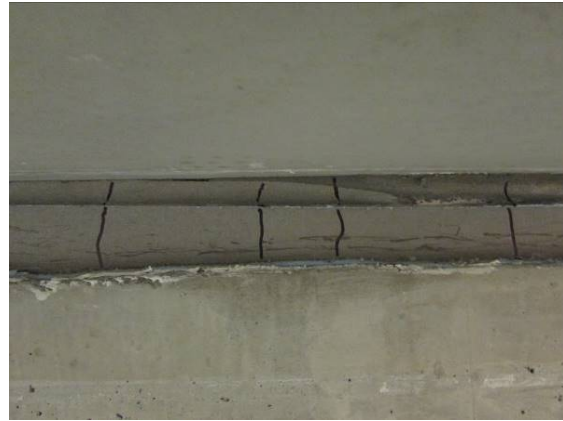
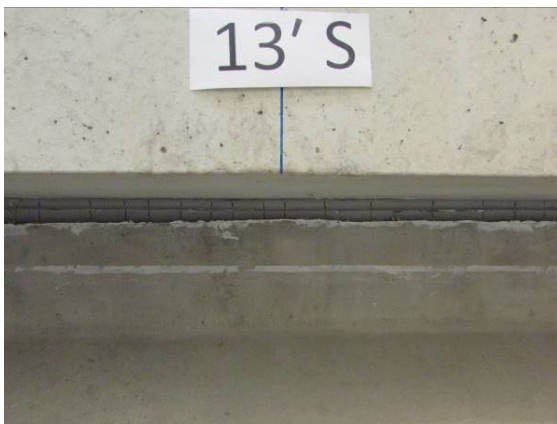
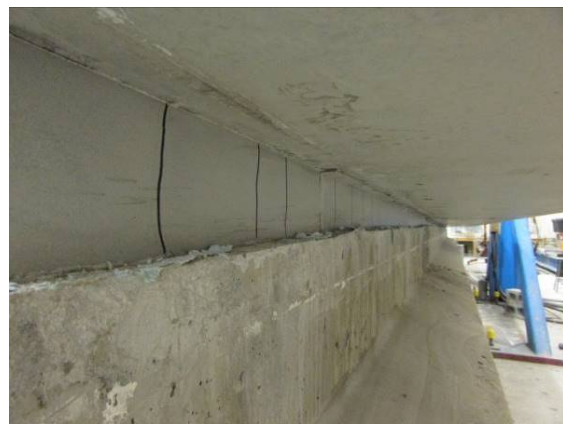
- Shrinkage cracks were observed at 125,000 load cycles in almost all of the full-depth shear pockets, all of the transverse joints, and the grouted haunch. These cracks were shallow since there was no water seepage when the deck was tested for water leaks.

(b) Close Up of Girder A Haunch Region Filled with Latex Modified Concrete

(c) Shrinkage Cracks in Haunch Region of Girder B Filled with Non-Shrink Grout

(d) Close Up of Girder B Haunch Region Filled with Non-Shrink Grout

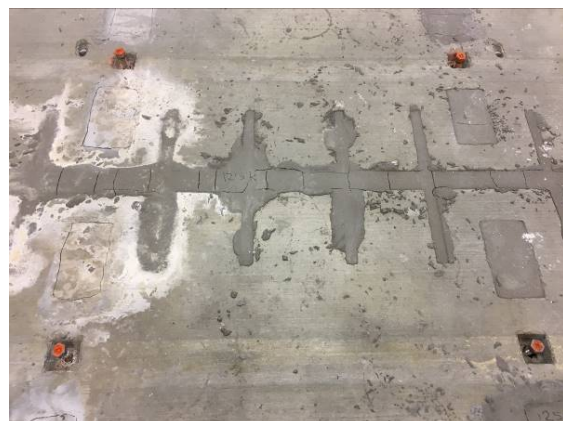
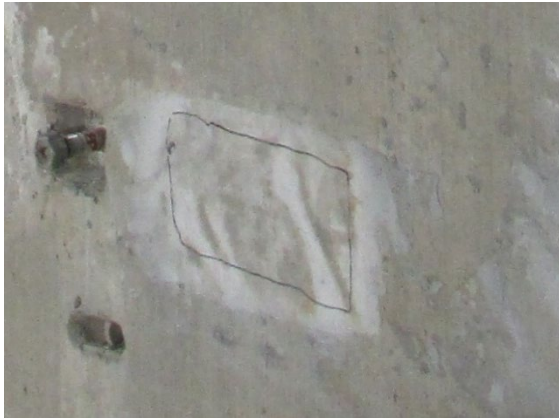
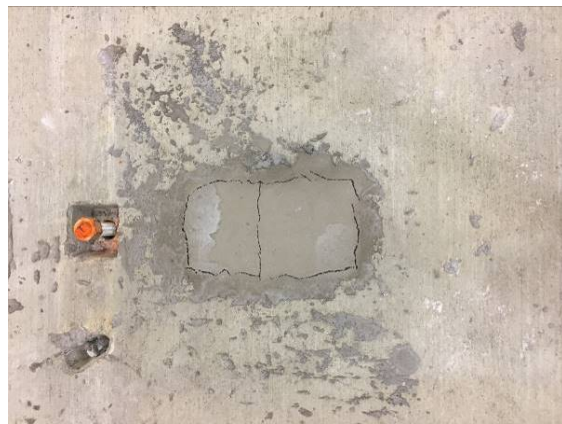
(b) Latex Modified Concrete at 650,000 Cycle

Figure 4.21 Transverse Joint Cracks in the Precast Bridge Specimen

(a) Non-Shrink Grout at 125,000 Cycle

(c) Latex Modified Concrete at 125,000 Cycle

(d) Latex Modified Concrete at 650,000 Cycle

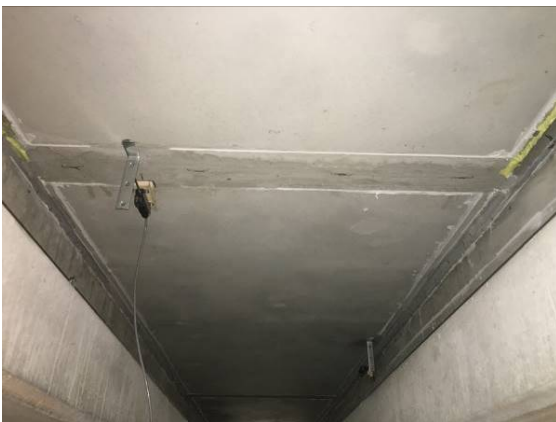
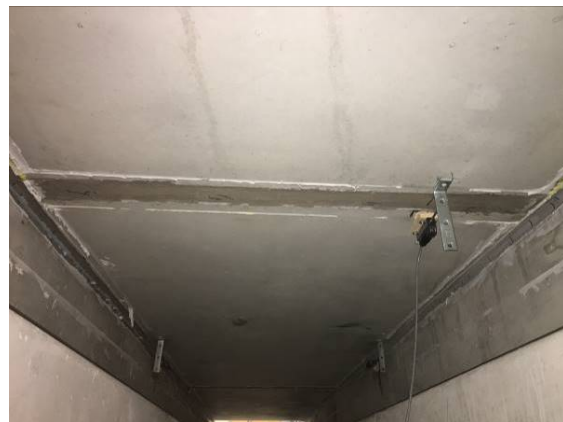
Figure 4.28 shows the middle panel transverse joints with either non-shrink grout or latex modified concrete after applying 150,000 cycles of joint loading. All joints remained watertight through the fatigue loading. No significant damage of the bridge components, in addition to what was reported in Phase I testing, was observed.

(a) Joint with Non-Shrink Grout – Deck Underneath

(b) Joint Latex Modified Concrete – Deck Underneath

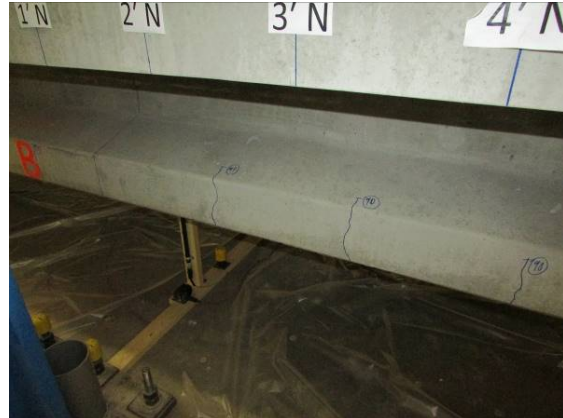
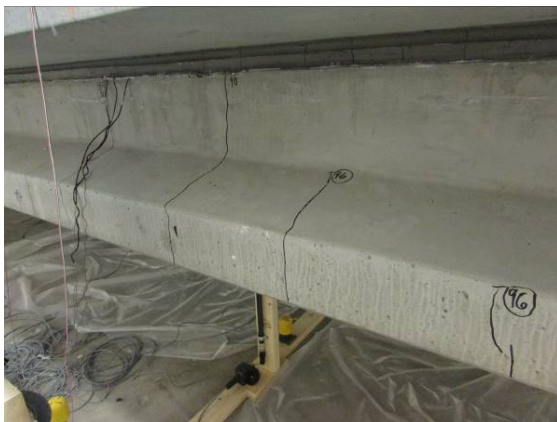
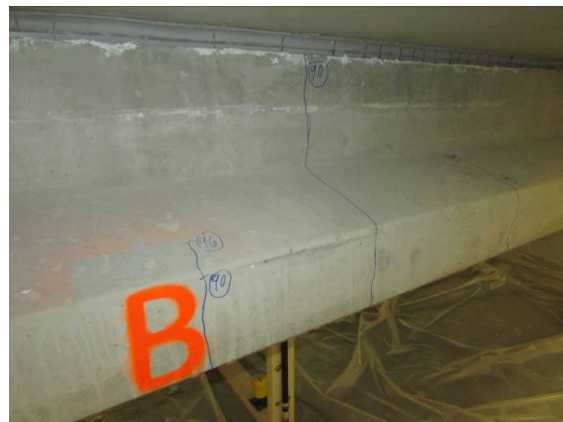
(a) First Crack, Mid-Span of Girder A at P = 251 kips

(b) First Crack, Mid-Span of Girder B at P = 251 kips

(c) Crack Pattern for Girder A at P = 263 kips

(d) Crack Pattern for Girder B at P = 263 kips

- The bridge girders did not crack until the applied load exceeded the equivalent Strength I limit state load, indicating adequate design and performance.

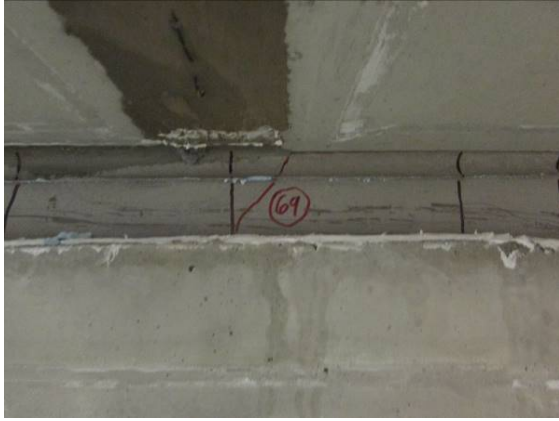
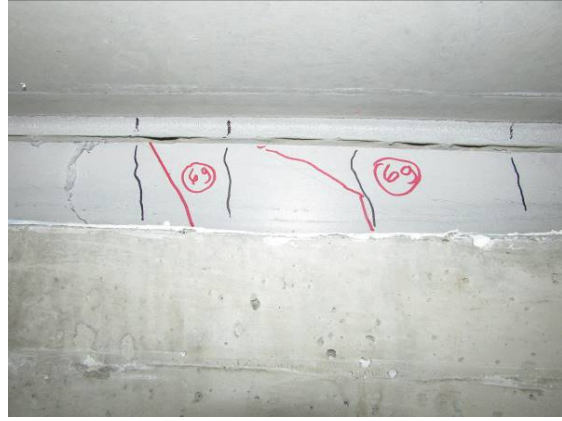
The first horizontal shear crack in the grouted haunch region of the precast bridge (Fig. 4.34) was observed at an actuator load of 200 kips, which corresponds to a girder load of approximately 100 kips. However, horizontal shear stud strain gauge data suggests that cracking occurred at lower loads. Additional shear cracks appeared at an actuator load of 226 kips (Fig. 4.35). Note that shear cracks did not form under an equivalent strength I limit state load for this bridge, which was 131.4 kips, indicating that the shear reinforcement detailing was sufficient.

(a) 14-ft North of Mid-Span (Girder A)

(b) 14-ft South of Mid-Span (Girder A)

Figure 4.34 Haunch Region Horizontal Shear Cracks at an Actuator Load of 200 kips During Strength Testing of the Precast Bridge Specimen

- The first horizontal shear cracks in the grouted haunch region were observed at an actuator load of 200 kips, which was higher than the equivalent AASHTO Strength I limit state load of 131 kips.

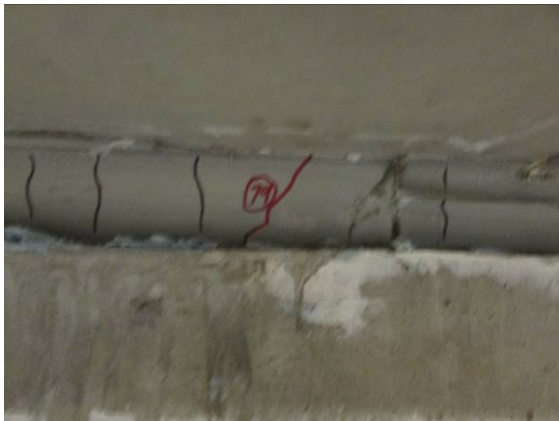
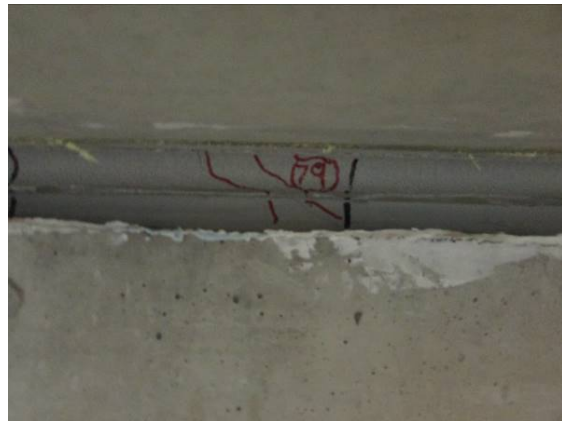
(a) 16-ft North of Mid-Span (Girder B)

(b) 14-ft South of Mid-Span (Girder B)

Figure 4.35 Haunch Region Horizontal Shear Cracks at an Actuator Load of 226 kips During Strength Testing of the Precast Bridge Specimen

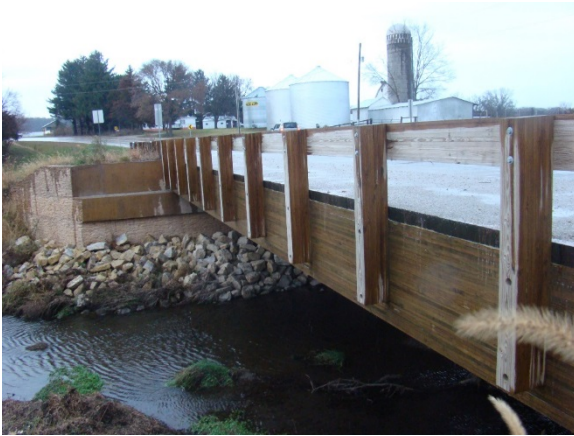
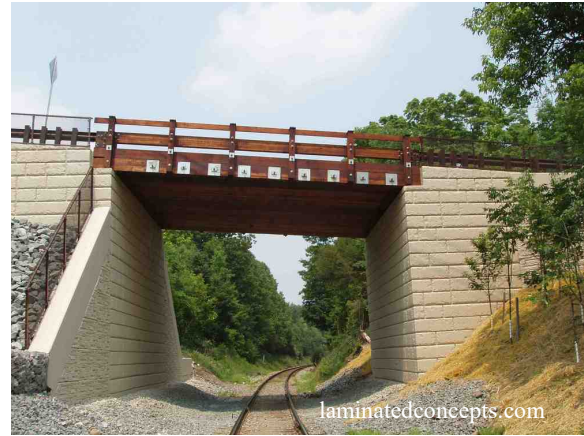
Figure A.16 Timber Railing for Timber Bridges

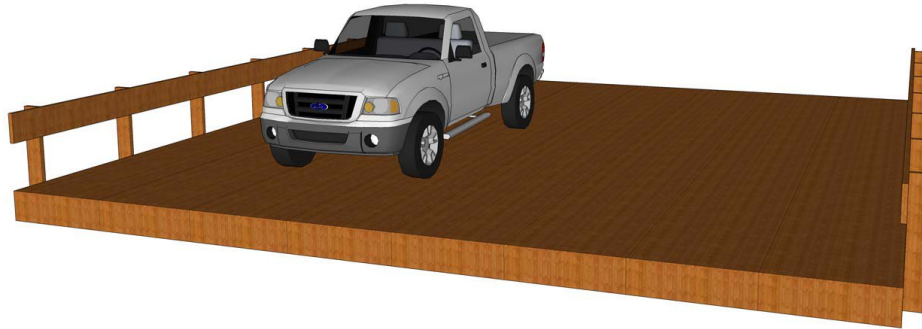
Figure A.18 Typical Glulam Timber Slab Bridge
