MPC 19-399.1 | D.S. Shinstine, K. Ksaibati, and D. Trusty

Regional Implementation of
Tribal Transportation Safety
Program:
Standing Rock Sioux
Tribe Roadway Safety
Improvement Program

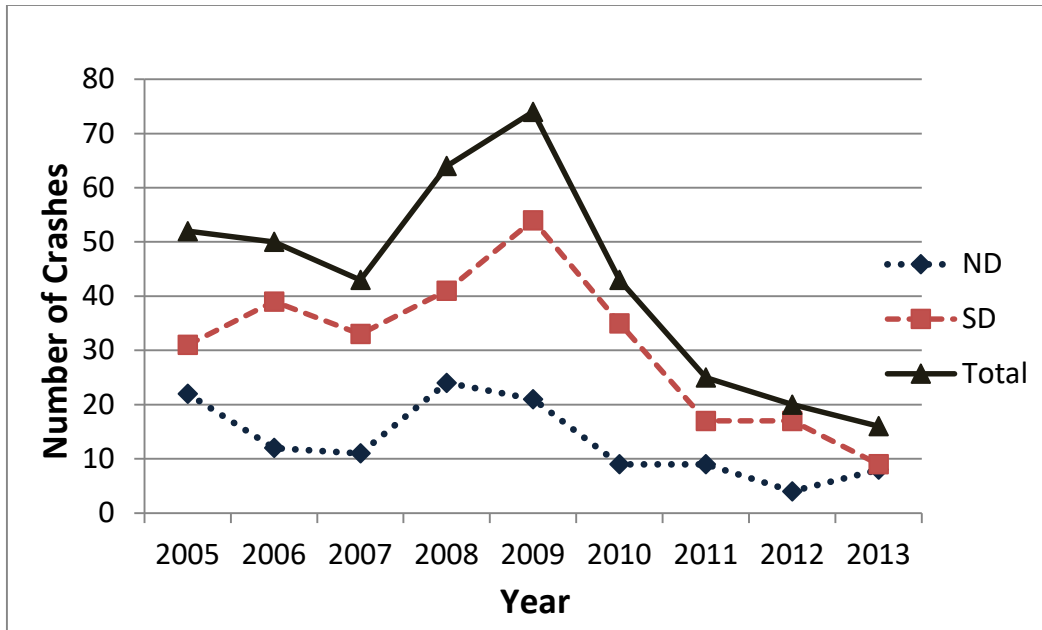
Figure 4.1 SRST Crashes 2005-2013

There were 276 crashes recorded for Corson County and 120 crashes recorded for Sioux County, yielding a total of 396 crashes for the entire reservation from 2005 through 2013. Although the North Dakota portion is much smaller than the South Dakota portion, the total number of crashes for the reservation from both counties appears to be quite low for a reservation of this size. It can also be observed in Figure 4.1 that the number of crashes has dropped since 2009. Initially, this was thought to be due to a change in reporting rather than actual reduction in crashes. A similar problem was encountered when crashes on the WRIR were first analyzed. Initially, only 245 crashes were reported for an 11-year period (2000-2010) in the state database, and crash numbers dropped significantly in 2006. Once the reporting issues were corrected for the tribal law enforcement crash records, the total crashes jumped to 673 for the same 10-year period. Discussions with the Corson County Sheriff revealed that enforcement was increased in 2009 and reductions were realized. However, the numbers are still low for a reservation of this size, and no crashes are identified on county or BIA roads. This indicates a discrepancy in crash reporting and warrants further study.

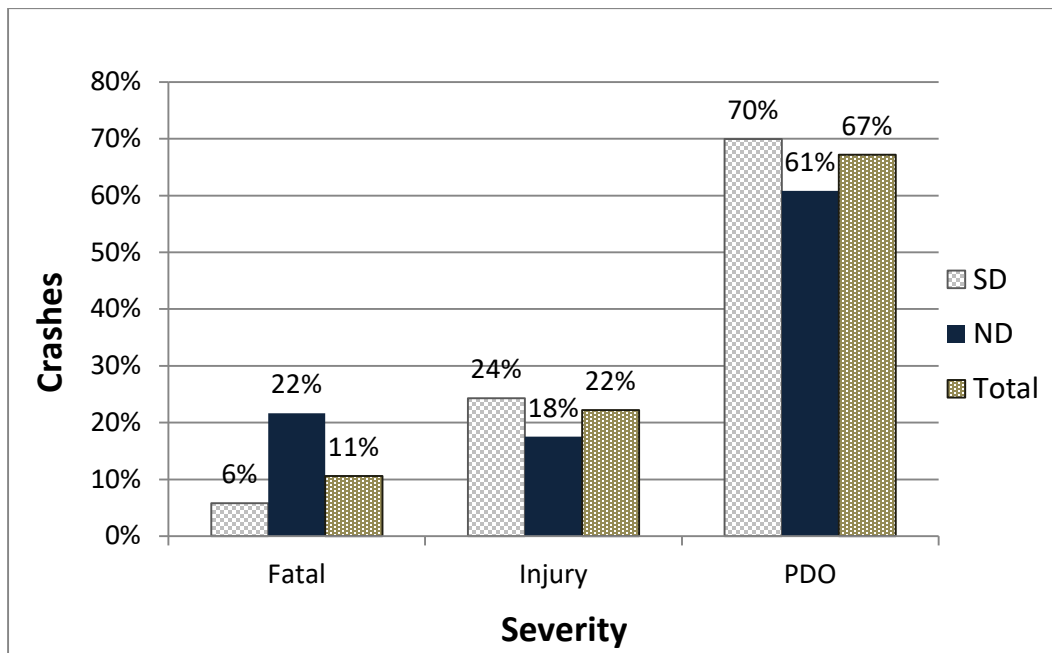
Figure 4.2 SRST Crash Severity 2005-2013

Crash severity was divided into fatal, injury, and property damage only (PDO). As seen in Figure 4.2, 11% of all crashes on SRST were fatal, although 22% of crashes in Sioux County were fatal and only 6% in Corson County were fatal. This could be due to how much non-fatal crashes are reported in North Dakota compared with South Dakota.

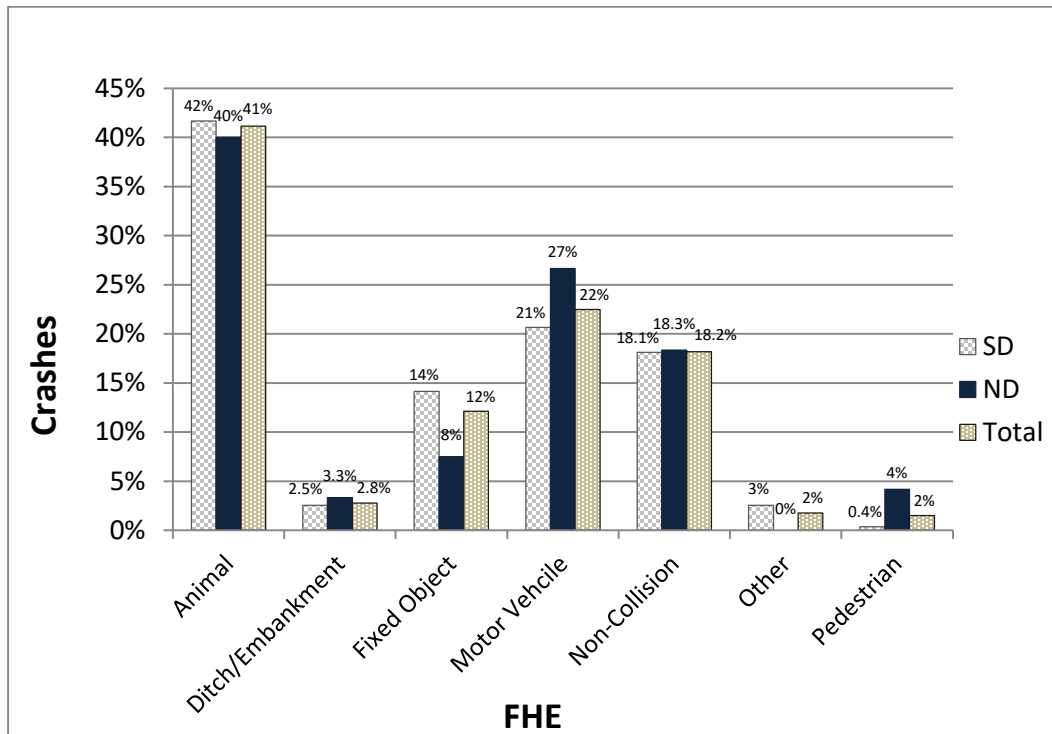
Figure 4.3 SRST First Harmful Event 2005-2013

The first harmful event (FHE) revealed that 41% of crashes involved animals, followed by collisions with another vehicle at 22%. Of all animal crashes, 85% were wild animals such as deer, elk, and moose. Two percent of all crashes involved pedestrians, with 4% occurring in Sioux County and 0.4% occurring in Corson County. Most of the reservation is rural with long distances between communities. The Prairie Knights Casino and Ft. Yates are located in North Dakota along a major highway, which could account for higher pedestrian traffic in areas where limited pedestrian safe facilities exist. The FHE results are located in Figure 4.3.

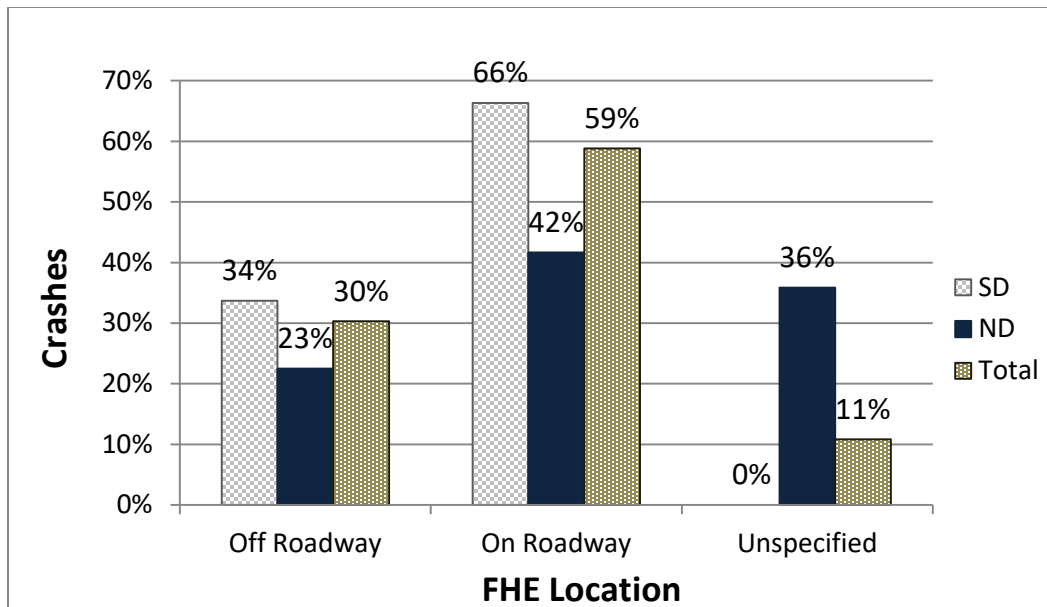
Figure 4.4 SRST First Harmful Event Location 2005-2013

Of crashes reported, 59% occurred on the roadway. However, only 1% of crashes were reported as occurring off the roadway in North Dakota. But North Dakota also reported that 22% of crashes occurred on the shoulder and 36% were unspecified. This is compared with South Dakota, where 32% were off the roadway, only 1% on the shoulder, and none were unspecified. This could also be due to different reporting procedures between the states. See Figure 4.4.

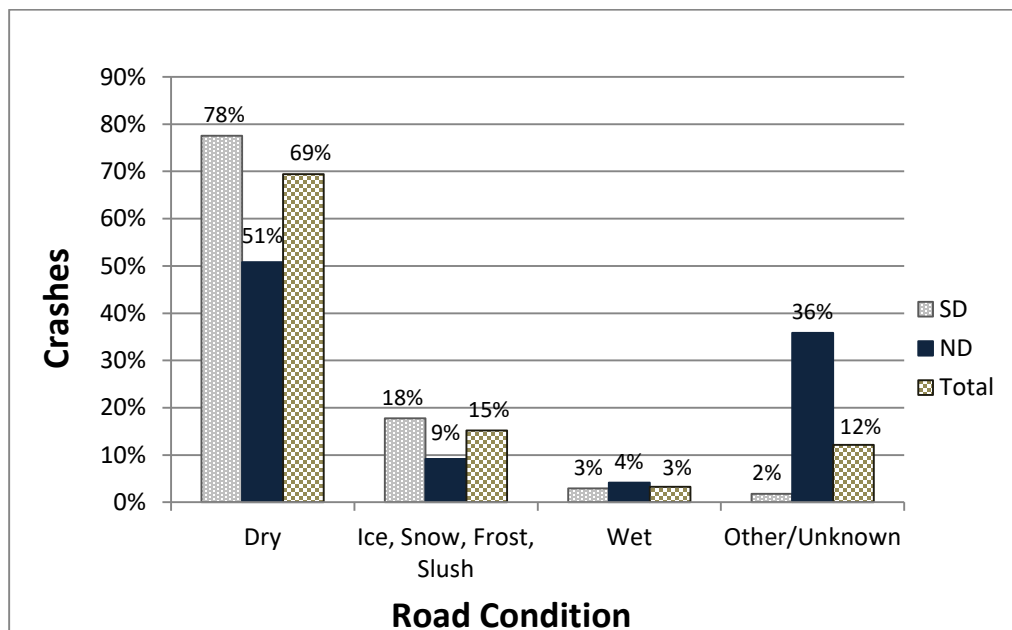
Figure 4.5 SRST Road Conditions 2005-2013

Road conditions were reported as dry for 69% of the crashes, and as ice, snow, frost, or slush for 15% (Figure 4.5). When comparing the two counties, 78% of all crashes in Corson County and 51% in Sioux County were reported as dry conditions. In Sioux County, 36% of crashes had unspecified road conditions compared with Corson County, which had only 2% unspecified. This could be due to a difference in reporting procedures. Lighting conditions for the most part showed that crashes were evenly distributed between daylight and dark at 43% and 48%, respectively (Figure 4.6).

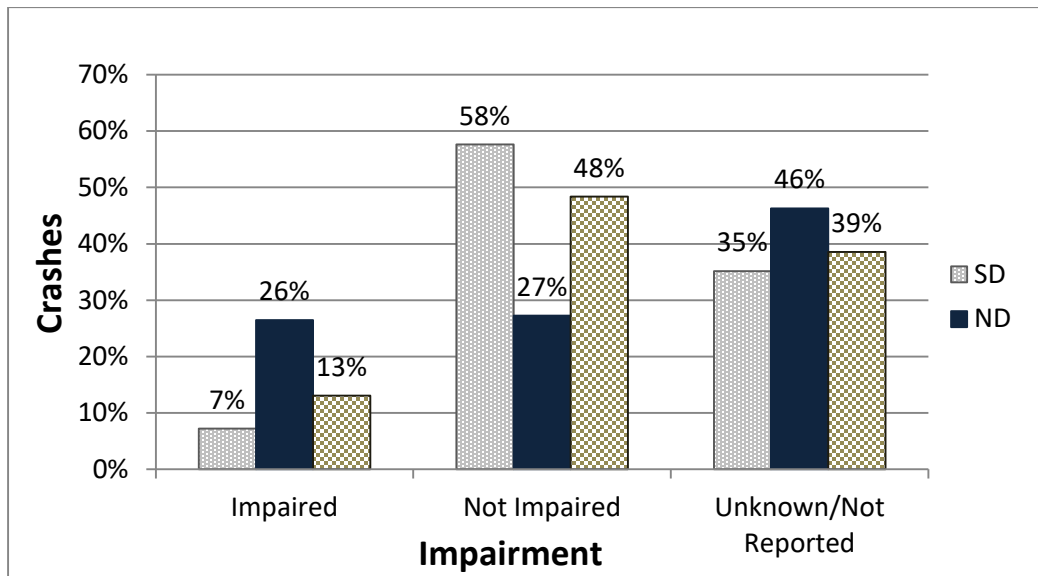
Figure 4.7 SRST Crashes Involving Alcohol 2005-2013

There is a large disparity between North Dakota and South Dakota regarding crashes involving alcohol. North Dakota has a much higher percentage of alcohol being involved in crashes at 26%, compared with 7% for South Dakota. It should be noted that both have a high percentage of unknown or unreported alcohol involvement. See Figure 4.7.

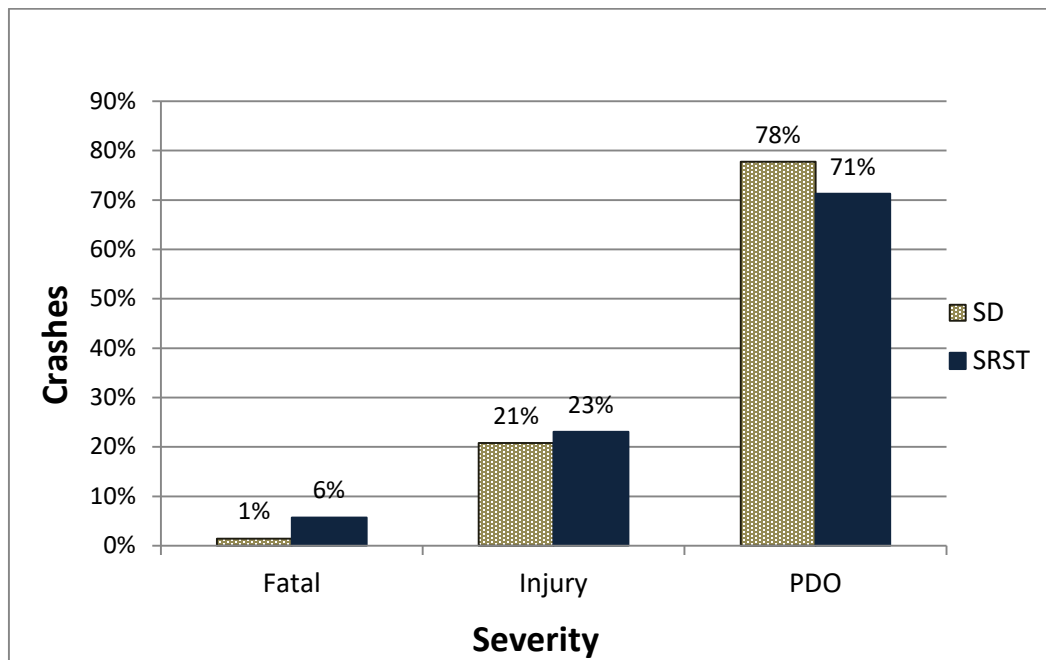
Figure 4.8 Crash Severity South Dakota and SRST 2004-2013

The portion of the SRST reservation contained within Corson County, South Dakota, was compared with crashes throughout the state on rural roadways for a 10-year period between 2004 and 2013. At the time of this analysis, statewide information had not been obtained from North Dakota. When comparing crashes on the reservation in South Dakota, it was found that similar trends existed. In Figure 4.8, injury crashes were 12% and 23%, respectively. However, there were 6% fatal crashes on the reservation as compared with 1% across the state.

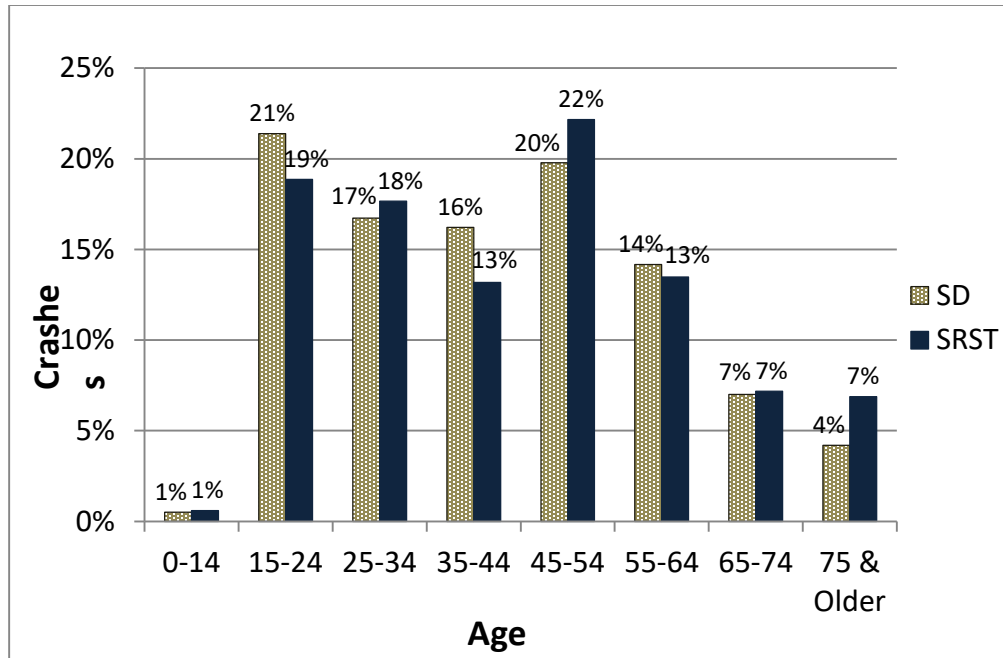
Figure 4.9 Driver Age South Dakota and SRST 2004-2013

Crashes involving alcohol were higher on the reservation at 7%, compared with 4% in the state. Among all crashes on the reservation, 64% involved males, compared with 63% for the state. Figure 4.9 shows that a slightly higher percentage of drivers were between the ages of 15 and 24 for the state at 21% and 19% for the SRST. A slightly higher percent of drivers was between the ages of 45 and 54 on the reservation at 22%, compared with the state at 20%.

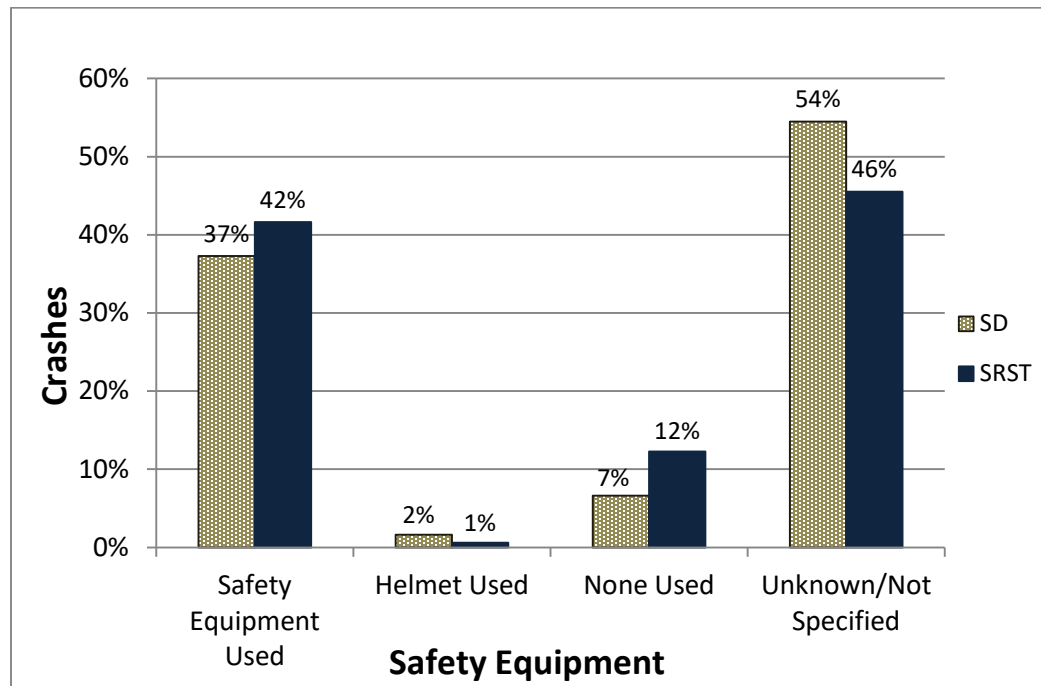
Figure 4.10 Safety Equipment Use in South Dakota and SRST 2004-2013

FHE, FHE location, road conditions, and lighting conditions were all very similar. Animal crashes appear to be a major concern across the state. Of all crashes in South Dakota, 52% involved animals, and 95% of those crashes involved a wild animal. Safety equipment use is reported as higher on the reservation at 42%, compared with 37% across the state. On the reservation, 12% of crashes were reported as no safety equipment used, compared with 7% for the state (Figure 4.10). It might be more accurate to determine when safety equipment was not used rather than when it was.

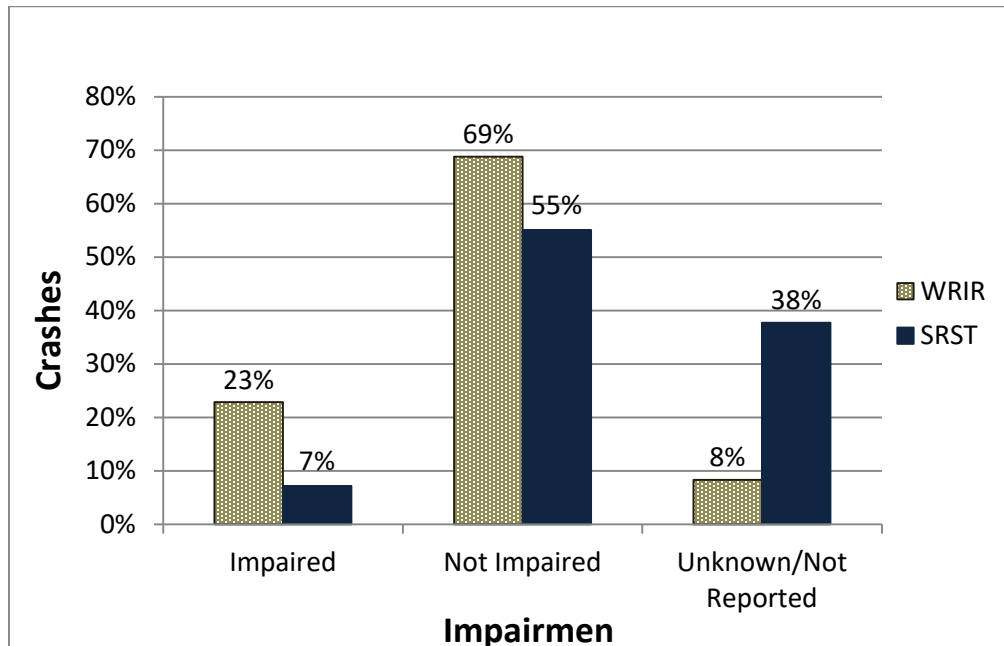
Figure 4.11 Alcohol Involvement on SRST and WRIR, 10-Year Analysis

SRST and the WRIR are similar in size at 2.3 million acres and 2.2 million acres, respectively, and they are both rural. A 10-year analysis was performed for both. Only Corson County had 10 years of data along with driver information. The WRIR was analyzed from 2002 through 2011 and Corson County was analyzed from 2004 to 2013. Several differences were noted between the two reservations. WRIR had a slightly lower number of fatal crashes at 4%, compared with SRST at 6%, but the number of injuries was higher at 32% compared with 23%. Alcohol involvement was much higher on the WRIR at 23%, with only 7% on the SRST. However, 38% of crashes on the SRST did not report, or reported as unknown, alcohol involvement; whereas, only 8% of crashes on the WRIR were unreported (Figure 4.11).

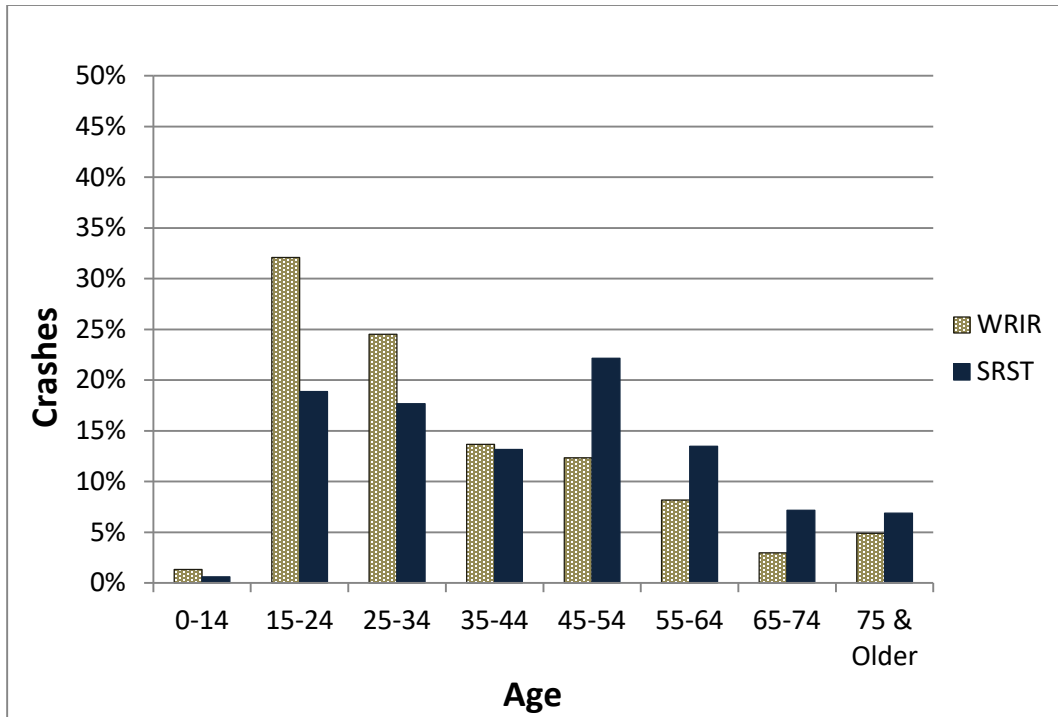
Figure 4.12 Driver Age SRST and WRIR, 10-Year Analysis

The distribution of driver age was much different. More young drivers were involved in crashes on the WRIR as compared with SRST. In Figure 4.12, drivers between the ages of 15 and 34 accounted for 77% of all crashes on the WRIR. On the SRST, the highest number of crashes was among drivers between 45 and 54.

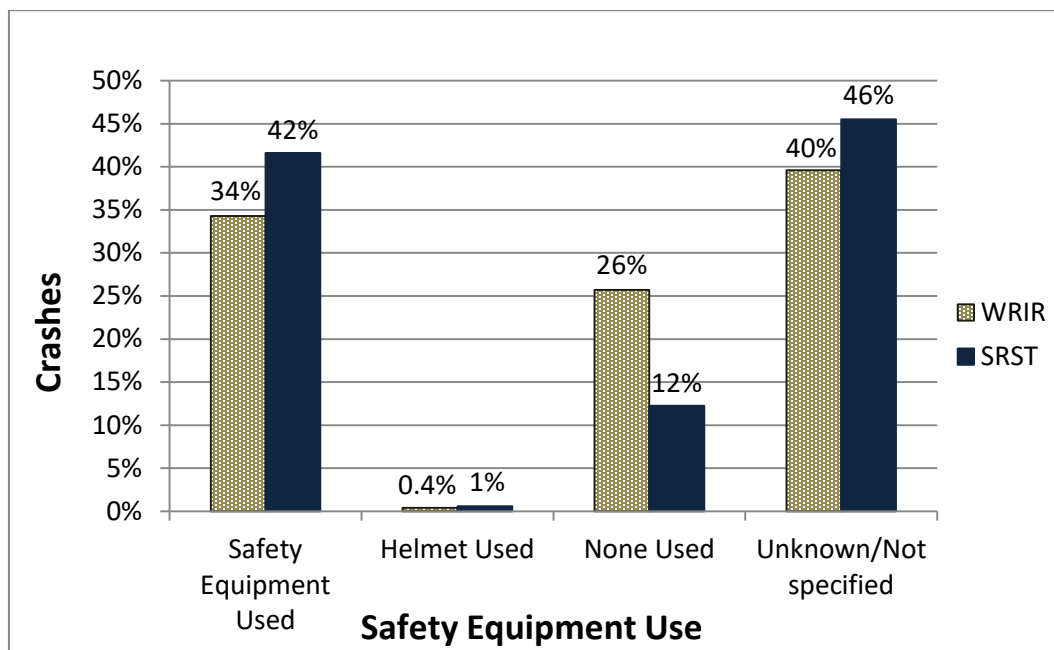
Figure 4.13 Safety Equipment Usage SRST and WRIR, 10-Year Analysis

The lack of safety equipment use was more than two times higher on the WRIR than the SRST, where in 26% of crashes, safety equipment was not used on the WRIR, compared with 12% for SRST. (Figure 4.13)

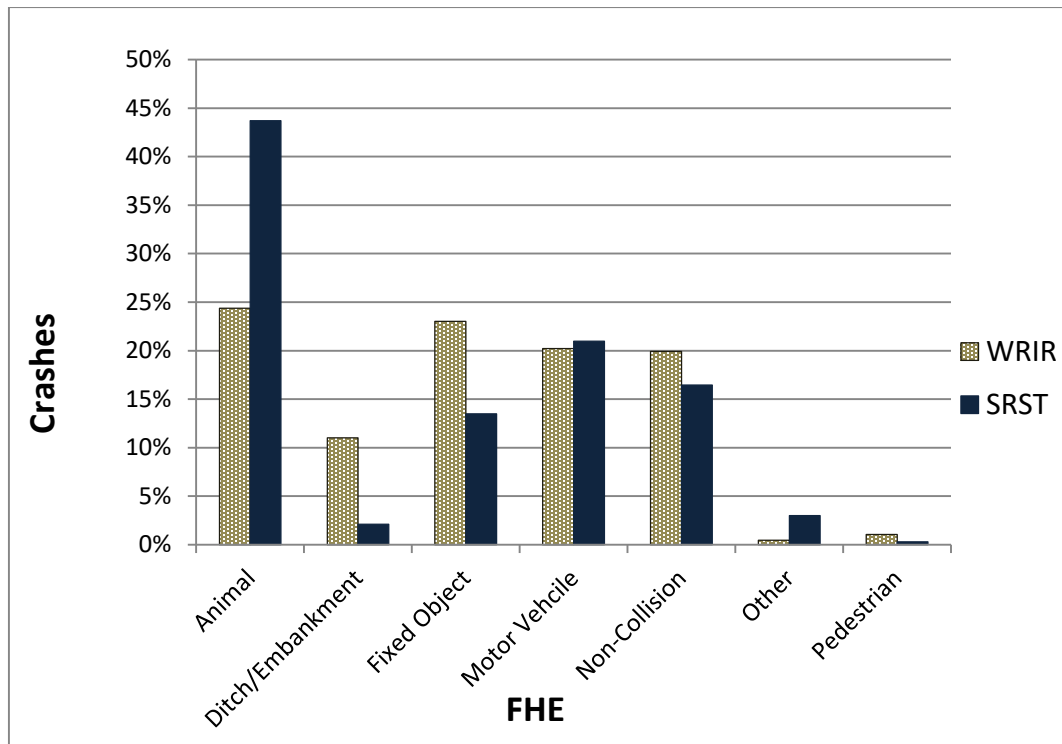
Figure 4.14 First Harmful Event SRST and WRIR, 10-Year Analysis

The other major differences observed were the FHE and FHE location. Almost half as many crashes on the WRIR involved animals than on the SRST at 24% and 44%, respectively (Figure 4.14).

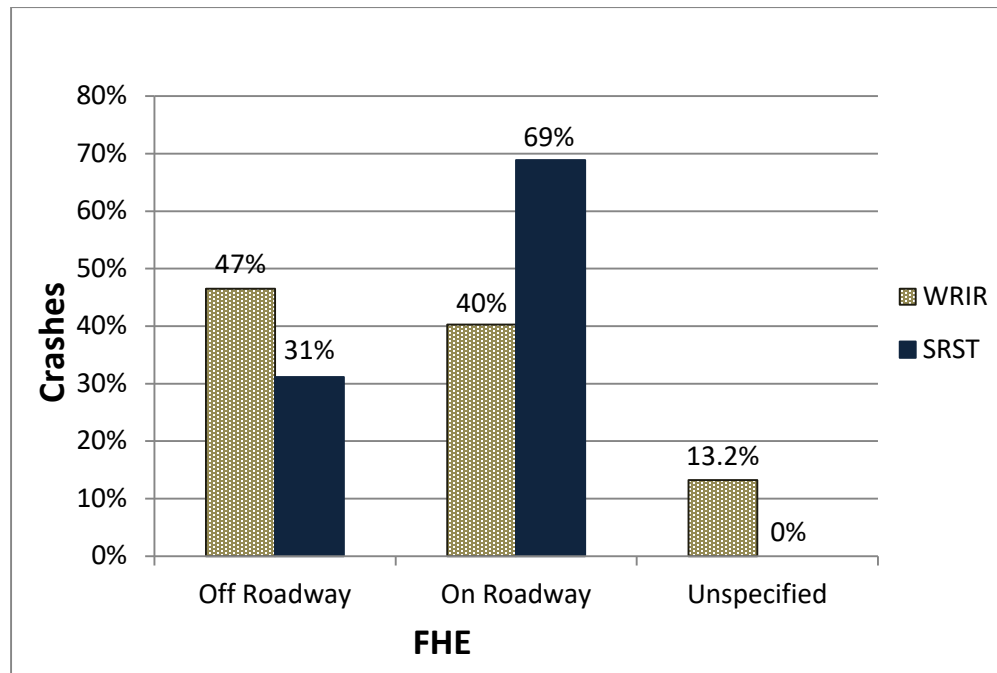
Figure 4.15 FHE Location SRST and WRIR, 10-Year Analysis

Finally, more crashes occurred off the roadway on the WRIR at 47%; whereas 69% of crashes on the SRST occurred on the roadway (Figure 4.15).

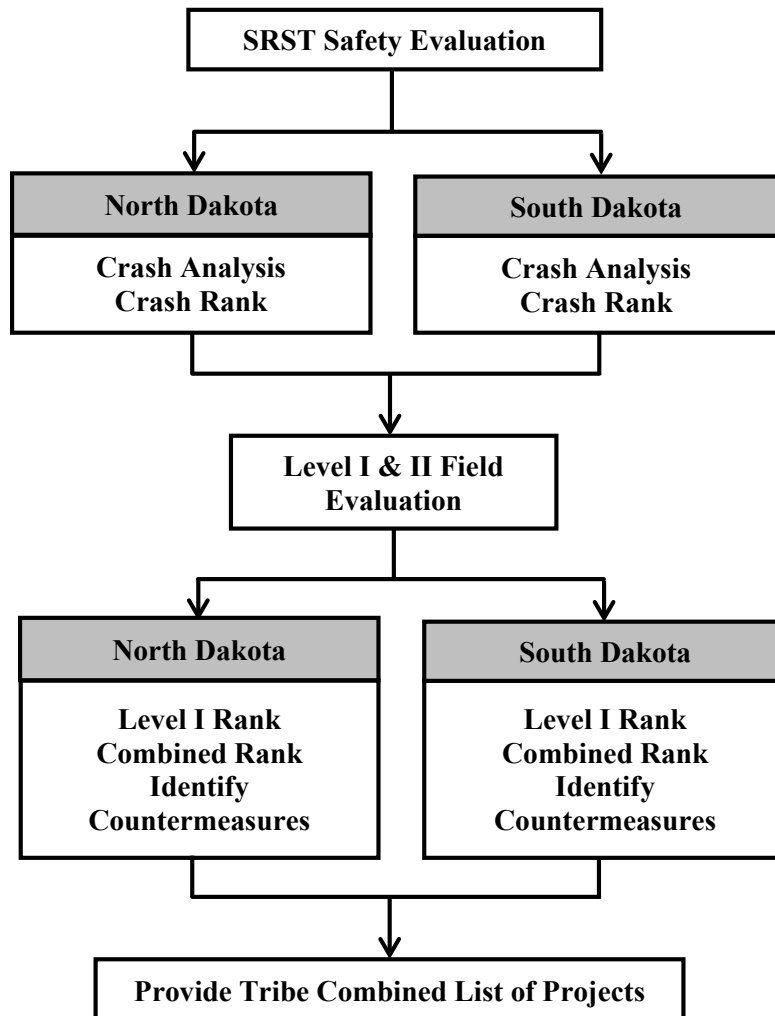
Figure 5.1 Applied Methodology

Because Standing Rock Reservation lies within two states, the methodology was altered to rank the crashes and the Level I field evaluation separately for each state. A combined ranking and countermeasures were determined separately as well. In order to maximize resources, the Level I and Level II evaluations were performed simultaneously. See Figure 5.1.

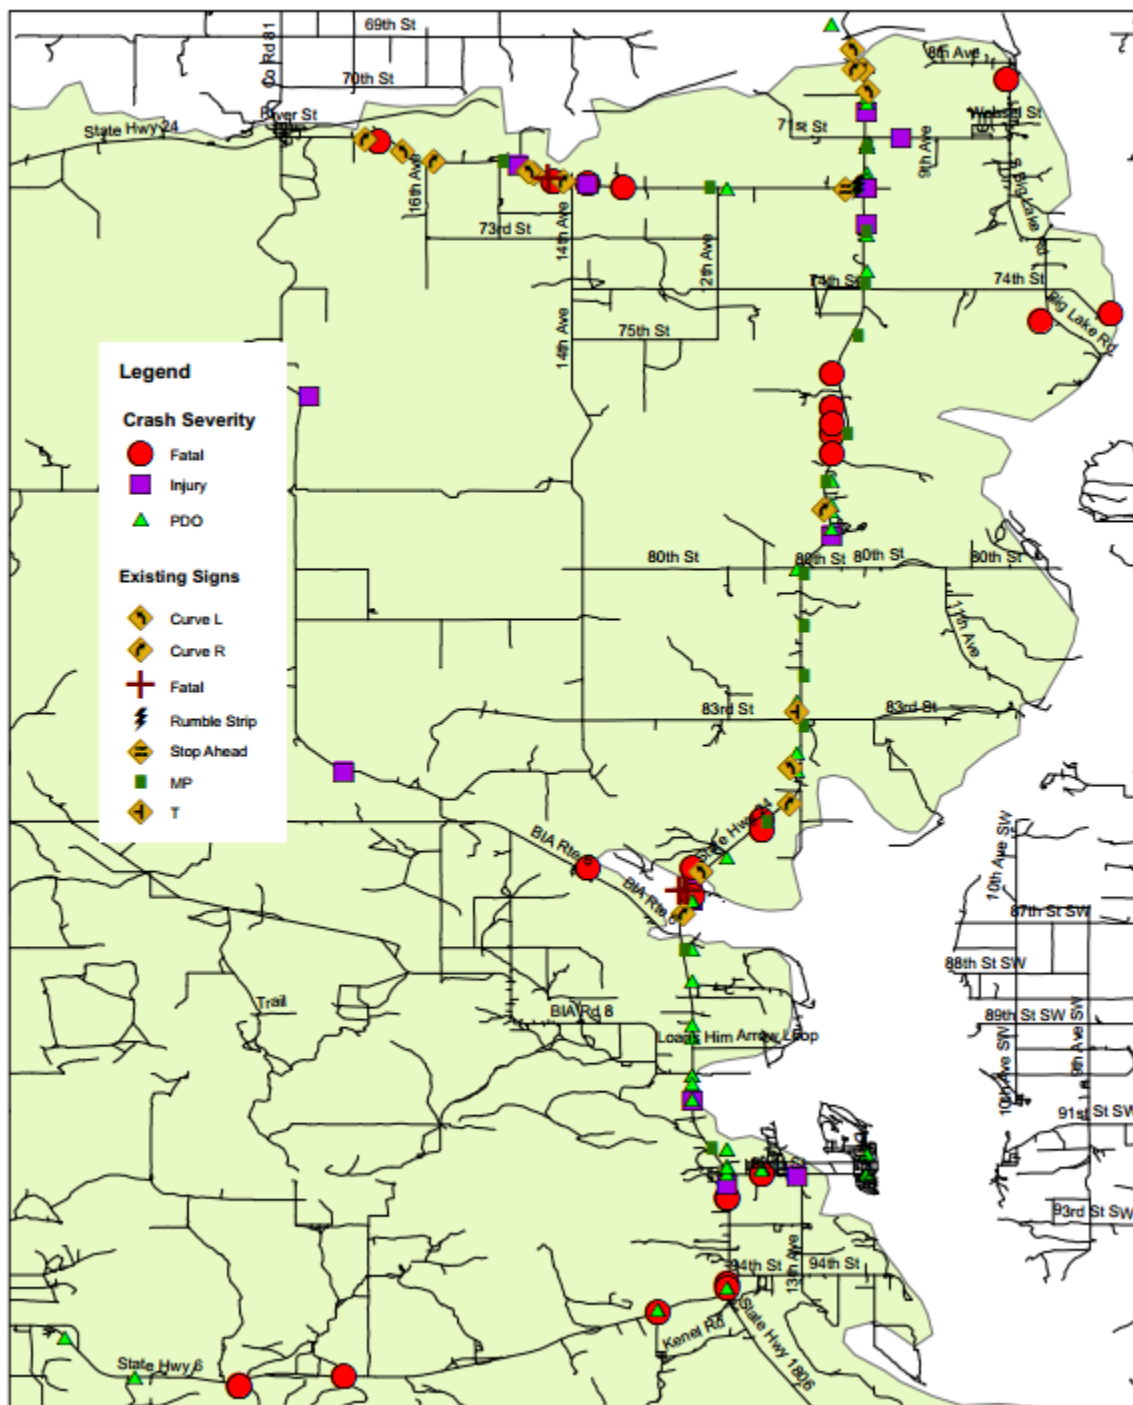
There were two main stretches of ND 24 that had high combined rankings, the north-south section between Ft. Yates and ND 1806 (MP 9 to MP 28), and the east-west section from ND 1806 to Solen (MP 28 to MP 43). In three locations, the road was straight with wide shoulders and rumble strips. One location included the intersection of ND 24 and ND 1806. There were PDO crashes with deer and two fatal rollover crashes at two of the locations. Figure 5.2 presents the existing signage along ND Highway 24 with crash locations shown.

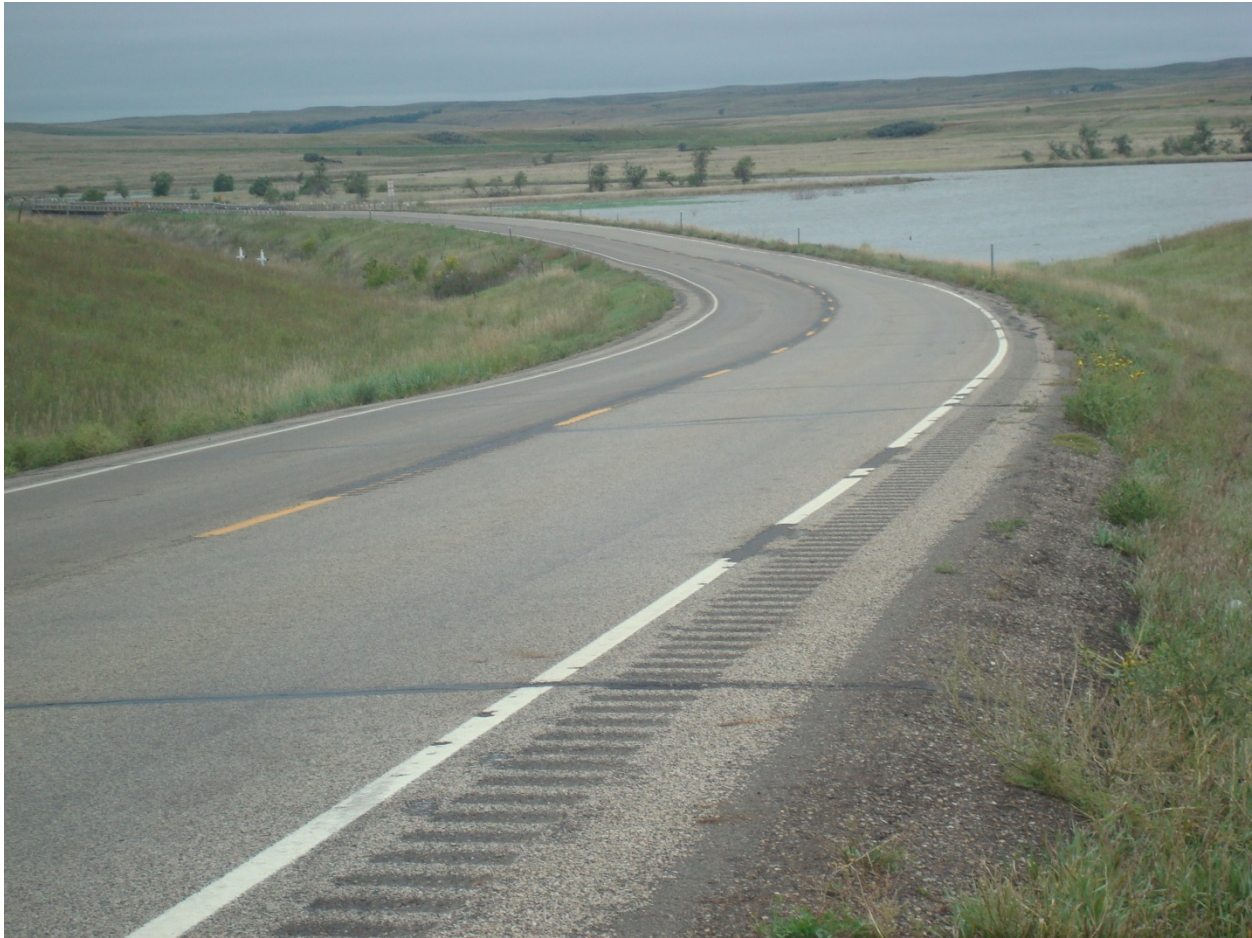
Figure 5.3 ND Highway 24 Curve at Bridge (MP 14 to MP 15)

There were two locations along ND 24 where fatalities occurred along a horizontal curve. One location in particular is also located near a bridge (MP 14 to MP 15). These locations contain curve warning signs with no advisory speeds. One of the curve locations (MP 34 to MP 35) appears to have good sight distance along a wide radius. This location could have some speeding issues, and a speed and safety study by NDDOT would be recommended. Near the bridge location, a guard rail is recommended (see Figure 5.3).

In Sioux County, the emphasis was on state highways based on feedback from the tribe. They have safety concerns for ND Highway 24 and ND Highway 1806. Based on the crash analysis and field evaluations, three roads were reviewed for safety improvements, ND 24, ND 1806, and Big Lake Road. Several fatalities are reported along ND 24. Signage will provide low-cost safety improvement. Just north of a bridge along a horizontal curve (MP 16), fatalities were reported along with known run-off-the-road crashes. Guardrails are recommended for this location.

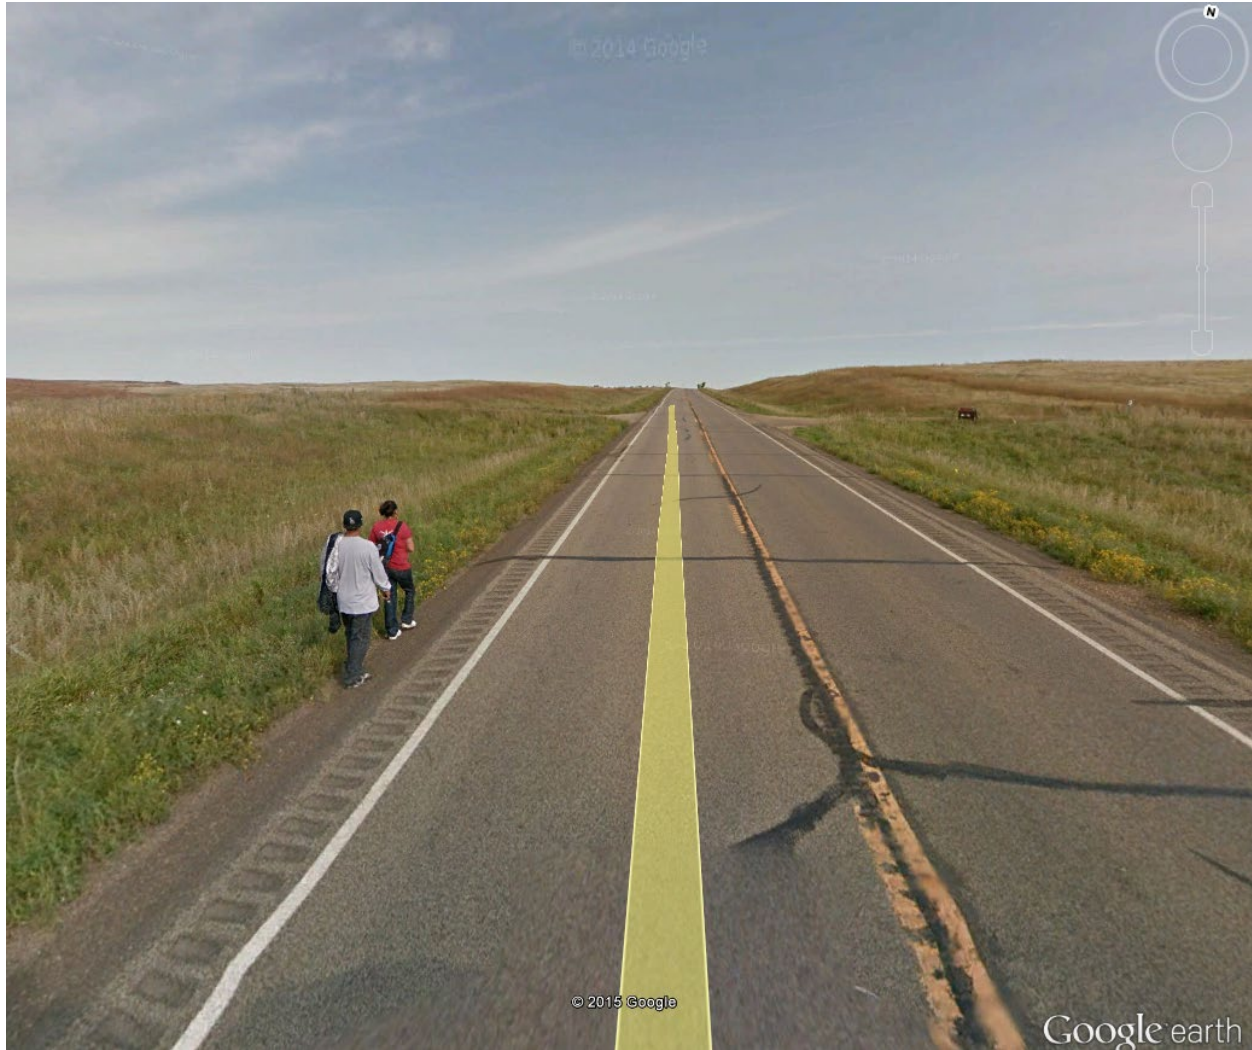
Figure 5.4 ND Highway 24 North of Prairie Knights Casino (MP 24)

Pedestrian safety is a concern on SRST. Pedestrian crashes resulting in fatalities were identified along ND 24. People will walk to work and to other services on the reservation. Some pathways have been constructed around Ft. Yates, but pedestrian travel extends across the reservation. Without adequate pedestrian facilities, individuals are forced to walk along the rural highways, which have narrow shoulders and high-speed traffic. Figure 5.4 shows how ND 24 is used by pedestrian.

Safe pedestrian access is a concern for the tribe. Fatal pedestrian crashes have been reported along ND 24. High-speed traffic and narrow shoulders are extremely hazardous conditions for pedestrians. However, tribal members walk across the reservation to get to work and other services. A long-range pedestrian access plan should be developed for the tribe to identify the high pedestrian traffic locations and needed improvement areas, which should then be included in the strategic plan.

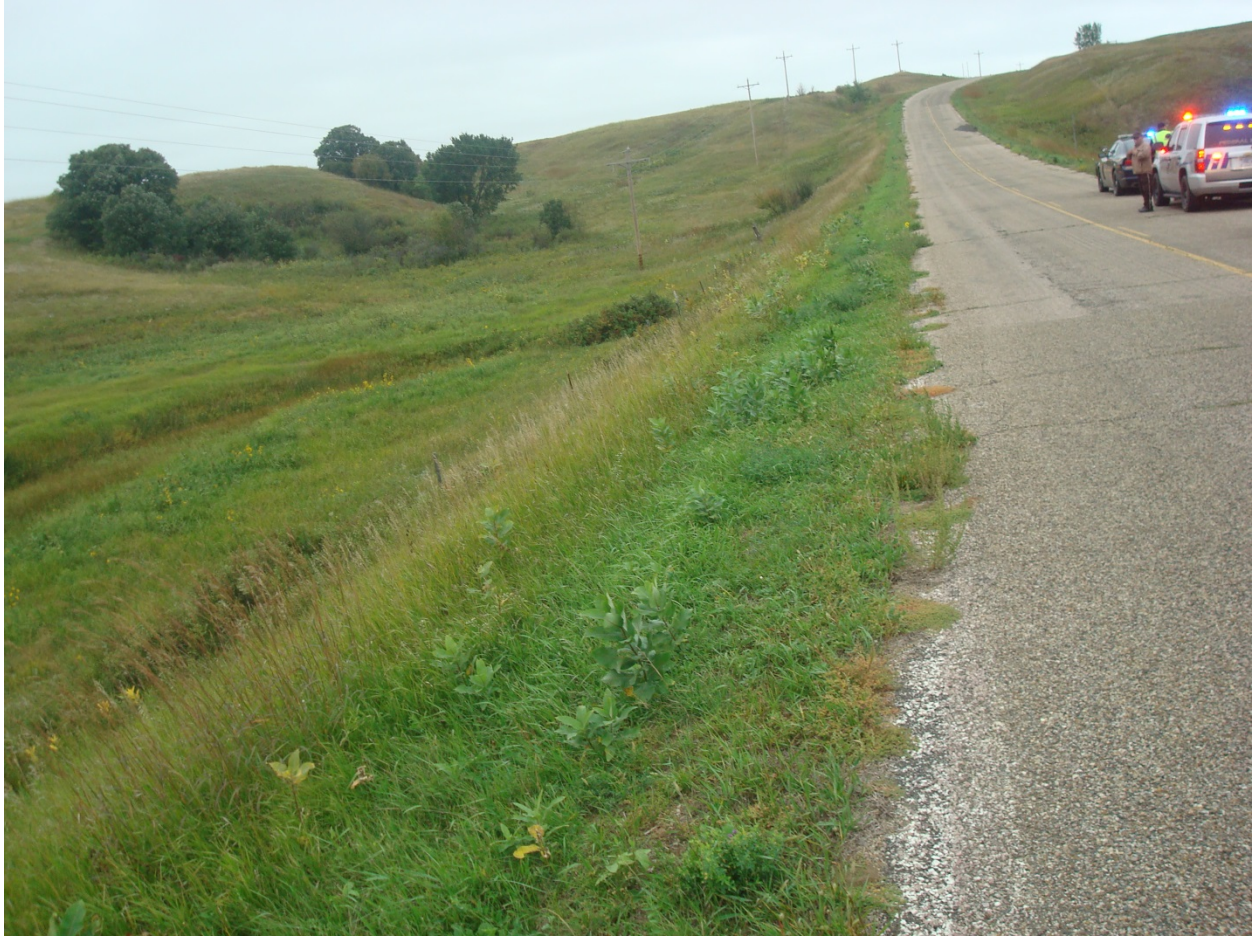
Figure 5.5 Big Lake Road

Big Lake Road was the only tribal road reviewed for safety improvements. This road is very narrow with no shoulders or recovery slopes. There are no pavement markings or lighting along this roadway. The slightest distraction or any reduction in visibility could lead to a serious incident. Three fatal crashes were recorded along this road. It is unknown how many other crashes of less severity have occurred there. The best solution for this roadway would be to widen it along the section that traverses a stream with a high drop-off (see Figure 5.5).

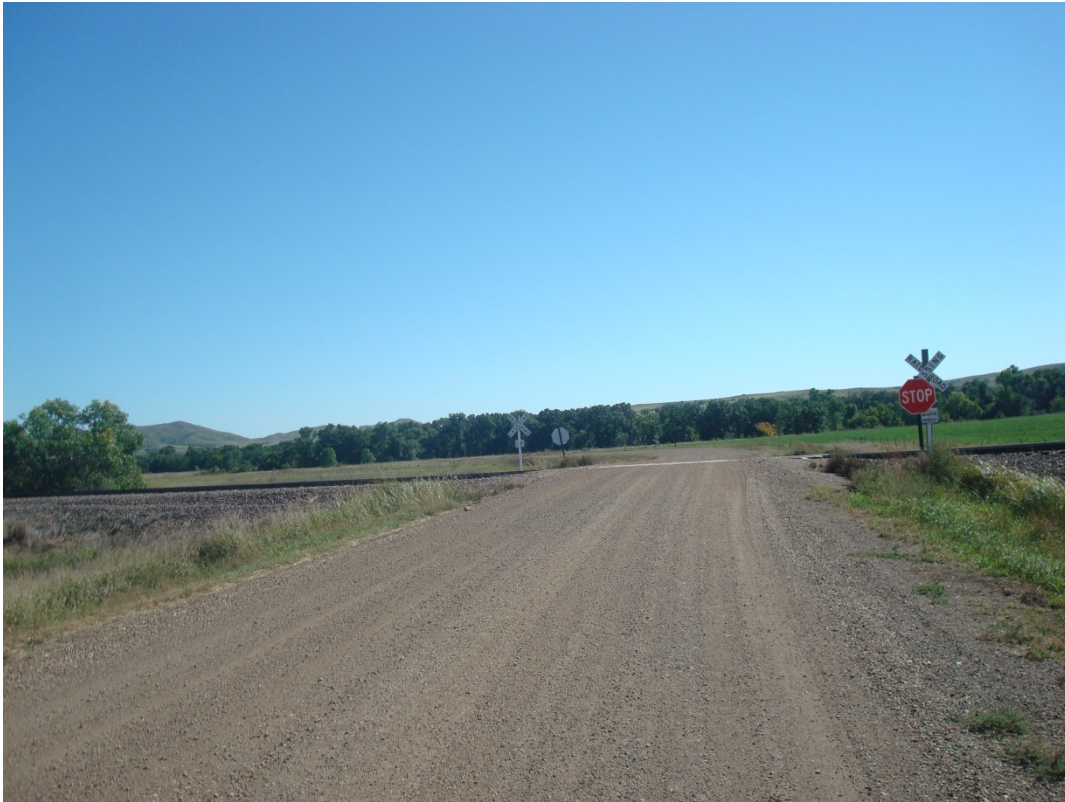
Figure 5.6 BIA 44 at Railroad Crossing (MP 2.5)

BIA 44 is a gravel road with varying conditions throughout. The evaluation started at 272nd Avenue and proceeded to Wakpala (MP 0 to 11). Areas along the segment have vegetation within the clear zone that could easily be removed. Several curves exist with curve warning signs in place. In two locations the road curved immediately after a railroad crossing, and neither location was signed properly for the curves (See Figure 5.6 and Figure 5.7). Advance warning signs for stop ahead and/or railroad crossing ahead should be added. An advanced curve warning sign should be added for the curve at MP 2.5. The curve warning signs should include the proper advisory speed plate.

BIA 44 is a gravel road in average condition. Some areas had vegetation in the clear zone and are recommended to be removed. Two railroad crossings exist along this roadway, with curves immediately after the crossings. Stop signs exist at the crossings, and one curve warning sign exists at the second crossing but with a regulatory speed limit sign. It is recommended that curve warning signs with advisory speed plates be posted for both curves. In addition, either stop ahead signs or railroad crossing ahead signs (or both) should be installed.

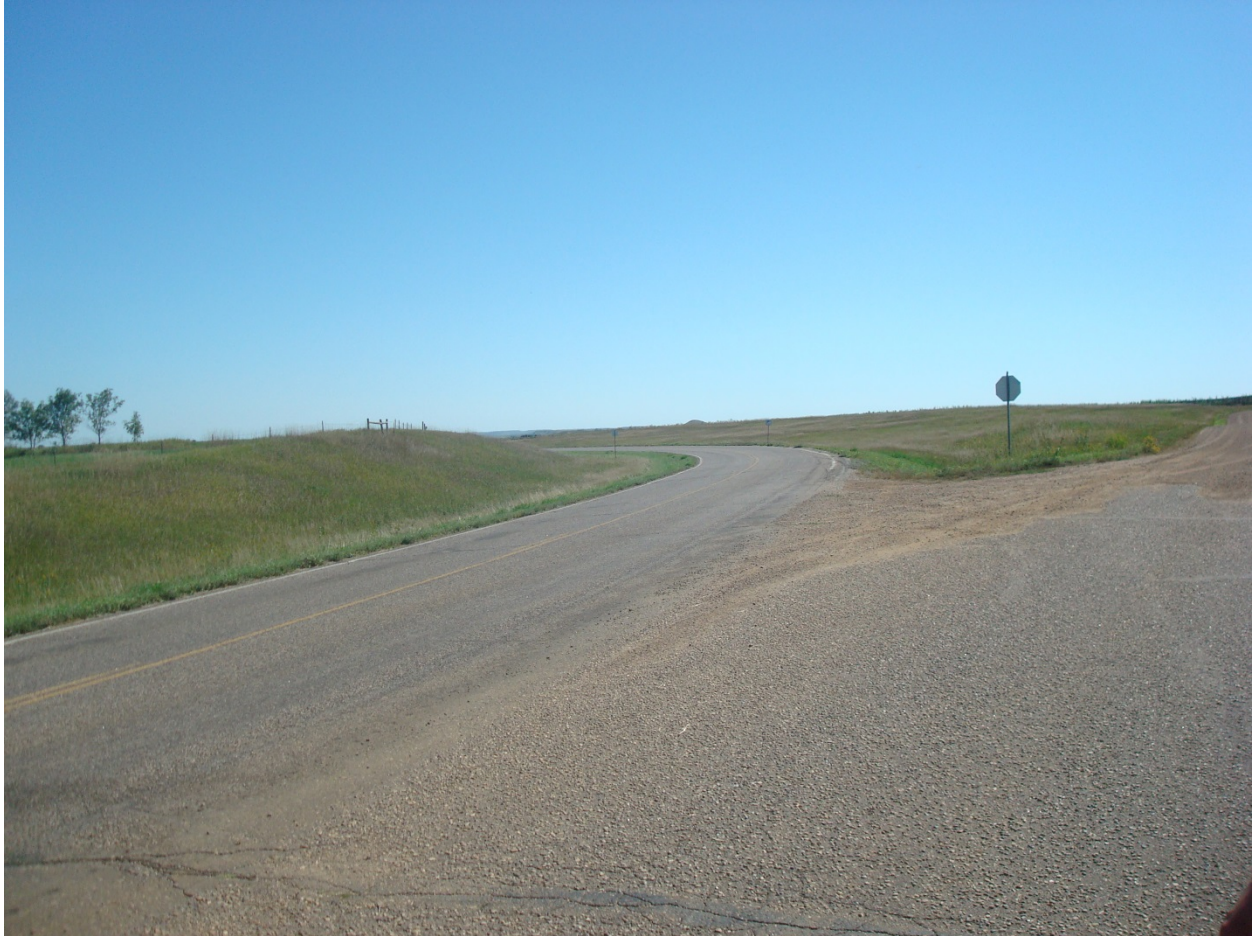
Figure 5.8 BIA 3 at State Line (MP 8)

No curve warning signs exist at the 90-degree curve at the state line (MP 8). At the curve, the pavement continues to extend to 100th Street. This allows drivers to continue at a high speed off the main roadway. Drivers entering as they head north are entering at a skew (see Figure 5.8). Advanced curve warning signs and possibly chevrons should be installed. The tribe should consider realigning the intersection at the curve to a 90 degree intersection, as illustrated in Figure 5.9. With the new construction starting at MP 12.4, it should be verified that curve warning signs were added.

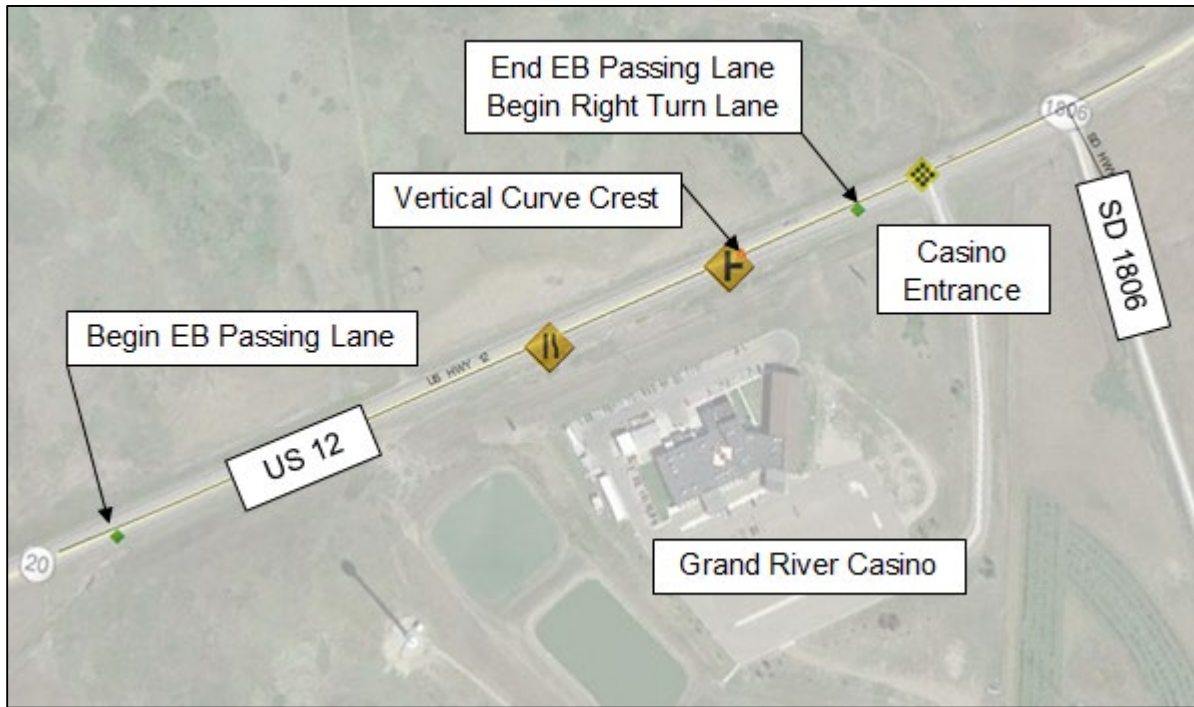
Figure 5.11 US 12 at Grand River Casino (MP 183 to 185)

The next segment of concern on US 12 is at the Grand River Casino (MP 183 to 185). Many safety concerns have already been addressed at the casino entrance, which was identified in a previous study. A left-turn lane and a right-turn lane have been constructed. A 2,000-foot eastbound passing lane exists prior to the road leading to the casino. The right-hand lane becomes the right-turn lane 600 feet before the casino entrance. This is because of the long climbing grade starting at the bridge 3,300 feet east of the casino entrance. Signage for the lane merge and T intersection exist as well. See Figure 5.11 for locations.

With the improvements in place, safety is still a concern at the casino entrance. A fatal crash occurred in 2014 at the intersection of the entrance to US 12. Just east of the entrance is the crest of a vertical curve. Although the proper sight distance may exist, which should be verified, the perception is that eastbound oncoming traffic cannot be seen in time to enter the highway safely. The speed limit is 65 MPH eastbound and 55 MPH westbound. A speed safety study and sight distance determination should be performed by the DOT. Additional signage warning of the dangerous intersection or a flashing warning sign could be considered to get drivers to slow down and be more aware of the situation.

Collisions crashes were recorded for the intersection of US 12 and Grand River Casino. With a crest vertical curve east of the casino entrance, sight distance should be verified. A speed safety study should be performed and proper speed limits posted. It is recommended that an advanced warning flasher be installed east of the casino entrance.
