MPC 19-410 | C. Pantelides, B. Kunwar, and V. McEntee

Seismic Rehabilitation of Reinforced Concrete Bridge Wall Piers

Department of Civil and Environmental Engineering
The University of Utah

December 2019

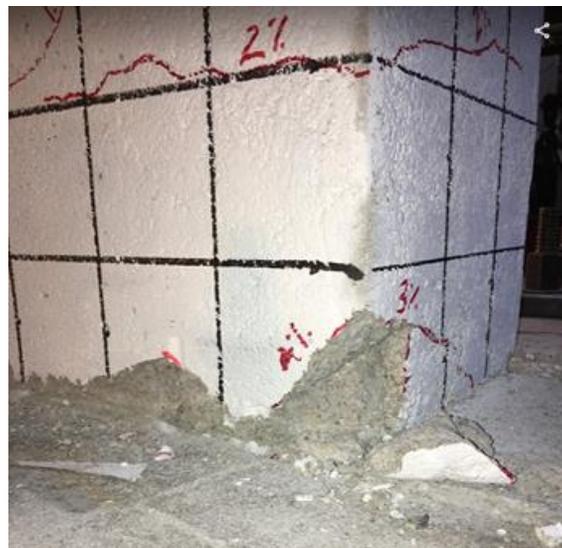
Figure 3.10 Spalling at 4% drift of as-built wall pier

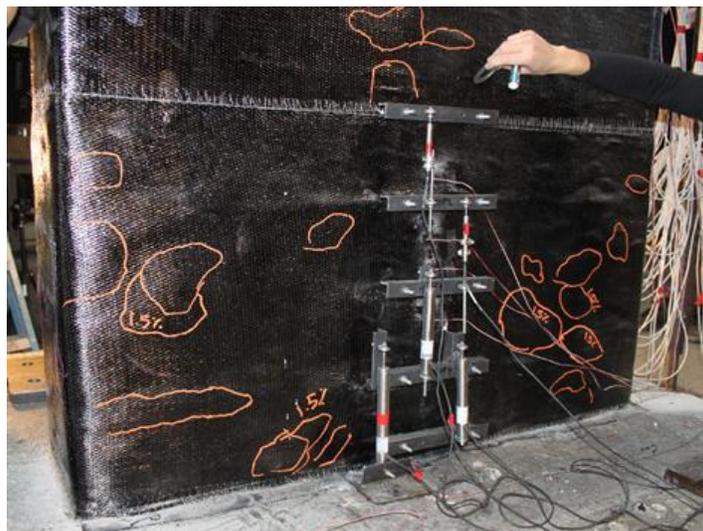
Figure 5.10 CFRP jacket debonding at 1.5% drift ratio for specimen R1

Debonding of the CFRP composite did not occur until the 1% drift ratio. These regions began to form 10 in. (25.4 cm) above the footing, and the largest of these debonded regions measured about 3.0 in² (19.4 mm²). At the 1.5% drift ratio, debonded areas grew larger and more small bubbles were present on the CFRP composite surface. The debonding can be seen in Figure 5.10. A peak load of 27.0 kips (120.1 kN) was reached at this drift ratio.

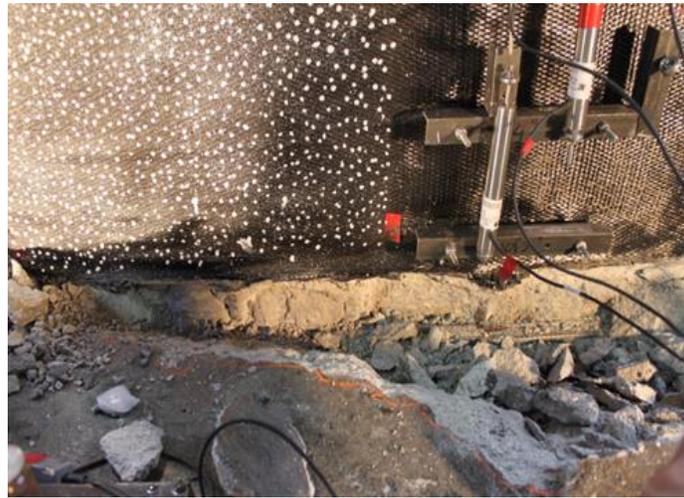
Figure 5.13 Footing damage at the end of the test for specimen R1

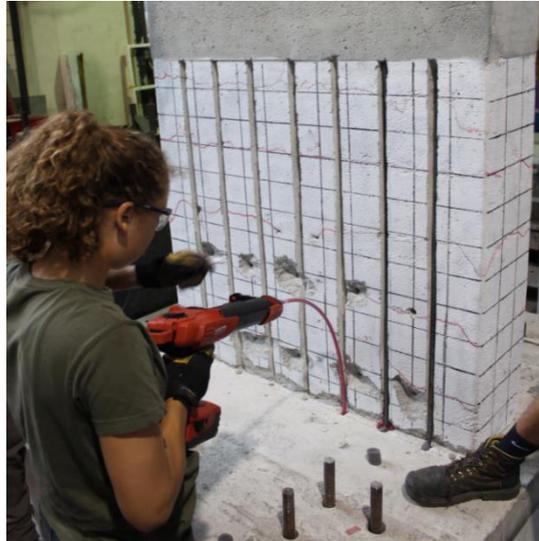
Figure 7.2 Mild steel NSM bar placement for specimen ABRP

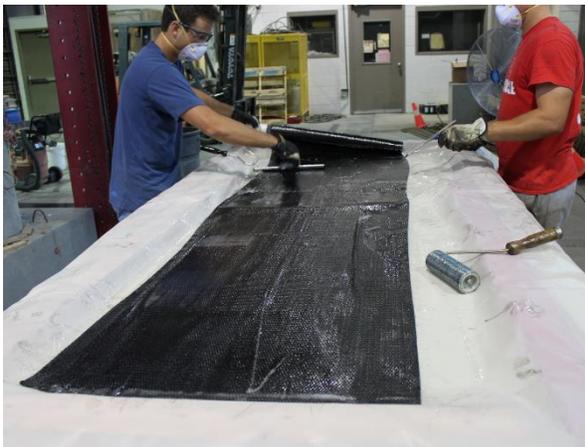
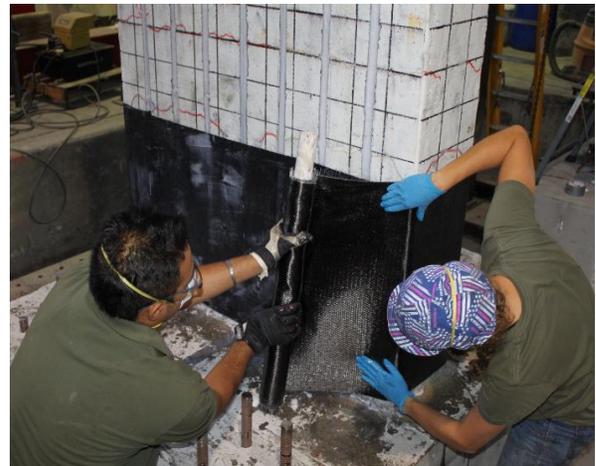
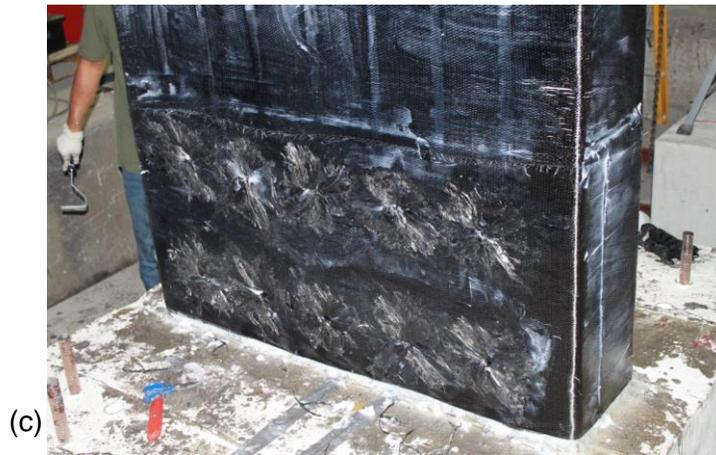
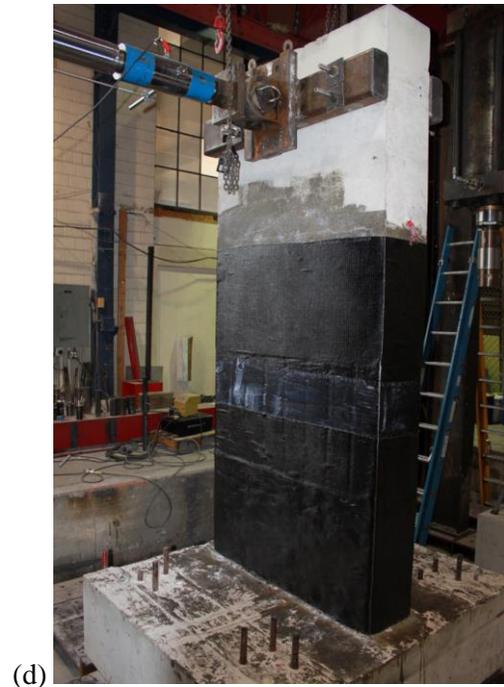
Figure 7.4 Repair application process for specimen ABRP: (a) fiber saturation, (b) hoop direction CFRP wrap application, (c) horizontal CFRP anchors, (d) final wall repair

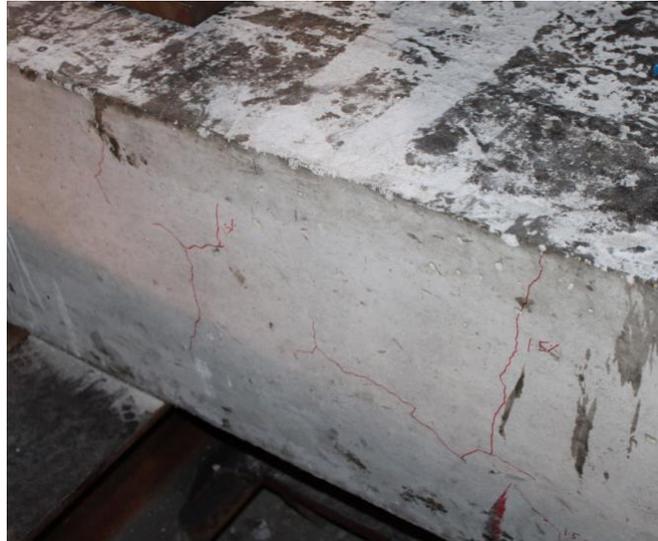
Figure 7.11 Footing cracks at 1.5% drift ratio for specimen ABRP

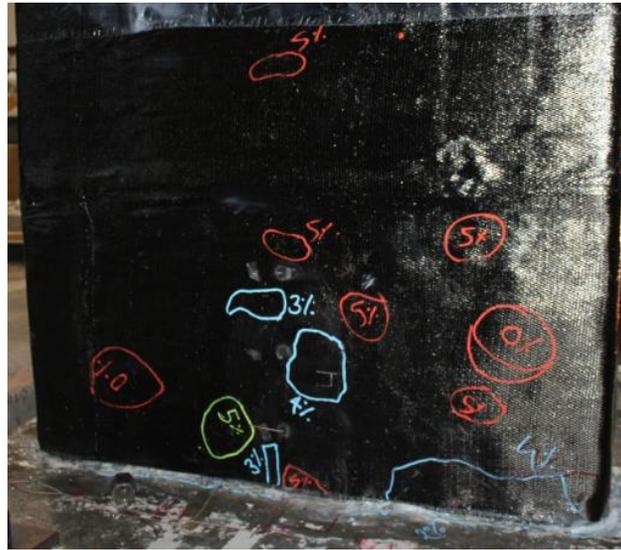
Figure 7.12 West face CFRP wrap debonding at 4% drift ratio for specimen ABRP

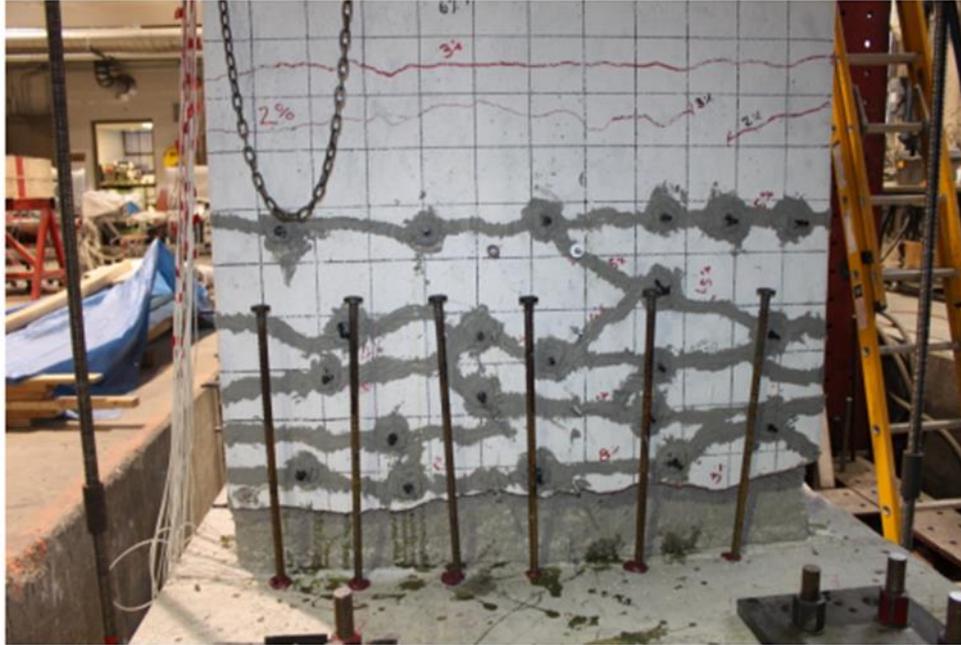
Figure 8.3 Installed headed steel bars for repaired specimen MCRP

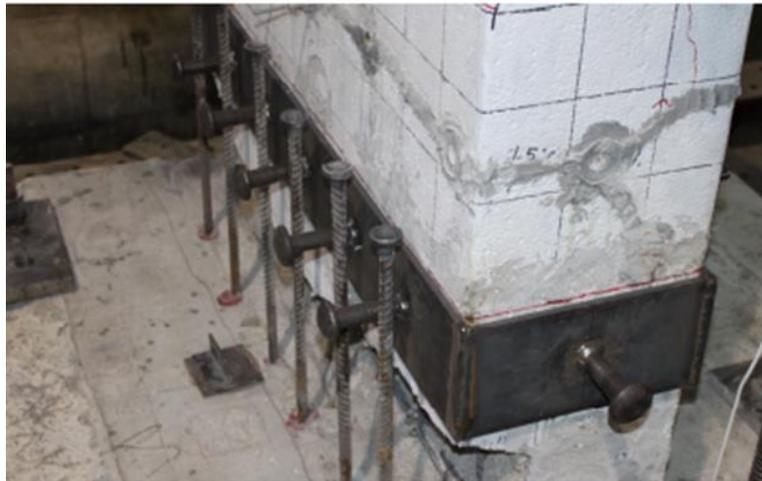
Figure 8.4 Steel collar with welded studs for specimen MCRP

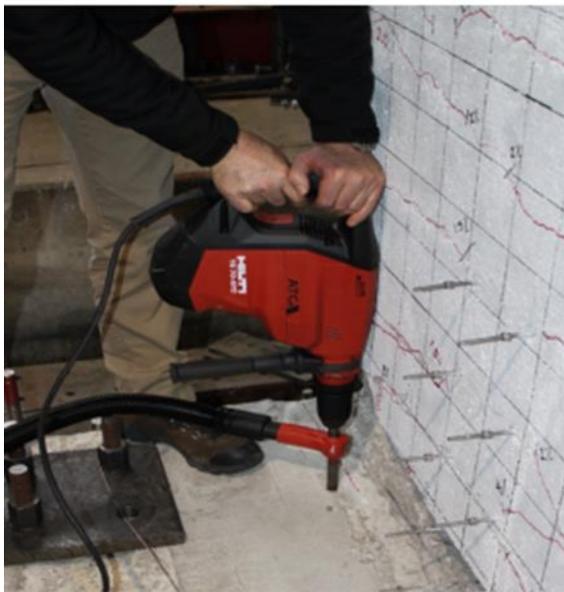
Figure 8.6 Headed steel bar installation process: (left) drilling holes; (right) headed bar placement for specimen MCRP

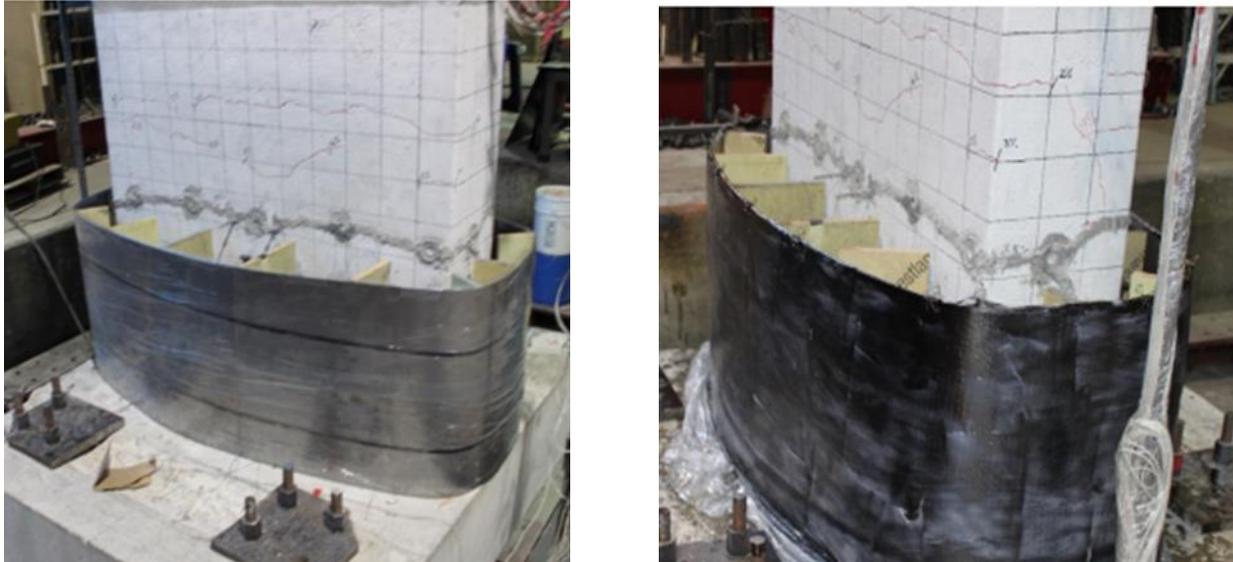
Figure 8.7 CFRP donut formation: (left) shell formation with precut aluminum foil; (right) CFRP wrapped around the aluminum form

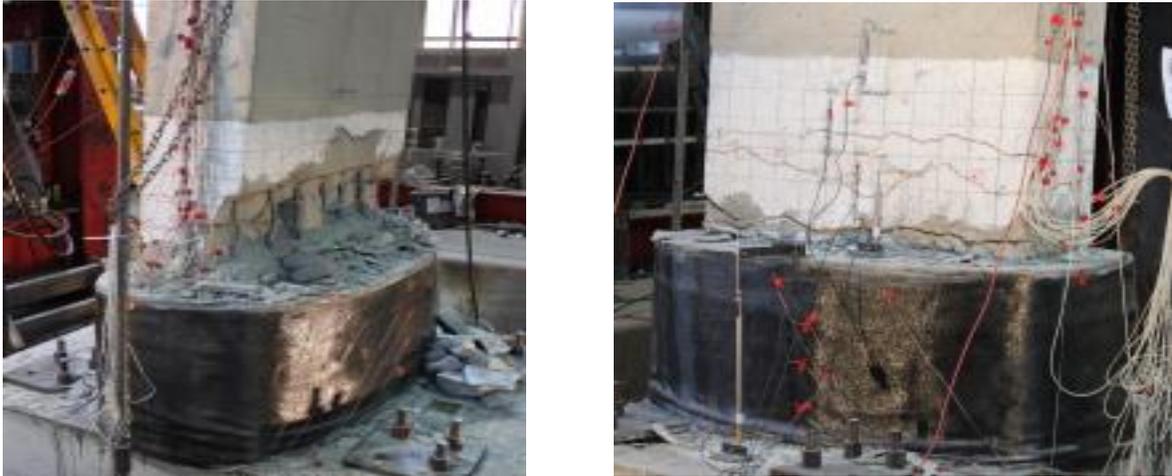
Figure 8.15 Experimental observation of specimen MCRP at a 6% drift ratio:
(a) east side and (b) west side
