MPC 21-434 | A. Jones, N. Wehbe, S. Klay and S. Maassen

Mitigation of Corrosion in
Continuously Reinforced
Concrete Pavement

Volume 1 – Final Report

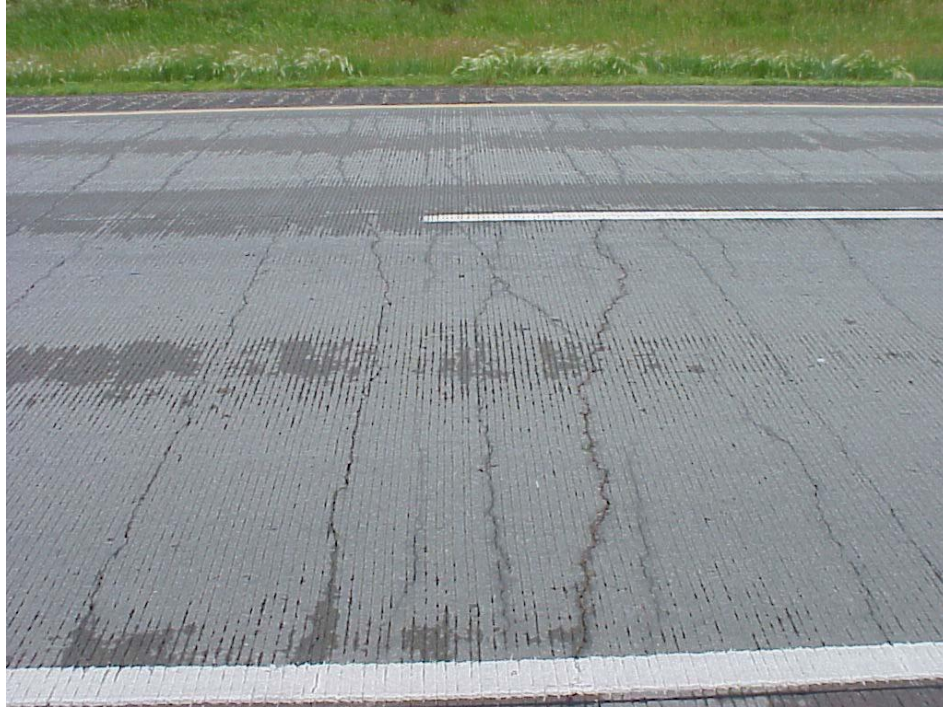
Figure 3.1 Network and Y-cracking (Johnston 2009)

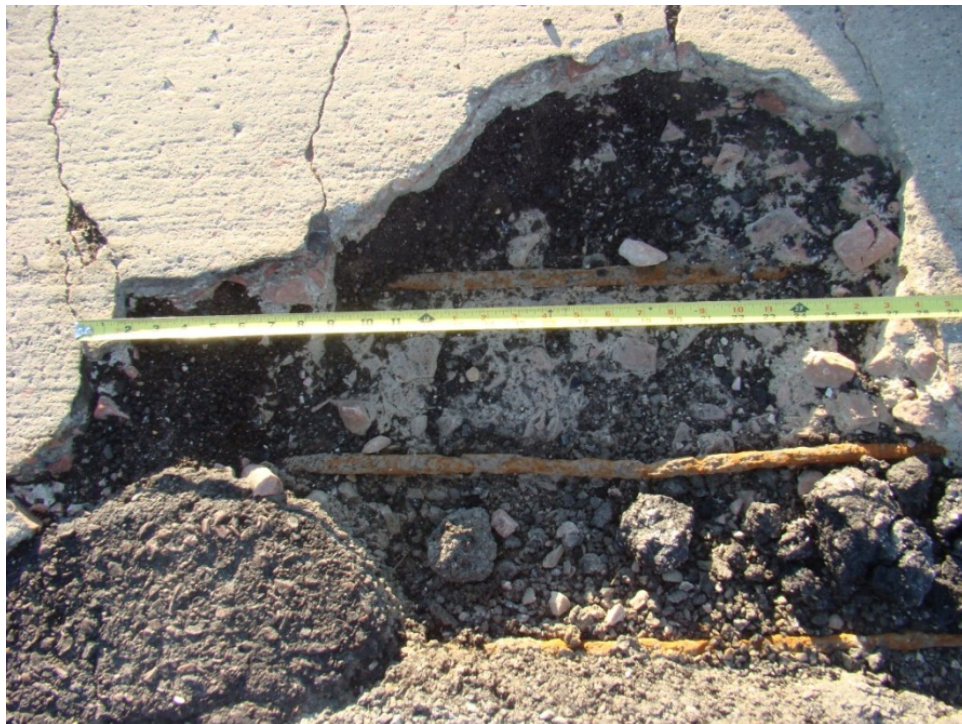
Tests conducted by Arya and Ofori-Darko (1996) indicate that crack width, effective depth, frequency, orientation (whether a crack is transverse or longitudinal to the steel bar), and the ability to self-heal are all factors that contribute to corrosion. Others have concluded that wider cracks cause higher corrosion rates (Otieno, et al. 2006). In light of this research, corrosion may be an increasing problem in the recently constructed CRCP in South Dakota because some of these pavements exhibit wide cracks, which are either transverse or longitudinal to the reinforcement. Examples of corrosion of reinforcement in some CRCP sections in South Dakota are shown in Figure 3.3 and Figure 3.4. The reinforcement shown in these photographs are from CRCP constructed in 1968.

Figure 3.3 Corroded reinforcement exposed during CRCP removal

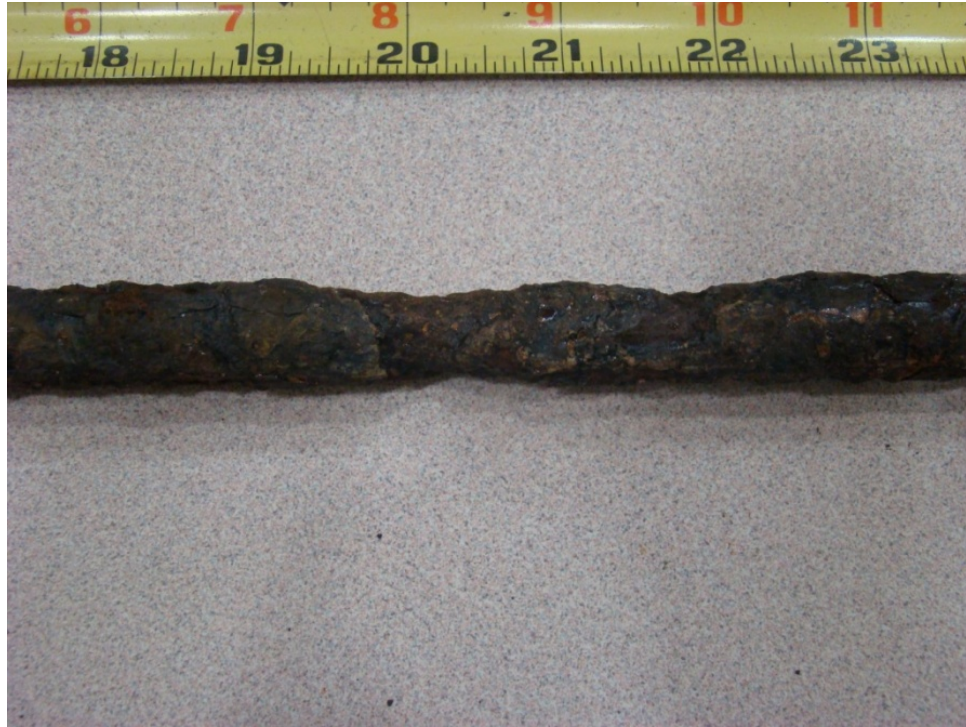
Figure 3.4 Corroded reinforcement removed from degraded CRCP

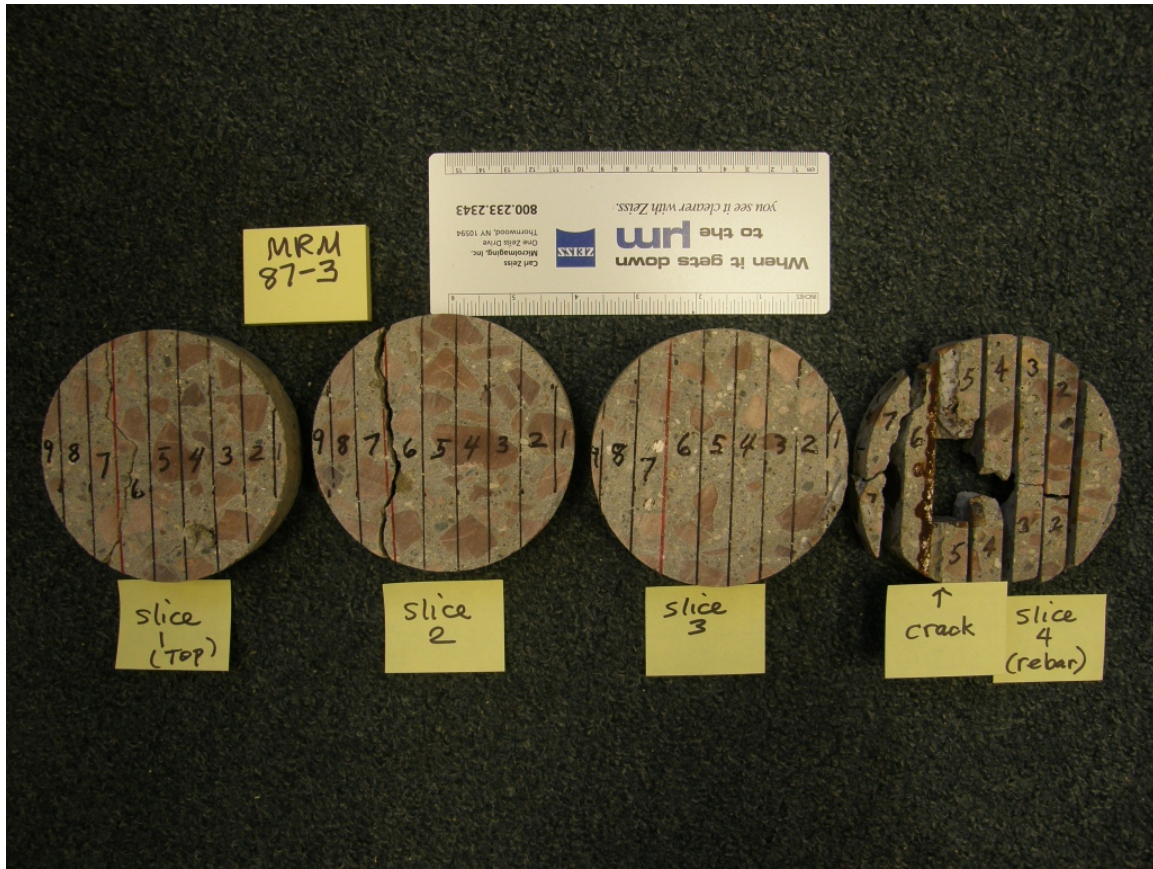
Each core that underwent laboratory testing was prepared for chloride ion analysis by initially slicing the core horizontally at 1-inch increments down to the level of the top of the reinforcement. The final horizontal slice of the core was made directly below the reinforcing bar. The horizontal slices were then cut vertically at 0.5-inch increments away from crack locations. Each of the resulting samples was subsequently pulverized for the purpose of chloride ion testing. Figure 4.1 shows the horizontal slices of one of the cores prior to sectioning it vertically. Chloride testing of these samples was performed to determine the distribution of the chlorides laterally from crack locations at 1-inch depth increments. All the chloride test samples in this study were tested using the alternative potentiometric method.

Figure 4.1 Horizontal slices of cores

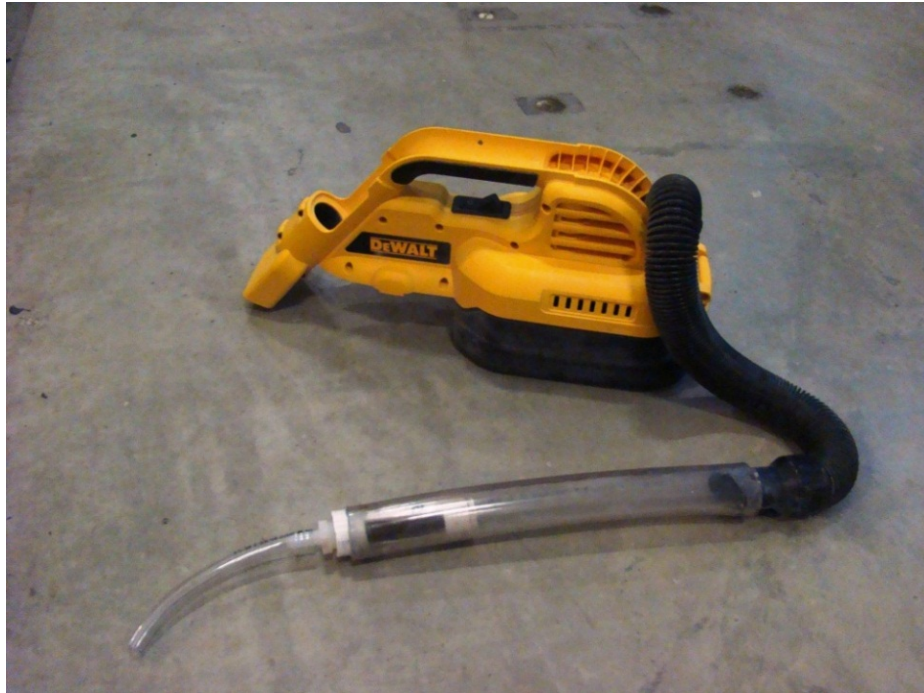
Four composite dust samples were collected near core sample locations at all three sites. A composite dust sample consisted of four individual dust samples collected at depths of 1, 2, 3, and 4 inches from the pavement surface. At the location of the dust sample, three 0.5-inch diameter holes within 6 inches of each other were drilled using a hammer drill. The dust created by the drilled hole was gathered using a filter collection device and handheld vacuum cleaner (Figure 4.2). The filter collection device was made of PVC pipe, plastic tubing, and a high efficiency particulate air (HEPA) filter backed by a U.S. No. 200 sieve screen (Figure 4.3). Figure 4.4 through Figure 4.6 show members of the research team collecting dust samples.

Figure 4.2 Filter collection device and vacuum

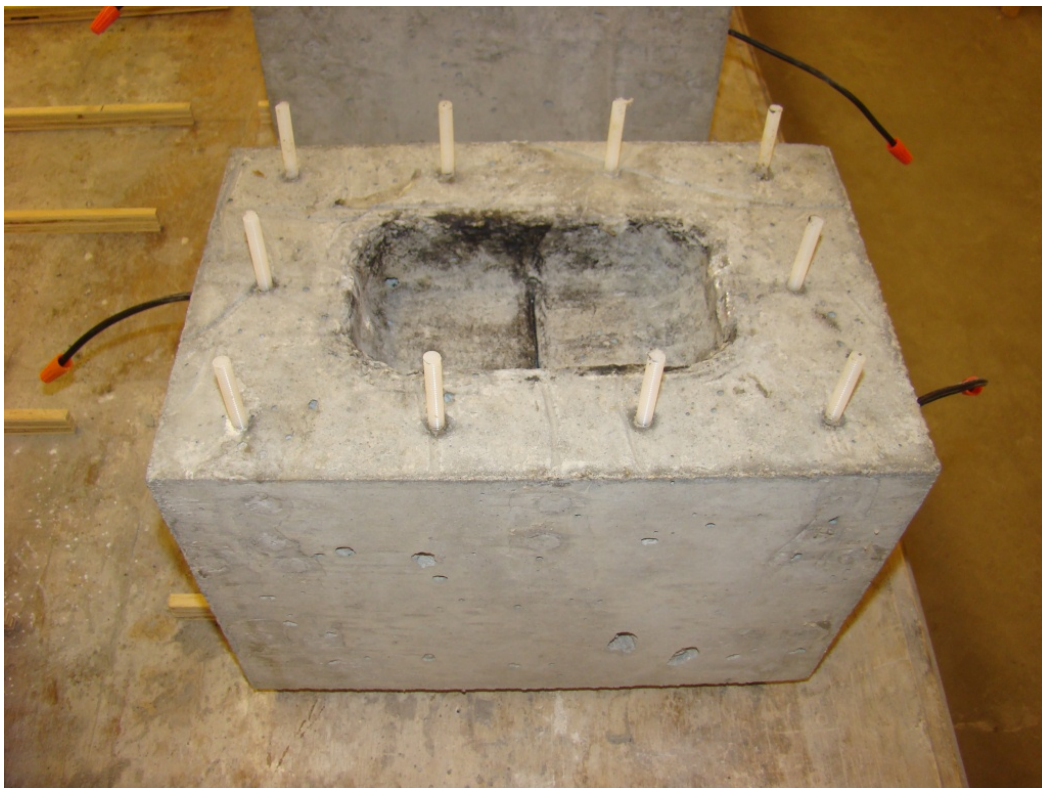
Figure 4.14 Cracked specimen

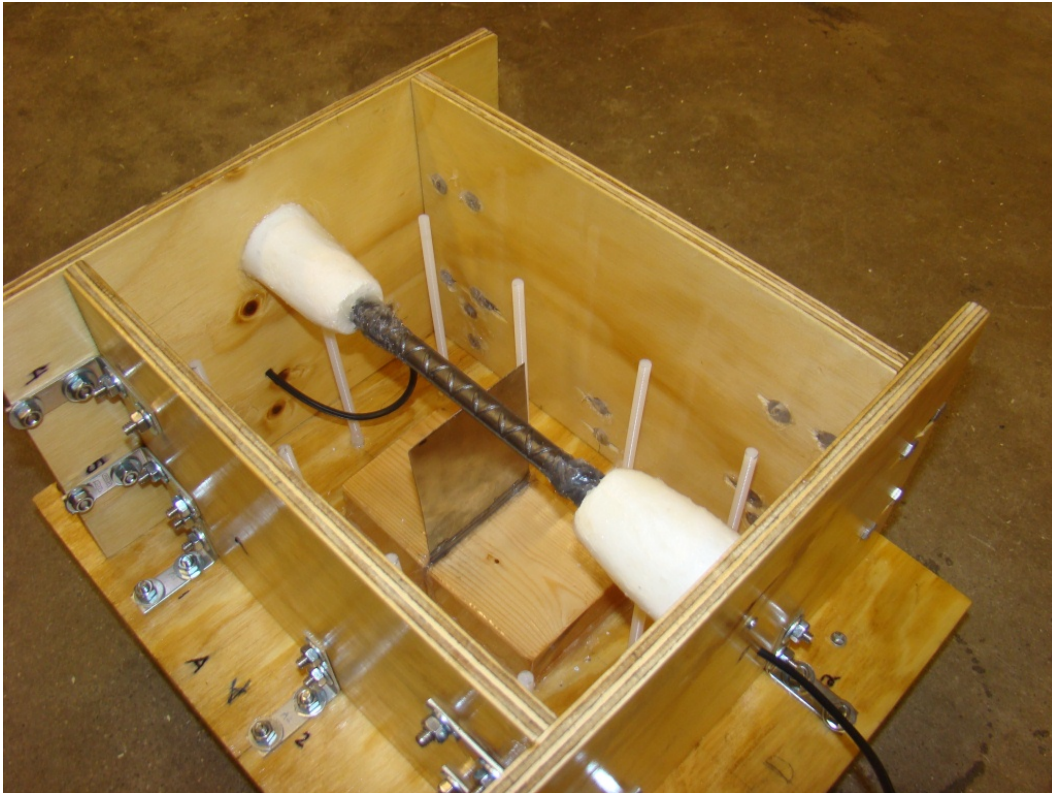
inches deep. Some specimens were cast with a steel shim to simulate a crack; the simulated crack was introduced into the specimen by placing 0.01-inch-thick shim stock into the specimens between the well and reinforcing. The average crack thickness of cracks surveyed at the Sioux Falls Sites was 0.01 inches; therefore, that was the thickness used to simulate cracks. The steel shim was cut so that it tapered from 3-inches long at the top to 2.5-inches long at the level of the reinforcement. The steel shim extended 4 inches from the bottom of the well to the top of the reinforcement. After the specimens cured for 48 hours, the steel shims were removed from the specimens leaving a simulated crack. Uncracked specimens were also produced as part of the study.

Figure 4.15 Form and steel shim for a cracked specimen

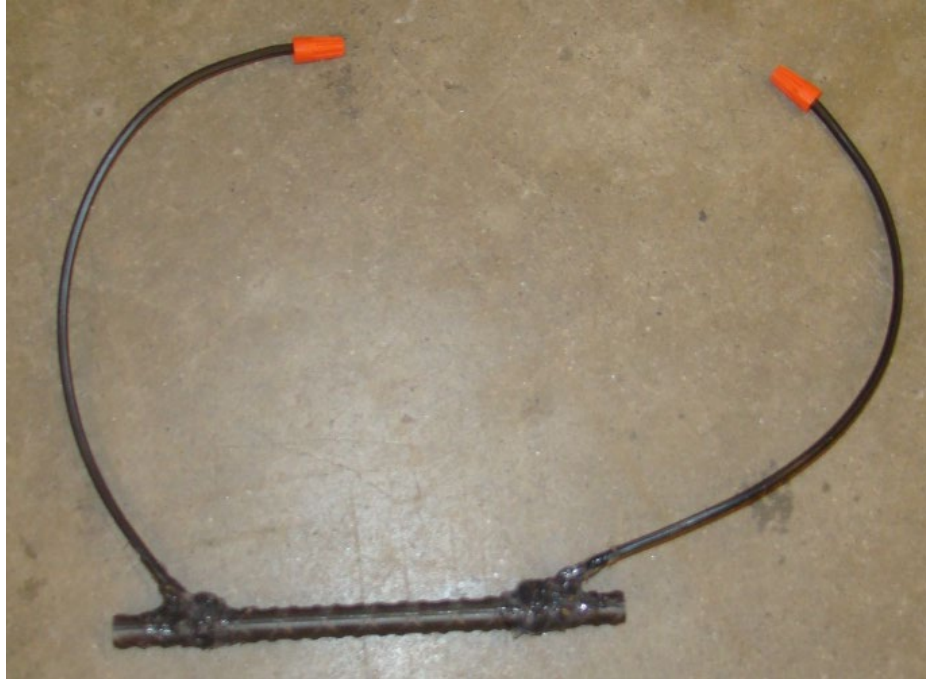
The steel reinforcement was wire brushed prior to casting the specimen to remove all corrosion and oil. The reinforcement was then connected to 14-gauge, insulated copper wires that extended out of the side of the specimen. These wires were used to obtain half-cell potential measurements. The wires were connected to the reinforcement by drilling a hole through the reinforcing and then attaching the wire with a screw and electrical lug. The connections were covered with butyl rubber, which was then covered with silicone sealer as shown in Figure 4.16, to prevent the connections from corroding and affecting electrical connection. The reinforcement was held in place by Styrofoam inserts while the specimens were cast as shown in Figure 4.15. Once the specimens were cured, the Styrofoam was removed and the holes were patched with Quikcrete®.

Figure 4.16 Reinforcement prior to placement in the forms

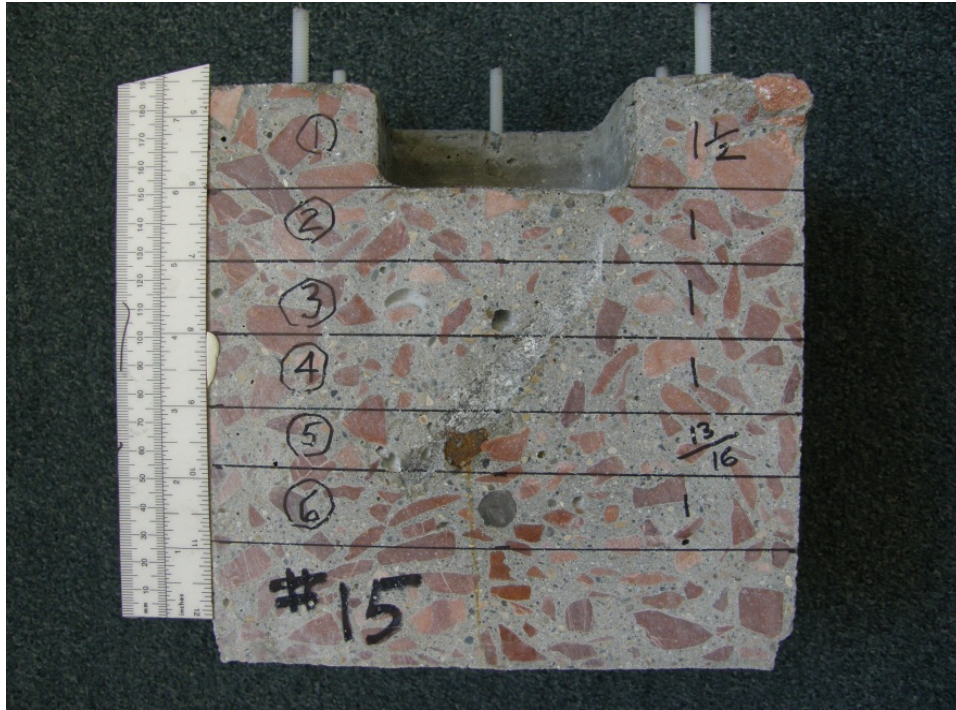
To perform the chloride ion analysis, the laboratory specimens were sliced using a vertical and horizontal scheme. The specimens were first cut into five horizontal slices below the well. The top three slices were 1-inch thick and the fourth slice, directly above the reinforcement, was approximately $\frac{3}{4}$ -inches thick as shown in Figure 4.17. The fourth horizontal slice was reduced to less than 1-inch thick due to cutting equipment limitations. The horizontal slices were then cut vertically at 1/2-inch increments away from the simulated crack location. Figure 4.18 shows the horizontal slices with the vertical cuts marked on them. Each of the resulting samples was then pulverized prior to chloride testing.

Figure 4.17 Horizontal slice scheme for concrete specimen

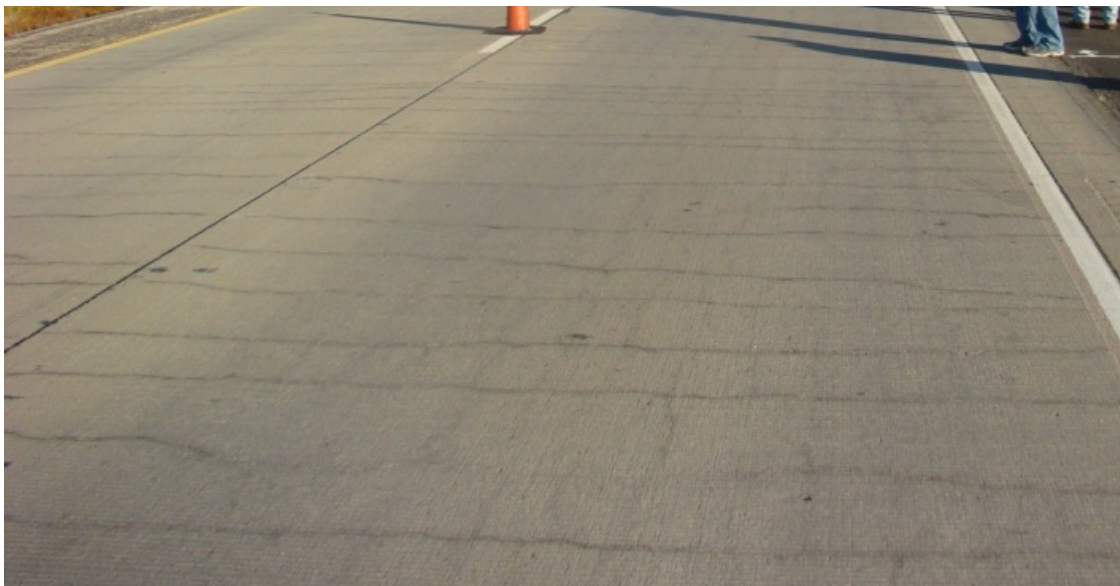
Crack mapping, dust sampling, and core sampling was completed for site MRM 87 on September 30, 2010. The first set of half-cell potential measurements was obtained on October 12, 2010. A second set of half-cell potential measurements was obtained on June 14, 2011, to determine the effect of one winter maintenance cycle on the half-cell measurements. Transverse, longitudinal, and Y-cracking were observed. The measured crack width at this site averaged 0.013 inches with minimum and maximum widths of approximately 0.006 inches and 0.033 inches, respectively. The crack density was 0.681 foot/square foot. Transverse crack spacing ranged from less than 1 to 4 feet apart. Figure 5.1 presents a picture of a section of this CRCP site.

Figure 5.1 Cracking on Interstate 29 at MRM 87

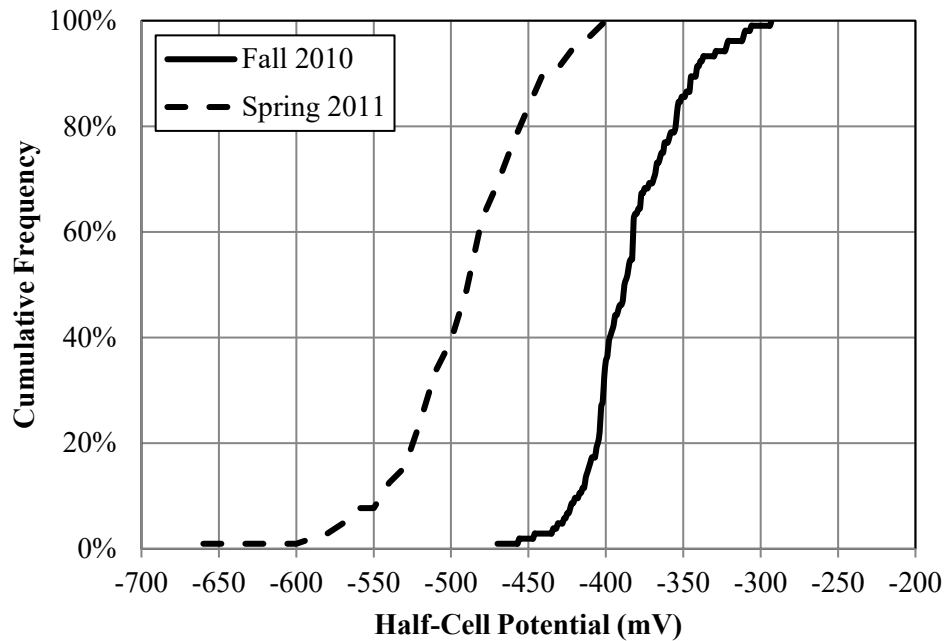
Figure 5.8 presents the cumulative frequency distribution for half-cell potential at this site and Table 5.4 presents a summary of the data points that fall within ranges of the corrosion probabilities suggested in ASTM C876-09.

Figure 5.8 MRM 87 half-cell cumulative frequency distribution

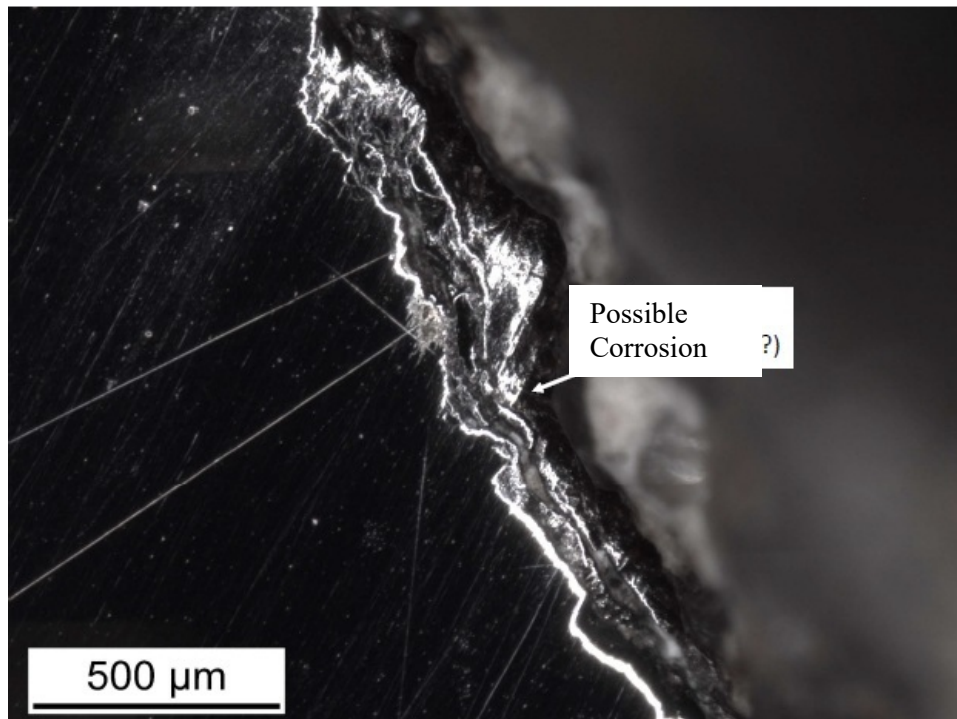
the optical microscope. This is shown in Figure 5.10. Figure 5.11 shows a secondary electron image of the possible corrosion zone.

Figure 5.10 Thin layer of rust or possible corrosion

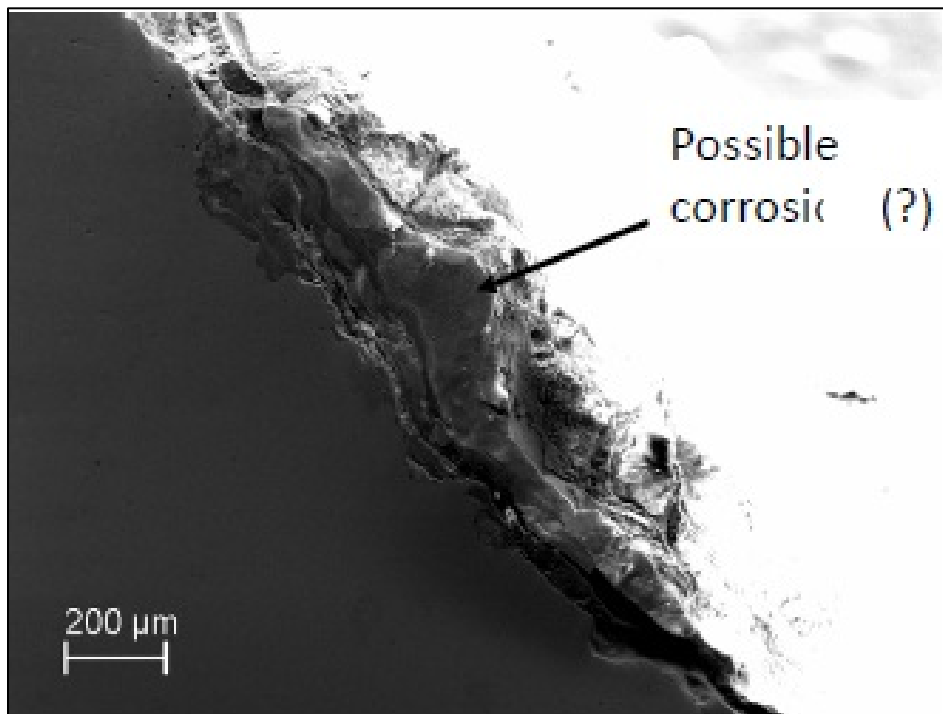
Figure 5.11 Secondary electron image of possible corrosion zone

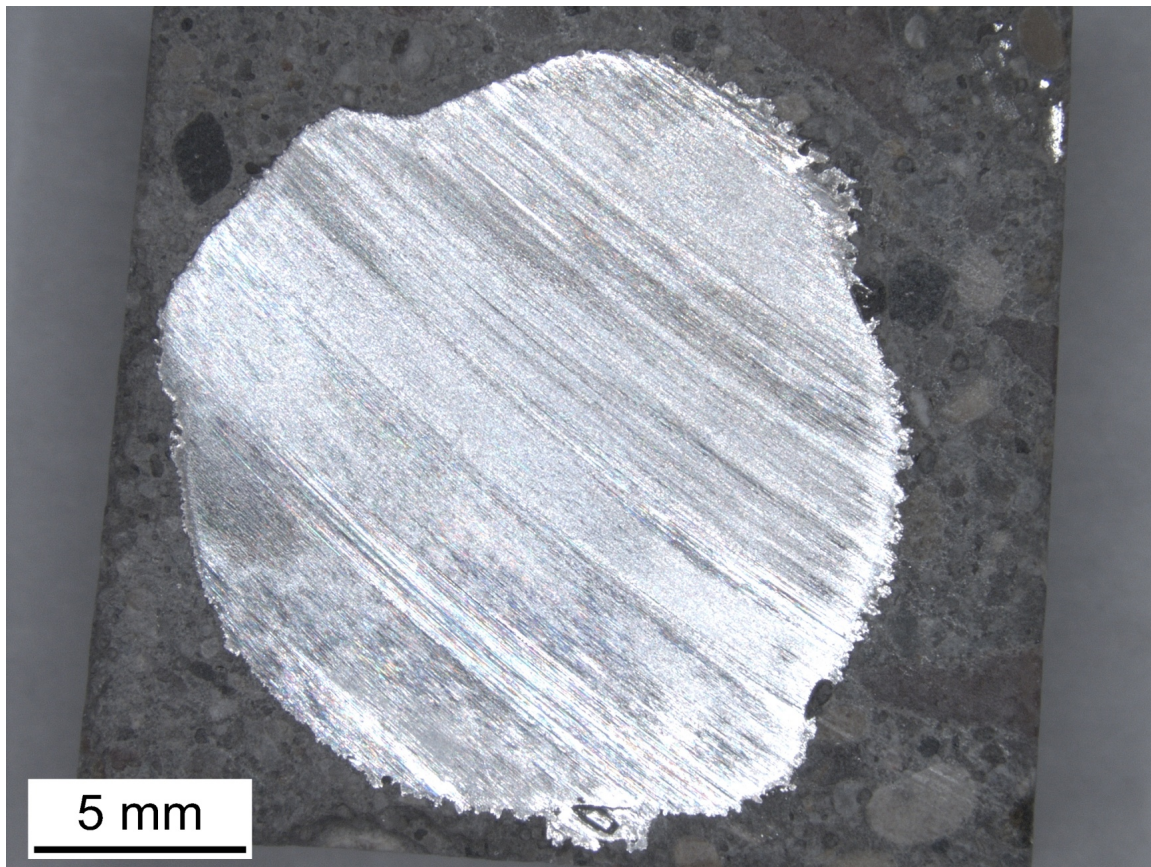
The reinforcement in an uncracked concrete core from site MRM 87 was also analyzed to determine if corrosion was present in the reinforcement away from pavement cracks. The core was labeled MRM 87-4. A photograph of the polished section of reinforcement from this core is shown in Figure 5.12. The photograph shows that there are no signs of corrosion in the reinforcement. As with cracked core MRM 87-3, the intact core exhibited a thin oxidized layer around the entire perimeter of the steel bar. This layer was analyzed using SEM, and the results showed no signs of chlorine or corrosion. Figure 5.13 shows the energy dispersive spectrum of the sample. Only iron peaks are present.

Figure 5.12 Steel bar section from core MRM 87-4 (uncracked concrete core)

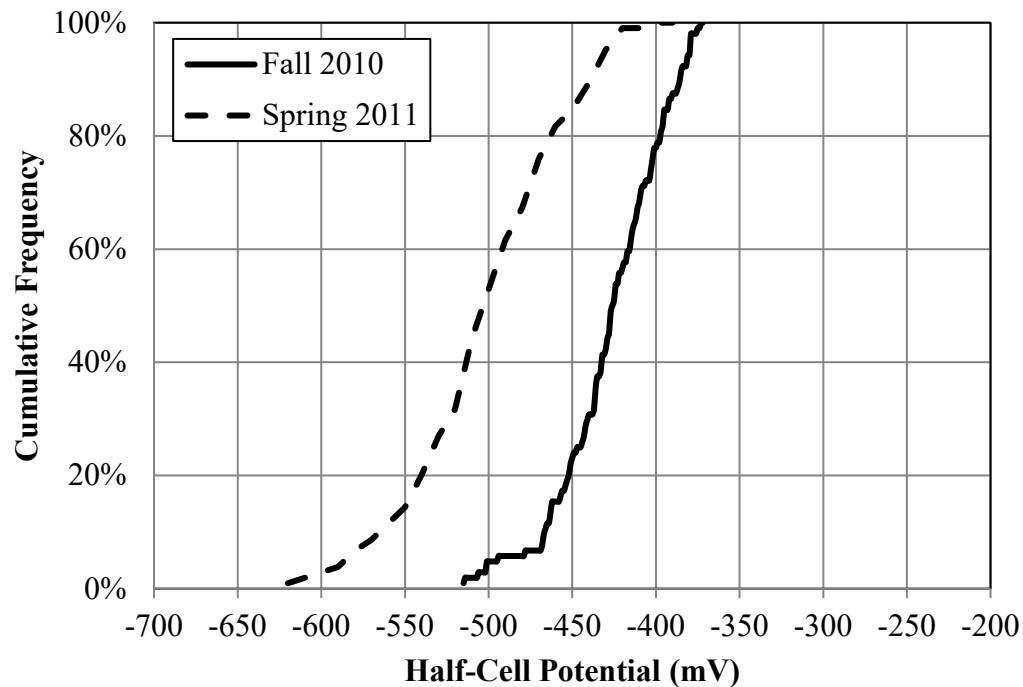
Figure 5.14 presents the cumulative frequency distribution for half-cell potential at this site and Table 5.6 presents a summary of the data points that fall within certain ranges of corrosion probability. The figure and the table show that all the measurements obtained at this site indicate high probability of corrosion according to ASTM C876. Equipotential contour maps of both sets of half-cell potential measurements are presented in Appendix B.

Figure 5.14 MRM 68 half-cell cumulative frequency distributions

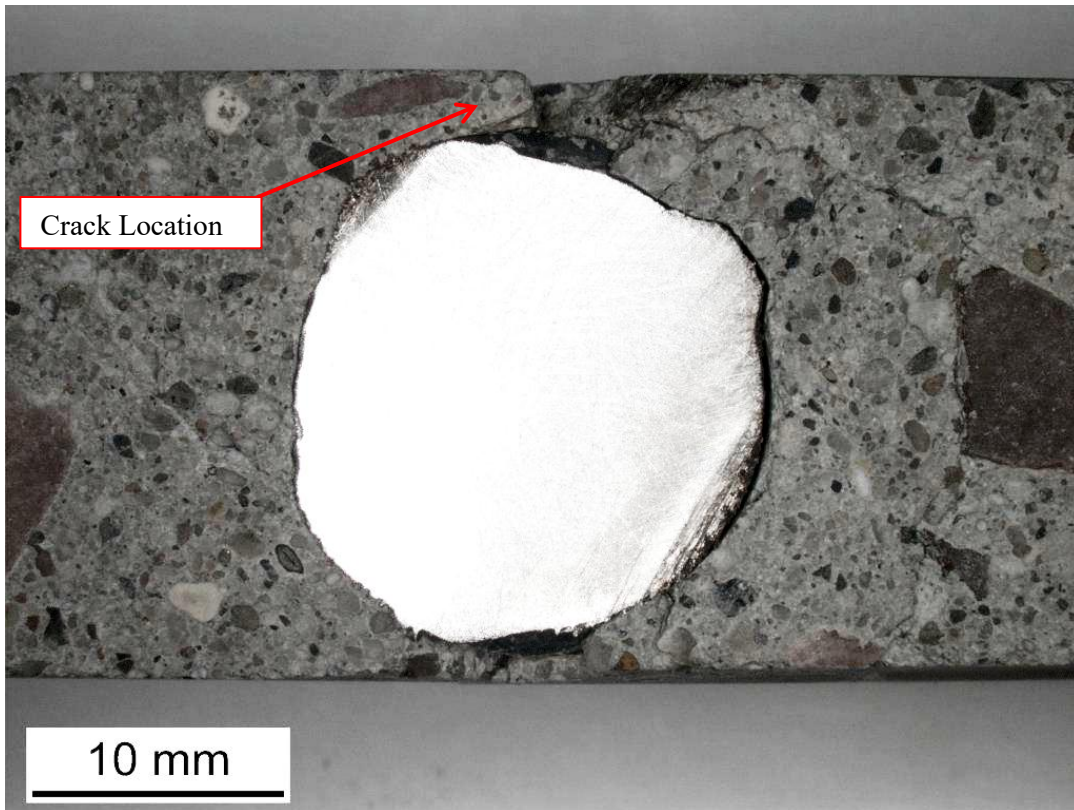
The steel reinforcement of one of the concrete core samples from this site was analyzed using SEM. The core selected was MRM 68-3. The concrete cover to the reinforcement was 5.25 inches. The core had a main vertical crack approximately 0.037 inches wide. Other minor cracks were observed that intersected the main crack. The main crack intersected the reinforcement in core MRM 68-3. However, corrosion was not evident (see Figure 5.15). After polishing the reinforcement and examining it with the SEM, a thin oxidized layer (30-50 μm) was detected, consistent with that observed in core MRM 87-3. A backscattered electron image of a portion of the reinforcement is shown in Figure 5.16. There did not appear to be corrosion, even though there was local delamination evident along the reinforcement, which could potentially allow the intrusion of chlorides.

Figure 5.15 Main crack intersecting reinforcement

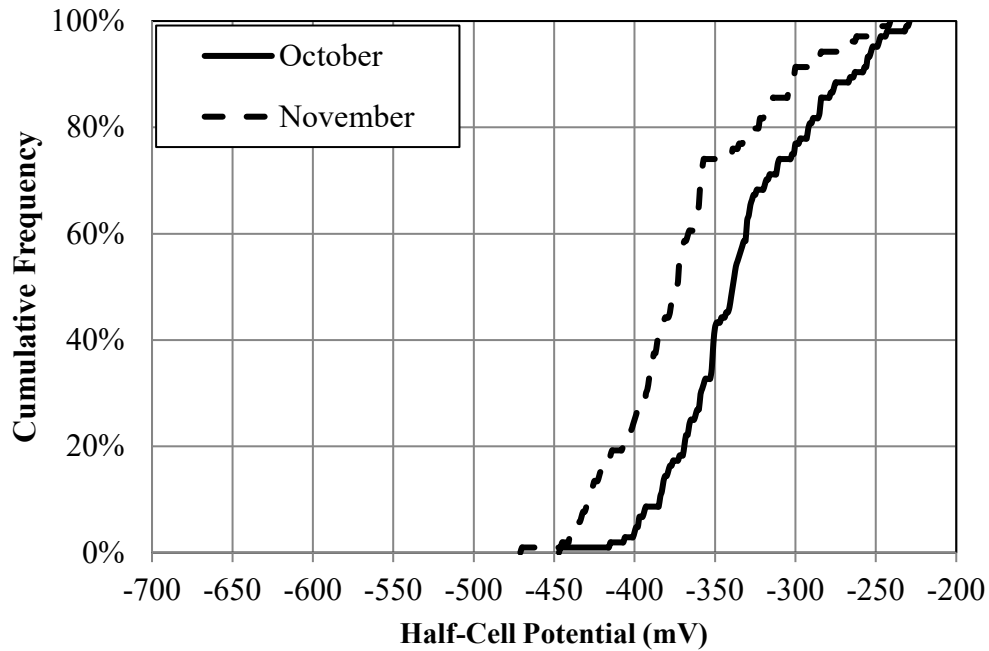
The initial and follow-up half-cell potential measurements obtained on October 14 and November 3, 2010, respectively, were compared to determine if there was a drift in the measurements. In general, the half-cell follow-up measurements were more negative than, but within 10% of, the initial measurements. The distributions from the two sets of measurements are presented in Figure 5.17.

Figure 5.17 MRM 411 Half-cell potential cumulative frequency distribution during fall 2010

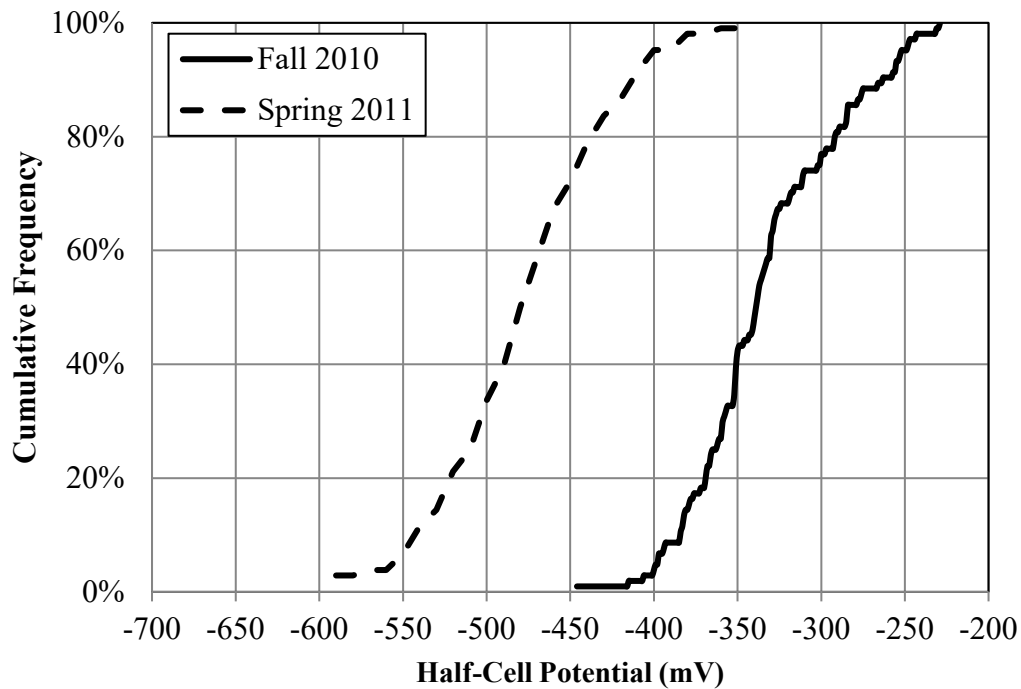
Figure 5.18 presents the cumulative frequency distribution for half-cell potential before and after one winter maintenance cycle. Table 5.8 presents a summary of the data points that fall within certain ranges of corrosion probability. Equipotential contour maps of both sets of half-cell potential measurements are presented in Appendix B.

Figure 5.18 MRM 411 half-cell potential cumulative frequency distribution

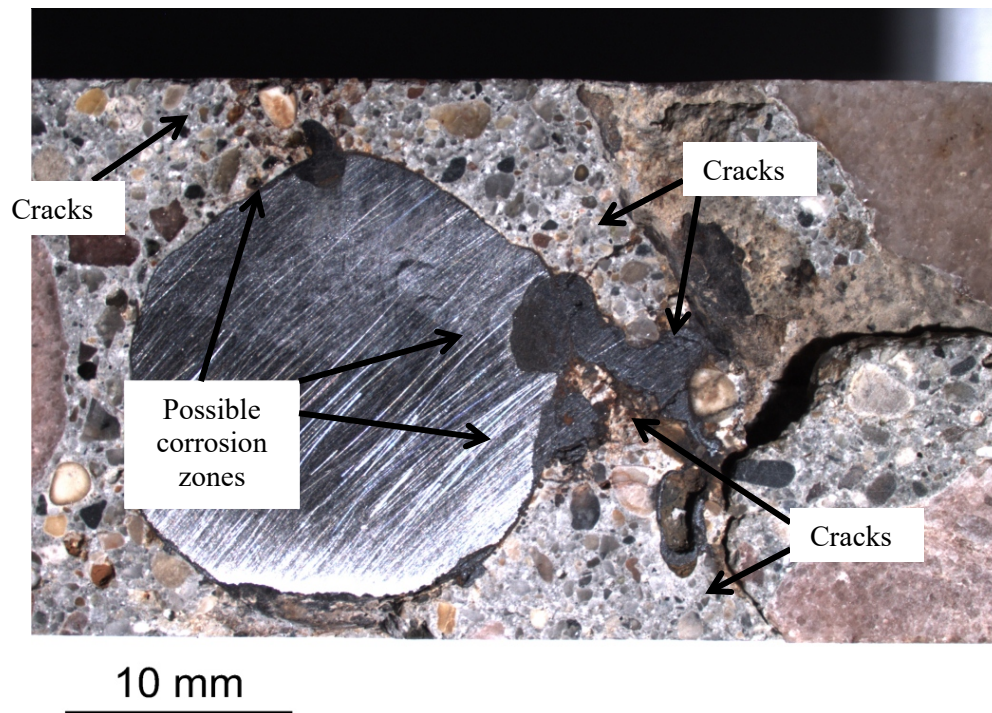
The steel reinforcement of one of the concrete core samples from site MRM 411 was analyzed using SEM. The core selected was MRM 411-1. The concrete cover placed above the reinforcement was 3.5 inches, and a crack of width 0.012 inches was observed on the core. Figure 5.19 shows a core slice through the steel bar. It was observed that the steel bar intercepted several concrete cracks. Corrosion was detected at three locations around the bar perimeter. The corroded spots coincided with the locations of the cracks. The loss of cross-sectional area of the polished section of reinforcement due to corrosion was determined to be approximately 0.026 in², or 6.0%.

Figure 5.19 Corrosion at crack locations

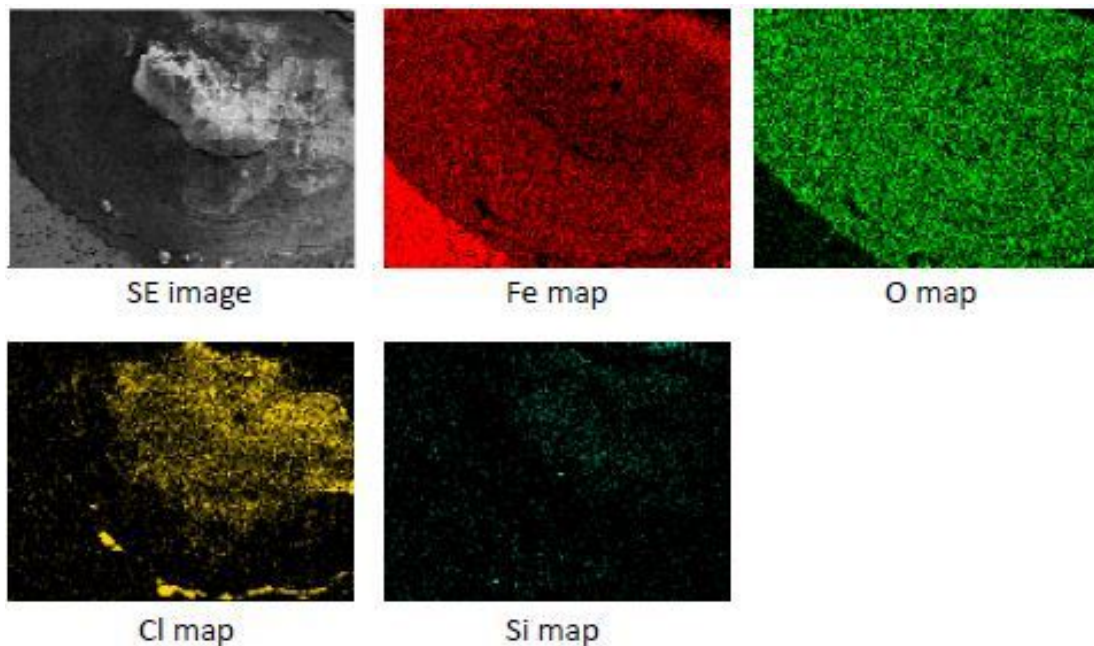
Figure 5.21 Elemental maps of corroded area (scanning electron microscope image, iron map, oxygen map, chlorine map, and silicon map)

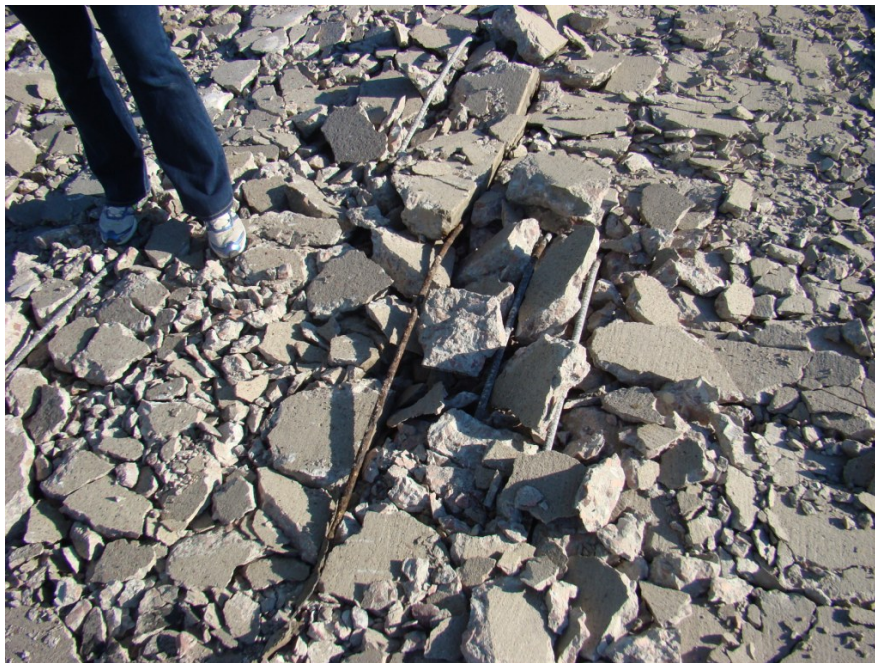
The research team observed a longitudinal reinforcing bar that was severely corroded throughout its length as shown in Figure 5.25. This bar had been placed below the longitudinal center joint in the pavement section.

Figure 5.25 Corroded longitudinal reinforcing bar

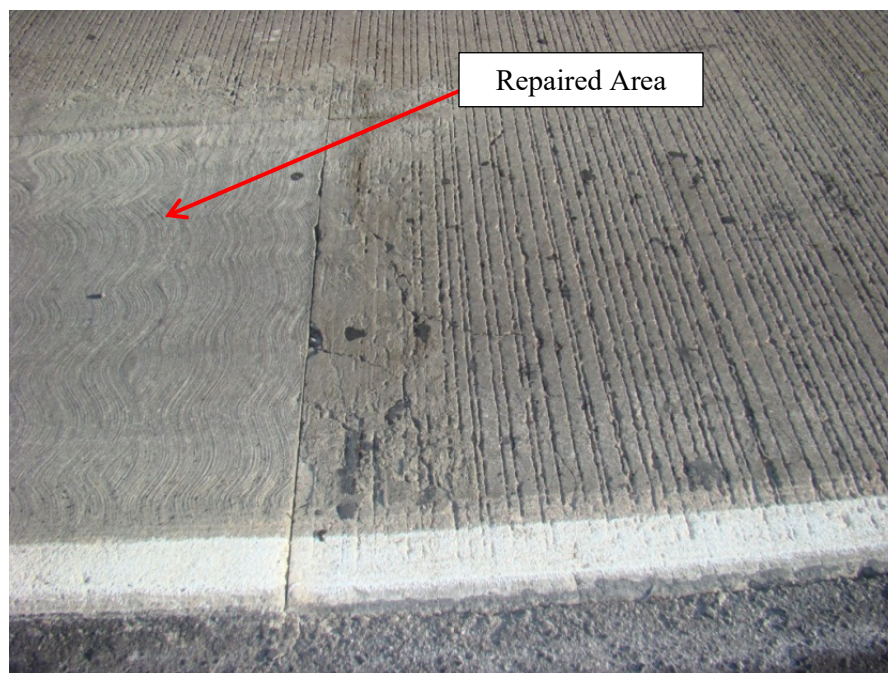
The inspection of the CRCP repair sites and the surrounding intact pavement on Interstate 90 was performed and documented in the summer of 2010. The concrete surface of the existing pavement showed several signs of distress, including longitudinal cracking, transverse cracking, and spalling. Figure 5.26 shows transverse cracking and spalling close to a newly repaired section of CRCP. Figure 5.27 shows a wide longitudinal crack next to the longitudinal joint in the pavement.

Figure 5.26 Spalling and transverse cracking close to a repaired section

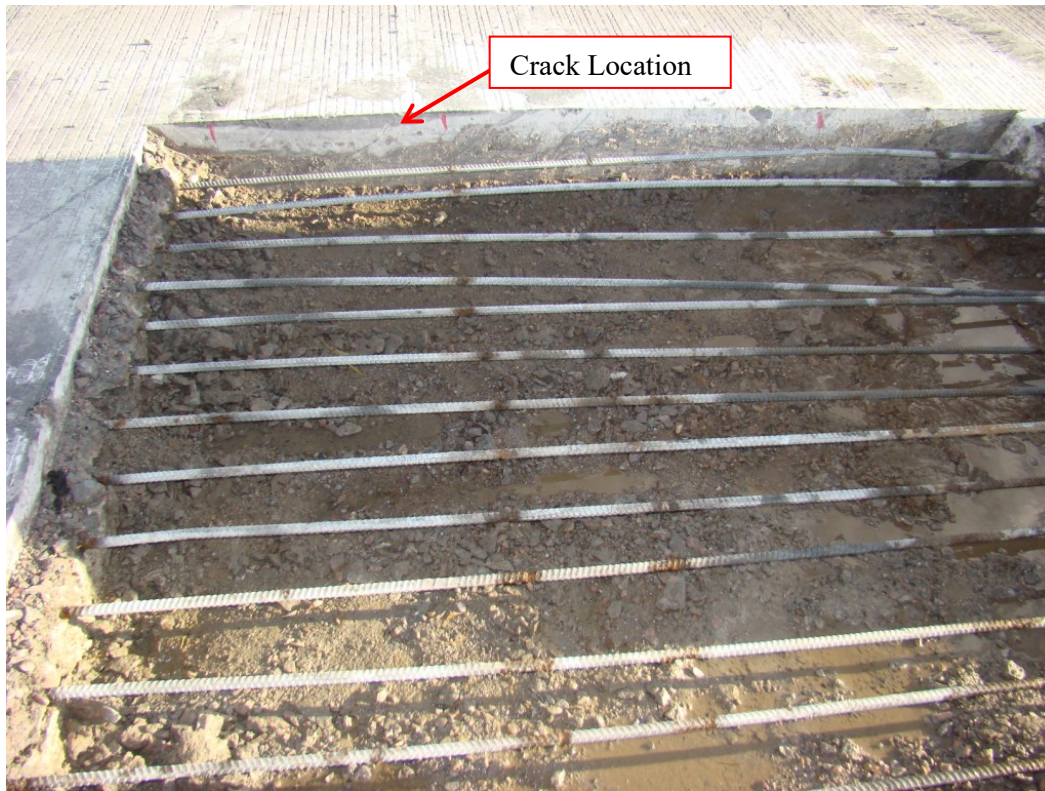
Figure 5.29 Corrosion at transverse crack location

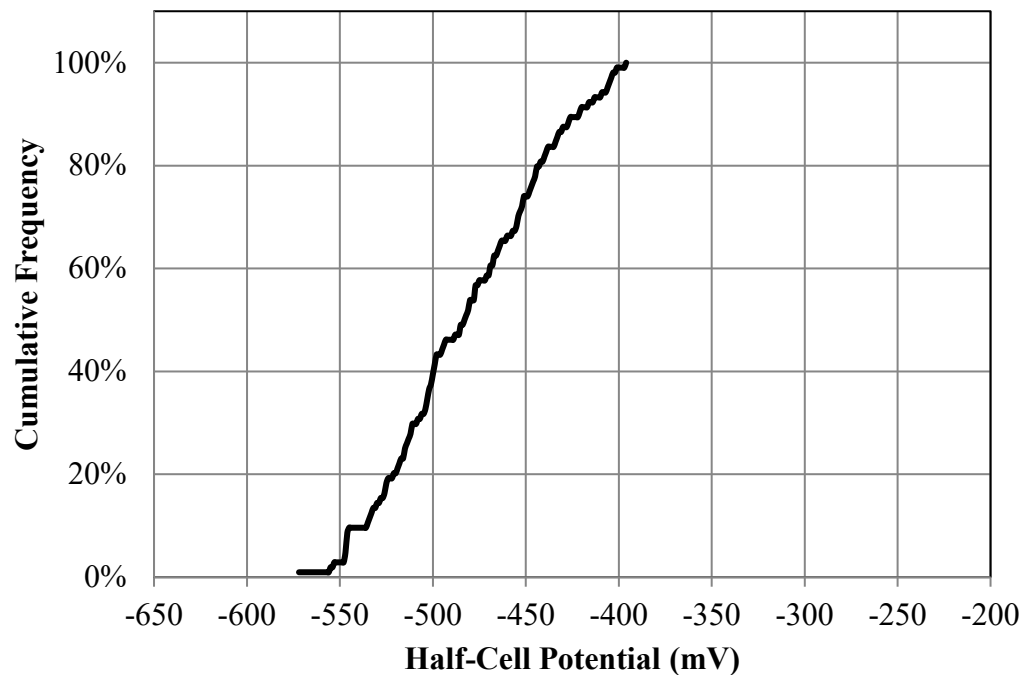
measurements is presented in Figure 5.34. The equipotential contour maps are presented in Appendix B. The probability of corrosion activity based on the measured data, as suggested by ASTM C876, is presented in Table 5.12.

Figure 5.34 MRM 44 half-cell cumulative frequency distribution

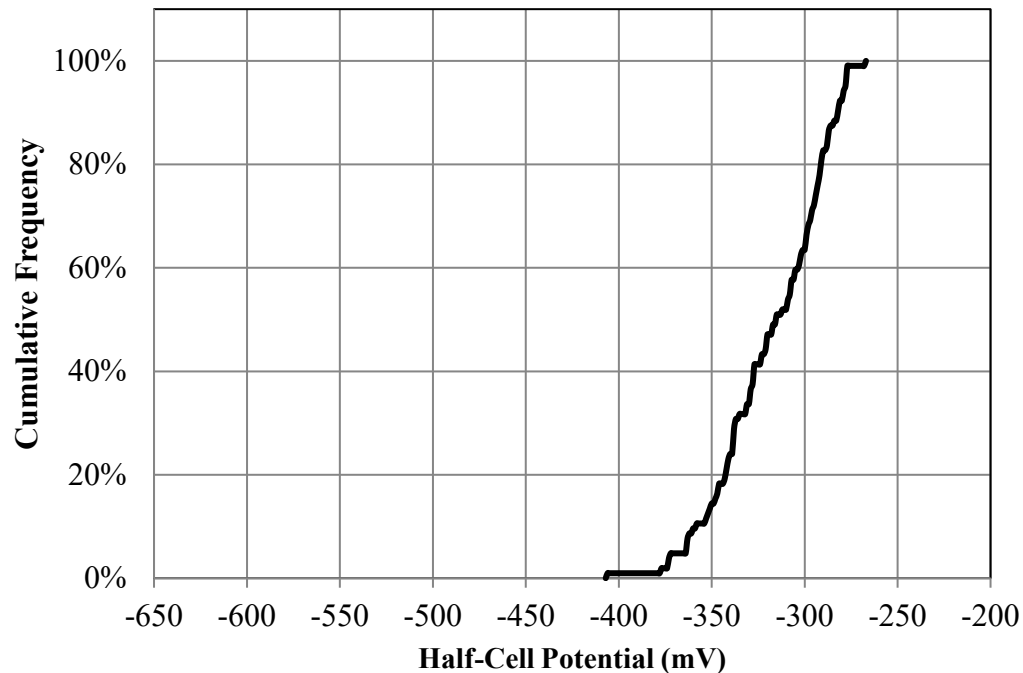
The results of the half-cell measurements were between a minimum of -407 mV and a maximum of -268 mV, with an average of -318 mV and standard deviation of 42.2 mV. The distribution of the half-cell measurements is presented in Figure 5.35. The equipotential contour maps are presented in Appendix B. The probability of corrosion activity based on the measured data, as suggested by ASTM C876, is presented in Table 5.13.

Figure 5.35 MRM 25 half-cell cumulative frequency distribution

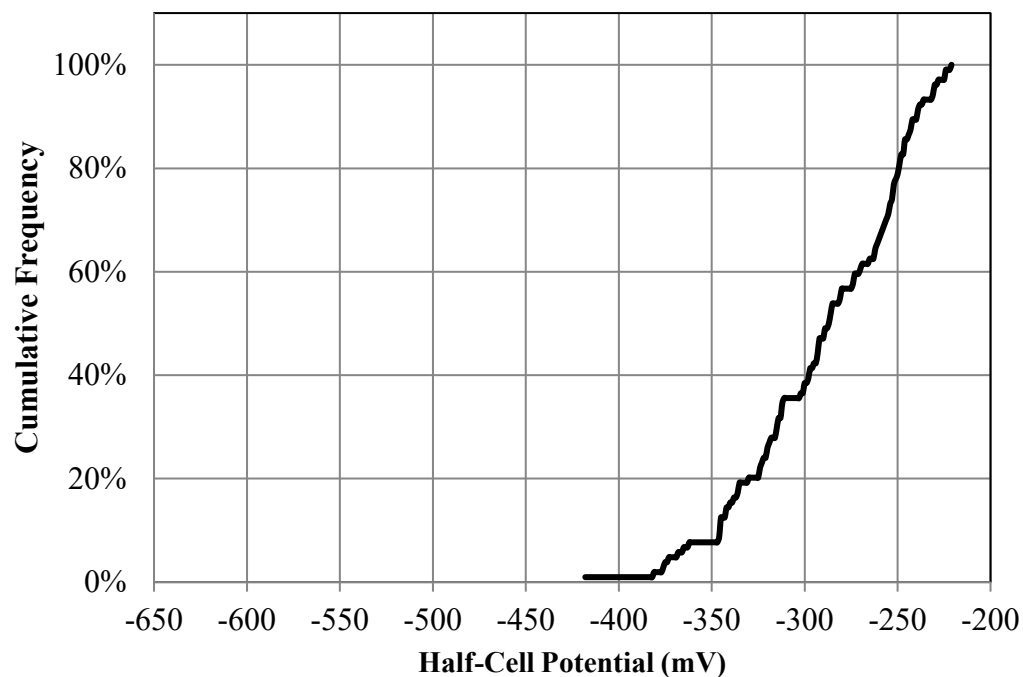
The results of the half-cell measurements were between a minimum of -418 mV and a maximum of -221 mV, with an average of -290 mV and standard deviation of 51.5 mV. The distribution of the half-cell measurements is presented in Figure 5.36. The equipotential contour maps are presented in Appendix B. The probability of corrosion activity based on the measured data, as suggested by ASTM C876, is presented in Table 5.14.

Figure 5.36 MRM 54 half-cell cumulative frequency distribution
