MPC 21-434 | A. Jones, N. Wehbe, S. Klay and S. Maassen

Mitigation of Corrosion in
Continuously Reinforced
Concrete Pavement

Volume 1 – Final Report

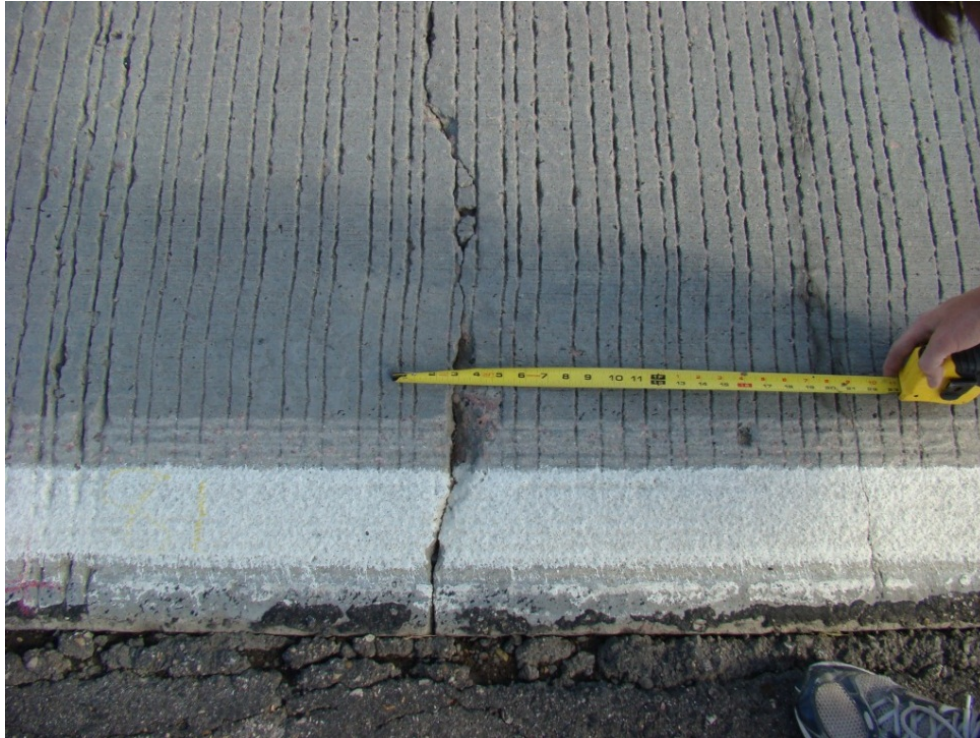
Evaluation of site MRM 222 occurred on July 27, 2011. The crack density of the surveyed section was 0.334 foot/square foot. Transverse and Y-cracking were observed. The transverse cracks were spaced approximately every 2 to 4 feet. Several cracks were wide and exhibited spalling (Figure 5.37). No longitudinal cracking was identified within the 100-foot section. The depth to the reinforcement was measured as 5 inches with a hand-held tape measure.

Figure 5.37 Wide crack exhibiting spalling at MRM 222

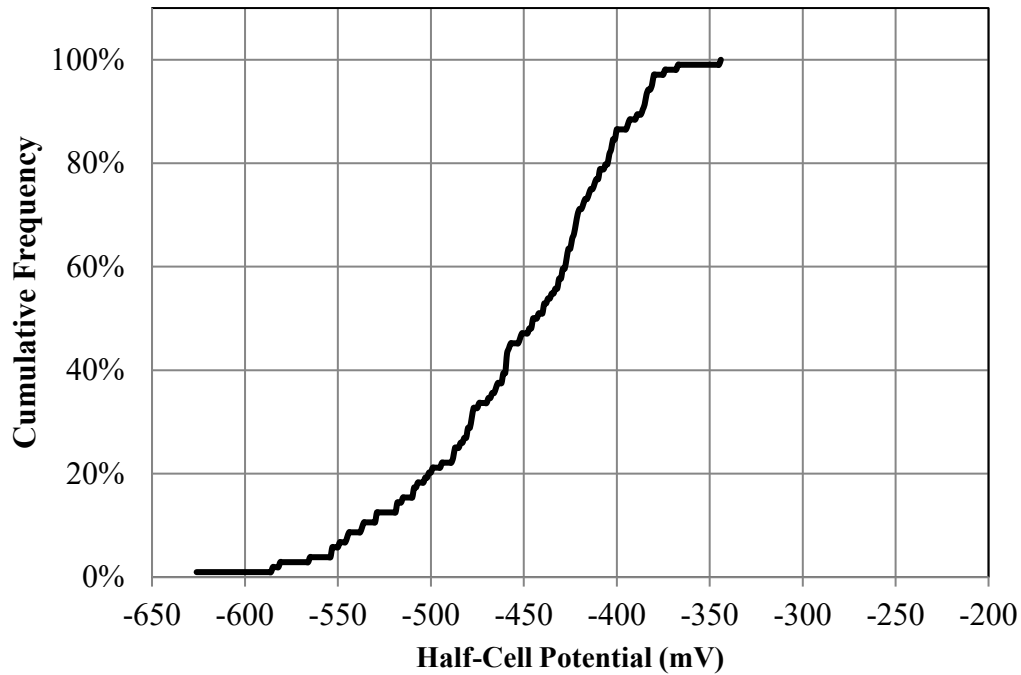
The results of the half-cell measurements were between a minimum of -626 mV and a maximum of -344 mV, with an average of -453 mV and standard deviation of 70.4 mV. The distribution of the half-cell measurements is presented in Figure 5.38. The equipotential contour maps are presented in Appendix B. The probability of corrosion activity based on the measured data, as suggested by ASTM C876, is presented in Table 4.16.

Figure 5.38 MRM 222 half-cell cumulative frequency distribution

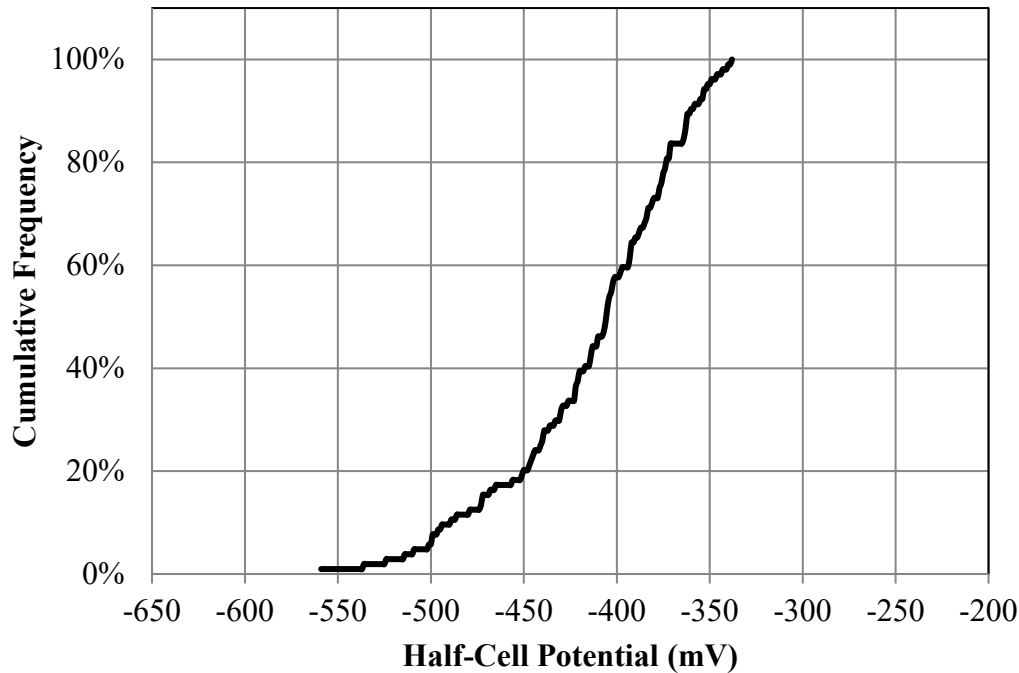
The results of the half-cell measurements were between a minimum of -559 mV and a maximum of -338 mV, with an average of -414 mV and standard deviation of 62.6 mV. The distribution of the half-cell measurements is presented in Figure 5.40. The equipotential contour maps are presented in Appendix B. The probability of corrosion activity based on the measured data, as suggested by ASTM C876, is presented in Table 5.16.

Figure 5.40 MRM 246 half-cell cumulative frequency distribution

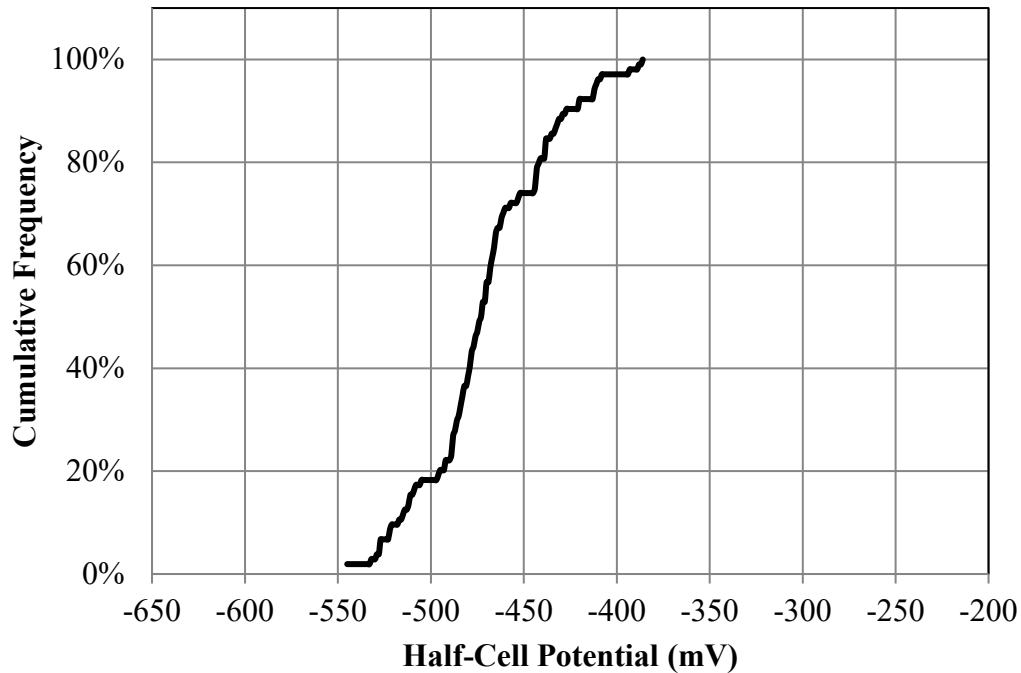
Figure 5.41 MRM 168NB half-cell cumulative frequency distribution

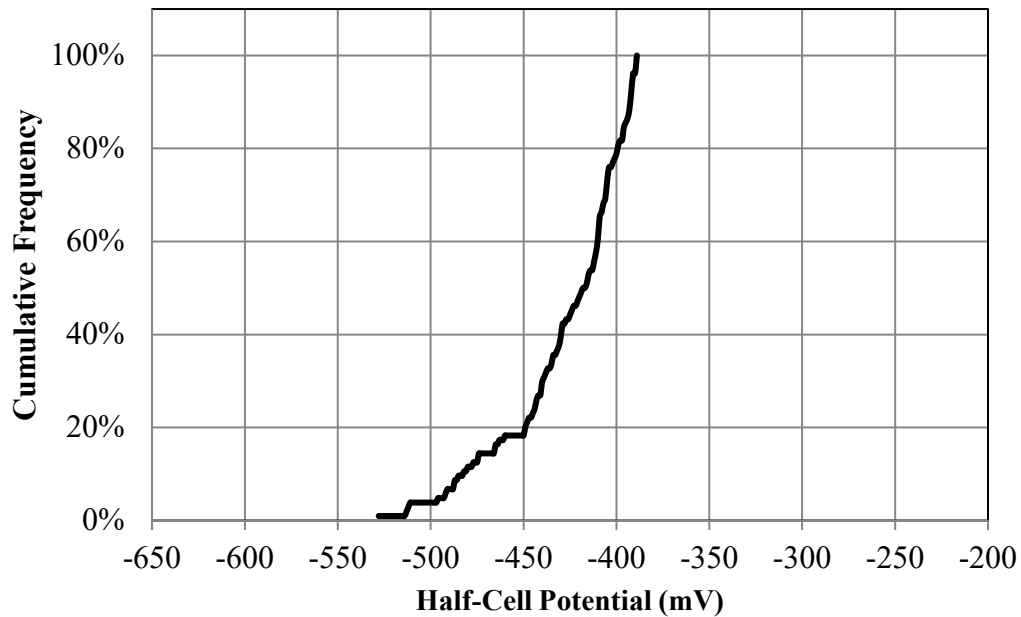
Figure 5.43 MRM 168SB half-cell cumulative frequency distribution

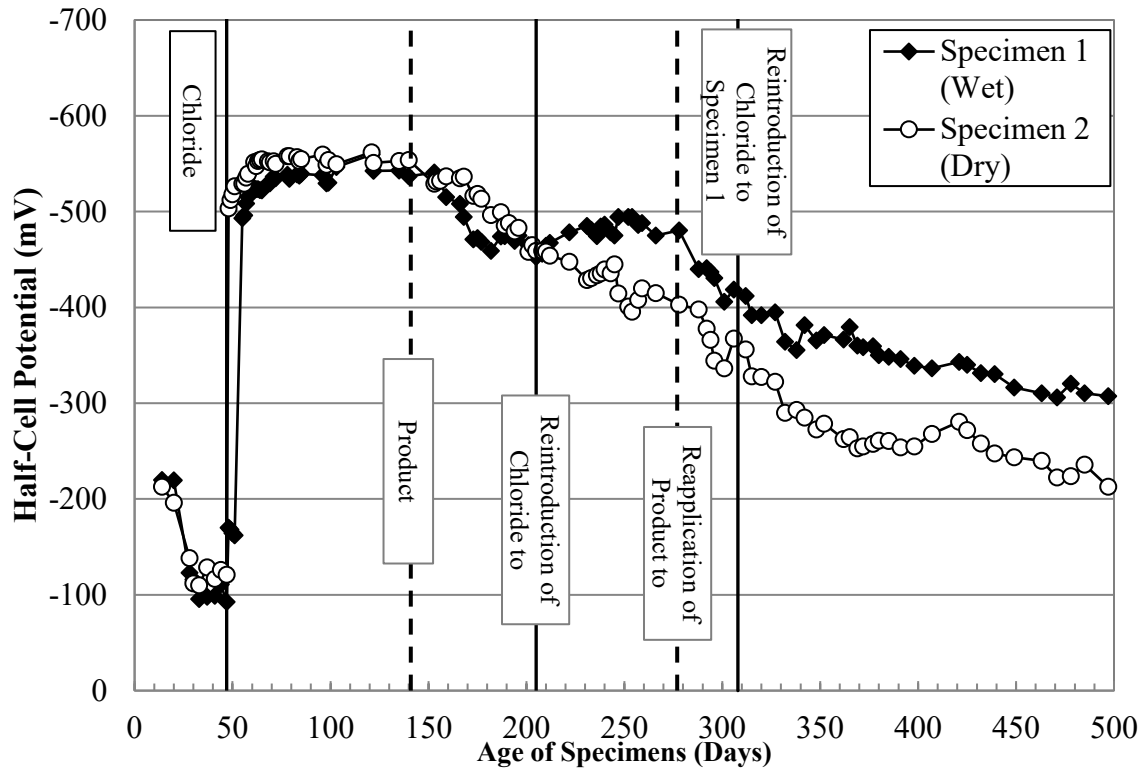
Figure 5.55 Half-cell potential measurements for MCI-2018, cracked specimens

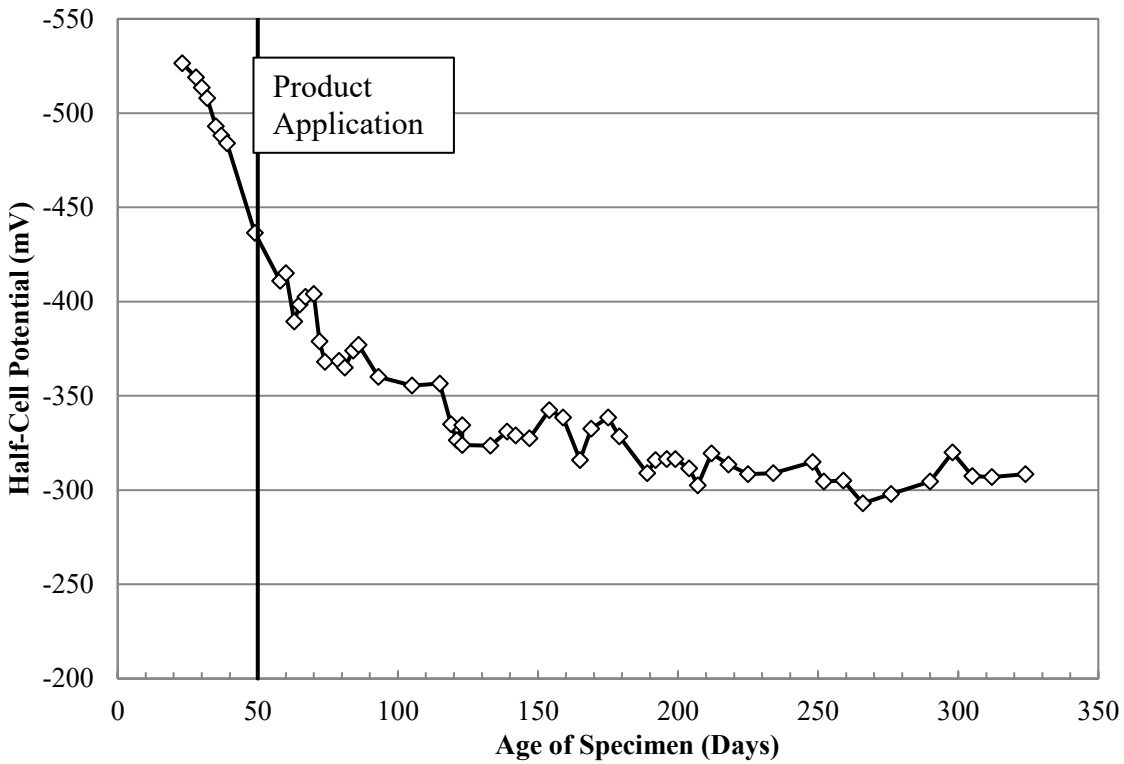
Figure 5.56 Half-cell potential measurements, MCI-2018, uncracked, salt in mix specimen

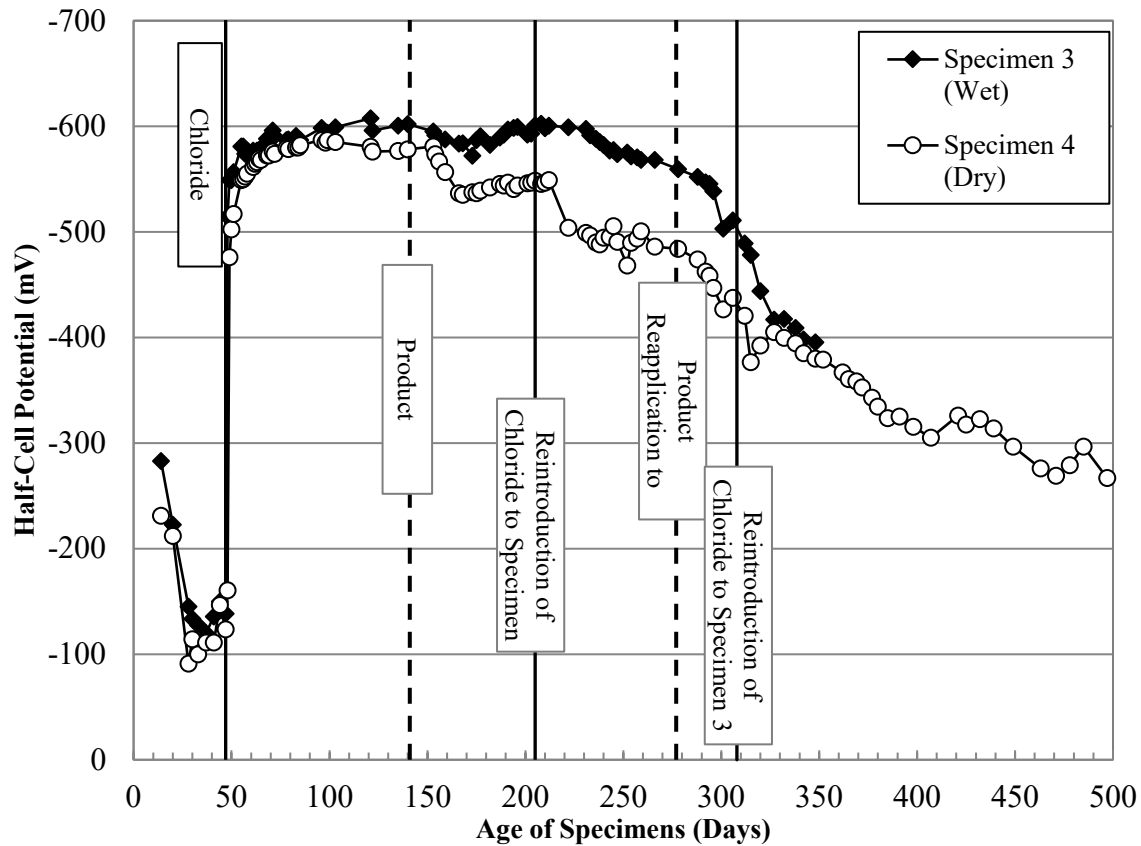
Figure 5.57 Half-cell potential measurements, Ferrogard 903 & Protectosil CIT, cracked specimens

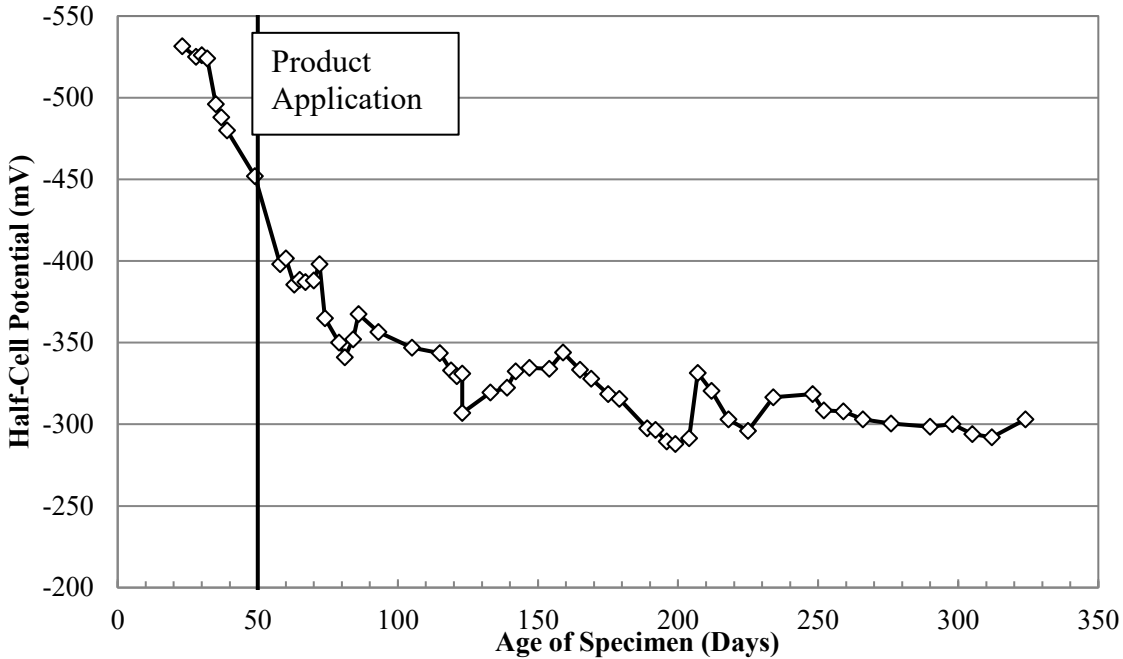
Figure 5.58 Half-cell potential measurements, Ferrogard 903 and Protectosil CIT, uncracked, salt in mix specimen

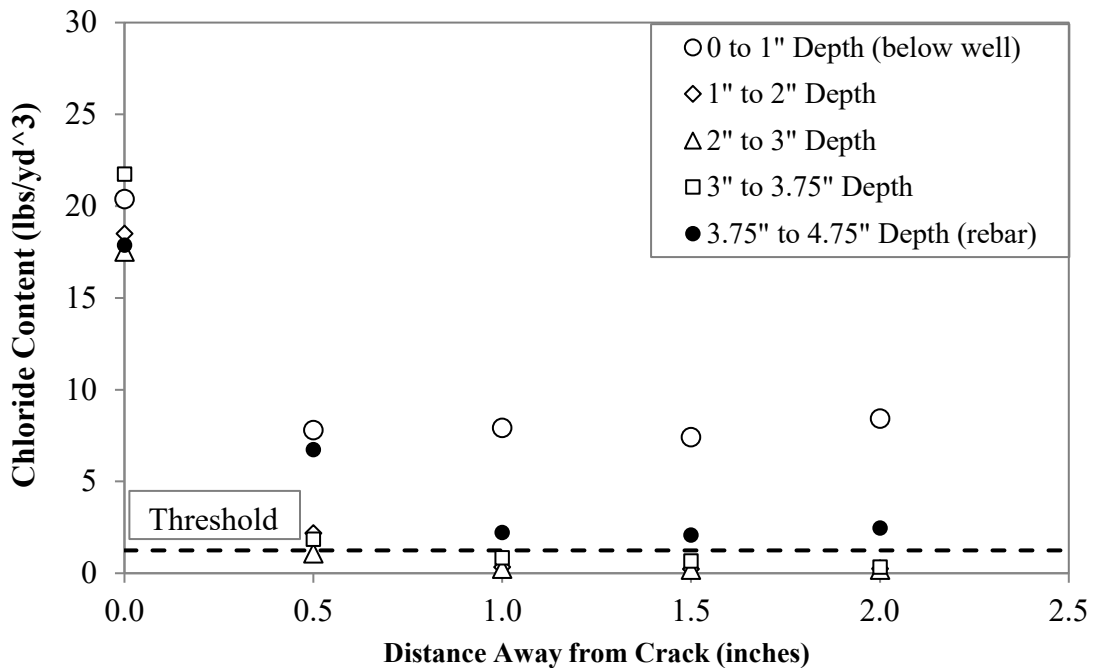
Figure 5.59 Chloride profiles for Ferrogard 903 and Protectosil CIT

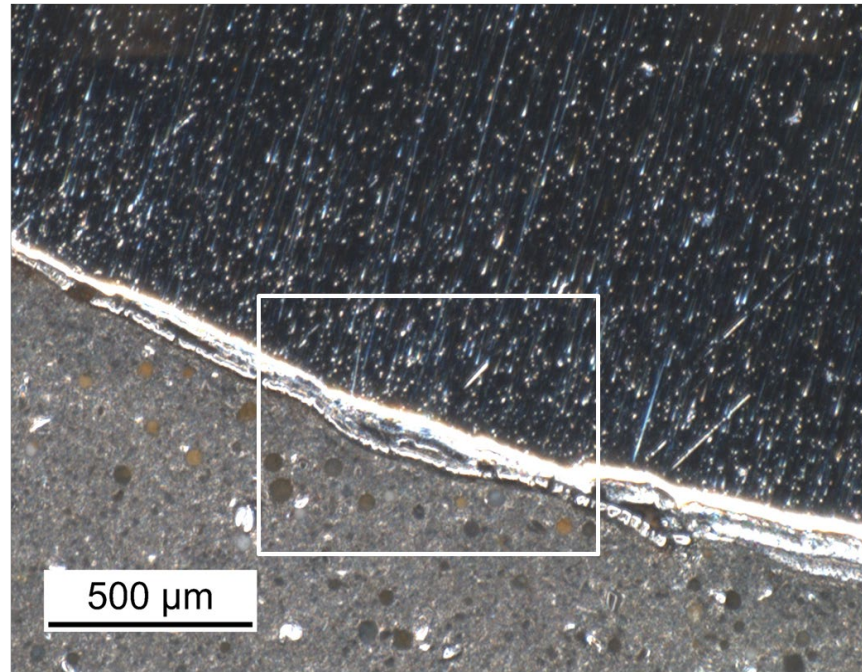
Figure 5.60 Optical image for Ferrogard 903 and Protectosil CIT

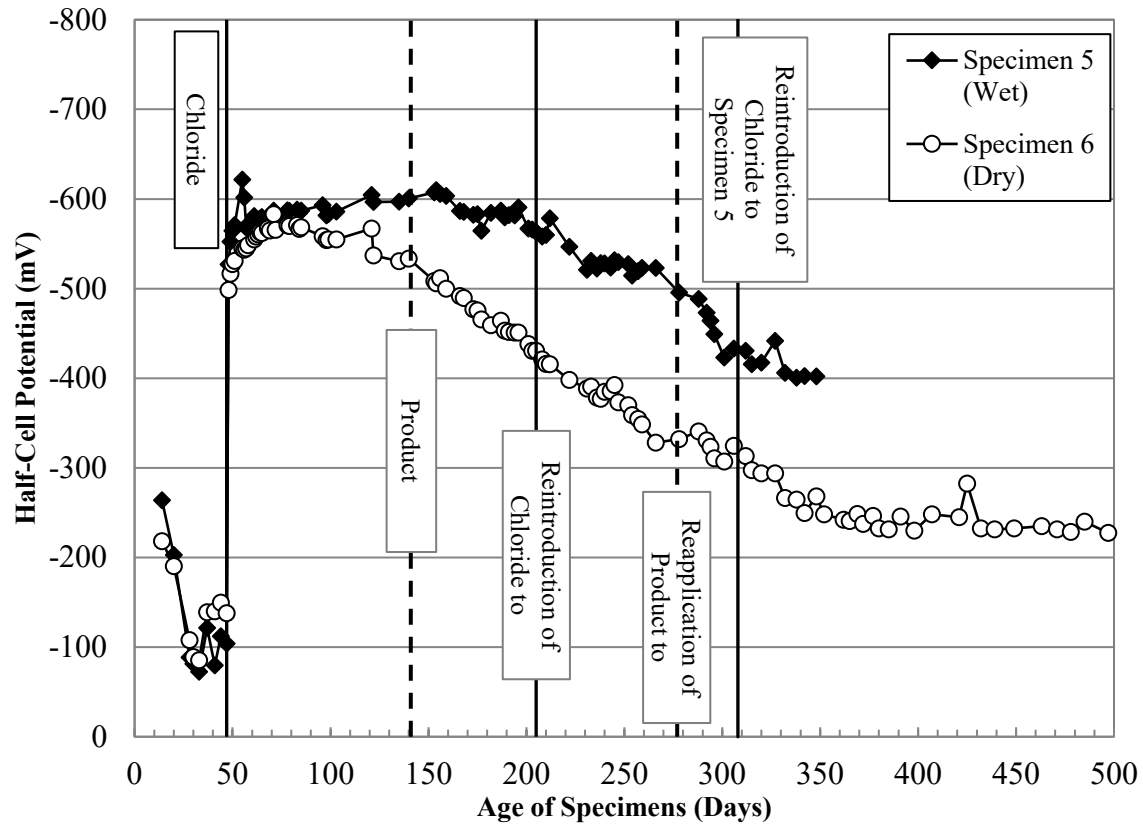
Figure 5.64 Half-cell potential measurements for Protectosil CIT, cracked specimens

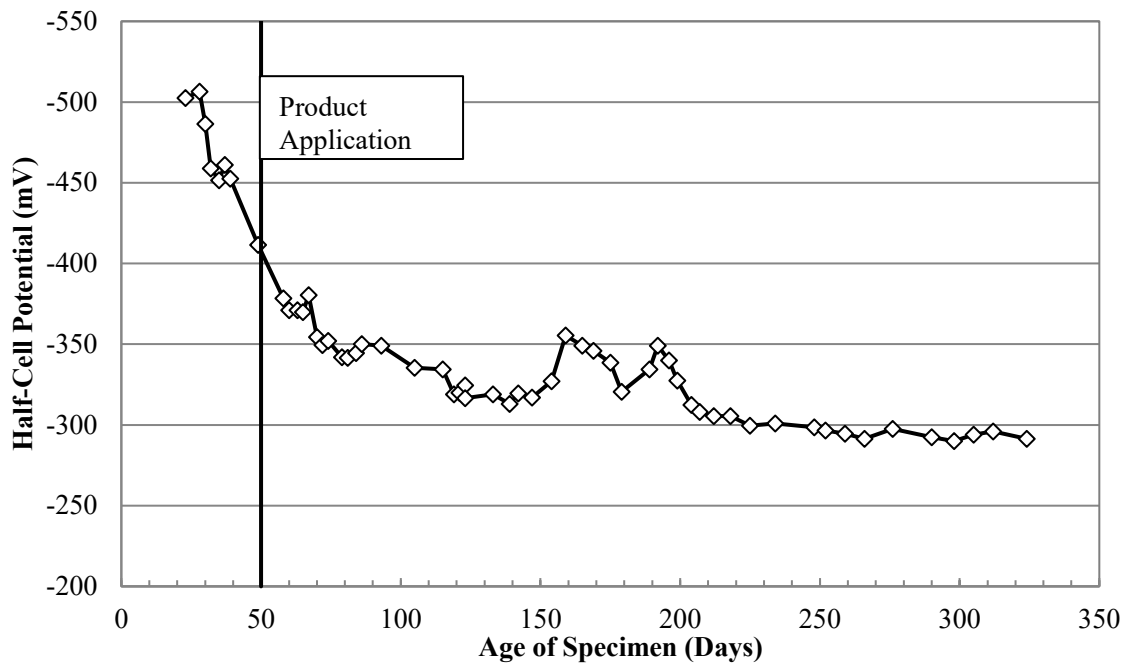
Figure 5.65 Half-cell potential measurements for Protectosil CIT, uncracked, salt in mix specimen

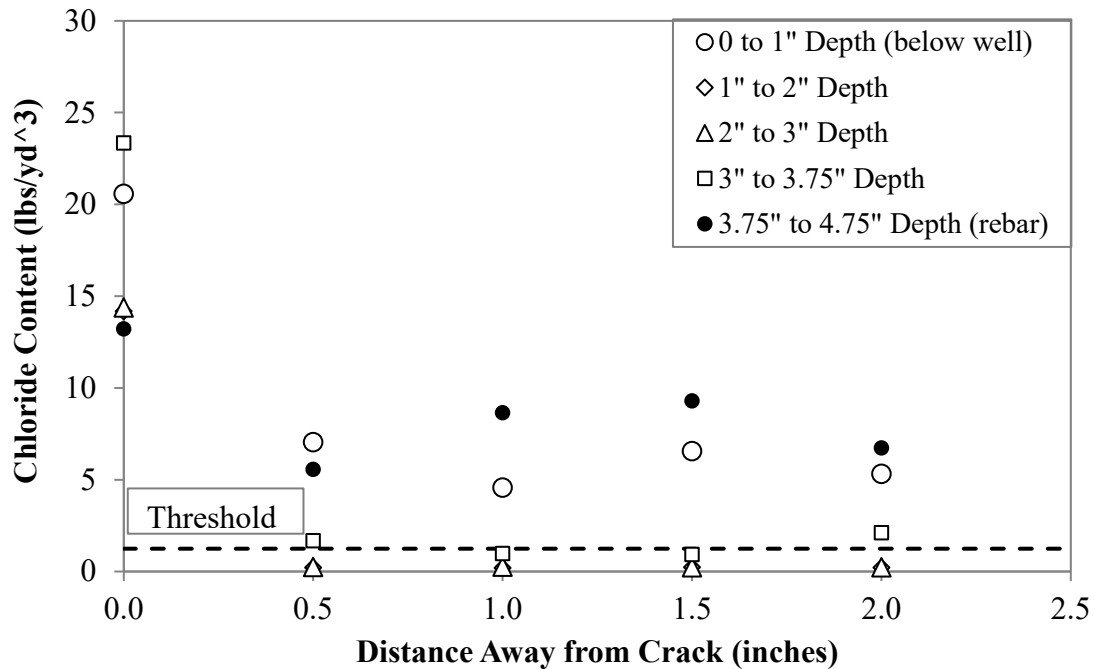
Figure 5.66 Chloride profiles for Protectosil CIT

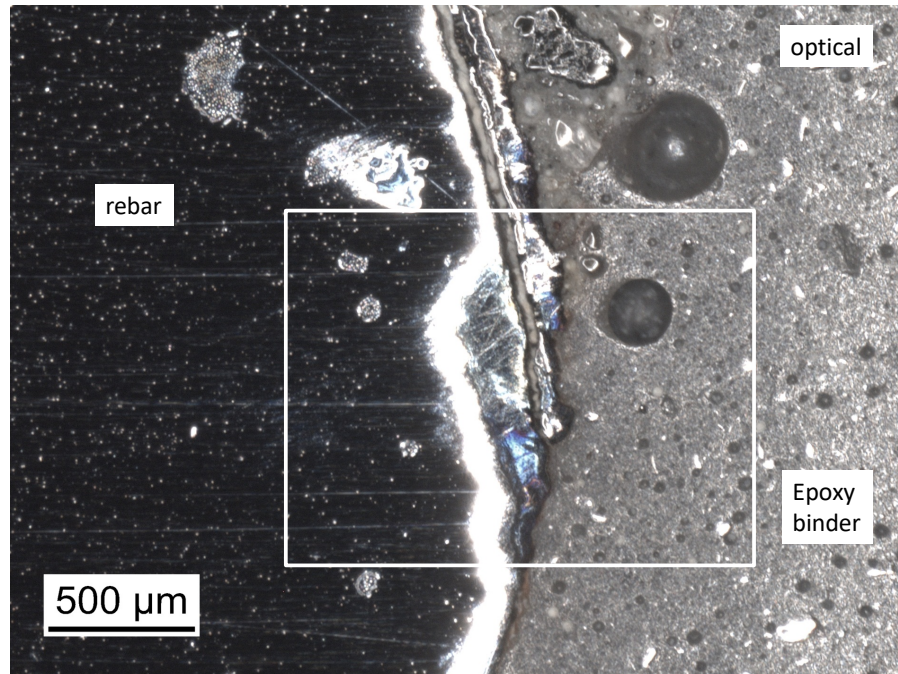
Figure 5.67 Optical image for Protectosil CIT

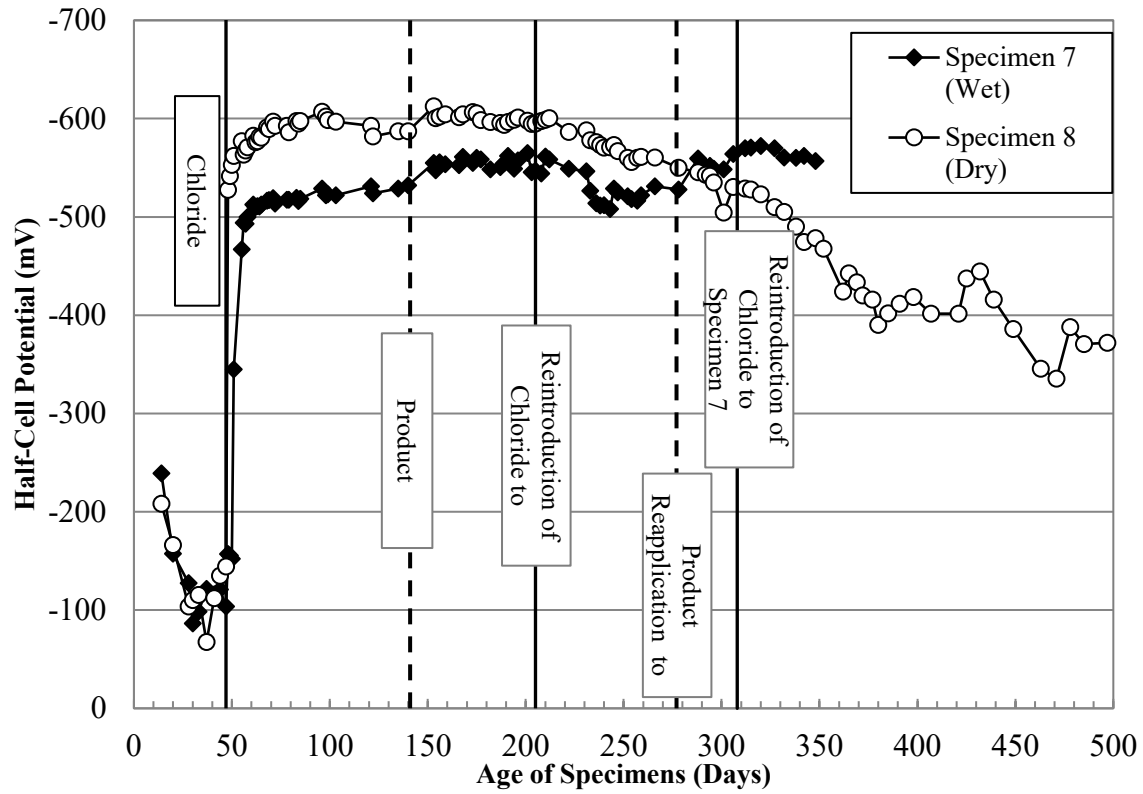
Figure 5.70 Half-cell potential measurements, Ferrogard 903, cracked specimens

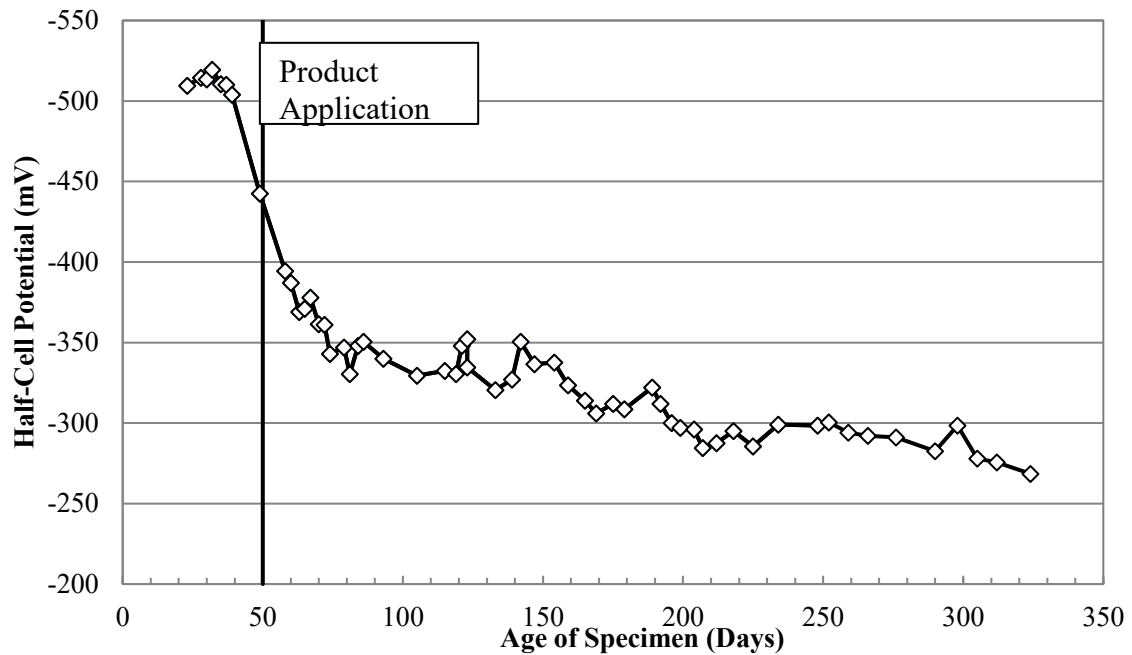
Figure 5.71 Half-cell potential measurements, Ferrogard 903, uncracked, salt in mix specimen

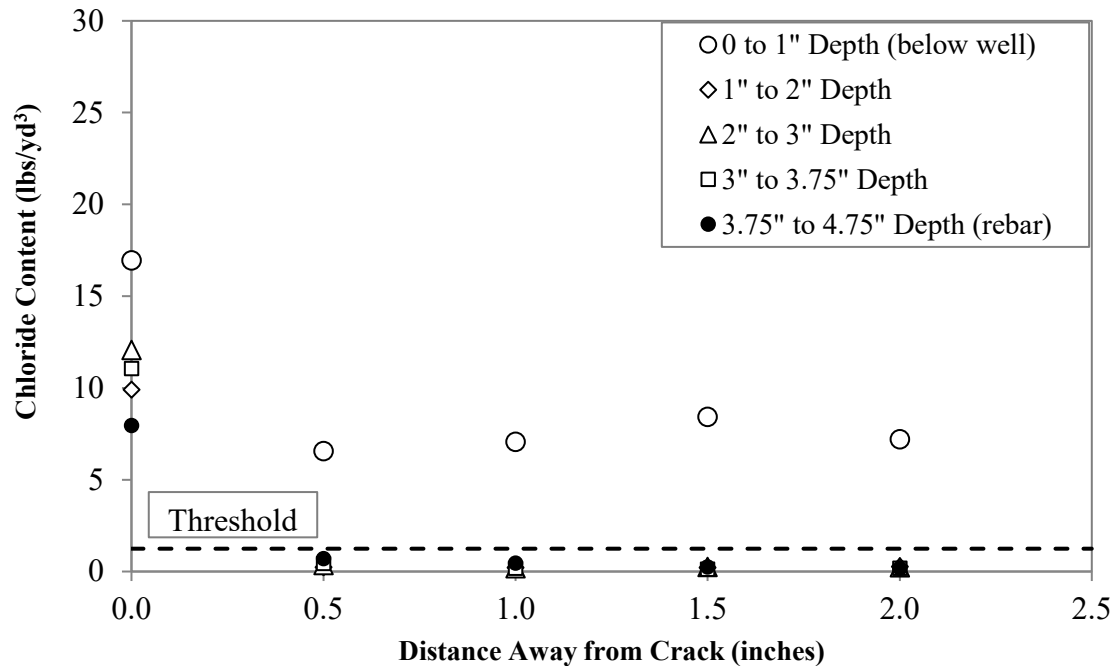
Figure 5.72 Chloride profiles for Ferrogard 903

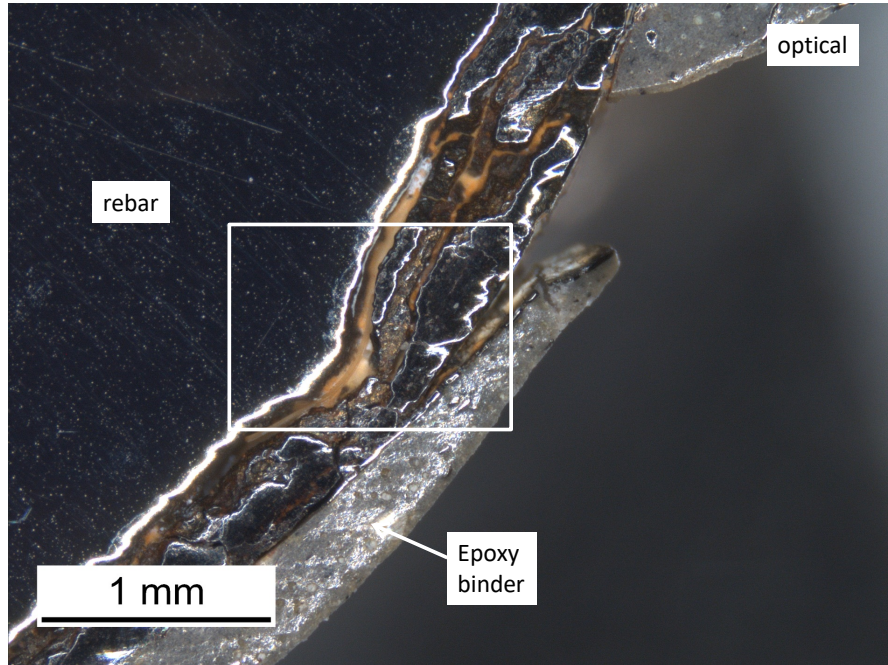
Figure 5.73 Optical image for Ferrogard 903

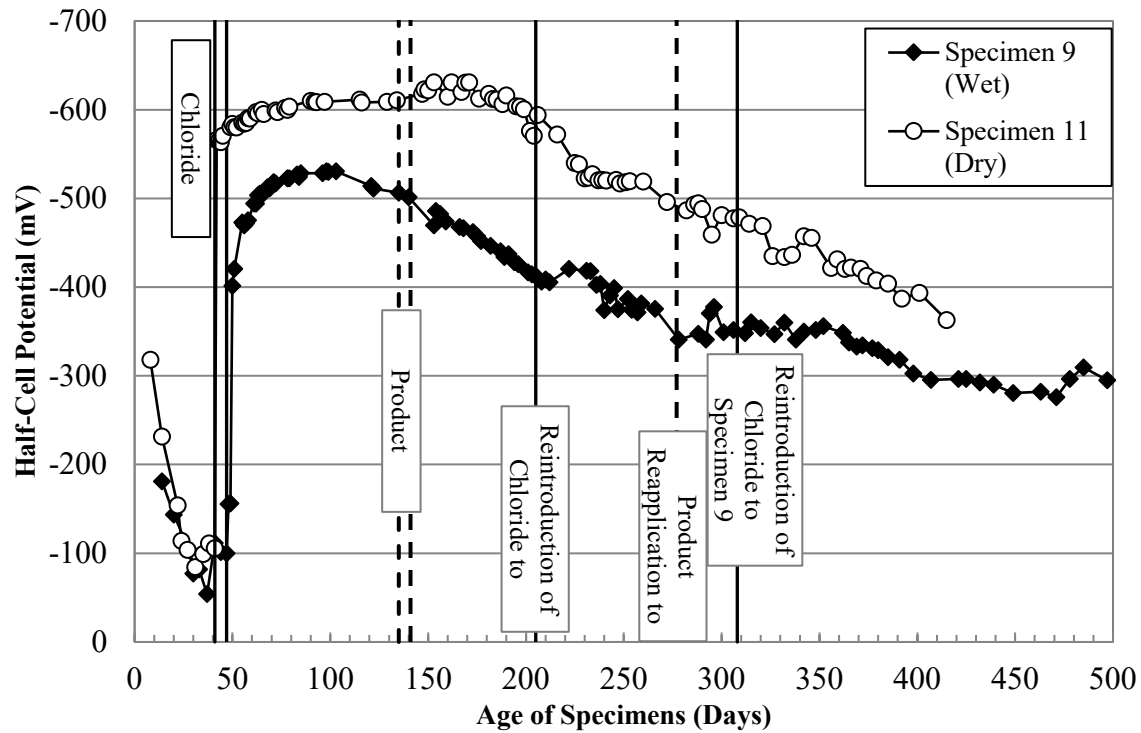
Figure 5.76 Half-cell potential measurements for Duralprep 3020, cracked specimens

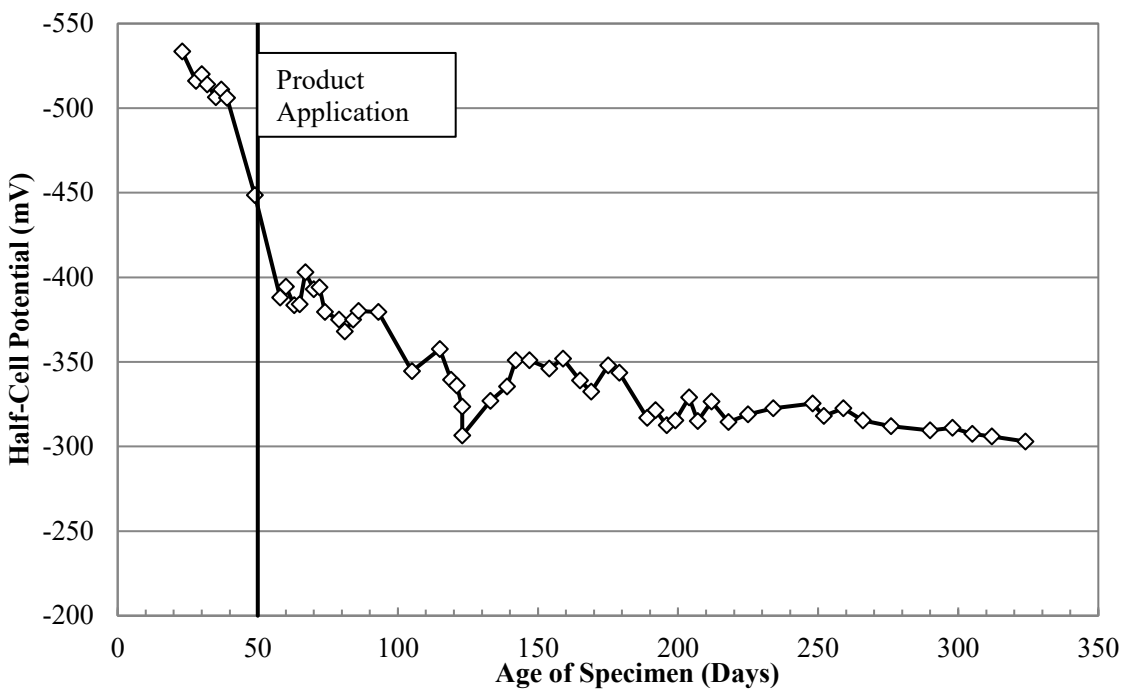
Figure 5.77 Half-cell potential measurements for Duralprep 3020, uncracked, salt in mix specimen

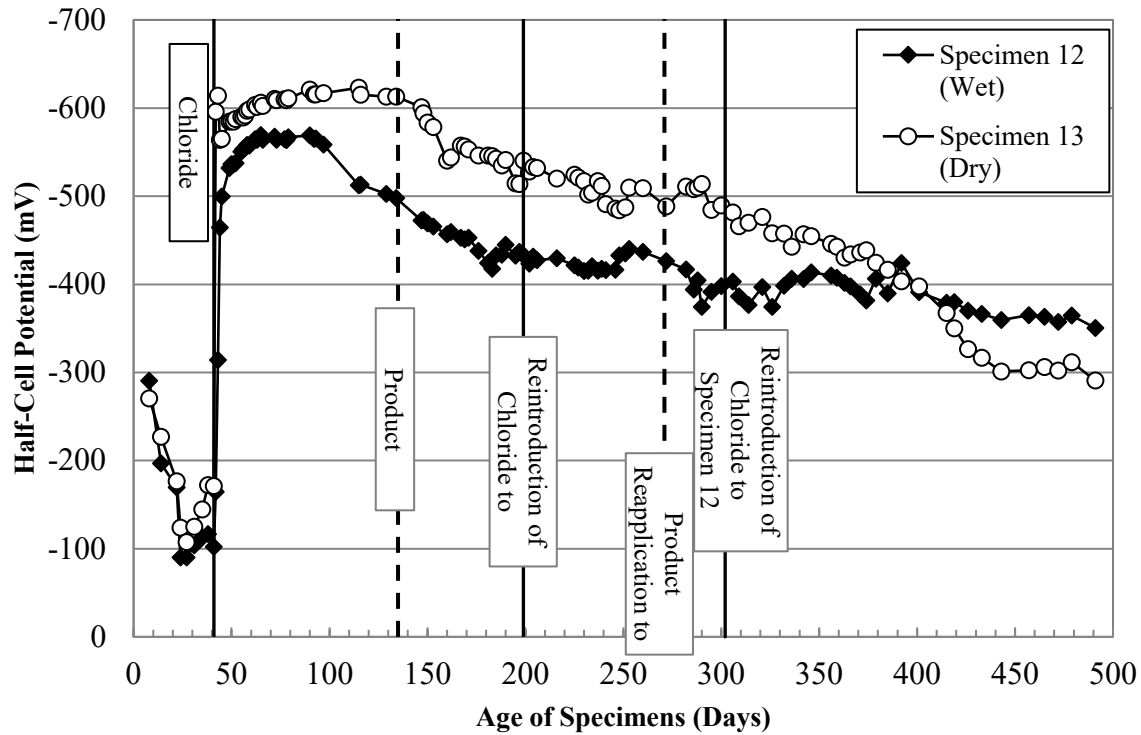
Figure 5.78 Half-cell potential measurements for Chemtrete 40, cracked specimens

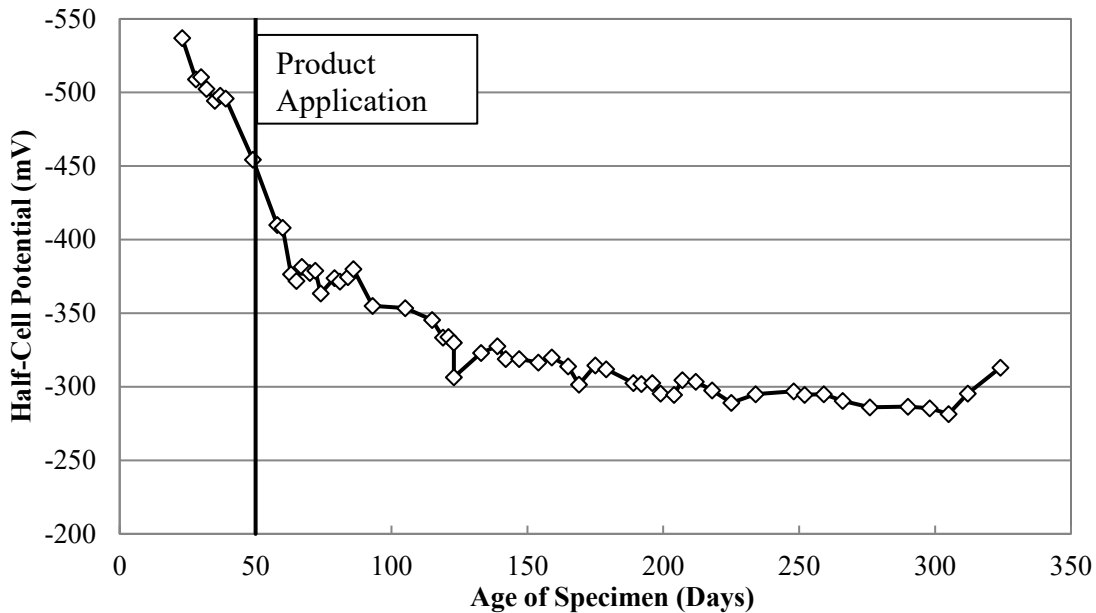
Figure 5.79 Half-cell potential measurements for Chemtrete 40, uncracked, salt in mix specimen

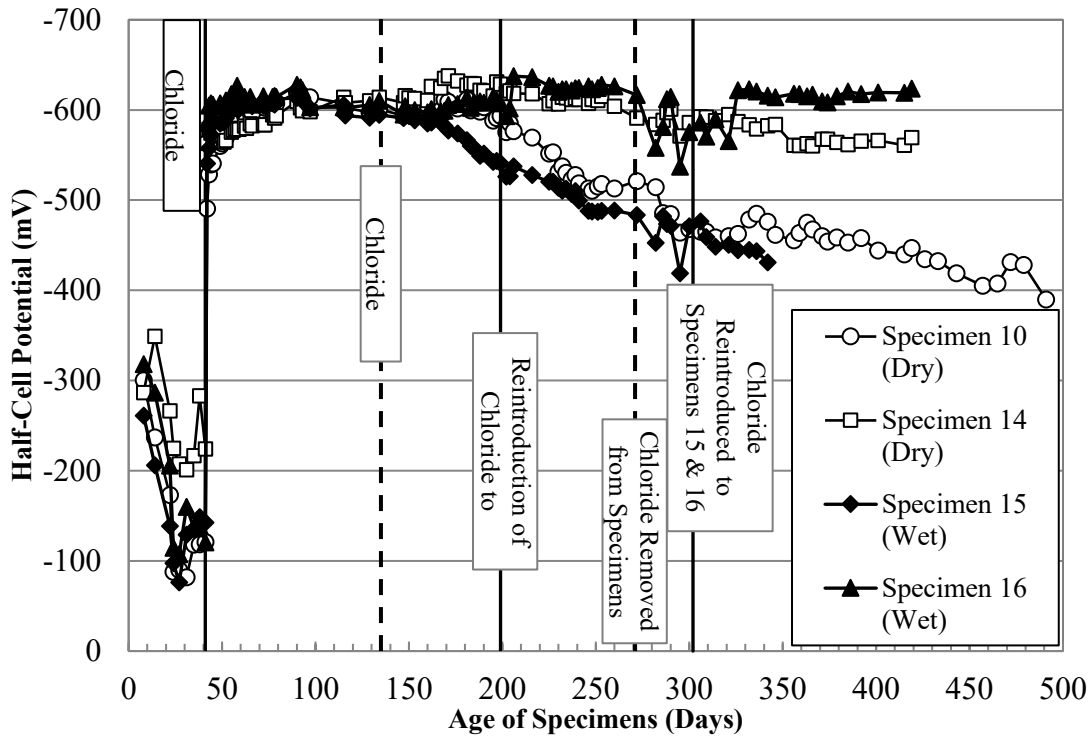
Figure 5.80 Half-cell potential measurements for cracked, control specimens

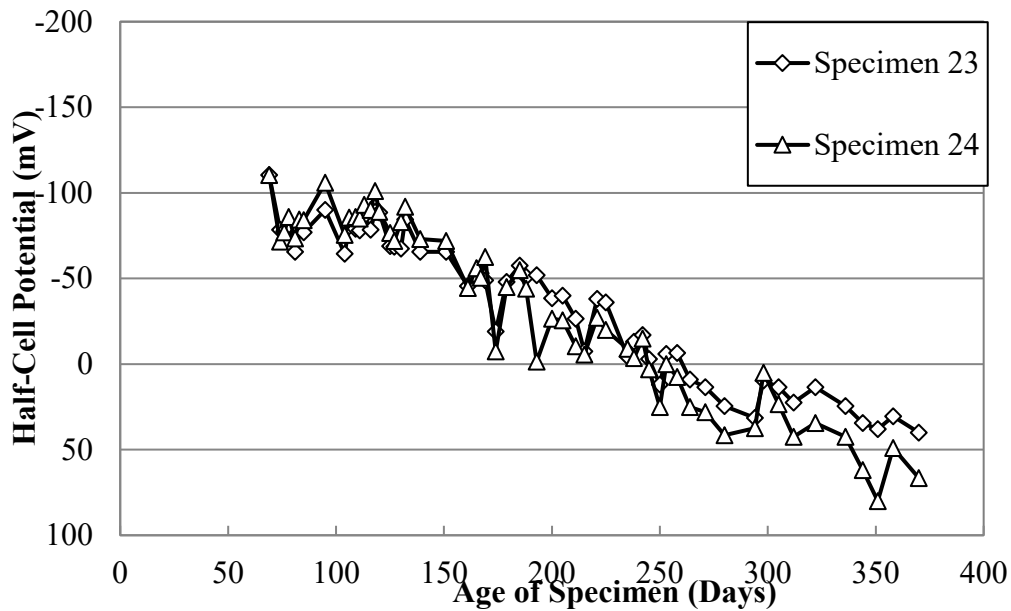
Figure 5.81 Half-cell potential measurements for uncracked, control specimens

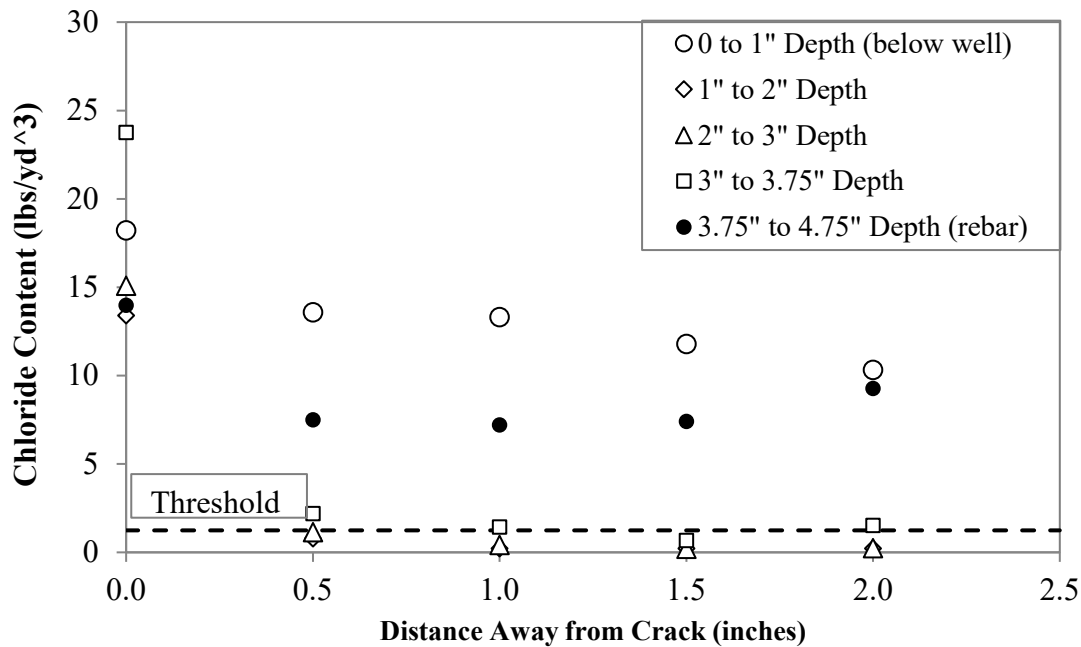
Figure 5.82 Chloride profiles for wet, cracked control specimen

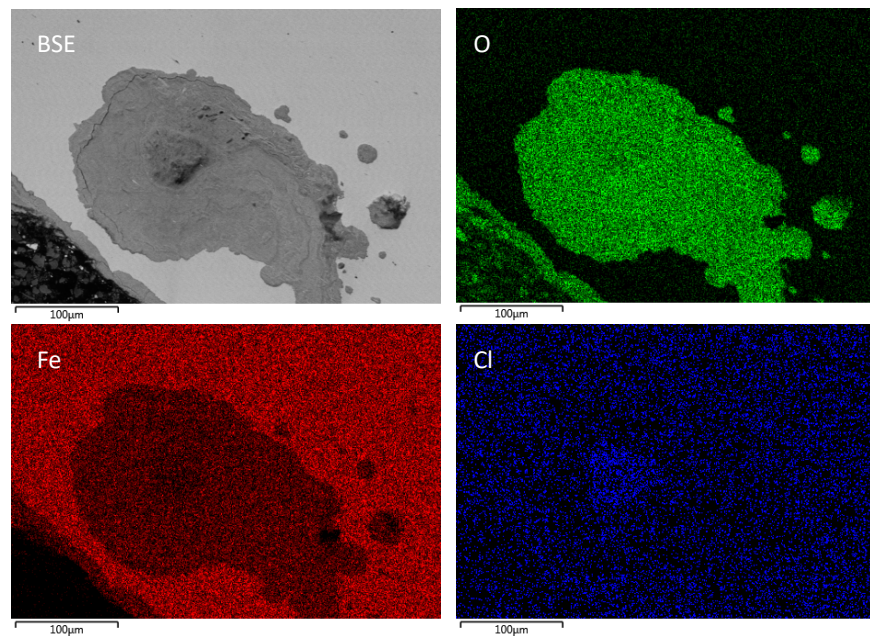
Figure 5.84 BSE and element maps for wet, cracked control specimen

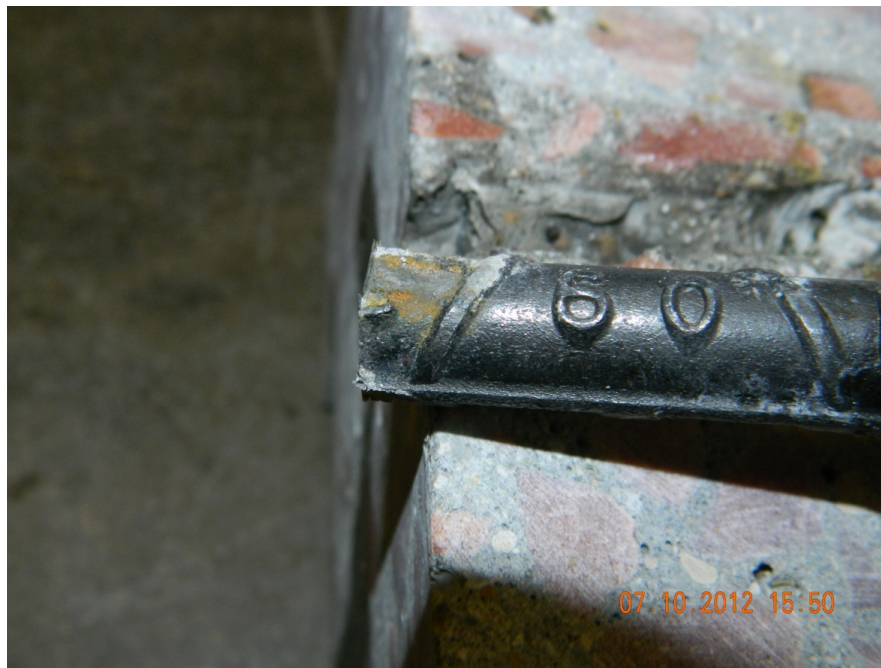
Figure 5.87 Close-up of corrosion of dry, cracked control specimen

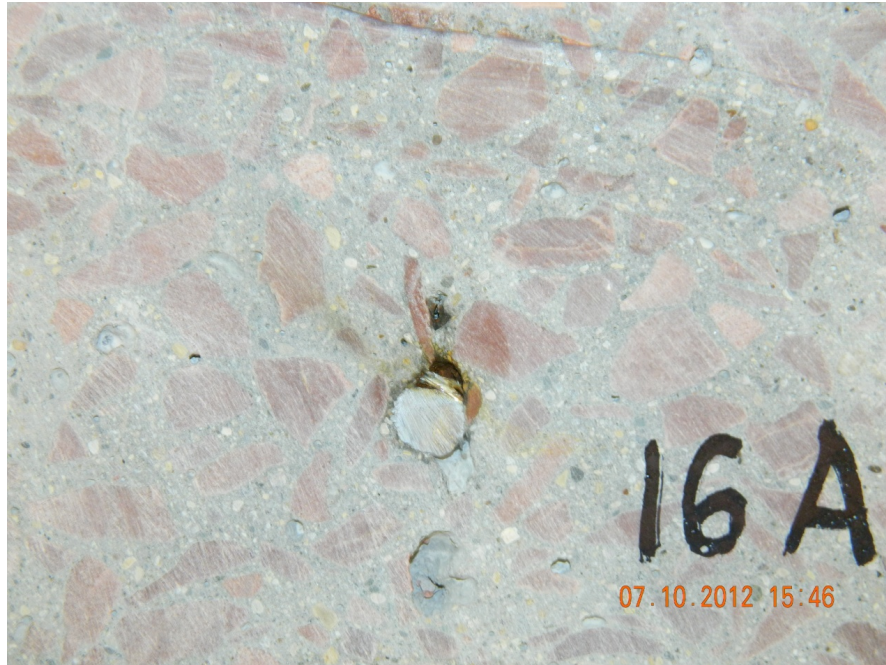
Figure 5.88 Saw cut along the simulated crack of Specimen 16

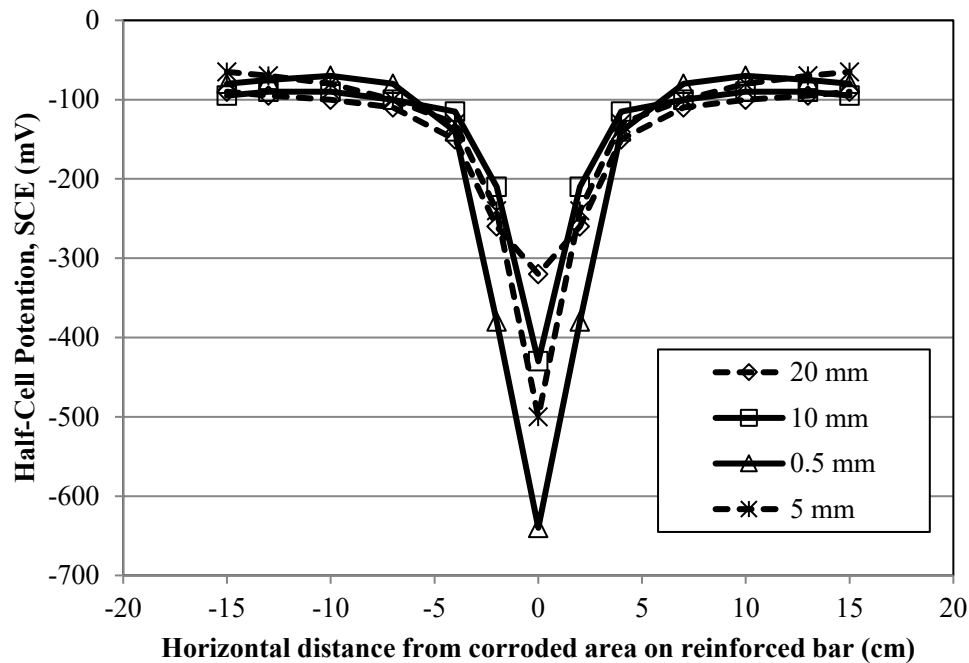
Figure 6.1 Influence of cover depth on half-cell potential measurements (after Elsener 2003)
