MPC 21-434 | A. Jones, N. Wehbe, S. Klay and S. Maassen

Mitigation of Corrosion in
Continuously Reinforced
Concrete Pavement

Volume 1 – Final Report

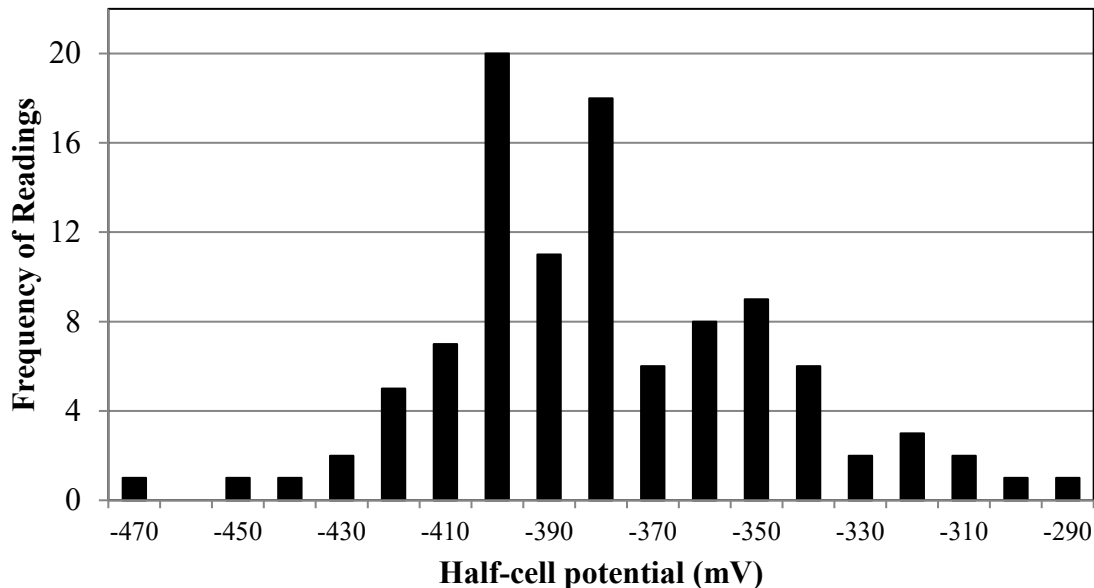
Figure 6.2 Frequency distribution of half-cell measurements at MRM 87

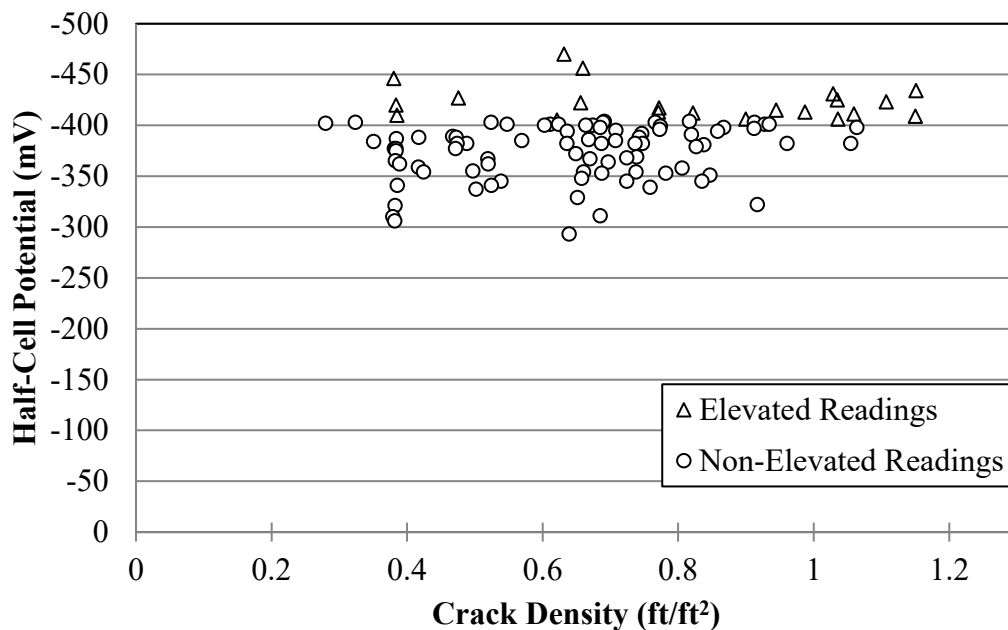
Figure 6.4 Example of half-cell potential measurements plotted against crack density values

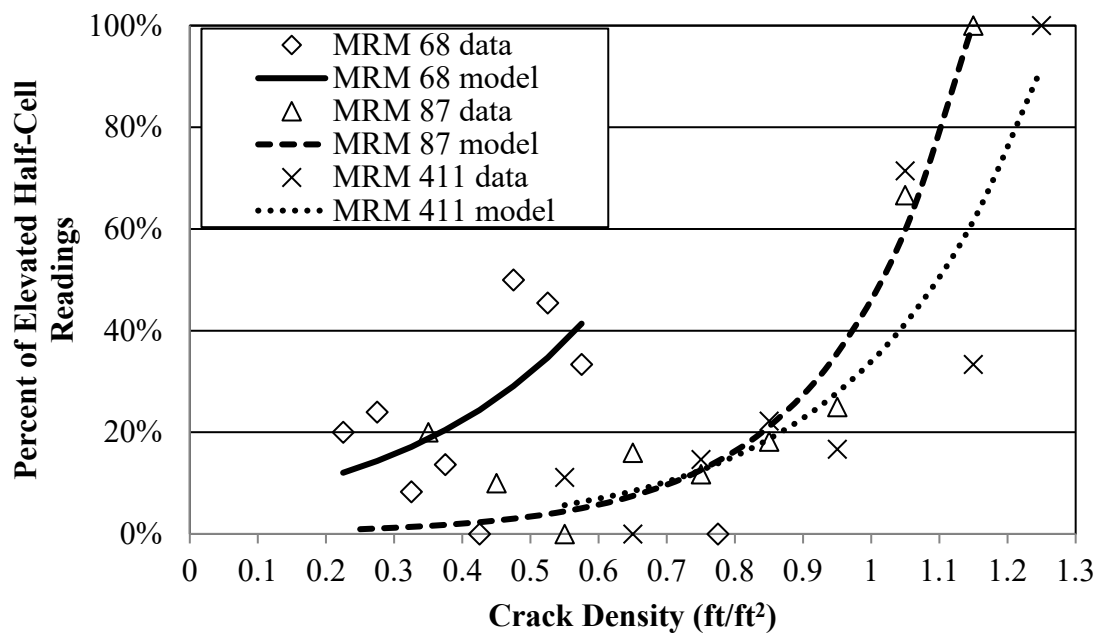
**Figure 6.5** Correlation models for Sioux Falls sites

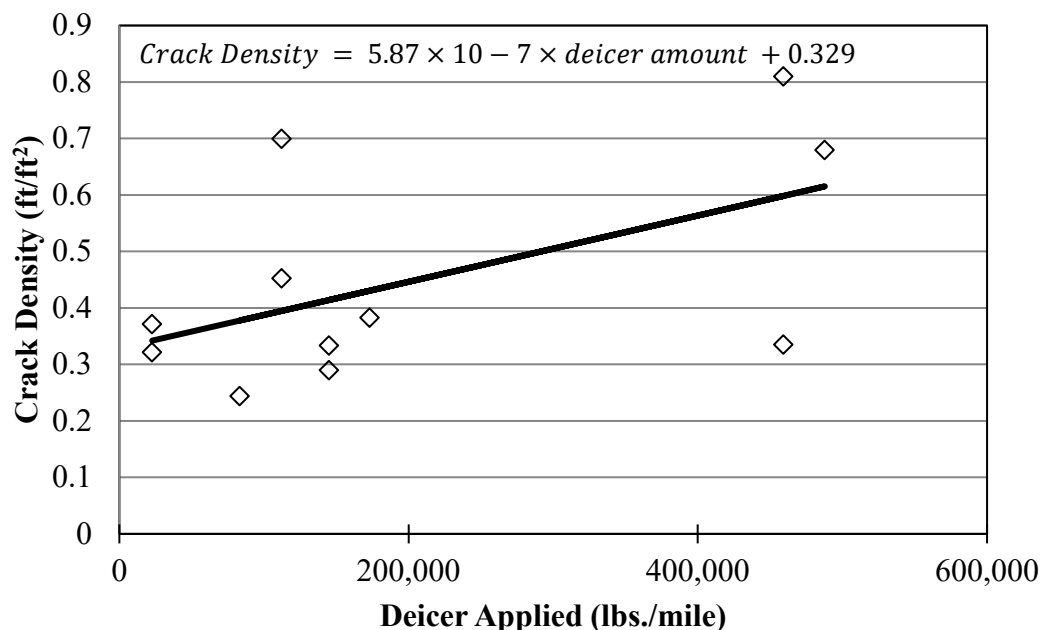
Figure 6.10 Crack density versus deicer applied for all sites surveyed

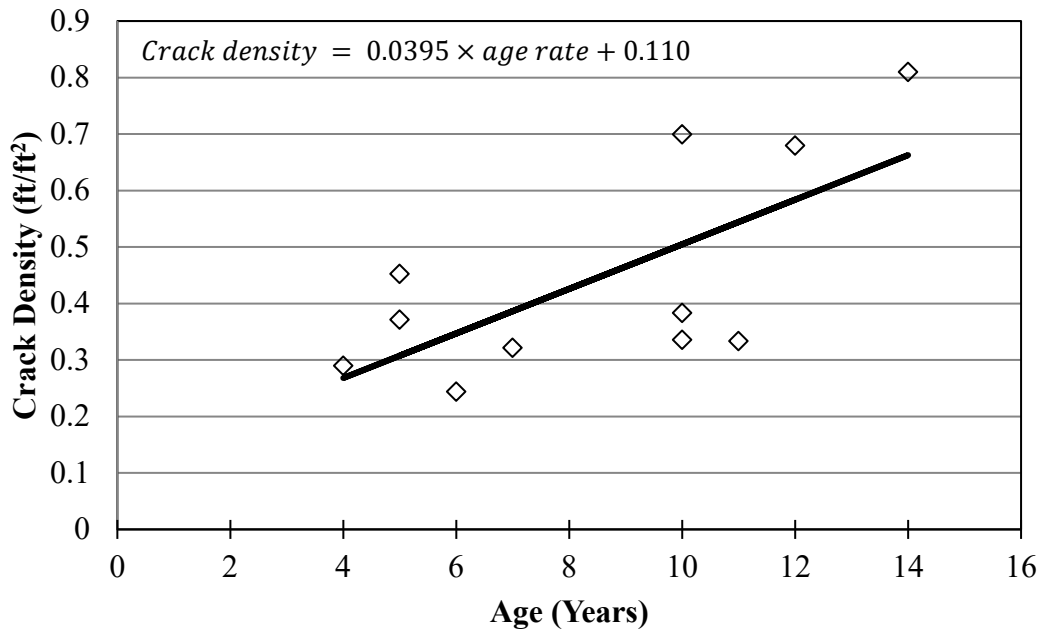
Figure 6.11 Crack density versus age of all sites surveyed

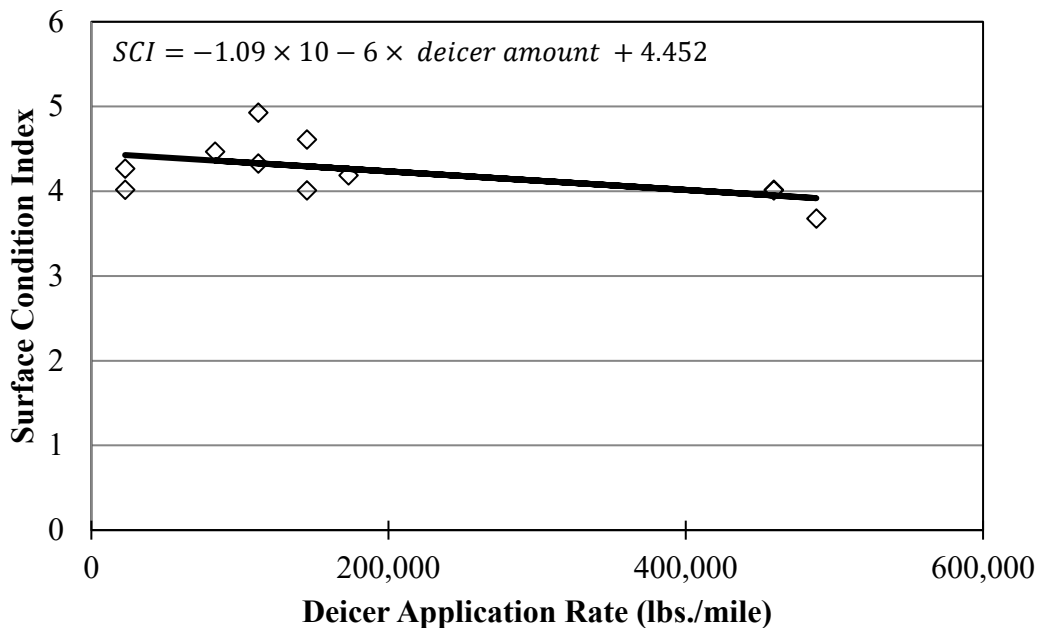
Figure 6.12 Surface condition index versus deicer application rate (all sites)

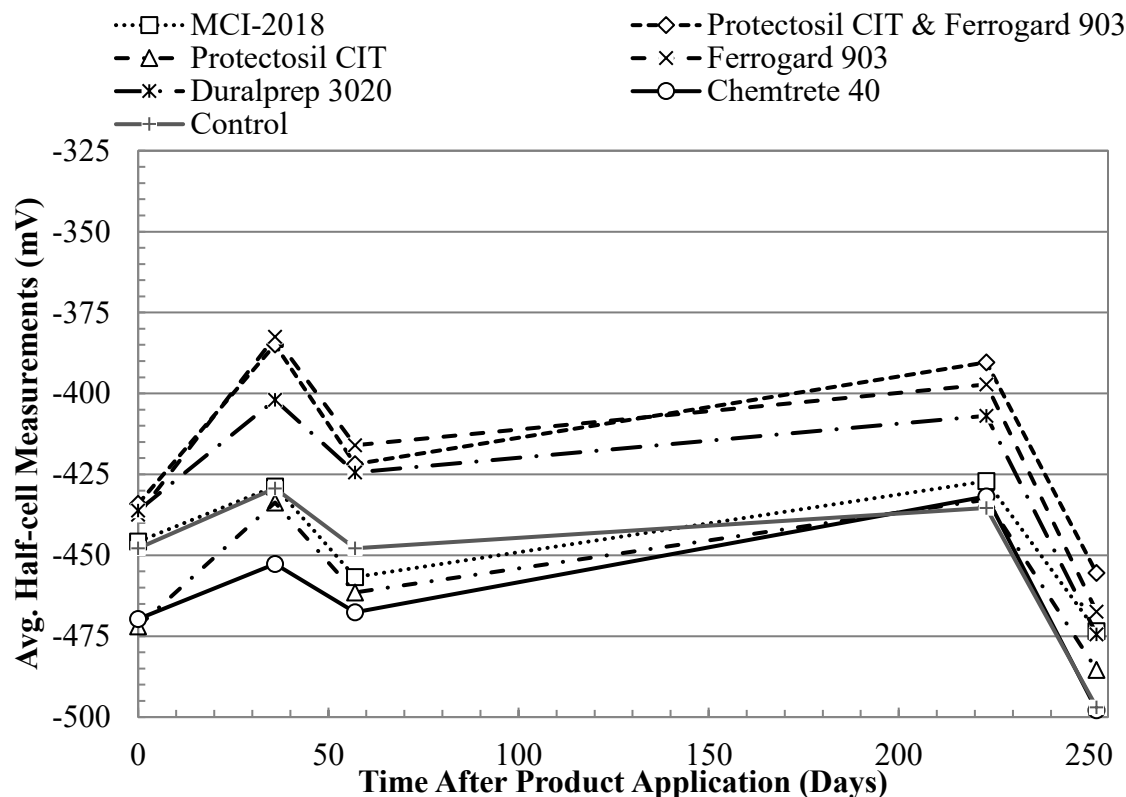
Figure 6.13 Average half-cell measurements for each section versus time

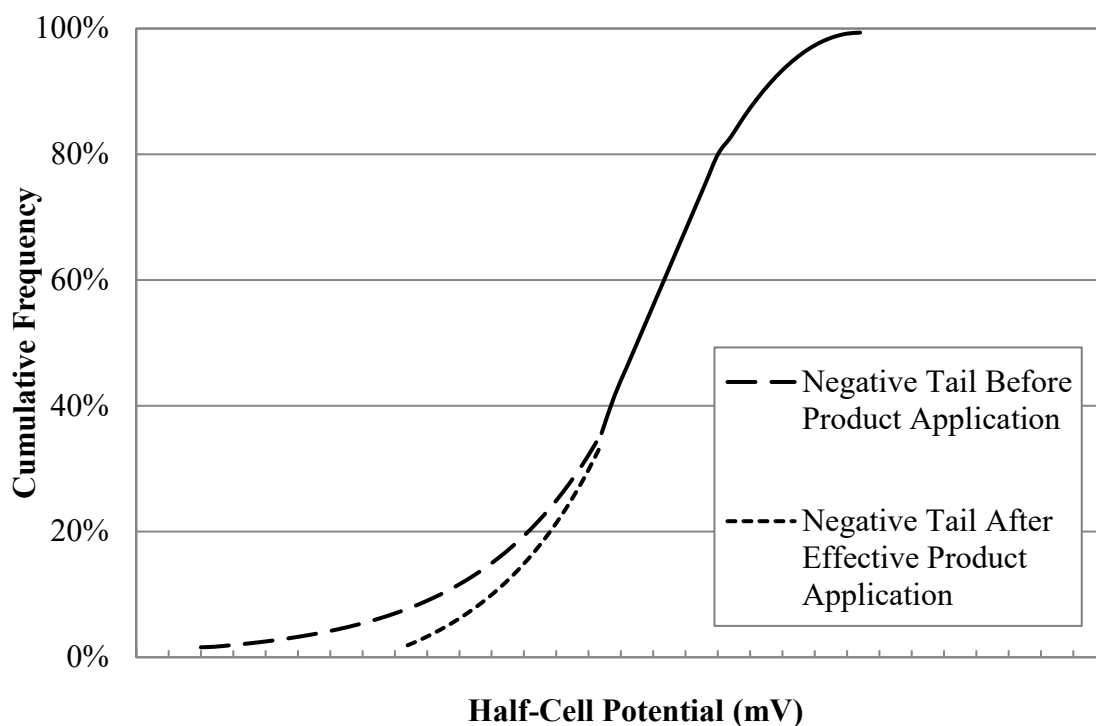
Figure 6.17 Expected change in cumulative frequency distribution for effective product

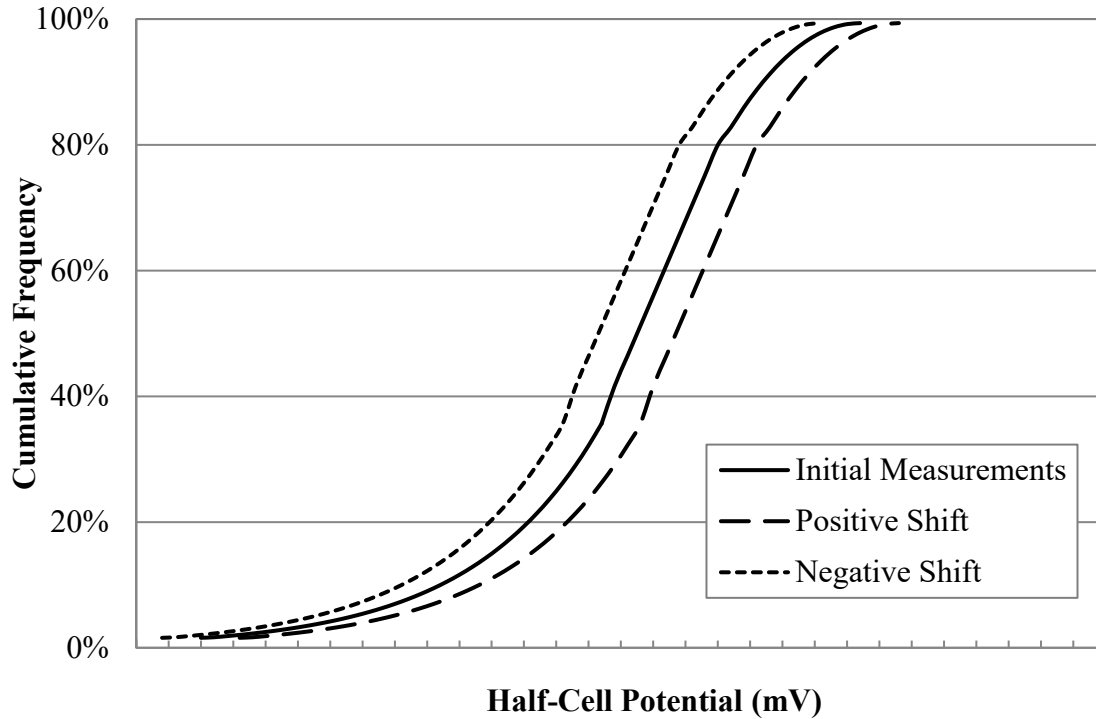
Figure 6.18 Parallel cumulative frequency distributions

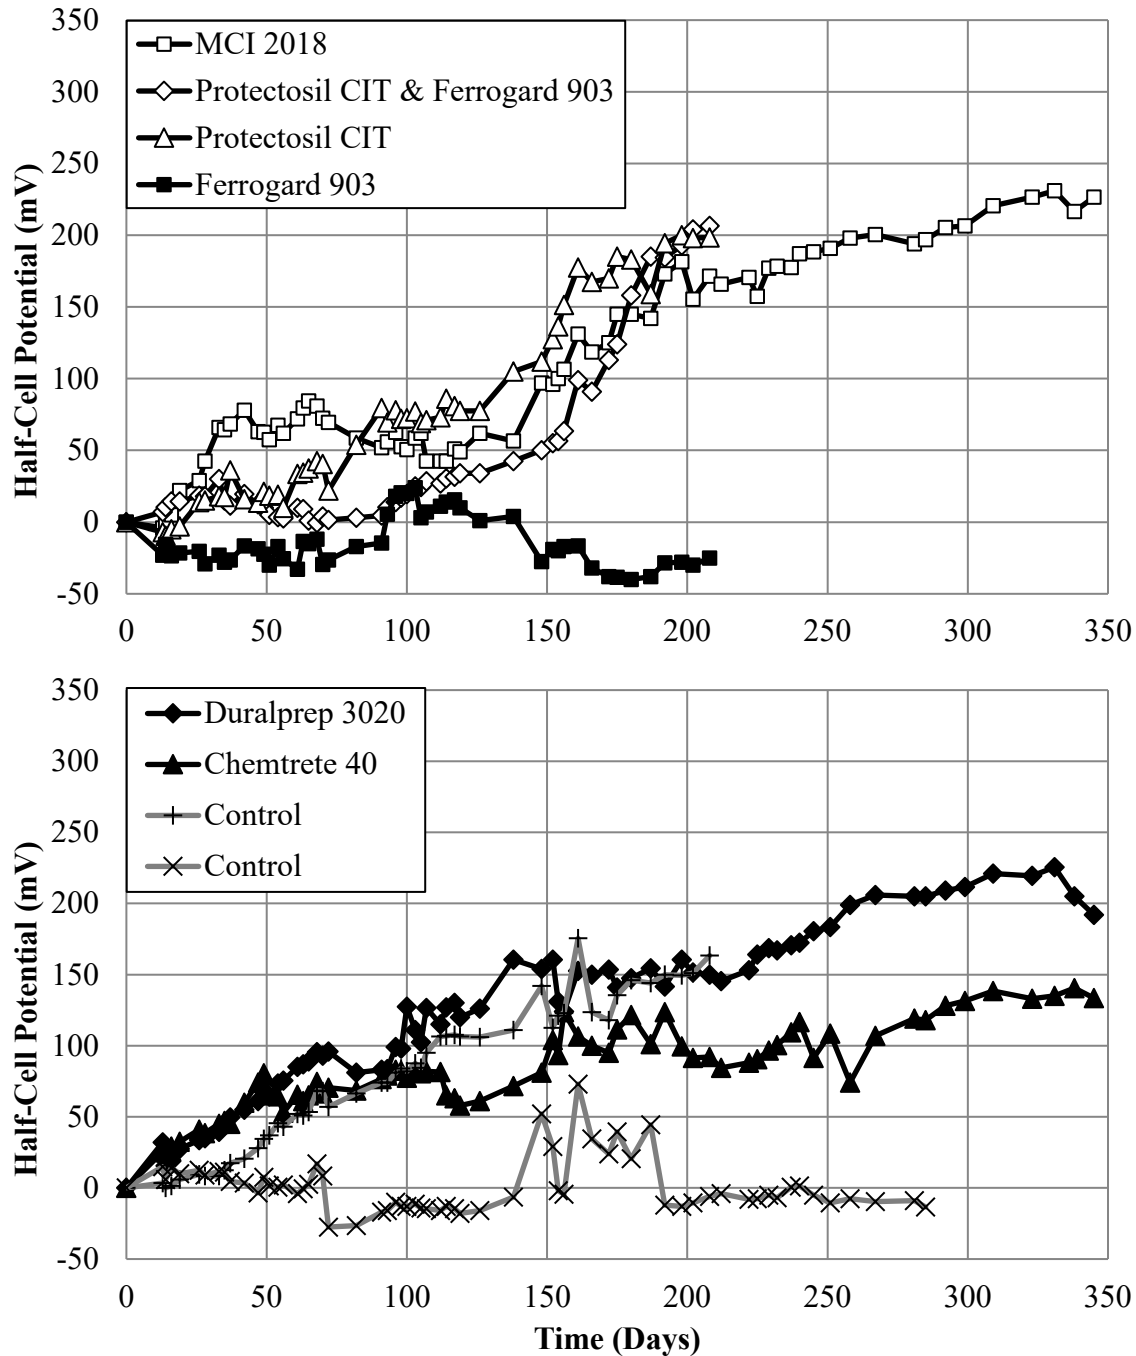
Figure 6.19 Wet specimens – change in half-cell potential after initial product application

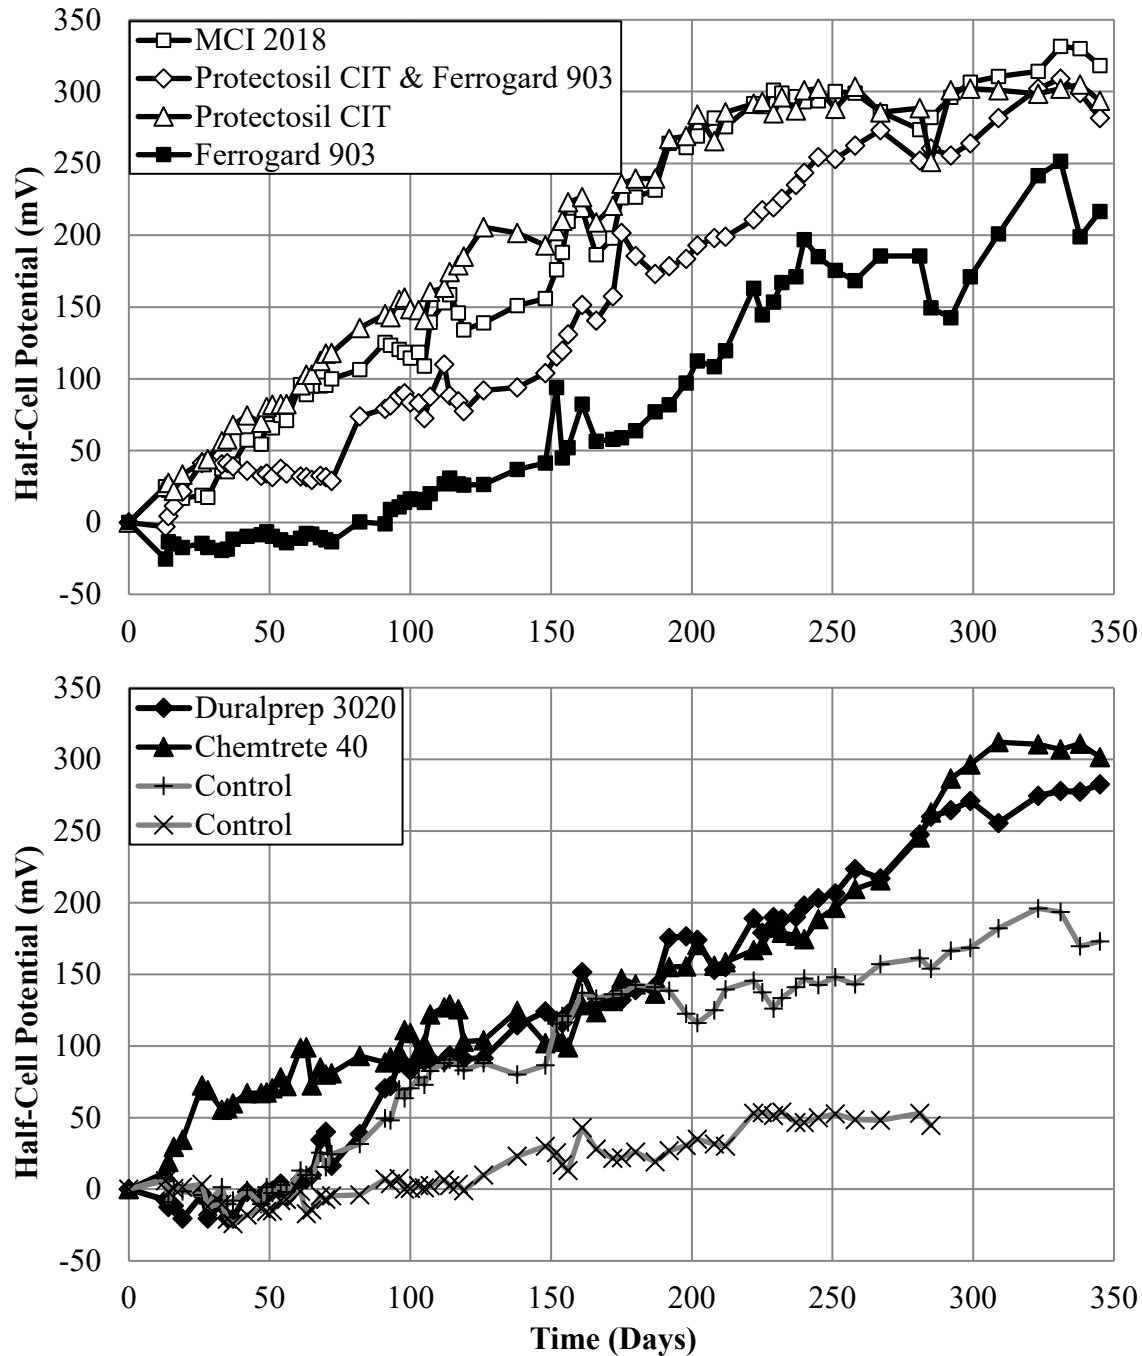
Figure 6.20 Dry specimens – change in half-cell potential after initial product application
