MOUNTAIN-PLAINS CONSORTIUM

MPC 22-466 | P. Romero

FIELD PERFORMANCE
OF ASPHALT MIXTURES
BASED ON FLEXIBILITY
INDEX RESULTS

Field Performance of Asphalt Mixtures Based on Flexibility Index Results

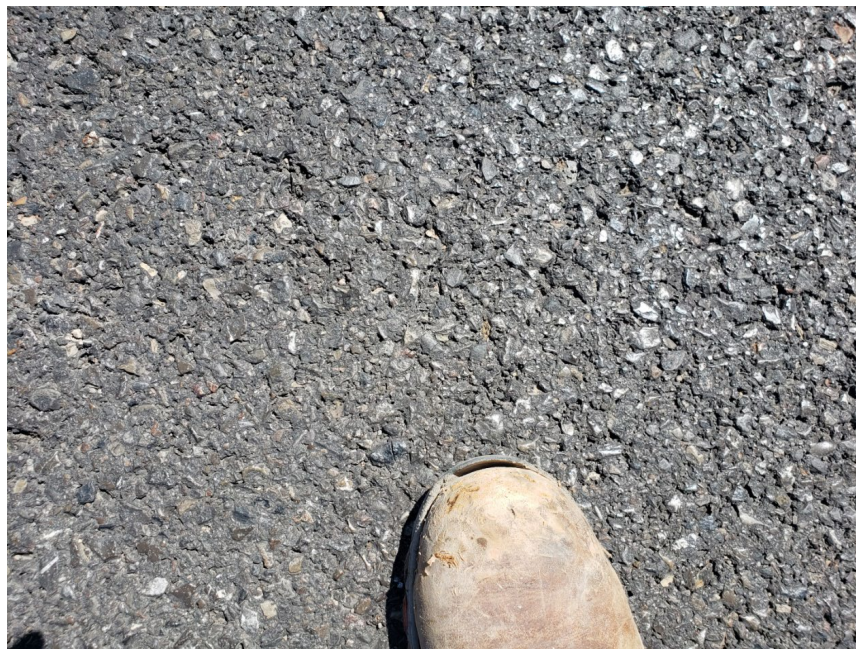
This section is located in Tooele City, Skyline Drive, approximately 100 feet west of 200 East on the westbound travel lane (40°31'20.45"N 112°17'37.01"W). The pavement is not holding well; it shows sign of raveling and there is noticeable cracking observed in the section. This is shown in Figure 3.1.

Figure 3.1 Section UT-02 showing fatigue cracking and raveling

The observations described in this chapter indicate that section UT-02 has not performed well as far as fatigue cracking distresses. This section had the most distresses after only two to three years of service. Section UT-03 showed significant thermal cracking. Section UT-05 shows some joint opening, which is considered a construction issue and not a materials issue. No distresses were seen in sections UT-04 or UT-07.

As previously discussed, FI values between 6 and 10 have been suggested as limits or thresholds in terms of performance, but no value has been specifically selected for Utah. The results shown in Table 2.2 indicate that section UT-02 is the only section with an FI value below 6 based on material sampled at both locations. Therefore, it is likely to be the worst performer of the group. As shown in the previous section, this was indeed the case, as this was the only section that showed signs of fatigue cracking.

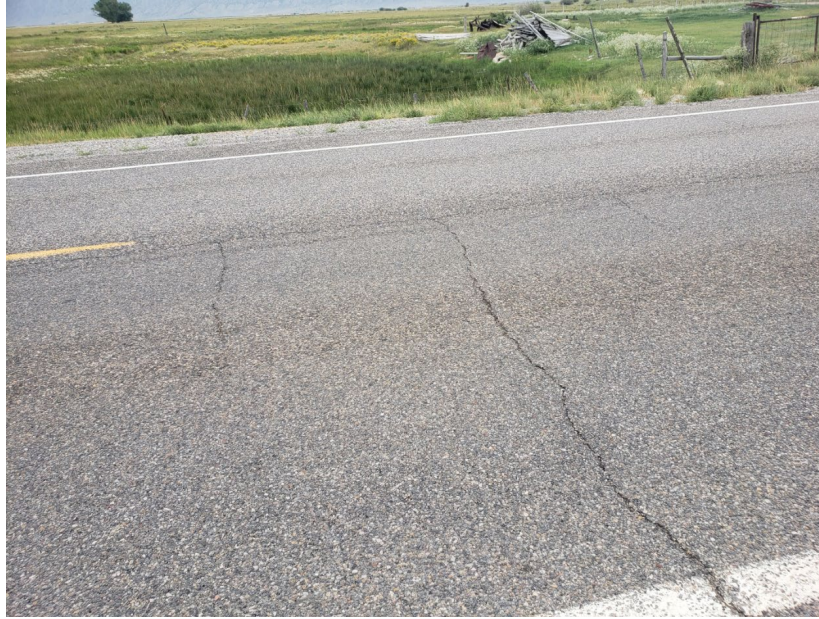
This section is located in Randolph, approximately 1.5 miles south of Church Street on the southbound travel lane (41°38'37.16"N 111°11'0.34"W). Randolph is at an elevation greater than 6,200 feet, and it is worth mentioning that Rich County, where this is located, has often set low temperature records for the state of Utah. Therefore, it is not surprising that Figure 3.2 shows severe thermal and reflective cracking.

Figure 3.2 Section UT-03 showing thermal and reflective cracking

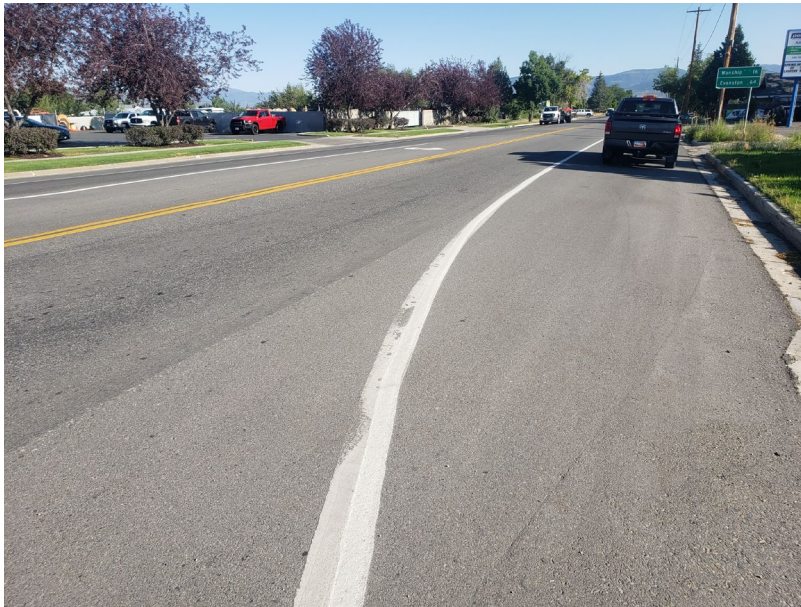
This section is part of SR 32 in Kamas. It is in the 200 North eastbound lane, in line with the east sidewalk ($40^{\circ}38'46.93''\text{N}$ $111^{\circ}16'50.26''\text{W}$). The section shows some longitudinal joint opening but no other distress. This is shown in Figure 3.3.

Figure 3.3 Section UT-04 Showing some joint opening

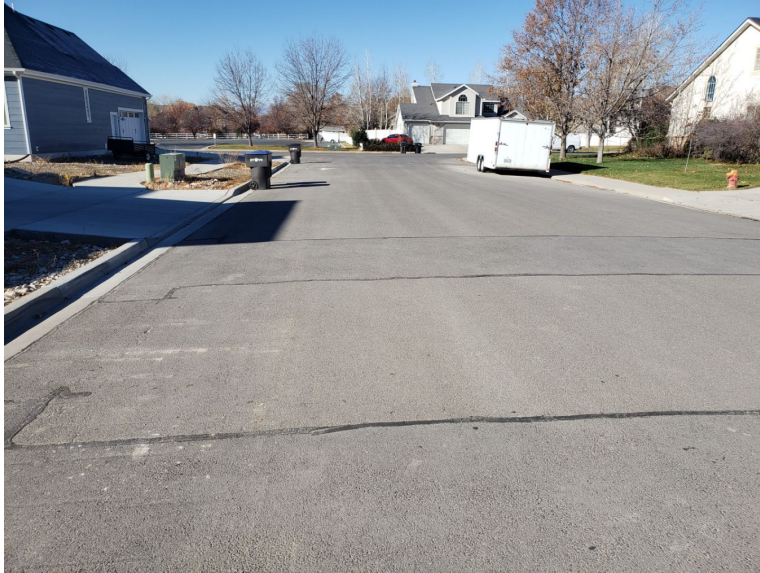
This section is located in a subdivision in Provo at 3550 N 180 E. The material was used as a patch and was sampled from a 17-hour-old stockpile for custom sales. The small size of the patch makes any performance evaluation meaningless. Figure 3.4 is a picture of the section.

Figure 3.4 Section UT-05 used as a patch material

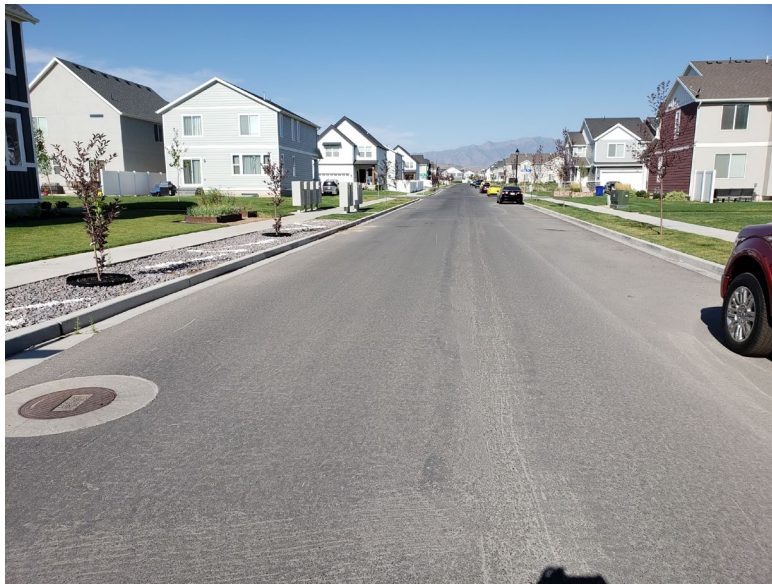
This section is located on Heartstone Lane in Saratoga Springs, between Valkyries and School House (40°21'9.41"N 111°54'33.27"W). As shown in Figure 3.5, the road is part of a residential area and shows no visible distresses.

Figure 3.5 Section UT-07 showing no visible distresses
