MPC 24-523 | K. Sharma

FORT TOTTEN WALKABILITY
ASSESSMENT AND
RECOMMENDATION REVIEW

Fort Totten Walkability Assessment and Recommendation Review

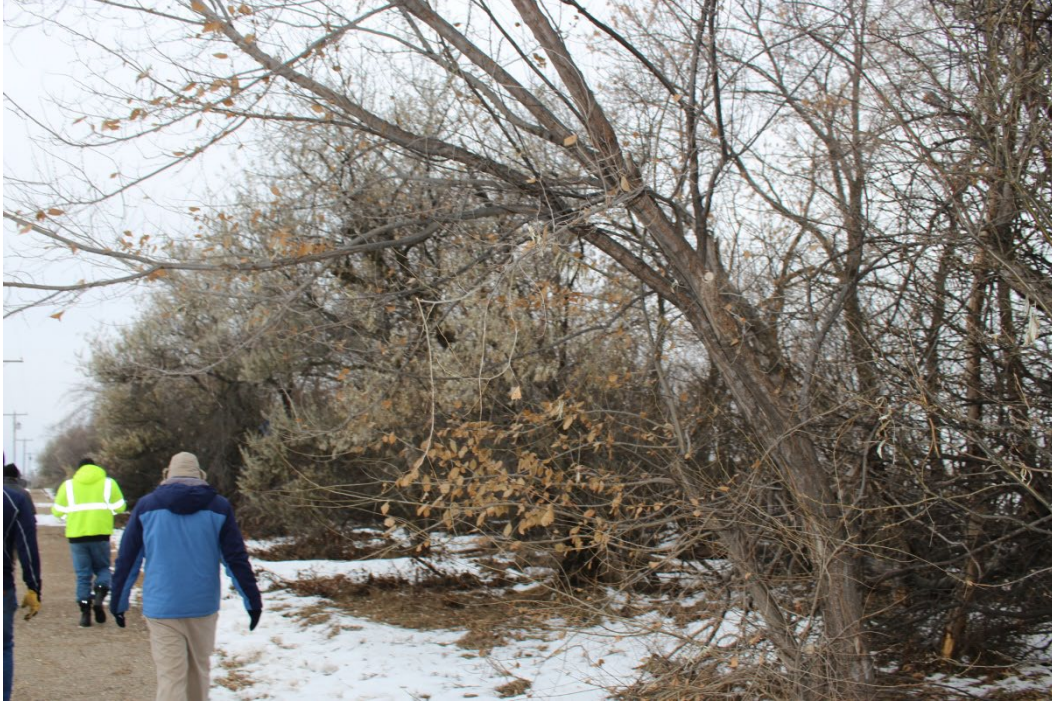
Figure 5.1 Overhanging trees along ND57

The team observed an overgrowth of trees and shrubs along the sidewalks. The overgrowth encroached upon the walkable areas of the sidewalk as seen in Figure 5.1. Note that the assessment was completed during the fall. During spring, summer, and early fall, the overhanging branches can be expected to drop further and encroach on the sidewalk even more. This overgrowth is not only a sidewalk-constricting nuisance but a hazard with the potential of injuring sidewalk users, especially during low-light hours of the day.

A review of maintenance practices should be completed. In addition to using plows, brushing snow away from the walking surface should be considered. De-icing and traction improvement strategies should be instituted to maintain sidewalks and shared-use paths in safe walking conditions. Other considerations include regular maintenance of nearby trees/shrubbery and weed control. Trash receptacles could be installed at regular intervals along the entire path to encourage users to keep the area clear of any garbage.

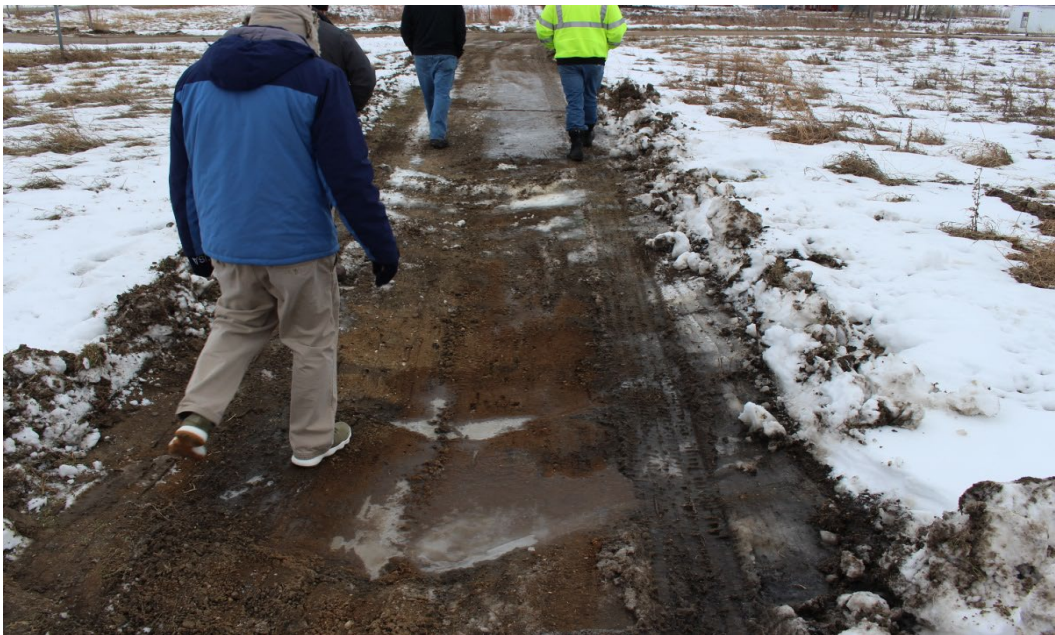
Figure 5.2 Discontinuity in sidewalk

At several locations, as seen in Figure 5.2, the sidewalk had deteriorated, leading to the substantial loss of the wearing course and allowing the subgrade to surface. In these locations, the sidewalk had the appearance of a gravel path. Such conditions, especially during wet weather, are not conducive to walking or running. The issue is particularly precarious for those using wheelchairs and strollers.

Sections of the sidewalks in poor condition should be rebuilt to current standards. In doing so, there should be no discontinuities across driveways or along parking lots. It would likely be beneficial to complete several smaller related work items at the same time, including:

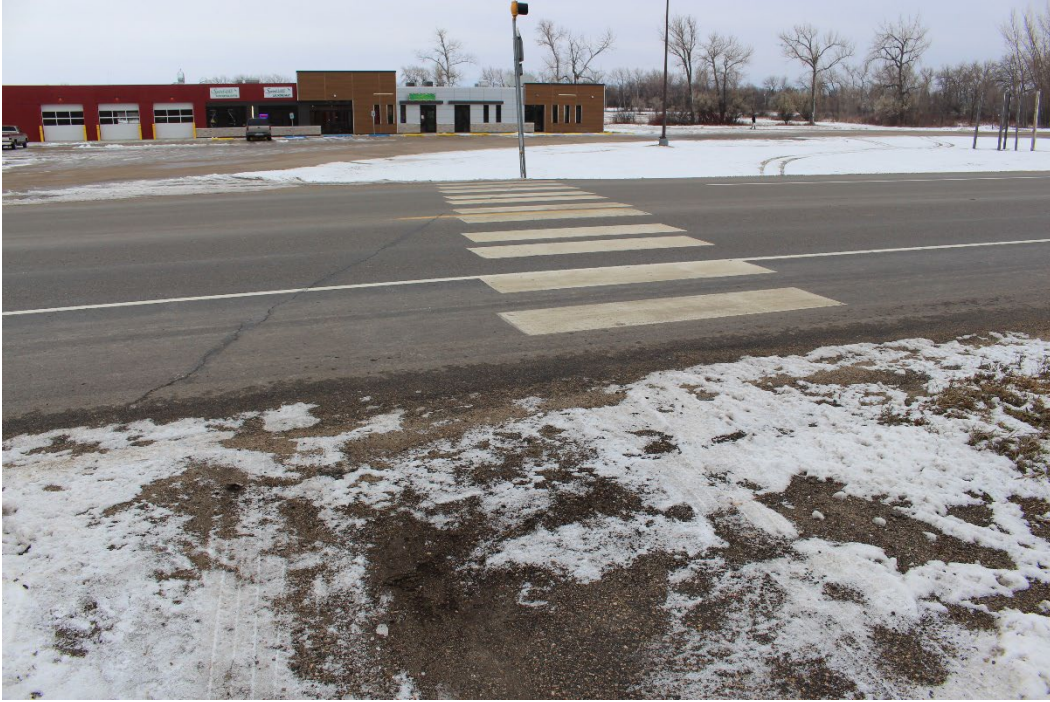
Figure 5.3 Missing ramp near Four Winds High School

At some locations, as seen in Figure 5.3, ramps connecting the sidewalk to the crosswalk were missing. They appear to have never been constructed.

- Installation of missing ramps
- Pavement marking updates
- Missing sign installation
- Damaged sign replacement

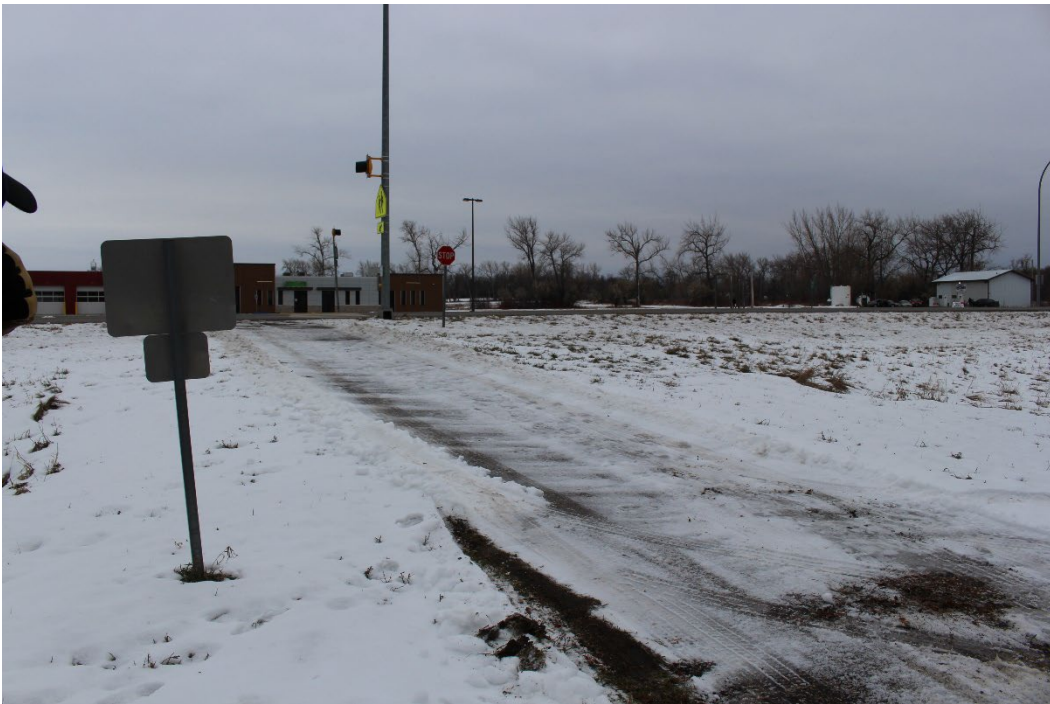
Figure 5.4 Slippery sidewalk conditions

At several locations, as seen in Figure 5.4, the sidewalk was icy. At multiple locations, signs were missing, graffiti-covered, or otherwise vandalized as seen in Figures 5.5 and 5.6.

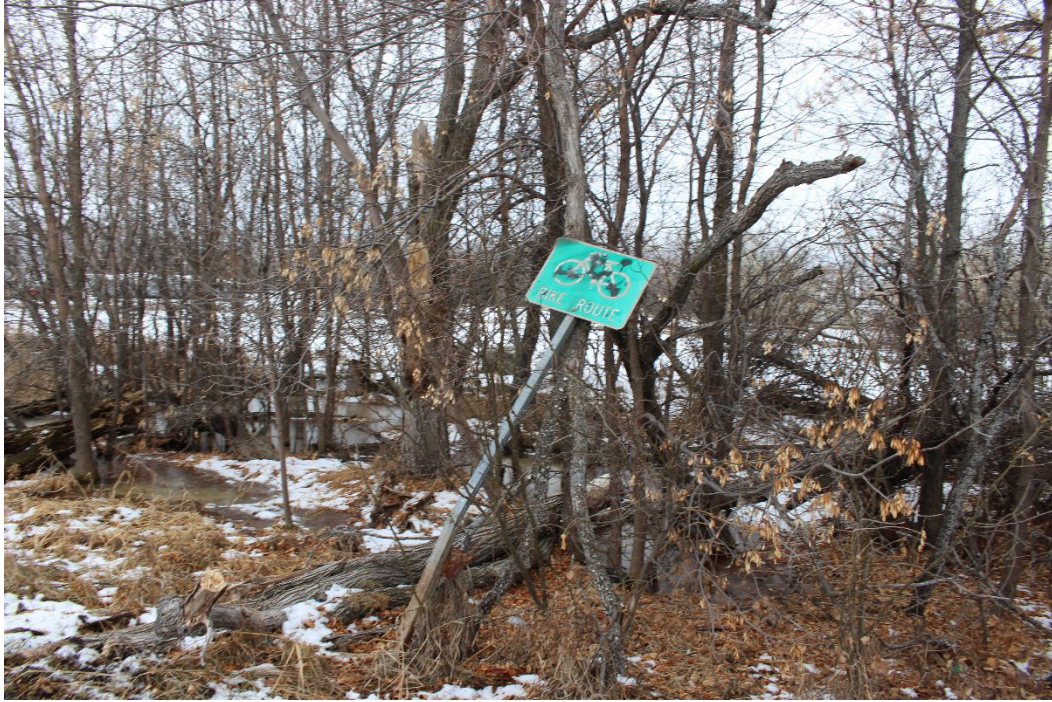
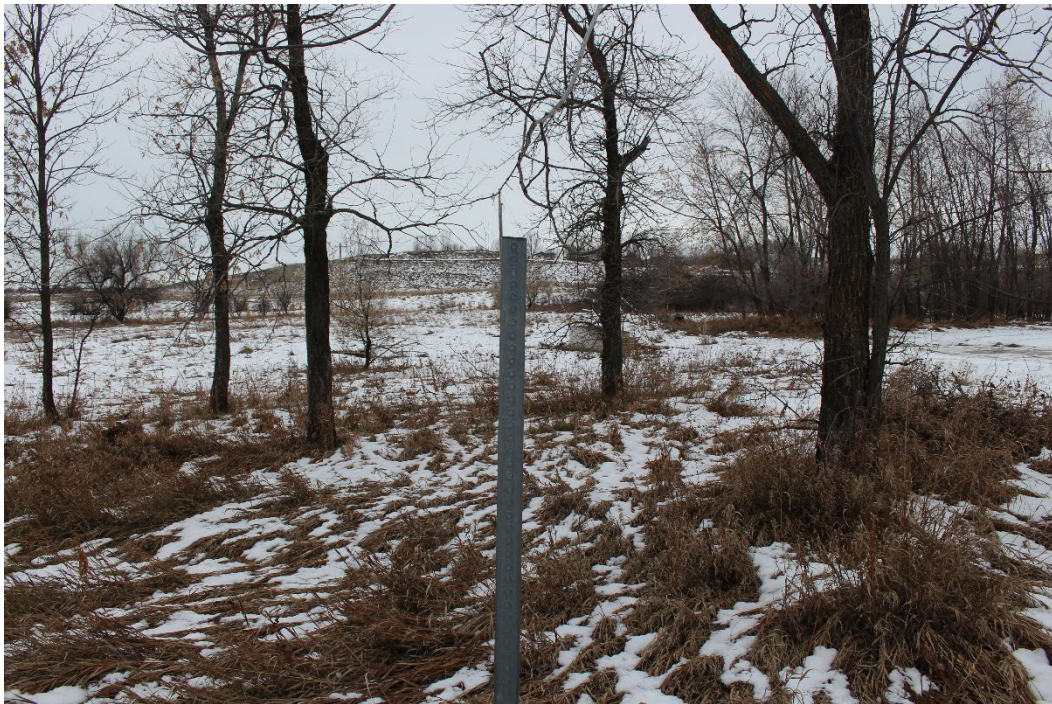
Figure 5.5 Damaged bike route sign

Figure 5.6 Sign post missing sign

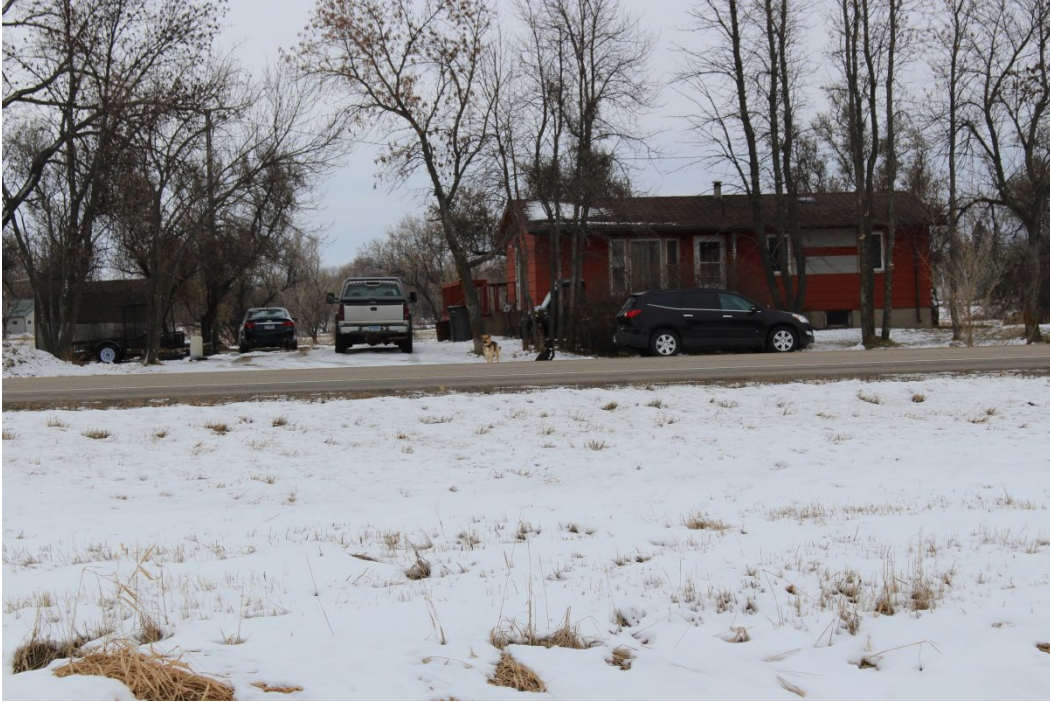
Figure 5.7 Unleashed pet dog

The team observed unleashed pet dogs near the apparent owner's house as seen in Figure 5.7. This creates an uninviting walking environment that is further exacerbated by a lack of lighting at night or during low-light hours.

A local ordinance should be considered to assure that pets, which many assessment participants considered potentially harmful (e.g., unleashed pets), are kept away from the walking area at all times unless leashed.

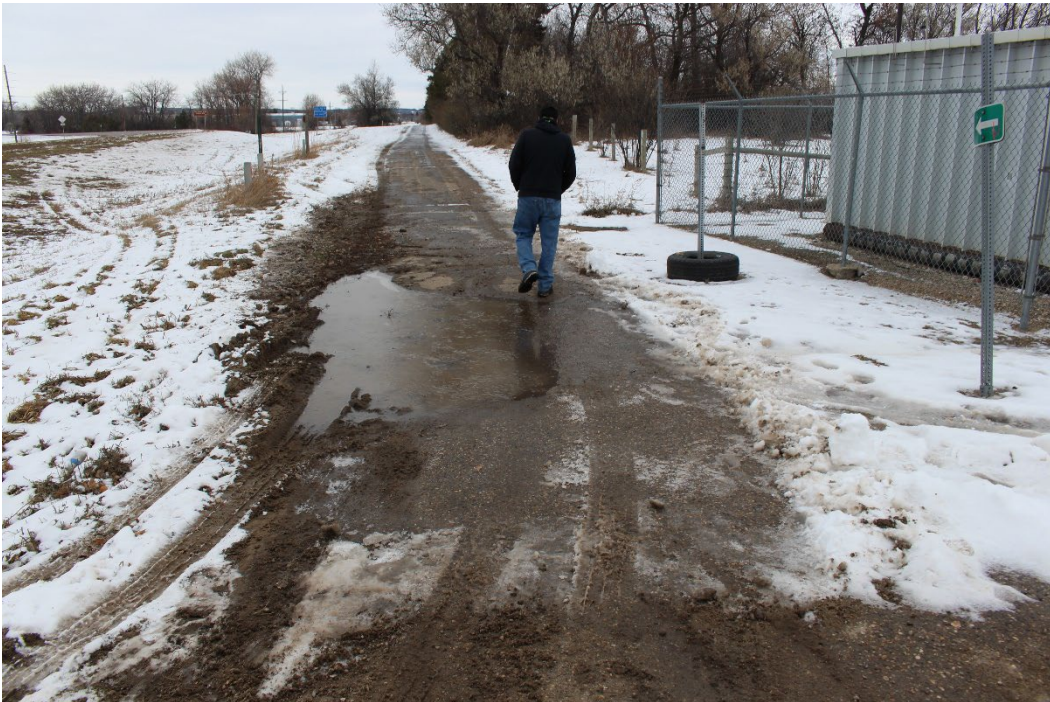
Figure 5.8 Puddle of water on damaged sidewalk

Some places had water puddles on the sidewalk. The area under water in Figure 5.8 appears to have been damaged/cracked. Also, note the missing sign on the post to the right. At other locations, most of the walking surface had weathered and weeds were growing where the sidewalk used to be, as shown in Figure 5.9.

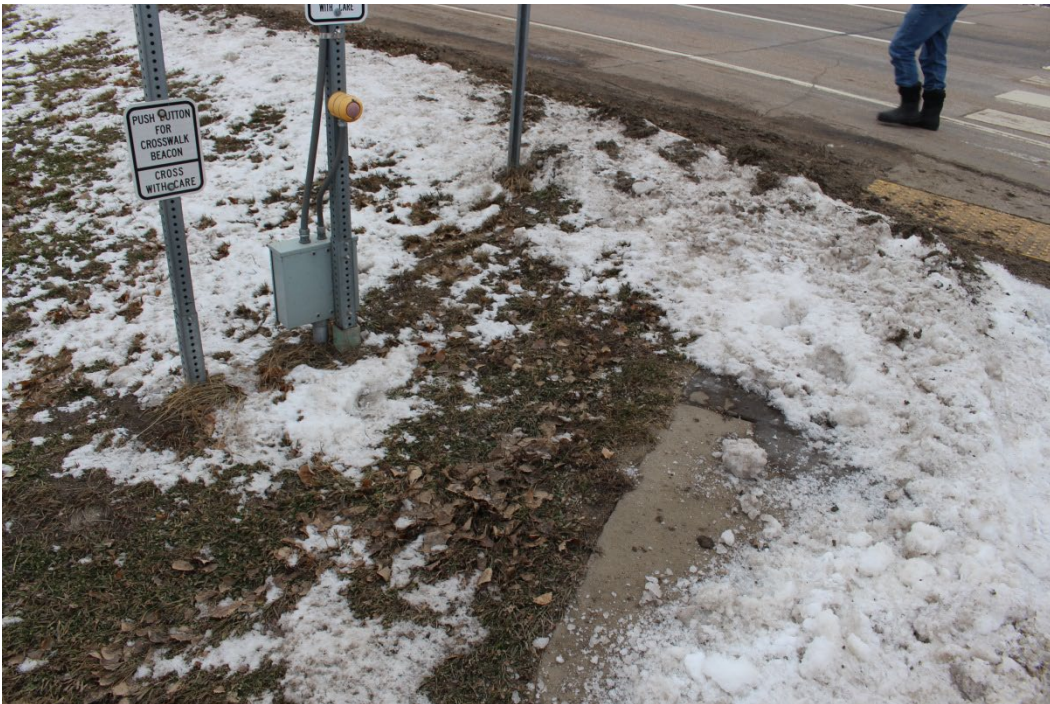
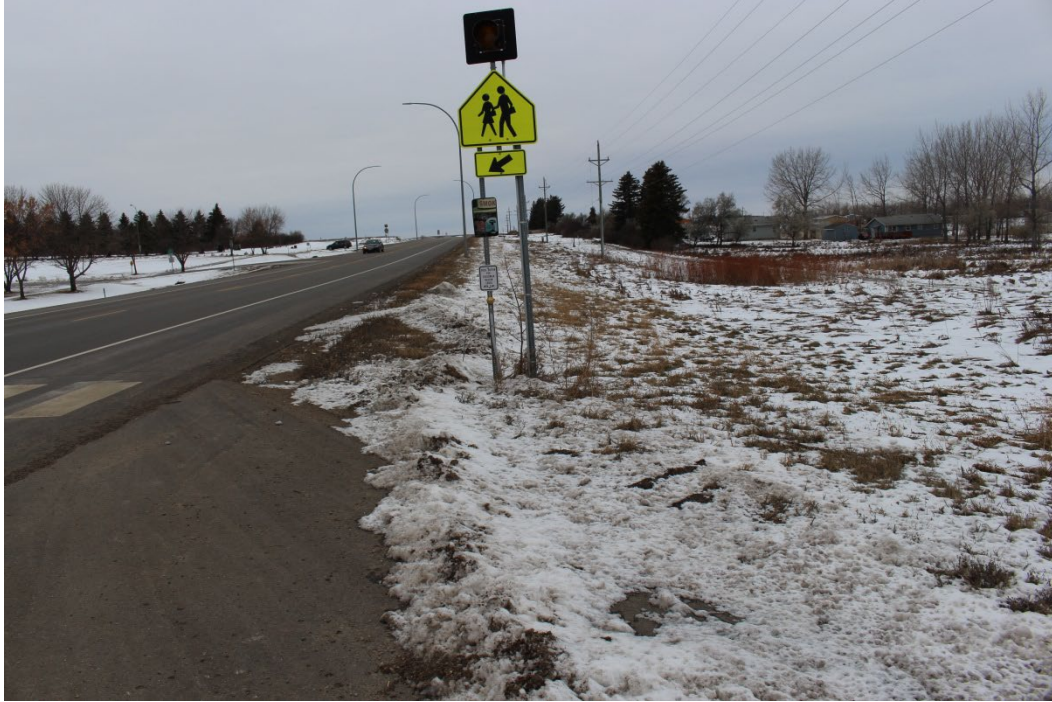
Figure 5.10 A location missing landing for the pedestrian push button

At some locations, landings next to the pedestrian push buttons were missing, as seen in Figures 5.10 and 5.11. At such locations, it can be very difficult to reach the push button, especially for children and other vulnerable members of the community. The landings appear to have never been built.

Figure 5.11 Another location with missing landing for pedestrian push button

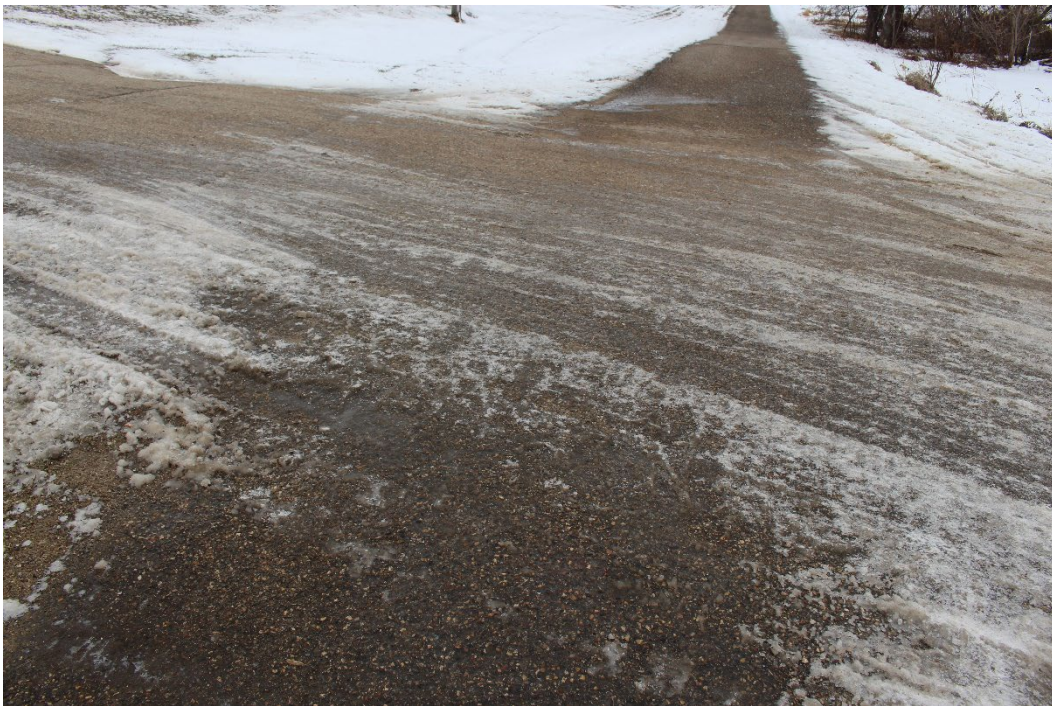
Figure 5.12 Discontinuous sidewalk

At several locations, as seen in Figure 5.12, the team found the sidewalk to be discontinuous, especially across driveways. Another discontinuity location was where the sidewalk led into a parking lot; the difference between the parking lot and the sidewalk was not discernible.

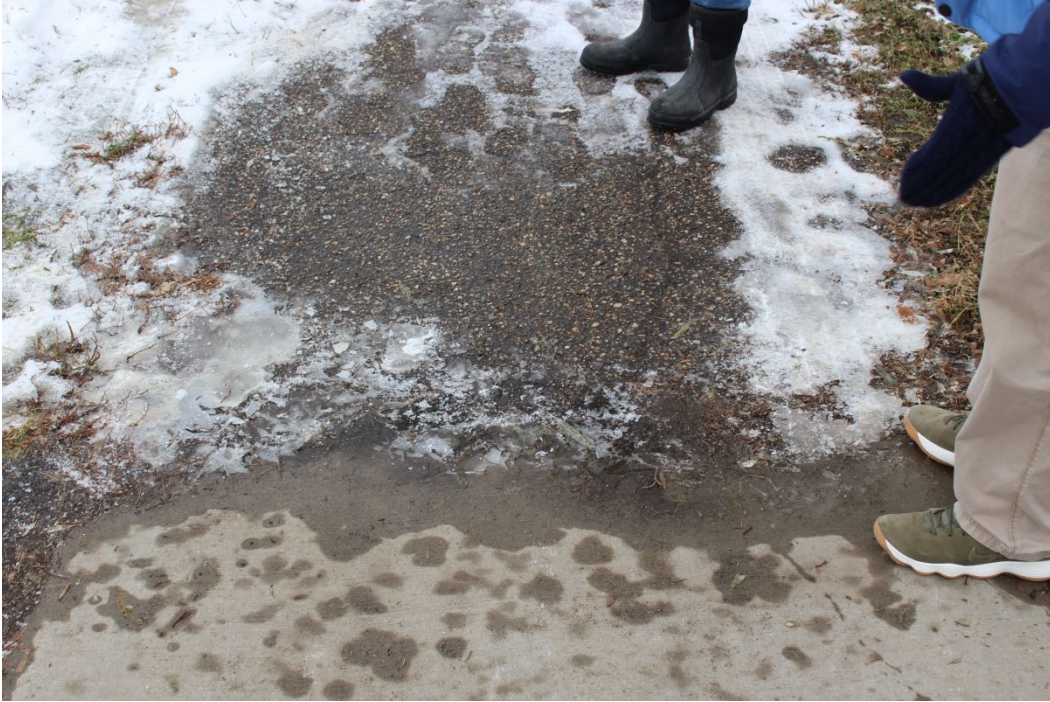
Figure 5.13 Different top layers used for sidewalk

In some locations, different top layers (asphalt and concrete) were observed on the sidewalk. A mix of materials, as seen in Figure 5.13, may present challenges for repair and maintenance.

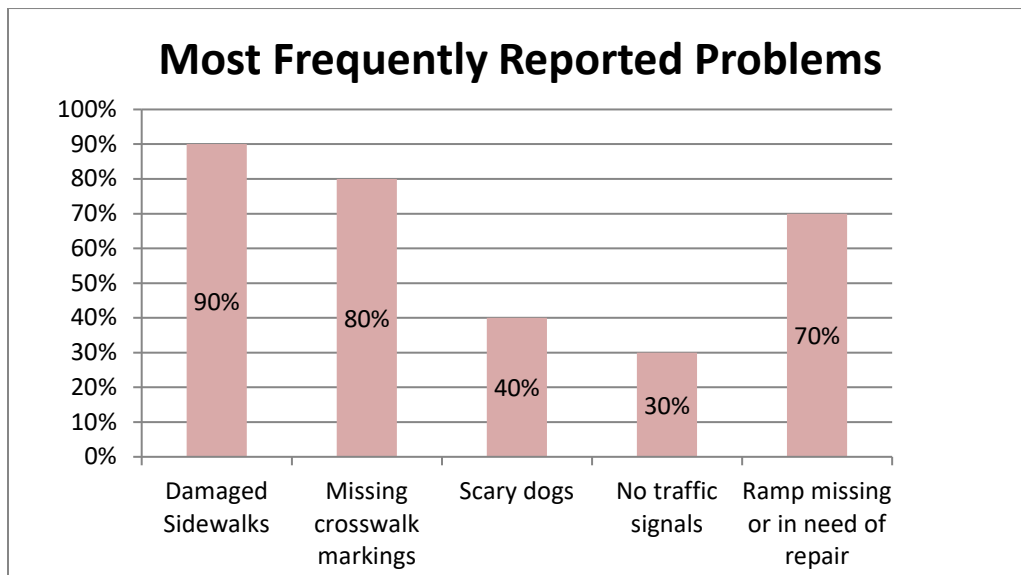
On average, participants rated their walk and the infrastructure at about 15 as seen in Figures 6.1, 6.2, and 6.3 below. The assessment results also show that most participants agreed that the infrastructure needed a lot of work.

Figure 6.1 Walkability ratings totals chart

Figure 6.2 Most frequently reported problems chart

Figure 6.3 Walkability total ratings categories chart
