**MPC 24-536** | S. Ni, A. Sorensen, I. Unobe and A. Pokhrel

## IMPACT OF VEHICLE FIRES ON POLYMER CONCRETE BRIDGE DECK OVERLAYS

# **Impact of Vehicle Fires on Polymer Concrete Bridge Deck Overlays**

July 2024

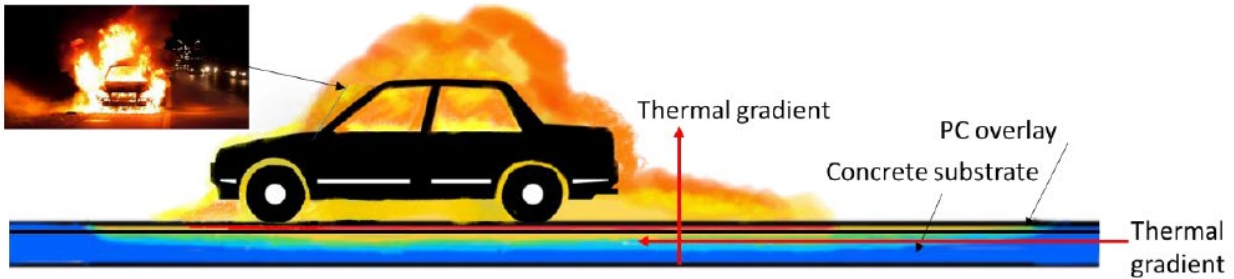
**Figure 1.1** Thermal gradient of a bridge deck under a vehicle fire

While some prior research has focused on the potential negative impacts of the significant difference between the thermal expansion coefficient of PC and that of conventional concrete [6,7], such studies primarily focused on ambient temperature ranges and the exposure of PC to relatively uniform temperature increases or decreases. However, the heat exposure of a PC overlay from a vehicle fire does not fit into such scenarios as the temperatures will be much higher than ambient temperatures. Also, the temperature changes will not be uniform either across the surface or over the duration of exposure. In addition, the composite panel experiences thermal gradients not only along its thickness (as illustrated by the vertical red arrow in Figure 1.1), but also along its surface (the horizontal red arrow) due to the low thermal conductivity of materials and the non-uniform heat exposure of a surface under a vehicle fire. Such gradients along a panel surface may result in overlays directly exposed to a vehicle fire expanding against the cooler surrounding areas and thus damaging them.

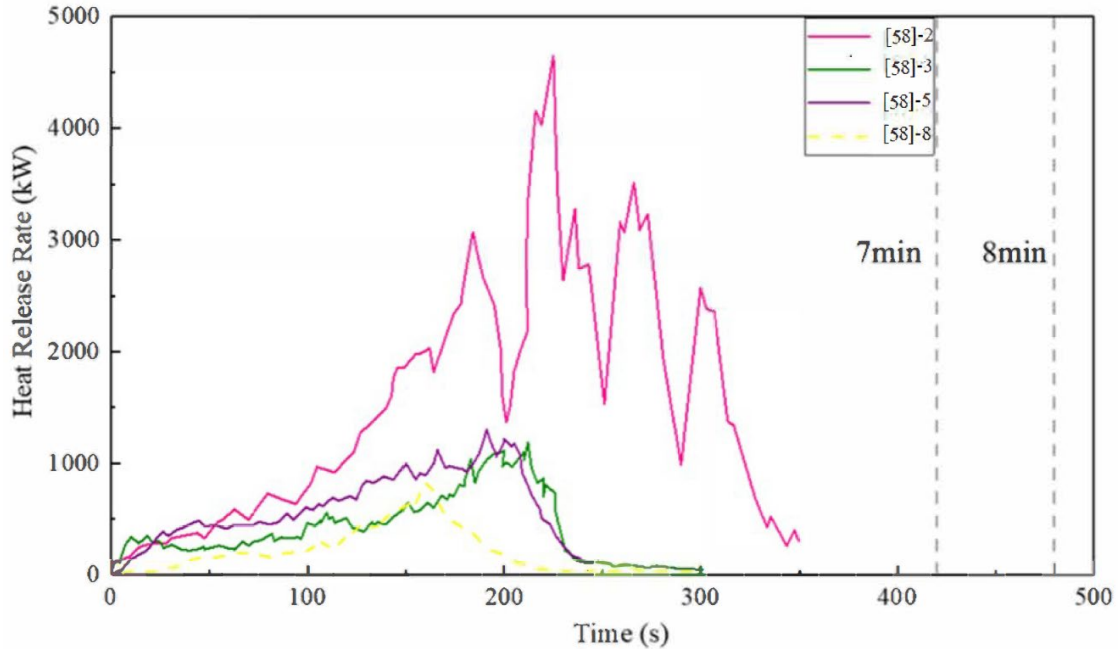
**Figure 2.2** Fire departments' emergency response time compared with heat release rates from experiment

An important variable in understanding the response of PC surfaces to elevated temperatures from fires is the exposure time. This is dependent on the spread of vehicle fires and time of burn. NFPA 1710: Standard for the Organization and Deployment of Fire Suppression Operations, Emergency Medical Operations, and Special Operations to the Public by Career Fire Departments establishes the criteria for emergency response to fire. This standard prescribes that the first engines should arrive at a fire scene within 240 seconds of a call being made for 90% of fire incidences [59]. However, one study [60] analyzed 13,463 daytime fire response records and 2,681 recorded nighttime responses and found that fire departments' emergency response time is usually between seven and eight minutes, including travel time. Figure 2.2 shows the response time relating this to the heat release rate for vehicle fires ignited by gasoline leakage.

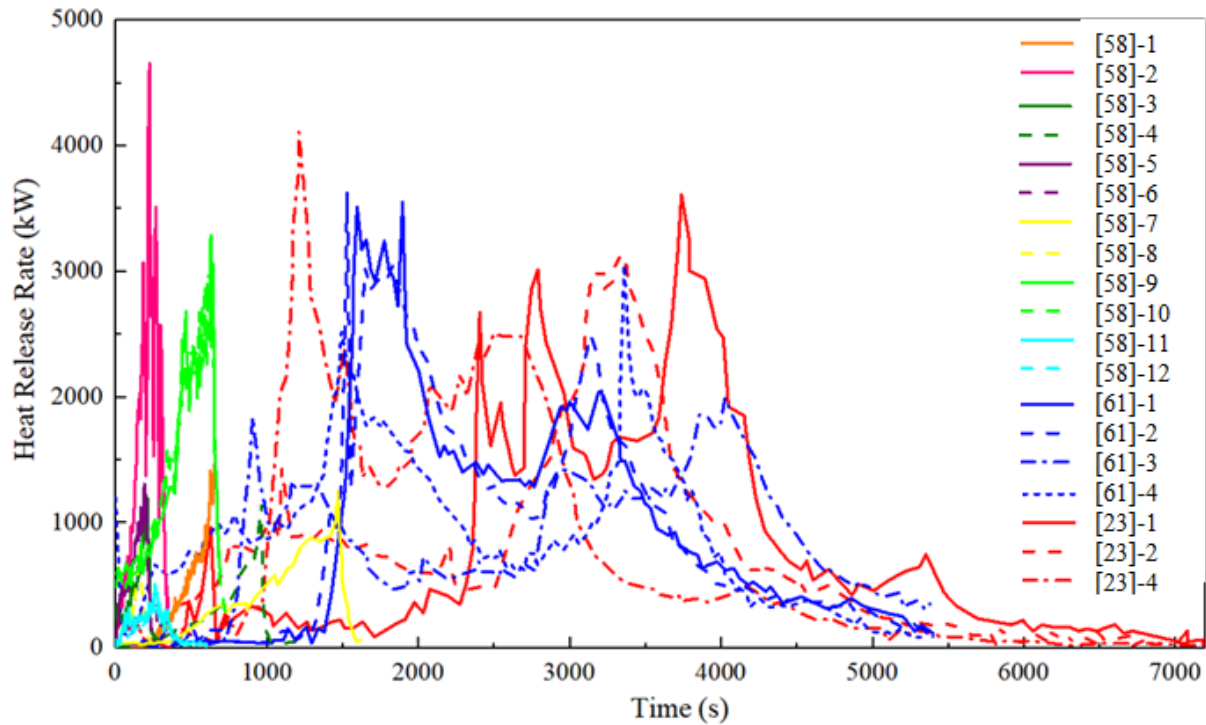
**Figure 2.3** HRR curves in references [23, 58, 61]

From the plots in Figure 2.3, two distinct sets of patterns can be noted. The first for short duration fires (under 1,000s), and the second for much longer fires. In the short duration tests, the fires were suppressed after a predetermined interval, while in the second set, the fires were allowed to run their full course. Although influencing the heat release patterns, the length of the fires did not seem to affect the maximum

HRR. Rather, the HRR seems to be a function of the parts of the vehicle that caught fire. Curve 2 from [58], which showed the highest HRR of about 4,700 kW, was ignited by gasoline leaking out of the vehicle under the gas tank, creating a flammable pool beneath the vehicle. In this test, the flames spread rapidly, and the fire reached the maximum HRR in about 260s. Manual suppression meant that the fire was also quickly put out, with the whole test lasting under 300s. Similarly, curve 9, also from [58], started by igniting the engine compartment fluids, reached a maximum HRR of 3,300 kW at about 780s, at which time it was quickly suppressed. The HRR in other short duration tests did not reach these heights. For the longer duration fires, the trends show similarities to the shorter duration fires except with multiple peaks and lasting for longer periods. With the burning regimen lasting much longer than the short duration tests, these tests had distinct periods where different ignitable fluids caught on fire, and thus developed multiple HRR peaks congruent to these time instances.

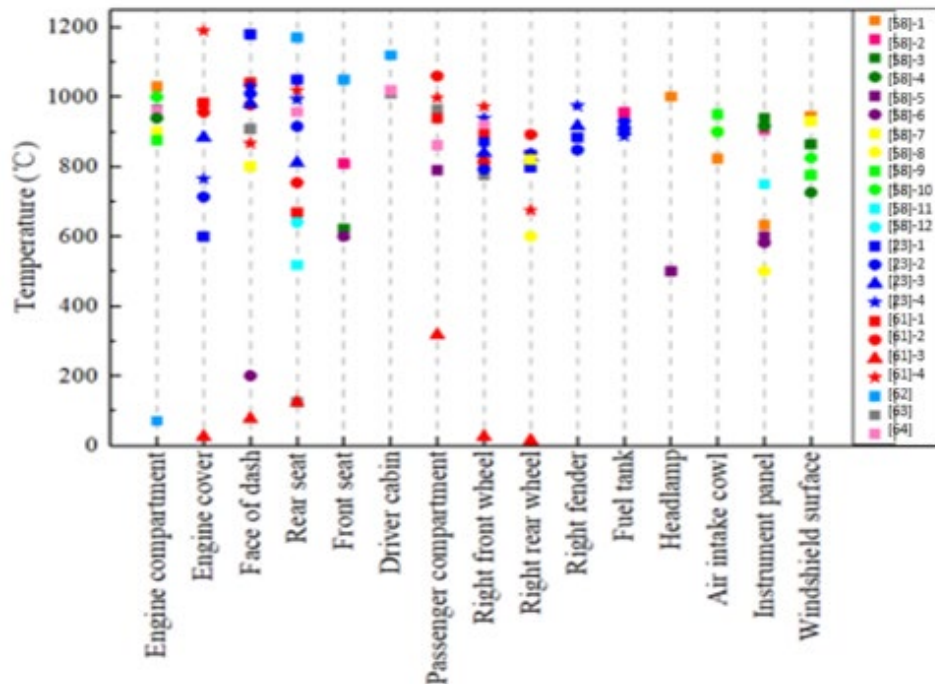
**Figure 2.4** Temperature at different locations [23, 58, 61–64]

From Figure 2.4, it can be noted that the temperatures in different locations for the same vehicle fire tests differ significantly. In addition, the maximum temperatures for different vehicle fire tests in the same locations also has some dispersion. Both can be attributed to flammability of materials encountered by the flames. Some areas of the vehicle such as the engine compartment and areas close to the gas tank are exposed to fires which give off more heat, and thus record higher temperatures than areas with less flammable materials. The maximum temperature recorded in these tests was close to 1200°C. These tests indicate that irrespective of duration, highway/bridge surfaces exposed to vehicle fires can be exposed to temperatures exceeding 1000°C, and thus, an experimental vehicle fire carried out to determine the behavior of overlay materials, needs to attain such temperatures.

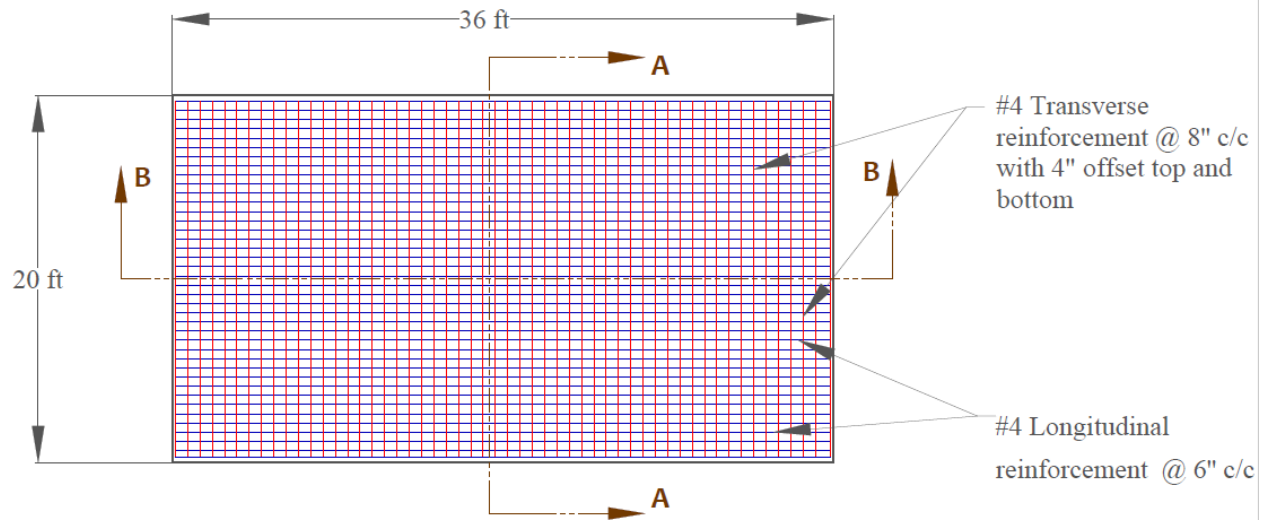
**Figure 3.1** Layout of the reinforcement

The layout of reinforcement is shown in Figures 3.1 to 3.3. Figure 3.1 shows the plan view of the reinforcement layout, while Figures 3.2 and 3.3 show the cross-section view of the reinforcements for the 20 ft and 36 ft directions, respectively. Call outs are used to offer a detailed view of the reinforcements in both cross-section figures. Figure 3.4 shows the various stages of the construction process for the concrete slab.

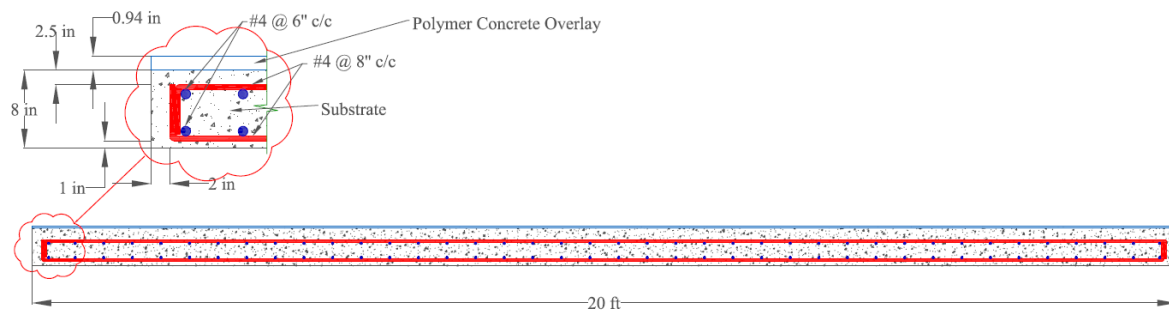
**Figure 3.2** Section A-A

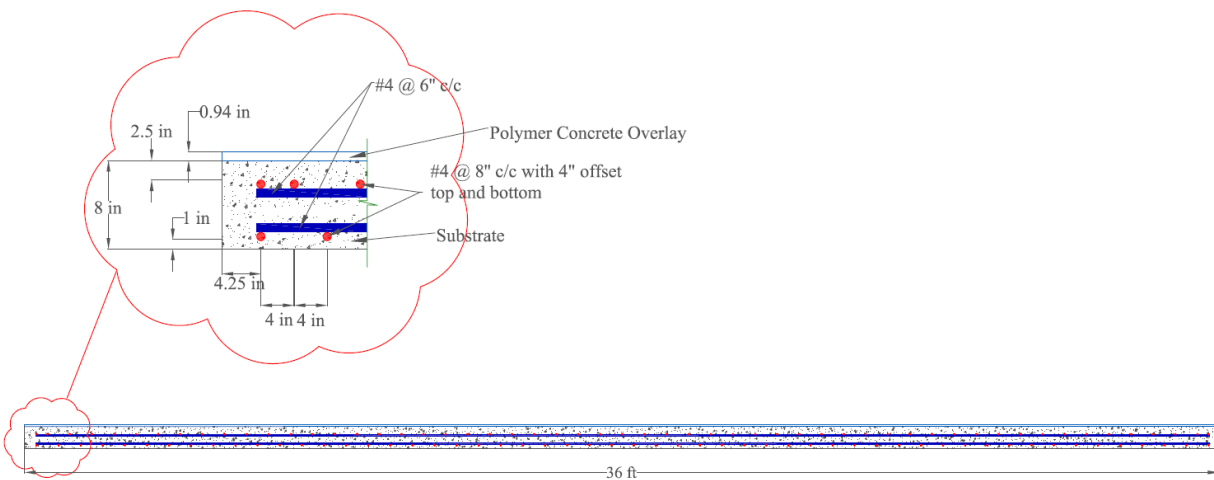
**Figure 3.3** Section A-A

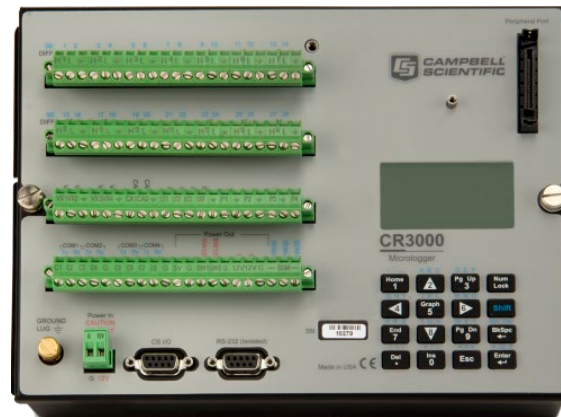
**Figure 3.7** CR3000 Data Acquisition System

Several data acquisition systems from Campbell Scientific Inc. (CR 1000, CR1000X and CR3000) were used to collect the temperatures over the test duration. The data acquisition frequency was set to 1s, thus meaning a temperature and heat flux was recorded from each thermocouple and heat flux sensor every second over the duration of the test. An example of a data acquisition system is shown in Figure 3.7.

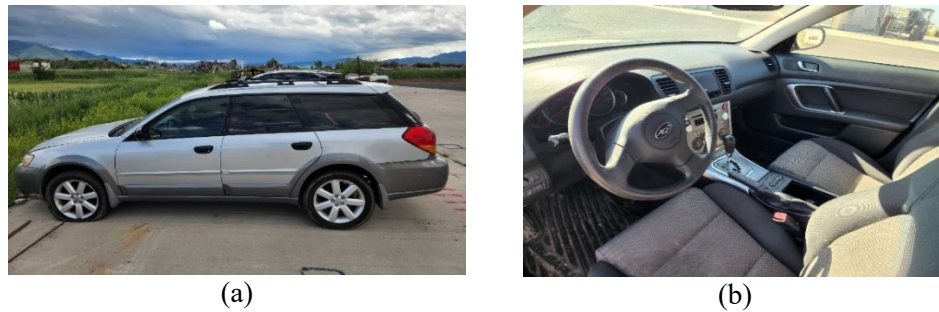
**Figure 4.1** 2007 Subaru outback (a) exterior appearance and (b) interior

The vehicle tested in the fire was a 2007 Subaru Outback, as shown in Figure 4.1. This is an all-wheel drive, gas powered four-cylinder vehicle. All the auto parts and interior decoration and components were kept intact before the experiment. The interior of the vehicle was made of fabric and fiberglass, and the fuel tank holds 15.9 gallons when full. The configuration parameters of the experimental vehicle are shown in Table 4.1. Figure 4.2 shows the placement of the vehicle on the slab.

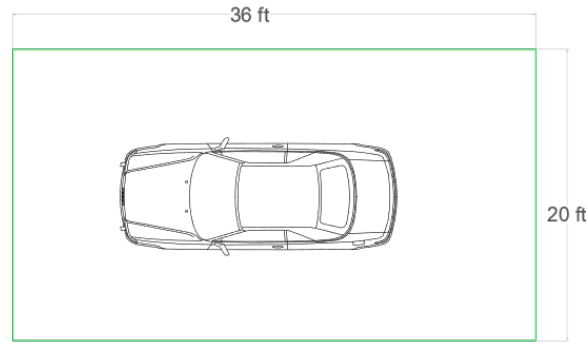
**Figure 4.2** Simplistic view of fire test for polymer concrete overlay over bridge deck

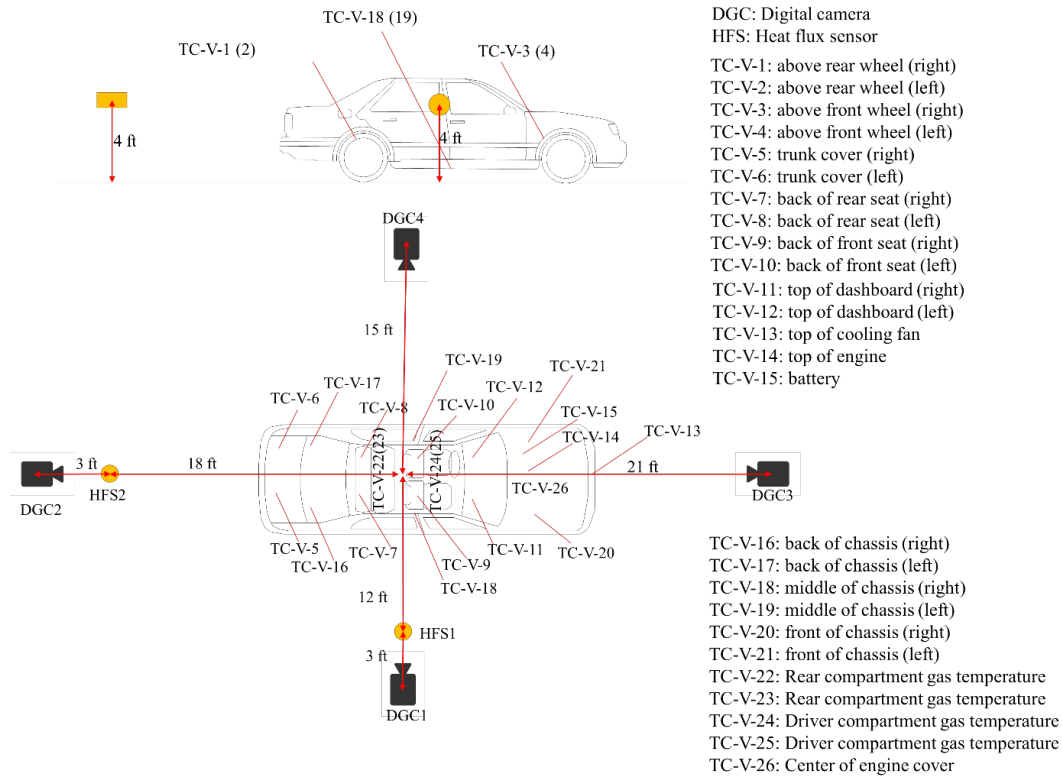
**Figure 4.4** Locations of thermocouples placed in and around the test vehicle

thermocouples were firmly fixed with high temperature resistant tape and aluminum foil tape to prolong the effectiveness of thermocouple temperature measurement during the vehicle fire. Some of the thermocouples were placed against surfaces to collect surface temperatures, while others were placed with the sensors hanging free to collect gas temperatures. Figure 4.4 shows the placement of thermocouples around the vehicle.

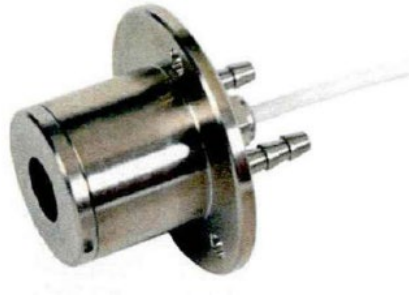
**Figure 4.5** MedTherm 64 series heat flow meter

Beyond temperatures, flame radiation is another important parameter to quantify the thermal harm of flame to the surrounding environment. Two heat flux meters were installed to measure the radiant heat flow at the back and on one side of the burning vehicle to quantify the heat radiation flux at these locations. These sensors were placed 12 feet from the center of the vehicle (around 9 ft from the edge) and 18 feet from the center (around 10 ft from the edge), at the side and rear, respectively, with both at a height of 4 feet from the panel surface, as shown in Figure 4.4. MedTherm 64 series water-cooled protection wide-angle heat flux sensors, with a range of  $10\text{kW/m}^2$ , were used in the test [74]. These Schmidt Boelter type sensors measure both radiant heat flow and convective heat flow. During the experiment, the heat flow meters were continuously water cooled to ensure the accuracy of measurements. Cooling the heat flux gauges with water helped to ensure that their surfaces remain close to the ambient temperatures, maximizing the convective heat transfer and minimizing radiative losses. The gauges' surfaces are also coated with high emissivity paint to maximize the absorbed radiation. Figure 4.5 shows an example of a heat flux sensor used, and Table 4.2 gives the parameters of the sensor.

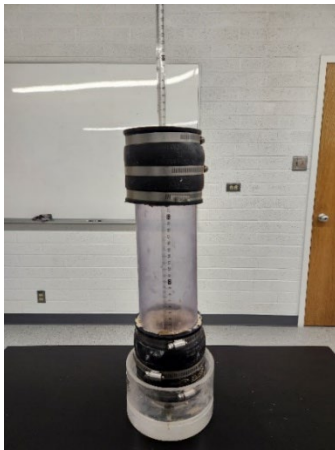
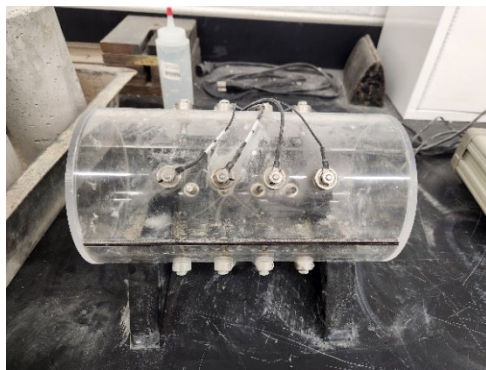
**Figure 5.1** Instruments and equipment used for the performance tests: a) British pendulum tester for skid resistance, b) Rebound hammer for surface hardness, c) FLIR T640 IR camera for delamination, d) Proceq Dyna Z16, e) Falling head setup for water penetration, f) Setup for abrasion resistance tests, g) Wenner probe array for resistance to chloride penetration tests

Figure 5.1 shows the instruments and equipment used for the different tests. To determine control values for the destructive test, 4-inch cores were collected from an extension made to the main slab, constructed to the same specifications and at the same time as the area to be tested. Other cores were also made in this area to test the strength of the PC overlay to substrate concrete bond before the vehicle fire. These control tests enabled a comparison of the test results before and after the fire and quantitatively determined the changes to the PC material due to exposure to high temperatures. The locations for the pre-fire tests and the drilled cores are as shown in Figure 5.2, and the number of tests for each experiment is shown in Table 5.1.

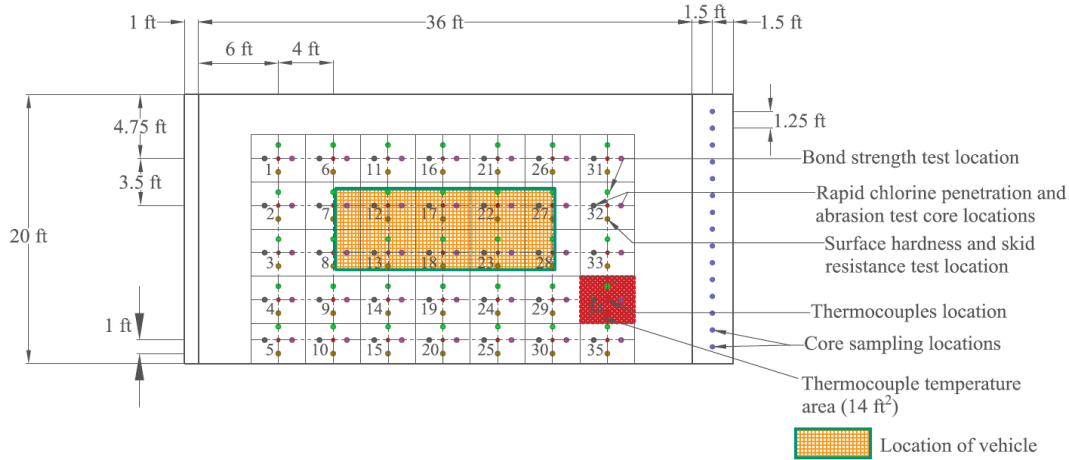
**Figure 5.2** Test sampling locations (units in ft)

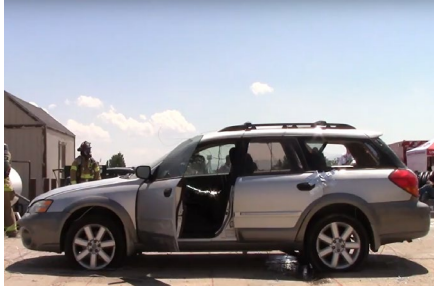
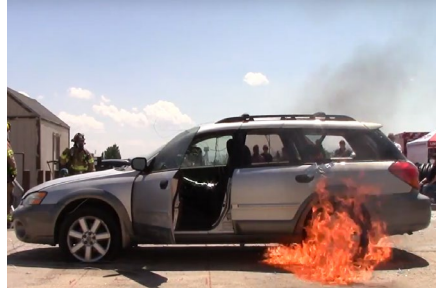
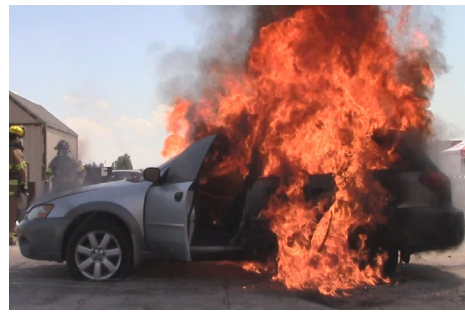
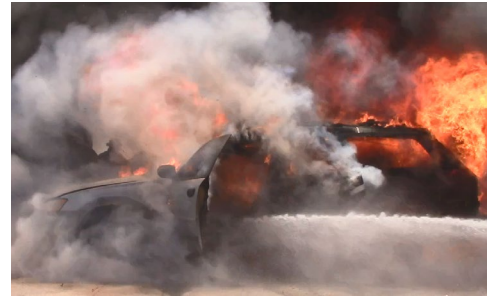
138	Small explosions due to the ignition of rear airbags.	225	Firefighters began to put out the fire

**Figure 6.1** Burning process of the vehicle fire

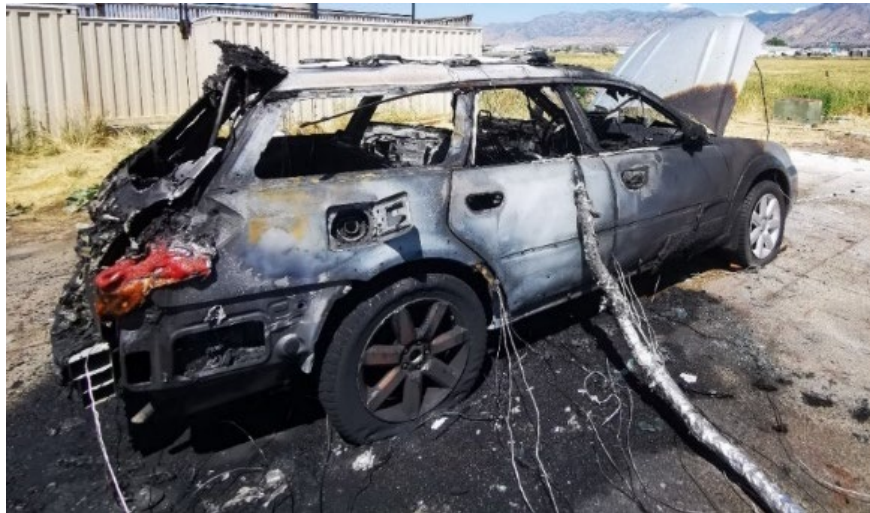
Figure 6.2 shows the burned vehicle after the test. Most of the vehicle sustained significant damage, but the front and engine compartment were relatively undamaged due to the intervention of firefighters to put out the fire. Later examination of temperature data shows that the temperatures within the engine compartment did not rise significantly. The short duration of the fire limits the possibility of extrapolating the results to longer lasting fires and the response of PC overlays exposed to such scenarios. Also, during the test, firefighters consistently used water hoses on surrounding infrastructure to keep them cool and prevent the spread of the fire beyond the panel. The water from the hoses could potentially have affected the vehicle fire.

**Figure 6.2** Burned vehicle

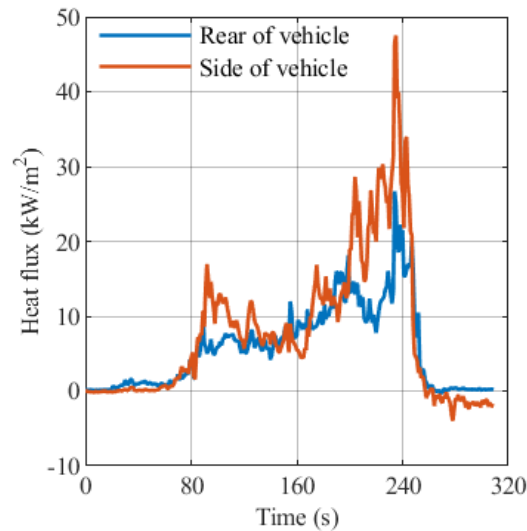
**Figure 6.3** Heat flux from vehicle during test with maximum heat fluxes recorded at 224 s and 225 s at the back and side of the vehicle, respectively

Similarly, the plot for the sensor at the rear of the vehicle shows a distinct peak of  $18.1 \text{ kW/m}^2$  at 199 seconds. This peak occurred shortly after flames fully engulfed the exterior leading to heightened heat transfer to surrounding areas. A second distinct peak of  $26.7 \text{ kW/m}^2$  at 224 seconds occurred just after the jet flame from the gas tank ignition. The maximum heat flux recorded by the heat flux sensor placed at the back of the vehicle was just over half of that recorded by the sensor at the side. This can be attributed to multiple factors, including the shorter distance between the side heat flux sensor and the vehicle's edge, the sensor's proximity to the fuel tank, and the potential influence of wind direction. Overall, these peak incidental heat flux measurements fall in line with what has been observed in other vehicle fire tests [58, 77, 78], and offer a glimpse into the potential adverse effect of vehicle fires on surrounding infrastructure.

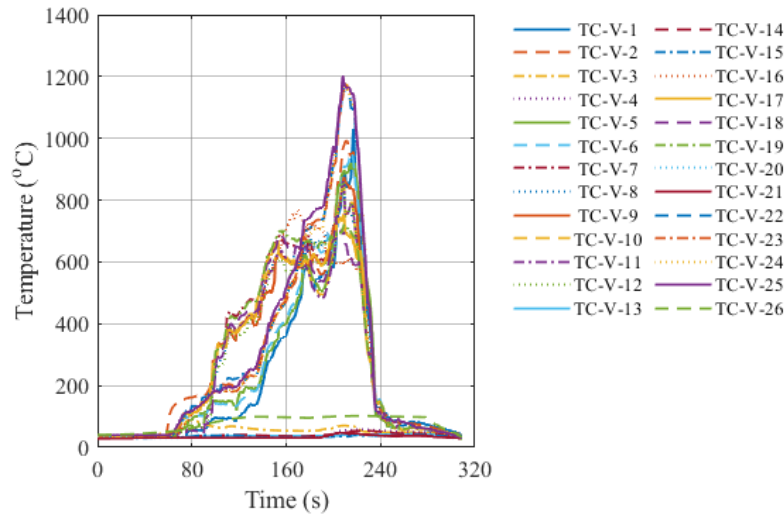
**Figure 6.4** Temperature evolution at different locations inside the vehicle

Figure 6.4 shows the temperature history of different locations inside the vehicle. Two distinct patterns can be seen in the temperature evolution over the test period. First, the area of the vehicle, between the dashboard and the trunk, shows a steady increase in temperatures as the fire spread and burned through the interior of the vehicle. These areas were significantly damaged as the fire progressed toward the front of the vehicle. On the other hand, the regions surrounding the vehicle engine showed minimal temperature increases, as these areas were farthest from the point of ignition and were not ignited before the fire was extinguished. The highest temperatures recorded were gas temperatures in the interior of the vehicle, which peaked at around  $1,200^\circ\text{C}$ , while the lowest peak temperature was just over  $40^\circ\text{C}$  at the top of the battery in the engine compartment. Moreover, at some locations such as the chassis that was close to the panel, the temperatures peaked and evened out at about 160 seconds into the test and remained relatively steady until the fire was put out; while at other locations such as the interior spaces, temperatures continued to rise, peaking out when the jet flame from the gas tank occurred.

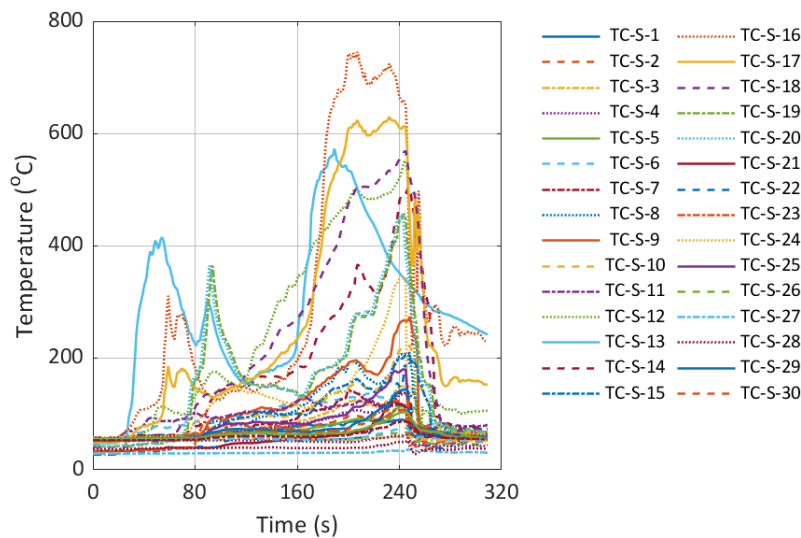
**Figure 6.6** Temperature evolution at surface of overlay over time of the vehicle fire test

from the vehicle recorded much lower temperatures. Generally, areas within a few feet of the vehicle in all directions recorded significant temperature rise, indicating exposure to high levels of heat from the fire. For areas that experienced significant temperature rise, two peaks in temperature were recorded. The first peak, predominantly observed within the initial 100 seconds, is linked to the ignition of the leaked gasoline and the burning of falling plastic on the panel. This initial combustion ceased when the fuel load on the panel was exhausted, indicated by a marked decrease in temperature. However, temperatures soon began to escalate once more as the fire proliferated throughout the vehicle and more melting plastic dropped onto the panel. This exposed additional surface areas to more severe fire exposure (including direct flame contact), resulting in heightened temperatures. The second peaks observed between 189 seconds and 247 seconds for different thermocouples can be attributed to the fire engulfing the vehicle, causing more plastic debris to fall onto the panel and burn directly on the surface. This is also accompanied by a jet flame from the gas tank around 213 seconds. Even after the onset of firefighting efforts, certain peaks were observed because the process of extinguishing a fire is not instantaneous. Figure 6.7 provides a visual representation of the distribution of the maximum temperatures at the surface. Significant temperature increases were recorded in a small area around the location of the vehicle.

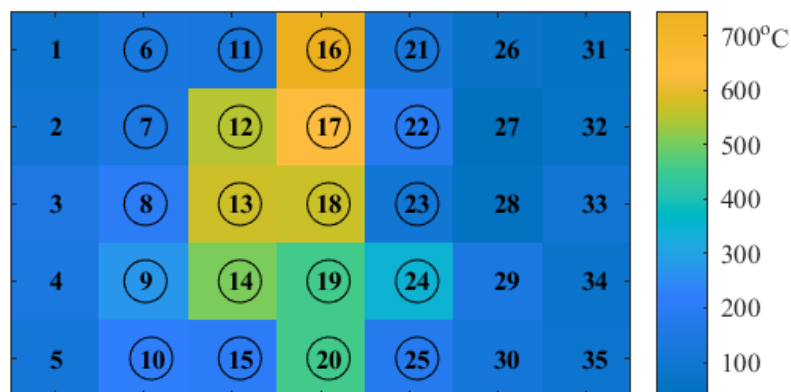
**Figure 6.7** Maximum recorded temperature at different locations over the surface (circles shows the locations for post-fire test sampling)

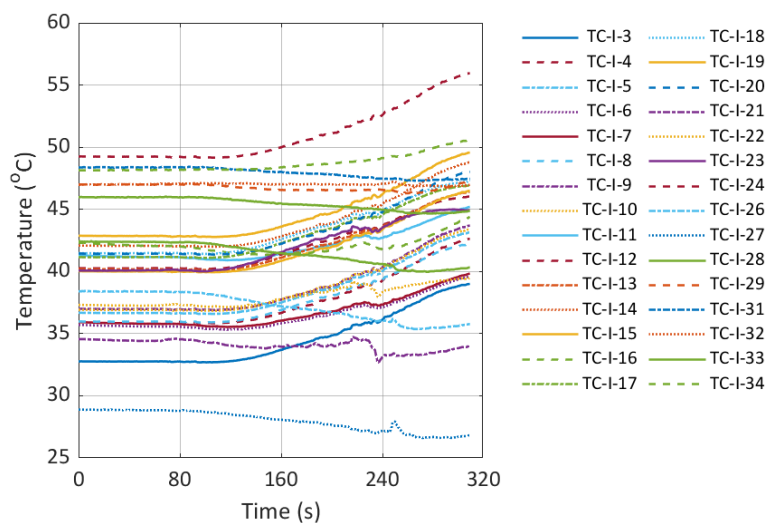
**Figure 6.8** Temperature evolution at interface between overlay and concrete during the vehicle fire test

Figure 6.8 shows the temperature evolution at the interface between the PC overlay and substrate concrete, while Figure 6.9 shows the maximum temperature recorded at the interface across different locations. The interface temperature barely rises despite the exposure of the surface to elevated temperatures. It began to rise just as the test ended, indicating that the heat was starting to transfer through the overlay and onto the substrate concrete. These results suggest that PC overlays offer some thermal protection to structural concrete in highways and bridge decks at high temperatures by slowing down the transfer of damaging heat to the concrete.

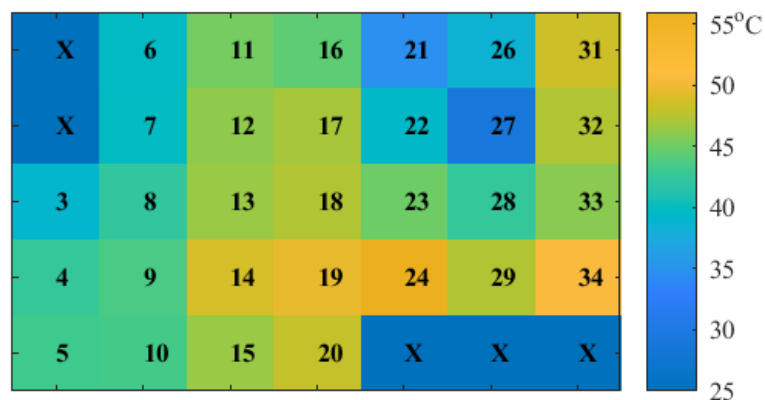
**Figure 6.9** Maximum recorded embedded temperature distribution (X's indicating locations where no thermocouple was installed)

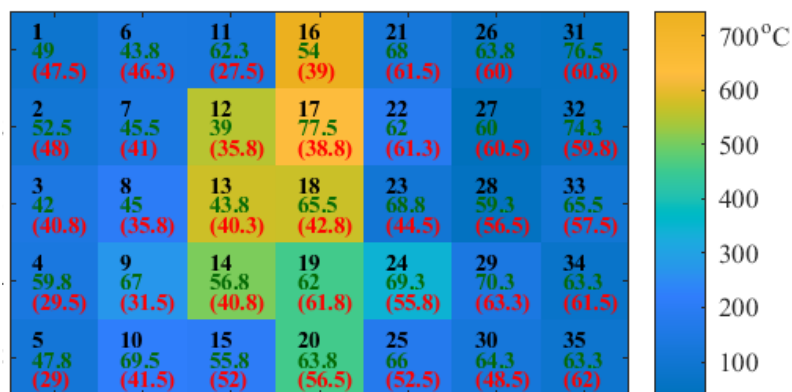
**Figure 7.1** Pre-fire and post-fire skid resistance results (green values are pre-fire skid resistance and red values are post-fire skid resistance)

The non-destructive nature of the skid resistance test allowed it to be repeated in the same locations before and after the vehicle fire. Skid resistance of a surface is determined as the average of measurements taken at different locations over a surface. Figure 7.1 presents the BPN at each test location before and after the fire. The colors on the figure represent the maximum temperatures recorded at each location during the fire. The numbers in each location are the location index, the pre-fire BPN (in green), and the post-fire BPN (in red and brackets). The results presented in Figure 7.1 demonstrate the negative impact of fire on the skid resistance of the PC overlay. Prior to the vehicle fire test, the average skid resistance recorded as BPN at all 35 locations over the surface was 59.89. This value dropped to 48.32 after the vehicle fire test, representing a 19% reduction in the skid resistance. Comparatively, for areas registering high maximum surface temperatures (represented by the areas selected for post-fire testing and circled in Figure 6.7), the skid resistance dropped from a pre-fire average of 59.25 to a post-fire value of 45.3, representing a 24% decrease. Although the average BPN over the surface still exceeds the nominally acceptable value of 45, the notable drop from its pre-fire value is indicative of the negative effect of the fire on the skid resistance of the PC overlay.

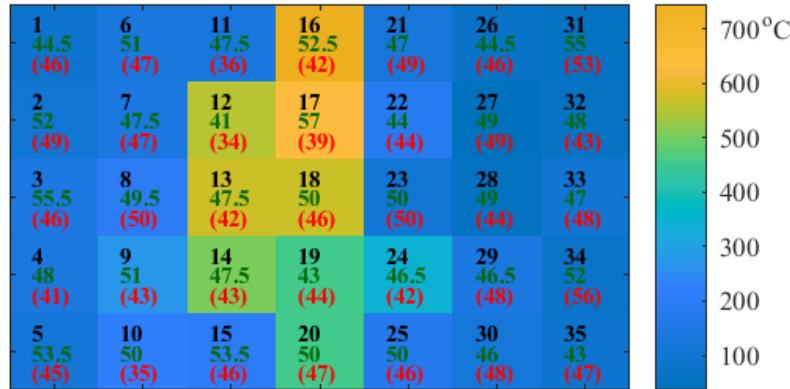
**Figure 7.2** Pre-fire and post-fire surface hardness results (green values are pre-fire surface hardness and red values are post-fire surface hardness)

Similar to the skid resistance test, the surface hardness tests were carried out on the same locations prior to and after the vehicle fire test. Figure 7.2 presents the results of these non-destructive tests at the specific locations where they were conducted both before and after the vehicle fire. The figure includes a thermal map of the surface with the maximum recorded temperature at each location, the location indices, and results (pre-fire results are in green and post-fire results are in red and brackets) for the surface hardness tests. A decline in the surface hardness due to the fire exposure can be observed across the surface. Over the entire surface, this resulted in an average drop in hardness from 48.8 to 45.7, representing an 8% decrease. Within the areas exposed to very high temperatures from the vehicle fire (between locations #6 and #25, as indicated in Figure 6.7), this change was more pronounced with the surface hardness reducing from 48.8 to 43.6 after the vehicle fire, representing an 11% drop in surface hardness.

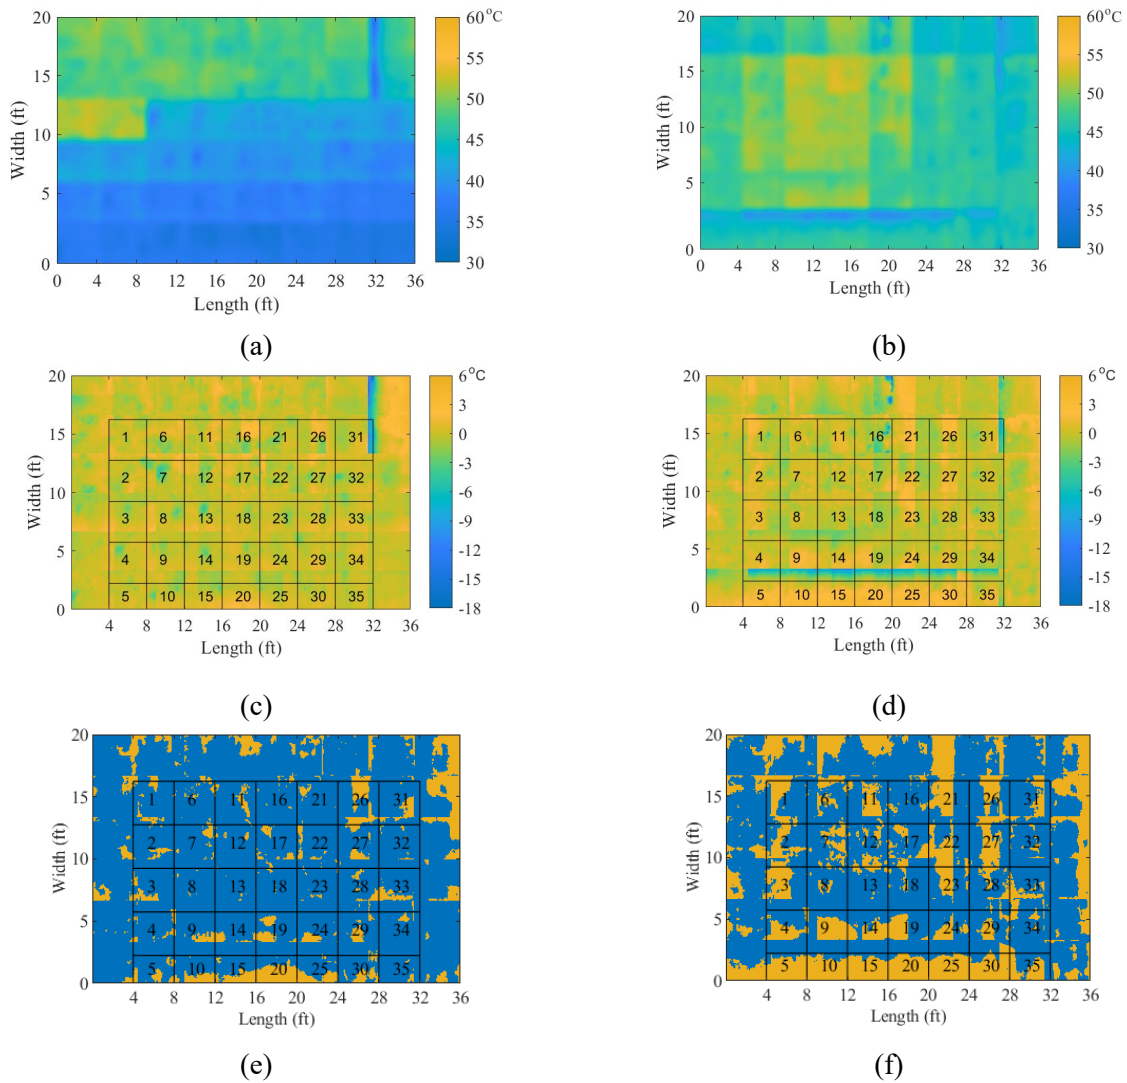
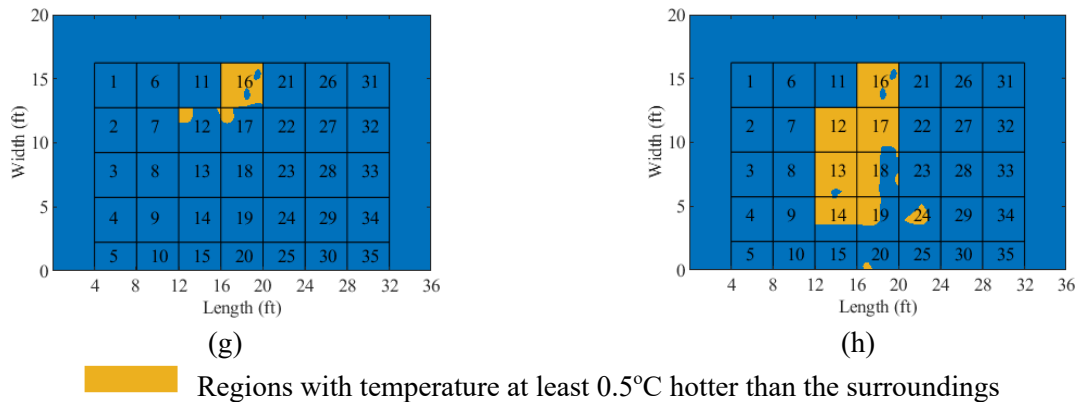
**Figure 7.3** Panel surface a) thermal map before fire exposure, b) thermal map after fire exposure, c) thermal map before fire test with average temperatures subtracted, d) thermal map after fire test with average temperature subtracted, e) hot spots before fire exposure identified within each sub image, f) hot spots after fire exposure identified within each sub image, (g) hot spots before fire exposure identified by comparing hot areas with cool areas, (h) hot spots after fire exposure identified by comparing hot areas with cool areas.

Although the described processing steps helped mitigate the effect of environmental variations, they did not entirely eliminate these effects. Ideally, alternative methods such as using UAVs to capture thermal images of the entire panel in a single thermal image could further mitigate this issue, reducing the impact of environmental changes, and ensuring that the temperature differentials obtained are more reliable for assessing delamination.

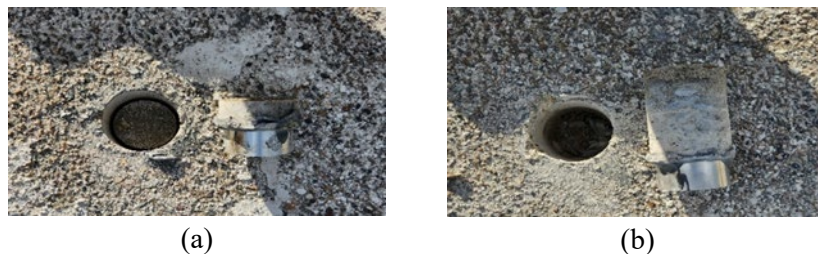
**Figure 7.4** Failure modes recorded during bond strength tests a) bond failure and b) failure in substrate

To determine the nominal bond/tensile strength of the PC overlay to the concrete substrate, five tests were carried out at the added-on section of the slab. Failures that occur in the substrate concrete are recorded as tensile strengths, while those that occur in the bond between both materials are recorded as bond strength. The resulting strengths from these tests range from 298 psi to 327 psi. The resulting average strength of the samples was computed as 312.7 psi. Four of the tests resulted in failure in the substrate concrete and one resulted in failure in the bond between the overlay and the substrate concrete. This indicates that the bond strength of the overlay exceeds the tensile strength of the underlying concrete. Figure 7.4 provides examples of the two different failure modes as they occurred at different areas of the surface. After the vehicle fire, similar tests were carried out around the locations marked out in Figure 6.7, and the failure modes recorded for these tests are shown in Figure 7.5. In the figure, the colors represent the maximum temperatures recorded during the test, and the circled numbers indicate areas where the failure mode was bond failure. It is evident that bond failure prevailed in the tested regions of the panel, rather than concrete breakout, which differs from the findings of the pre-fire tests. The increased observed bond failures indicate a clear reduction in bond strength due to heat exposure. Notably, these areas experiencing bond failure align with the regions exposed to the highest temperatures during the vehicle fire test.

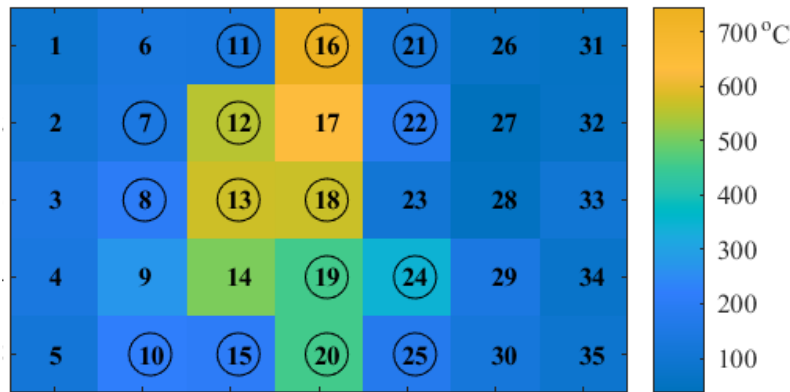
**Figure 7.5** Failure mode in bond strength test (colors represent the maximum recorded temperatures, and the circles around numbers represent locations with bond failure).

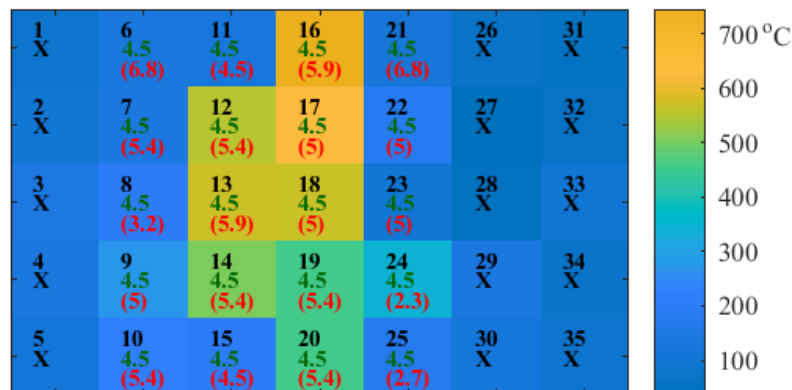
**Figure 7.7** Pre-fire and post-fire abrasion resistance results. The change in weights overlaid on the surface temperature map (green values are pre-fire weight changes and red values are post-fire weight changes. “X” indicates areas where no cores were taken) (units are grams).

The abrasion resistance of a sample is determined by measuring the amount of material removed using rotating cutters. This is done by comparing the weight of the sample before and after running the cutters on its surface. For the pre-fire tests, five core samples were tested, and the average weight loss of the samples was computed. This average value is considered as the expected weight loss for the PC surface and describes its abrasion resistance. After the vehicle fire, a core sample was collected from each location marked in Figure 6.7 and tested. The results of the abrasion resistance tests, including both the pre-fire average value and the post-fire location-specific values, are presented in Figure 7.7. Each location on the figure includes a location index number, the average change in weight of core samples prior to the vehicle fires (in green), and the change in weight of the sample collected at the location after the vehicle fire (in red and brackets). The background color of each area represents the maximum temperature recorded in the area. The weight loss after abrasion testing was found to be greater in the samples that were exposed to the vehicle fire compared with the pre-fire average (4.5g weight loss for samples before the vehicle fire compared with 5g weight loss after the fire, representing an average of 11% increase in weight loss). This suggests a reduction in the abrasion resistance of the overlay. This decrease in abrasion resistance can be attributed to thermal degradation of the polymer matrix, resulting in a reduction of mechanical properties and increased susceptibility to wear and tear. This could lead to a reduction in the service life of the overlay and the need for regular maintenance and repair.

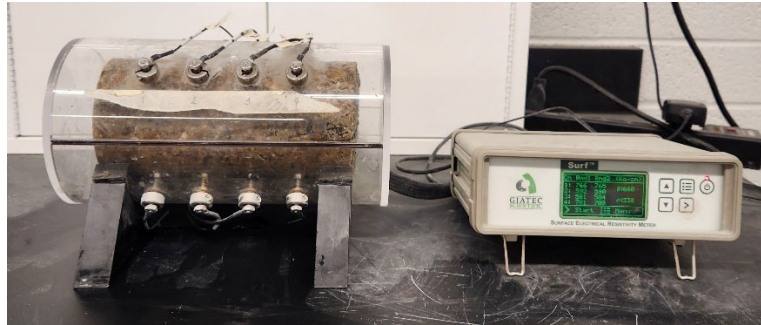
**Figure 7.8** Sample in the Wenner probe setup to test for resistivity to chloride penetration

Using the Wenner probe, the resistivities of six specimens were determined before and after exposure to elevated temperatures. After collecting the resistivities of the specimens, they were exposed to two different temperatures (300°C and 500°C) using heating rates replicative of the heating rates from the vehicle fire tests. Limitations of the equipment used meant that it was not possible to get the specimens heated to the maximum temperatures achieved in the actual vehicle fire tests. However, the use of similar heating rates and the attainment of high temperatures far exceeding the gas transition temperature of PC mean that the tests should adequately characterize the behavior of PC overlays on exposure to a vehicle fire. Figure 7.8 shows a sample in the test setup.

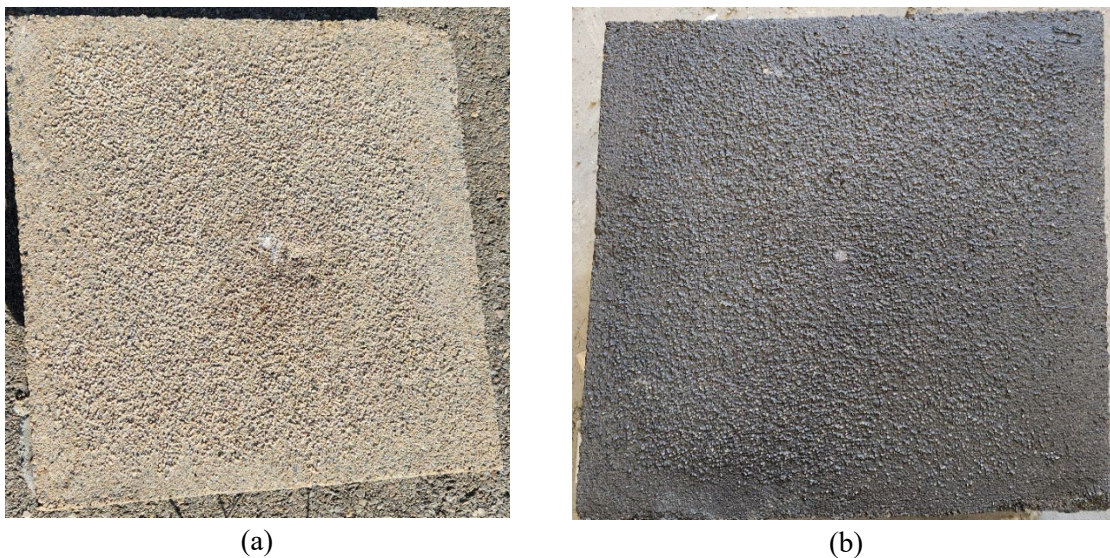
**Figure 8.1** Test slabs a) control slab without intumescent layer and b) slab with intumescent layer applied

Twelve small slabs (each measuring 2 ft x 2 ft x 8 in) were cast and overlaid with PC in a manner similar to the large slab tested in the vehicle fire. In testing these slabs for improving the fire resistance, four were reserved to obtain cores without exposure to the fires for use in tests that require a process that does not involve heating the entire panels. Two of these four panels were overlaid with the intumescent layer and two were not and as such served as the control slabs. The remaining eight were earmarked for testing under elevated temperatures (four plain and four with the intumescent coating), with four tested using each of the exposure temperatures. Figure 8.1 shows the panels with and without the intumescent layers, respectively.

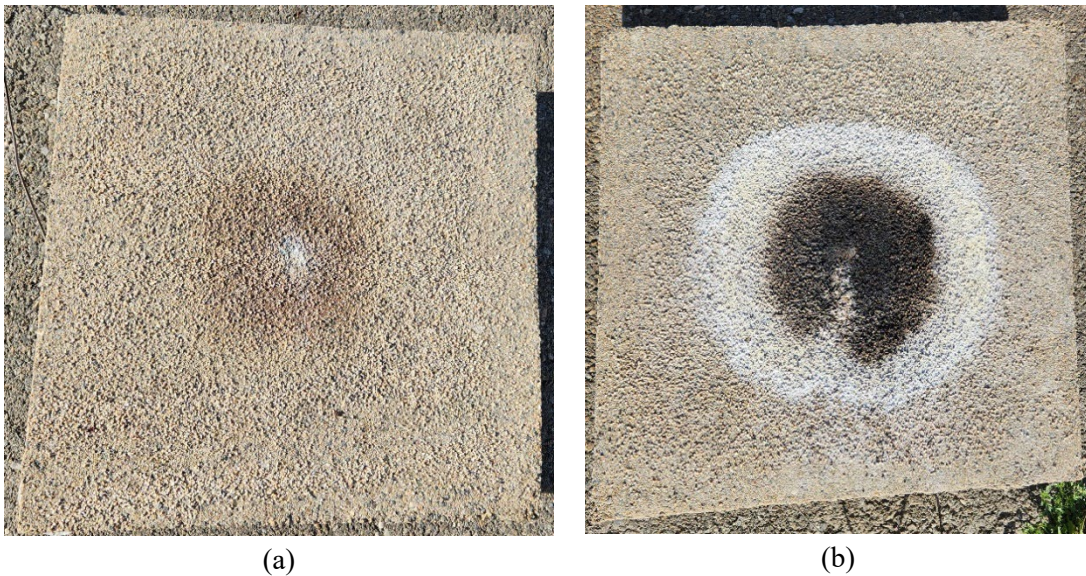
**Figure 8.2** Control slabs after exposure to temperatures of a) 300°C and b) 500°C

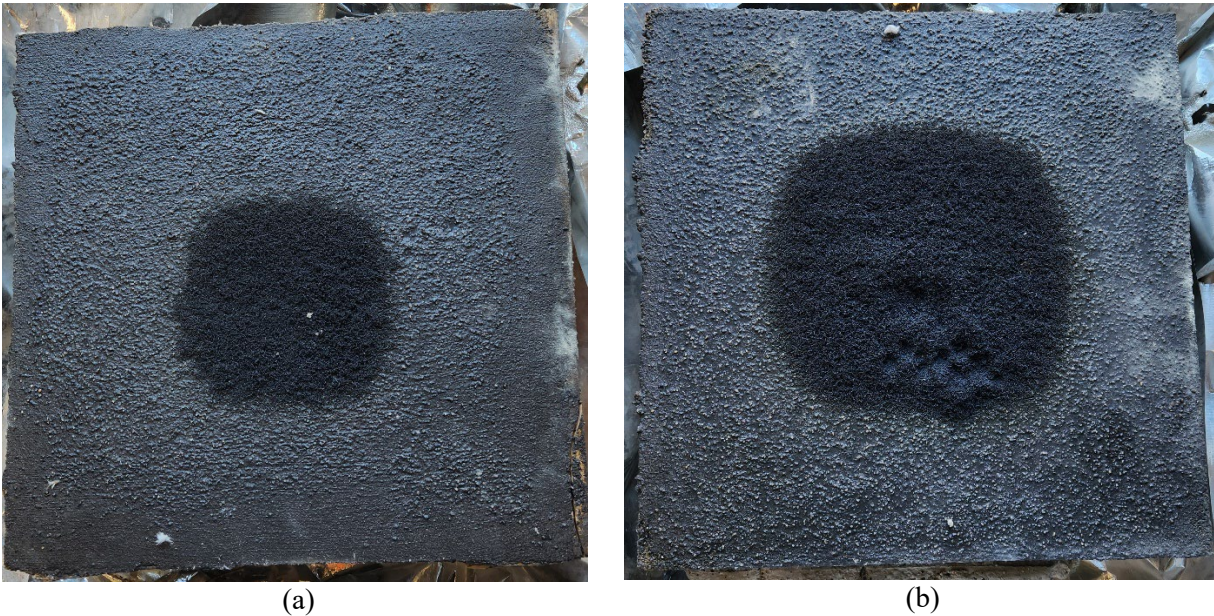
**Figure 8.3** Coated slabs after exposure to temperatures of a) 300°C and b) 500°C
