**MPC 24-536** | S. Ni, A. Sorensen, I. Unobe and A. Pokhrel

## IMPACT OF VEHICLE FIRES ON POLYMER CONCRETE BRIDGE DECK OVERLAYS

# **Impact of Vehicle Fires on Polymer Concrete Bridge Deck Overlays**

July 2024

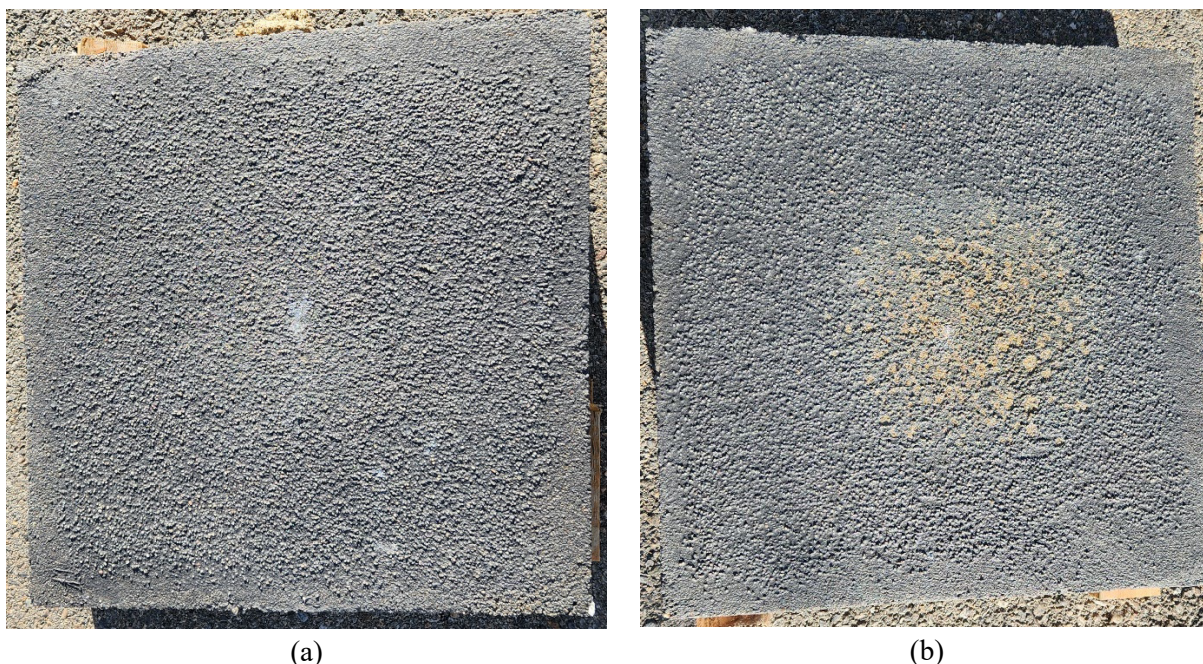
**Figure 8.4** Coated slabs without reacted coating after exposure to temperatures of a) 300°C and b) 500°C

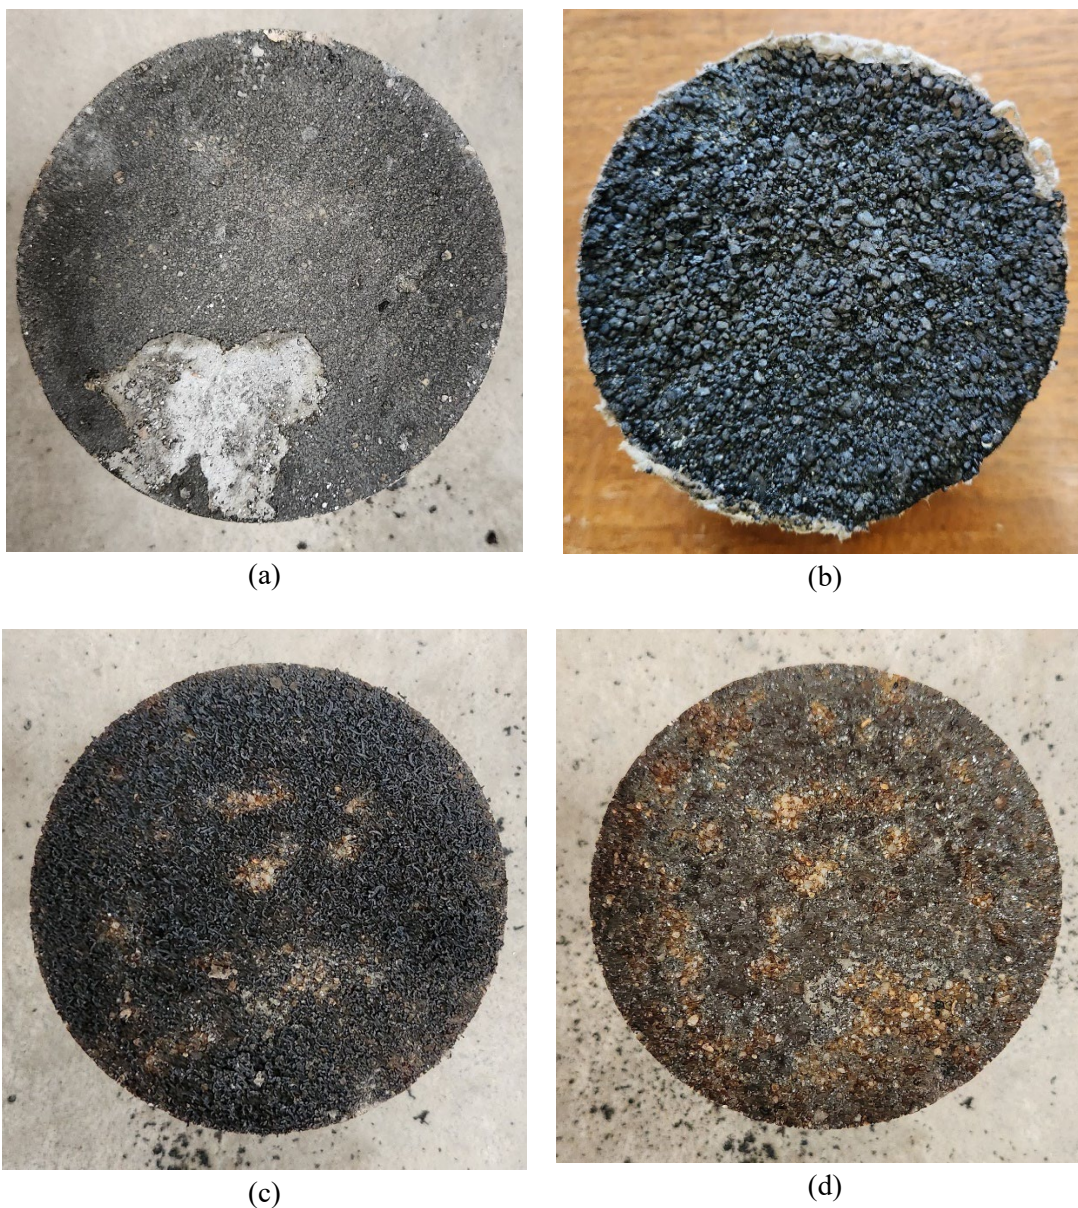
**Figure 8.5** Core samples for water penetration a) control sample after exposure to 300°C, b) control sample after exposure to 500°C, c) coated sample after exposure to 300°C, and d) coated sample after exposure to 500°C.

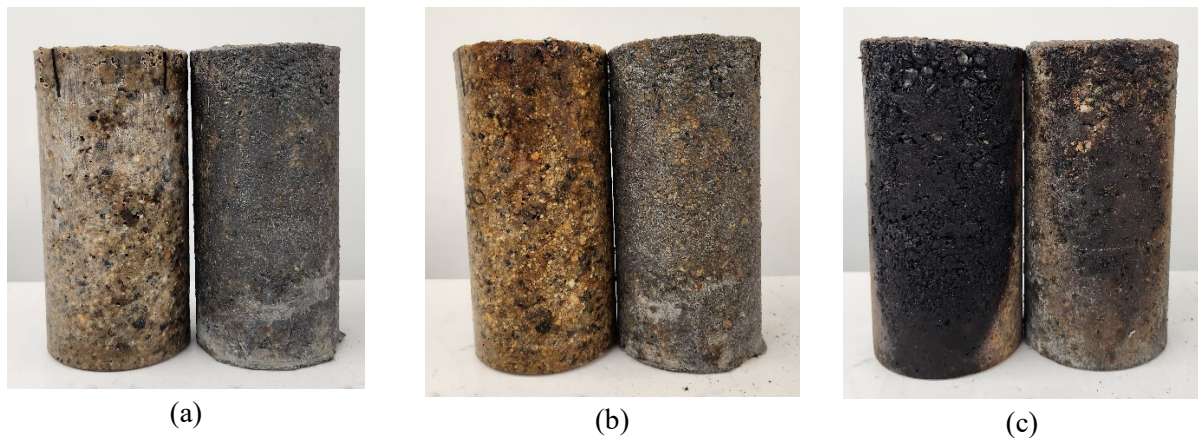
**Figure 8.6** Control and coated cylindrical specimens for RCPT a) prior to testing, b) after exposure to 300°C, and c) after exposure to 500°C

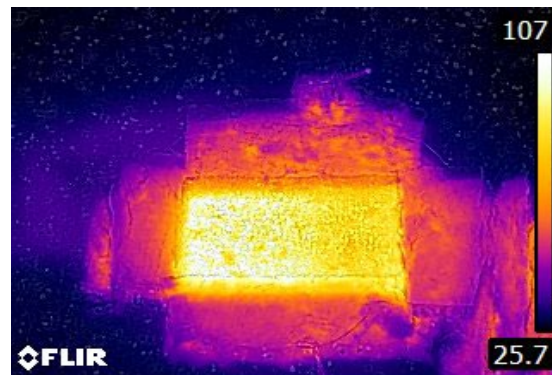
**Figure 11.2** Thermal MSX image of sample after removing from oven
