Michigan Tech Research Institute

Deliverable 7-B: Performance Evaluation of Recommended Remote Sensing Systems in Unpaved Road Type Condition Characterization

Characterization of Unpaved Road Condition Through the Use of Remote Sensing Project

November 26, 2013

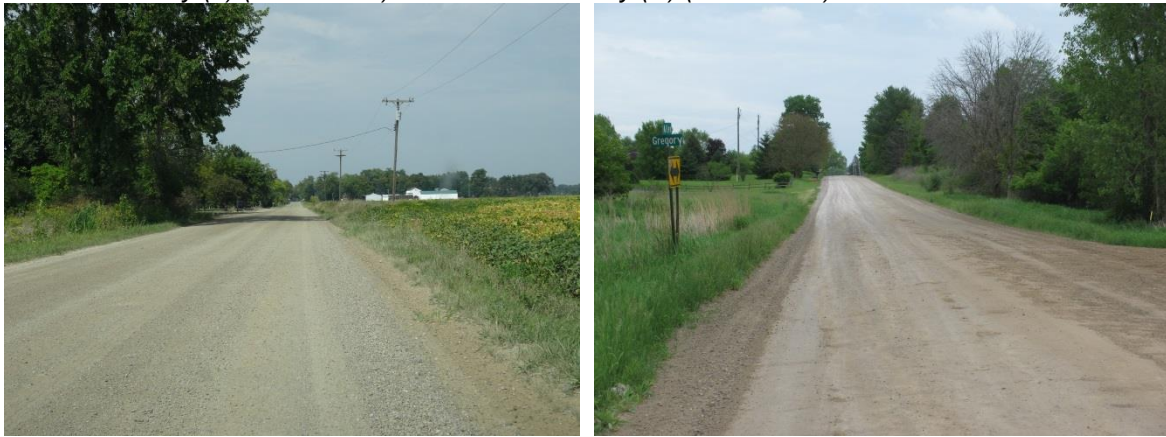
DSC00684 Macomb County (L) DSC_4855 Livingston County (R)

Figure 2: Sample road conditions and landscapes in several counties within SEMCOG.

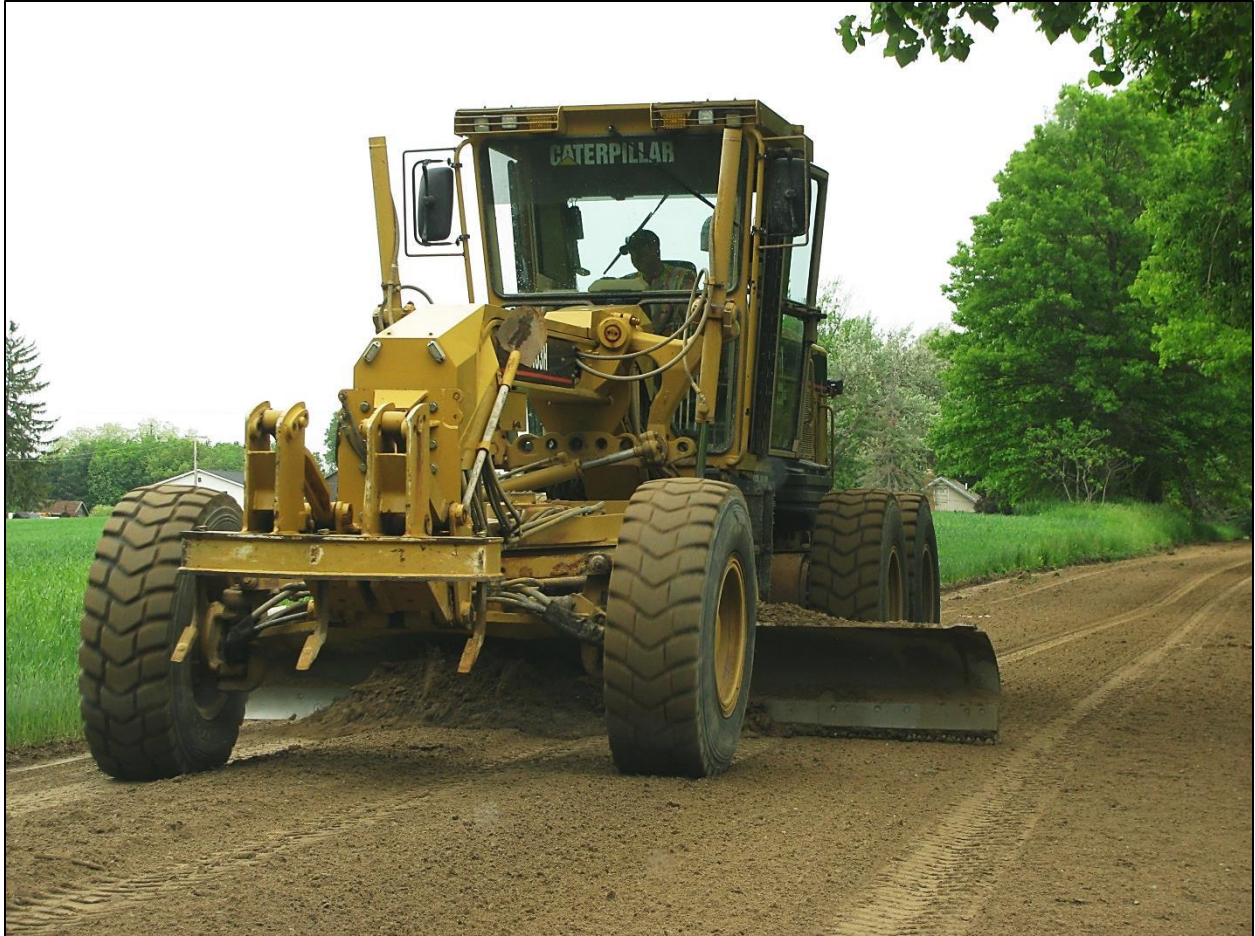
Figure 3: A road grader working on a rural road in Livingston County, MI, as seen by data collection team while looking for distressed unpaved roads.

A challenge faced by the field team was staying ahead of graders once suitably distressed unpaved roads were located (see Figure 3). Often, the grader would pass over distressed unpaved roads between the time the field team identified the distresses and when the data collection team could get out to the site. This delay may have been only a day or two, but graders beat the data collection team to the distressed unpaved roads several times.

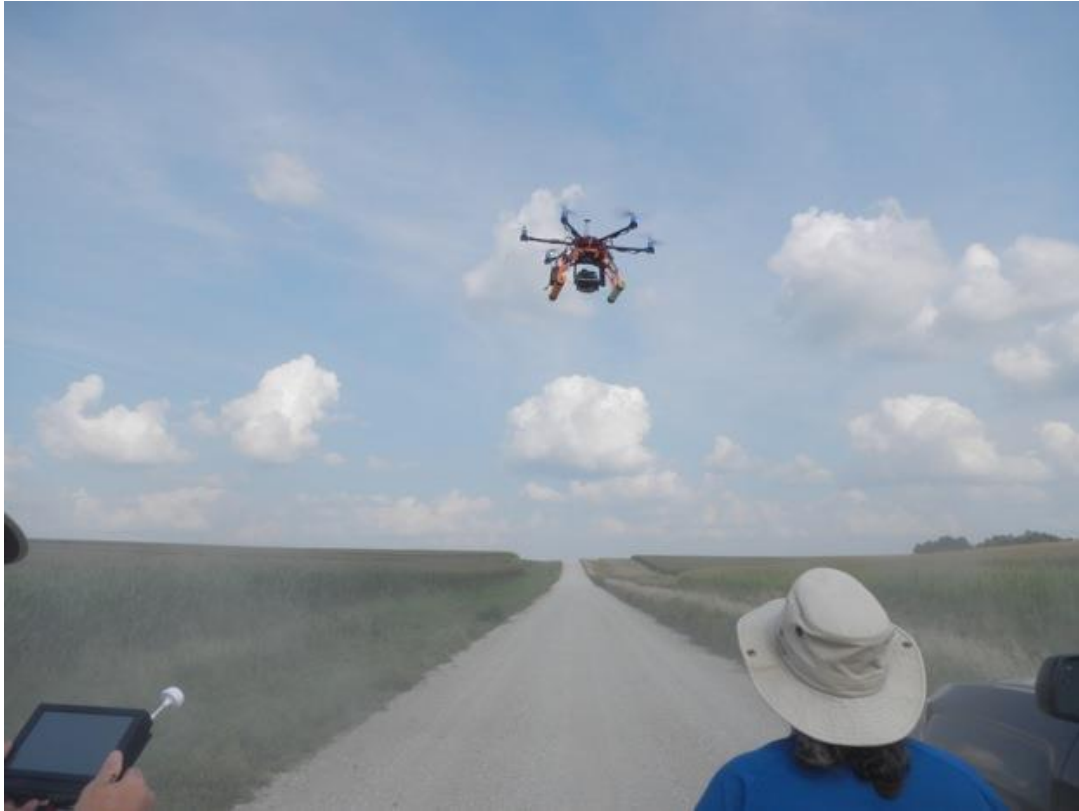
Figure 4: Overflight of an Iowa road, also assessed for condition.

In addition, there were two collections of opportunity in Iowa and one in Nebraska, made in late August 2013 (Figure 4). The purpose of this collection was to verify that roads maintained in other states, using potentially different materials and methods, could be characterized with the same processing suite as Michigan roads. These sites were chosen from reviews of Google Earth imagery, within several miles of I-80, to minimize transit time to the site. All three sites were judged to be undamaged, and typical of the surrounding rural roads. Examination of the results indicated that there were no problems in assessing road conditions on these other types of roads.

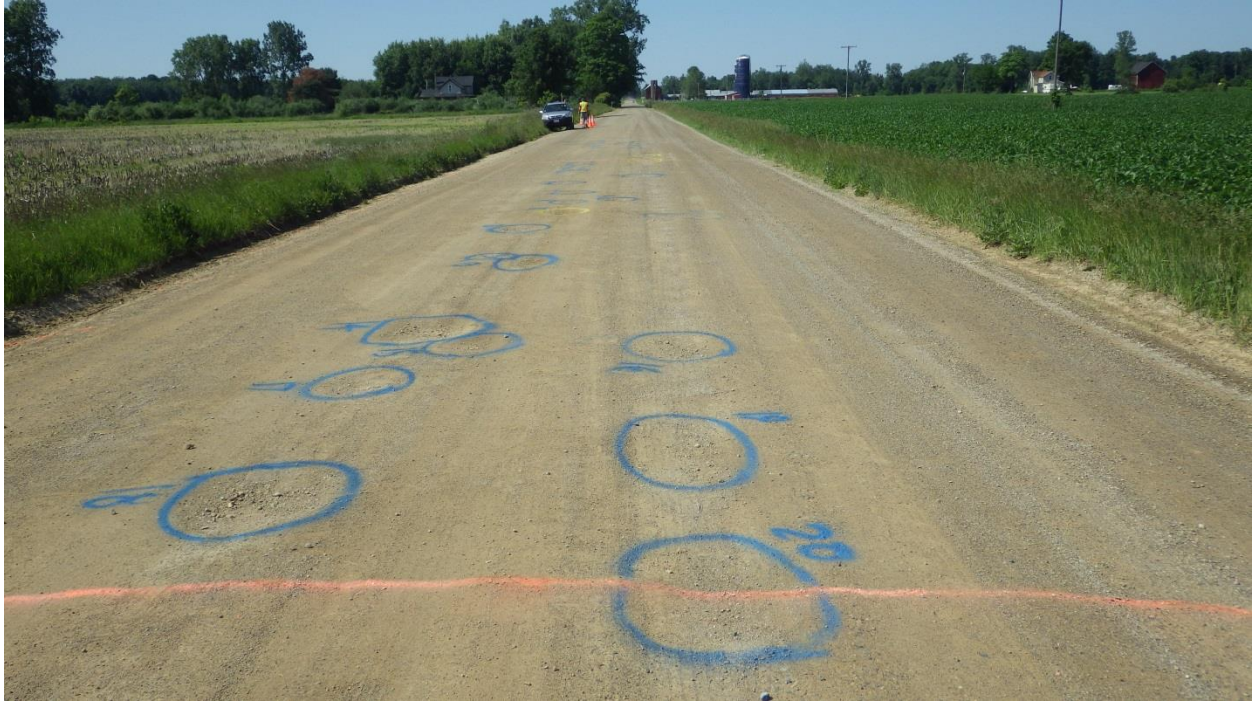
Figure 8: Fleming Road segment 2 looking north. Distresses have been marked, measured, mapped and numbered prior to overflight. This image correlates to the south end of the distress map above.

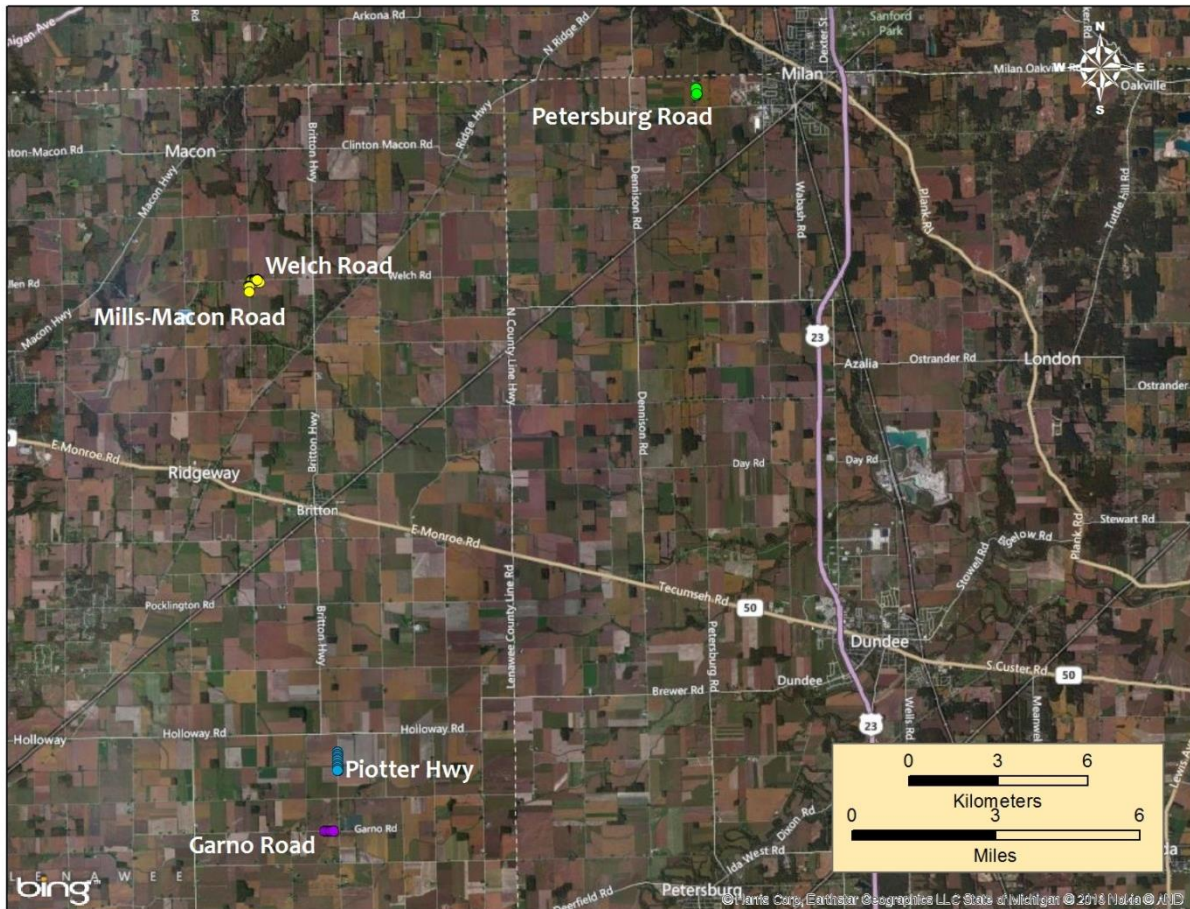
Figure 11: Focus map of the 2012 unpaved roads project field study sites.

Figure 11 shows the five main locations evaluated during the project's initial 2012 field season: Petersburg Road, Welch Road, Mills-Macon Road, Piotter Highway, and Garno Road (see Figure 1 for their context in the rest of southeastern Michigan). Descriptions of each of the evaluated sites follow.

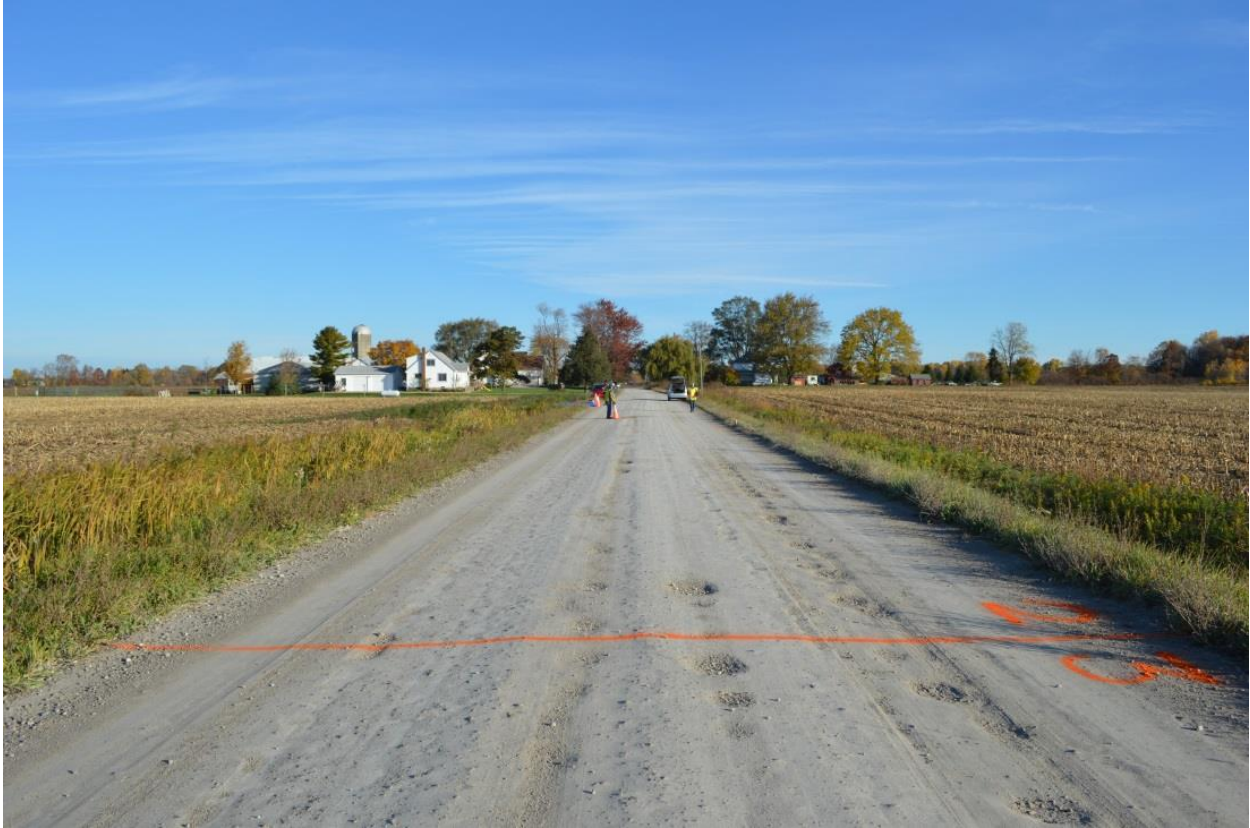
Figure 12: Petersburg Road near Milan MI looking north. Note visible distresses (potholes).

The road was broken down into 100 foot / 30.5 meter segments and the segments were marked with fluorescent orange marking paint (Figure 12). The URCI method is based on taking one or two 100 foot samples to represent approximately a one mile stretch of road (Department of the Army 1995). The road width was measured and recorded, then distresses were measured and values recorded (Figure 13). While the road was marked and measured, the Bergen Tazer 800 helicopter was prepared and programmed for flight. When the helicopter was ready, the road was briefly closed for safety and to keep vehicles from passing under the helicopter during a data collection.

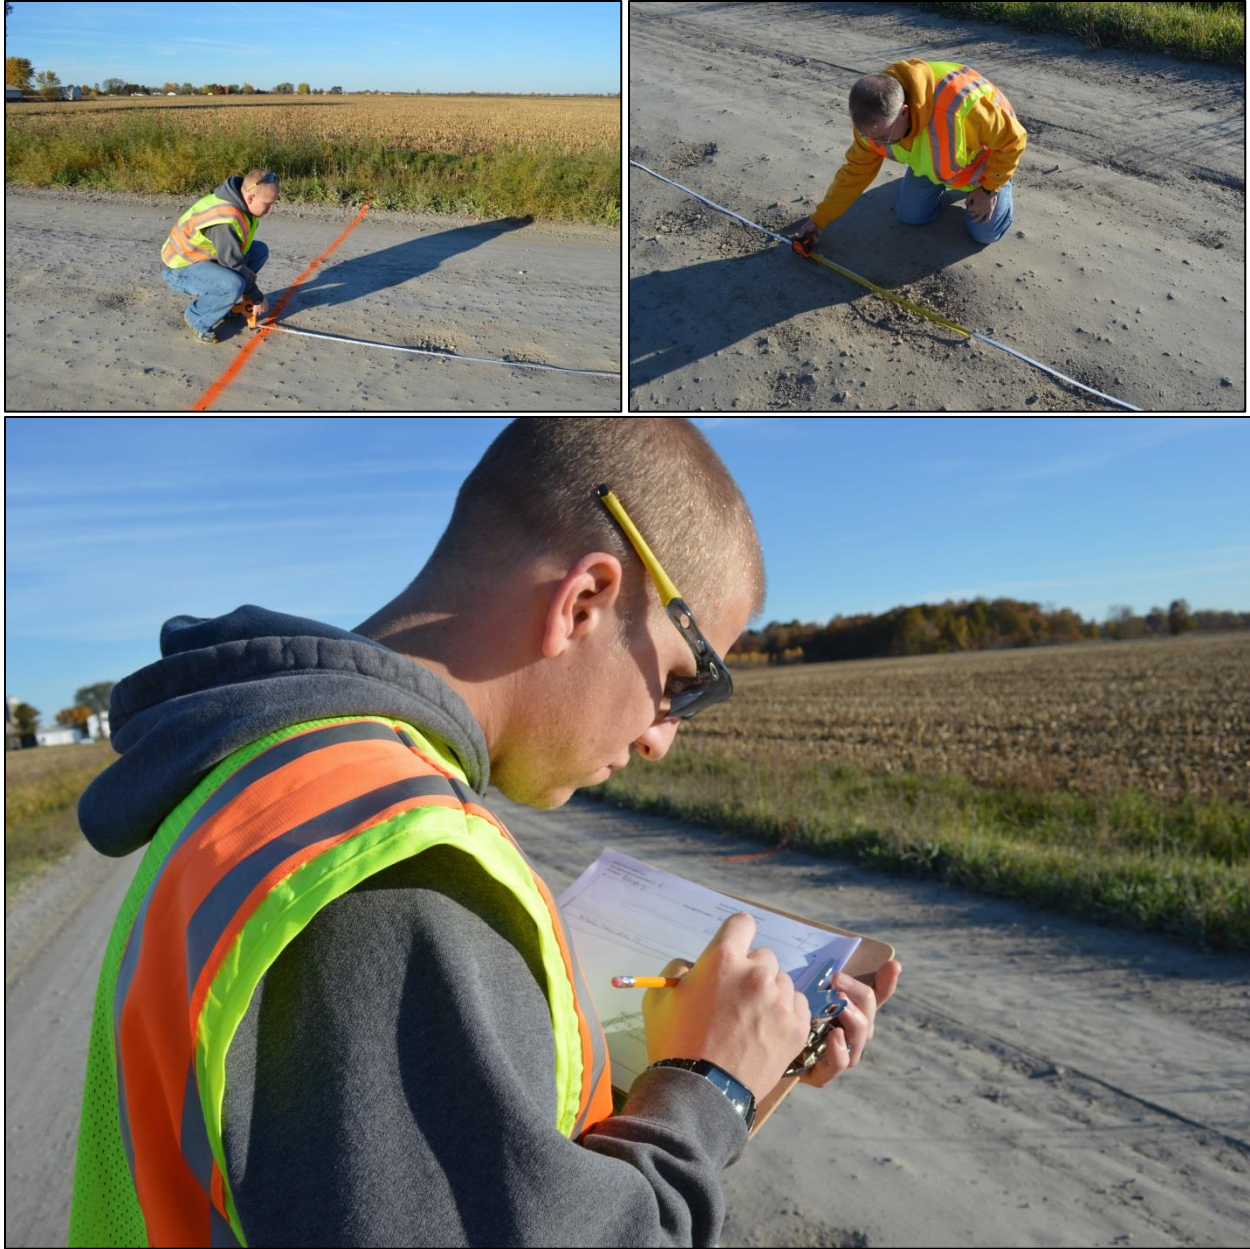
Figure 13: Location and attribute data about distresses found in each road segment were measured and recorded for comparison to image processing results. (three photos above): (DSC1285, DSC1295, DSC1297)

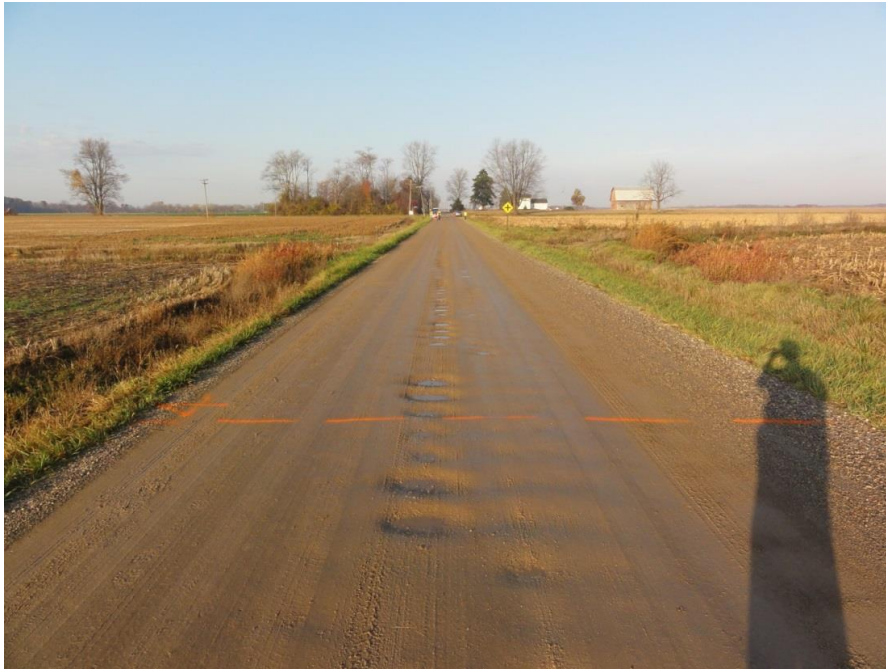
Figure 14: Welch Road (facing west) near Mills-Macon Road, Lenawee County, MI. Road segmentation marks, potholes, washboarding (corrugation) and float aggregate are visible in this image. (DSC03546)

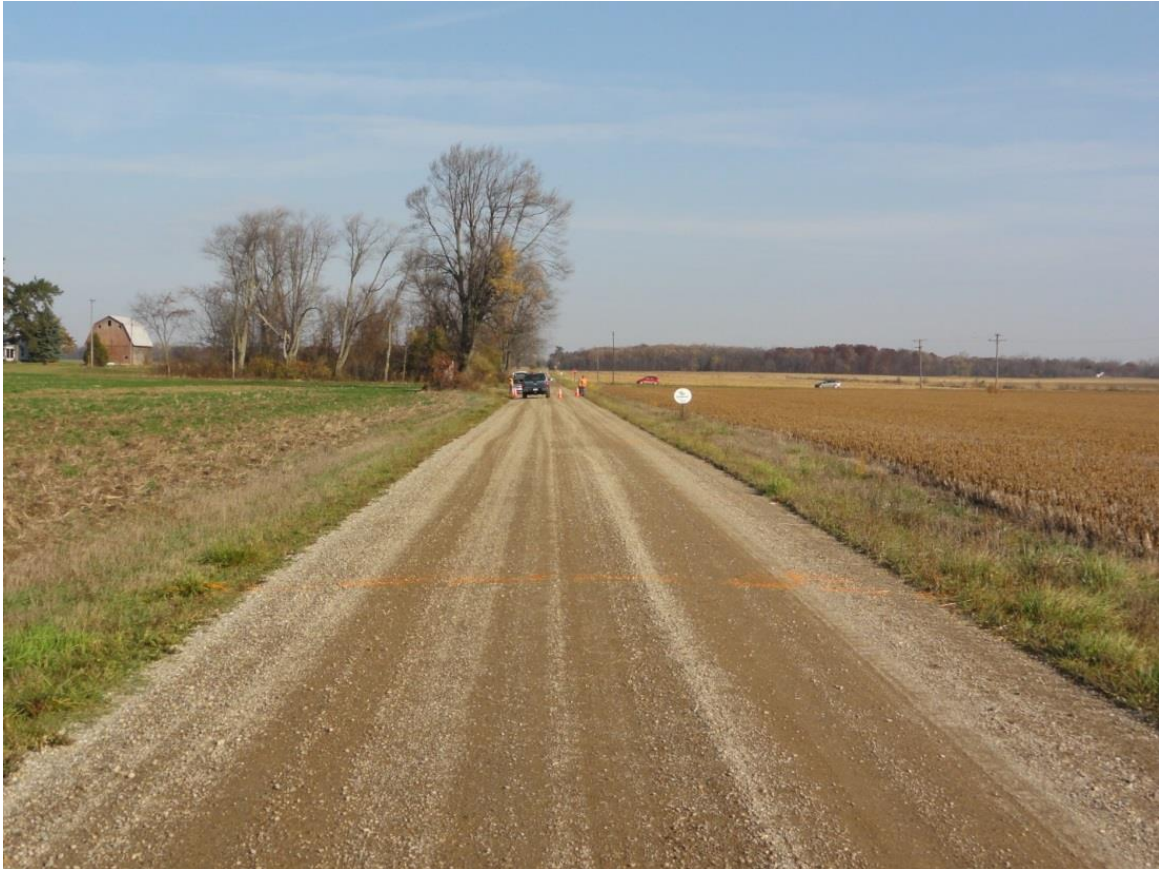
Figure 18: Mills-Macon Road south of Welch Road looking north. Note thin layer of loose aggregate on the road surface and lack of other distresses on the road surface. (DSC03667)

The road surface as shown in Figure 18 (from the ground) and Figure 19 (from our UAV imagery) appears to be natural aggregate, with possibly some crushed limestone added when the road was last graded. Mills-Macon Road showed no significant distresses other than a minimal crown and some loose aggregate on the road. Mills Macon Road was used for prototype analysis; this sample output with few distresses was compared to known good road surfaces.

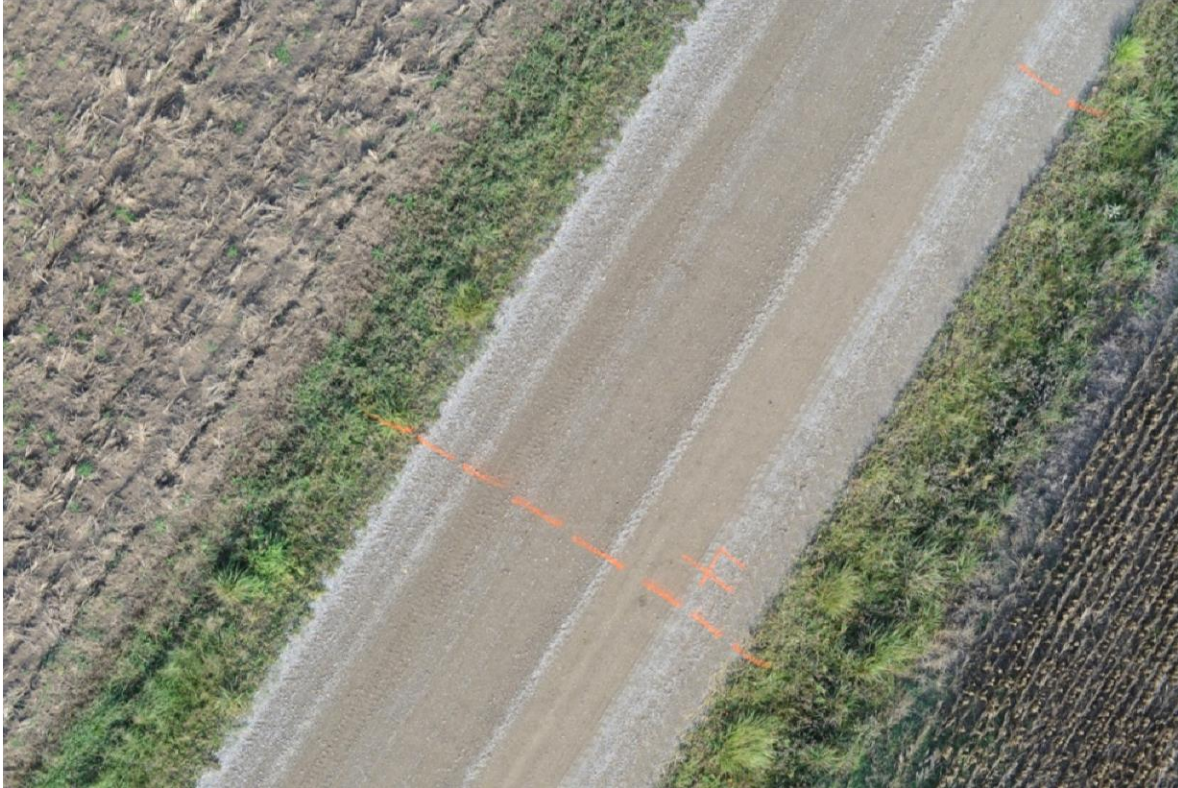
Figure 19: Aerial view of same segment of Mills-Macon Road as Figure 18 above, seen from the MTRI remote control helicopter flying at 25 meters above the ground. Note the road segmentation marks and slight windrowing of the loose aggregate on the road surface. (DSC3440)

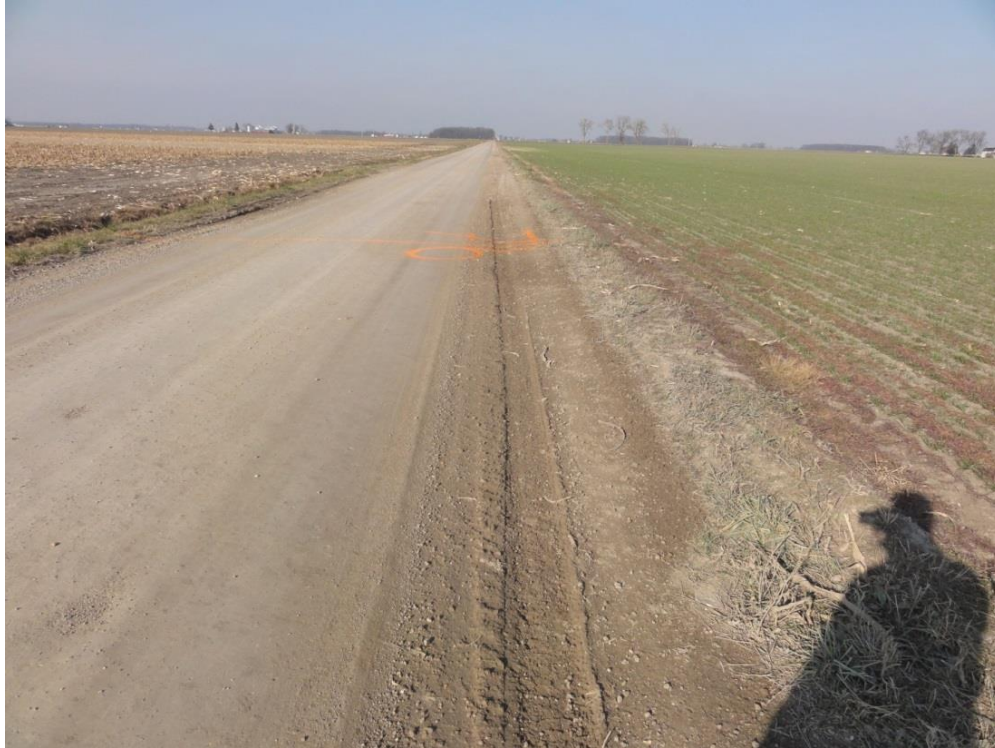
Figure 20: A ground level view of part of segment 6 on Piotter Hwy, Lenawee County MI. View is to the north.

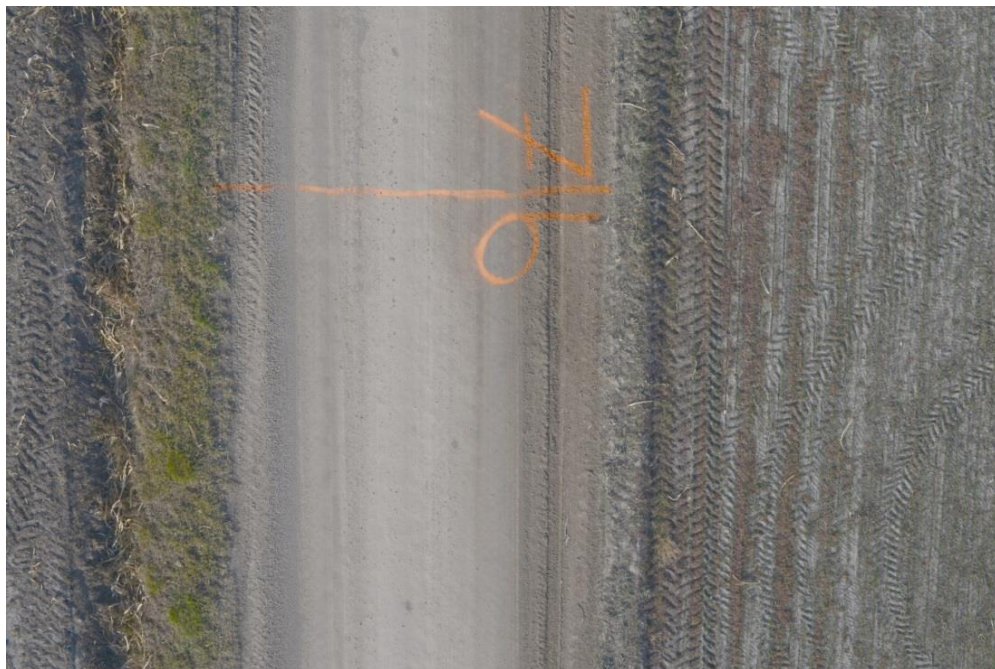
Figure 21: The same segment of Piotter Hwy seen in Figure 20 above from the MTRI remote control helicopter flown at 25 meters. Few potholes are visible in this image but a long rut on the right side of the road is visible in both this image and the ground view of the same area. (DSC3449_gamma.jpg)

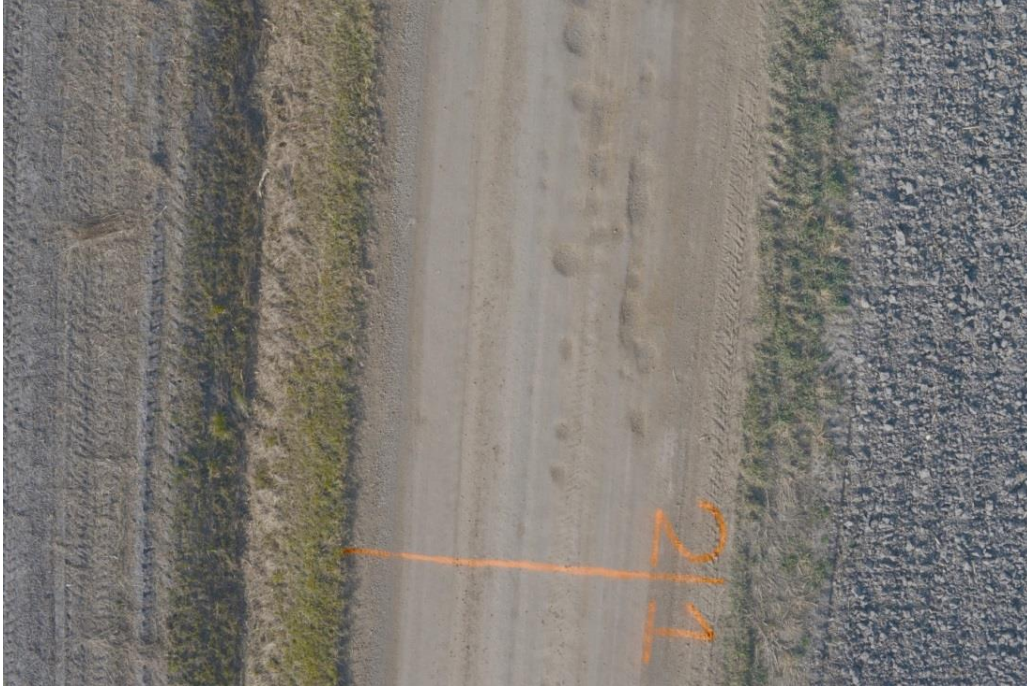
Figure 22: Aerial view of Piotter Hwy from the MTRI hexacopter flown at 25 meters altitude. Note the segment markings and clearly visible distresses (potholes) in the road surface. (DSC3227_gamma.jpg)

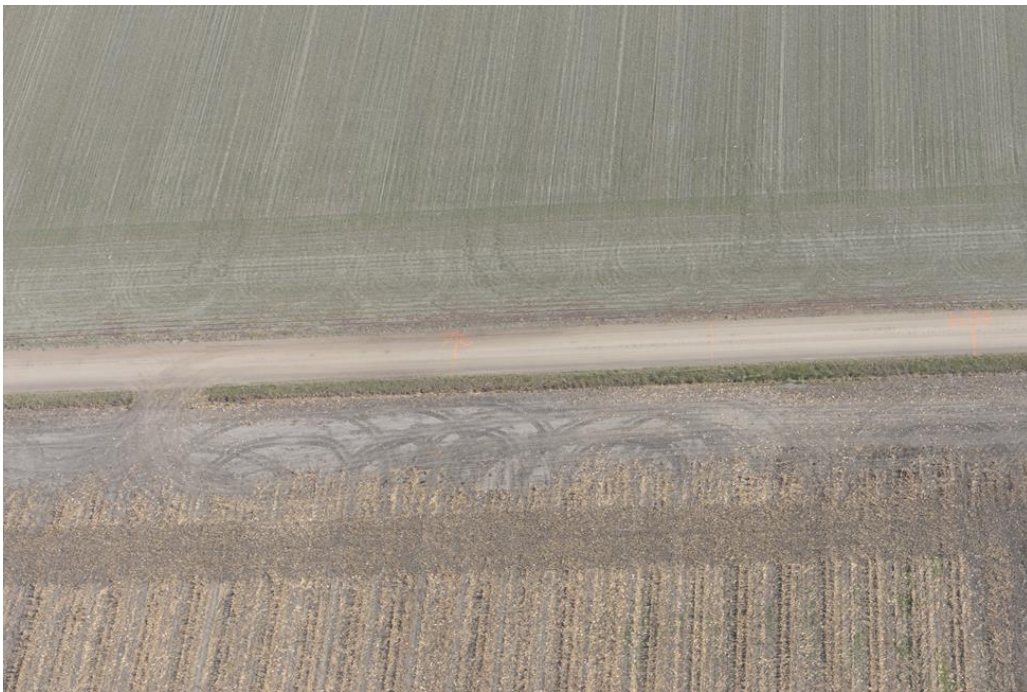
Figure 23: An aerial view of segment 6 of Piotter Rd from a Cessna 172 flying at approximately 500 feet above ground level. The orange segment marks are clearly visible, but distresses are difficult to identify from this angle and altitude. (DSC5879)

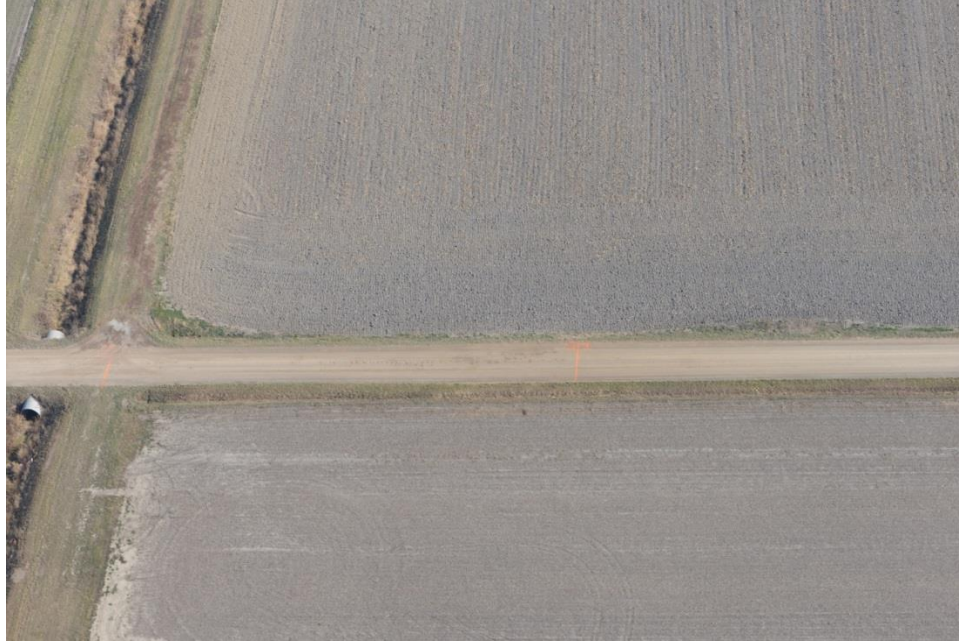
Figure 24: Low oblique aerial photograph of Piotter Hwy segment 2 from the Cessna 172. Markings are clearly visible but distresses while visible are too small to be characterized into classes based on size. (DSC5855)

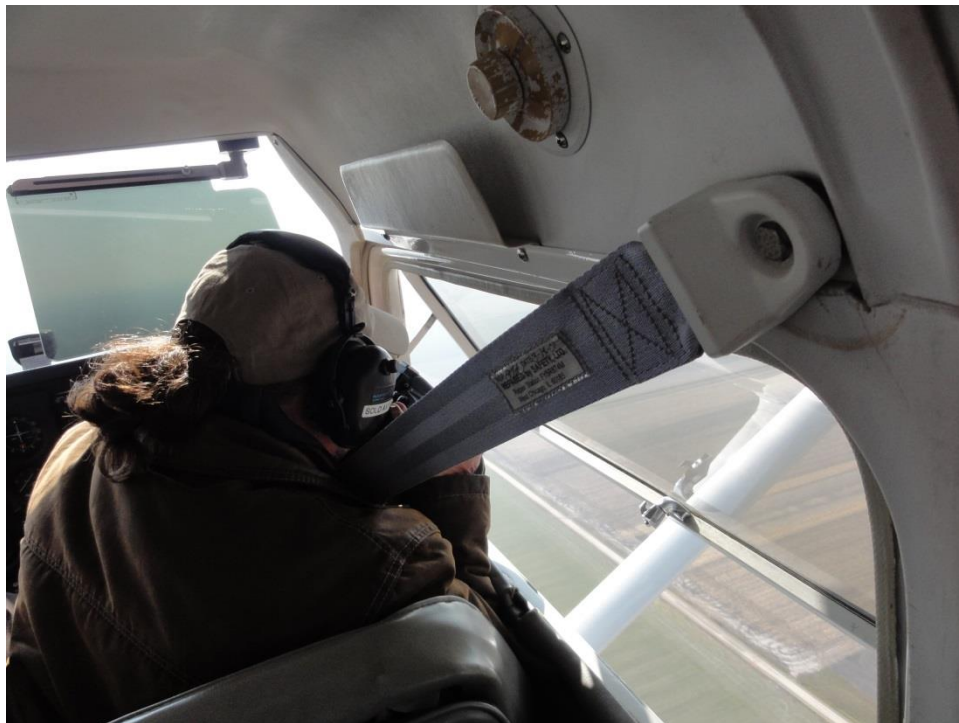
Figure 25: View from the Cessna 172 over Piotter Rd while taking aerial photographs of the Piotter Hwy study area.

Piotter Highway is a north - south road located south of the town of Britton in eastern Lenawee County, MI. The study area is approximately midway between Laberdee and Holloway Roads. The road surface appeared, at the time of the survey, to be mostly natural aggregate although some crushed limestone may be present (Figure 20). Distresses found on Piotter Hwy in the fall of 2012 were generally potholes of various sizes irregularly scattered down the length of the study area along with a few ruts. The road was broken up into 100' (30.5 meter) segments and marked with fluorescent orange marking paint. The location and size (length, width and depth) of distresses on the road were documented for later comparison to image processing results. Imagery was collected from the MTRI helicopter at 25 meters (about 82 feet; see Figure 21 and Figure 22) and 30 meters altitude (about 100 feet) as well as from a manned fixed wing aircraft (a Cessna 172) flying over the road at approximately 150 meters (about 500 feet) above ground level (Figure 23 and Figure 24). The helicopter captured overlapping aerial imagery at nadir, while the imagery taken from the Cessna 172 was taken out the passenger side window at an angle (Figure 25).

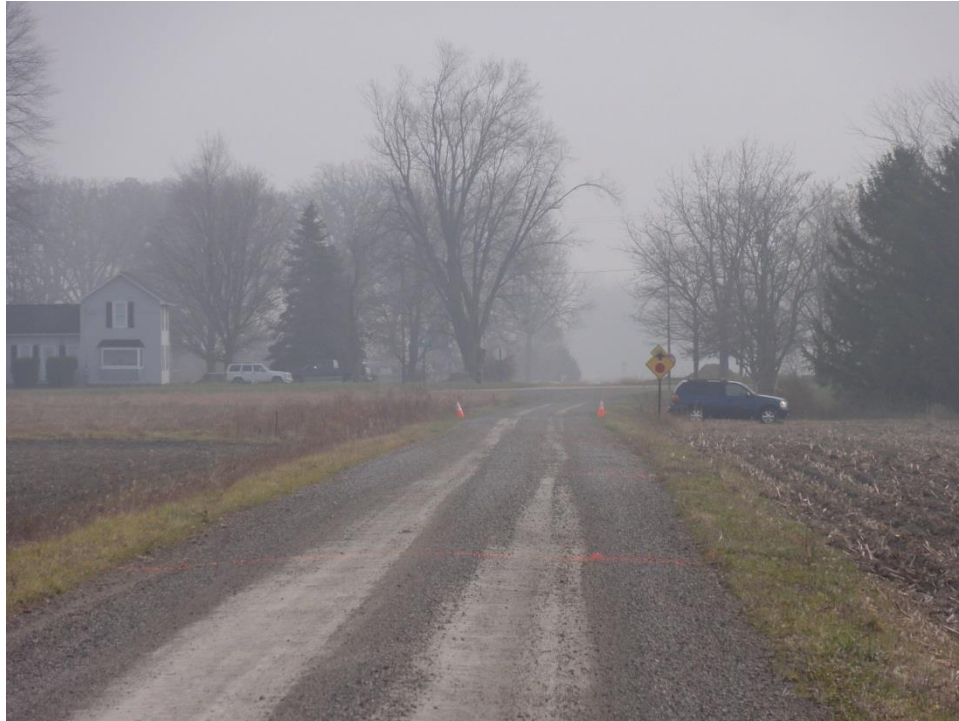
Figure 26: Garno Road looking east. Note the loose/float aggregate on the road shoulders and along the crown of the road.

Garno Road is an east-west road located about one mile south and a little west of Piotter Highway in Lenawee County MI. The study site consists of four 100 foot (30.48 meter) segments between Piotter Hwy and Sisson Hwy. The only distress noted by field crews on Garno Road in the fall of 2012 was float aggregate (see Figure 26 for a ground-based view).

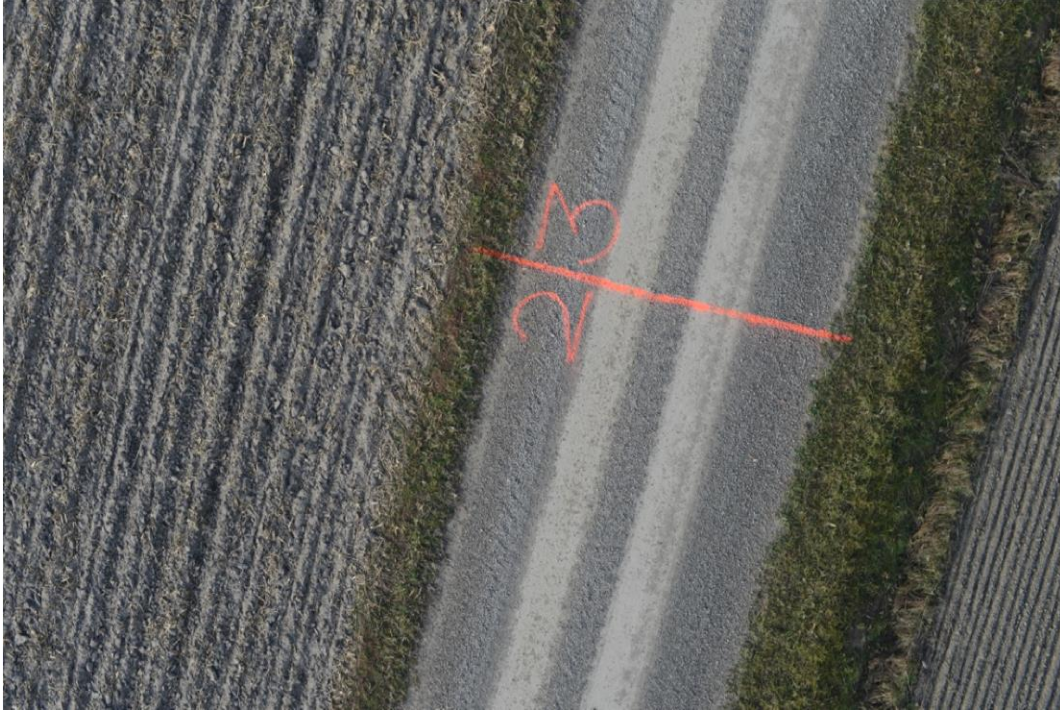
Figure 27: Garno Road from the MTRI helicopter at 25 meters. Loose/float aggregate is the only distress present. Note the marks in the loose gravel from the tires of farm equipment.

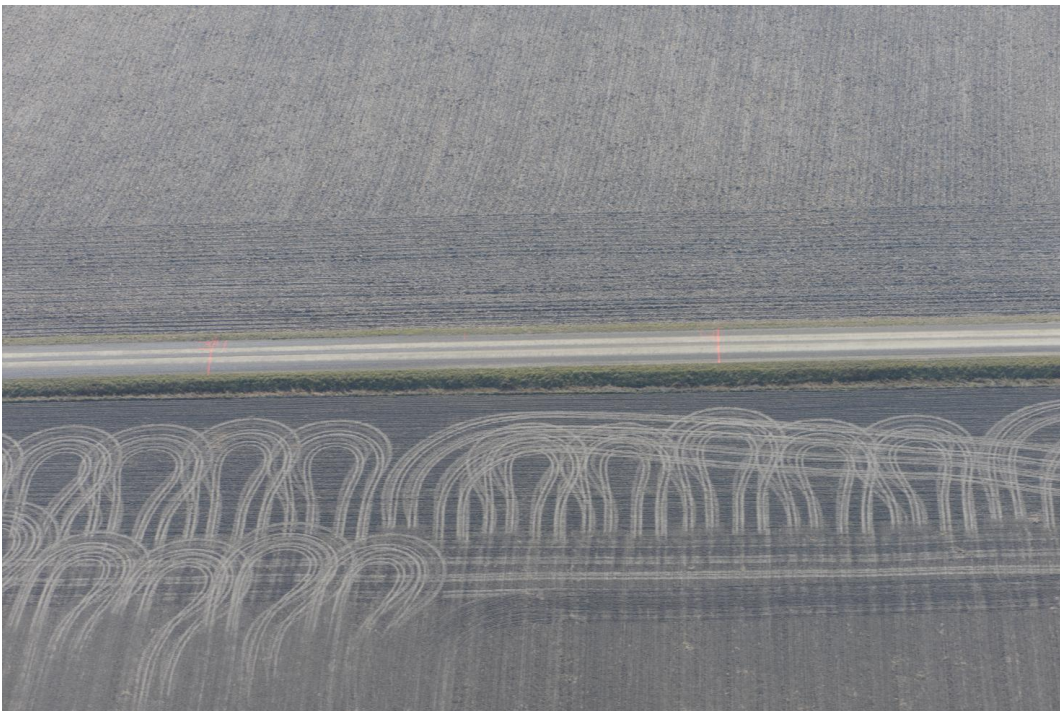
Figure 28: Garno Road from a manned fixed wing aircraft at approximately 150 m / 500 feet agl (above ground level). The float aggregate distress is visible, but not easily characterized from this angle and altitude.

Data were collected on Garno Road from the MTRI helicopter and fixed wing aircraft (a Cessna 172) on the same day. The data were collected with the helicopter in the morning (Figure 27) and Garno Road, along with Piotter Hwy, was overflown in the early afternoon (Figure 28).

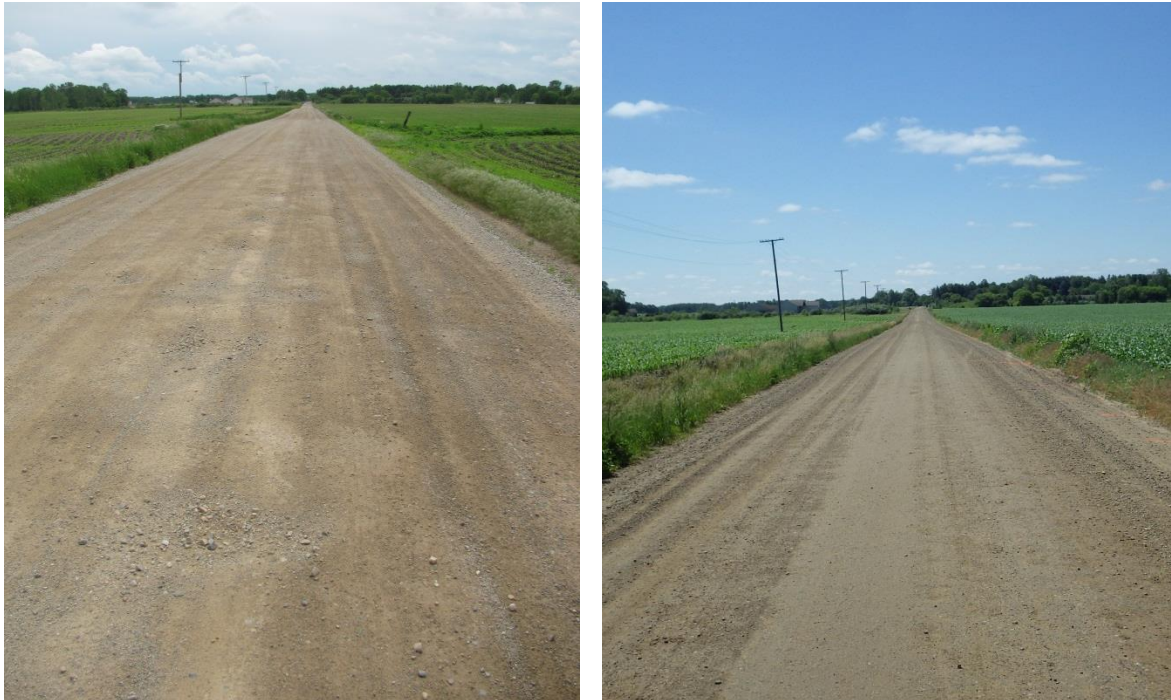
Figure 30: Marsh Road, north of Fowlerville, Livingston County, MI looking south. Image on the left illustrates some of the distresses present on May 31, 2013; the image on the right was taken June 18, 2013. (IMG_4890 (L); IMG0030 (R))

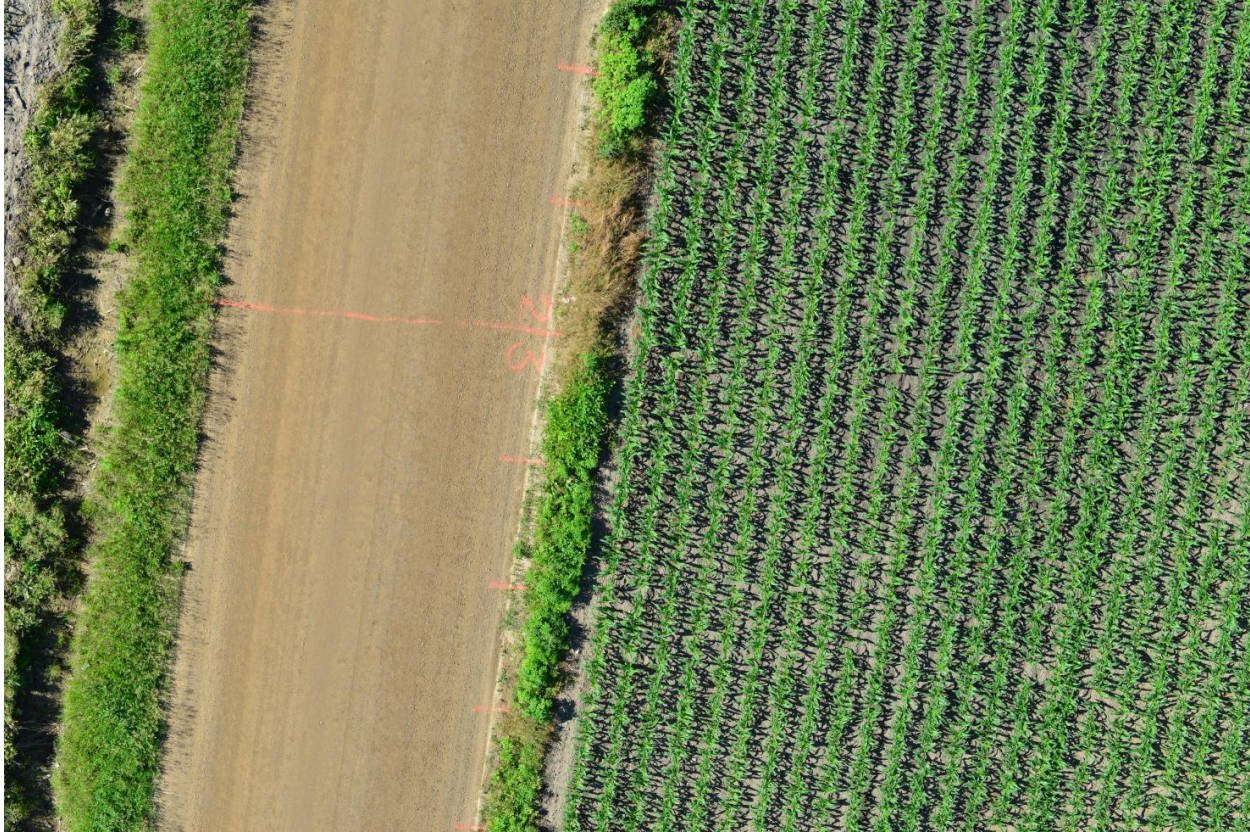
Figure 31: A segment of Marsh Road from the MTRI hexacopter. No significant distresses were present, however crown measurements were taken on Marsh Road for comparison to the results from image processing.

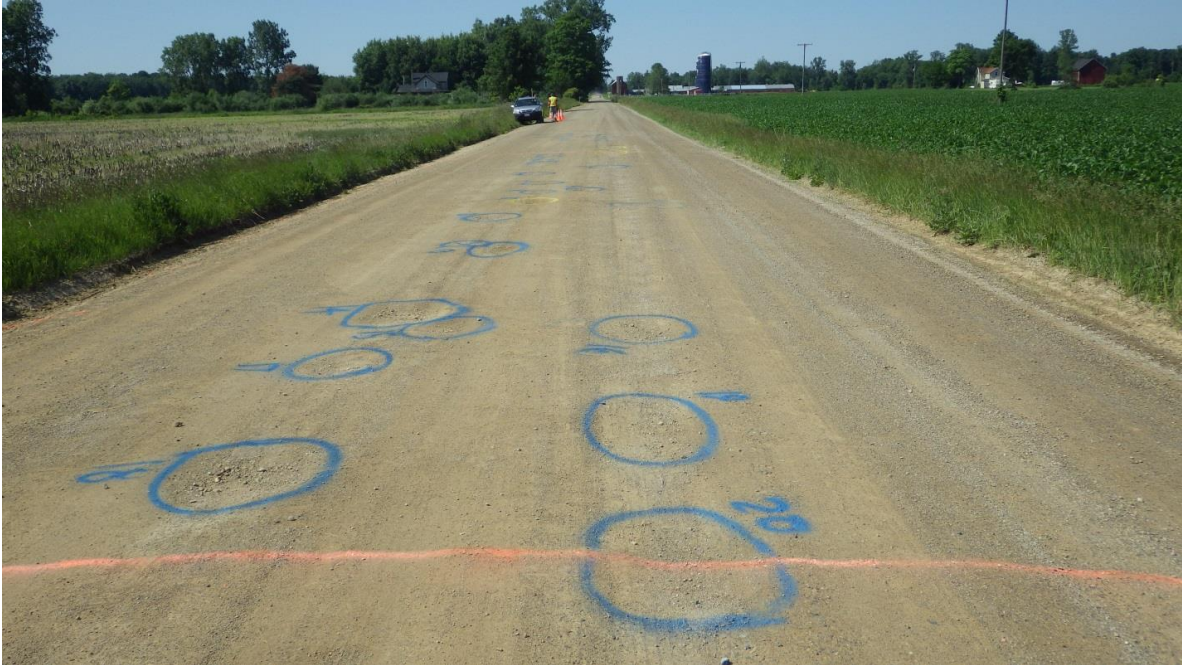
Figure 32: Distress markings on analysis segment 2, Fleming Road, Livingston County MI. Each distress feature was circled and numbered when it was mapped.

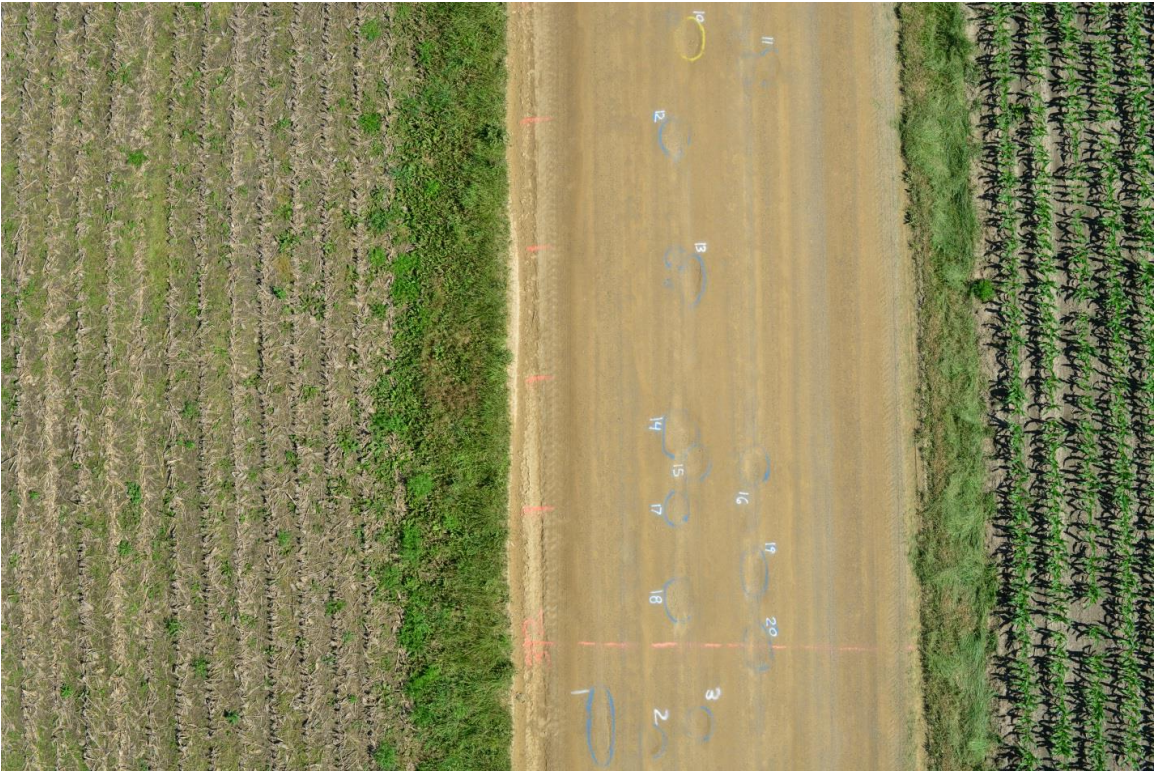
Figure 33: Part of Fleming Road segment 2 with marked, numbered distresses as captured by the MTRI hexacopter flying the Nikon D800 DSLR camera. Data were collected the day after the road was marked. Note the blue distress feature markings have been worn by passing traffic. Feature numbers were refreshed with white marking paint.

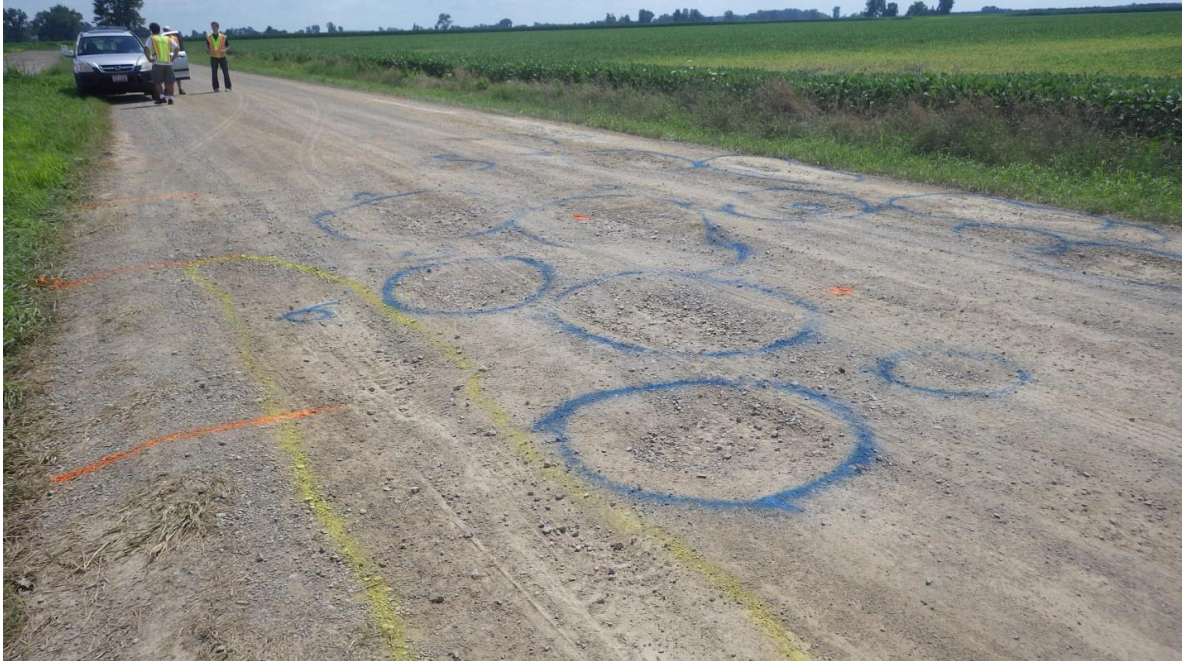
Figure 35: Piotter Hwy marked and measured during the 2013 data collection. Note the clustering of potholes at this particular location, which as a feature of the 2013 distress patterns (IMG0262.jpg)
