Michigan Tech Research Institute

Deliverable 7-B: Performance Evaluation of Recommended Remote Sensing Systems in Unpaved Road Type Condition Characterization

Characterization of Unpaved Road Condition Through the Use of Remote Sensing Project

November 26, 2013

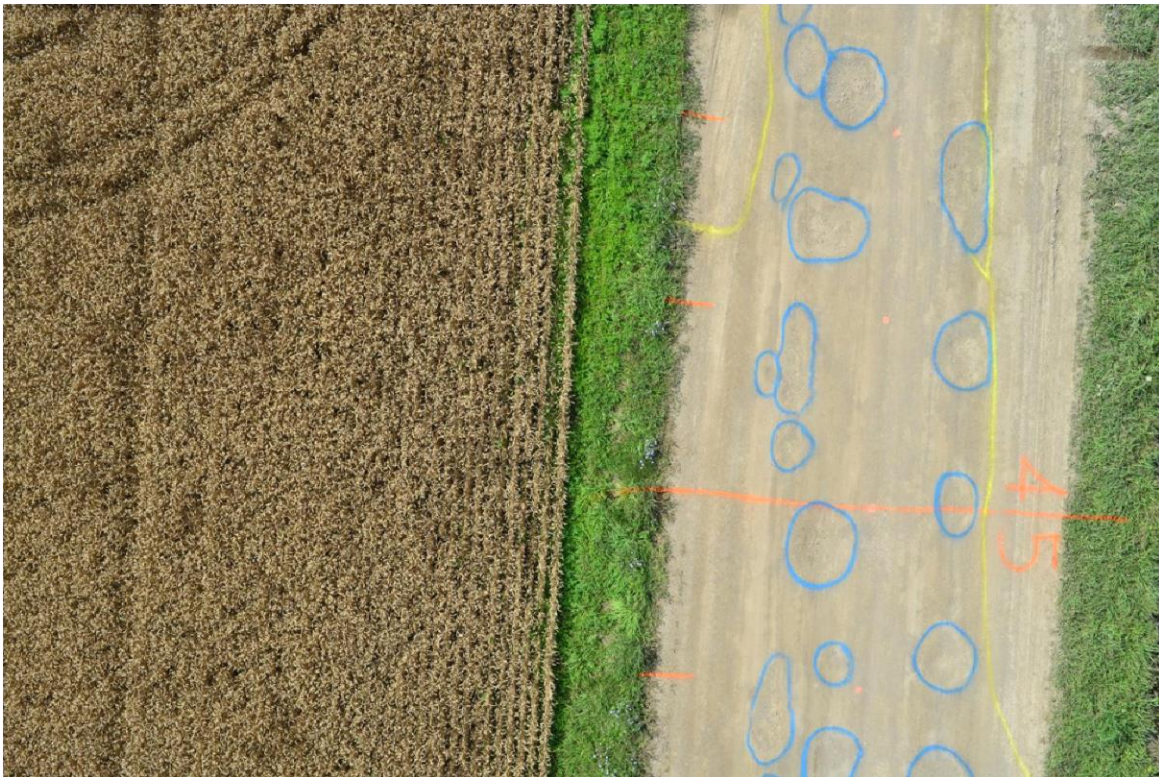
Figure 36: An image of Piotter Hwy from the hexacopter flight. This is approximately the same location as in the previous figure. Above, however the hexacopter flight was made before the distress features were numbered. (975-7916.jpg)

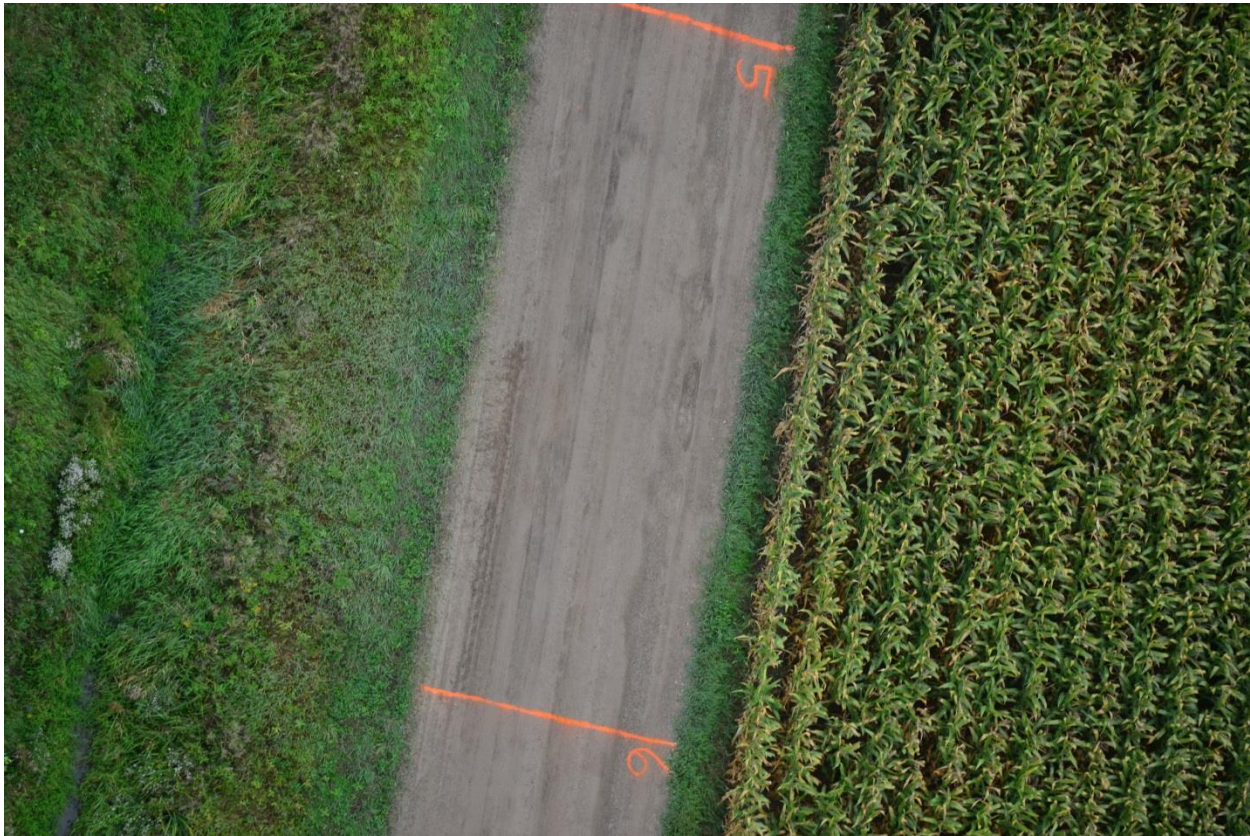
Figure 37: An image of an approximately 50 foot / 15 meter section of Palmer Hwy taken with the Nikon D800 camera with a 200mm lens from the manned Cessna 172 flight. Altitude and airspeed can make it difficult to capture usable overlapping aerial imagery from a manned fixed wing aircraft at a reasonable cost. (CJR_4426.jpg)

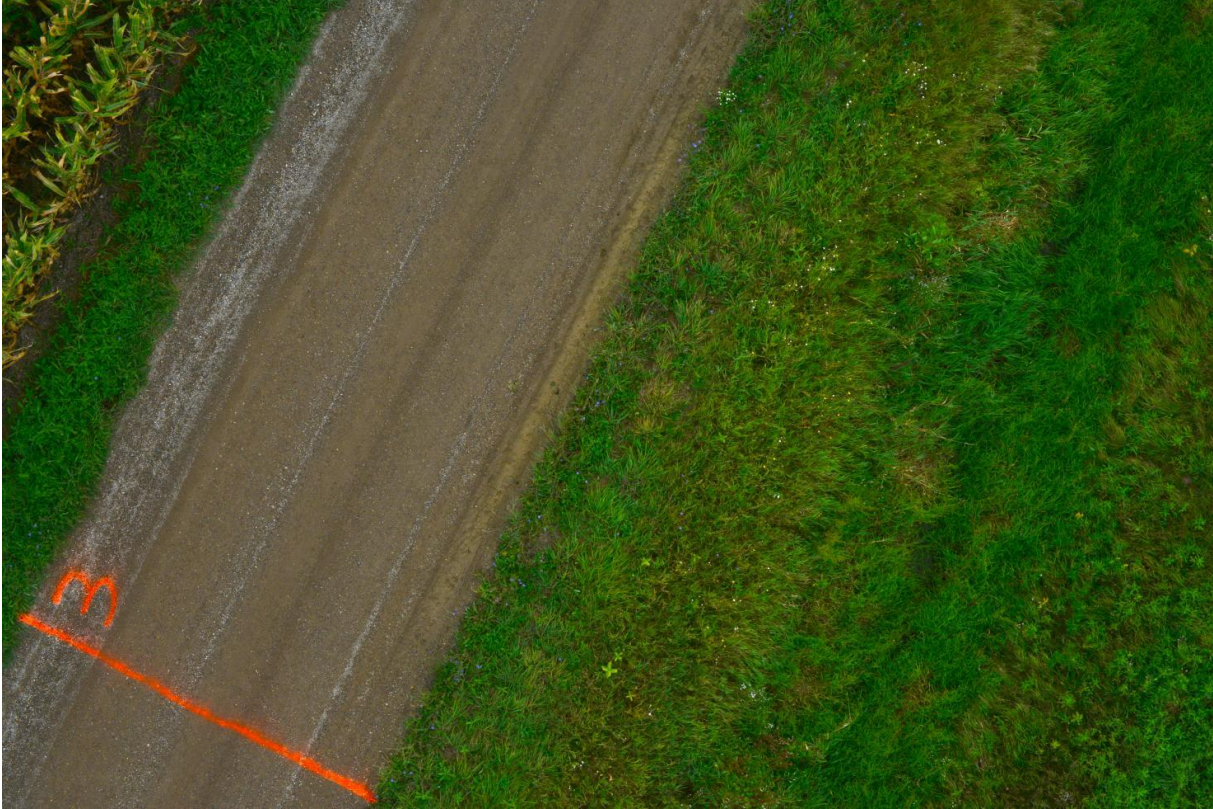
Figure 38: Segment 3 of Palmer Road from the MTRI hexacopter from approximately 25 meters altitude. A rut is visible on the right side of the road just above the segment line.

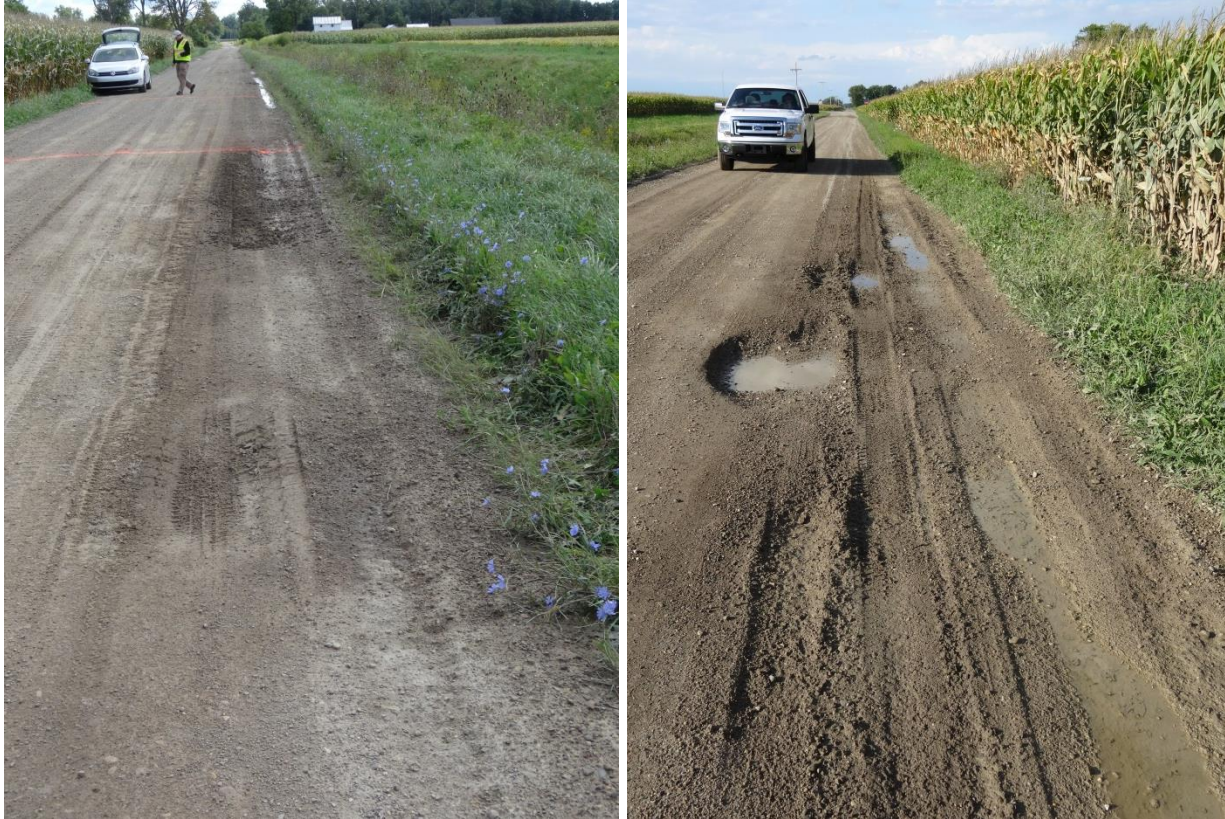
Figure 39: Ruts and potholes on Palmer Road. Note deformation along edge of road in left hand image. DSC00691 (R) and DSC00717 (L)

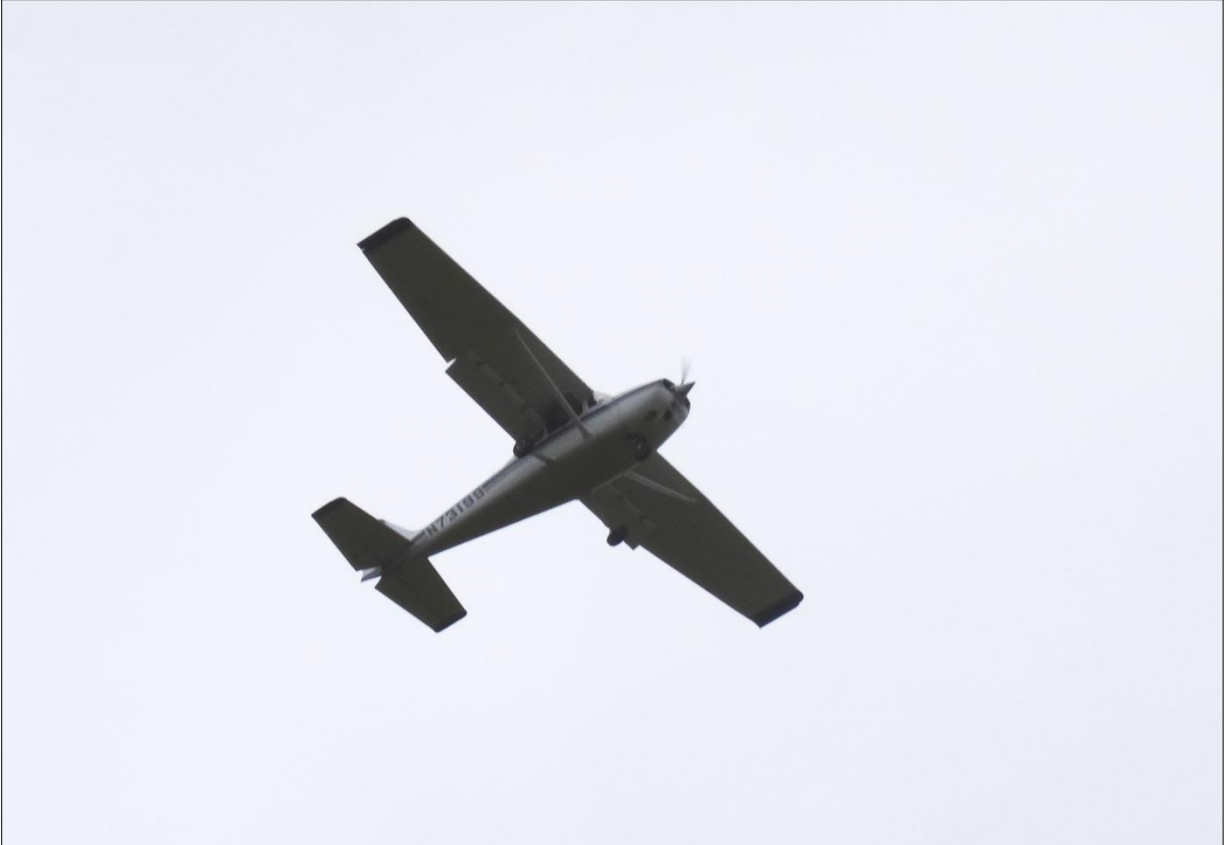
Figure 40: Cessna 172 flying over Palmer Road collecting the unpaved roads assessment project imagery. (DSC00708.jpg)

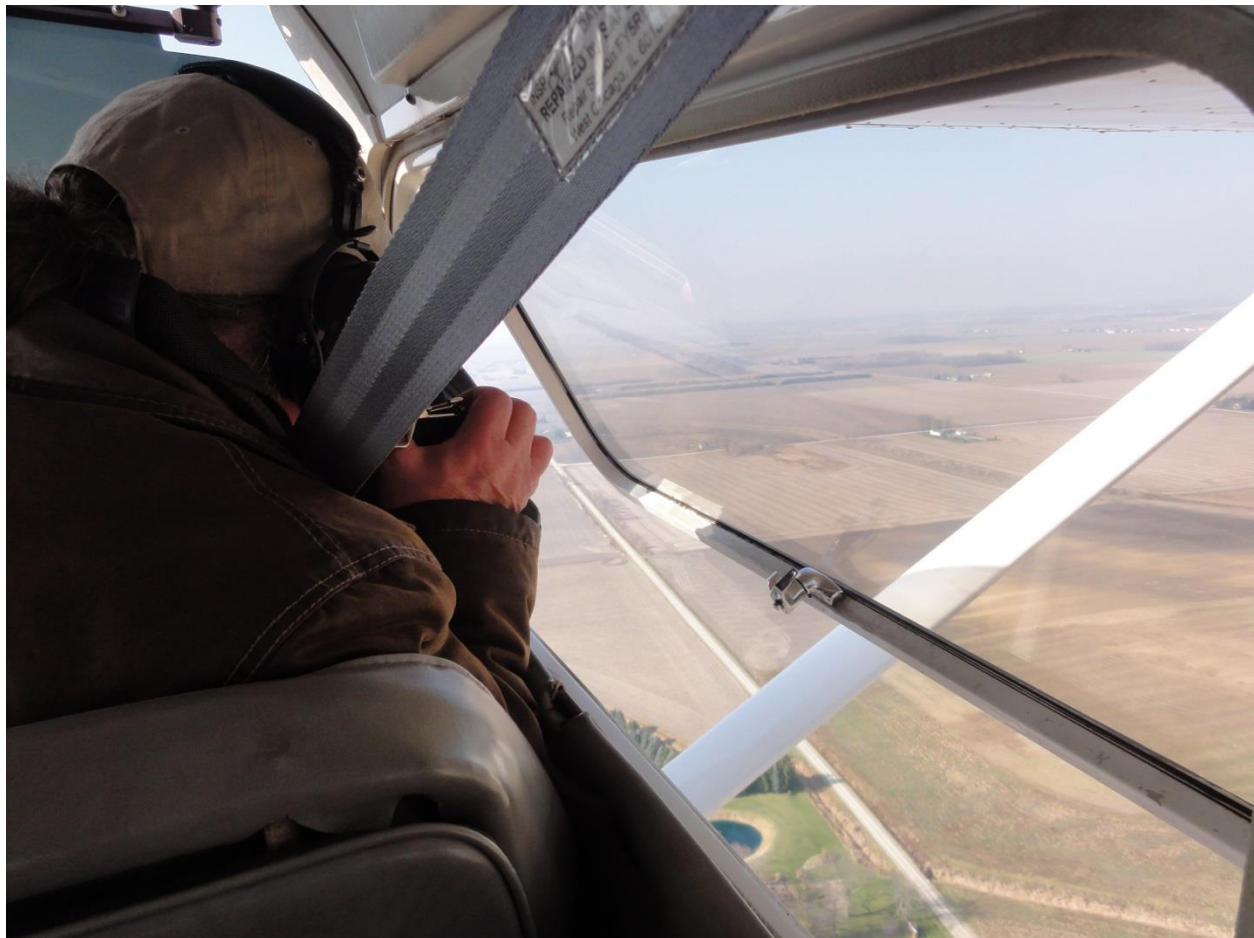
Figure 41: A first pass at determining whether good data could be collected from a manned fixed wing aircraft. At 500 feet agl over Garno Road, Lenawee County, October 2012.

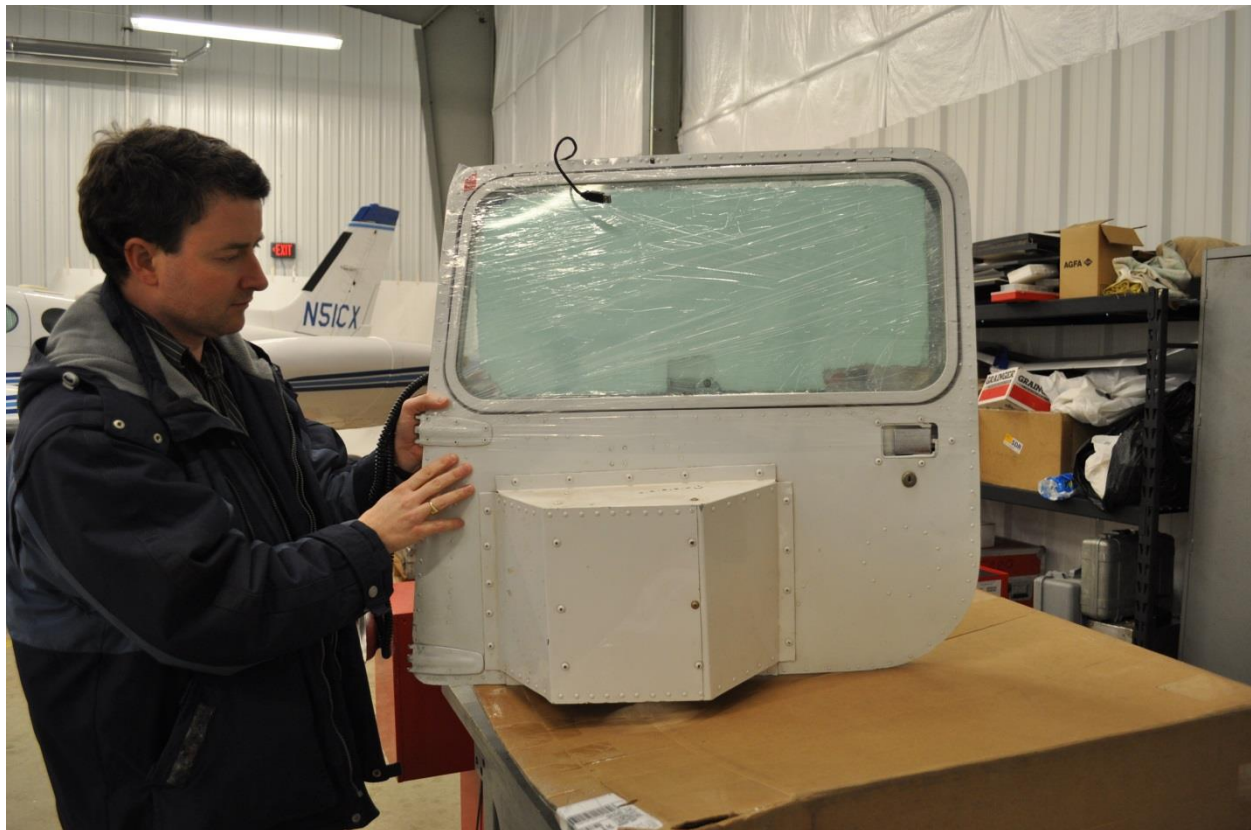
Figure 42: The door of a Cessna 152 with a fairing allowing the mounting of a camera pointed straight down (nadir).

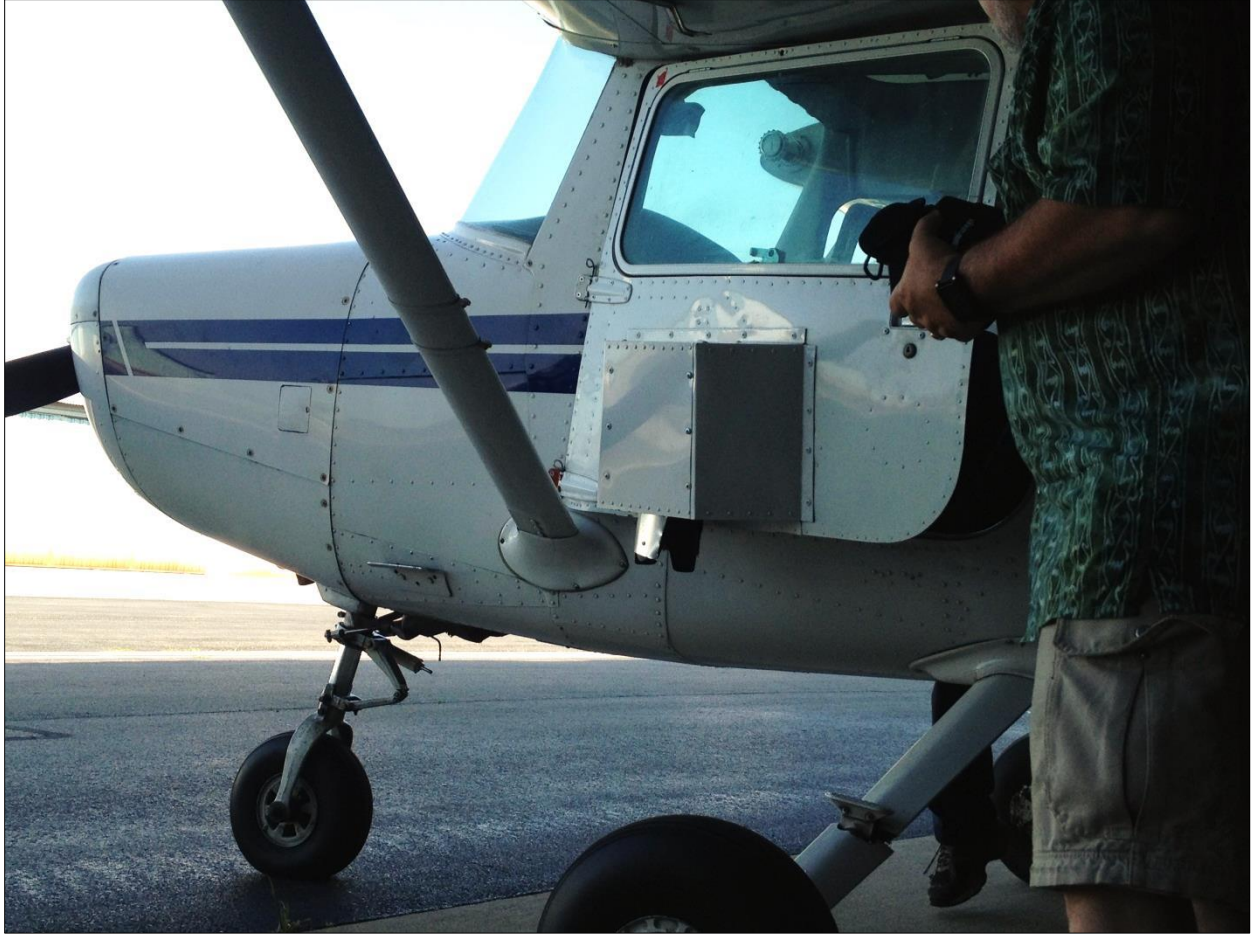
Figure 43: The Nikon D800 camera mounted on the door of a Cessna 152. The protective shade at the end of the camera lens can be seen at the bottom of the door.

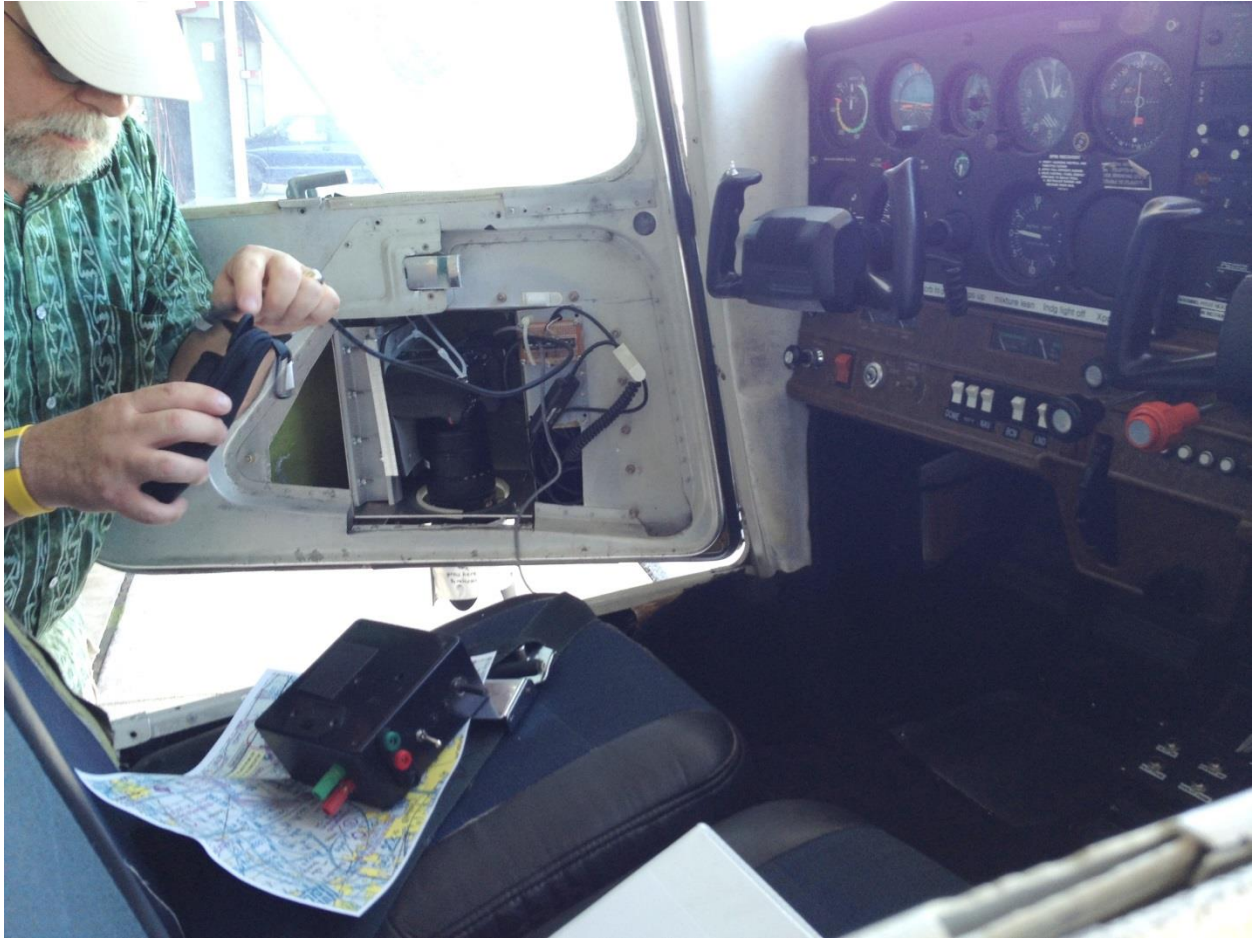
Figure 44: Preparing to fly the D800 in the door of the Cessna 152. The camera can be seen in the door, the camera trigger mechanism can be seen on the pilot seat.

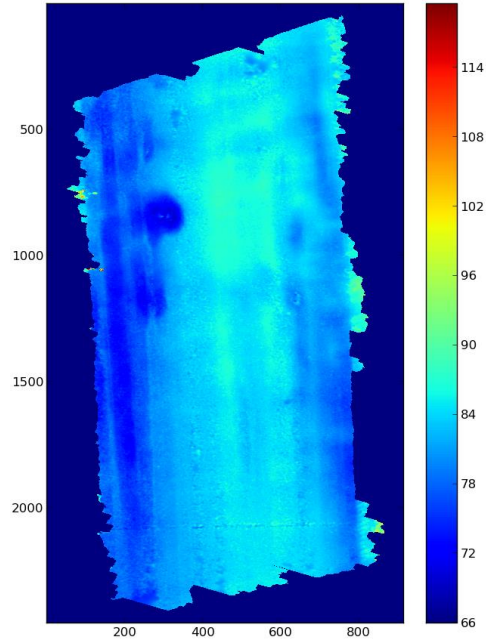
Figure 48: Height map of a 15m road segment with a rut. Values in cm.

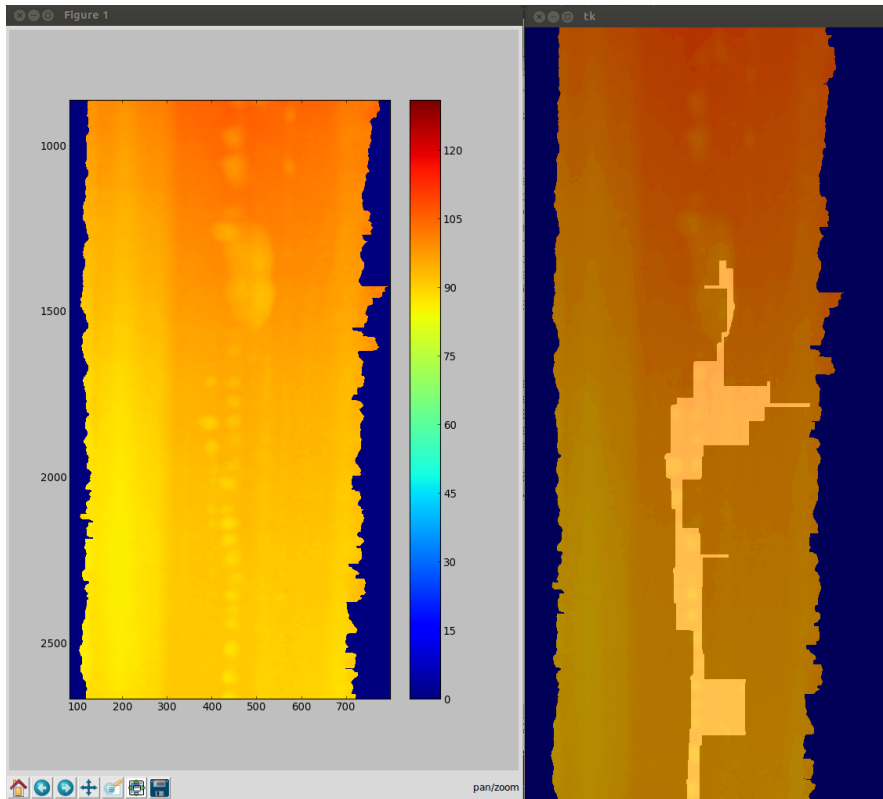
Figure 51: On left is the original image, showing potholes in a line. On the right is a mask showing the detected corrugations.
