Remote Sensing of Roads and Highways in Colorado

**Large-Area Road-Surface Quality and Land-Cover Classification Using
Very-High Spatial Resolution Aerial and Satellite Data**

Quarterly Progress Report #3

Quarter from 04/01/2013 to 06/30/2013

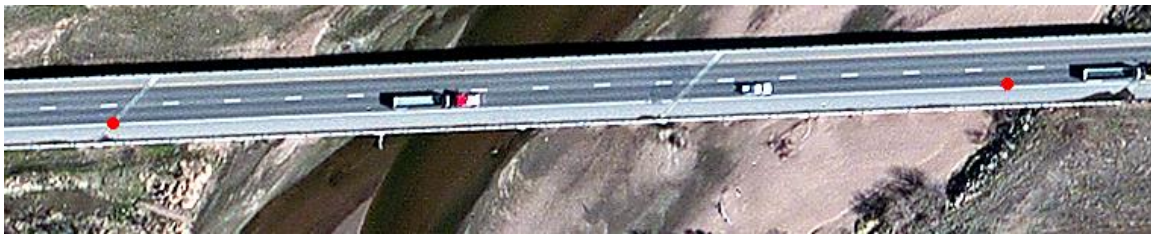
Figure 1: CDOT Highway Stretch #34A (Mile 114.6-114.7)

In these photographs, there are visual signatures that might indicate road quality. The low fatigue road piece in Figure 1 is noticeably darker and smoother. By contrast, the high fatigue road piece in Figure 2 is lighter and cracking is evident.

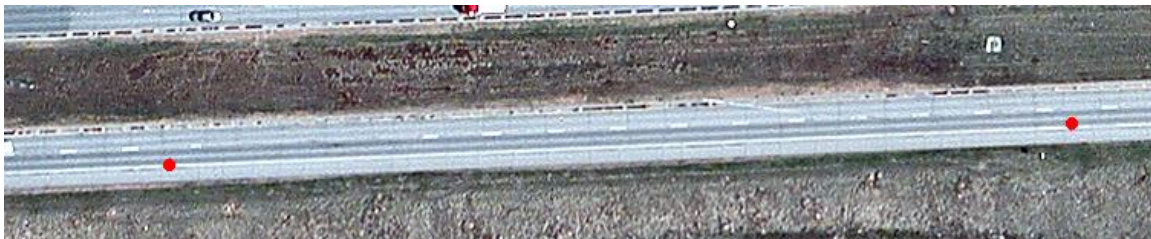
Figure 2: CDOT Highway Stretch #34A (Mile 114.8-114.9)

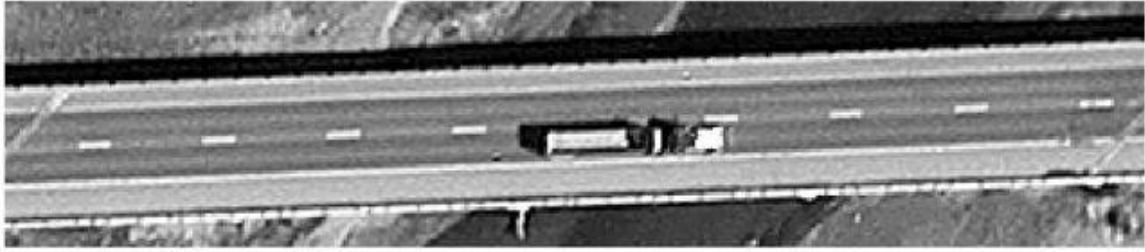
Figure 3: Panchromatic Aerial Image (Low Fatigue)

Although the quality of the images decreases with lower spatial resolution, the visual signatures of road fatigue are still discernible. Some preliminary analysis was performed to assess whether fatigue could be determined from the optical information within the photographs. Using the ENVI software, a variety of statistical analysis procedures were applied to the images, which resulted in new images corresponding to these procedures. The first order metrics were data range, mean, variance, entropy, and skewness with a 3x3 pixel window. The second order metrics were mean, variance, homogeneity, contrast, dissimilarity, entropy, 2nd moment, and correlation with a 3x3 pixel window and 1x1 pixel offset. Finally, image entropy metrics were calculated with 3x3, 5x5, and 7x7 pixel windows. A geographic transect was drawn over these new sets of images (both the low fatigue set and the high fatigue set) and the values representing the pixels underneath them were extracted and plotted against normalized distance. The plots that show the most notable features are presented in Figures 9-11.

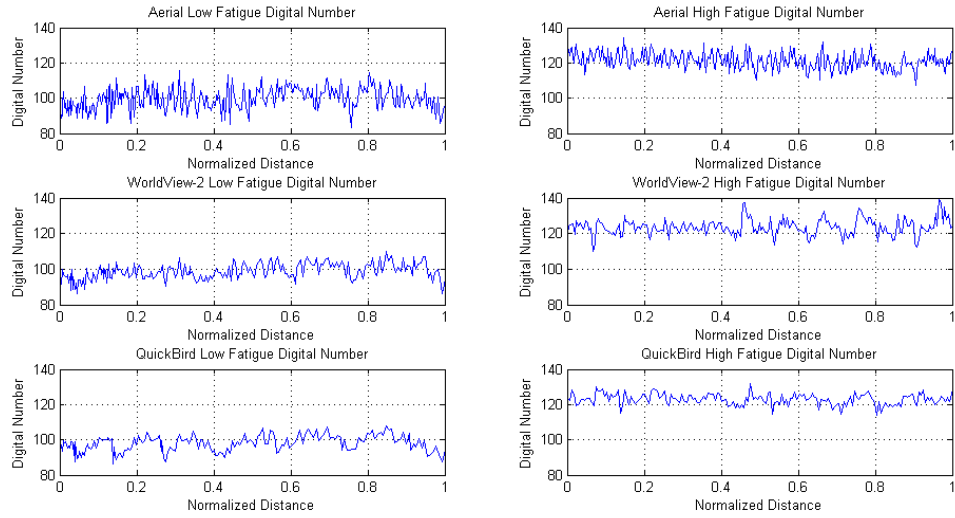
Figure 9: Digital Number Comparison

There is an obvious difference in the 8-bit digital number values between the low fatigue and high fatigue road pieces. The former is lower (~100) whereas the latter is higher (~120). This is consistent with visual observations of the photographs, since the low fatigue road piece is darker and the high fatigue one is brighter. The second correlation and first skewness metrics may also suggest road fatiguing. In both Figures 10 and 11, the high fatigue plots contain more variation than the low fatigue ones, which are comparatively flatter. Because this is only a two-case study, there is not enough evidence to conclude whether these metrics are true indicators of road fatiguing. Perhaps a multiple-case study combined with spectral analysis will determine the full extent of these metrics' potential.

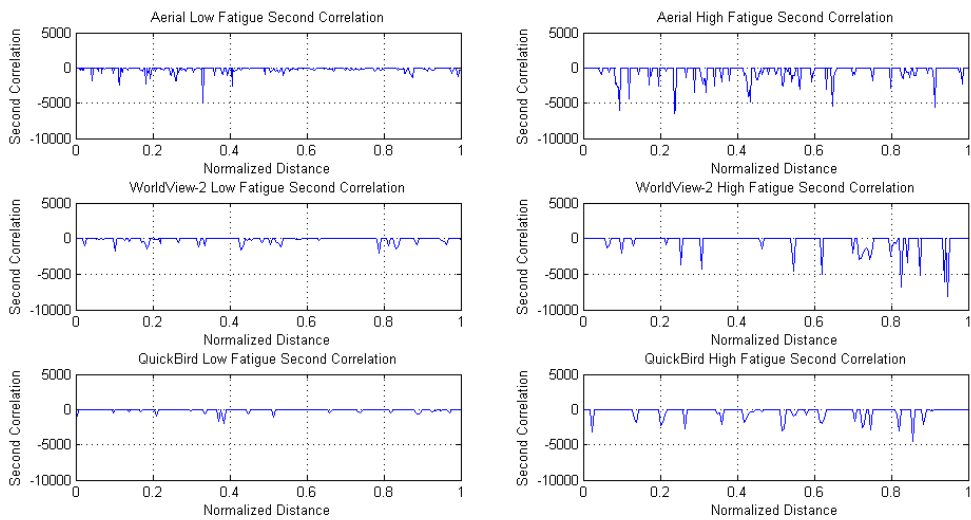
Figure 10: Second Correlation Comparison

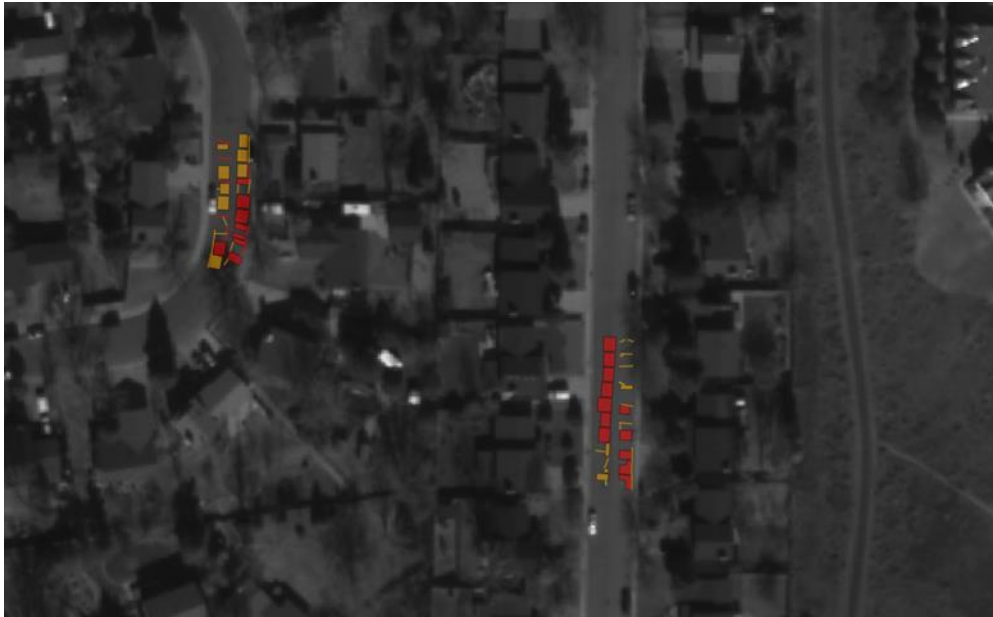
Figure 12: WorldView-2 Panchromatic Image with Road Damage Information

In Figure 12, the red shapes and lines represent severe road distress and the orange ones represent moderate distress. The allegedly severe damage is not obvious from eyeball inspection when the road damage information is removed. Perhaps they could be revealed when the statistical analysis described in the two-case study is implemented.

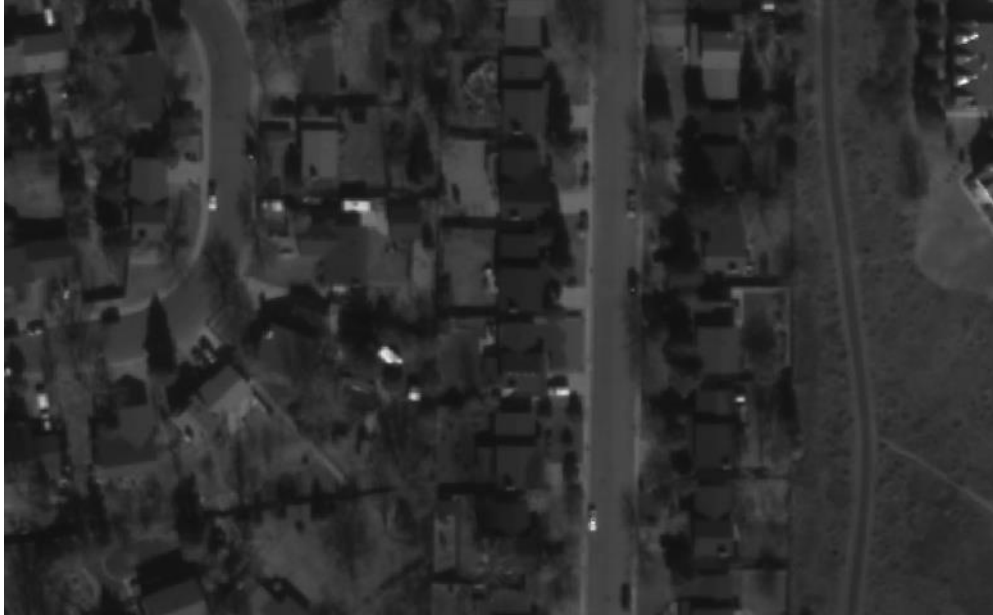
Figure 13: WorldView-2 Panchromatic Image without Road Damage Information

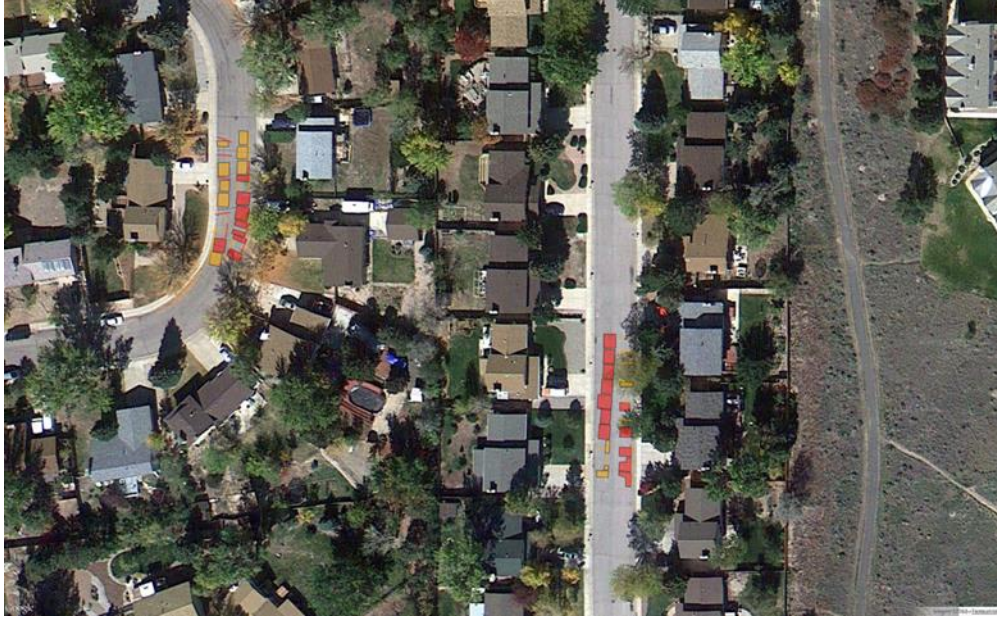
Figure 14: Google Maps Aerial Image with Road Damage Information

These particular photographs were collected on 10/22/2011, approximately a year before the PPACG road survey. It is assumed that the road quality has not changed considerably in the time lag. With the higher resolution and color, the visible signs of fatigue, which include greyness and cracking, are more apparent. Although the Google Maps images are not the purest form of scientific remote sensing data, they do provide a qualitative indication of road surface conditions.

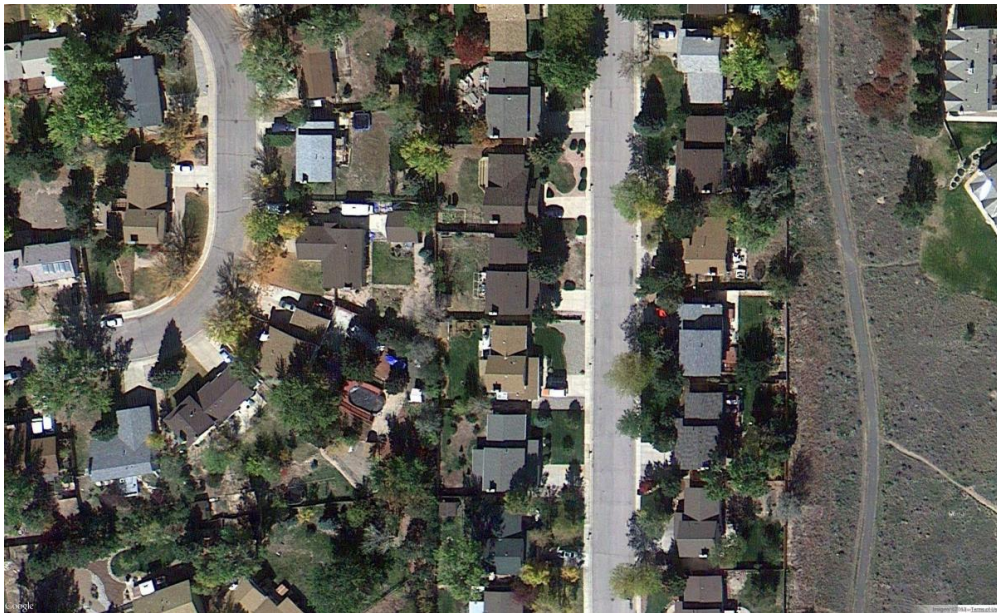
Figure 15: Google Maps Aerial Image without Road Damage Information
