Remote Sensing of Roads and Highways in Colorado

**Large-Area Road-Surface Quality and Land-Cover Classification Using
Very-High Spatial Resolution Aerial and Satellite Data**

Quarterly Progress Report #4

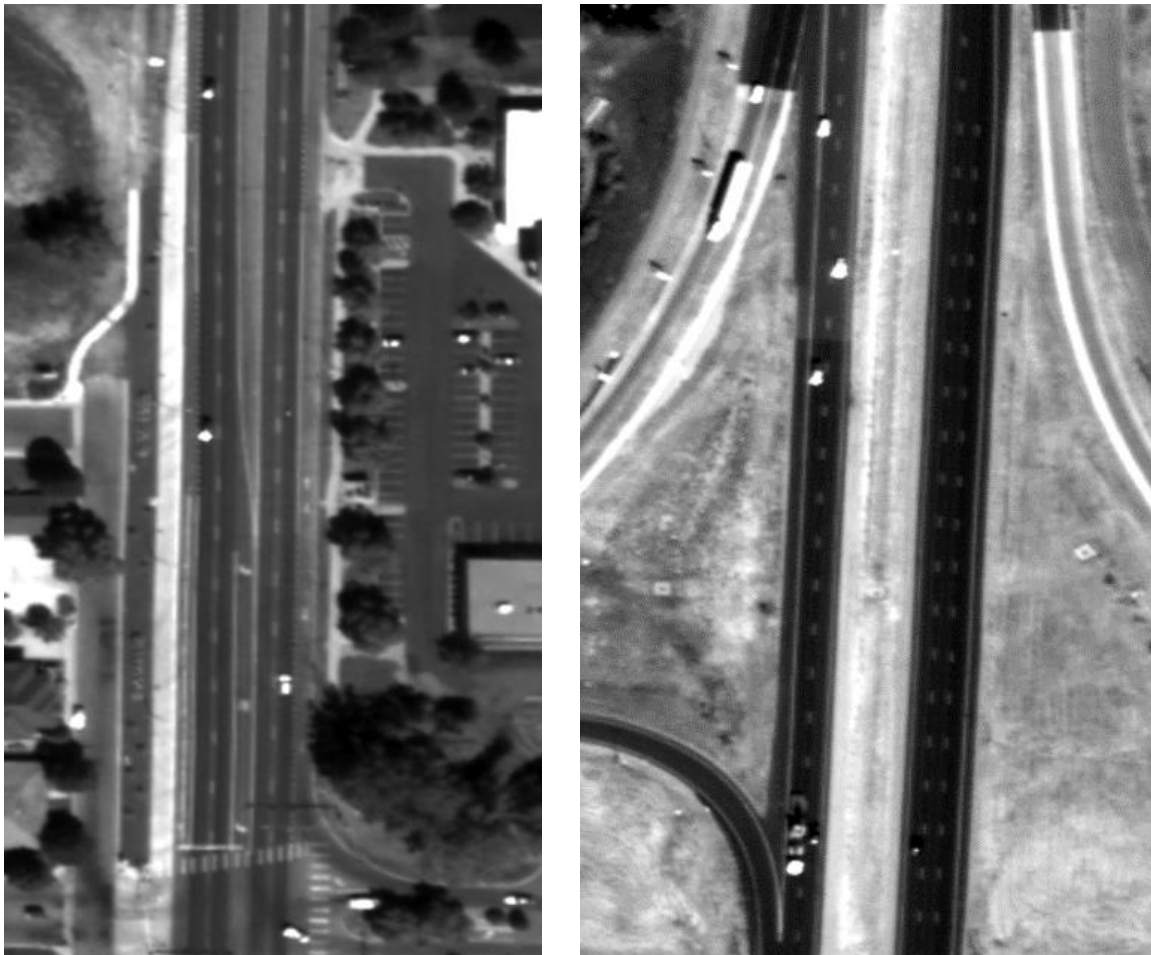
Fig. 1: US 287 (left) and I-25 (right) from a WorldView-2 image collect on Aug. 8, 2012

In these coincident images, we can clearly see what we know to be better surface conditions of I-25 as indicated by the I-25 (paved in 2011) corresponding to the darker color of the road surface. Looking at the right northbound lanes, we

can really sense the degraded condition of US 287 in this area by the apparent lighter colors of the road. Still, the highway condition appears to be better than the condition of the frontage road that parallels US 287 at this location.

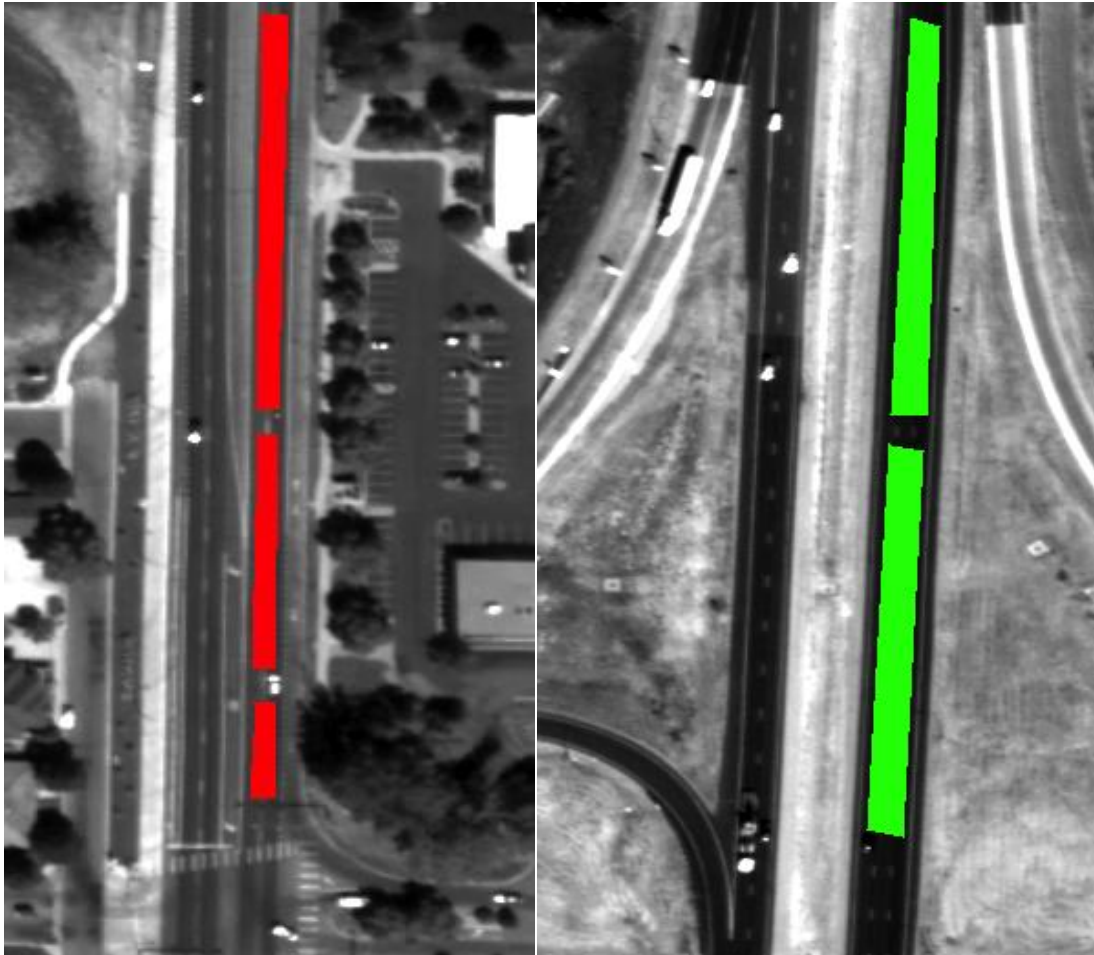
To quantitatively assess the condition of these surfaces, we selected regions of interest indicated by the colors on the roads in question in Fig. 2.

Fig. 2: Regions of interest (ROIs) for the statistical calculations for US 287 (left) and I-25 (right)

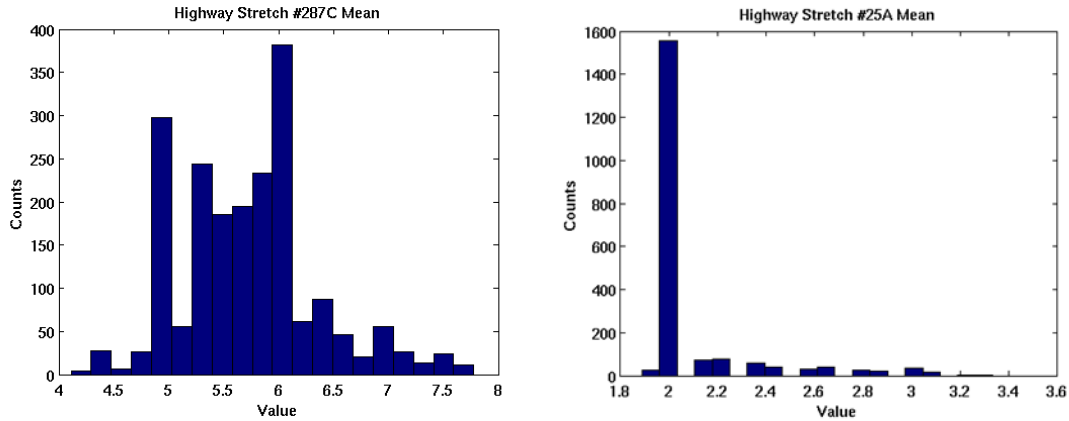
Fig. 3: Histograms of the mean value in a 2D pixel moving region for US 287 (left) and I-25 (right).

In these histograms, the recently repaved I-25 has a single peak at a relatively low value, which indicates a uniform dark reflectance of the highway surface. US 287, on the other hand, exhibits a wide range of values with the maximum number of points at a value of 6 which is below the maximum at about 7.8. This indicates a serious degradation of the highway surface leading to a wide range of increased reflectances and a lighter gray color of the highway.

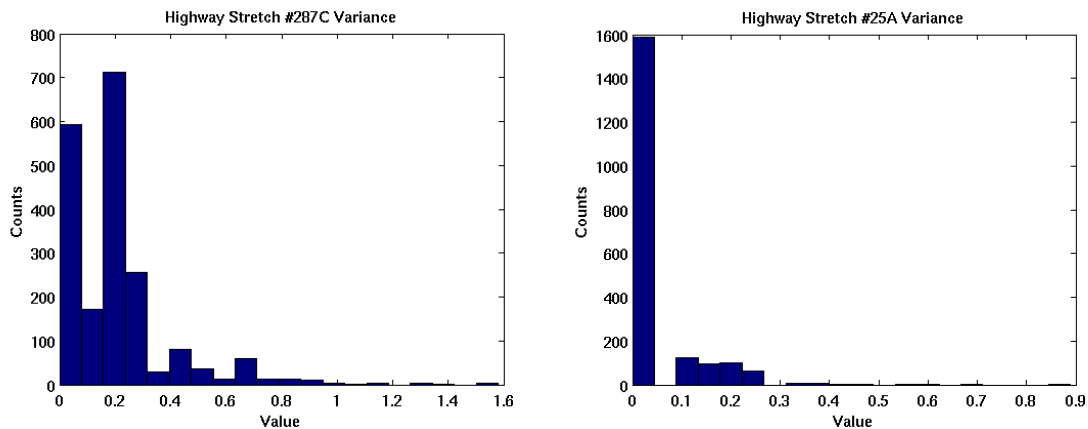
Fig. 4: Histogram of the variance in a 2D pixel moving region for US 287 (left) and I-25 (right).

Again, there is a marked difference in the variance of these two roads with I-25 having a very low and uniform variance as expected while the US 287 variance had larger values with a peak at about 0.25. An analysis of any highway would clearly show these differences indicating the quality of the road surface.

The better-conditioned surface of I-25 on the right of Fig. 11 has a peak near zero as does the histogram of I-25 farther north on the right of Fig. 4. The primary difference in these two histograms is that the higher values peaks in Fig. 11 right are slightly larger than those for Fig. 4 right. This is likely because the I-25 represented by Fig. 11 on the right was paved in 2007 while that on the right of Fig. 4 was paved in 2011. So this degradation appears as slightly higher contributions to the variance. The 2001 paved surface by comparison has two large peaks at 0.2 and 0.5 and a wider range of values than in the right panel of Fig. 11.

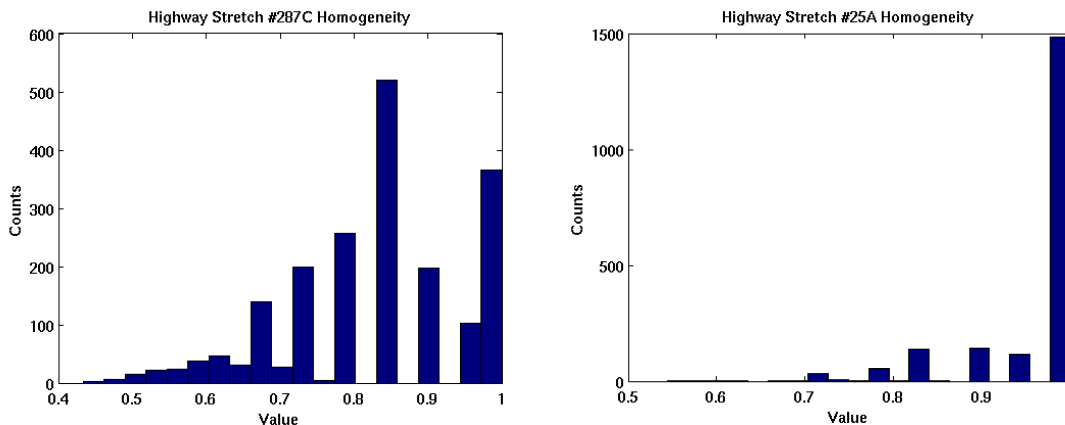
Moving on to homogeneity, we find (Fig. 6) that I-25 is extremely homogeneous (values mostly at 1) while US 287 has its contrast peak at about 0.85.

Fig. 6: Histograms of homogeneity over a moving 2D region for US 287 (left) and I-25 (right)

There is an interesting almost Gaussian series of histogram values surrounding this peak value. Again, the values away from 1 for I-25 are likely due to the presence of white lane markers.

very high homogeneity for the smooth appearing surface of I-25. However, this 2007 paved I-25 surface has many lower peaks when compared with the 2011 paved I-25 surface in the right panel of Fig. 6. This may indicate its condition.

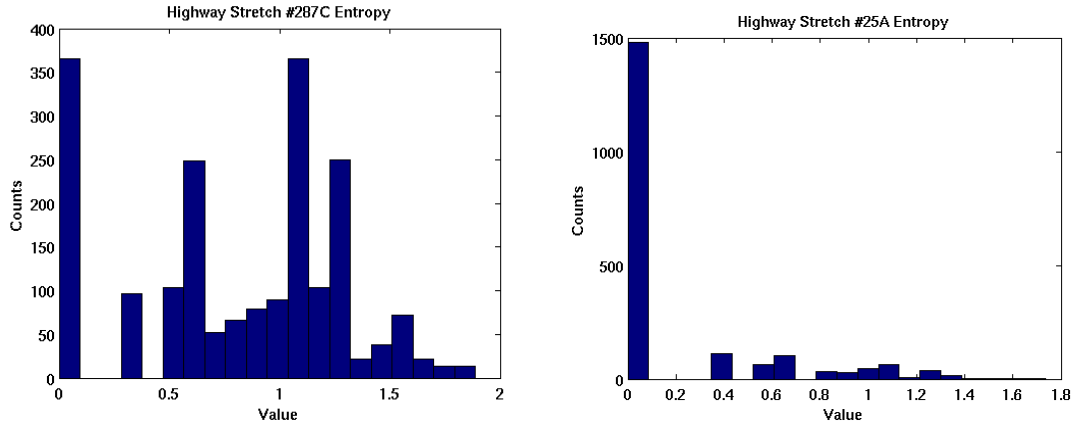
Fig. 7: Histograms of entropy computed for a moving 2D region for US 287 (left) and I-25 (right)

As a measure of disorder this parameter is particularly telling of the condition of the road surface. The left side of Fig. 7 shows a large spread again with a maximum about 1.2 in spite of values at zero. This variety of entropy values suggests that the surface is not at all uniform and that a great variety of conditions are present. However, the I-25 values are mostly at zero with again some off-zero values due to the presence of white lane markers in the analysis.

compared to Fig. 7. It is interesting that both of them show a range of very small peaks.

The entropy histogram of the 2001 paved surface in Fig. 14 has a peak at about 1.25 with other significant peaks at values stretching from 0.4 to 2. A comparison with the poor road surface conditions of the 1998 maintained US 287 in Fig. 7 show some surprising results. The older surface of US 287 still exhibits a large peak at 0 suggesting that in some ways this older surface is in better condition than that of the 2001 paved I-25 surface, which does not have very many values near zero. Again, there is a suggestion here that these texture statistics could be used to infer conditions of the road surface relevant to whether or not they need repaving.

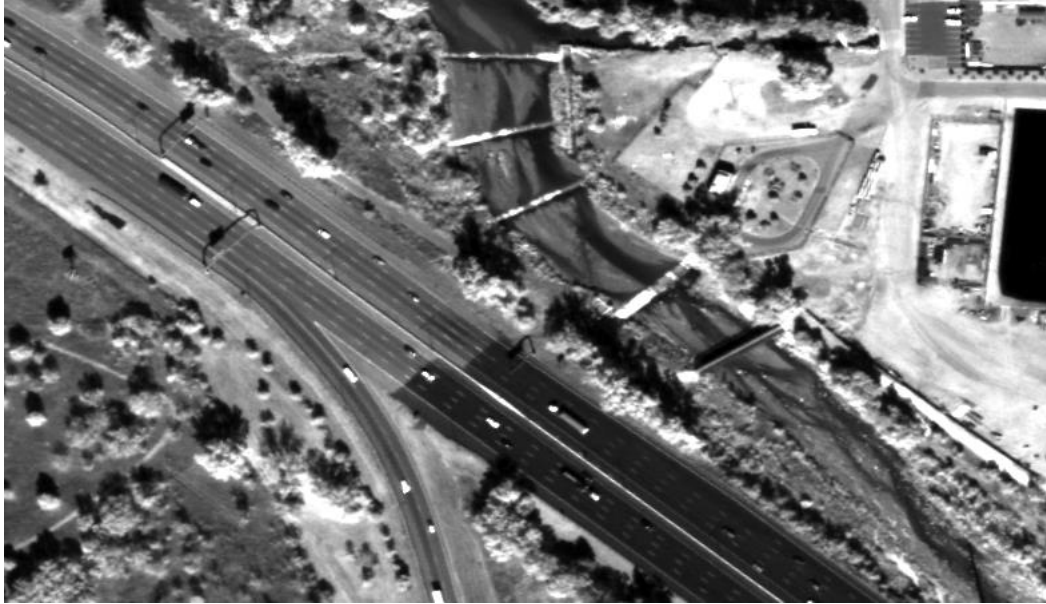
Fig. 8: Quickbird 60 cm panchromatic image of I-25 south of Colorado Springs.

The dramatic change in appearance of these road surfaces is due to a six-year difference in paving. The darker homogeneous surface was repaved in 2007 while the lighter degraded surface was repaved in 2001. This is a relatively short period to have a major degradation in surface condition. We selected portions of this roadway for our statistical analysis as shown here in Fig. 9.

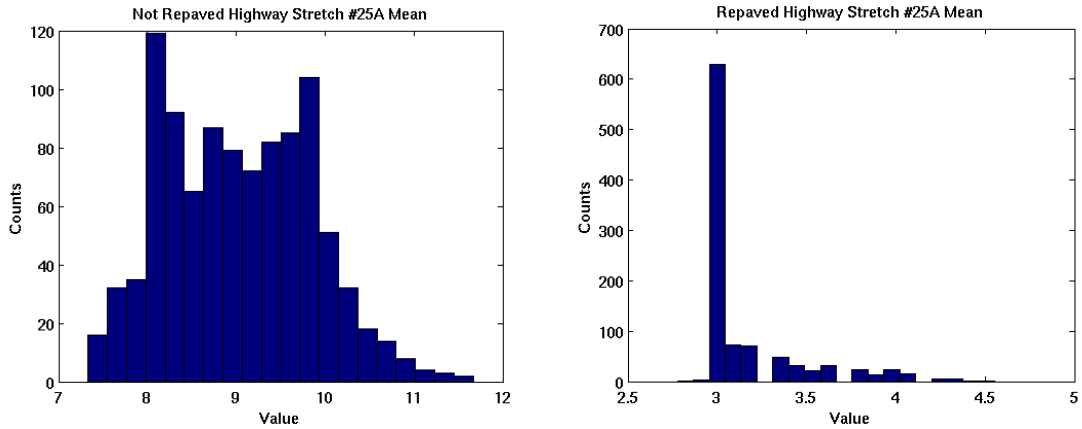
Fig. 10: Histograms of the mean reflectance from two segments of I-25 south of Colorado Springs. The 2001 paved surface is on the left while the 2007 paved surface is on the right.

Here the 2001 paved surface is on the left and the 2007 paved surface is on the right. The degraded surface histogram on the left has a wide range of values with peaks at 8.1 and 9.9 while the good surface has only one peak at 3. The really surprising thing here is that the histogram of the good surface of I-25 on the right is similar to the histogram on the right of Fig. 3, which is also from I-25 but much farther north. The main difference here is that the peak in Fig. 8 right is at 3 while the previous peak in Fig. 3 right is at 2. This might indicate that the better I-25 surface here has degraded slightly for the 2007 paved surface when compared with the 2011 farther north. At the same time, the histograms of the 2001 surface and the 1998 paved surface of US 287 (Fig. 3 left) are very different which suggests that roads degrade differently. However, both Fig. 3 and Fig. 10 left panels exhibit large ranges in values that demonstrate the degraded highways.

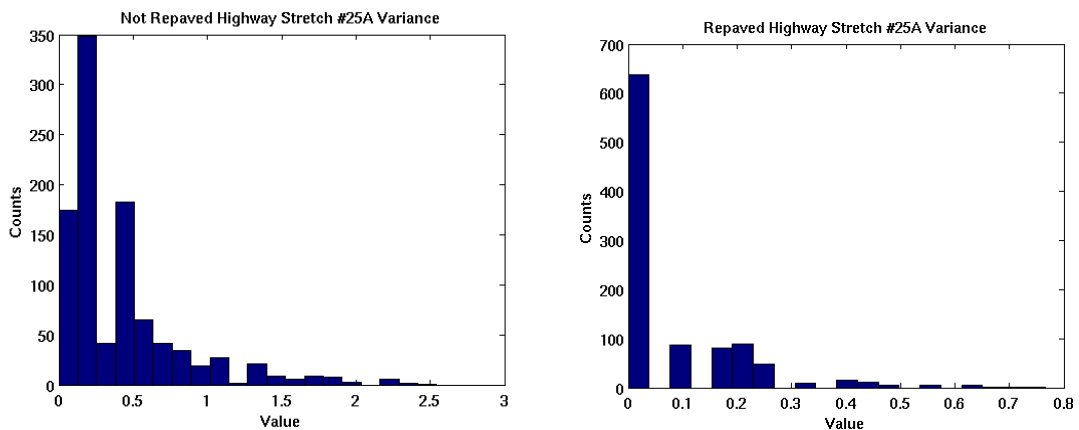
Fig. 11: Histograms of the variance of surface texture for the 2001 I-25 surface (left) and the 2007 I-25 surface (right).

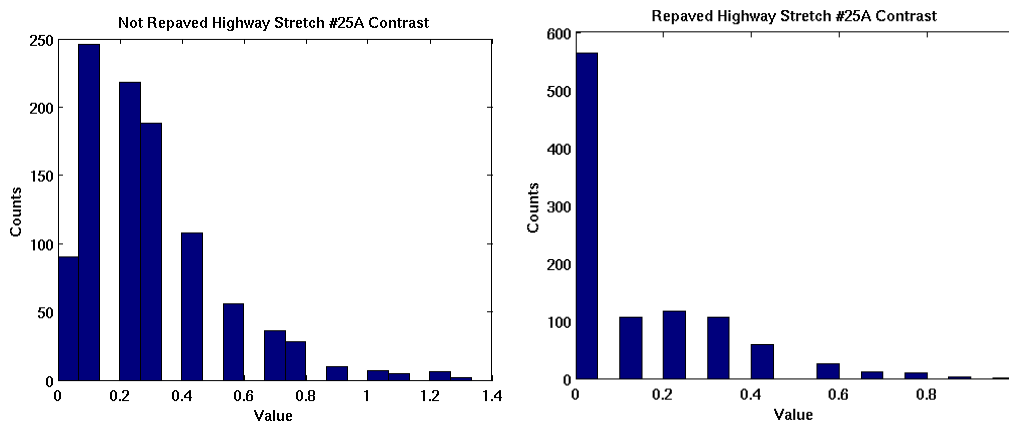
Fig. 12: Histograms of reflectance contrast for the 2001 paved segment of I-25 (left) and the 2007 paved segment of I-25 (right).

Here again, we see a very large peak near zero in the more recently paved portion of I-25 (Fig. 12 right) and a series of large peaks for the 2001 paved portion of the same highway (Fig. 12 left). In fact, the peak close to zero on the left is much smaller than that of four other peaks, which range up to 0.43. In addition, the histogram on the left of Fig. 12 ranges all the way up to 1.35. A comparison of the right panel of Fig. 12 with the right panel of Fig. 5 shows some very interesting differences. While the peak is again near zero there are a series of larger peaks strung across the x-axis up to about 0.6, which cannot be explained by the presence of white lane markers. These histogram peaks may indicate the degradation that must have occurred in the 2011 paved surface of I-25 in Fig. 5 versus the 2007 paved surface of the same highway in Fig. 12.

There is again a very marked difference between the left and right panels with a number of higher histogram peaks in the left panel indicating the increased road surface deterioration in the segment of the road paved in 2001. More comparisons of this kind can likely develop in to an algorithm that could be used to indicate conditions leading up to a paving decision.

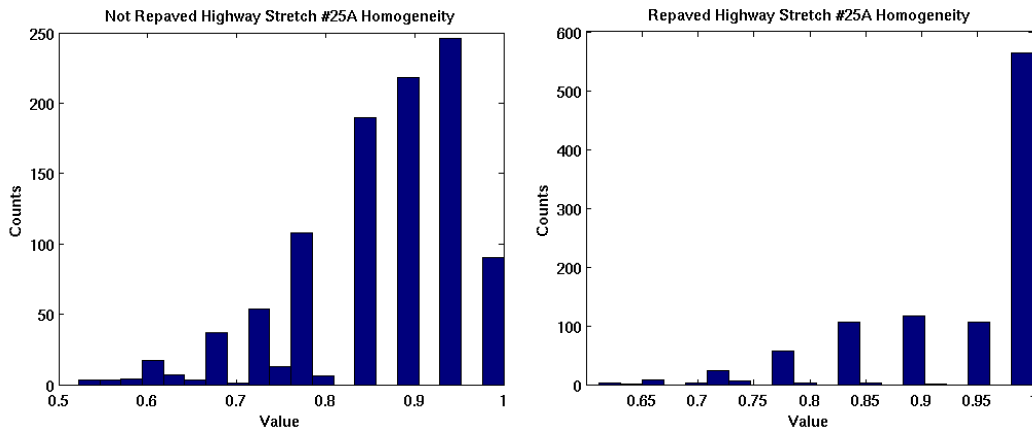
Turning to homogeneity, the histograms in Fig. 13 again show the difference between these two surfaces. As suspected, the right panel of Fig. 13 shows a

Fig. 13: Histograms of texture homogeneity for I-25 paved in 2001 (left) and paved in 2007 (right)

There are significant differences again between the right and left panels of Fig. 13 that are consistent with the degradation of the 2001 paved surface. A comparison of left panels in Fig. 13 and Fig. 6 do clearly suggest much worse surface conditions of the US 287 road consistent with its last maintenance in 1998 compared with the 2001 paving of the surface on the left of Fig. 13.

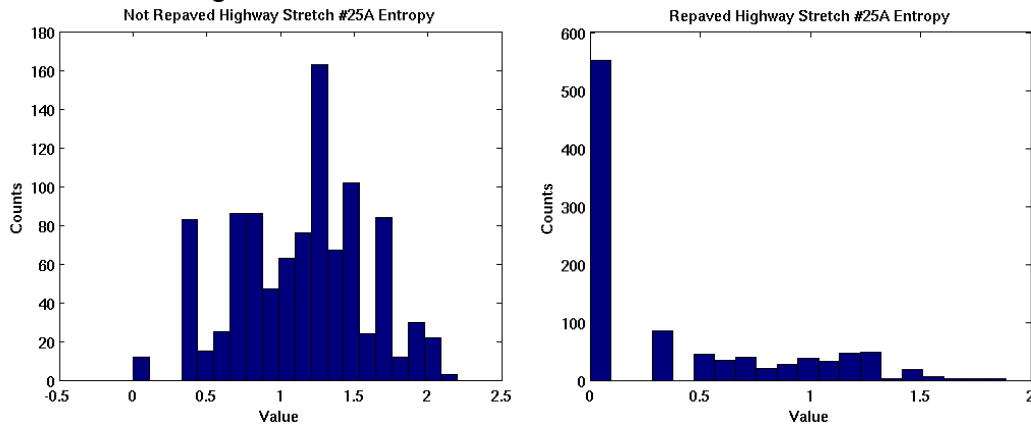
Fig. 14: Histograms of texture entropy for I-25 paved in 2001 (left) and paved in 2007 (right).

Here again, the entropy shows a dramatic difference between the more recently paved portion and that paved back in 2001. Since entropy is a measure of disorder, you want the value to be near zero, which is the case for the 2007 paved surface on the right of Fig. 14. A comparison with the right panel of Fig. 7 suggests the difference between the 2007 paved surface and the 2011 paved surface. Here the differences aren't as great as they were in other statistical parameters, but there are still some higher peaks at larger values in Fig. 14 when

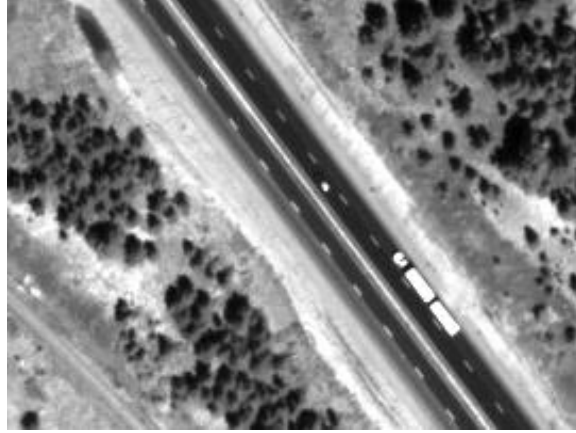
As can be seen in the image of Fig. 15, the poor condition of this right eastbound lane visually differs from the left eastbound lane and both of the west bound lanes.

Fig. 15: Worldview 1 panchromatic image of I-70 just to the west of Vail Pass.

In fact the right eastbound lane is only slight darker than the shoulder of the highway. We selected the regions of interest for good and bad pavement as shown here in Fig. 16.

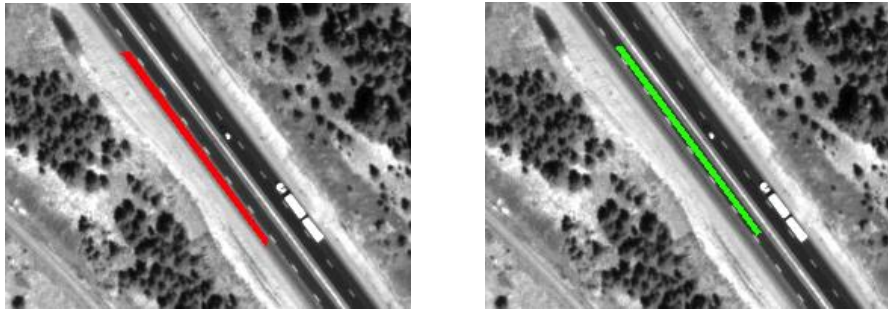
Fig. 16: Regions of interest for statistical computations of the poor road surface (red) on the left and the good road surface (green) on the right.

We have used the two eastbound lanes rather than mix between east and westbound lanes. We unfortunately do not know when the left eastbound lane was last paved nor when the right (poor condition) eastbound lane was paved. Hopefully upon receipt of this report, CDOT will provide us with those dates so that we can update the report.

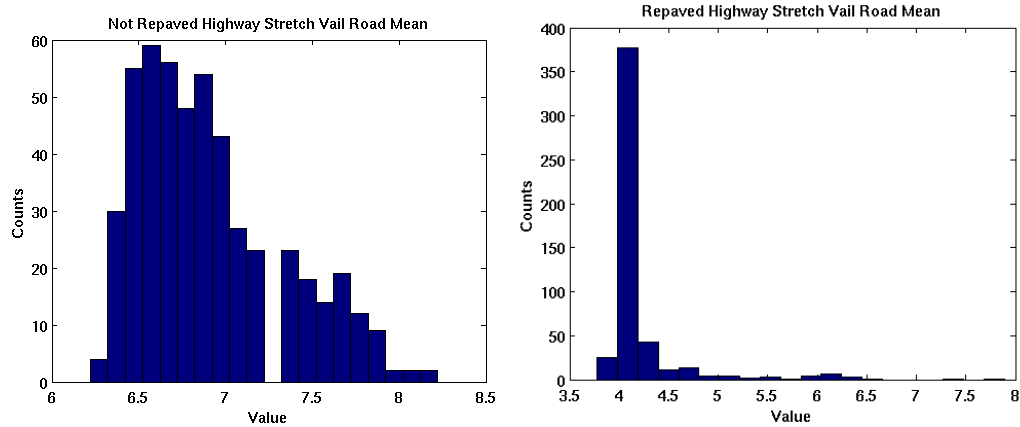
Fig. 17: Histograms of texture mean reflectance from the right eastbound lane of I-70 (left) and the left eastbound lane of I-70 (right).

Again there is a dramatic difference in these statistics. The "poor" surface values are all greater than the peak value of the "good" surface. In addition, the "poor" surface histogram has a very large range of values with peaks ranging from 3 to 8. It is this range of higher histogram values that seems to be very characteristic of poor road surfaces. The good surface has a single large histogram peak at about 4.1. Comparison between this good histogram with previous mean good histograms in Figs. 3 and 10 all show similar behavior with a single large peak but it is very interesting that the peak in Fig. 3 is at 2 for a road paved in 2011, in Fig. 10 is at 3 for road paved in 2007 and here in Fig. 17 is at 4 for a road that may have been paved prior to 2007. The mean histogram peak may suggest the progressive degradation of the road according to its age.

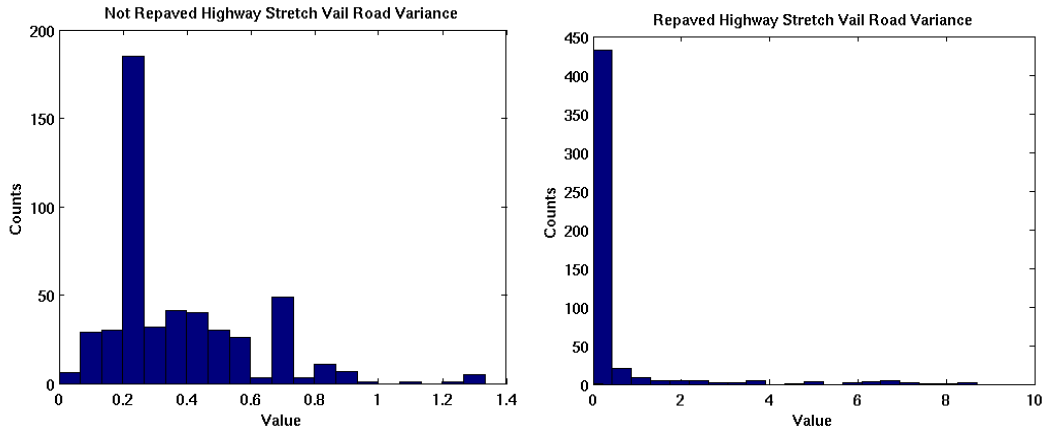
Fig. 18: Histograms of texture variance for the right eastbound lane of I-70 (left) and the left eastbound lane of I-70 (right).

As expected, the good surface condition on the right has a single large peak near zero. The poor lane has its largest peak at 0.2 but again the peaks are all spread over the range of values up to about 1. The right panel of Fig. 18 is very similar to the corresponding panels in Figs. 4 and 11 but the left panel is very different than the corresponding panels in Figs. 4 and 11.

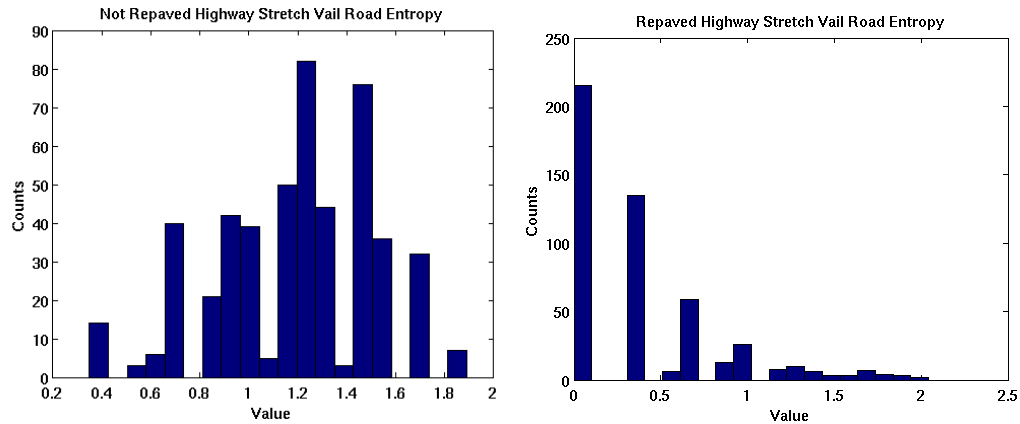
Fig. 19: Histograms of texture entropy for the right eastbound lane of I-70 (left) and the left eastbound lane of I-70 (right).

As before, the main entropy peak is near zero for the good surface (right) and is widely spread for the poor surface on the left. There are, however, a lot more peaks on the right at higher values than what appeared in any of the earlier entropies for good road condition. Since we do not know the date of repaving of the good lane, this might reflect that this date is not particularly recent. This was suggested by the earlier comparisons of the mean values that appear to be confirmed here by the entropy.

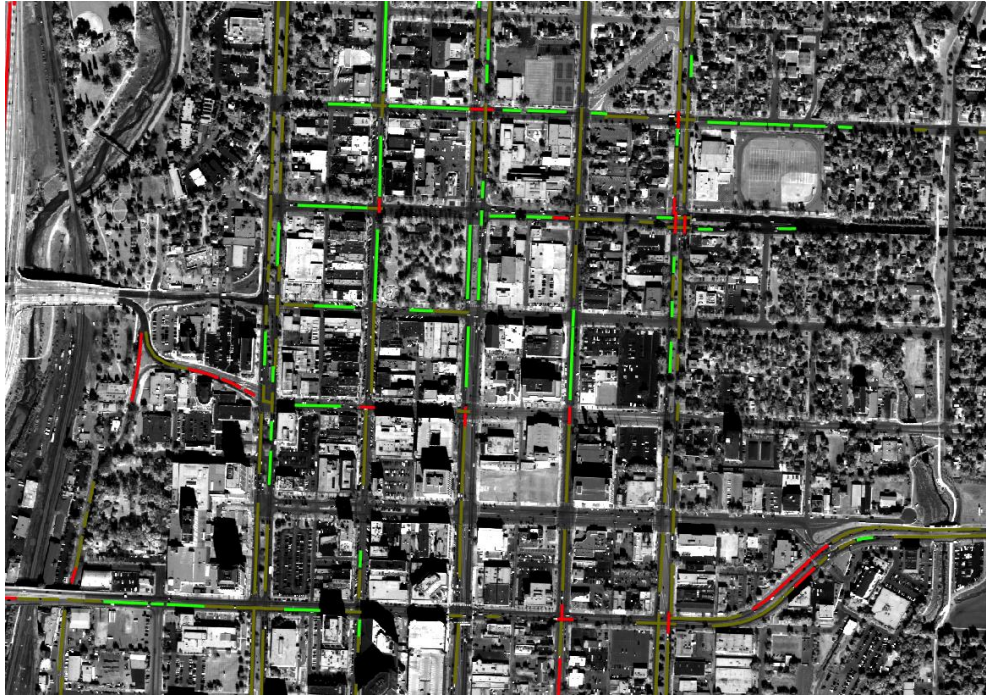
We did, however, carry out an analysis of the 2007 data set. Once again, we were frustrated in trying to regress the extracted satellite measurements against the *in situ* dataset. Realizing that much of this problem was due to scatter in the *in situ* dataset, we decided to again look only at the satellite data. But now, it was extracted along the polylines that describe the tracks of the vans collecting data. Linear statistics along these lines were used to classify the conditions of the road surfaces. We basically had three classes: good condition (bright green), poor (red) and intermediate (olive drab). These classes were used to classify the roads in central Colorado Springs in Fig. 20. It can be seen that poor patches are juxtaposed to good and intermediate road conditions. This is typical of city streets, which are basically maintained according to citizen complaints about road conditions rather than by any predetermined maintenance schedule. Intersections are particularly susceptible to surface degradation as evidenced by the numerous red line segments at or around intersections.

It seems strange that the I-25 corridor has good, fair, and poor conditions but in light of the second case above, this is an expected condition depending on the road's paving history. It is very likely that these surface conditions can be directly linked to the past paving schedule. In Fig. 21, we present the same analysis for different parts of the satellite image that show similar features. Intersections are again the sites of poor surface conditions even when the road surface itself is in good condition. Here the I-25 surface exhibits largely poor (red) surface condition, but in the north of the image, the surface now appears to be in good (bright green) condition. Most of the rectangular crossing streets are in good condition with the caveat for the numerous intersections.

Fig. 20: Road surface conditions computed from a 60 cm resolution QuickBird image in 2007.
