Remote Sensing of Roads and Highways in Colorado

**Large-Area Road-Surface Quality and Land-Cover Classification Using Very-High  
Spatial Resolution Aerial and Satellite Data**

Quarterly Progress Report #5

Quarter from 10/01/2013 to 12/31/2013

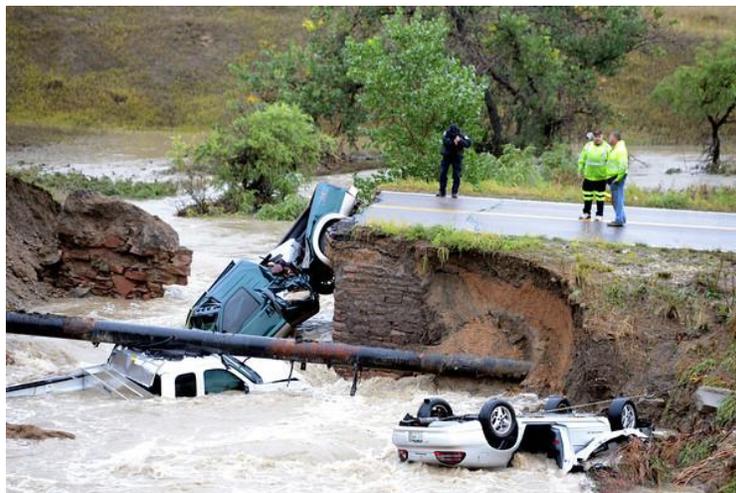
Fig. 1: A bridge collapse on a business access road at Highway 287 and Dillon Road In Lafayette causes three cars to fall into the creek on Sept. 13.

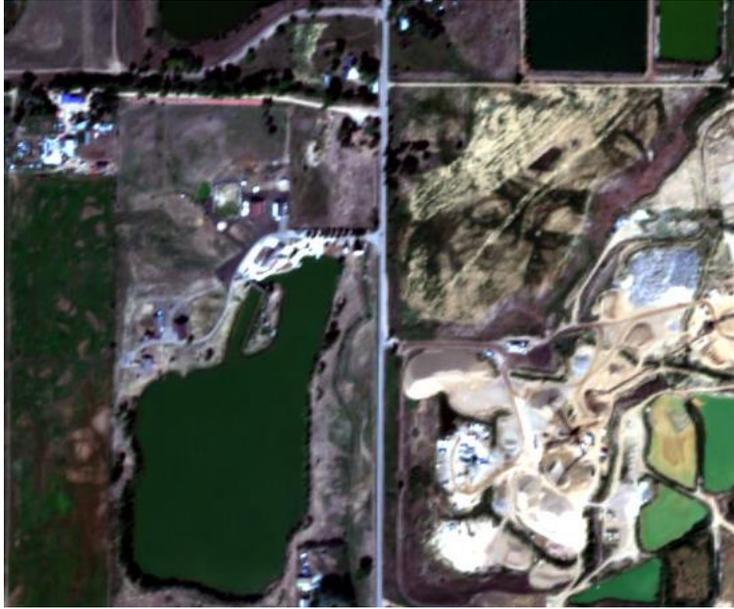
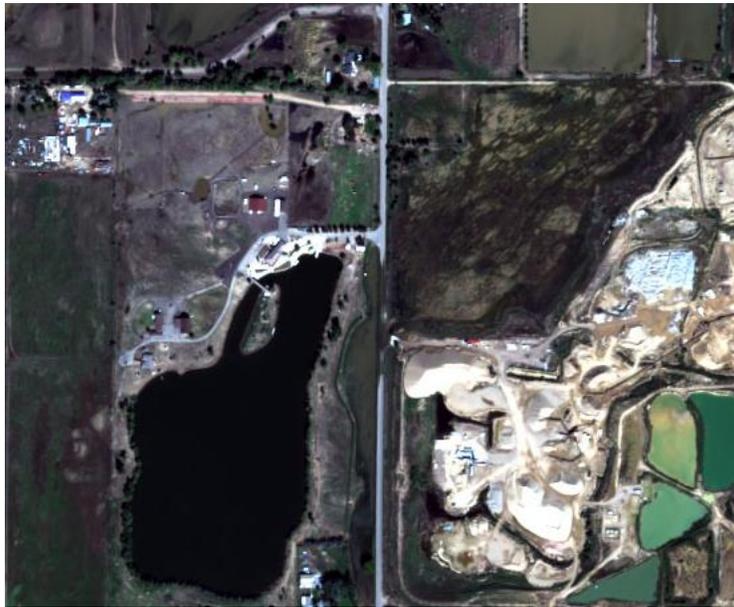
Fig. 2: Before the flood

Fig. 3: After the flood

It can clearly be seen here that the highway in the middle of the image was washed out in the lower half by the flood. Water has completely erased the road surface and the reflectivity now merely indicates the presence of water.

High-resolution (~2 m) satellite images clearly show these disruptions when comparing an image before the flood (Fig. 2) and after the flood (Fig. 3).

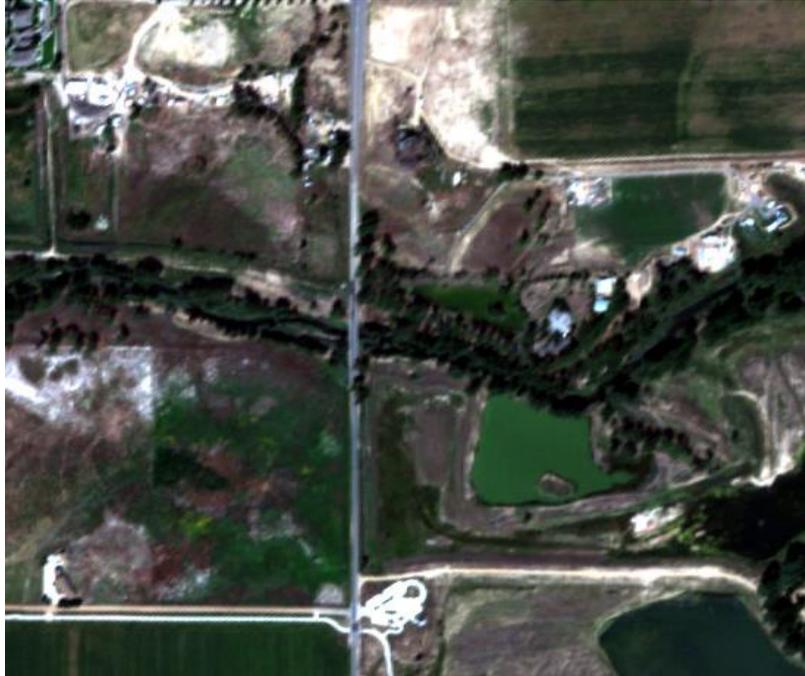
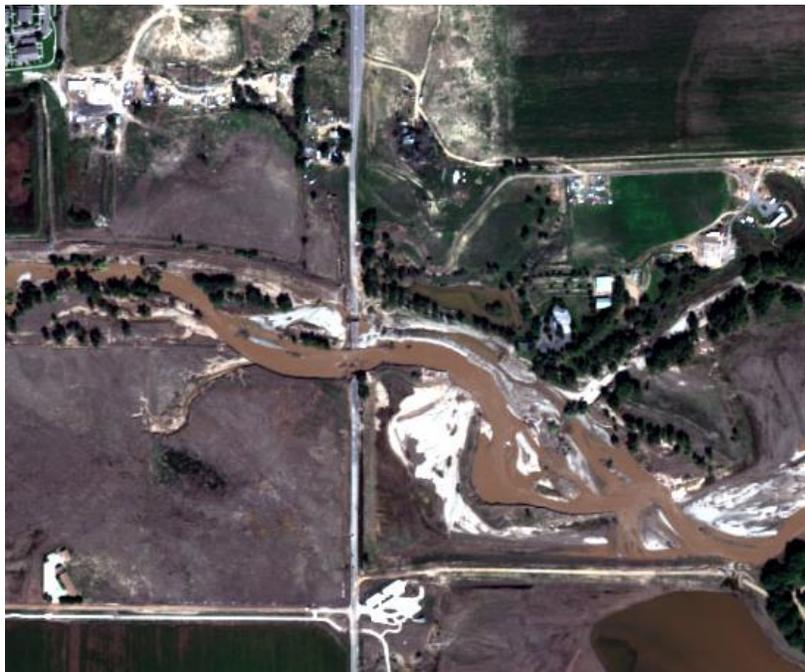
Fig. 4: Before the flood

Fig. 5: After the flood

In Figs. 4 and 5, one can see the destruction of a highway bridge as the river rerouted its path and flooded many regions downstream of the bridge. This was one of the more destructive effects of the flood which resulted in permanent rerouting of the river and the need for new bridges to be built or an effort be made to return the river to its original course. It is this type of destruction that led to scenes like that in Fig. 1. Again, these two high-resolution satellite images clearly depict the damage caused and suggest solutions that need to be considered.

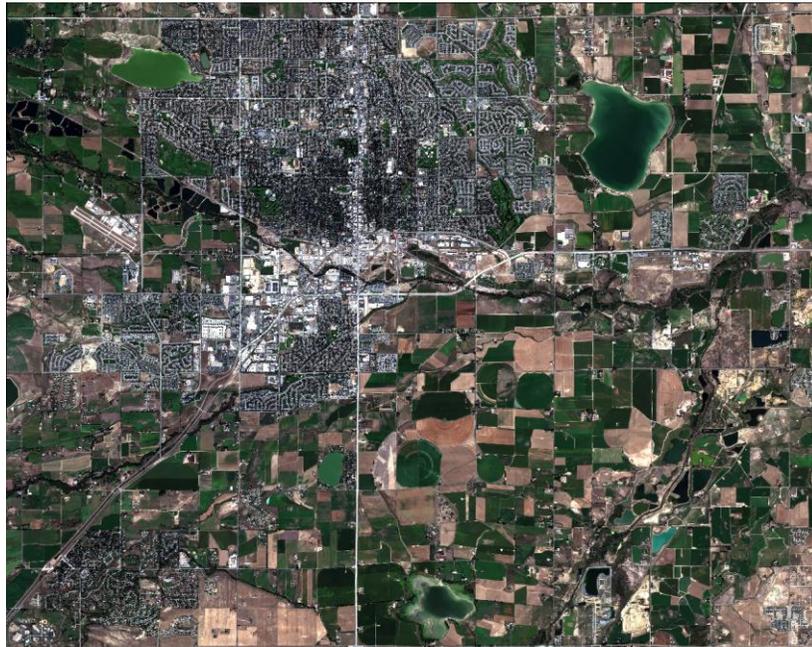
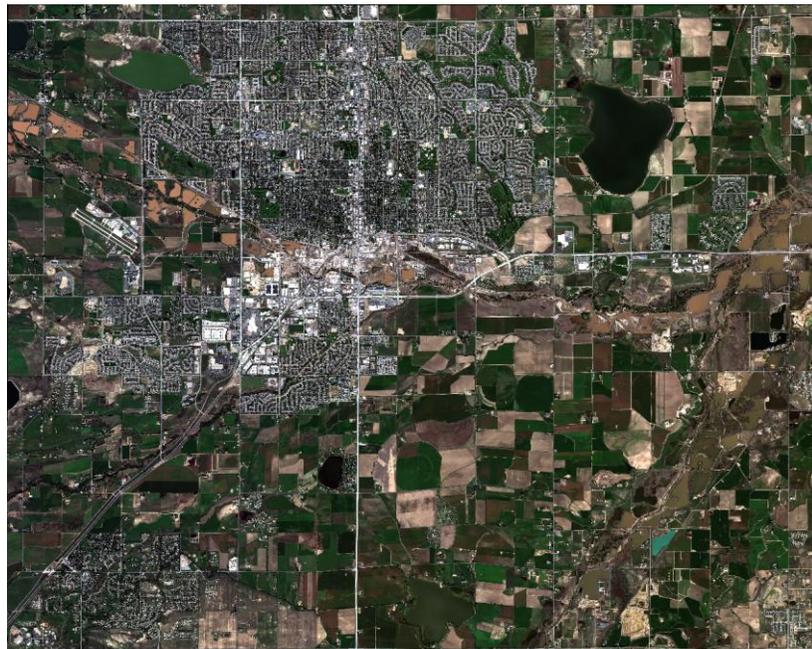
Fig. 6: Before the flood

Fig. 7: After the flood

These images cover part of the western side of Longmont, Colorado where east-west Colorado State Highway 119 intersects with north-south U.S. Route 287.

A change detection study of two satellite images from this period demonstrated the very marked changes from non-flooded (Fig. 6) to flooded conditions (Fig. 7).

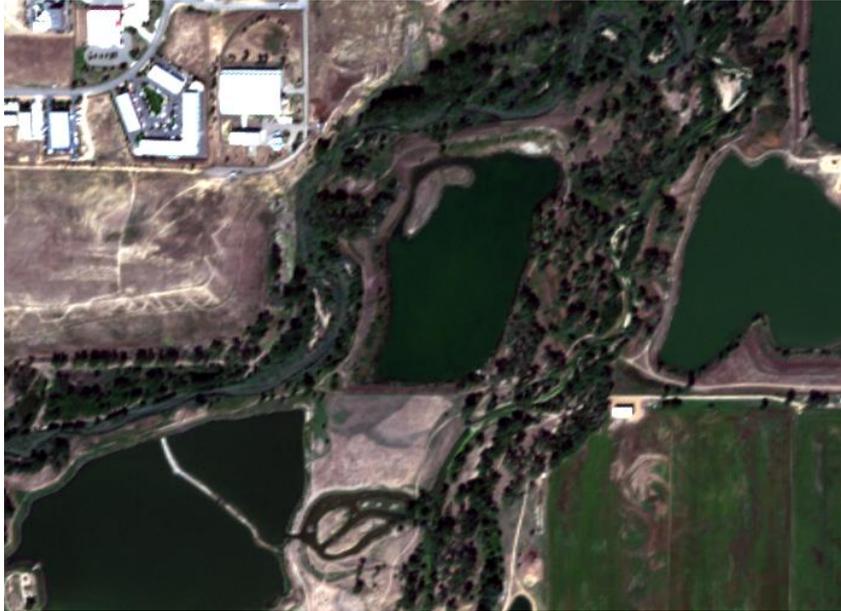
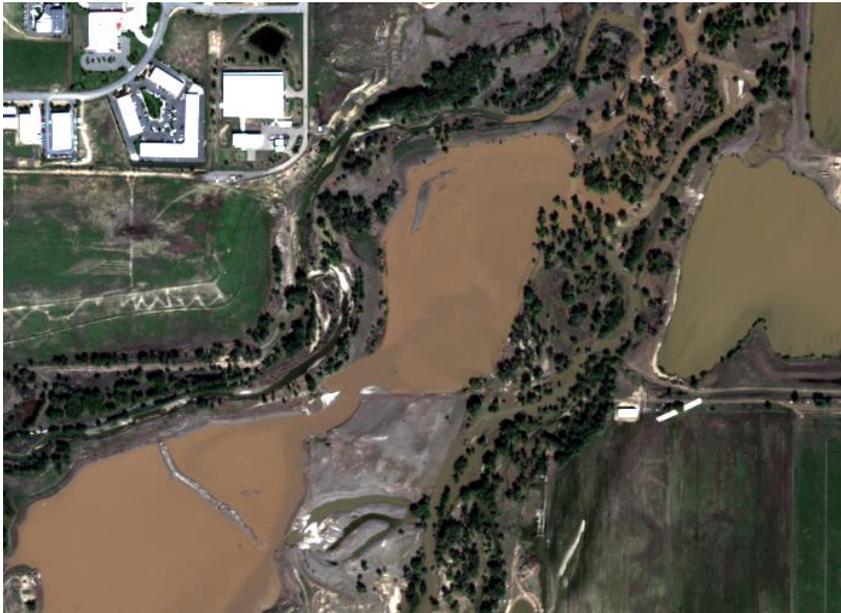
Fig. 8: Before the flood

Fig. 9: After the flood

Here, flooding is again readily apparent in the muddy water that now connects the two central lakes and has expanded their boundaries. The other lake in right hand side of the image has also changed to muddy water. Using Change Vector Analysis (CVA), the changes between these last two images were classified. In this algorithm, the changes are resolved in 2D vector space to normalize the changes. Using image reflectances to compensate for solar illumination, the CVA analysis was carried out between Fig. 8 and Fig. 9. The results are shown here in Fig.

Due to the computational complexity of classifying these large high-resolution images, smaller image segments were selected and analyzed for surface changes due to flooding. One such image segment is shown in Fig. 8 before the flood and in Fig. 9 after the flood.

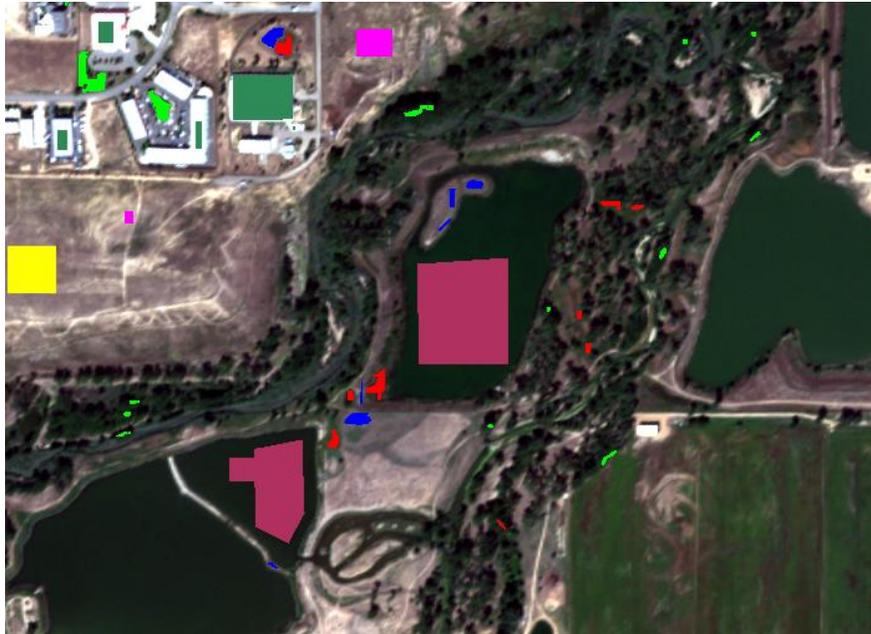
10, where changed areas are marked by specific colors. The legend to these changes is also given in the figure. In most cases, the changes are to water but in some soil areas, the immediate response to being soaked was a rapid response to vegetation. This is typical of Colorado where the generally dry soil transitions quickly to vegetation when water is applied particularly in large amounts.

Red:	veg2wat
Blue:	soil2wat
Green:	veg2veg
Magenta:	soil2soil
Cyan:	wat2wat
Sea green:	roof2roof
Yellow:	asph2asph

Fig. 10: The “before” satellite image with colors marking the “after” changes

There is, however, asphalt (parking lot) that does not change and remains asphalt.

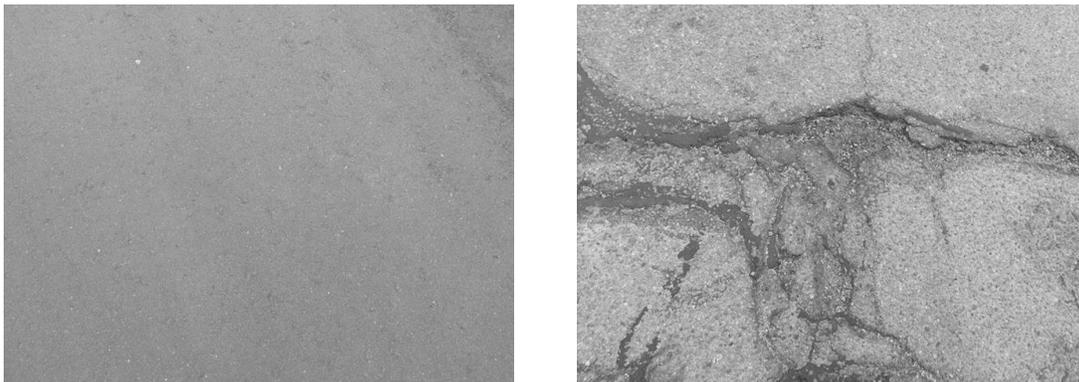
Fig. 11: Parking lot images, good pavement on the left and poor pavement on the right

Notice the relatively smooth appearance of the good pavement compared to the speckled and distressed appearance of the poor pavement.

These texture filters were initially applied to the full digital images shown here in Fig. 11. Looking first at the digital numbers before applying the texture filters, we find that even here there are some marked differences between the good and poor parking lot surfaces.

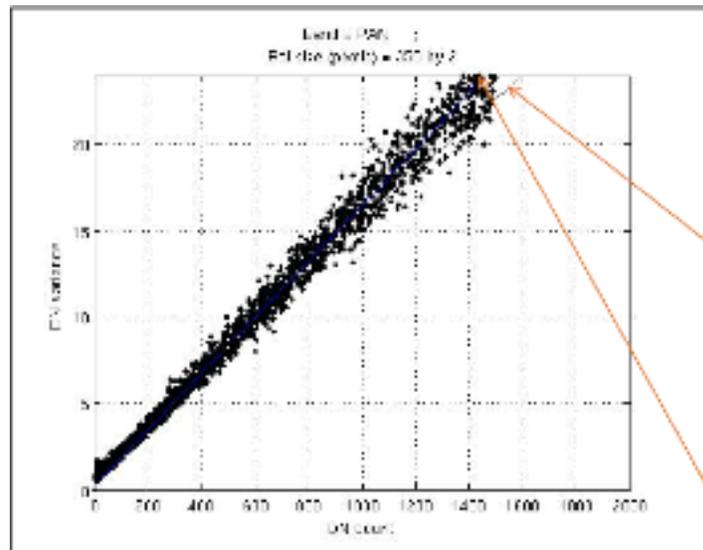
Fig. 12: WV-2 DN Variance vs. DN Count.

The next step was to add noise to these 7x5 images representative of the noise characteristics of the WV-2 sensor. The WV-2 images provided by DigitalGlobe have 11-bit digital number (DN) values. Brighter landscapes have higher DN values and darker landscapes have lower DN values. Experiments conducted by scientists at DigitalGlobe have determined that the noise variance associated with DN is linearly proportional to DN itself. To measure the sensor's noise, the WV-2 radiometer was pointed at a cloudless scene of free space between the Moon and the Earth. The DN values in the two-dimensional image of this scene are constant in the horizontal direction but continuously varying in the vertical direction. Sample image chips were collected along the horizontal direction at different vertical positions. The DN variances and DN means of each chip were obtained and plotted against each other. The results of one trial are shown in Fig. 12 below.

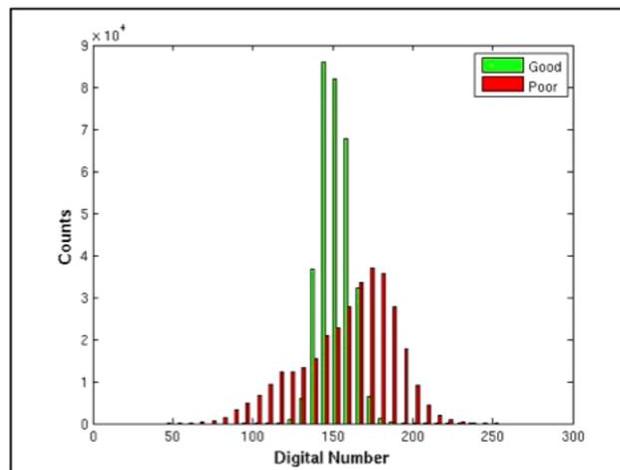
Fig. 13: Histogram of DN values for both surfaces.

Note the dramatic difference between the poor histogram with its wide spread in values versus the good histogram which has a much more limited range of values.

While the spread of the good histogram is much greater than that in Fig. 13, it is again located in the center of the DN range at numbers very close to those in Fig. 13. Qualitatively, the Fig. 13 and 16 are very similar.

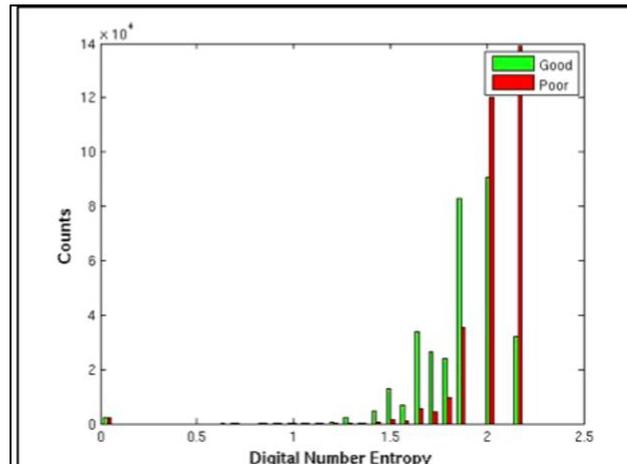
Fig. 14: Image entropy Histogram

good mean histogram also has a narrow distribution and the poor mean histogram also has a wide distribution. The variance (not shown) reveals a very high histogram for the good image at the lower values suggesting a relatively uniform response for the smallest scales. The poor pavement surface has a slightly wider range but also falls off exponentially as the bins get higher. Turning to entropy, we find in Fig. 14 that the good pixels overall have lower values than the poor pixels, which stand out at the highest bins. This is again consistent with the poor surfaces linking to high entropies and the good surfaces corresponding to low entropies.

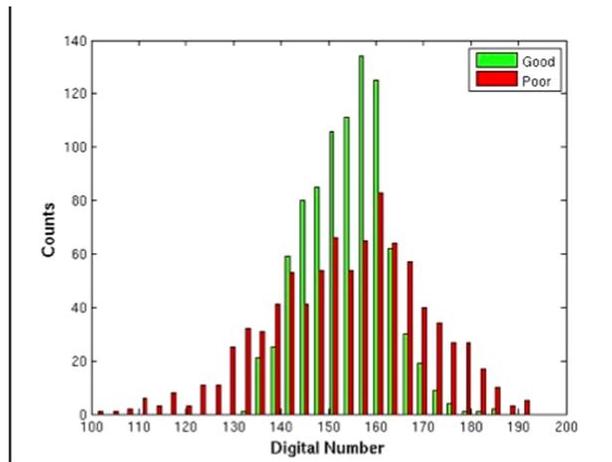
Fig. 16: Histograms of synthetic satellite image DNs.

The DN histogram is presented here in Fig. 16 using the same labels as in the previous histograms.

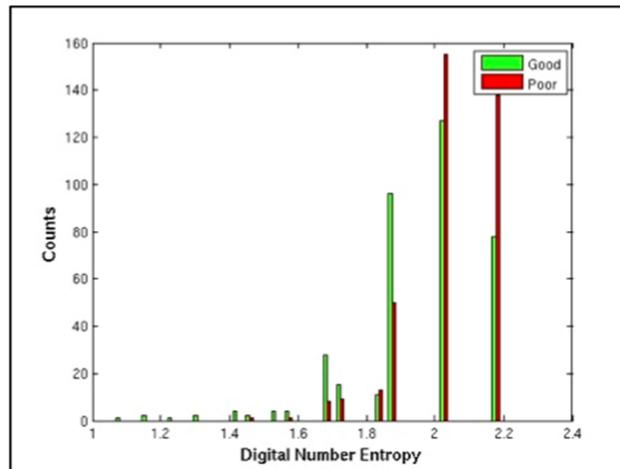
Fig. 17: Histograms of synthetic image entropies.

Once again, the mean histograms of the lower resolution histograms (not shown) look very similar to the histograms of the DN values, like what was seen in the higher resolution example. The variance (not shown) is also very similar between these two different resolutions. Finally, the entropy histograms of Fig. 17 look similar to the same entropy plot for the high-resolution images in Fig. 14. Again, the poor pavement histogram has very high peaks at the largest bins while the good surface histogram peaks spread out over a much larger range and have overall lower values.

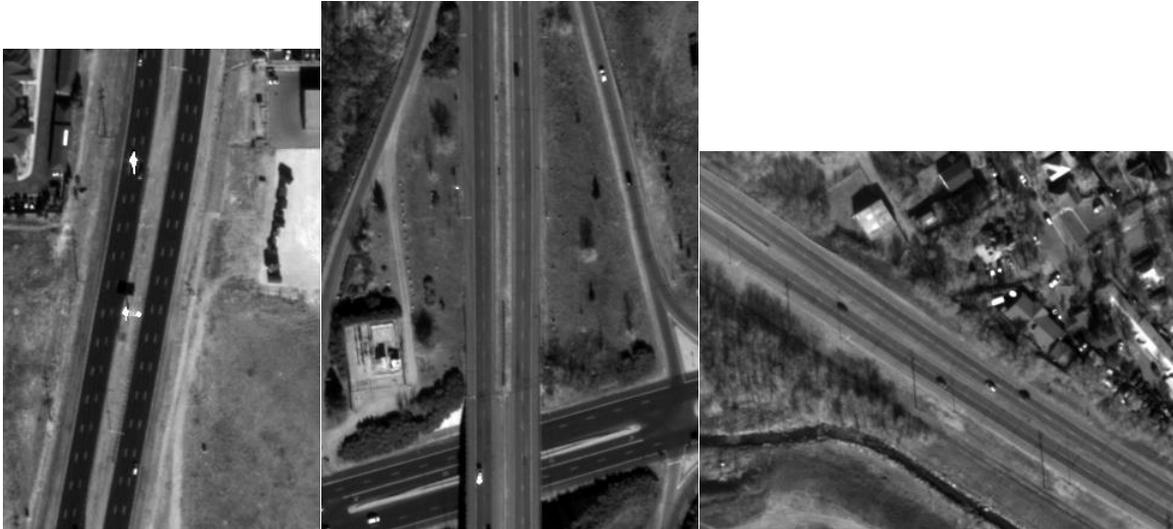
Fig. 18: From left to right, 21B, 115A, and 24A

The roads that were examined in this study are located around Colorado Springs. They are segments of highway stretches 21B, 115A, and 24A (Fig. 18). They have been rated by CDOT as having conditions of good, fair, and poor respectively. The remotely sensed images were collected by WorldView-2 last year around Thanksgiving. The aforementioned highways are shown below.

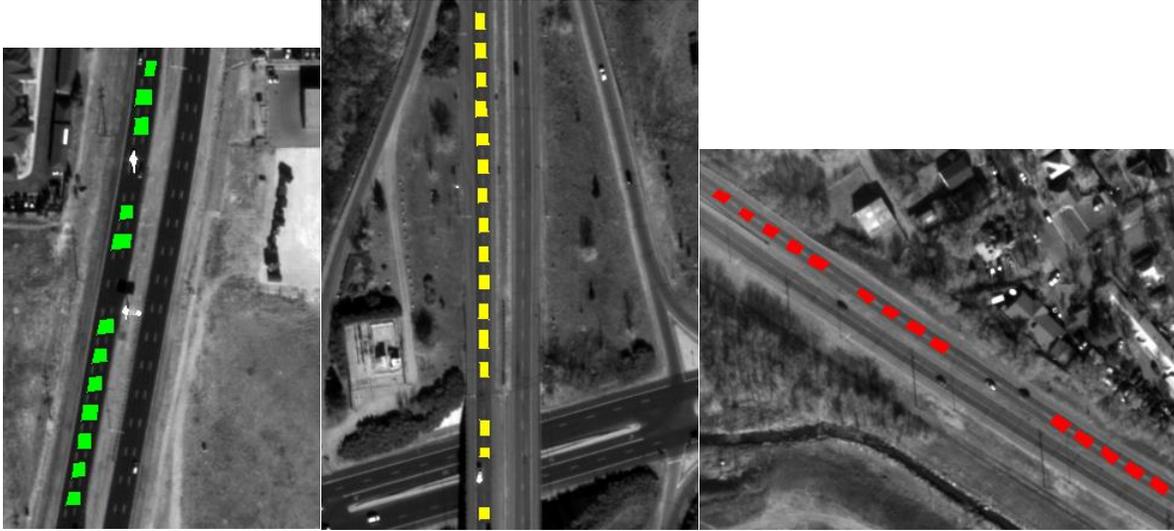
Fig. 19: From left to right: 21B, 115A, and 24A ROIs

We selected Regions of Interest (ROIs) from these images to study. We were a bit more meticulous than before regarding which parts of the roads were selected. We avoided objects that obviously weren't part of the roads like vehicles and shadows. Another test case that we previously worked on showed that the paint lines throw off the statistics. So by avoiding the paint and other non-road surface image elements only the pavement was looked at. The pictures below show the ROIs laid over the roads (Fig. 19).

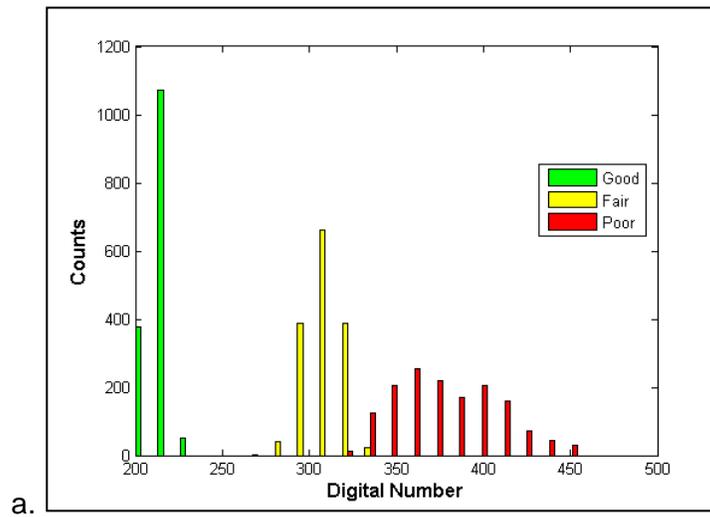
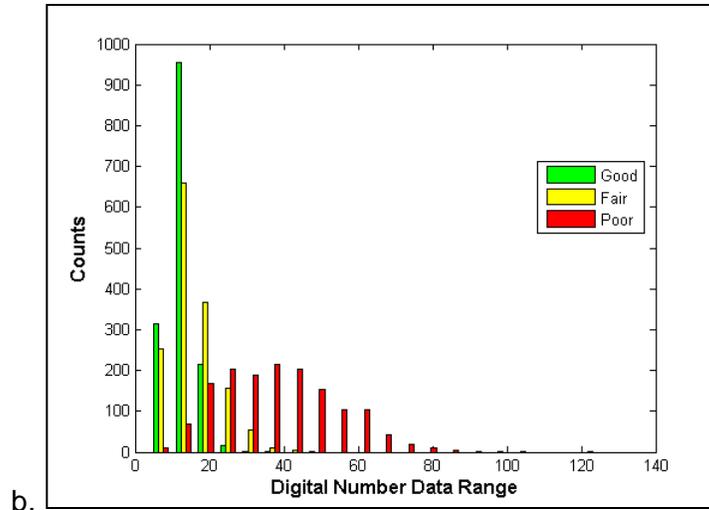
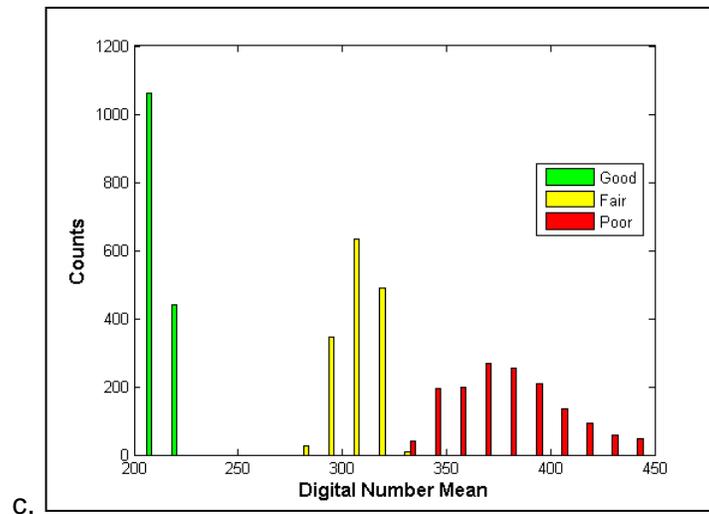
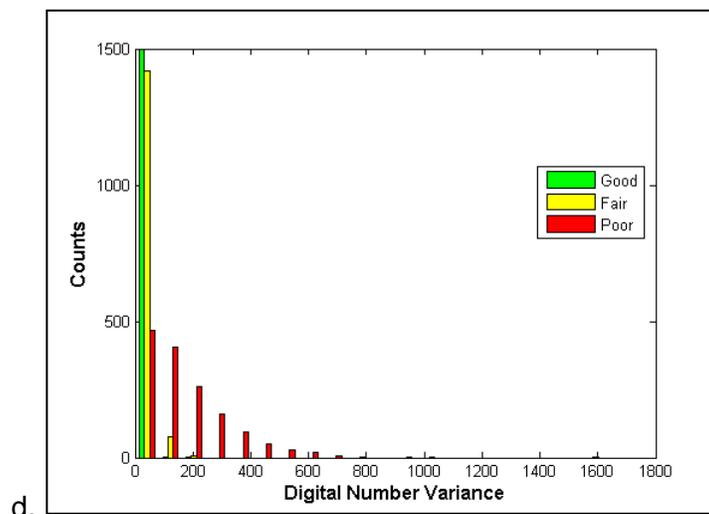
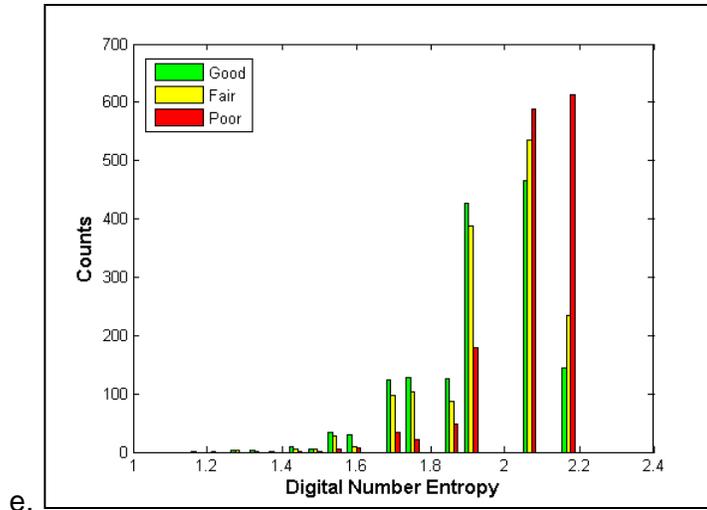
Fig. 20: Histograms of (a) DN, (b) data range, (c) mean, (d) variance, (e) and entropy

We extracted the digital numbers contained within the pixels underneath the ROIs. We also applied the occurrence-based texture filters to these images and extracted data from those same pixels. There were about 1600-1800 data points for each road segment, so we just randomly selected 1500 from each segment. We plotted the data from each texture parameter as histogram shown below (Fig 20).

Once again, the results suggest that as a road's condition worsens, its appearance becomes more heterogeneous. But these results are even stronger than what we had before. In the previous analyses, we were only comparing good and poor. But here, we have the intermediate fair condition. In every single one of the texture parameters, the fair data lies between the good and the poor, which is what should happen. Hence we believe we should be able to detect and define Good, Fair and Poor road surface conditions based on WV high-resolution satellite imagery. The next step will be to work with CDOT to develop some test cases where the satellite imagery can be used to determine conditions that are then confirmed by in situ sampling and CD field analyses.
