MAPPING ASPHALT ROAD CONDITIONS WITH HYPERSPECTRAL REMOTE SENSING

Martin Herold ^a and Dar A. Roberts ^b

KEY WORDS: remote sensing, imaging spectrometry, asphalt road survey, hyperspectral, AVIRIS

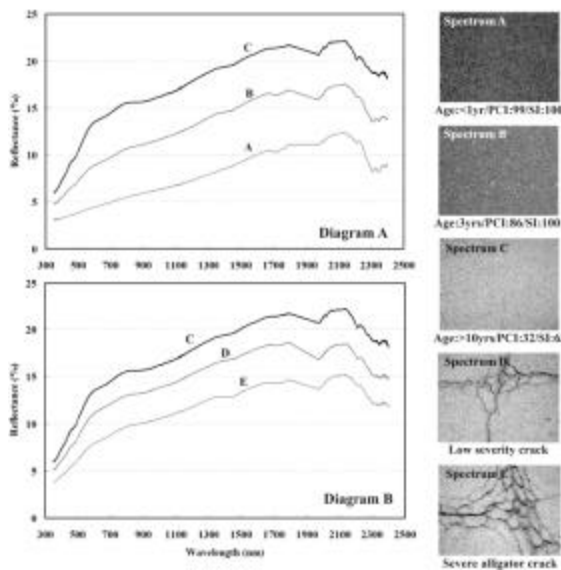
Figure 1: Spectral effects of asphalt aging and deterioration from the ASD ground spectral measurements. The individual road surfaces of Diagram A are labeled with age, Pavement Condition Index (PCI) and the Structure Index (SI) from the Roadware vehicle observations. Diagram B compares Spectrum C with surfaces (same PCI and SI) with different severity cracking (the major water vapor absorption bands are interpolated).

For the first time we were able to provide spectral evidence for the aging and degradation processes of in-situ asphalt pavements (Figure 1). New asphalt pavements are dominated by hydrocarbon absorptions. Pavement aging and erosion of the asphalt mix results in a gradual transition from hydrocarbon to mineral absorption characteristics with a general increase in brightness and changes in distinct small scale absorption features. Structural road damages (e.g. cracks) indicate a somewhat contrary spectral variation.

Cracking decreases the brightness and emphasizes hydrocarbon absorption features. In cracks deeper layers of the pavement with a higher content of the original asphalt mix are exposed, which results in increased expression of hydrocarbon absorption features. An aging road surface becomes brighter with decreasing hydrocarbon absorptions while structural distresses lower reflectance but increase the expression of hydrocarbon features. However, the reflectance difference and intensity of the hydrocarbon absorptions is less for cracks than for new asphalt surfaces

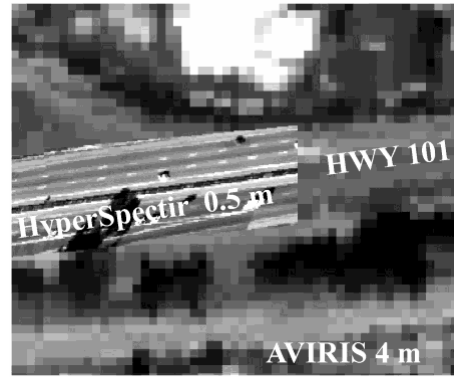
Figure 2: Visual different between AVIRIS (4 m) and Hyperspectir (0.5 m) data emphasizing expected limitations due to the spatial resolution configurations.

The exploration of remote sensing mapping capabilities assessed two imaging spectrometers with different spatial resolutions (AVIRIS data – 4 m; HyperSpectir – 0.5 m). The study used a band difference in the visible region (spectral difference between the bands at 830 nm and 490 nm - VIS2-difference) and the local spatial variance to compare the remote sensing signals to in-situ pavement performance observations. Fine spatial resolutions are essential for the mapping of road deterioration. The GIFOV should be finer than 4 m and potentially as fine as 0.5 m for detailed road condition observations (Figure 2).

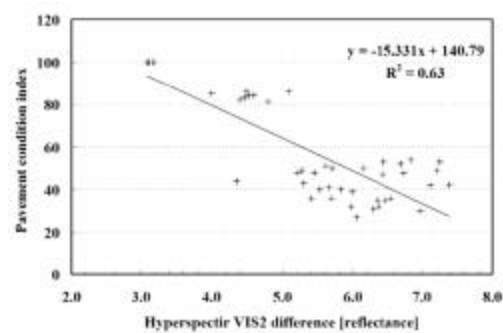
Figure 3: Comparison between Hyperspectir VIS2 difference values and the Roadware Pavement Condition Index (PCI).

The reflectance difference of the HyperSpectir data was compared to the Pavement Condition Index - PCI ($R^2 = 0.63$) and showed that imaging spectrometry has potential for representing road conditions (Figure 3). The relationship between the remote sensing signal (image band difference) and the PCI is strong for roads in good conditions but declines for lower quality roads. Roads that required no management action could be discriminated from roads that do. Currently, the algorithm is not able to discriminate between management actions (i.e., maintenance versus rehabilitation).

The statistical relationship shown in Figure 3 is strong enough to estimate a PCI from the HST difference (Figure 4). The PCI patterns highlight recently paved roads with high values (blue colors). Road surfaces in poorer condition show lower PCI values (and higher variability yellow – green colors). Specific

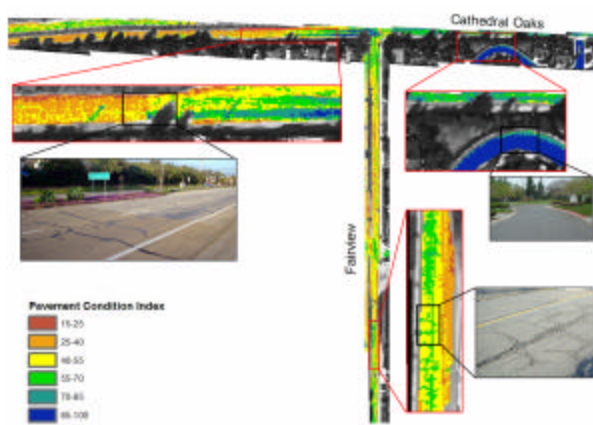
Figure 4: Spatial distribution of Pavement Condition Index derived from Hyperspectir data.

cracking patterns are revealed in the highlighted area of Fairview. The cracks appear with relatively higher PCI values. This again is due to the contrary spectral contrast of cracks versus aging. Considering scatter in the relationship between the difference and the Roadware PCI for older surfaces, PCI estimates for older surfaces should be viewed with some caution before labeling roads as in poor condition. If the estimated PCI is high it is highly likely that the road is in good or very good condition. Obviously, the current mapping algorithm can clearly identify high quality pavement. However, both the “common practice” methods (PMS, in-situ vehicle inspections) and the remote sensing analysis are effective in identifying roads in good and very good condition. The variance and uncertainty in the data significantly increases for road surfaces in poor condition. Only the expert in-situ observations can be considered a reliable differentiation between roads that need i.e. rehabilitation versus replacement. The broader issue in this context is that pavement health estimation of low quality road surfaces is a complex science and art. There are about 40 different physical pavement properties listed in the international pavement condition rating manual (ASTM D6433, 2003). Some of these refer to visual characteristics, while others address subsurface conditions (e.g. depths of cracks and small distinct scale variations within cracks) that all surface sensors (Vehicle observations or remote sensing) are currently unable to do. In summary, road condition mapping from imaging spectrometry has potential. It is not likely that remote sensing will replace field inspection, but the spectral signal is an additional level of information not considered in other pavement assessment methods and it can offer insights into surface conditions and other aspects that the inspector cannot evaluate except with considerable labor.
