Spectral characteristics of asphalt road aging and deterioration: implications for remote-sensing applications

Martin Herold and Dar Roberts

We integrate ground spectrometry, imaging spectrometry, and *in situ* pavement condition surveys for assessment of asphalt road infrastructure. There is strong spectral evidence for asphalt aging and deterioration. Several spectral measures derived from field and image spectra correlate well with pavement quality indicators (e.g., a pavement condition index). However, the potential for mapping is limited by fine spatial resolution requirements (as fine as 0.5 m) and by the spectral confusion between pavement material aging and asphalt mix erosion on the one hand and structural road damages (e.g., cracking) on the other. © 2005 Optical Society of America

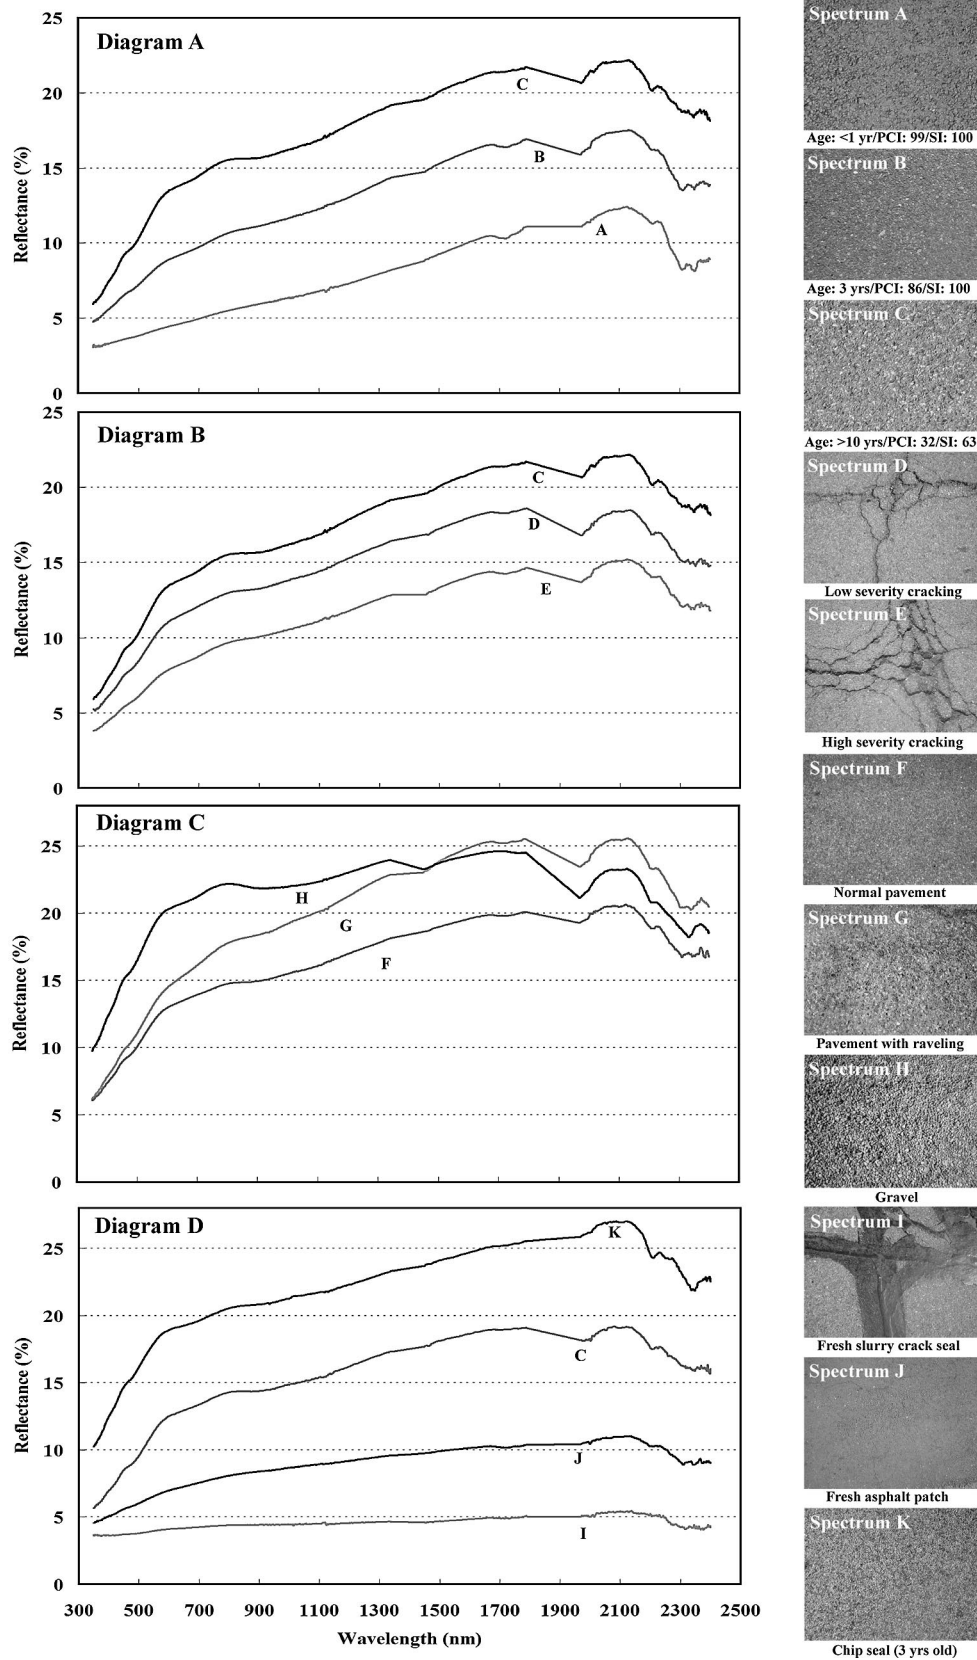
Fig. 1. Spectral effects of the asphalt surface characteristics of aging from the ASD ground spectral measurements (the major water-vapor absorption bands are interpolated). A, asphalt aging and erosion; B, structural road damages (cracks); C, structural road damages (raveling); D, pavement maintenance.

Diagram A in Figure 1 presents spectral samples from the ground spectral library of pure road asphalt with no obvious structural damages or cracks. The age of the pavement, the PCI, and the SI are shown, with photographs of each surface. Spectrum A shows a recently paved road. The surface is completely sealed with asphalt mix. The spectral reflectance is generally low, and hydrocarbon constituents determine the absorption conditions. The minimum reflectance is near 350 nm, with a linear rise toward longer wavelengths. Hydrocarbon compounds exhibit electronic transitions that arise from excitation of bonding electrons in the UV and the visible, causing this strong absorption. The absorption is broad, and there are no individual resolvable absorption bands in this spectral region because of the complex nature of bitumen. A decrease in absorption strength toward longer wavelengths results in a broad overall reflectance increase toward longer wavelengths, as is also seen in coals, oil shales, and chars.¹³

Spectrum C shows an old, deteriorated road surface. The photograph of the surface shows that the asphalt seal is widely eroded and the remaining asphalt mix has undergone aging. The natural aging of asphalt is caused by reaction with atmospheric oxygen, photochemical reactions with solar radiation, and the influence of heat, and it has three major results¹⁴: loss of oily components by volatility or absorption, changes of composition by oxidation, and molecular structuring that influences the viscosity of the asphalt mix (steric hardening). The loss of oily components is relatively short term; the other two are longer-term processes. With the erosion and aging of the asphalt mix the road surface is less viscous and more prone to structural damages such as cracking.

The spectral effects represent a mixture of exposure of rocky components and asphalt aging. The loss of complex hydrocarbons causes a general increase in reflectance in all parts of the spectrum. This difference is highest in the near IR and the SWIR, resulting in an increase of more than 10% reflectance. The electronic absorption in the VNIR reflects the dominance of minerals and results in a concave shape with distinct iron oxide absorption features that appear at 520, 670, and 870 nm. The typical SWIR hydrocarbon absorption properties near 1700 and 2300 nm vanish for older road surfaces and are replaced by mineral absorptions. For example, there is a significant change in slope at the transition from hydrocarbon to mineral absorption. For older road surfaces the slope increases from 2120 to 2200 nm as the 2200 nm silicate absorption becomes more prominent. The slope is higher for new pavement materials at 2250 to 2300 nm, which correlates with the intensity of the 2300 nm hydrocarbon feature.

Spectrum B represents road pavement of intermediate age and condition. The surface exhibits both the asphalt mix and exposed minerals. The spectral characteristics reflect this intermediate stage by showing absorption features from hydrocarbons and minerals. The intensity and characteristics of the features are less distinct than for pure very new and very old road

The most common road distress and indicator of pavement quality is cracking. Diagram B in Fig. 1 shows the spectral effects of structural damages or cracks with different degrees of severity. The main spectral effect of cracking is a decrease in brightness in all on parts of the spectrum. The increasing surface roughness causes shadows and reflectance decreases of as much as 7%–8% in the near IR and the SWIR between the unshadowed pavement and high-severity cracks. The concave shape in the VNIR is more obvious for brighter, noncracked road pavements. There is also a subtle indication that the cracked surfaces have more-intense hydrocarbon absorption features in the 1700 and 2300 nm regions. The asphalt mix erosion and oxidations occur on the road surface. Cracking exposes deeper layers of the pavement with higher concentrations of the original asphalt mix, which are then manifested as an increase in the expression of hydrocarbon absorption features. This fact highlights the contrary spectral signal between road deterioration of the pavement itself (diagram A) and the severity of structural damages (diagram B). Whereas an aging road surface becomes brighter with decreasing hydrocarbon absorptions, structural distresses cause decreased reflectance but greater expression of hydrocarbon absorptions. Although the differences in reflectance and intensity of the hydrocarbon absorptions are less for cracks than for new asphalt surfaces, this fact indicates some limitations in spectrometry of road conditions.

A second common road distress is raveling. Raveling describes the progressive dislodgement of pavement aggregate particles. Spectra of normal pavement are compared with a raveled road surface in diagram C (Fig. 1). The spectrum with raveling exhibits larger amounts of rocky components and raveling debris (gravel) on the surface. This results in a general increase in the brightness of the surface caused by increasing mineral reflectance and less-prominent hydrocarbon absorptions. The raveling spectrum shows characteristics from both the normal pavement and Spectrum C. Spectrum C reflects a gravel parking lot surface. Compared with those of the pavement, the gravel surface has a higher reflectance

Besides rehabilitation treatments there are several maintenance methods to improve and maintain the quality of road surfaces. Their spectral characteristics are compared to those of a common asphalt road surface (diagram D in Fig. 1). Spectrum I shows a slurry crack seal that helps to prevent water or other noncompressible substances such as sand, dirt, rocks, and weeds from entering cracks. Slurry seal crack fillings are mixtures of emulsified asphalt or rubberized asphalt that are spread with a machine onto the asphalt surface. This treatment material has a constant low reflectance of the order of 5% reflectance. Only minor hydrocarbon absorption features, similar to those found for parking lot surfaces, are represented.⁶

Patches are used to treat areas of localized road distress. The material is similar to fresh pavement, and Spectrum J has similarity to a newly paved road (Spectrum A). Chip seal treatments include spraying an asphalt binder on the pavement and then immediately covering the binder with a single layer of uniformly sized chips. The new surface treatment is then rolled to seal the aggregate and broomed to remove any loose chips. Chip seal spectrum K has significantly higher reflectance than an untreated asphalt road surface with more-prominent mineral absorption features, similar to a raveled road surface (Spectrum G).

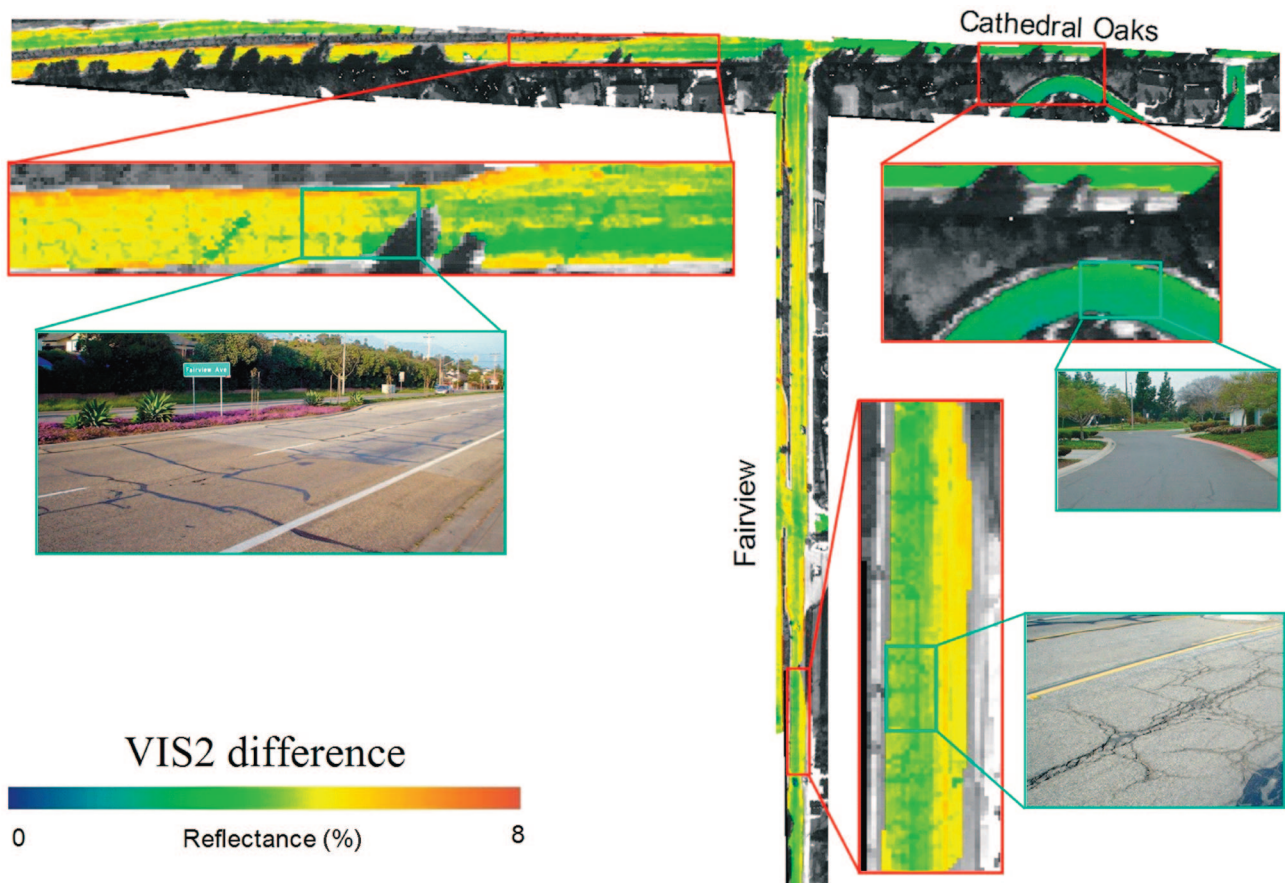
Fig. 2. Spatial distribution of the VIS2 difference derived from the HST data.

Figure 2 shows the VIS2 band difference calcu-

lated for the HST sensor, showing expected patterns on surface roads. Roads with recently paved surfaces (upper left in Fig. 2; east Cathedral Oaks) show low difference values, of the order of 2%–4% reflectance (dark green and blue) between 830 and 490 nm. The highlighted part of west Cathedral Oaks presents the transition between a newer split-seal refurbished road (green–yellow) and an older part with several sealed transverse cracks (yellow–orange). The southern part of Fairview Avenue shows an area with severe alligator and block cracking. The crack patterns

are visible in the VIS2 difference and match expected patterns from field spectra. Such surface characteristics add spatial variance to the difference values and appear for roads with structural damage.

However, Fig. 2 also shows that structural road damage adds spatial heterogeneity to the road surface, given the 0.5 m spatial resolution of the HST data. A second remote-sensing measure, the spatial variance of the VIS2 difference in the 3×3 pixel neighborhood, was investigated and compared to the Roadware SI (Diagram B, Fig. 3). This relationship shows that structural road damage adds spatial complexity to the spectral signal. Diagram B highlights a significant amount of variability for high SI values. This effect is caused by false positives, basically other features that add variability to the spectral signal and do not represent road damage such as shadows from light poles, cars, and street paint. Despite this variability, the relationship between SI and the VIS2 variance is significant and emphasizes that the both the spectral signal and the spatial variance are important indicators of road damage in hyperspectral remote-sensing data.

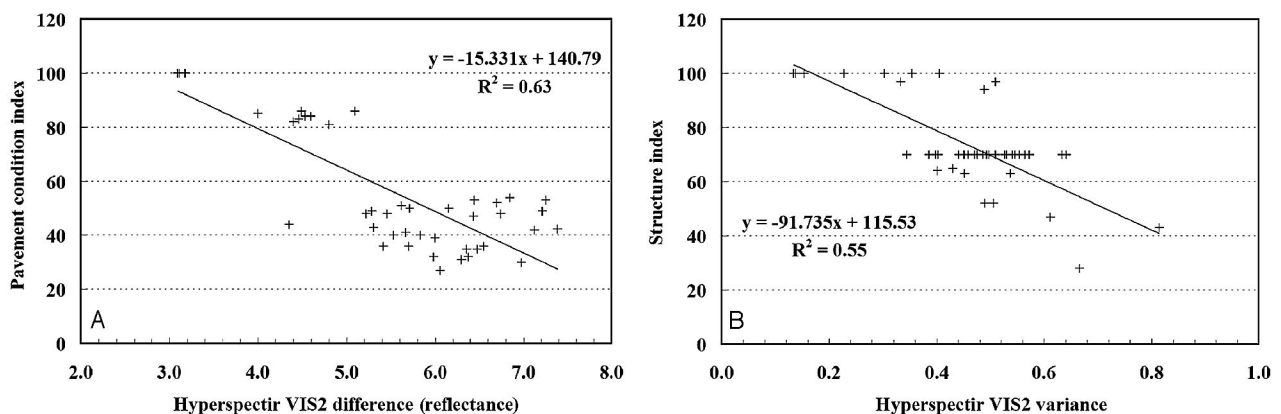
Fig. 3. Comparison of the HST (HyperSpectr) VIS2 difference and the Roadware PCI and SI.

The HST VIS2 difference values show a significant correlation with the Roadware PCI and SI values (Fig. 3). Both regression relationships are statistically significant at the 0.0001 probability level. The relationship is quite distinct for roads in good condition because the scattering of values is quite low. The variability increases for high difference–low PCI val-

ues. The spectral signal of the roads in poorer condition become more complex, and the relationship is not so obvious. This result agrees with observations from the field spectra. *In situ* material aging and asphalt-mix erosion cause an increase in the VIS2 difference. In contrast, structural road damages such as cracks can reverse this spectral gradient. The VIS2 difference decreases if more numerous and more severe cracks are present (Fig. 1) and make a deteriorated road surface look more like a newly paved surface.
