## Monitoring the condition of roads pavement surfaces: proposal of methodology using hyperspectral images

Marcos Ribeiro Resende, Liedi Legi Bariani Bernucci, José Alberto Quintanilha\*

Resende, M. R., Bernucci, L. L. B. and Quintanilha, J. A. (2014) Monitoring the condition of roads pavement surfaces: proposal of methodology using hyperspectral images. *Journal of Transport Literature*, vol. 8, n. 2, pp. 201-220.

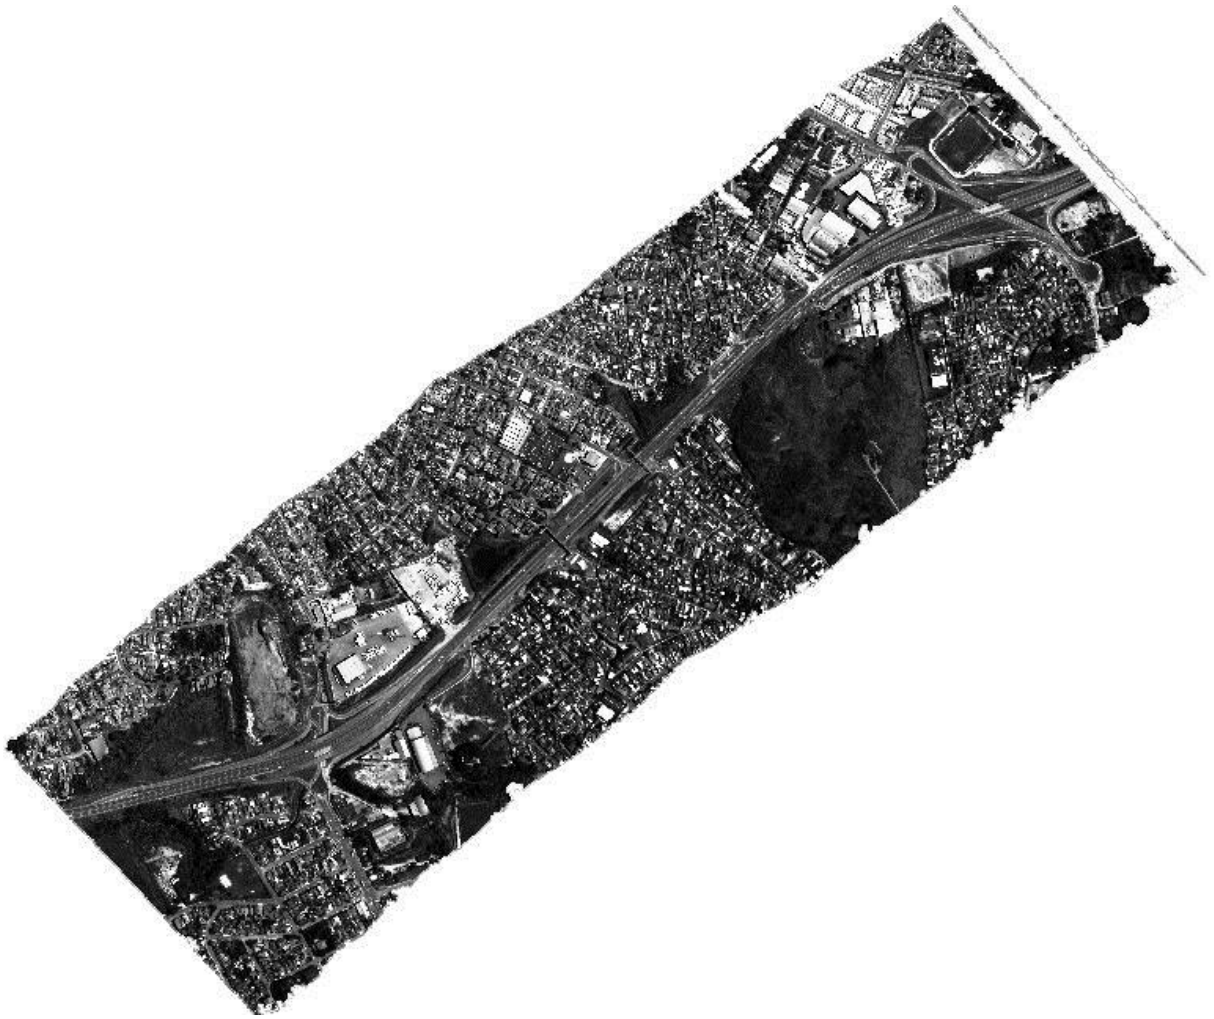
**Figure 1 - Image I01, with 24 spectral bands and a 50 cm spatial resolution, of the Study Area, Sorocaba, São Paulo - SP (ATECH, 2010)**

The study area shown in Figure 1 is located in the urban area of the city of Sorocaba, transected by the Raposo Tavares Highway, SP-270, inside the polygon defined by the points (23°31'47''S 47°28'08''W), (23°32'26''S 47°30'12''W), (23°31'41''S 47°26'14''W), and (23°31'13''S 47°26'28'' W).

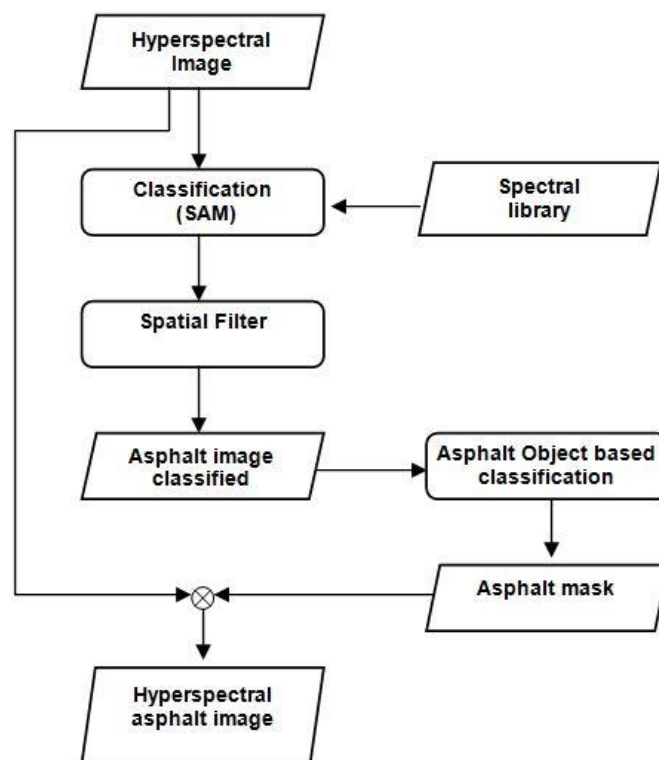
**Figure 2 - Methodology for the detection and separation of the asphalt areas in the hyperspectral images**

The methodology shown in Figure 2 was proposed to improve the efficiency of the identification of asphalt in hyperspectral images with high-spatial resolution. This methodology combines the pixel classification technique, which considers the nature of the spectral response, with the object-based classification technique, which considers the spatial and morphological features of objects under analysis in addition to the spectral information. Further details of the object-based classification technique can be found in Nobrega et al. (2008). For details of the particular methodology used in this study, consult Resende et al. (2012).

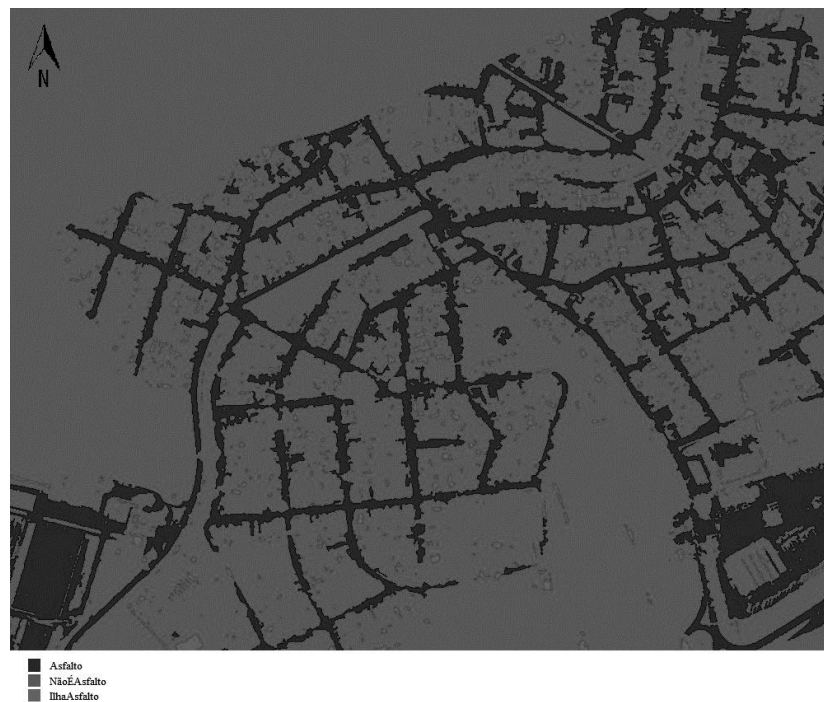
**Figure 3 - Image with asphalt classifications resulting from the object-based classification algorithm (Asphalt=dark gray, Non-Asphalt=light gray and Asphalt Island=gray)**

The Definiens Developer 7 software was used to complete the object-based classification in this study. Three classes were created: Asphalt, Non-Asphalt, and Asphalt Island. The Asphalt and the Non-Asphalt classes were defined by the spectral values of the object. The Asphalt Island class was defined by the neighborhood criteria. For an object to be considered an Asphalt Island, the object should belong to the Asphalt class and be surrounded by the Non-Asphalt class. After classification, the objects in the Asphalt Island and the Non-Asphalt

classes were discarded, leaving only the objects from the Asphalt class. The image was then transformed to generate a **binary mask** from the results of the object-based classification, as shown in Figure 3. This mask was applied to the original hyperspectral image to delineate and remove the asphalt regions from the original image. Figure 3 shows the final results of the classification for one part of the area studied: the Asphalt class is shown in dark gray and the Asphalt Island class is depicted in gray.
