Road Surface Fatigue Observations in Aerial Imagery

Ashwin Yerasi, Bill Emery
Aerospace Eng. Sci. Dept
University of Colorado

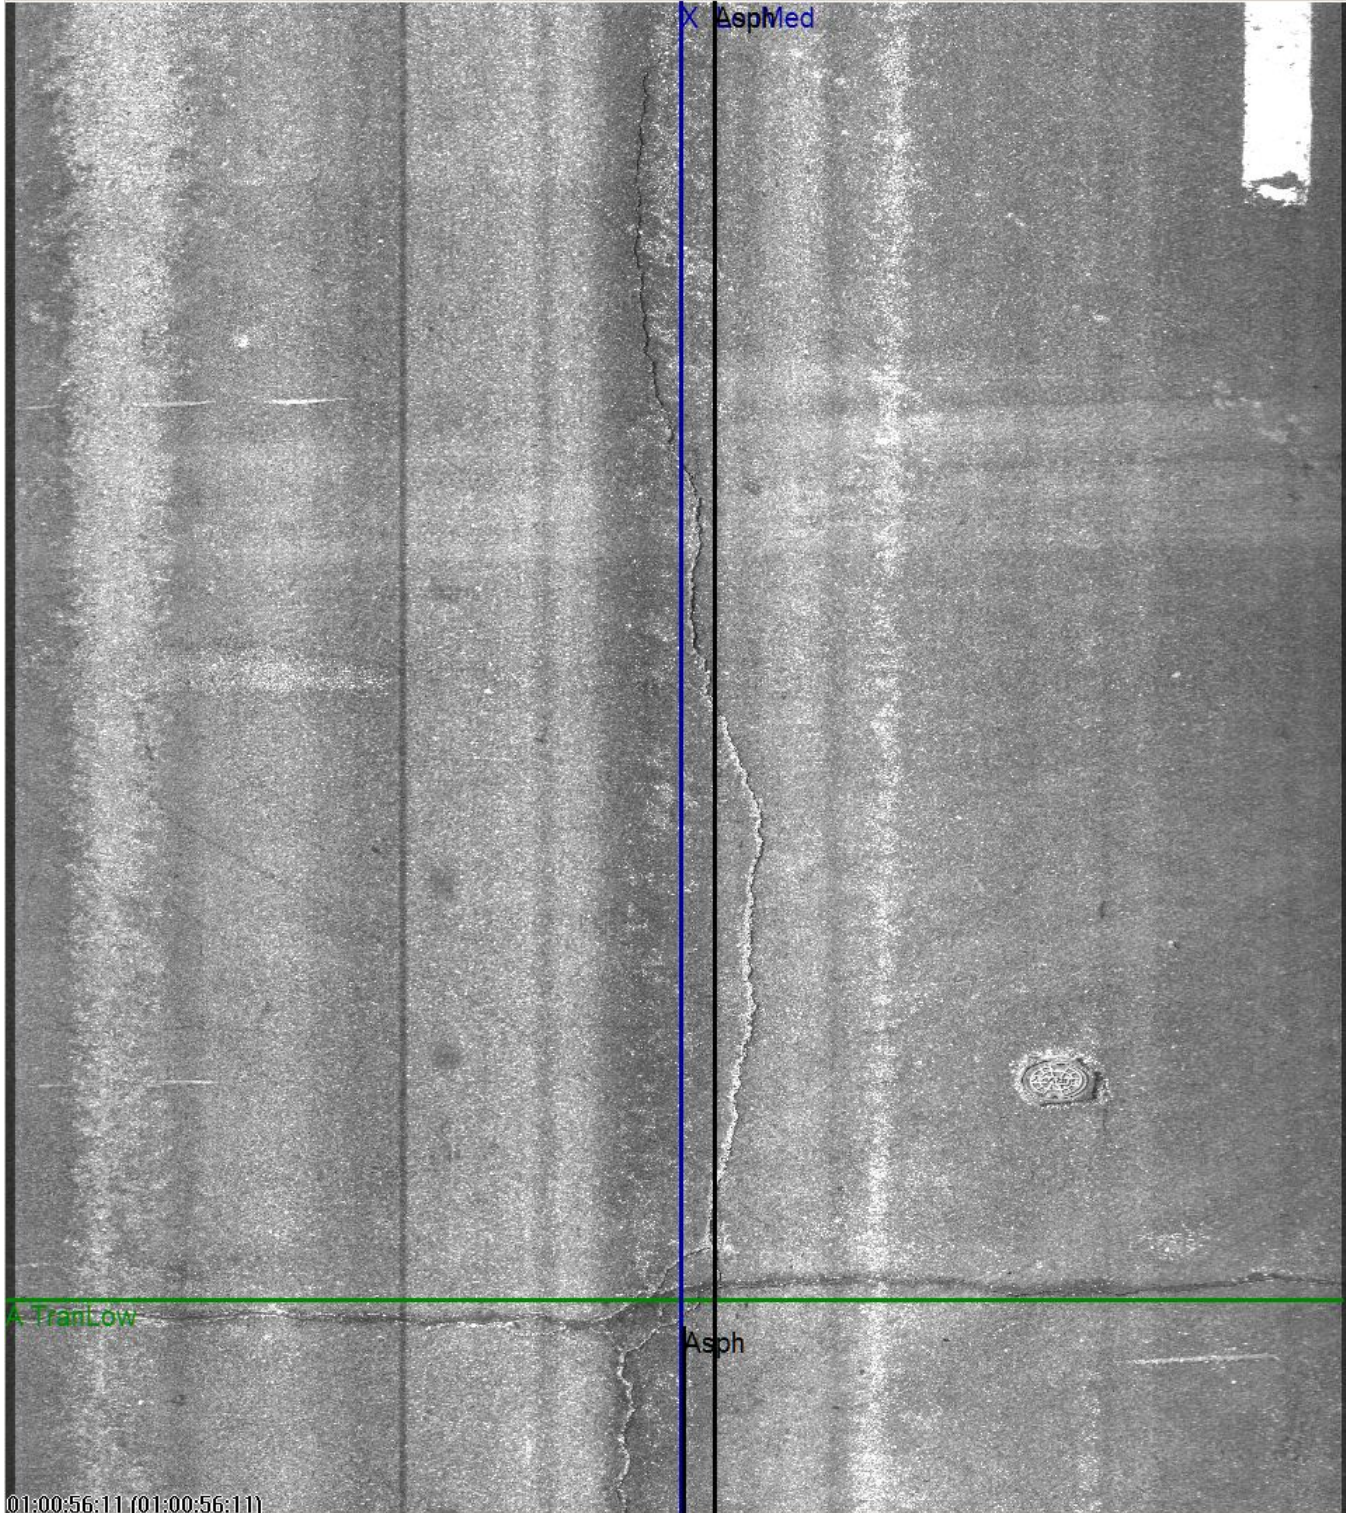
Examples of CDOT In Situ Data

- The next two slides are examples of the data collected by CDOT that are analyzed to produce the fatigue values that went into these wavenumber spectra.
- The data are collected from a van driving at highway speeds carrying high-resolution video cameras viewing the highway.
- The video imagery and analyzed manually to identify the cracks as show by the colored lines.
- These lines are then **counted** to give a value of fatigue (cracking) that covers a certain area of the highway surface

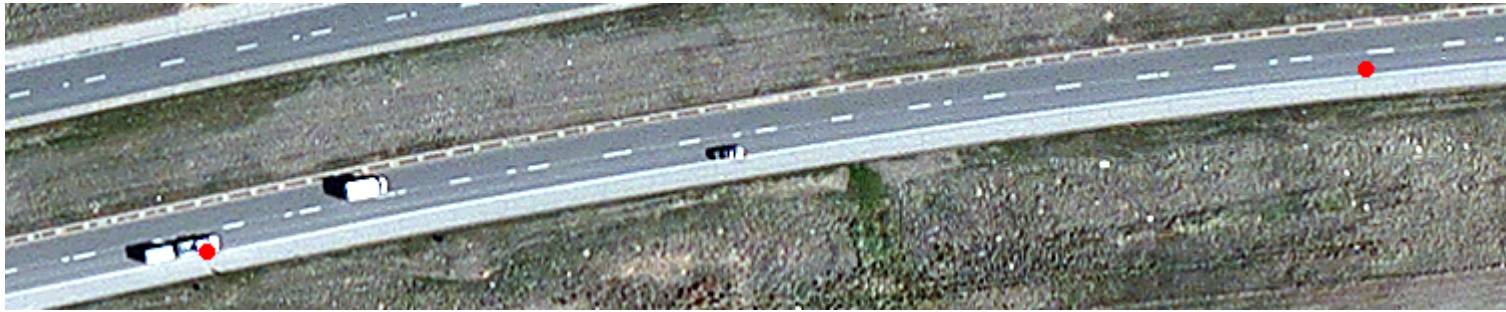
Mile 114.0-114.1 (between red dots), Fatigue 586 square meters

Cases of low fatigue values; road is dark and cracks are not apparent.

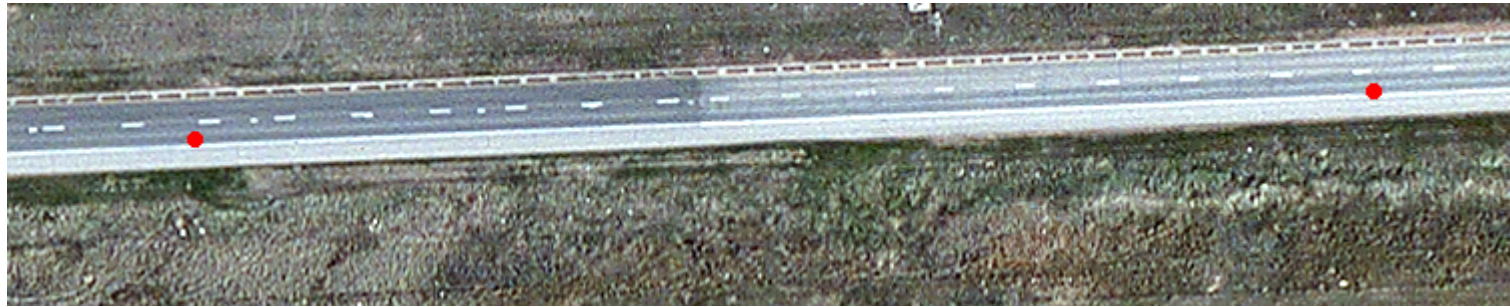
Mile 114.2-114.3, Fatigue 3250 square meters

Case where half of the segment has been paved and shows no cracks while the other half is lighter and shows cracks. The fatigue value is intermediate.

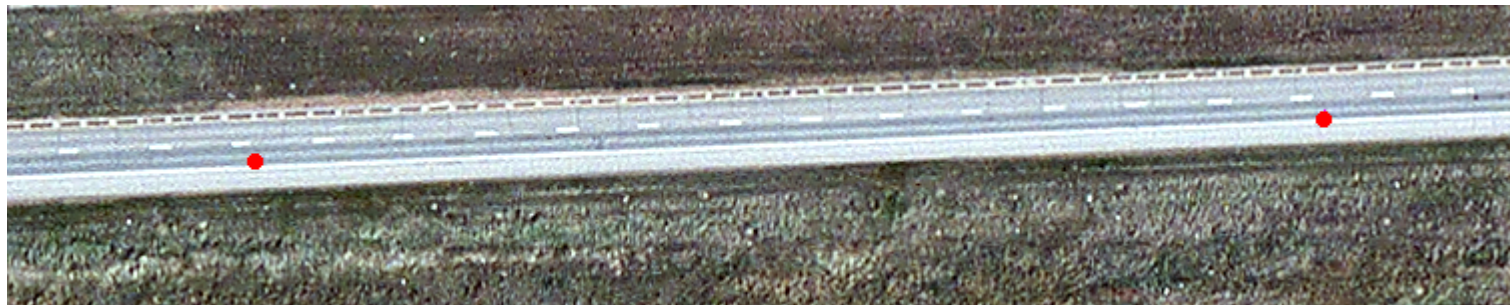
Mile 114.3-114.4, Fatigue 6578 square meters

Fatigue value is high consistent with the light colored road that clearly shows the cracks in the surface.

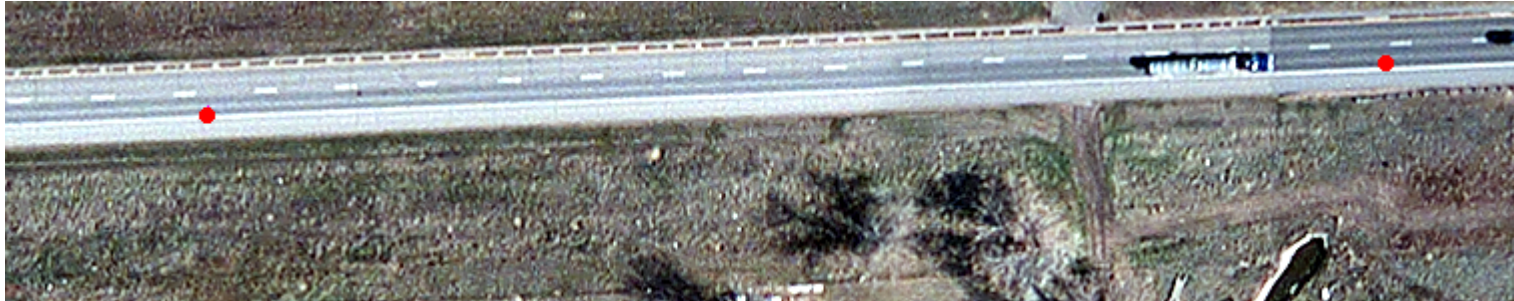
Mile 114.4-114.5, Fatigue 6578 square meters

Most of this road segment is light and shows cracks consistent with the high fatigue value.

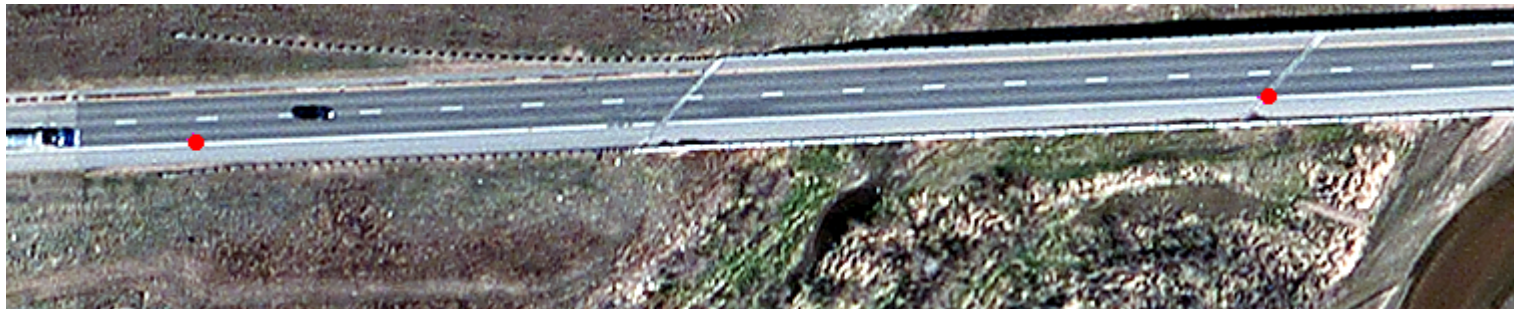
Mile 114.5-114.6, Fatigue 527 square meters

Large drop in fatigue value consistent with a dark road showing no cracks.

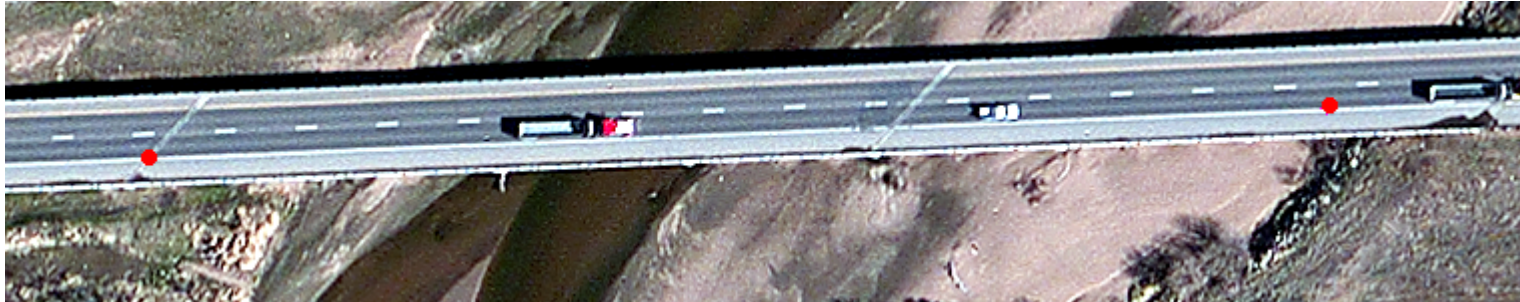
Mile 114.6-114.7, Fatigue 171 square meters

The lowest fatigue values are consistent with this dark road showing no cracks.

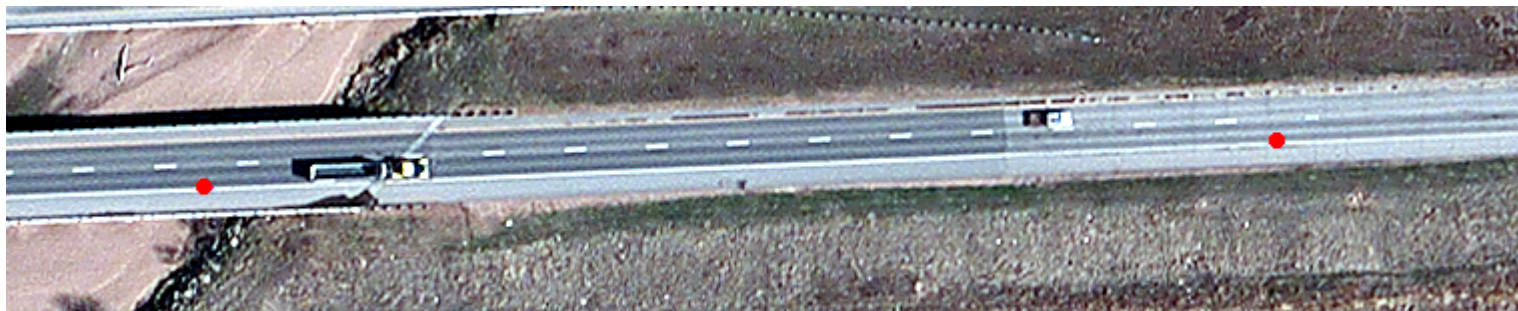
Mile 114.7-114.8, Fatigue 1239 square meters

A mixture of smoothed and cracked road surfaces leads to an intermediate value of fatigue.

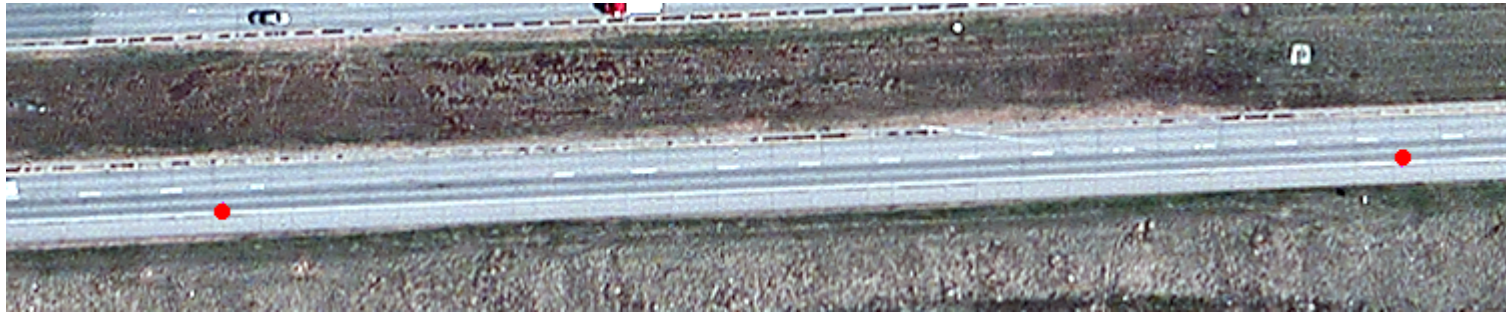
Mile 114.8-114.9, Fatigue 6567 square meters

Both of these roads clearly exhibit cracks and have relatively high fatigue values.

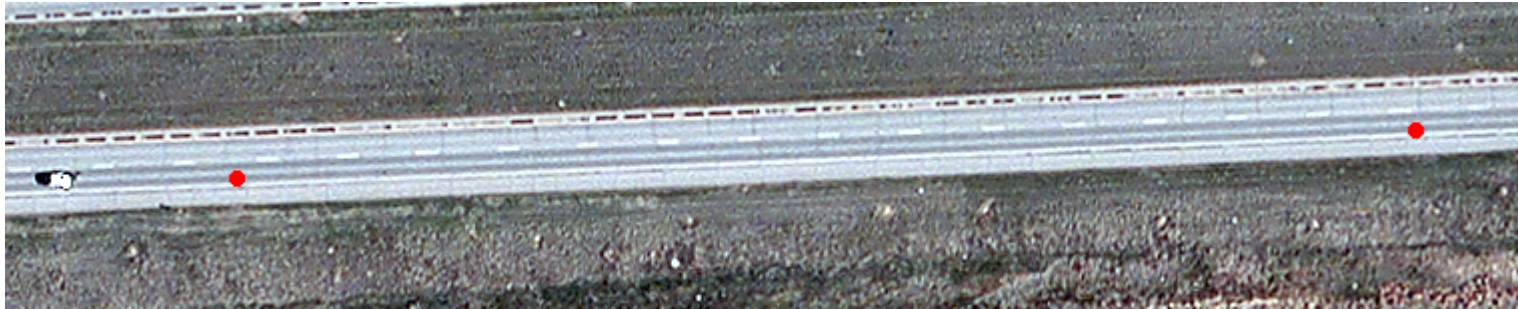
Mile 115.0-115.1, Fatigue 5760 square meters

This road indicates that we can optically quantify the cracks to properly estimate the moderate fatigue value.

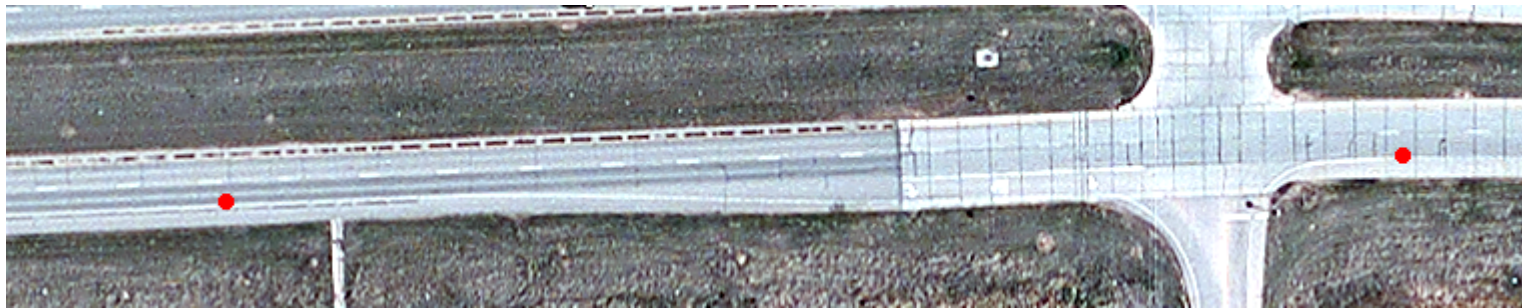
Mile 115.1-115.2, Fatigue 5014 square meters

Moderate fatigue values here reflect the combination of surfaces. The cracks in the intersection area have been filled with tar so appear slightly different than the other cracks.
