MPC 17-321 | C. Pantelides, D. Brown, J. Parks, and M.J. Ameli

Seismic Retrofit of Spliced Sleeve Connections for Precast Bridge Piers

March 2017

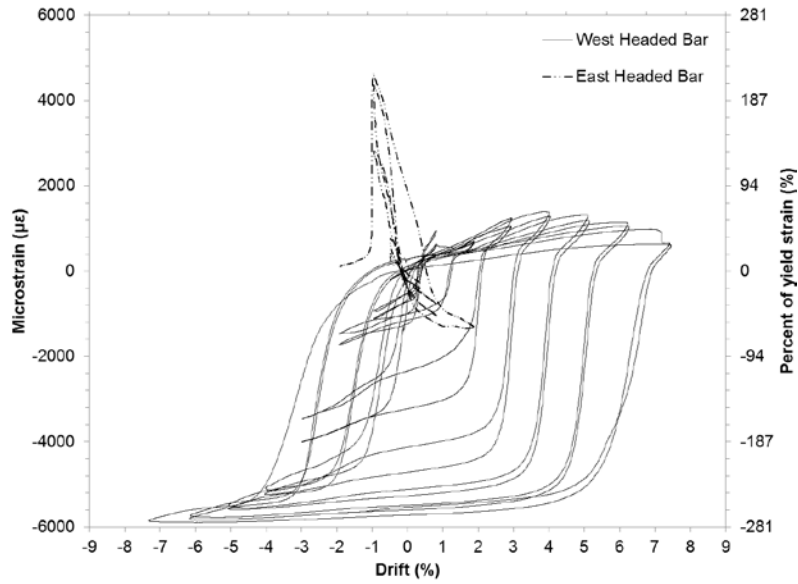
Figure 4.17 NM-R headed bar strain gauge data from 7.5 inches above the footing level

The behavior of the headed rebar observed during testing seems to be influenced by the final damage state. The east longitudinal rebar in the column of NM-R fractured during testing, diminishing the flexural capacity of the specimen in that direction. The headed rebar replaced this lack of flexural capacity in both tension and compression, creating a bending moment couple. The east headed rebar yielded in tension during the 1-in. displacement step, reaching strains of over 1.9 times the yield strain during this displacement step. After the 1-in. displacement step the east strain gauge was lost. It is assumed that the east headed bar went well beyond 1.9 times the yield strain in subsequent displacement steps. The west headed rebar yielded in compression during the 3-in. displacement step, reaching compressive strains of nearly 2.8 times the yield strain during the 7-in. displacement step.

Plastic hinge relocation of NM-O was successfully achieved by NM-R, as shown in Figure 4.17. The hysteretic response of the repaired specimen NM-R is compared in Figure 4.18 with the hysteretic response of the as-built specimen NM-O superimposed. It can be seen that the repaired specimen had an approximately 30% larger lateral load capacity than the as-built specimen. This increase in load capacity is thought to be due to two reasons. First, the moment arm for the repair test is decreased by nearly 20% due to the height of the repair; therefore, a larger load is required to achieve a plastic hinge. Second, the repair test occurred after the as-built test; therefore, the concrete compressive strength of the as-built concrete was larger.

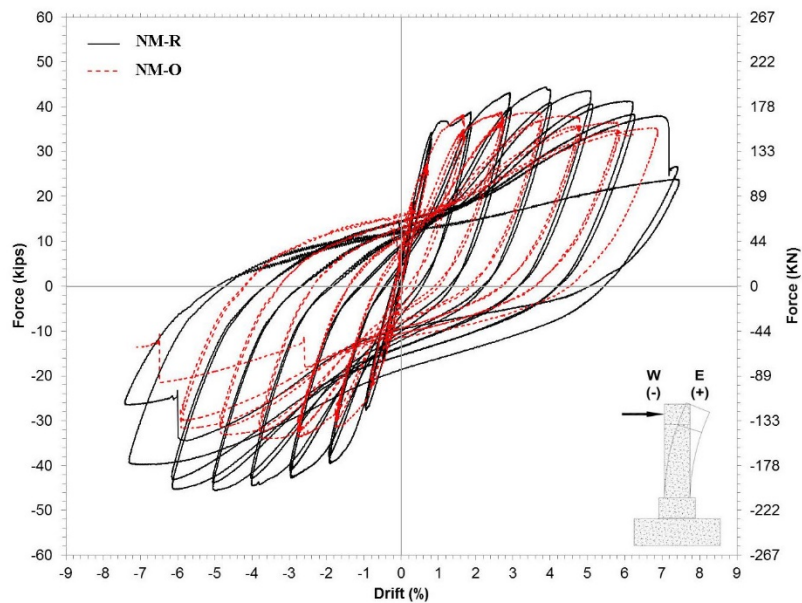
Figure 4.18 Comparison of hysteresis curves for NM-O and NM-R

The displacement capacity of NM-R is slightly greater than the displacement capacity of NM-O. This is an interesting outcome because the repair should have a decreased displacement capacity due to the shortened column length. The shortened column means that for a given displacement, the repair would have a larger rotational demand than the as-built one. However, the as-built joint is a connection of precast concrete elements using GGSS connectors, and the displacement capacity may be adversely affected due to slip and rocking. The repair transforms the precast joint into a system that performs more like a monolithic assembly. The averaged displacement ductility of NM-R of 5.95 is nearly identical to the displacement ductility of NM-O of 6.10. The repair was capable of restoring the diminished load,

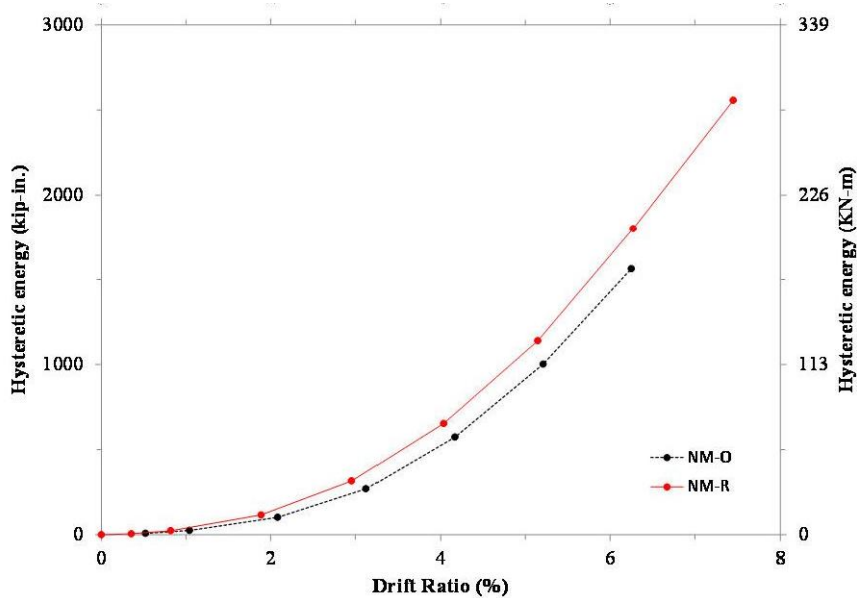
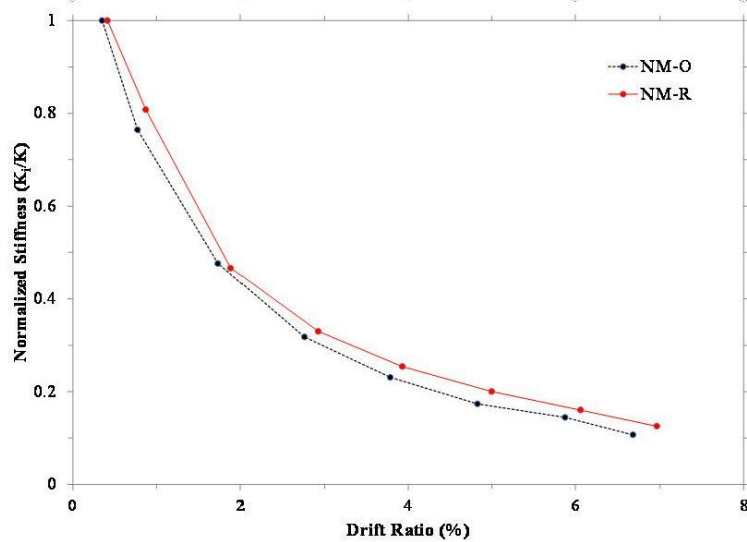
Figure 4.19 NM-R performance comparison: (a) hysteretic energy dissipation, (b) normalized stiffness degradation

The hysteretic energy dissipation and stiffness degradation characteristics were investigated and compared to NM-O, as seen in Figure 4.19(a) and Figure 4.19(b), respectively. The cumulative energy dissipation of NM-R is slightly greater than NM-O for all drift ratios; at the completion of the 6% drift ratio, NM-R has dissipated 15% more energy than NM-O. The stiffness degradation characteristics of NM-R and NM-O are very similar when normalized to the 0.5% drift ratio stiffness. The normalized stiffness of NM-R is slightly larger than NM-O at all drift ratios. These performance parameters confirm that the repair restored the assembly to a performance level similar to the original condition. Further details of the repair method for column-to-footing joints are presented elsewhere [18].
