# *Langdon Walkability Assessment 2022*

## Final Report

Prepared for:  
Cavalier County Health District  
Langdon, ND

Prepared by:  
Kshitij Sharma  
Advanced Traffic Analysis Center  
Upper Great Plains Transportation Institute  
North Dakota State University  
Fargo, North Dakota

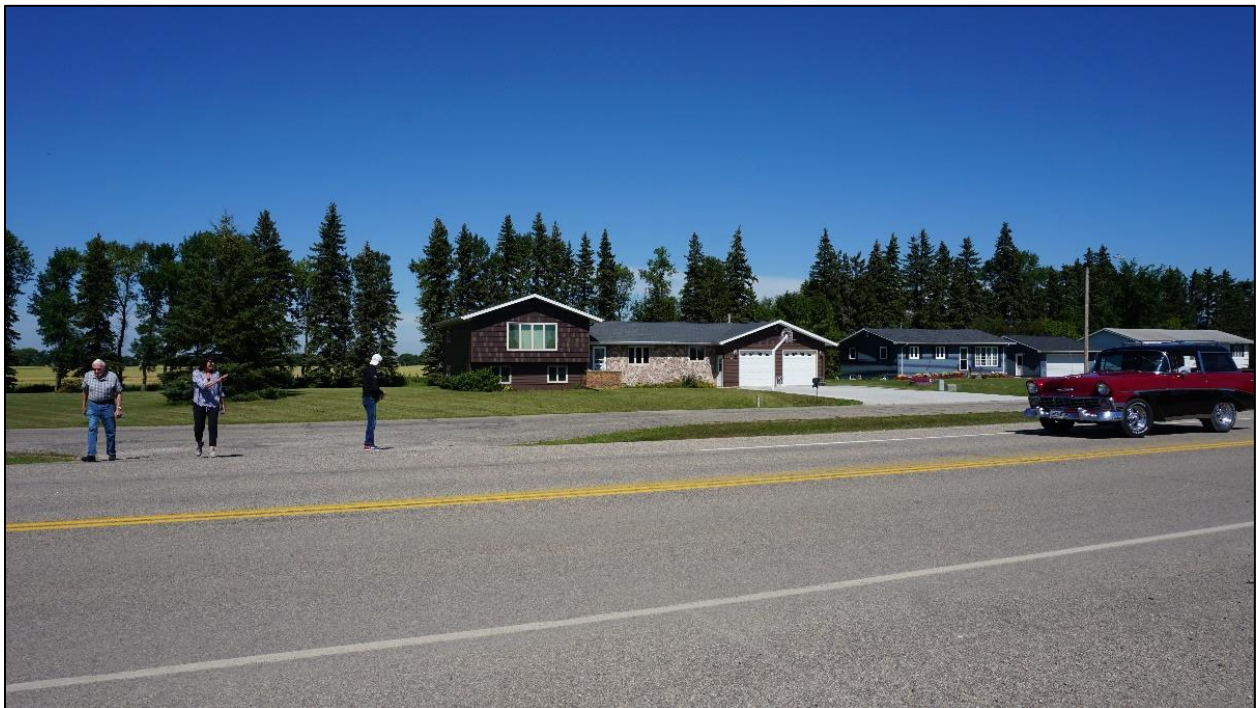
Throughout the assessment, drivers were observed to be courteous toward pedestrians, as seen in Figure 9.

**Figure 9.** Courteous behavior of drivers in the area

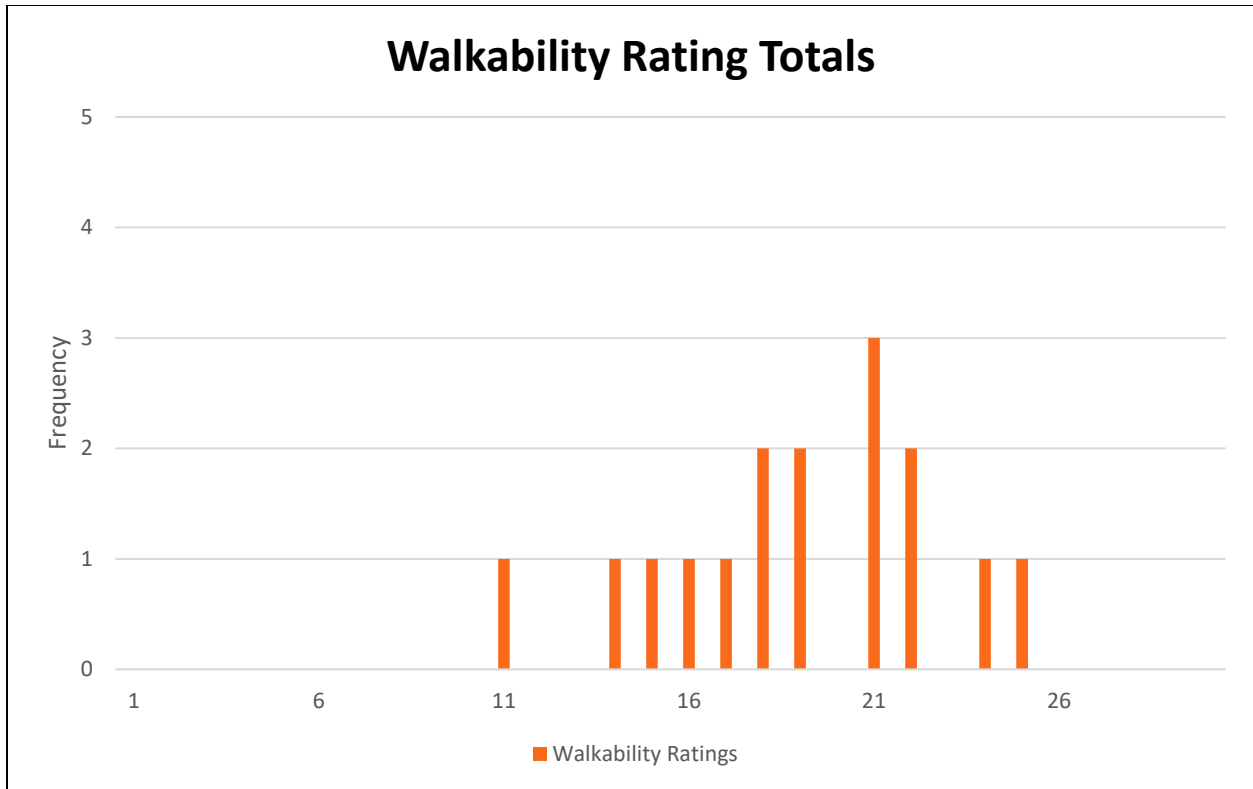
A total of 16 checklists were completed during this assessment. Based on the compiled results, participants rated their walk and the infrastructure at about an average of 21 as seen in Figure 21 below. As seen in Figure 22, the two most frequently reported problems were:

**Figure 21.** Walkability ratings totals chart

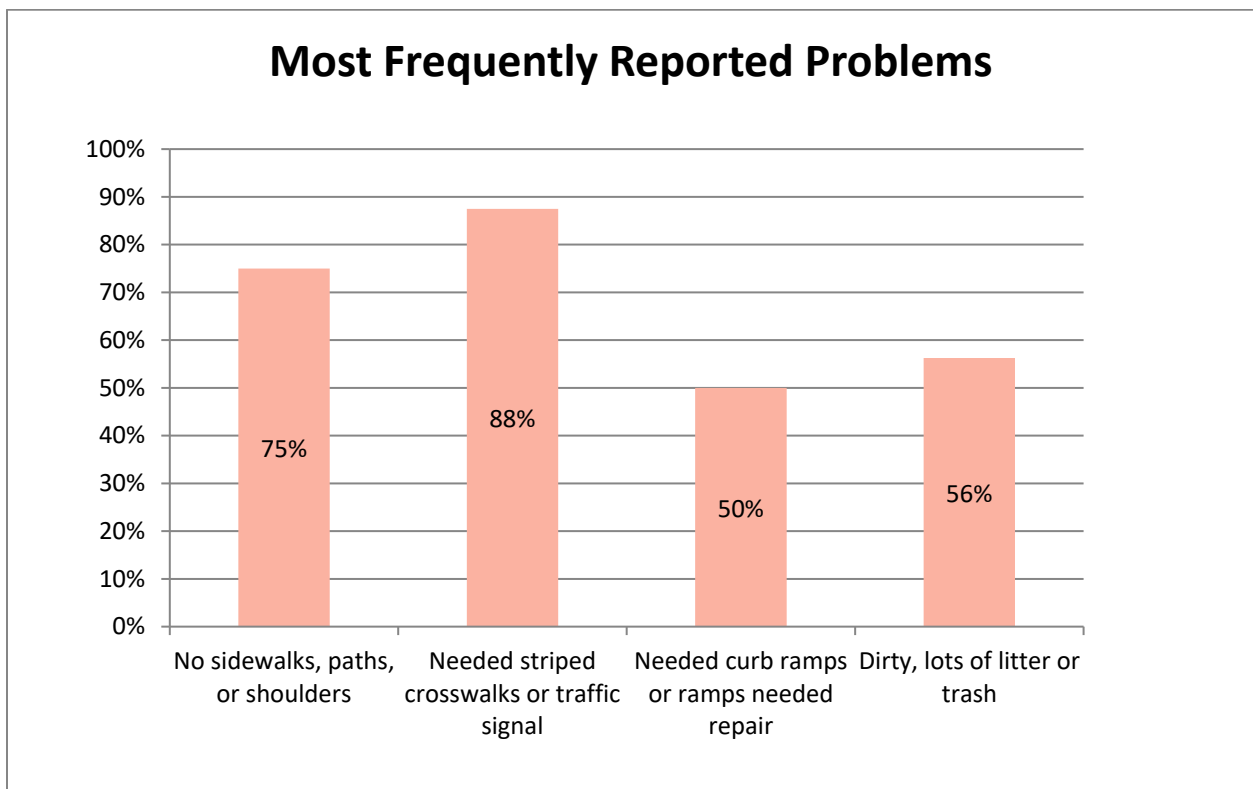
1. Needed striped crosswalk or traffic signal
2. No sidewalk, paths, or shoulder

**Figure 22.** Most frequently reported problems chart

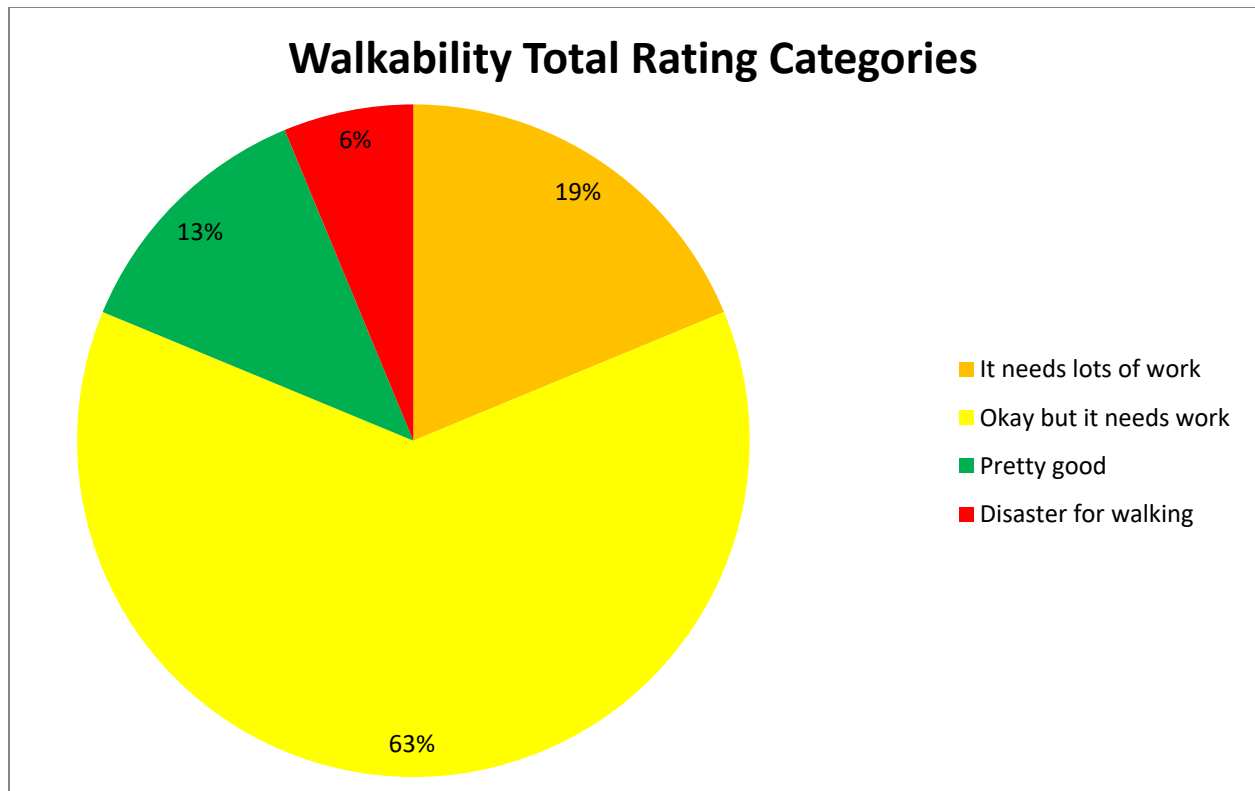
These reports and other results highlight the lack of pedestrian-related infrastructure along most of the assessed loop. The assessment results also show that most of participants agree that the infrastructure is in need of work (see Figure 23).

**Figure 23.** Walkability total ratings categories chart

Sections of the sidewalks that are in poor condition should be rebuilt to current standards. New facilities should be installed in locations where missing. In doing so, special attention needs to be paid to state highways. Although outside of town, these highways provide high-speed connectivity over long distances but within built-up albeit rural areas, the same highways need to accommodate access to businesses and other functions for all users including non-motorized users.
