**COMPOSITE REPAIR OF FULL-SCALE
TIMBER BRIDGE CHORD MEMBERS
THROUGH THE PROCESS OF SHEAR SPIKING**

Travis A. Burgers
Richard M. Gutkowski, Ph.D., P.E.
Donald W. Radford, Ph.D.
Jeno Balogh, Ph.D.

December 2005

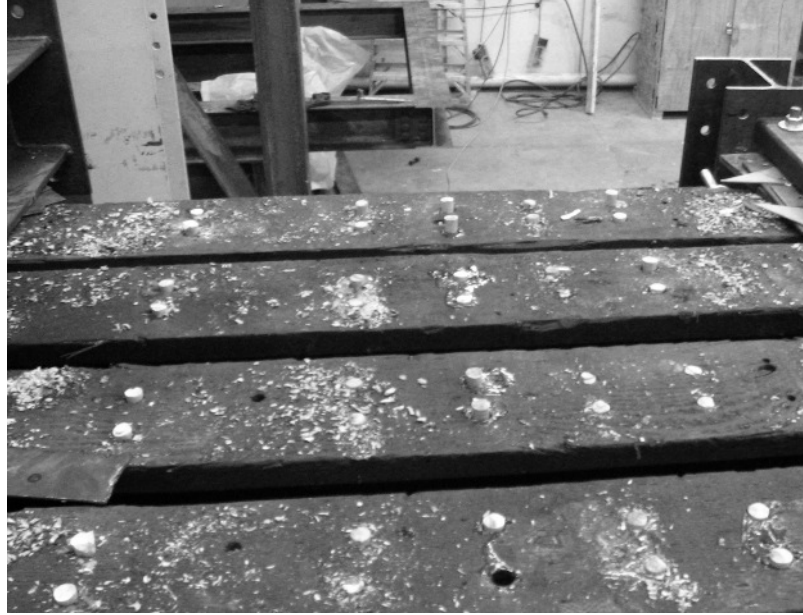
Figure 1.3: Photograph of inserted Z-spikes

Figures 1.2 and 1.3 show the shear spikes and the inserted Z-spikes used in the research described herein. The shear spikes used in this study had a 19 mm (3/4-inch) diameter and a 406 mm (16 inch) length.

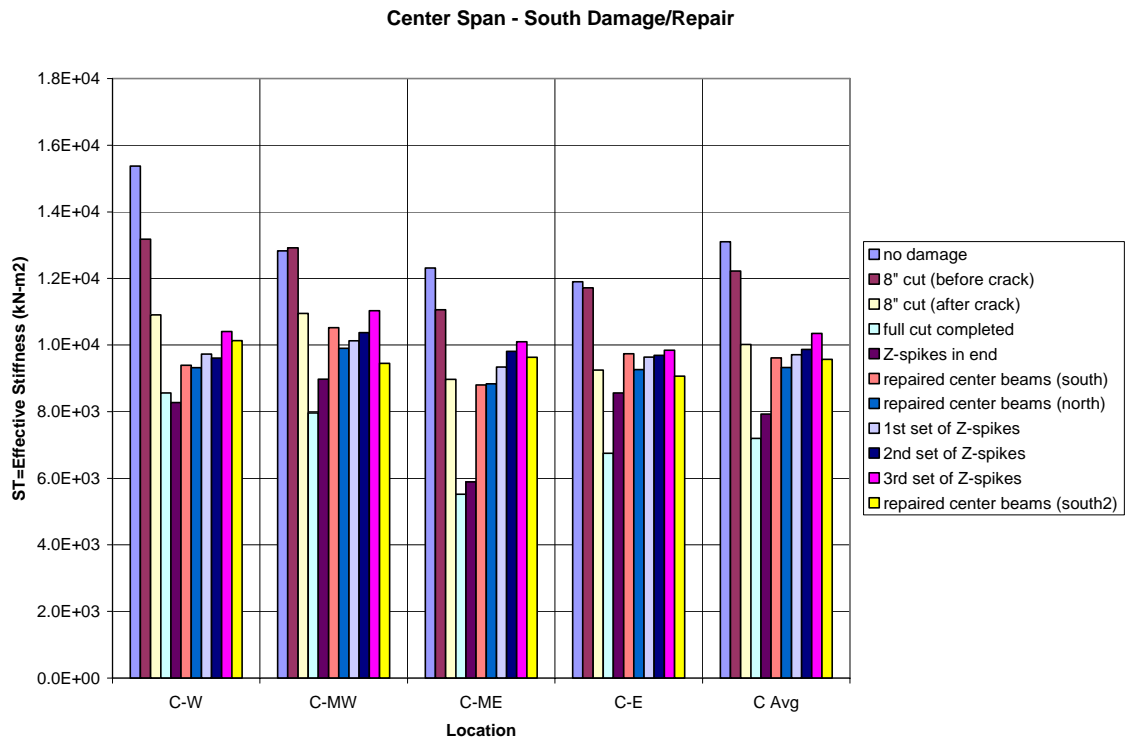
**Figure 5.2:** Effective stiffness of the center span due to south damage/repair (SI)

The patterns of changing measured ST of the center span because of the south end damage/repair are listed in Table 5.1 (SI units) and Table 5.2 (US customary units) and shown graphically in Figures 5.2 and 5.3 respectively. The load-deflection data used to calculate the effective stiffness for the south end damage/repair is found in Appendix C.

Stringer Condition	Stiffness (kN-m ²)				
	C-W	C-MW	C-ME	C-E	C Avg
no damage	1.44E+04	1.28E+04	1.23E+04	1.19E+04	1.31E+04
8" cut (before crack)	1.32E+04	1.29E+04	1.11E+04	1.17E+04	1.22E+04
8" cut (after crack)	1.09E+04	1.09E+04	8.97E+03	9.24E+03	1.00E+04
full cut completed	8.46E+03	7.97E+03	4.42E+03	6.74E+03	7.20E+03
Z-spikes in end	8.27E+03	8.97E+03	4.89E+03	8.46E+03	7.92E+03
repaired center beams (south)	9.40E+03	1.04E+04	8.80E+03	9.74E+03	9.61E+03
repaired center beams (north)	9.32E+03	9.90E+03	8.84E+03	9.26E+03	9.33E+03
1 st set of Z-spikes	9.73E+03	1.01E+04	9.34E+03	9.63E+03	9.71E+03
2 nd set of Z-spikes	9.61E+03	1.04E+04	9.81E+03	9.69E+03	9.87E+03
3 rd set of Z-spikes	1.04E+04	1.10E+04	1.01E+04	9.84E+03	1.03E+04
repaired center beams (south2)	1.01E+04	9.44E+03	9.63E+03	9.06E+03	9.47E+03
