DURABILITY AND ULTIMATE FLEXURAL LOADING OF SHEAR SPIKE REPAIRED, LARGE–SCALE TIMBER RAILROAD BRIDGE MEMBERS

R. Gutkowski H. Forsling Department of Civil Engineering

December 2007

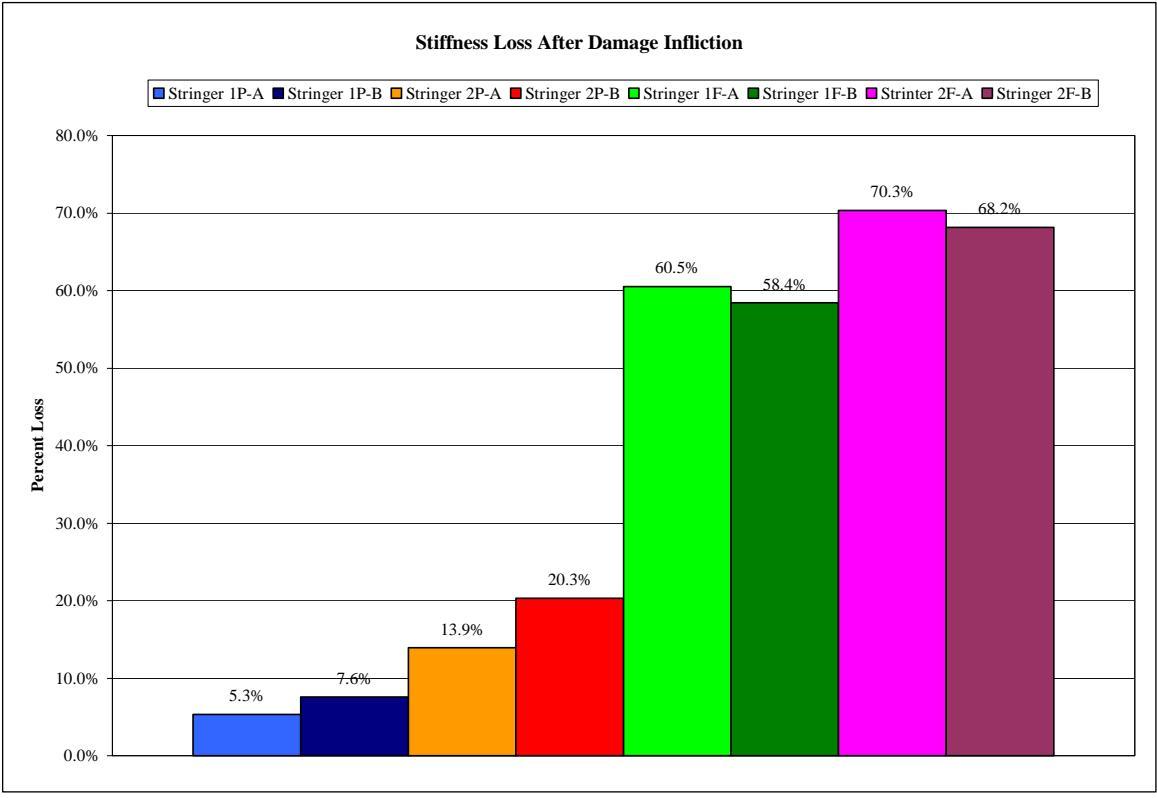
Figure 5.1 Percent loss in EI, relative to virgin state, after damage infliction.

Imposing either one or two partial cuts has a relatively small detrimental effect on stringer flexural stiffness (up to 20.3% loss for specimen 2P-B). By comparing average losses in specimens with two partial cuts (2P-A and 2P-B) to losses in specimens with one partial cut (1P-A and 1P-B), it can be seen the average flexural stiffness loss almost triples (from 6.4% to 17.1%). In the stringers with full cut(s), rather severe losses in flexural stiffness are observed; from 58.4% for specimen 1F-B to 70.3% for specimen 2F-A. There is also a loss of area moment of inertia from the removal of material from the saw cutting, which adds to the loss in flexural stiffness. An approximately 10% higher loss in flexural stiffness was observed in samples with two full cuts compared to stringers with one full cut.

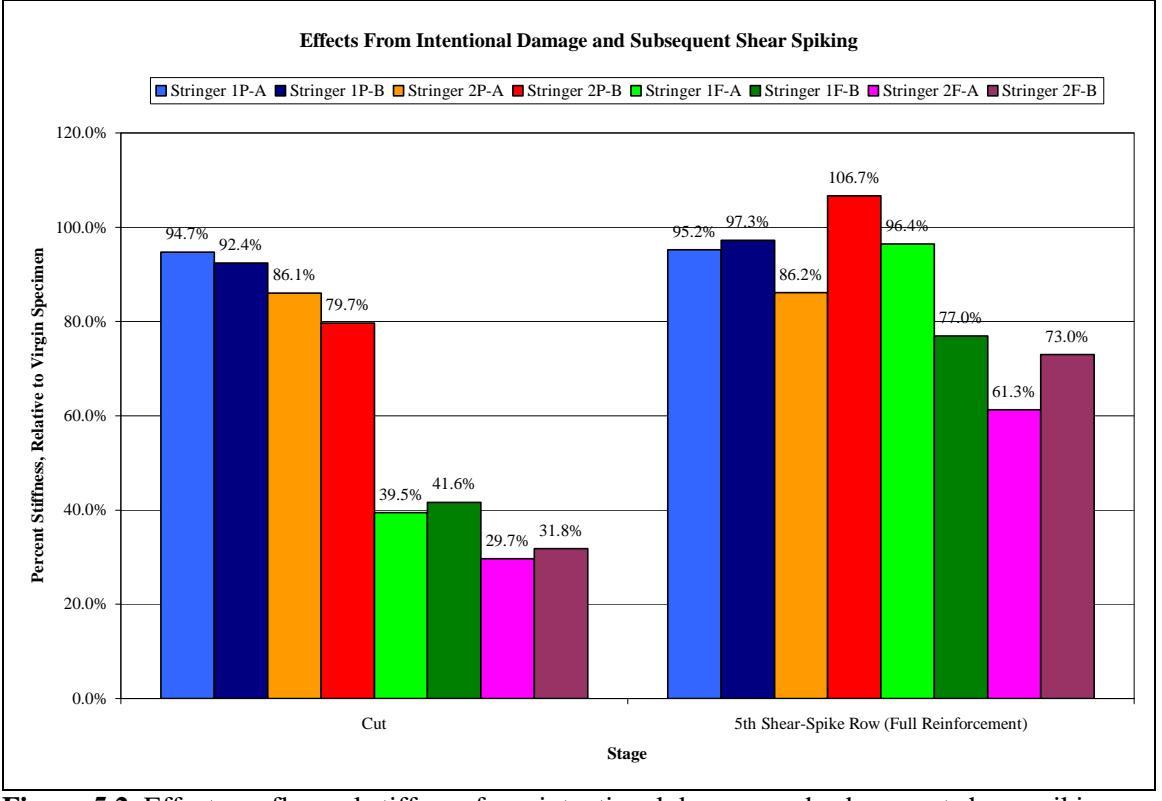
Figure 5.2 Effects on flexural stiffness from intentional damage and subsequent shear spiking.

Some general trends can be observed from comparing the flexural stiffness of damaged states to fully reinforced states of the respective stringers. Shear spiking of timbers that are in relatively good structural condition, that is stringers with partial cuts(s), have a relatively small absolute return in terms of improved flexural stiffness. It appears the flexural stiffness of the virgin state provides an upper limit on attainable stiffness of the shear spike strengthened specimen. However, stringer 2P-B had its stiffness after full reinforcement exceeded its virgin stiffness by 6.7%.

The larger gain, which is the greatest differential between damaged and fully reinforced states, is observed in specimens with full cut(s). These four stringers were all rather severely damaged, with losses of flexural stiffness from intentional damage in the region of 58.4% to 70.3% of the virgin stiffness. In the fully reinforced state, three of the four stringers have their flexural stiffness at least doubled from the damaged state, with the fourth stringer having its flexural stiffness rejuvenated from 41.6% to 77.0%. The stringers with one full cut have their flexural stiffness restored to 96.4% and 77.0% of the respective virgin state stiffness flexural (from 39.5% and 41.6% in the damaged state). Corresponding values for specimens with two full cuts are 61.3% and 73.0% (from 29.7% and 31.8%). Accordingly, strengthening through the process of shear spiking of appreciably damaged/deteriorated timbers is highly effective,

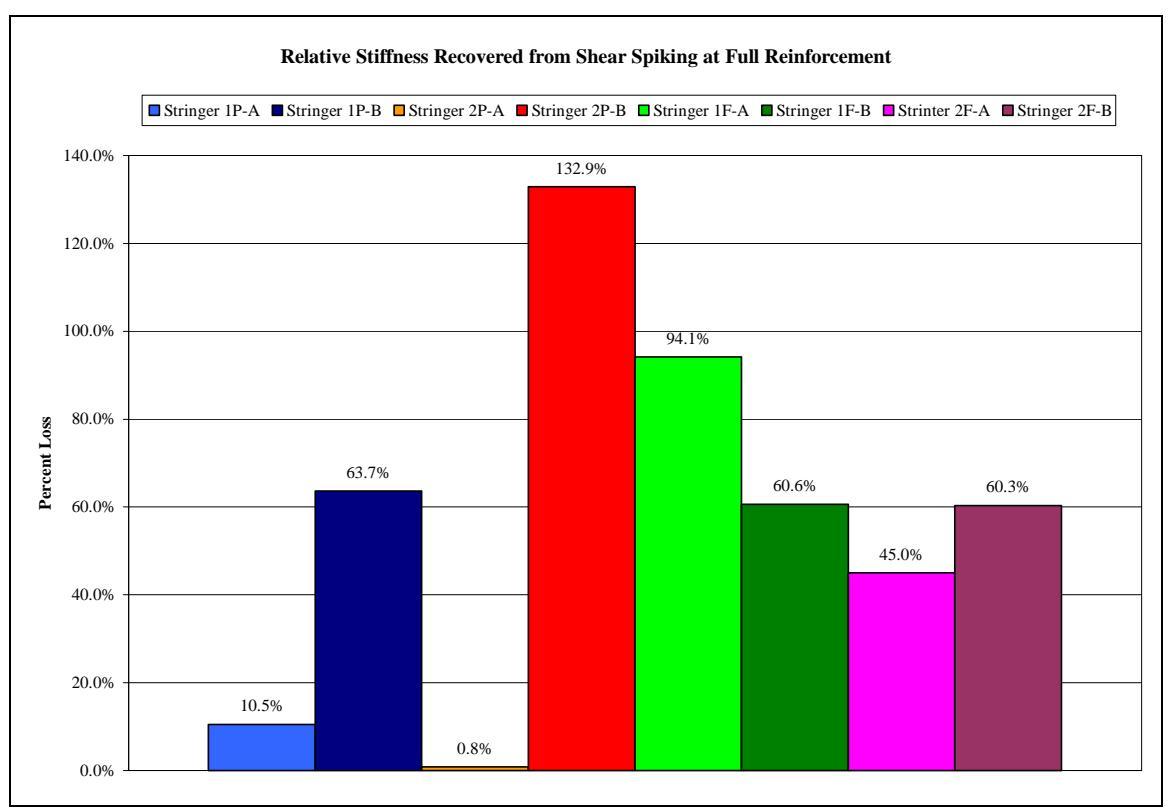
The average flexural stiffness relative recovery for specimens with partial and full cut(s) is 52.0% and 65.0%, respectively, and the average of all eight stringers is 58.5% of the stiffness that was lost from intentional damage. Therefore, it seems a higher portion of the flexural stiffness can be recovered in more severely damaged/deteriorated specimens, even though less damaged/deteriorated specimens can benefit significantly from shear spiking, on a relative percent regain basis.

Figure 5.3 Relative flexural stiffness regained from shear spiking, at the fully reinforced state.

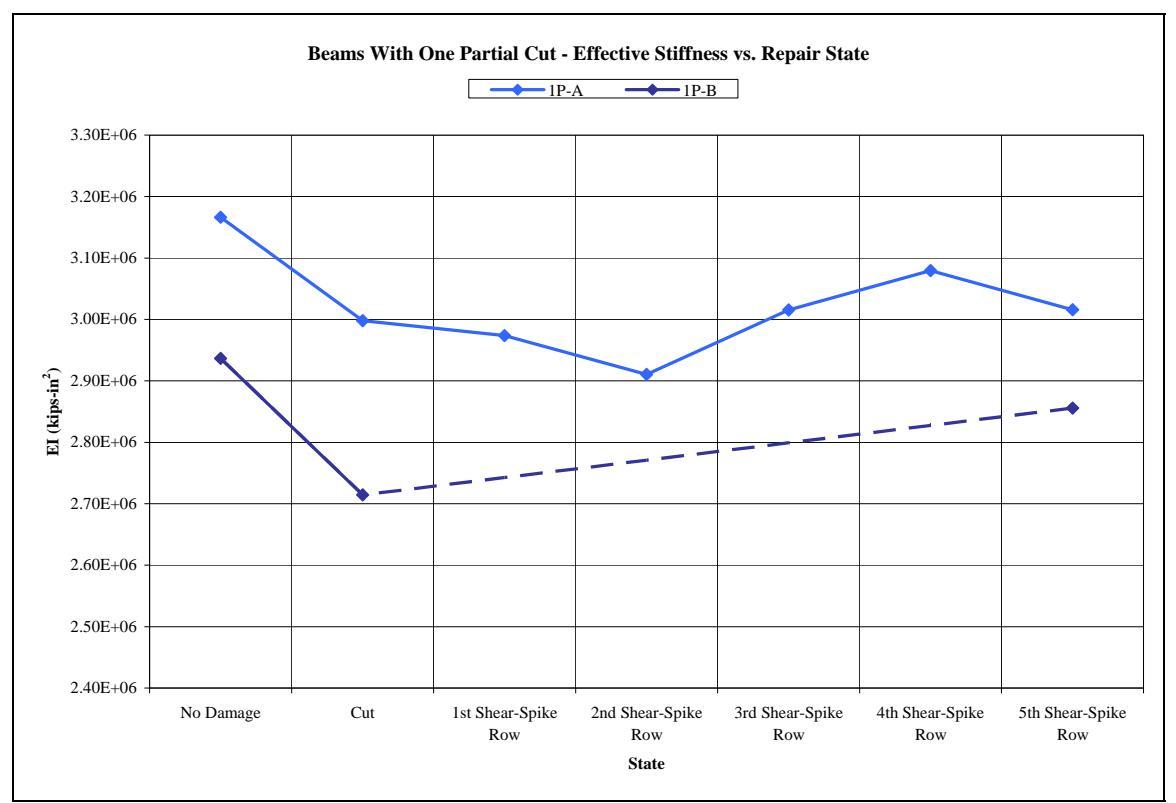
The specimens with one partial cut, 1P-A and 1P-B, show relatively small losses from the intentional damage. After damage infliction, the average flexural stiffness of these specimens is 93.6% of their average virgin stiffness (i.e. a 6.4% loss). In the fully reinforced state, the flexural stiffness is recovered to 96.2% on average. Figure 5.4 illustrates the magnitude of the flexural stiffness at various states for specimens 1P-A. For specimen and 1P-B, which was not incrementally tested, the data between "Cut" and "5th Shear-Spike Row" is linearly interpolated, as represented by the dashed line in Figure 5.4. Results from the incremental (1st, 2nd, 3rd, and 4th shear spike row) load testing are described later.

Figure 5.4 Flexural stiffness (EI) versus state for beams with one partial cut.

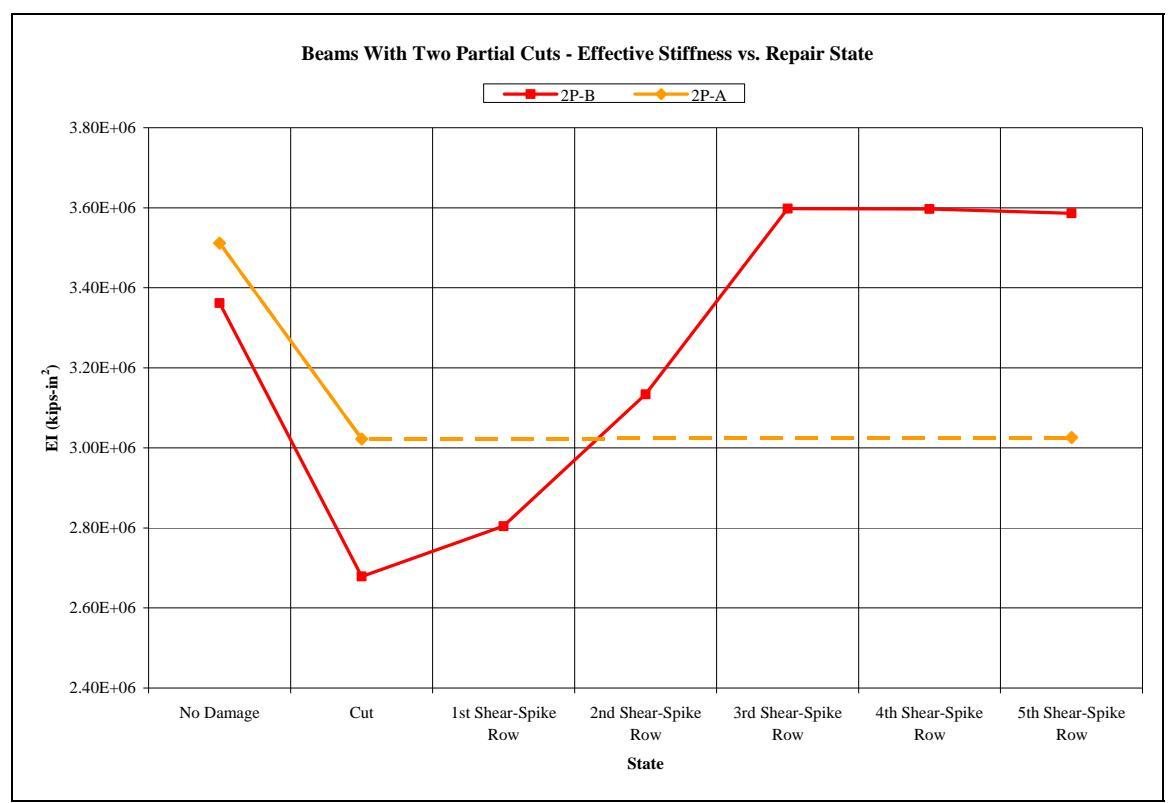
For the specimens with two partial cuts (2P-A and 2P-B), the average loss of flexural stiffness from the intentional damage and subsequent regain from shear spiking are 82.9% and 96.4%, respectively. It is interesting to note that specimen 2P-B suffered a flexural stiffness loss of 20.3% after damage, but the stiffness of its fully reinforced state exceeds the virgin state by 6.7% (e.g. flexural stiffness 106.7% relative to the virgin state). Specimen 2P-A, on the other hand, lost only 13.8% of its flexural stiffness because of intentional damage, but shows barely any rejuvenation in the fully reinforced state; 86.1% relative flexural stiffness after damage, 86.2% relative flexural stiffness after full shear spike reinforcement. Effects on flexural stiffness at various states for these two specimens are illustrated in Figure 5.5, including the linear assumption for the trend of specimen 2P-A. Again, results from the incremental (1st, 2nd, 3rd, and 4th shear spike row) load testing are described later.

Figure 5.5 Flexural stiffness (EI) versus state for beams with two partial cuts.

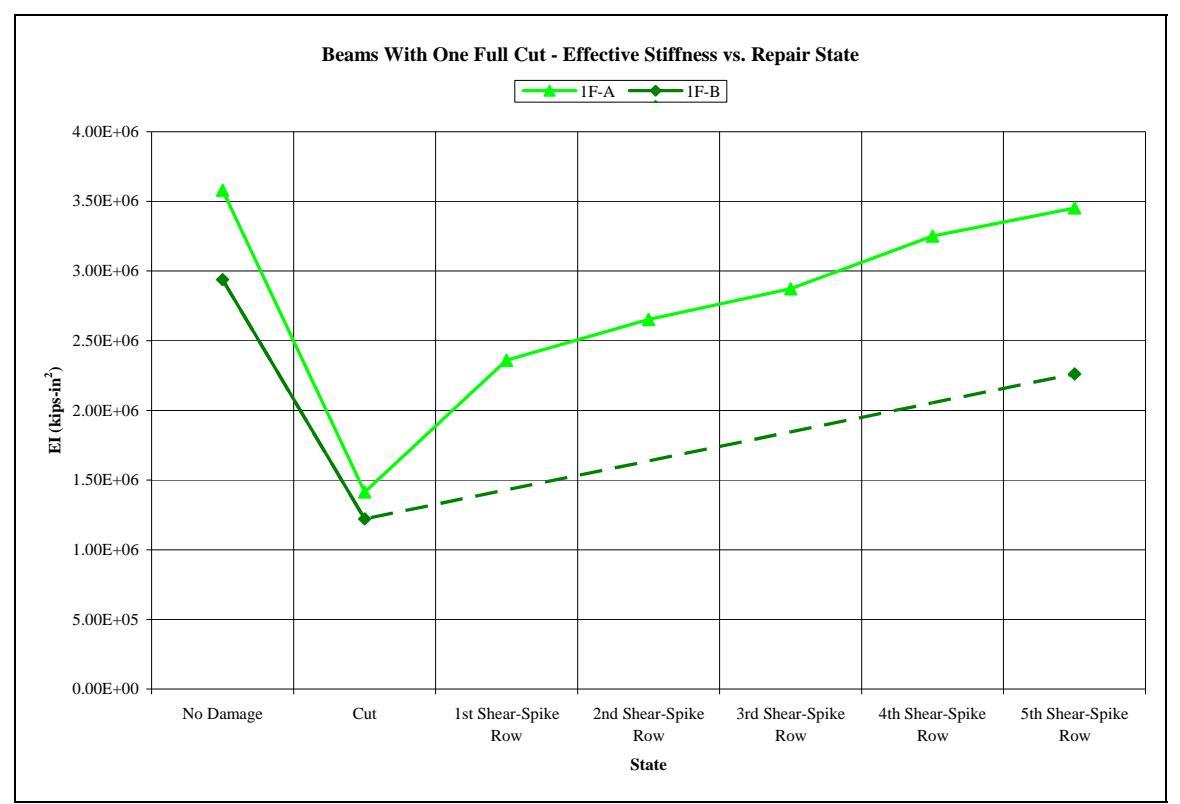
For the specimens with one full cut, flexural stiffness losses from the intentional damage are rather significant; 60.5% and 58.4% of the flexural stiffness is lost compared to the respective virgin specimens of stringer 1F-A and 1F-B. However, both these specimens have much of their flexural stiffness regained from shear spiking, especially stringer 1F-A, which has its flexural stiffness restored to 96.4%. Specimen 1F-B regained 77.0% of the virgin flexural stiffness in the fully reinforced state. Effects on flexural stiffness at various states of these specimens are given in Figure 5.6, where the dashed line of specimen 1F-B represents linear interpolation.

Figure 5.6 Flexural stiffness (EI) versus state for beams with one full cut.

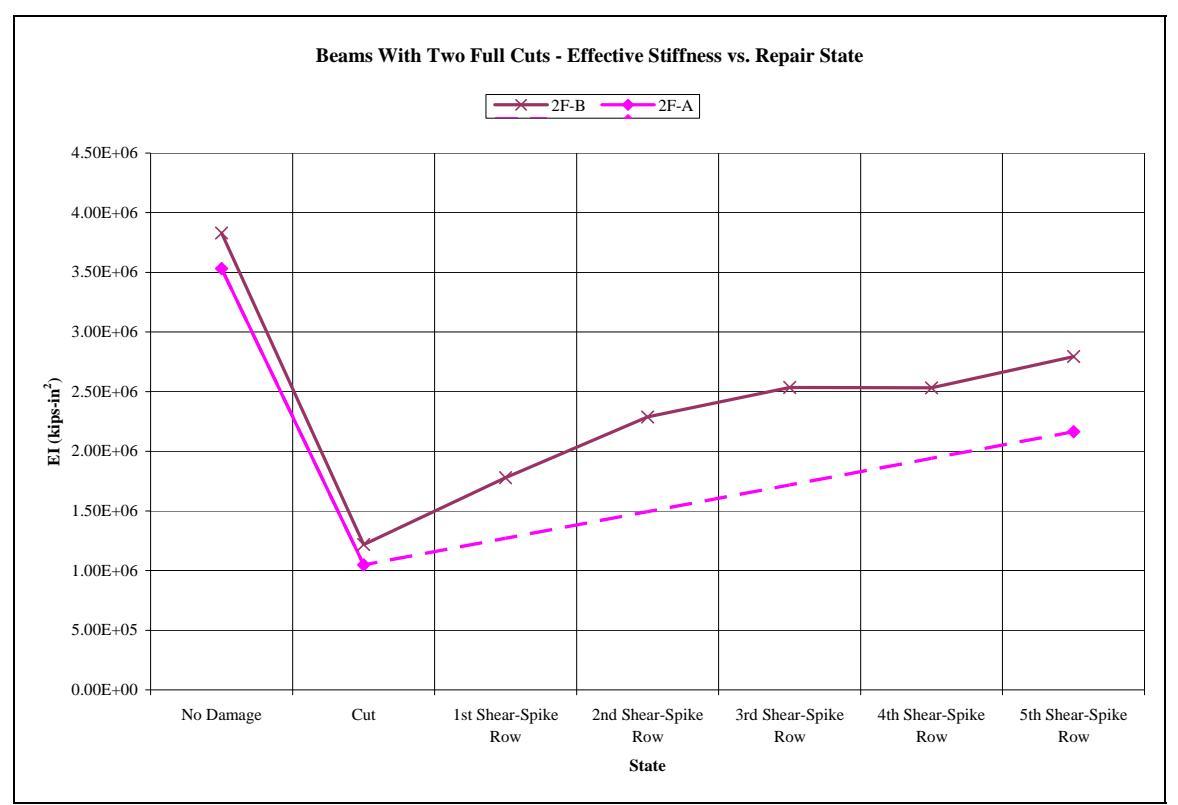
The most severely damaged specimens, 2F-A and 2F-B, have their flexural stiffness reduced to 31.8% and 29.7% of their virgin flexural stiffness, respectively, after intentional damage. These specimens have relatively similar percentage rejuvenation in the fully reinforced state; specimen 2F-A has its flexural stiffness recovered to 73.0% (from 31.8%); specimen 2F-B has its flexural stiffness restored to 61.3% (from 29.7%). The effects at various states on the flexural stiffness are presented in Figure 5.7 for these two specimens; the dashed line of specimen 2F-A represents linear interpolation.

Figure 5.7 Flexural stiffness (EI) versus state for beams with two full cuts.

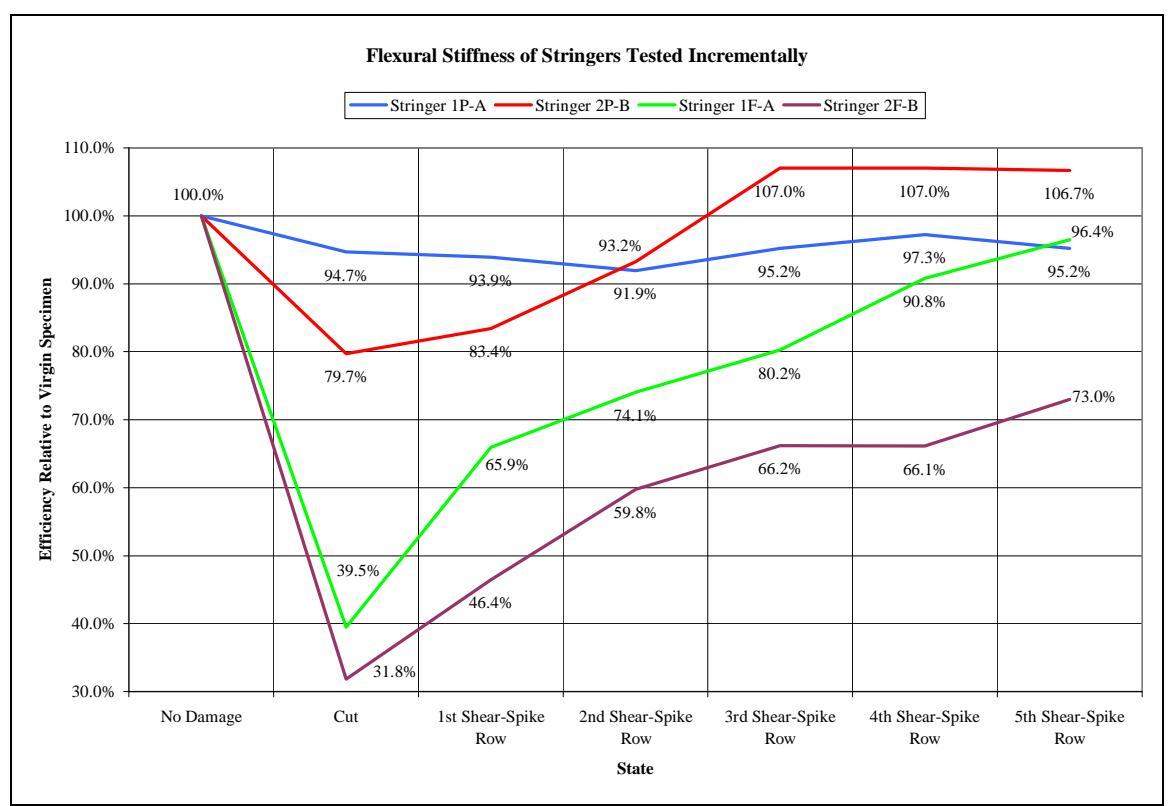
Figure 5.8 Effects from successive rows of shear spikes installed.

From Figure 5.8, two prominent trends can be observed; in the specimens with more severe damage inflicted (1F-A and 2F-B), the stiffness increases more or less linearly with each successive row of shear spikes installed. Moreover, there is no indication of this increase in flexural stiffness reaching a plateau state. Therefore, for more severely damaged/deteriorated members, a higher reinforcement ratio may be beneficial.

In the specimens with less prominent damage inflicted (1P-A and 2P-B), it seems a plateau state relative to increase in flexural stiffness from shear spiking is reached after the third and fourth row of shear spikes, respectively. As previously mentioned, stringer 1P-A has its fully reinforced flexural stiffness exceed its virgin state stiffness; a flexural stiffness of 107.0% is reached already after the third shear spike row. The fourth and fifth shear spike rows have very little effect on the flexural stiffness; there is in fact a small loss from the fourth to the fifth shear spike row. Finally, for stringer 1P-A there iss little overall gain from shear spiking. Small losses in flexural stiffness is improved from the third and fourth rows of shear spikes. However, the flexural stiffness is improved from the third and fourth rows of shear spikes. These negative effects from shear spiking are believed to be due to a loss of properties from drilling out sound wood exceeding what is gained from shear spiking at these locations. This interesting phenomenon was also occasionally observed in previous studies, i.e. Radford et al. [49-52], Schilling [55-57], and Burgers [15-16].

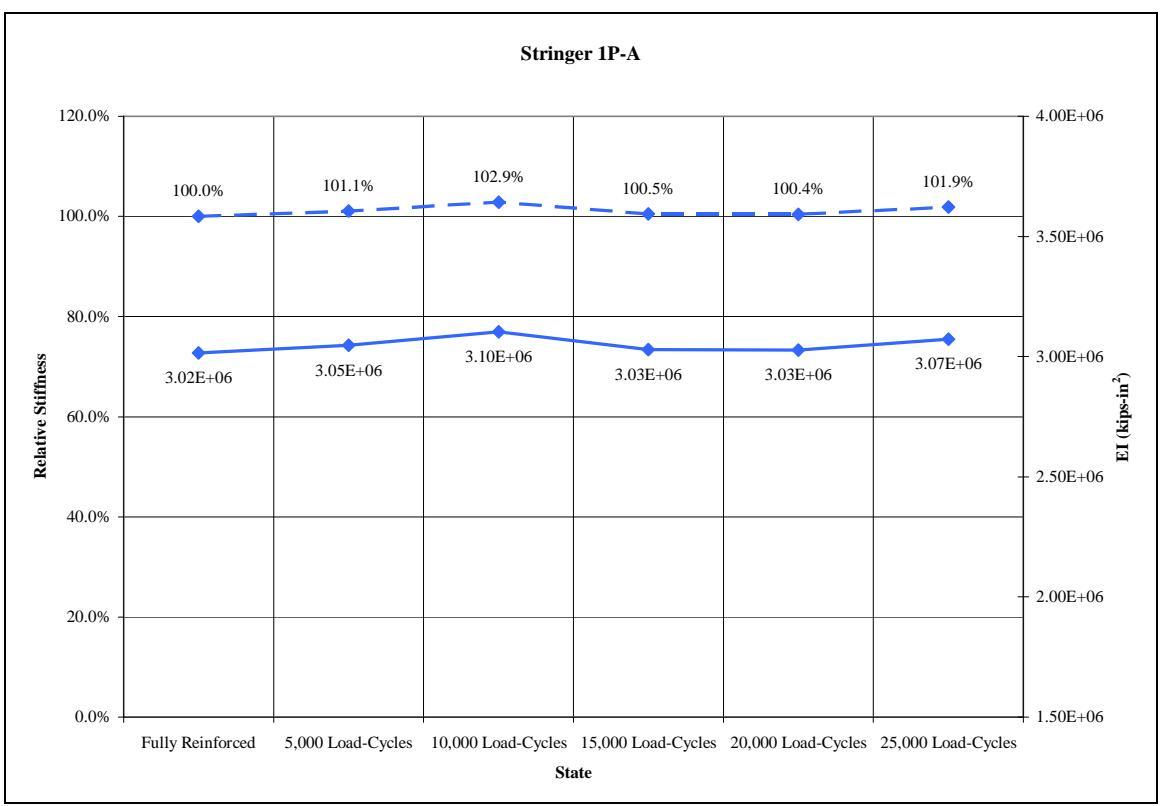
During durability loading, no physical indications of detrimental effects on stringer 1P-A from the cyclic loading were observed. These observations were verified from load test results, where no apparent detrimental effect from the repeated loading was evident. As can be seen in Figure 5.9, there are small variations in measured flexural stiffness after 5,000, 10,000, 15,000, 20,000, and finally after 25,000 load cycles. These variations are believed to be due to variables other than the mechanical properties of the strengthened stringer itself. Rather, slight movement of the stringer relative to its support locations during the durability loading and/or opening and closing of vertical gaps at damage locations during ramp load testing are believed to have contributed to these minute fluctuations in measured stiffness. In Figure 5.9, 100% on the left-hand y-axis corresponds to the flexural stiffness values, in units of kips-in.²; this is also the case in subsequent Figures 5.10 to 5.12 and Figures 5.14 to 5.17.

Figure 5.9 Stiffness of specimen 1P-A at various stages during durability loading.

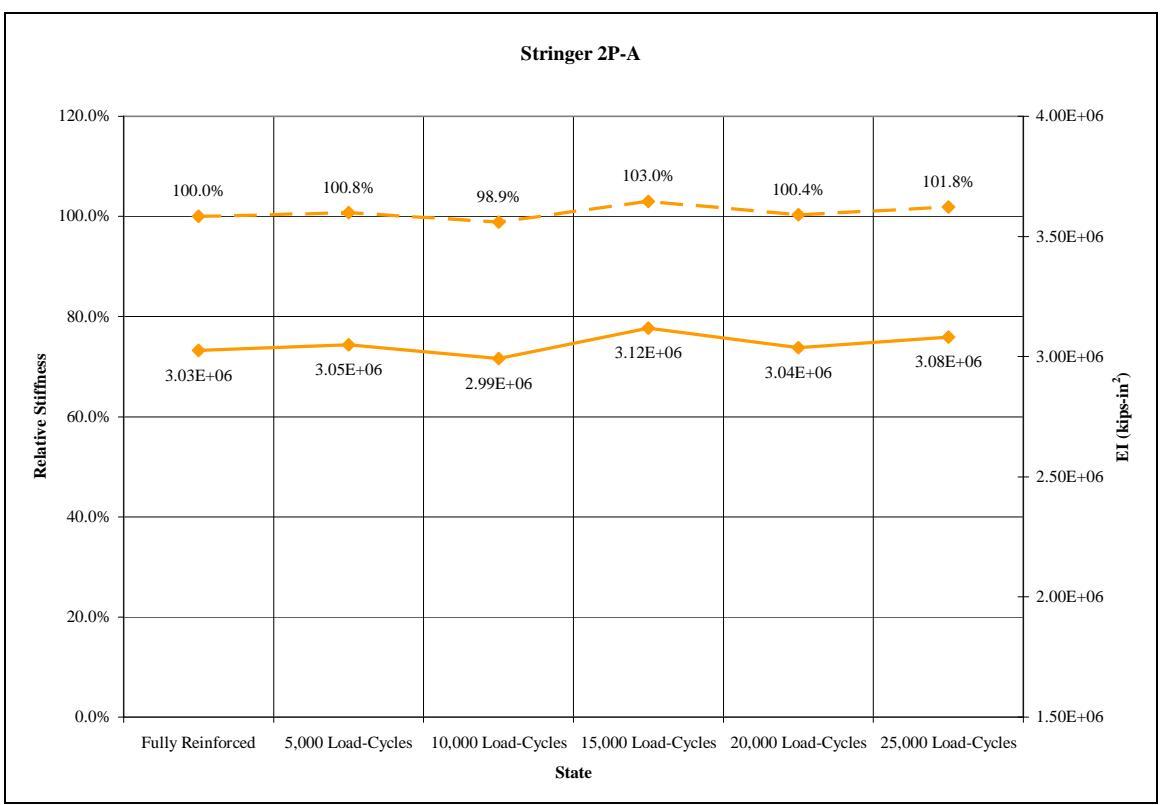
Results from ramp load testing of specimen 2P-A are presented in Figure 5.10. Similar to stringer 1P-A, no detrimental effect resulted on specimen 2P-A from the durability loading.

Figure 5.10 Stiffness of specimen 2P-A at various stages during durability loading.

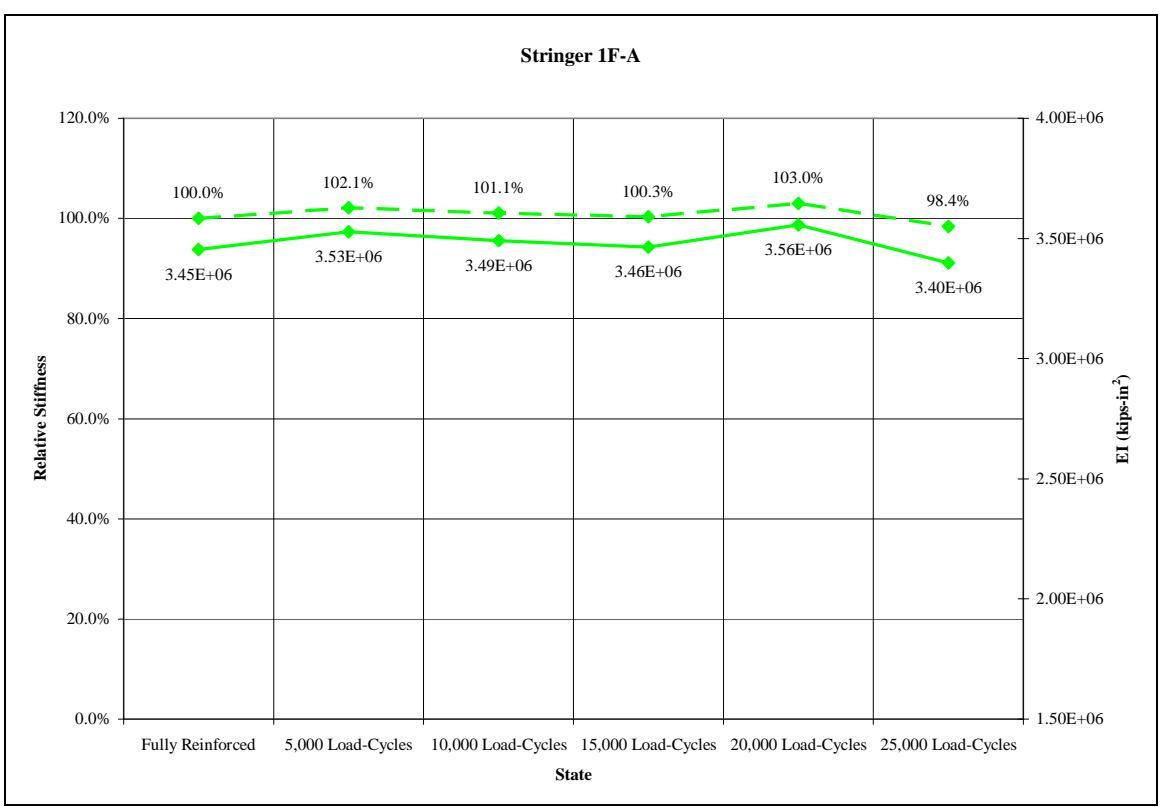
As can be seen from Figure 5.11, ramp load testing of stringer 1F-A shows no effects from the repeated loading up to 20,000 load cycles. The minute fluctuations that can be observed in Figure 6.11 are again believed to be due to external factors. However, there is a notable drop in flexural stiffness between 20,000 cycles and 25,000 cycles (from 3.56×10^6 to 3.40×10^6 kips-in² [1.02×10^4 to 9.76×10^3 kN-m²]). However, when the stiffness after 25,000 load cycles is compared to that at full reinforcement but before any durability loading (3.40×10^6 vs. 3.45×10^6 kips-in², [9.76×10^3 vs. 9.90×10^3 kN-m²]), this drop is small enough to be believed to result from the previously described external effects rather than an actual loss of flexural stiffness.

Figure 5.11 Stiffness of specimen 1F-A at various stages during durability loading.

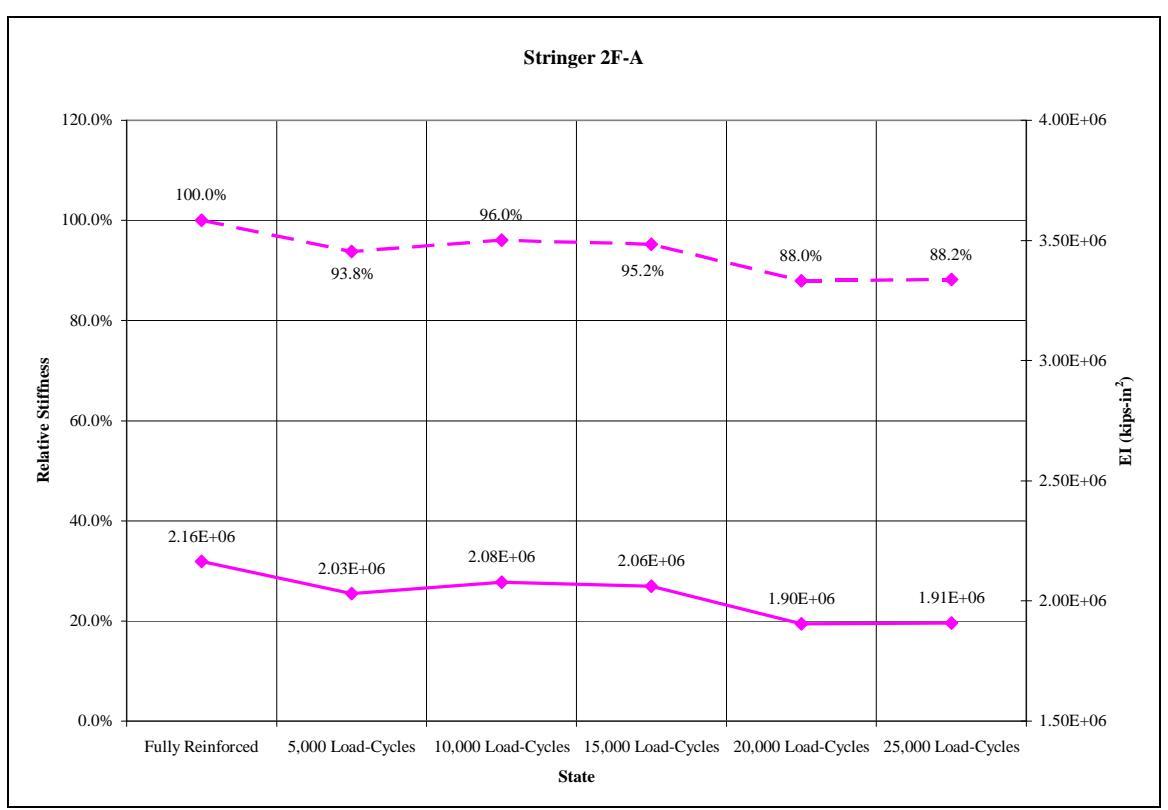
In contrast to the other three specimens exposed to a durability load level corresponding to a mid-span deflection of L/500, specimen 2F-A exhibits a trend of lost flexural stiffness resulting from the repeated loading, as can be seen in Figure 5.12. Already after 5,000 load cycles, the measured flexural stiffness is down to 93.8% of the fully reinforced state stiffness. Relative flexural stiffness after 10.000 and 15.000 load cycles, however, show no indication of further loss. Quite opposite, there is actually a small rebound in flexural stiffness after 10,000 and again after 15,000 load cycles, as compared to the measured flexural stiffness at 5,000 load cycles. However, the magnitude of "restored" flexural stiffness is small enough to be believed to be due to external factors or possibly an anomaly of a measurement error itself for the 5,000 cycle data point. Another noticeable drop in flexural stiffness occurs from 15,000 to 20,000 load cycles. The flexural stiffness drops by 7.2%, from 95.2% down to 88.0%. Yet, there is no apparent further loss in flexural stiffness from 20.000 to 25.000 load cycles. The loss in flexural stiffness that is observed at 20,000 load cycles is too large to be solely attributed to external factors; it is thus believed that the repeated loading does contribute to the reduction. Lateral movement of the upper relative to the lower half in the south half of stringer 2F-A was evident during durability loading post 15,000 load cycles. In other words, interlayer slip occurred at the south lengthwise half of the beam where the neutral axis cut acted as a slip plane.

Figure 5.12 Stiffness of specimen 2F-A at various stages during durability loading.

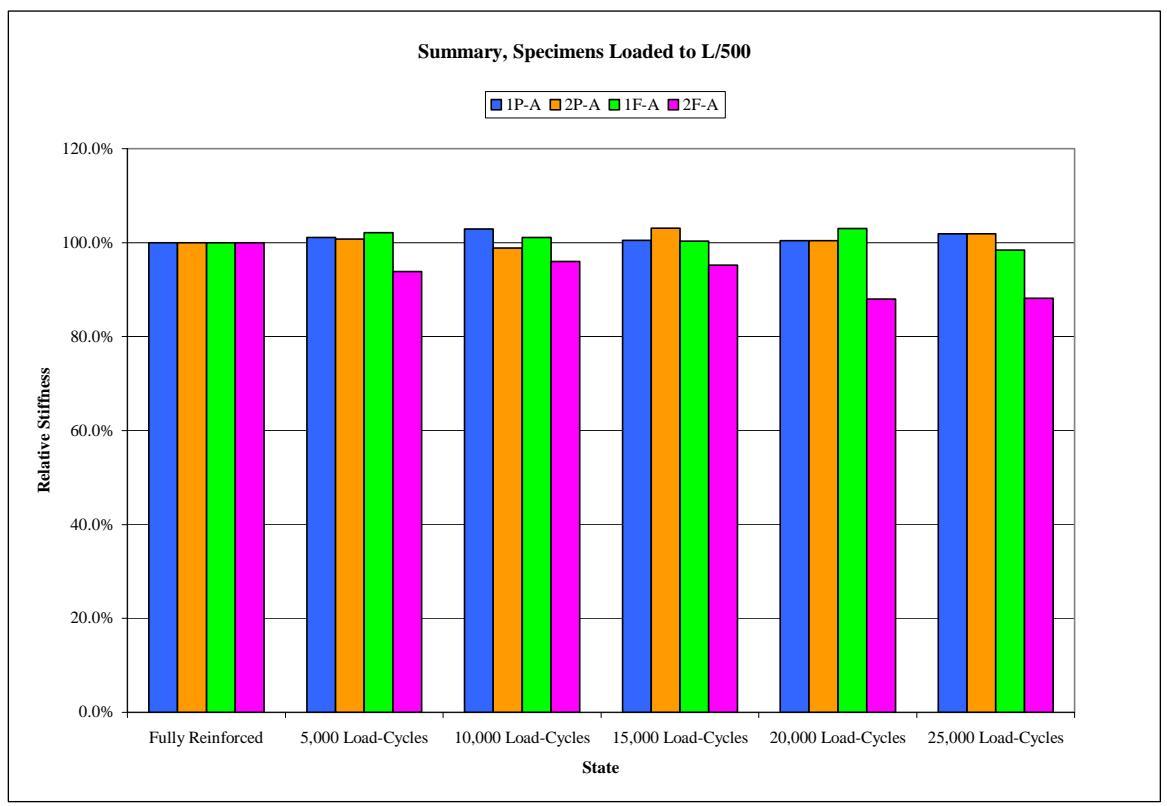
It is evident that the relative flexural stiffness remains near 100% for all stringers except specimen 2F-A. The two drops in flexural stiffness of specimen 2F-A, at 5,000 and 20,000 load cycles, are easily observed in Figure 5.13, which summarizes the results for all four specimens. All specimens (1P-A, 2P-A, 1F-A, and 2F-A) were ramp load tested to failure after conclusion of the durability loading, as described subsequently in Section 5.3.

Figure 5.13 Summary of effects from repeated loading on specimens loaded to mid-span deflection corresponding to L/500.

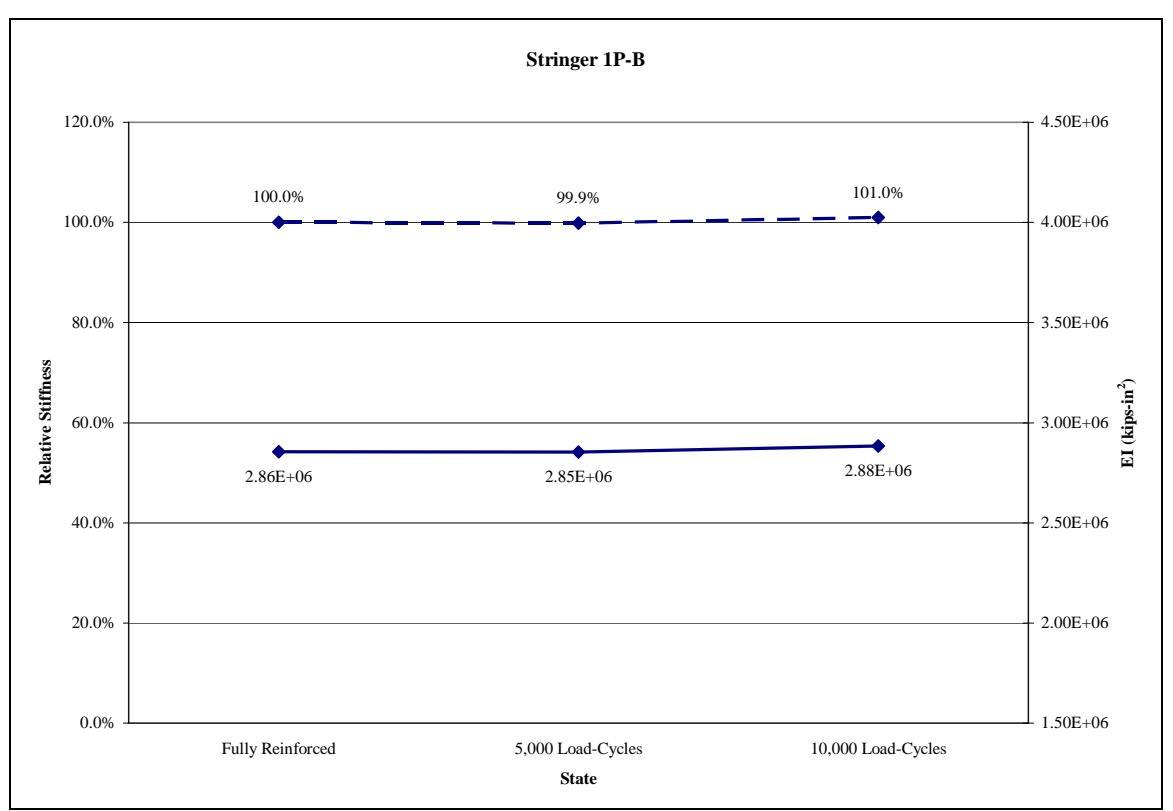
Figure 5.14 illustrates the results for specimen 1P-B. Specimen 1P-B shows no effect whatsoever from the durability loading. The percent flexural stiffness lingers very near 100%, i.e. the stiffness before any repeated loading, after both 5,000 and 10,000 load cycles. Stringer 1P-B was ramp load tested to failure after conclusion of the durability loading, as described subsequently in Section 5.3.

Figure 5.14 Stiffness of specimen 1P-B at various stages during durability loading.

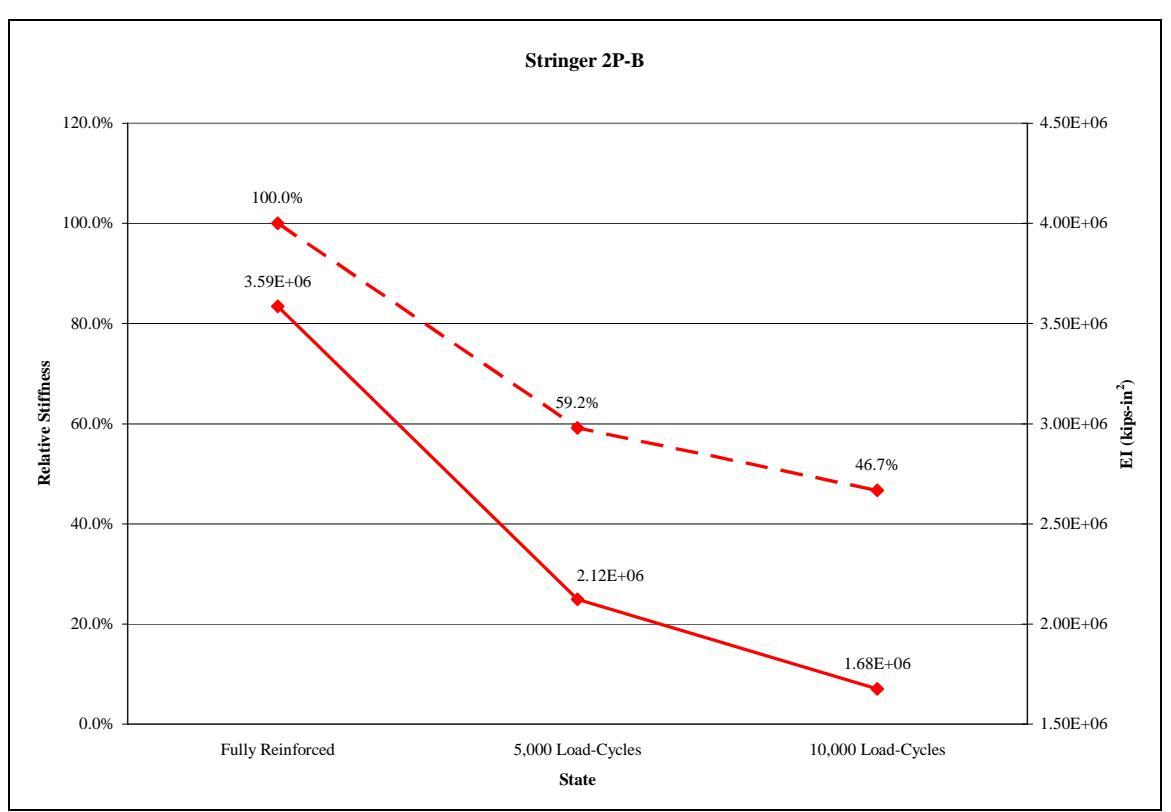
Stringer 2P-B showed physical signs of diminished structural integrity early on in the durability loading; already after fewer than 100 load cycles. Diagonal shear cracks at both butt ends became evident. These shear cracks had propagated between the two imposed partial cuts. During durability loading, significant interlayer slip occurred in the plane of these cuts. Since the shear failures were evident early on in the durability loading, it is believed that the failure stemmed from the load capacity being exceeded rather than resulting from the repetitive nature of the loading. Figure 5.15 depicts the effects from durability loading on specimen 2P-B. The flexural stiffness shows a significant drop between 5,000 to 10,000 load cycles, which suggests that after the initial shear failure(s), the repetitive loading further diminished the structural integrity, probably causing the initial failure to further propagate. Moreover, at the 5,000 load cycle mark, over 40% of the stiffness of the reinforced stringer had been lost. After 10,000 cycles, the flexural stiffness, it was determined that the stringer was not to be load tested to failure. The specimen was instead dissected to, if possible, determine the failure mode. Because of this diminished flexural stiffness, it was decided that subsequent specimens were to be ramp load tested at shorter load cycle increments (e.g. also after 100, 1,000, 2,500, and 7,500 load cycles).

Figure 5.15 Stiffness of specimen 2P-B at various stages during durability loading.

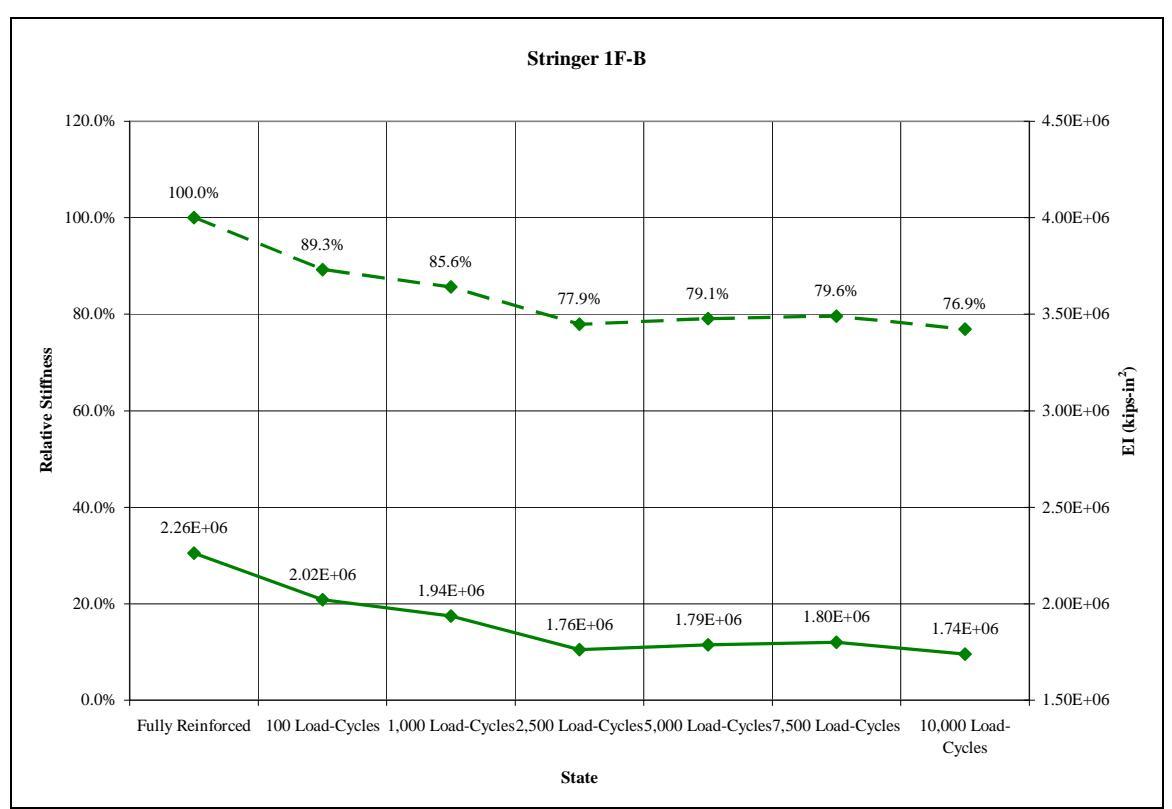
Much like specimen 2P-B, stringer 1F-B experienced an interlayer shear failure early on in the durability loading process. This shear failure became apparent almost immediately, and interlayer slip occurred between the two vertical halves separated by the intentional cut at the neutral axis location in both the south and north stringer end. Moreover, a shear crack propagated into the center-third of the beam from its south end. This horizontal crack commenced where the intentional horizontal cut had been terminated and made its way all the way to near the stringer midpoint. Figure 5.16 is a plot depicting the effects of durability loading on specimen 1F-B. There is an approximate linear loss of flexural stiffness up to 2,500 load cycles, after which the flexural stiffness remains fairly constant. It can also be seen that the flexural stiffness is reduced by more than 10% already after 100 load cycles. After 1,000 load cycles, the flexural stiffness is reduced to 77.9%. However, there seems to be little detrimental effect from further repetitive loading since only an additional 1% loss in stiffness is observed from 2,500 to 10,000 load cycles. Specimen 1F-A was later dissected to determine its failure mode; it was therefore not ultimate load tested.

Figure 5.16 Stiffness of specimen 1F-B at various stages during durability loading.

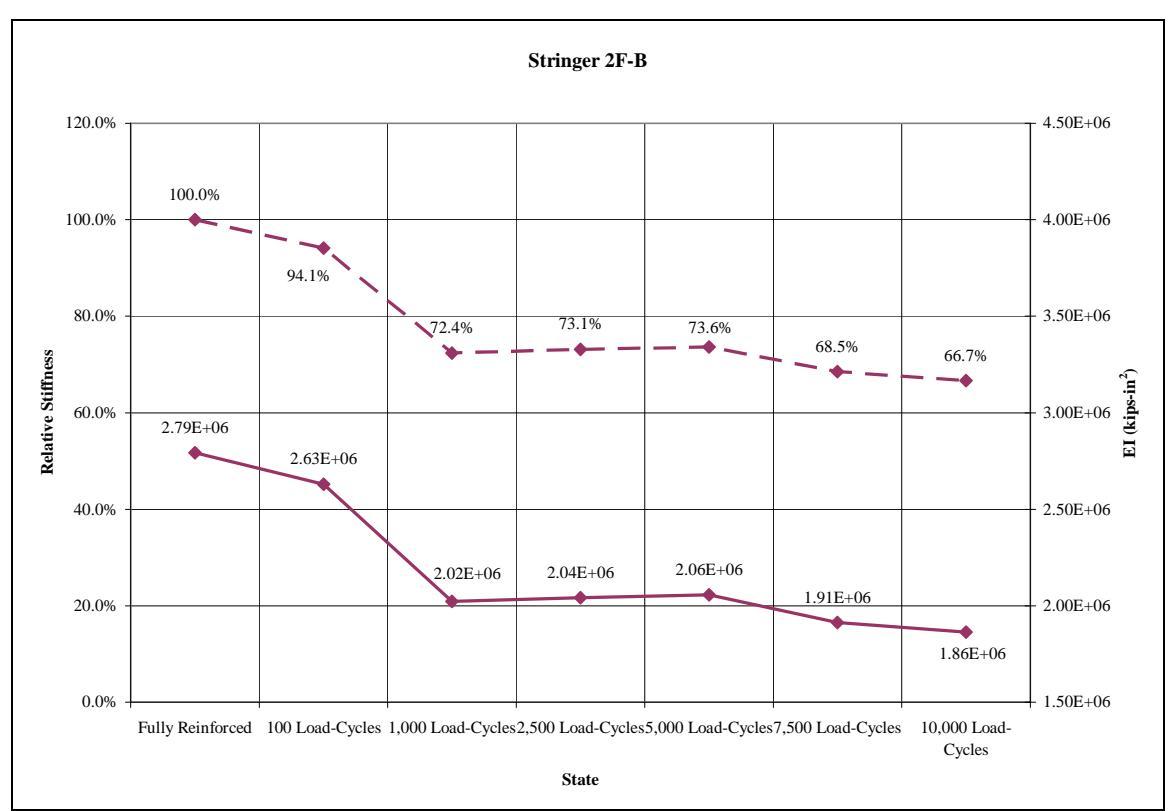
Stringer 2F-B had apparent shear failures at the neutral axis cuts, at both ends, and significant interlayer slip occurred in the early stages of durability loading; the north end shear crack extended into the middle-third of the stringer. The interlayer slip became evident almost immediately during the repetitive loading process, and became much more pronounced after approximately 500 load cycles. Figure 5.17 is a plot of its relative stiffness versus number of load cycles. There is a flexural stiffness loss of 5.9% already after 100 cycles. What is more interesting is the significant loss in stiffness from 100 to 1,000 load cycles. The measured flexural stiffness drops from 2.63x10⁶ to 2.02x10⁶ kips-in² (7.55x10³ to 5.80x10³ kN-m²) from 100 to 1,000 load cycles; a loss corresponding to 21.7%. However, post 1,000 load cycles show little effect on the stiffness from the repetitive loading. The stiffness remains fairly constant up to 5,000 load cycles, after which a 6.9% drop is observed over the next 5,000 load cycles. At the conclusion of durability loading, stringer 2F-B was dissected to determine the failure mode(s); it was therefore not load tested to failure.

Figure 5.17 Stiffness of specimen 2F-B at various stages during durability loading.

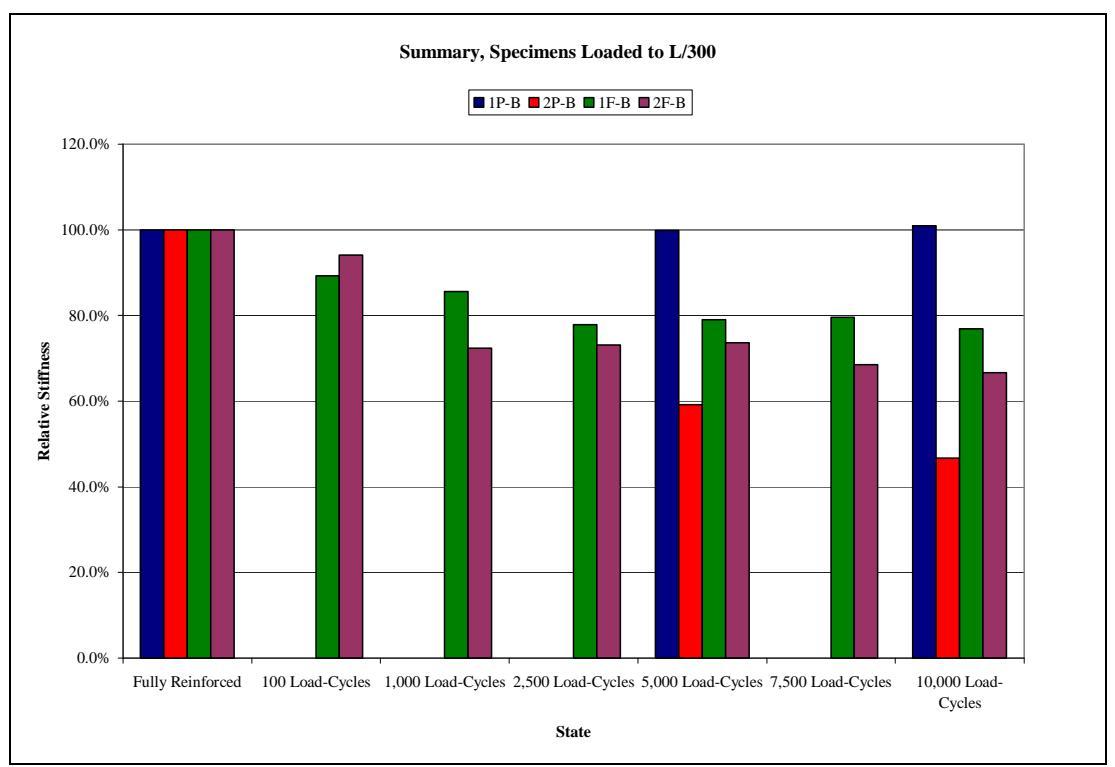
A summary of the results from load testing of specimens exposed to a repetitive load corresponding to a mid-span deflection of L/300 is given in Figure 5.18. Note again that stringers 1P-B and 2P-B were not ramp load tested at 100, 1,000, 2,500 and 7,500 load cycles; these increments are therefore not shown in Figure 5.18. It is evident that specimen 1P-B shows no effect from the durability loading. The other three stringers (2P-B, 1F-B and 2F-B), however, all exhibit significant stiffness losses from the durability loading. In specimens 1F-B and 2F-B it can be seen that the majority of loss has already taken place at 2,500 load cycles. Specimen 2P-B was not intermediately load tested; it is therefore not known if there was a sudden drop in stiffness somewhere between 1 and 5,000 load cycles or if this loss was relatively continuous. Nonetheless, since the bulk of loss in stiffness seems to have taken place before the 2,500 load cycle mark was reached, it is believed that the diminishing flexural stiffness resulted from overloading of the stringers rather than resulting from the repetitive nature of the loading.

Figure 5.18 Summary of effects from repeated loading on specimens loaded to mid-span deflection corresponding to L/500.
