DURABILITY AND ULTIMATE FLEXURAL LOADING OF SHEAR SPIKE REPAIRED, LARGE–SCALE TIMBER RAILROAD BRIDGE MEMBERS

R. Gutkowski H. Forsling Department of Civil Engineering

December 2007

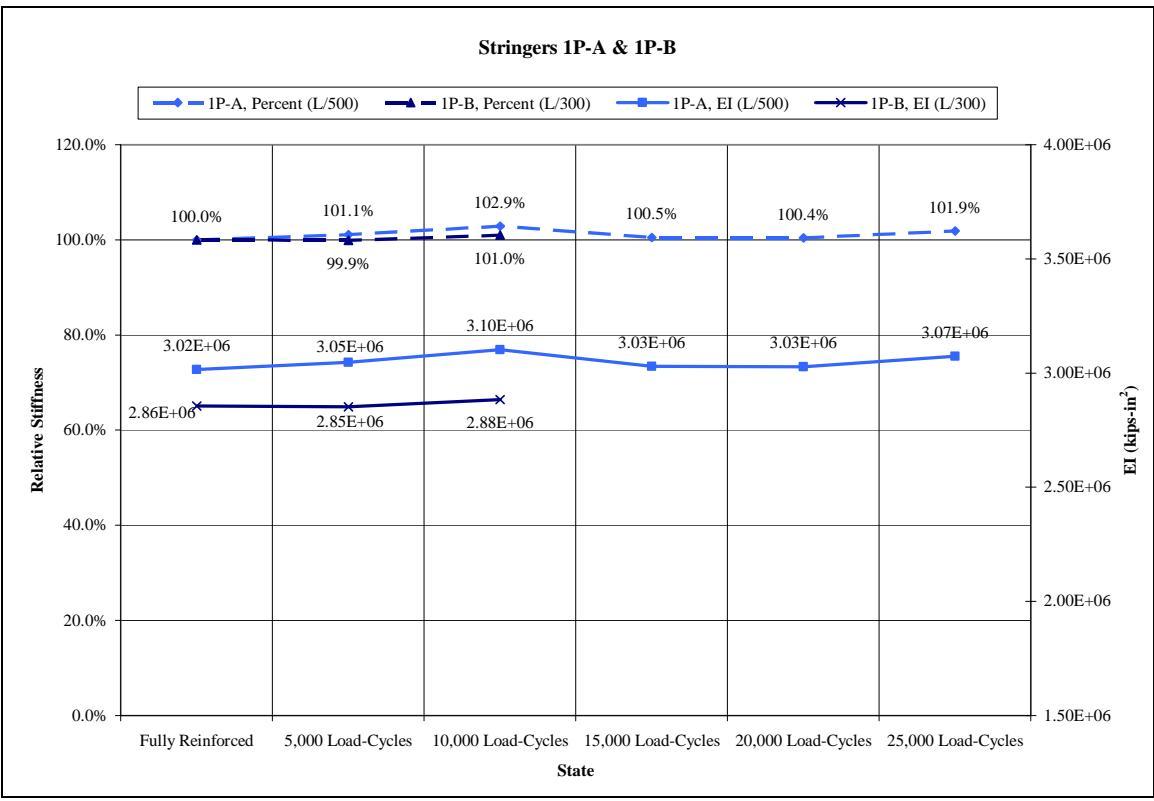
The effect of dissimilar load exposure on paired (matched) specimens is discussed in this section. Figure 5.19 depicts effects of cyclic loading on the two specimens with one partial cut. It can be seen that the specimens with one partial cut (1P-A and 1P-B) display almost identical responses from the durability loading. Both these specimens lingered at or near their respective virgin stiffness throughout durability loading. Also, as is discussed in Section 5.3, these two specimens exhibit similar structural responses and failure modes from the ramp load tests conducted to failure.

Figure 5.19 Comparison of effects of different durability loading configurations of stringers with one partial cut.

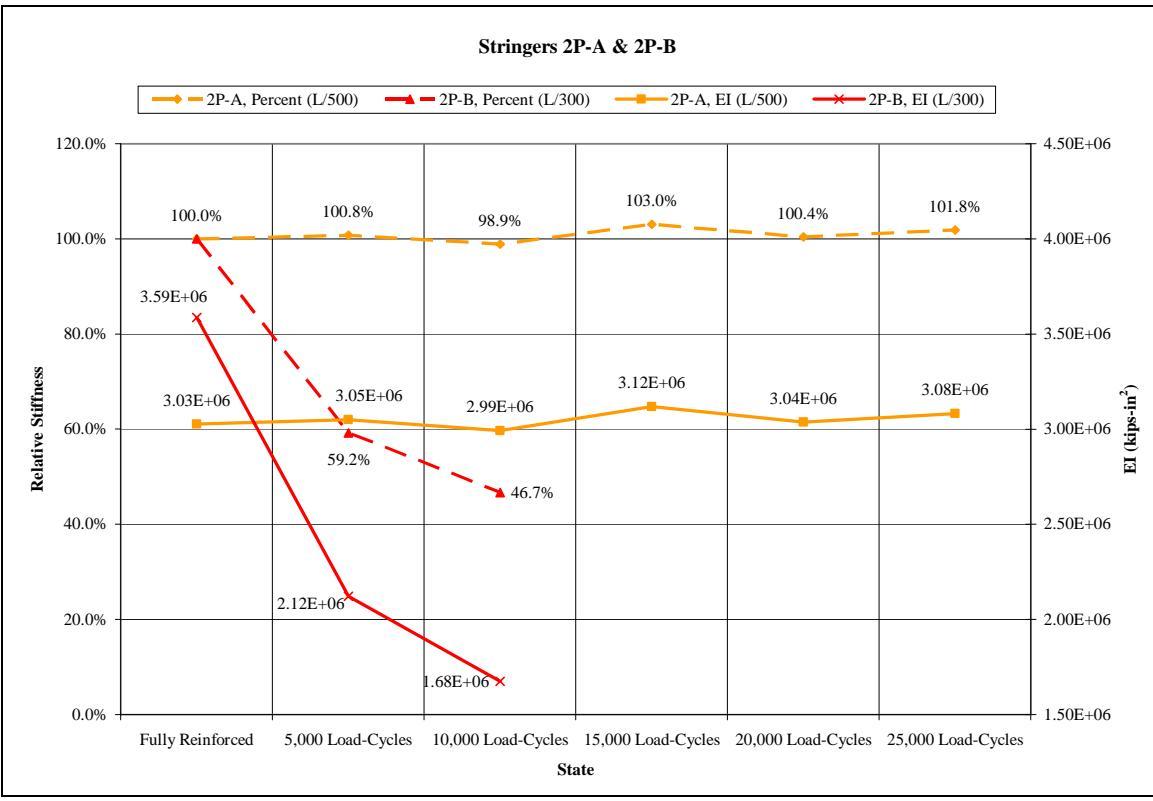
A clear distinction in effect of the durability loading was displayed by specimens 2P-A and 2P-B, as can be seen in Figure 5.20. Stringer 2P-A, which was durability loaded at the lesser load level than specimen 2P-B (25,000 load cycles at L/500 vs. 10,000 load cycles at L/300) shows little, if any, detrimental effect from the durability loading. Stringer 2P-B on the other hand has its flexural stiffness reduced by over 40% already after 5,000 load cycles, and shows a further reduction of 12.5% from the next 5,000 load cycles.

Figure 5.20 Comparison of effects of different durability loading configurations of stringers with two partial cuts.

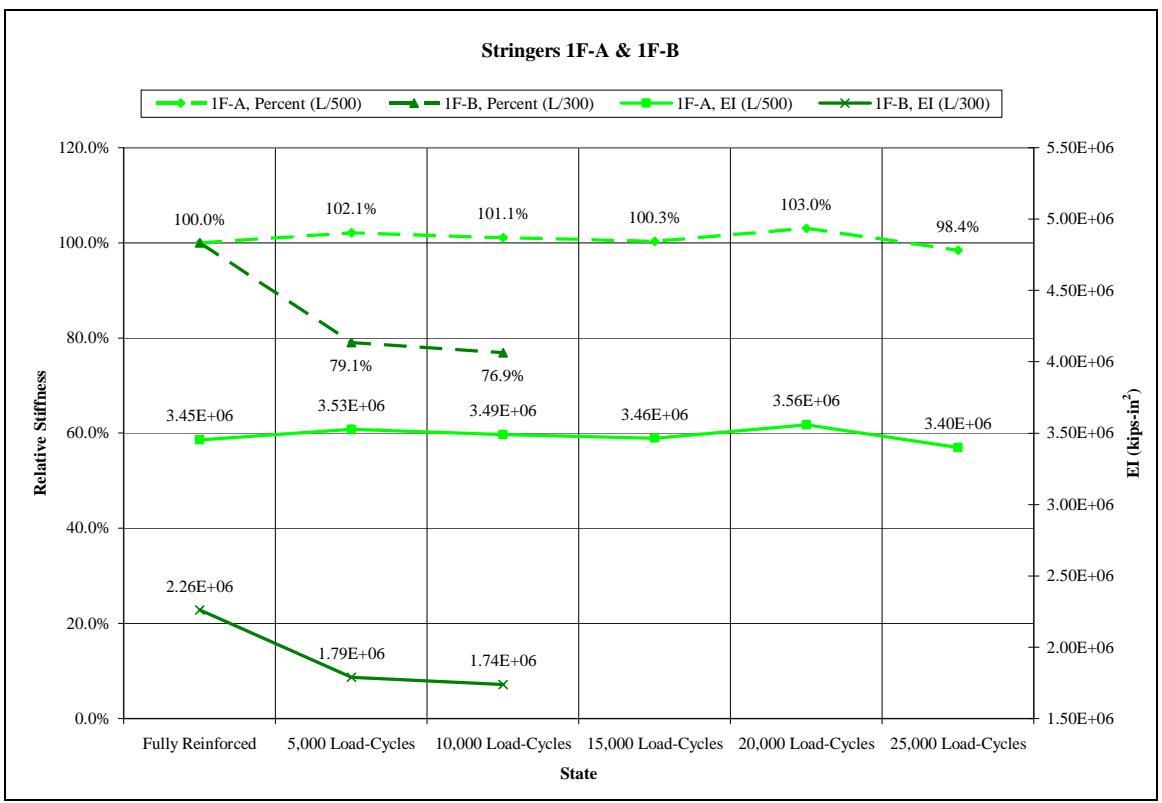
A similar trend is noted in specimens 1F-A and 1F-B, as shown in Figure 5.21. Specimen 1F-A exhibits no appreciable loss from the durability loading, whereas stringer 1F-B has a loss in flexural stiffness of over 20% at 5,000 load cycles. However, there is little further loss in flexural stiffness of stringer 1F-B from 5,000 to 10,000 load cycles.

Figure 5.21 Comparison of effects of different durability loading configurations of stringers with one full cut.

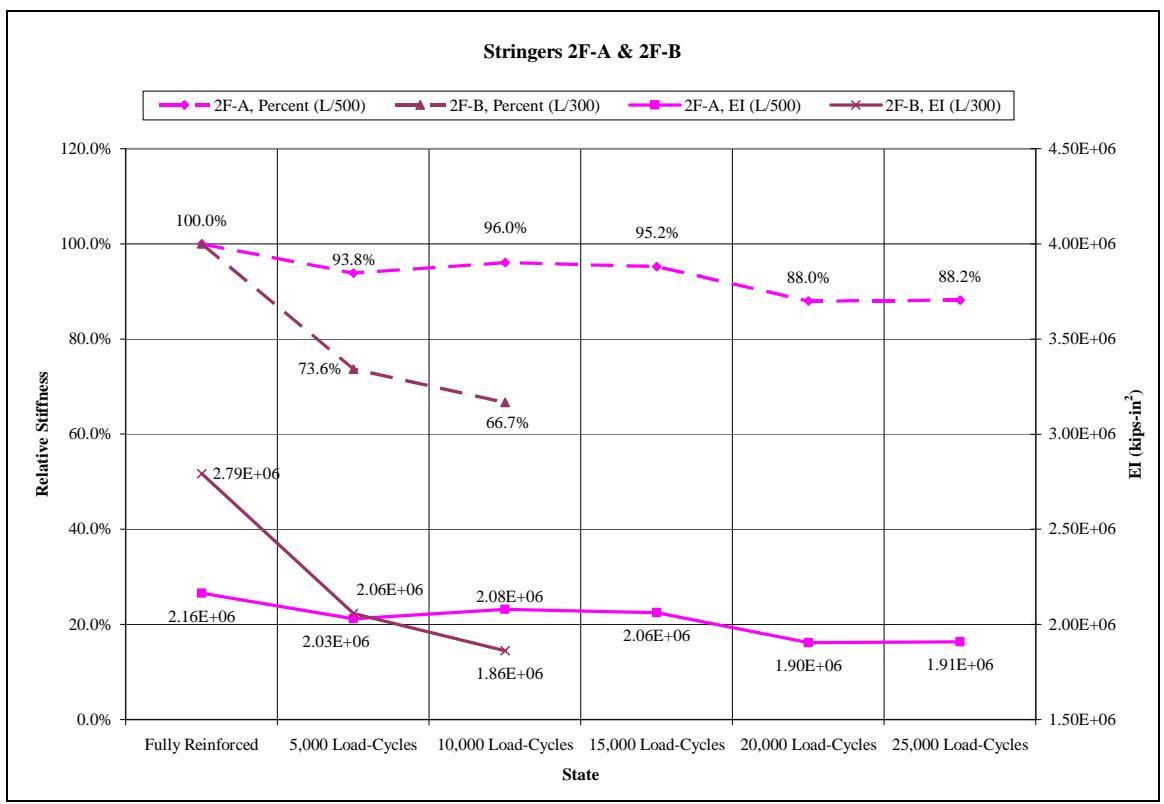
Figure 5.22 Comparison of effects of different durability loading configurations of stringers with two full cuts.

The stringers with two full cuts (2F-A and 2F-B) both show appreciable losses of flexural stiffness in the early stages of durability loading; a 6.4% and 26.4% loss at 5,000 load cycles, respectively. It is interesting to note in Figure 5.22 that there is a trend in both specimens where after 5,000 cycles, the rate of flexural stiffness loss, relative to number of load cycles, seems to level off. A similar settling trend after 5,000 load cycles can also be observed in stringer 2P-B (see Figures 5.15 and 5.20) and particularly in stringer 1F-B (see Figures 5.16 and 5.21). However, since only one of the specimens (2F-A) that displayed detrimental effects from the repetitive loading was loaded beyond 10,000 load cycles, it is unknown if these "asymptotic trends" would continue as the number of load cycles increases.

Since these losses in flexural stiffness generally took place in the early stages of durability loading, it is suspected that overloading was the cause, rather than the repetitive nature of the durability loading. Of the specimens that suffer losses in flexural stiffness from the durability loading, only one specimen (2P-B) has its flexural stiffness reduced below the flexural stiffness level after damage (but before any shear spiking). In all other specimens that suffer losses in stiffness during the durability loading, the level is still above the flexural stiffness after damage infliction, as can be seen in Figure 5.23.

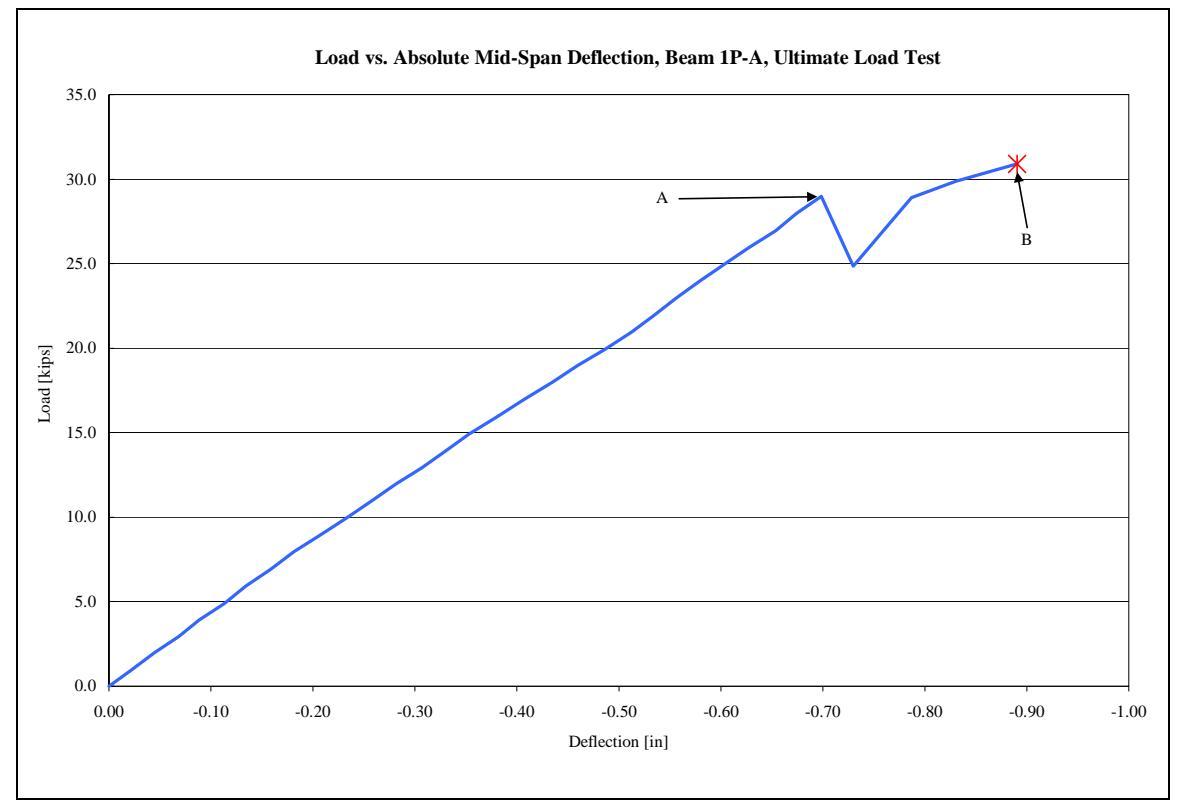
Figure 5.25 Load-deflection curve from ultimate load test of stringer 1P-A.

The five stringers that were not dissected were instead ramp load tested to failure at the conclusion of durability loading. The load-deflection curve from ultimate load testing of specimen 1P-A is given in Figure 5.25. Stringer 1P-A exhibits a linear load-deflection behavior up to approximately 29 kips (129 kN), when apparent shear failures near the neutral axis location within both end-thirds occur (at "A" in Figure 5.25). It is evident that the remaining wood in the center portion sheared, since significant interlayer slip is evident within both ends, and shear cracks are clearly discernible in both butt ends. The north end shear crack is highlighted in Figure 5.26. This particular crack propagates from one side face, almost through the entire stringer width, and branches down through the uncut center portion. A sudden drop in load, along with an increase in mid-span deflection, was observed when these shear failures took place. However, the stringer was further loaded up to 31 kips (138 kN) before a catastrophic flexural failure occurred ("B" in Figure 5.25); a diagonal flexural crack across the center third of the tension face resulted.

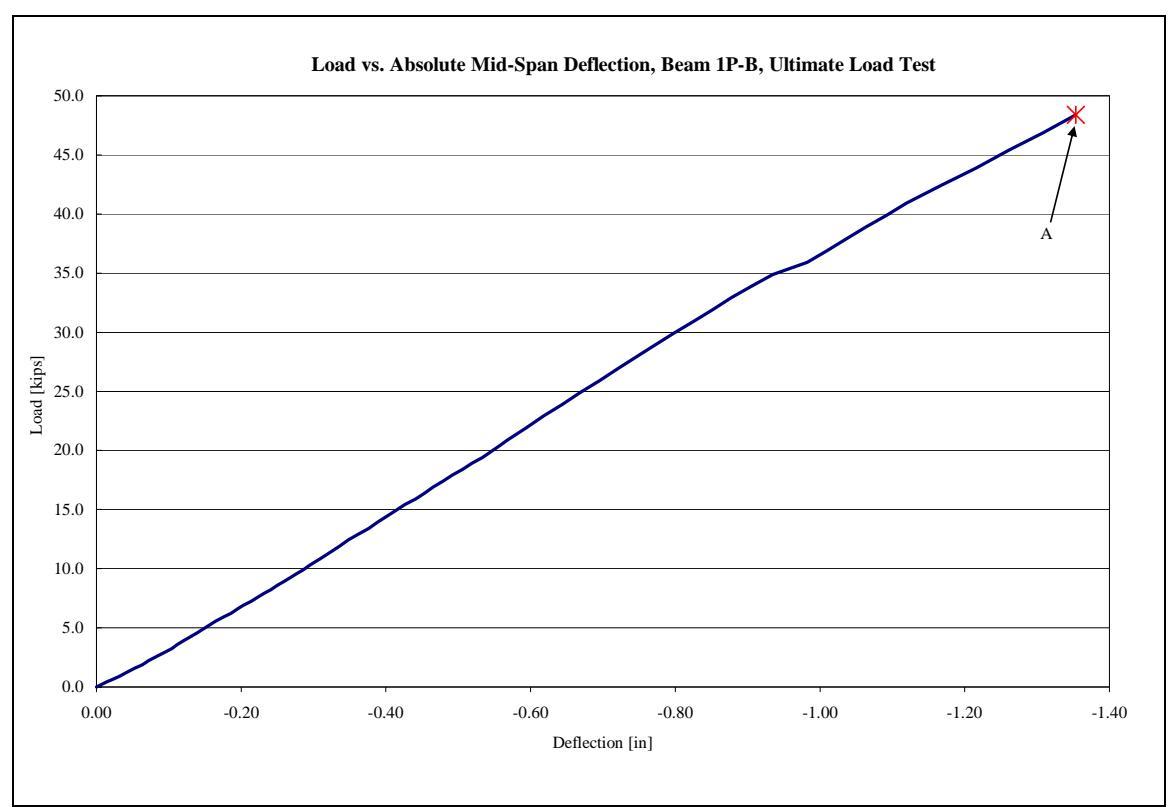
Figure 5.27 Load-deflection curve from ultimate load test of stringer 1P-B.

The load-deflection curve of stringer 1P-B is given in Figure 5.27. Stringer 1P-B had a more or less linear load-deflection behavior before its sudden and catastrophic failure (at "A" in Figure 5.27), when a deep flexural crack propagated diagonally across the center-third of the tension face, as show in Figure 5.28. This specimen withstood the highest ultimate load of all five stringers; approximately 48.5 kips (216 kN).

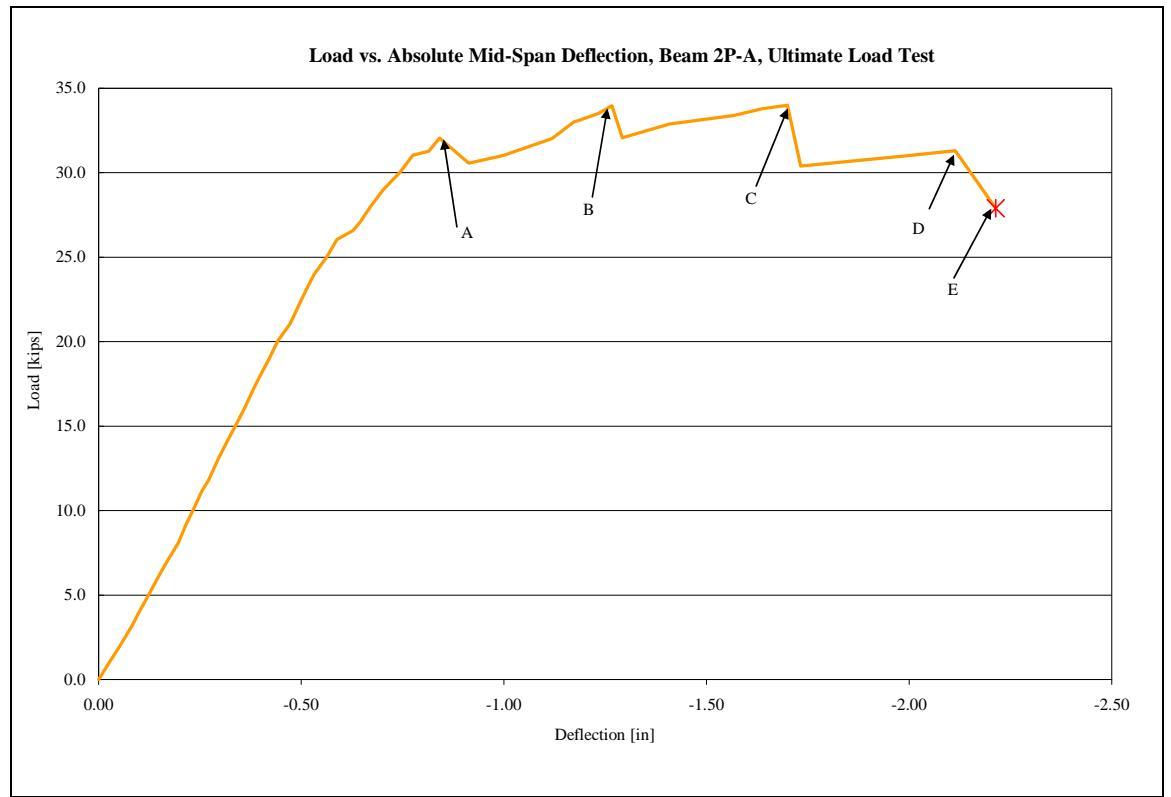
Figure 5.29 Load-deflection curve from ultimate load test of stringer 2P-A.

Stringer 2P-A experienced successive non-catastrophic shear failures in the south end during ultimate load testing (at "A" and "B" in Figure 5.29). These successive shear failures start at a load level of approximately 32 kips (142 kN) (at "A" in Figure 5.29). An "inverted C" shaped slip plane appears between the two partial horizontal cuts in the south stringer third, as can be seen in Figure 5.30. The stringer shows severe interlayer slip in along the "inverted C" shaped slip plane. Note in Figure 5.30 how this "inverted C" shaped crack propagates from the end of one partial cut, through the center portion of the member, and back to the other partial cut.

The stringer retains its load carrying capacity up to a load of approximately 34.5 kips (153 kN), when a perpendicular-to-grain tension failure develops at approximately the south third-point, initiated almost at the neutral axis and propagating upward, towards mid-span at an approximate 45-degree angle (at "C" in Figure 5.29).

At point "D," another non-catastrophic shear failure occurs along with further propagation of the just described perpendicular-to-grain failure. Finally, there is a catastrophic flexural failure in the tension face in the vicinity of the south third-point (at "E" in Figure 5.29). The propagation of this flexural crack is more or less perpendicular to the length of the beam. This ultimate failure occurs at load of 31.5 kips (140 kN).

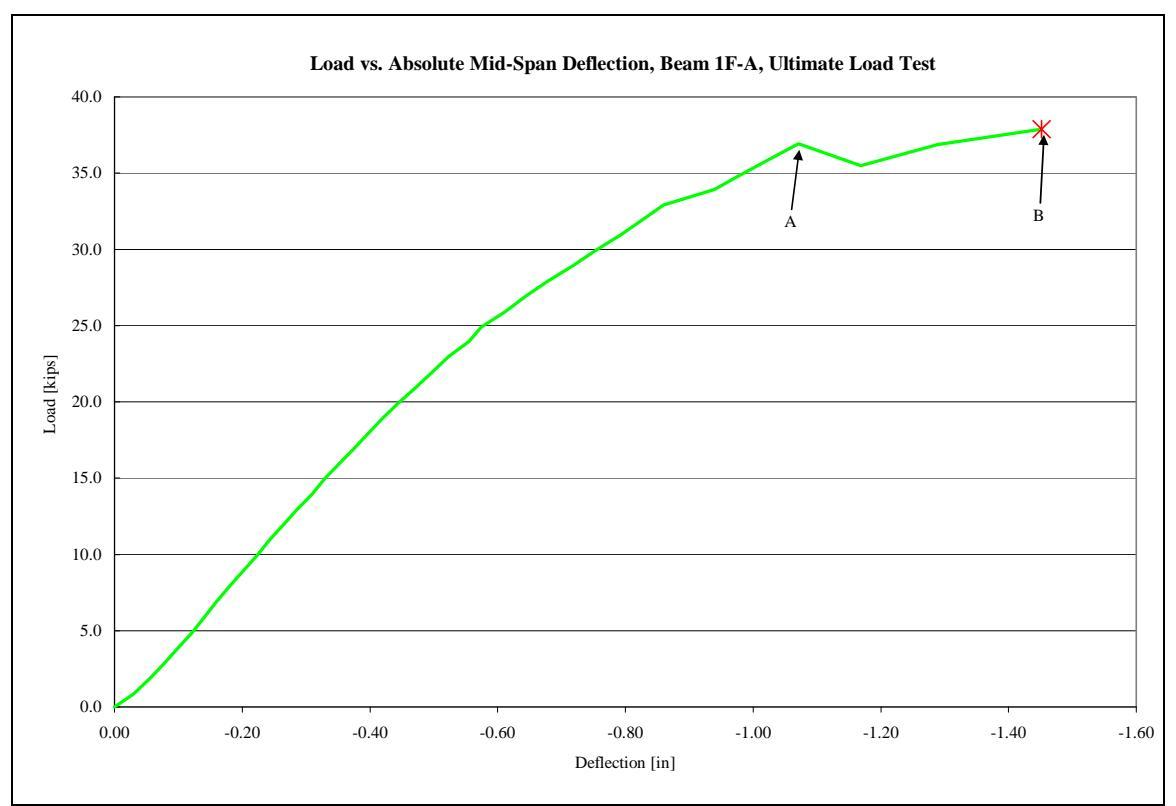
Figure 5.31 Load-deflection curve from ultimate load test of stringer 1F-A.

The load-deflection curve of ultimate load testing of stringer 1F-A is given in Figure 5.31. Specimen 1F-A first shows non-catastrophic shear failure along the neutral axis cuts at a load level of approximately 37 kips (165 kN) (at "A" in Figure 5.32). Significant related interlayer slip was observed at both stringer ends, where slip occurs in the plane of the intentional cuts. The specimen ultimately fails in flexure with a resulting diagonal flexural crack in the tension face, spanning the middle-third of the beam, as shown in Figure 5.32 ("B" in Figure 5.31). The load at failure is 38 kips (169 kN).

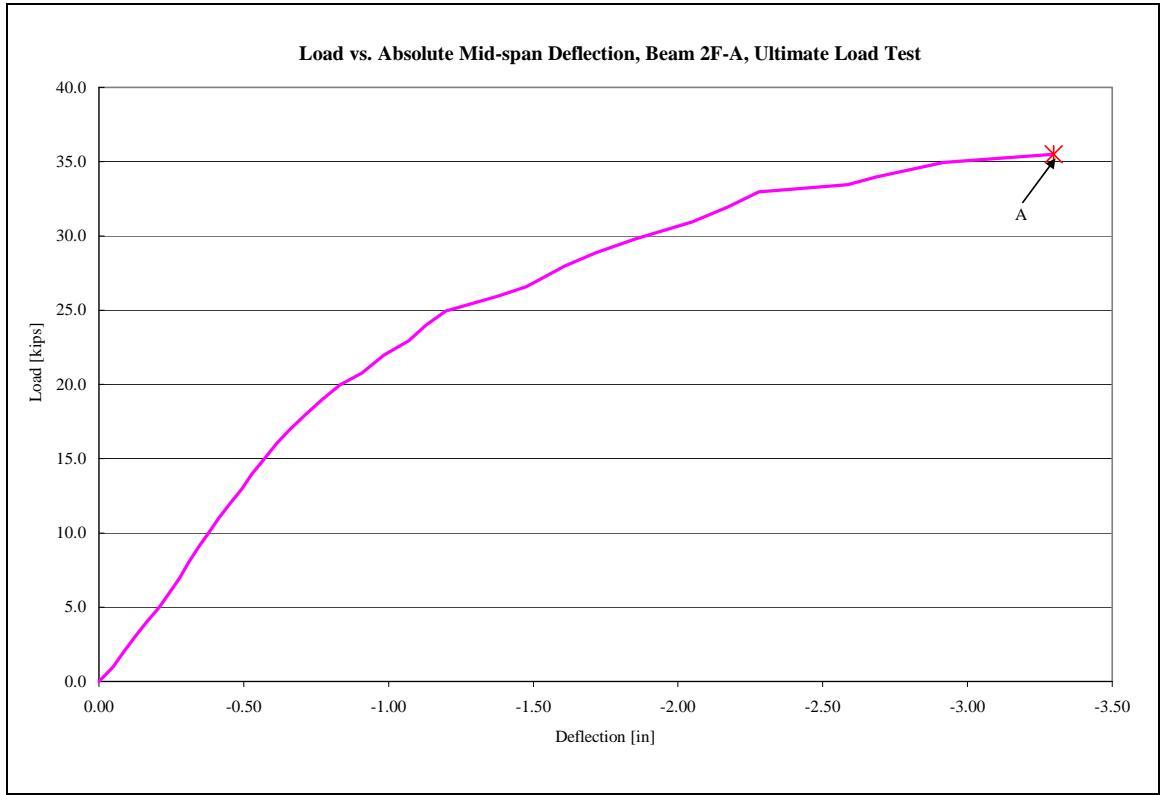
Figure 5.33 Load-deflection curve from ultimate load test of stringer 2F-A.

The load-deflection curve of stringer 2F-A is given in Figure 5.33. It shows several successive noncatastrophic shear failures during loading, first along the neutral axis cut and later, at a load of approximately 34 kips (151 kN), it also shows shear failures with corresponding interlayer slip at the quarter-depth cut, along with a non-linear load-deflection behavior as shown in Figure 5.33. This specimen finally fails catastrophically in flexure at a load of 35.5 kips (158 kN) (at "A" in Figure 5.33).

It is thus noted that despite intermediate shear failure(s) along the inflicted horizontal cuts, as observed in four of the five stringers, the governing (catastrophic) failure mode is a flexural failure in the tension face.
