Z-SPIKE REJUVENATION TO SALVAGE TIMBER RAILROAD BRIDGE MEMBERS

Nathan J. Miller
Richard M. Gutkowski, Ph.D., PE
Jeno Balogh, Ph.D.
Dept. of Civil and Environmental Engineering
Colorado State University
Ft. Collins, Colorado

December 2008

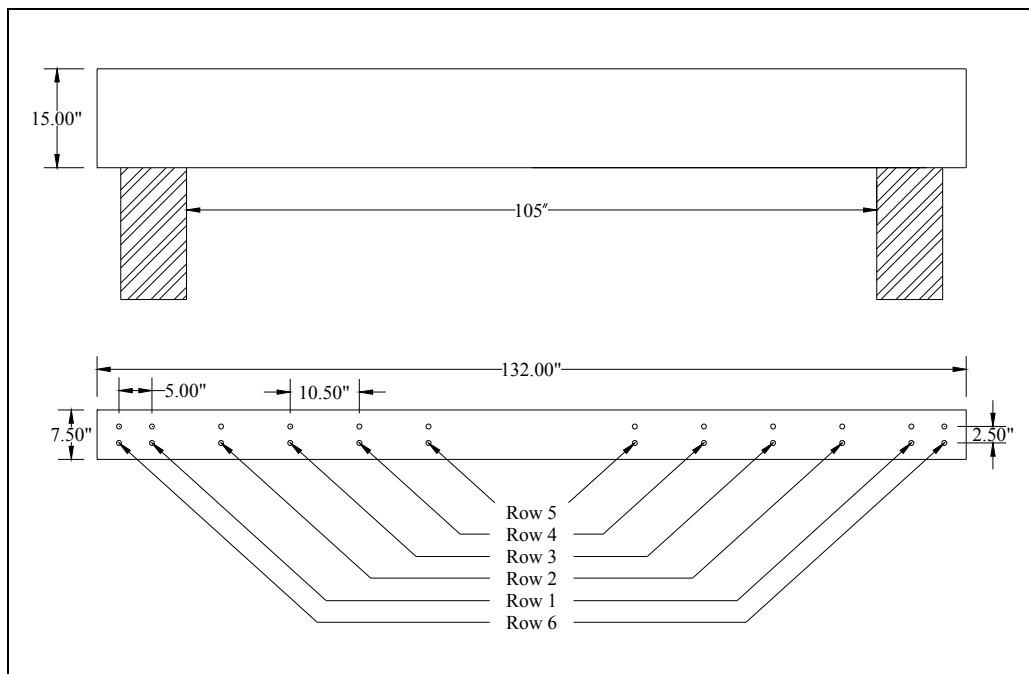
Figure 5.1 Specimen 1 spiking layout

Specimen 1 was a single 11-ft. long member with a 7- by 15-inch cross section which was slightly damaged. The most evident damage to the specimen was a horizontal crack running nearly the entire length of the specimen at about mid-depth which was visible on one side of the specimen. There was no severe damage to the stringer so it was believed that spiking would have a small impact on the EI of the stringer. For this stringer, the polyester resin was used to observe its effectiveness as an adhesive.

The testing of this specimen consisted of a series of load tests to the 15-kip load level followed by a single test to failure. The individual load tests were performed after each row of spikes was installed. The layout of the spikes is shown in Figure 5.1. The first five rows of spikes were installed using a 10.5 inch spacing to remain consistent with previous research. However, once those rows had been installed, the specimen still displayed an increasing EI, but there was no additional space to add spikes closer to midspan by the prescribed method. Because of this, the sixth row was added to the end of the specimen, 5 inches outside of the first row that was inserted. This is consistent with past research (Radford et al.) which showed such exterior spikes are effective.

The spiking procedure for this specimen involved first drilling the holes for the spikes. The holes were first predrilled to a diameter of $\frac{1}{2}$ in. Then the holes were drilled to the diameter of the spike, $\frac{3}{4}$ in. Two fl. oz. of the polyester resin were then poured into the hole, and the spike was inserted. The hole for the spike had no clearance, so a dead blow hammer (sand-filled plastic hammer) was used to drive the spike into place. In some cases, the dead blow hammer could not apply sufficient force so it was necessary to use a conventional hammer to install the spike. In general, a conventional hammer should not be used because it has a tendency to damage the end of the spike.

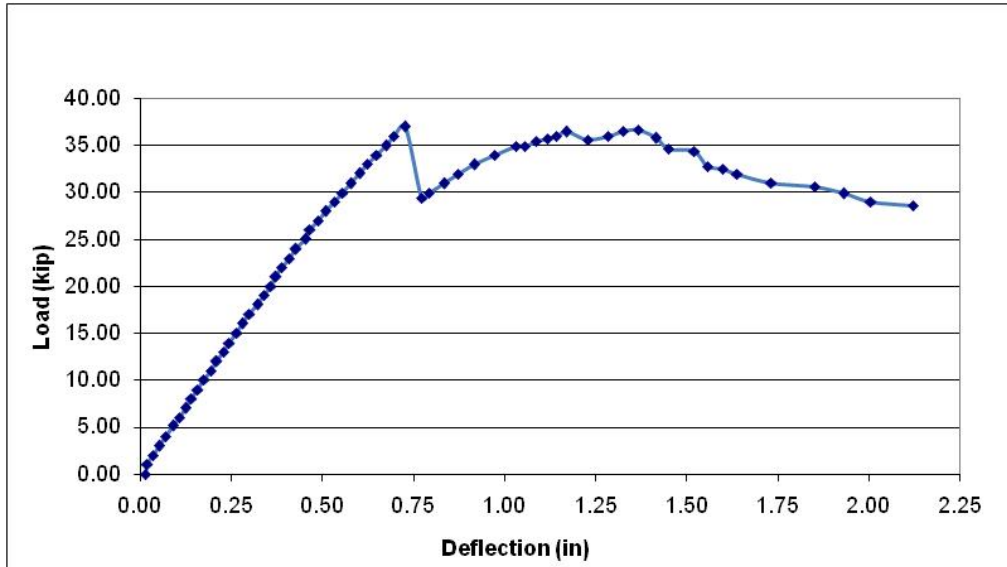
Figure 5.3 Load versus deflection plotted to failure – Specimen 1

As the specimen was loaded, it behaved as it had in the prior load tests up to a load of 23 kips. At this point, minor cracking and popping noises started to be heard and continued as the specimen loading progressed. The specimen maintained its linear behavior up to a maximum load of 37 kips. At this point, there was a very loud crack in the specimen. It is believed that this noise corresponded to the propagation of pre-existing horizontal cracks. This resulted in a noticeable decrease in the load resistance of the specimen, and the measured load dropped to 29 kips. From that point, the load slowly increased as more cracks were heard. After returning to a load of 36.65 kips, the load-deflection plot began to drop and continued to do so as more cracks were heard and the resistance decreased steadily. No dramatic failure occurred as this pseudo-ductile response took place.

A few characteristics of the test to failure are noteworthy. Under the high loads, the specimen experienced crushing both at the end supports as well as where the load was applied. At the west end support, the crushing was not consistent across the width of the specimen. This created an uneven surface as can be seen in Figure 5.4. As more load was applied, the uneven surface generated a torque in the specimen, and it began to slightly tilt and twist sideways. This caused a concern that the member might topple and that damage may be done to the actuator as the cylinder was being pushed to one side. Thus, the loading was stopped. However, the initial primary failure of the specimen had already been reached. Overall, this specimen displayed a pseudo-ductile mode of failure which is believed to have been due in part to the spikes installed in the specimen.

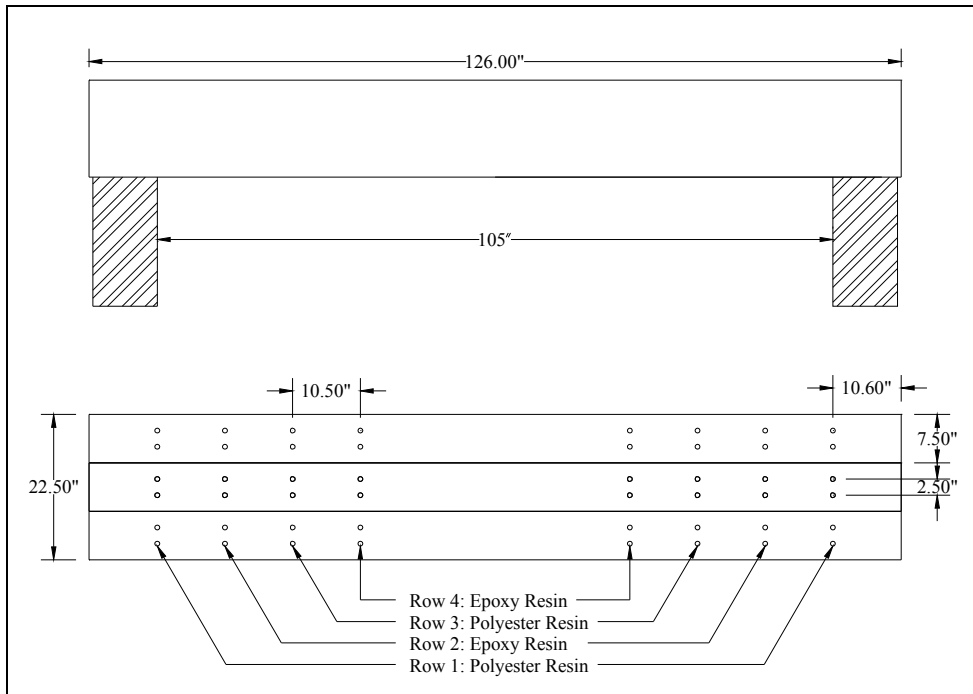
Figure 5.6 Spike layout for Specimen 2

the hole that had been drilled for the spike, and then the spike was inserted. This may have reduced the chances of having adhesive between the specimen and the entire length of the spike. The third change made in the spiking procedure was to use both the polyester resin, as used in Specimen 1, and an epoxy resin in an alternating pattern for each row of spikes added. This approach was taken to allow direct comparison of the performance of the two adhesives. The first row of spikes was installed at the edge of the end supports using the polyester resin. Rows of spikes were then incrementally placed across the width of the specimen spaced at 10.5 inches with epoxy used for the second and fourth rows and polyester resin used for the third row.

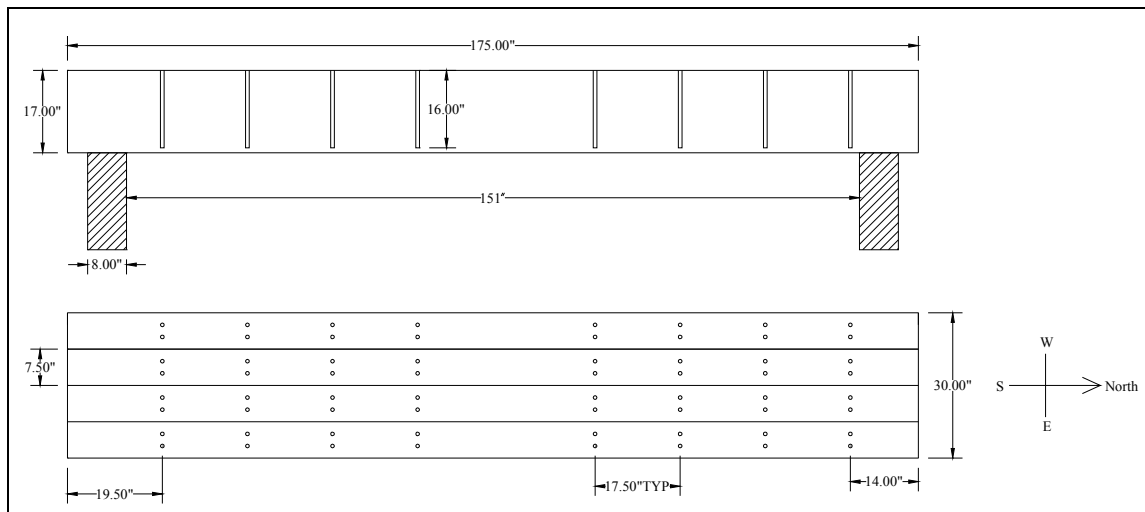
Figure 5.17 Specimen 3 spike layout

The spike placement in the chord was slightly revised from the previous chords. The spacing used can be seen in the spiking layout shown in Figure 5.17. In this case, the original crosstie placement was visible on top of the specimen. The spike placement was changed so there was one row of spikes between each crosstie. This was done to be consistent with how the spiking process would likely be used in the field. This resulted in a spike spacing of 17.5 inches for the final specimen. Also, because the spacing of the spikes was determined by the crosstie spacing, the spikes are not placed symmetrically relative to midspan. There are 19.5 inches between the end support and the first spike on the south end and 14 inches on the north end.

This chord was again spiked incrementally. The first increment was on the south end of the east side exterior stringer where some of the most significant damage was located. The next two increments finished repairing the east stringer of the chord. Next, the ends of the west side exterior stringer were repaired followed by the interior of the west ply. The same procedure was used for the repairing the middle-west and middle-east plies of the chord in that order. This resulted in nine increments in the spiking. Figure 5.17 shows the test set up for this specimen as well as the layout of the spikes as they were installed.

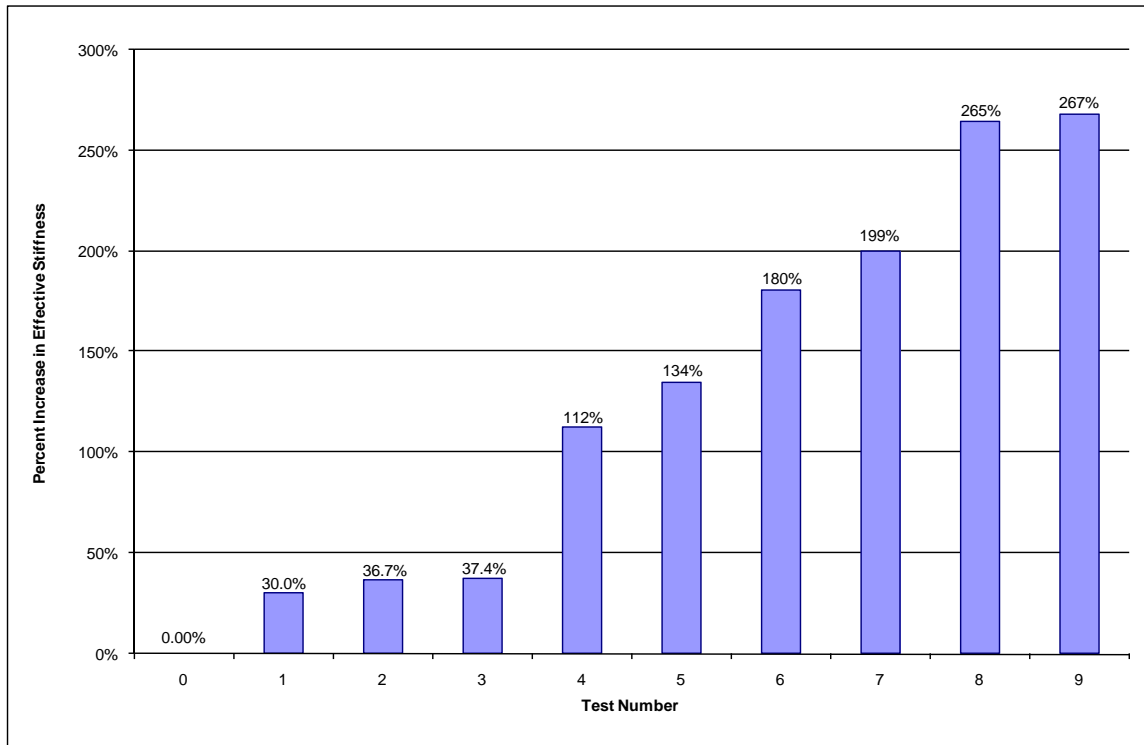
Figure 5.18 Percent increase in EI for Specimen 3

Figure 5.18 also shows the increases in EI that were seen with each increment of spiking. Each of the nine spike increments resulted in an increase in the magnitude of EI. The last increment of spikes resulted in a minimal increase in the EI so it was decided that there was little reason to add any more spikes. Also, all of the expected places to install spikes had been used which is likely what the railroad would do in actual use of the spiking procedure. The results of the spiking of Specimen 3 were very positive. This was the most damaged specimen, and it clearly had the most to gain from the spiking procedure. The total percent increase in EI for this specimen was 267%. This is far larger than the increases seen in either Specimen 1 or 2. This is a direct result of the amount of damage originally present in each of the specimens.

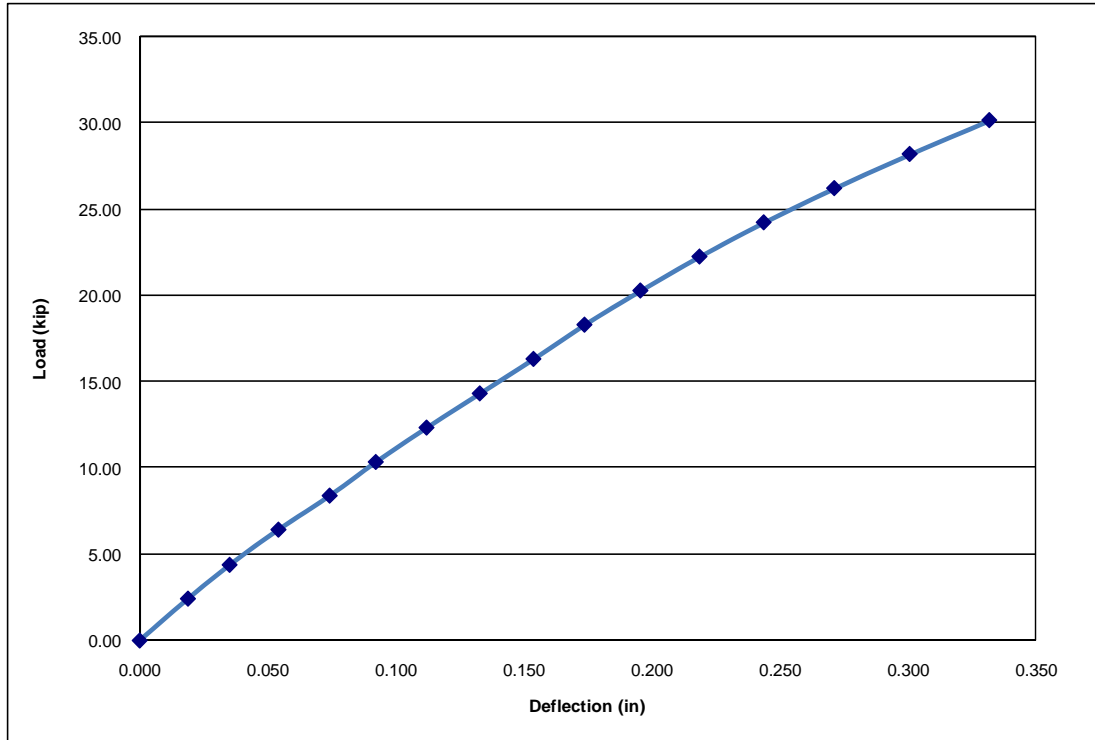
Figure 5.19 Specimen 3 loaded to 30 kips

First, the specimen was loaded to 30 kips. The chord performed without incident up to a load of about 24 kips when some minor cracking could be heard. Above this point, there was a small loss of stiffness as the specimen began to deflect more. It is unknown what the cause of the cracking sounds was. Specimen 3 had significant damage which included some large voids in the wood. The cracking sounds may have had to do with these large voids and the epoxy in them as the chords settled under loads which were higher than in any previous test. As the chord continued to be loaded, there was a loud crack at a load of 30 kips. Because of the loud crack, the specimen was unloaded, and the chord was inspected for signs of damage to the wood and spikes. There were no visible results from the cracking, so testing was resumed.

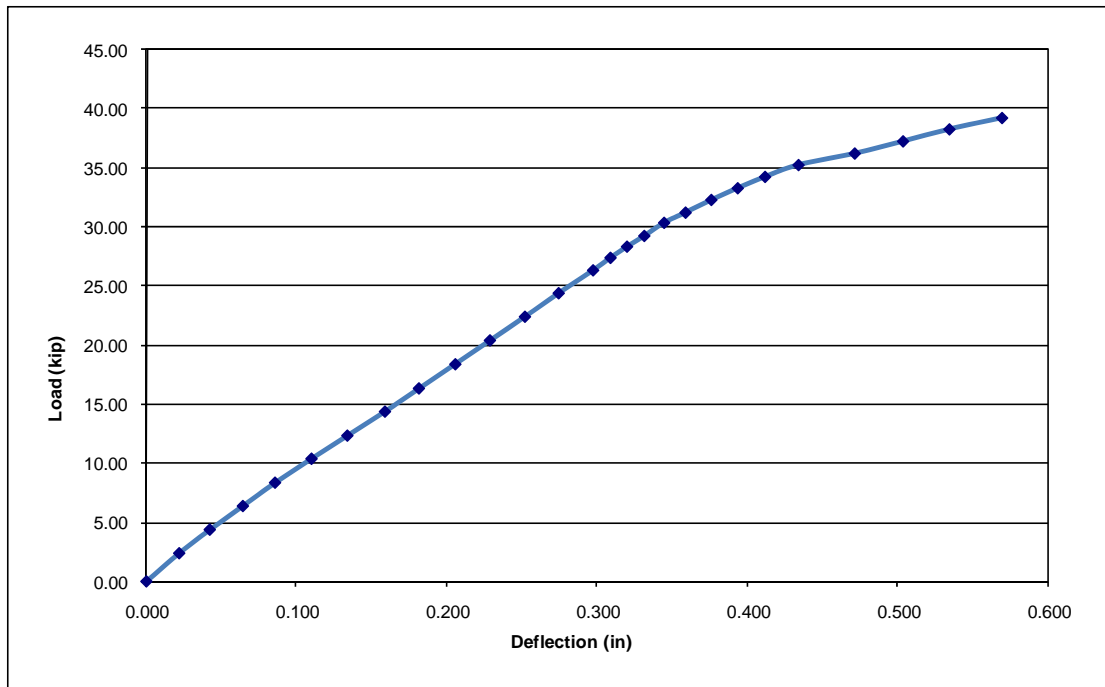
Figure 5.20 Specimen 3 loaded to 39 kips

The next loading was to a load of 39 kips. This was done to exceed the required chord capacity specified by the railroad. In this test, the specimen displayed a linear load vs. displacement behavior up to a load of 30 kips (the previous highest load). The slope of this line was slightly less than the slope from the previous test. This is likely the result of the small stiffness loss which occurred with the cracking in the specimen. Above 30 kips, there was a slight loss of stiffness followed by a significant loss of stiffness above 35 kips as more minor cracking could be heard. However, Figure 5.20 indicates the load level had not leveled off suggesting spiking may have again been contributing some pseudo-ductile characteristic as had been seen in the failure test of Specimen 1. Note that the previous Specimen 2 was not loaded to high enough levels to observe this pseudo-ductility. It showed a linear relation between load and deflection up to a load level of 15 kips.

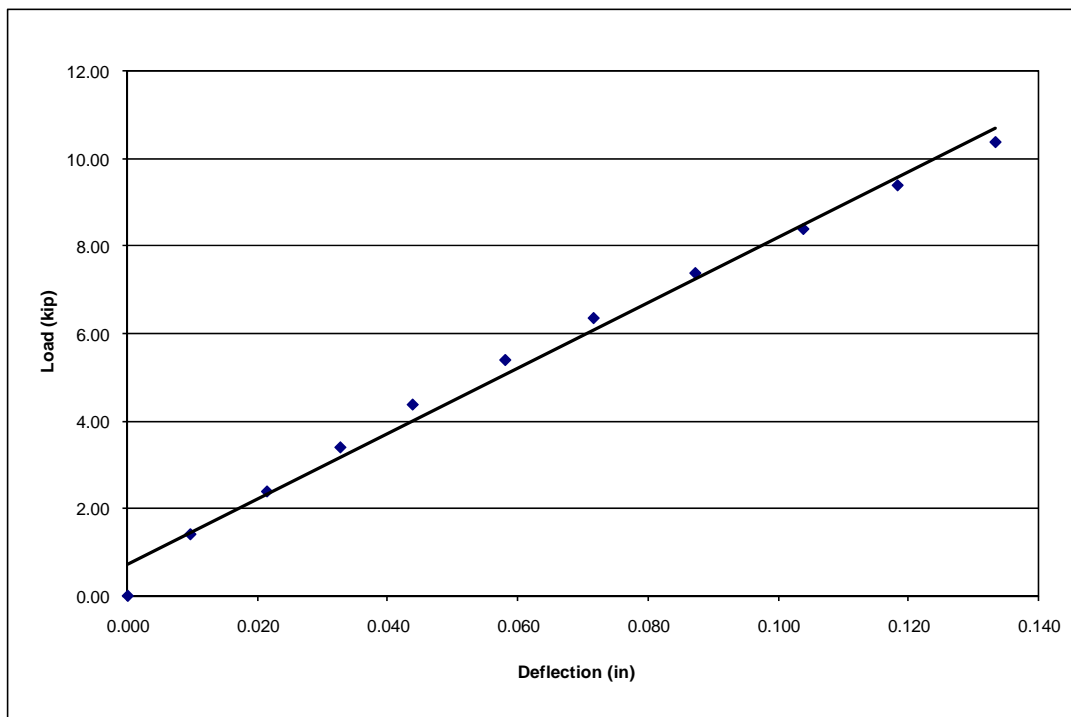
Figure 5.21 Specimen 3 loaded to 10 kips after high load tests

After the chord had been loaded to 39 kips, one more load test was done. This test was intended to determine the EI for the chord after the high load tests were completed. It was observed during the 39 kip and 30 kip load tests that under the high loads, there was some stiffness loss. An additional test to 10 kips was done to determine the EI for Specimen 3 after concluding the load tests to higher load levels. The results of the 10 kip load test are shown in Figure 5.21.

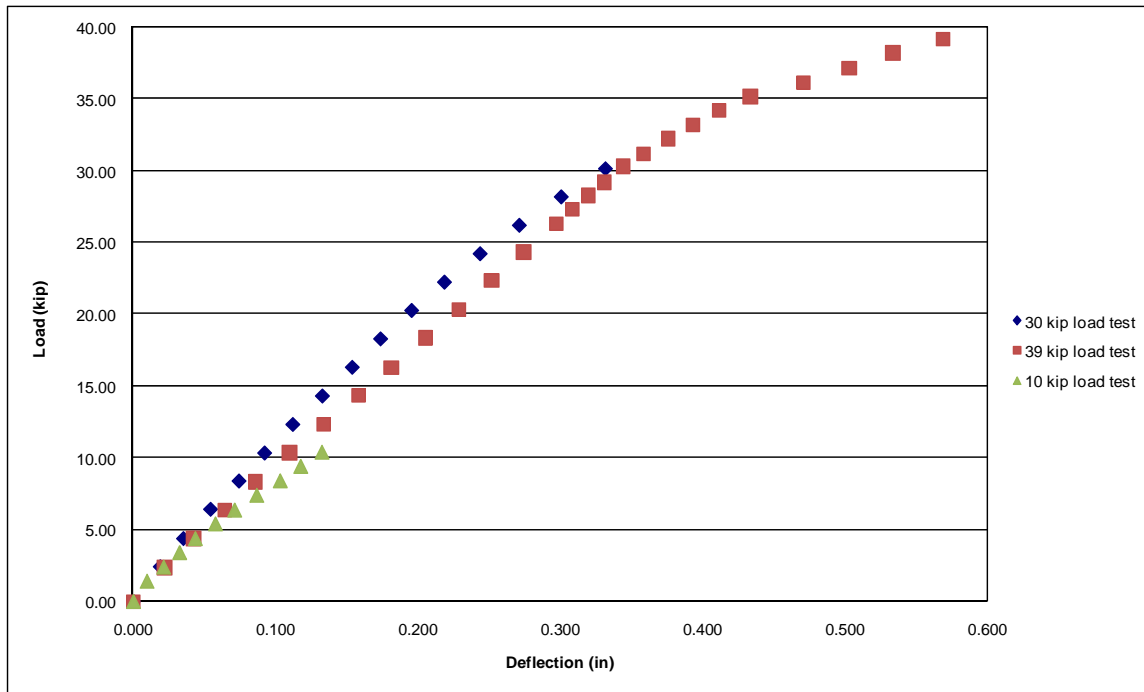
Figure 5.22 Specimen 3 load tests to 30 kips, 39 kips, and 10 kips plotted together

In order to compare the results of the three load tests and the changes in the effective stiffness as a result of those tests, Figure 5.22 has been included to show the plots of the load versus deflection data for each of the tests together. The small decreases in stiffness are evident from the decreasing slope of the data.

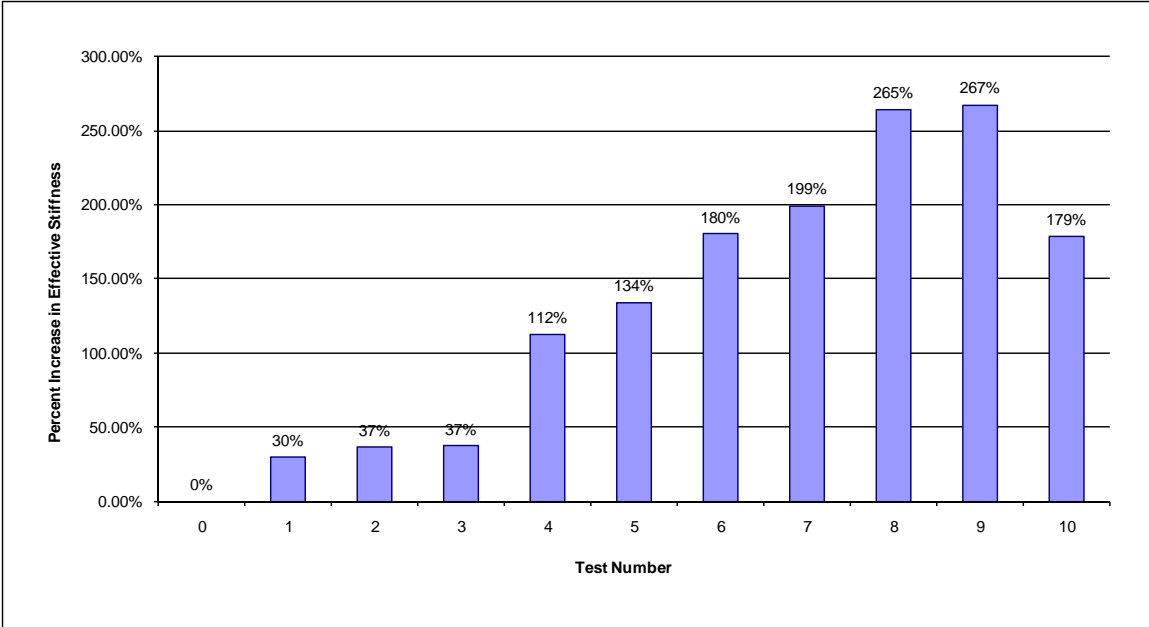
Figure 5.23 Percent increase in EI for Specimen 3 including test 10

It appears that the initial gains in EI from spiking may have been slightly optimistic. After loading, the EI was shown to be 37080 k-ft² which is down from 48860 k-ft² which was the maximum EI achieved after spiking. Even though there was a decrease from the maximum, the final EI was 179% greater than the initial EI. This is still a very significant increase. It is anticipated that additional load tests to 39 kips would demonstrate a linear relationship with an EI very similar to the EI from the 10 kip load test. Even with the loss in stiffness that was seen following the higher load tests, the spiking procedure was shown to be very effective in repairing the damaged specimens and regaining stiffness. Figure 5.23 shows the drop of in EI after the completion of the load tests. Test 10 in the figure is the load test to 10 kips after the 39 kip load test. As can be seen, there was a notable drop in EI after the final load test, but it is still a significant increase over the initial EI of the specimen. It is also unknown as to whether the original damaged member without spikes could have even resisted the 39 kip load. Instead, it had likely been removed because of concern it could not sustain such as load for a railroad bridge.
